Phase III Interim Action Summary Report –

Ditch Remediation – Phase II

Superlon Plastics Site Tacoma, Washington

April 15, 2025

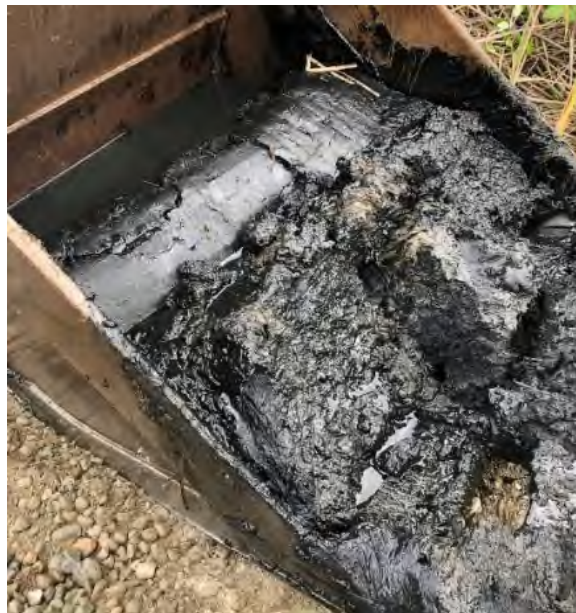
Although unexpected, soils containing petroleum (i.e., TPH) were encountered in RAU D23 through RAU D28. Following the remediation of these RAUs, the north and south sidewalls of the final excavations were sampled to determine if the soils adjacent to the Haug Log Yard retaining wall and Lincoln Ave still contained TPH concentrations greater than the remediation goals. TPH was not encountered in the biologically active zone. The results of this analysis are discussed in section 13.2, and the laboratory data reports are attached as Appendix 1.

Figure 7: TPH-Impacted Soil Found in Ditch Sediment

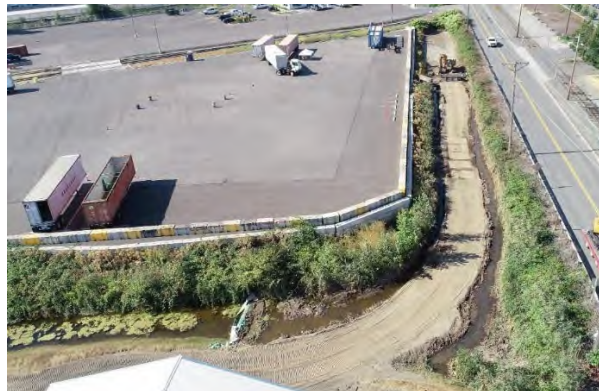
Clean imported two inch screened gravel borrow (approved by Ecology) was used to create the temporary access road over the sediment and ditch vegetation. The temporary access road was placed in the center of the ditch and was approximately 15 feet wide. The imported soil used to construct the road was excavated along with the underlying sediment/soil and disposed of at the LRI Landfill in Puyallup, WA.

Figure 8: Temporary Access Road Inside the Ditch

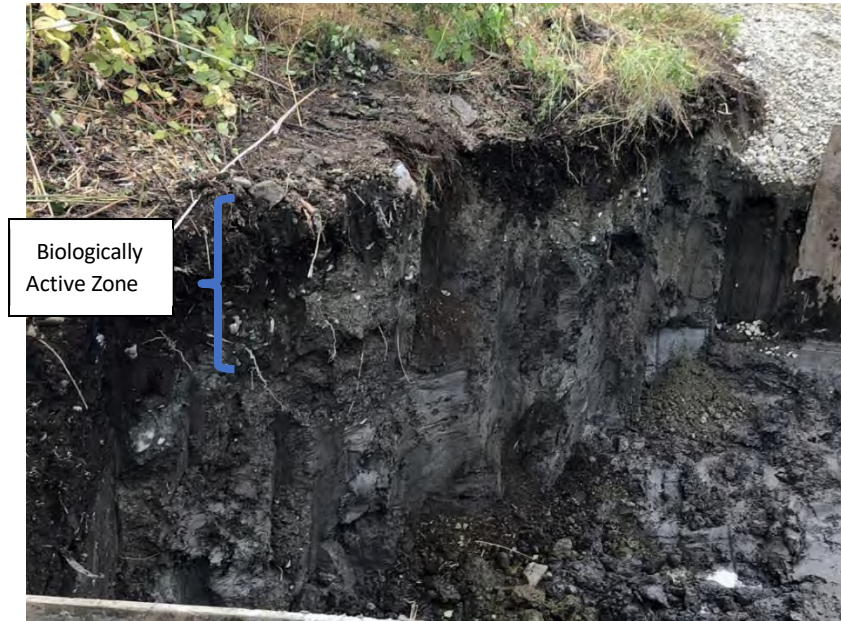
Throughout the remediation of ditch sediment, based upon the absence and presence of vegetation, the biologically active zone was observed to be up to two feet thick.³ The ditch sediment and underlying soil consisted of up 6-inches of fine sediment overlaying clay- rich silt with a high degree of marine grass (original tide flats) to approximately 2 feet. This was judged to be the biologically action zone (Figure 9). Under the top two feet was black clay- rich silt (original tide flats).

Figure 9: Cross Section of Sediments Showing Biologically Active Zone to Two Feet

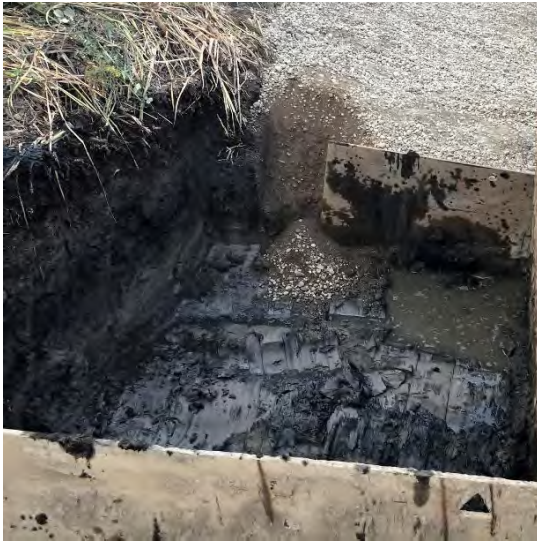
The southern excavation boundary was limited by the presence of the Haub Log Yard retaining wall. Excavation in the southward direction was stopped when the possibility of undermining the wall was present. The northern excavation boundary was limited by the presence of Lincoln Ave. Excavation in the northward direction was stopped when the possibility of undermining the road was present.

Figure 11: Southwestern Excavation Limit

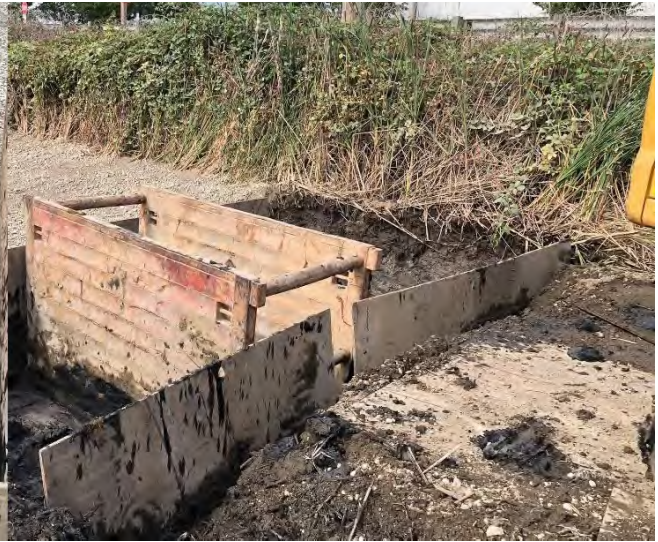
Figure 12: Northeastern Excavation Limit

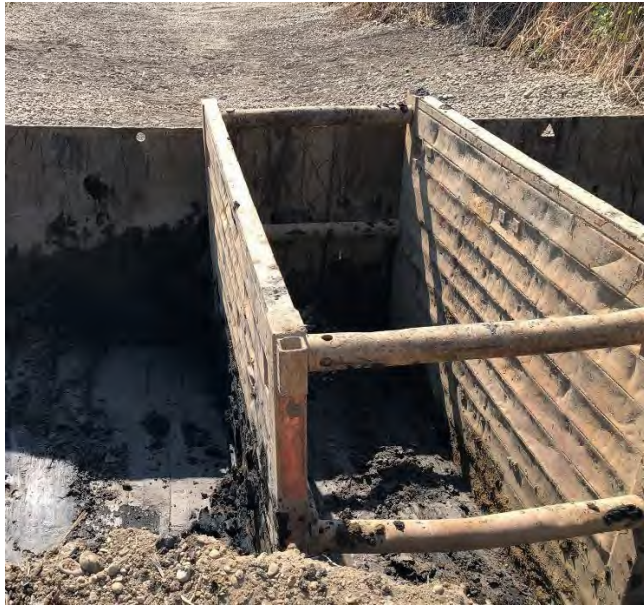
Figure 13: Use of a Trench Box and Steel Sheeting to Ensure that All Impacted Soils Are Removed and to Prevent Caving.

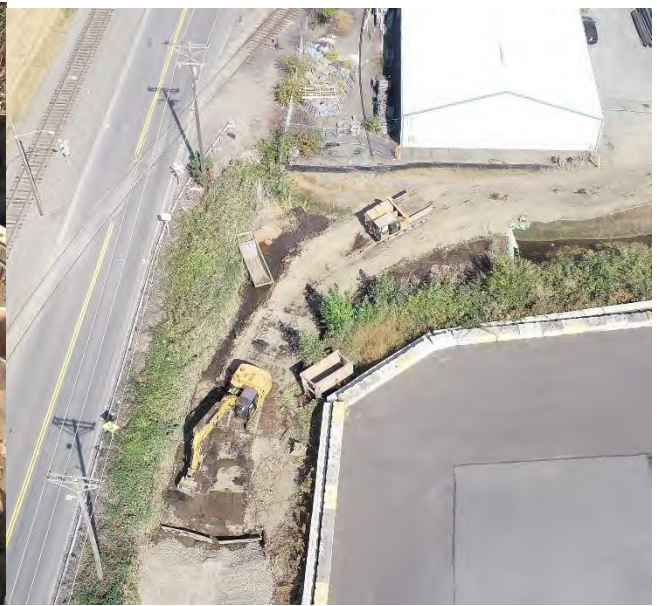
Figure 14: Excavation Process

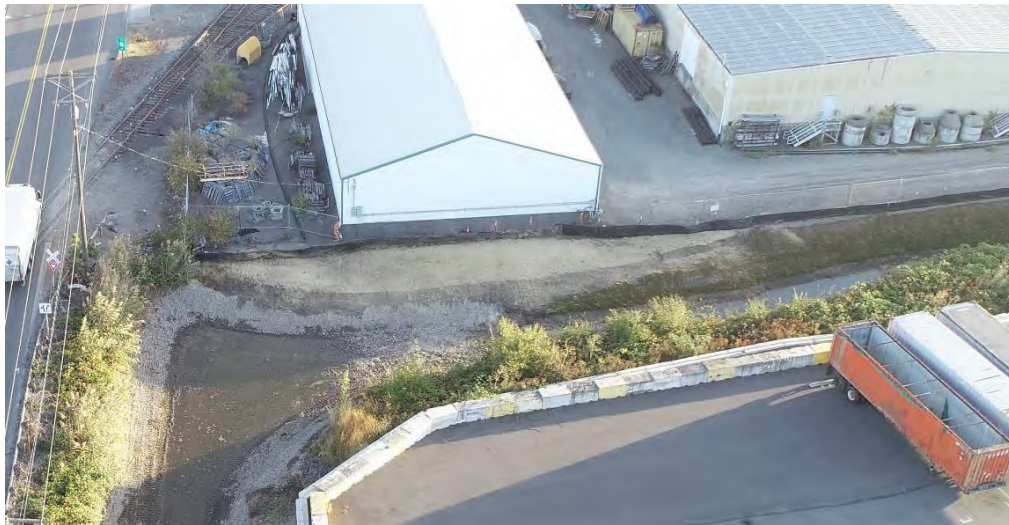
The application of the hydroseed was done by Bag Lady Incorporated (a commercial landscaper in Puyallup, Washington) on September 30, 2022. The hydroseed mix used was the Washington State Department of Transportation (WSDOT) seed mix without clover.

Figure 15: Aerial View 11 Days After Hydroseeding

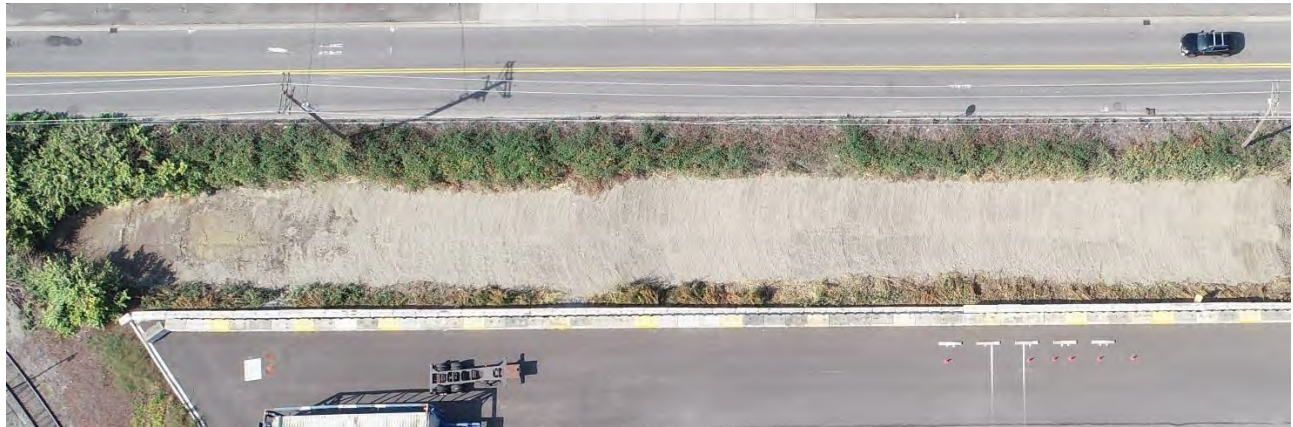
Restoration of the sediment excavation was done in three layers. The bottom of the excavation was replaced by 1 foot of imported pond grade clay in order to replace the clay-rich silt that was removed during the excavation. Following the addition of 1 foot of clay, 1-2.5 feet (depending on the depth of the overall excavation) of imported 2" screened gravel borrow was placed in the excavation. All sediment removed in the top two feet was replaced by a Streambed Sediment mix obtained from Corliss Resources (specifications included in Appendix 2).

10.4. Figure 16: Completed Ditch Bed Restoration

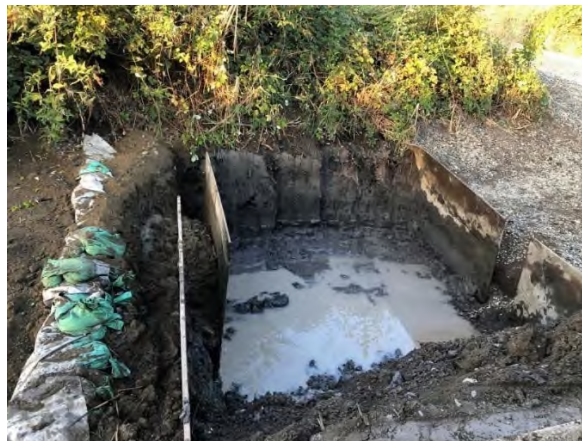
TABLE 4: Analytical Data - Bottom Samples RAU D12					
RAU	EU	DEPTH (ft bgs)	DATE SAMPLED	Arsenic (mg/kg)	Lead (mg/kg)
RAU D12	A1	5-5.5	9/27/2022	15	17
RAU D12	B1	5-5.5	9/27/2022	8	ND
RAU D12	C1	5-5.5	9/27/2022	ND	12
RAU D12	D1	5-5.5	9/27/2022	ND	15
RAU D12	E1	5-5.5	9/27/2022	ND	12
Average Concentration				5	12

Figure 17: Bottom of RAU D12

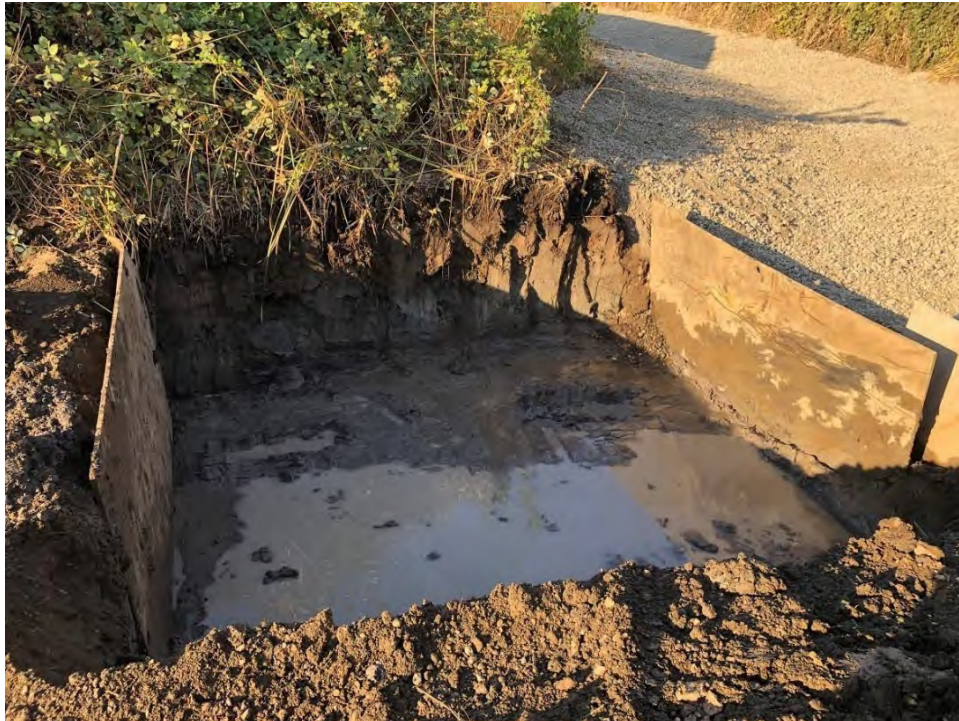
TABLE 5: Analytical Data - Bottom Samples RAU D13					
RAU	EU	DEPTH (ft bgs)	DATE SAMPLED	Arsenic (mg/kg)	Lead (mg/kg)
RAU D13	A1	5-5.5	9/26/2022	7	12
RAU D13	B1	5-5.5	9/26/2022	ND	16
RAU D13	C1	5-5.5	9/26/2022	7	19
RAU D13	D1	5-5.5	9/26/2022	ND	ND
RAU D13	E1	5-5.5	9/26/2022	ND	16
Average Concentration				3	13

Figure 18: Bottom of RAU D13

NOTE: Three-foot thickness of clay-rich silt bottom

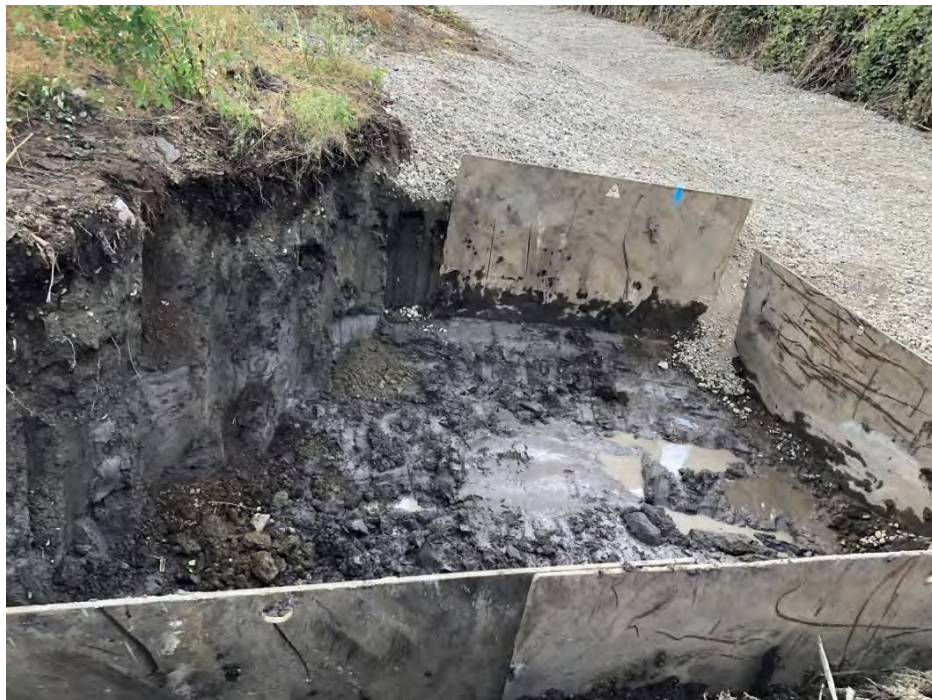
TABLE 6: Analytical Data - Bottom Samples RAU D14					
RAU	EU	DEPTH (ft bgs)	DATE SAMPLED	Arsenic (mg/kg)	Lead (mg/kg)
RAU D14	A1	5-5.5	9/22/2022	ND	14
RAU D14	B1	5-5.5	9/22/2022	7	20
RAU D14	C1	5-5.5	9/22/2022	ND	15
RAU D14	D1	5-5.5	9/23/2022	8	15
RAU D14	E1	5-5.5	9/23/2022	ND	12
Average Concentration				3	16

Figure 19: Bottom and Southwestern Sidewall of RAU D14

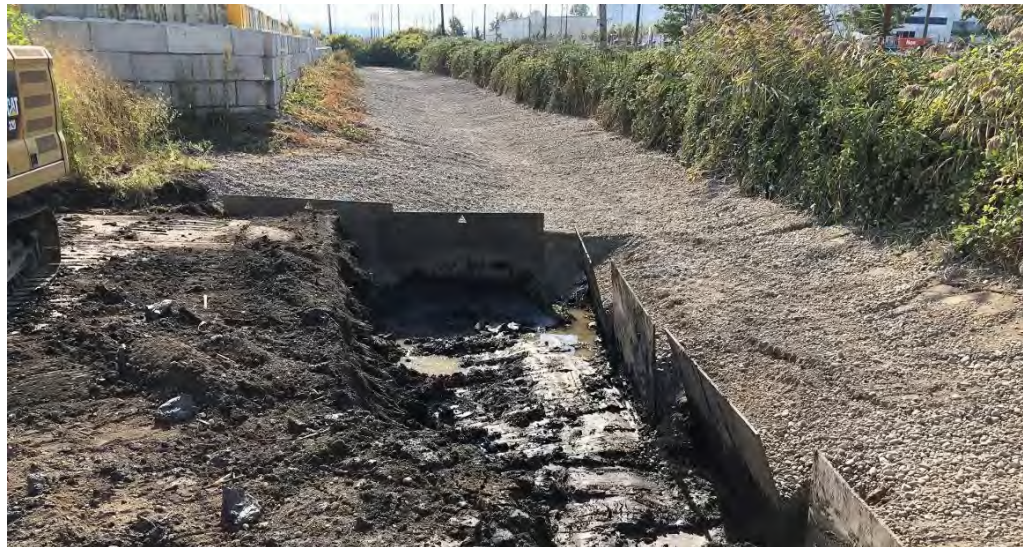
TABLE 7: Analytical Data - Bottom Samples RAU D15					
RAU	EU	DEPTH (ft bgs)	DATE SAMPLED	Arsenic (mg/kg)	Lead (mg/kg)
RAU D15	A1	5.5-6	9/21/2022	12	13
RAU D15	B1	5.5-6	9/22/2022	ND	12
RAU D15	C1	5.5-6	9/22/2022	ND	10
RAU D15	D1	5.5-6	9/22/2022	8	18
RAU D15	E1	5.5-6	9/22/2022	ND	22
Average Concentration				4	15

Figure 20: Bottom of RAU D15

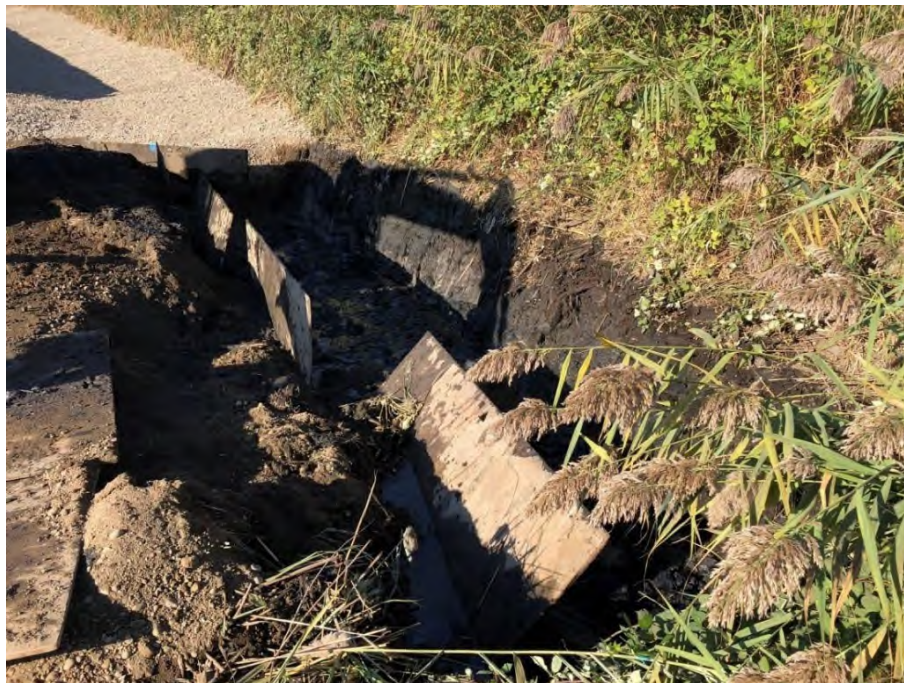
TABLE 8: Analytical Data - Bottom Samples RAU D16					
RAU	EU	DEPTH (ft bgs)	DATE SAMPLED	Arsenic (mg/kg)	Lead (mg/kg)
RAU D16	A1	5.5-6	9/21/2022	7	18
RAU D16	B1	5.5-6	9/21/2022	14	16
RAU D16	C1	5.5-6	9/21/2022	17	88
RAU D16	D1	5-5.5	9/21/2022	36	21
RAU D16	E1	4.5-5	9/21/2022	282	547
Average Concentration				72	138

Figure 21: Bottom and Northeastern Sidewall of RAU D16

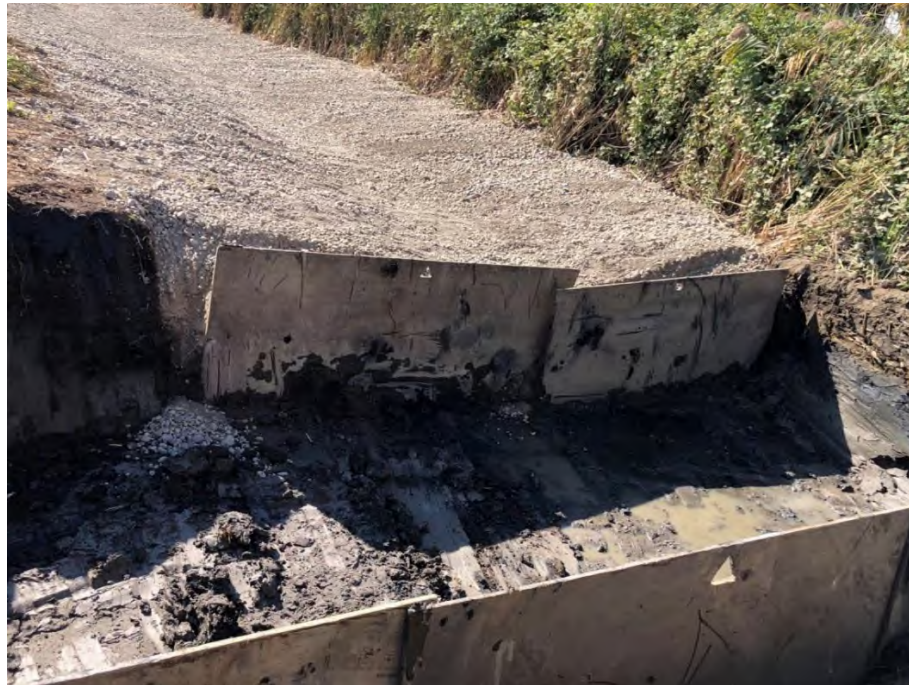
TABLE 9: Analytical Data - Bottom Samples RAU D17					
RAU	EU	DEPTH (ft bgs)	DATE SAMPLED	Arsenic (mg/kg)	Lead (mg/kg)
RAU D17	A1	5.5-6	9/20/2022	ND	20
RAU D17	B1	5.5-6	9/20/2022	ND	20
RAU D17	C1	5.5-6	9/20/2022	19	25
RAU D17	D1	5.5-6	9/21/2022	ND	ND
RAU D17	E1	5.5-6	9/21/2022	ND	20
Average Concentration				4	17

Figure 22: Bottom RAU D17

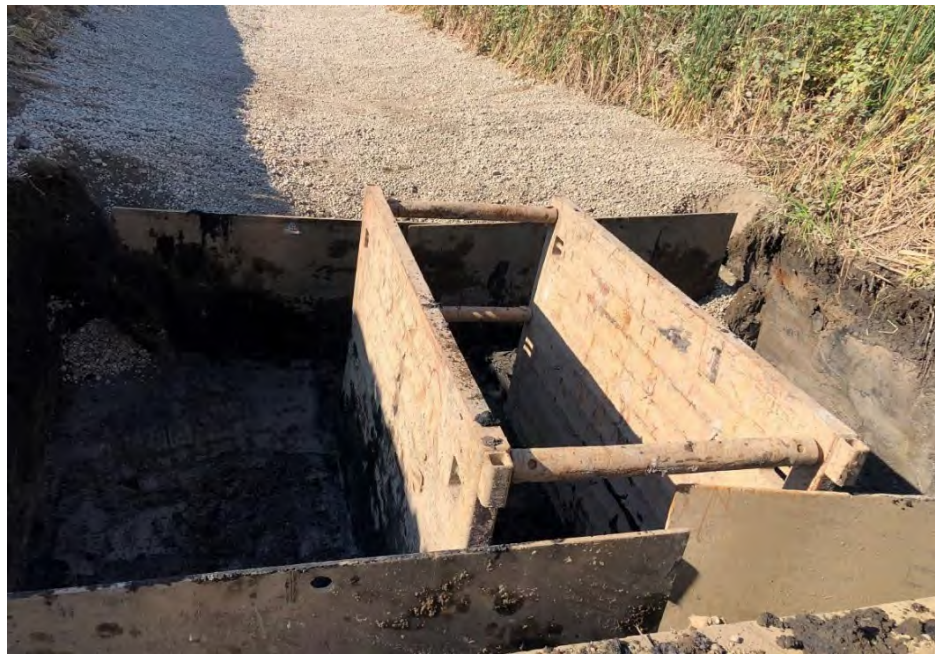
TABLE 10: Analytical Data - Bottom Samples RAU D18					
RAU	EU	DEPTH (ft bgs)	DATE SAMPLED	Arsenic (mg/kg)	Lead (mg/kg)
RAU D18	A1	5.5-6	9/19/2022	ND	17
RAU D18	B1	5.5-6	9/19/2022	14	16
RAU D18	C1	5.5-6	9/19/2022	9	ND
RAU D18	A2	5.5-6	9/20/2022	ND	10
RAU D18	B2	5.5-6	9/20/2022	15	16
RAU D18	C2	5.5-6	9/20/2022	ND	18
Average Concentration				7	13

Figure 23: Bottom of RAU D18

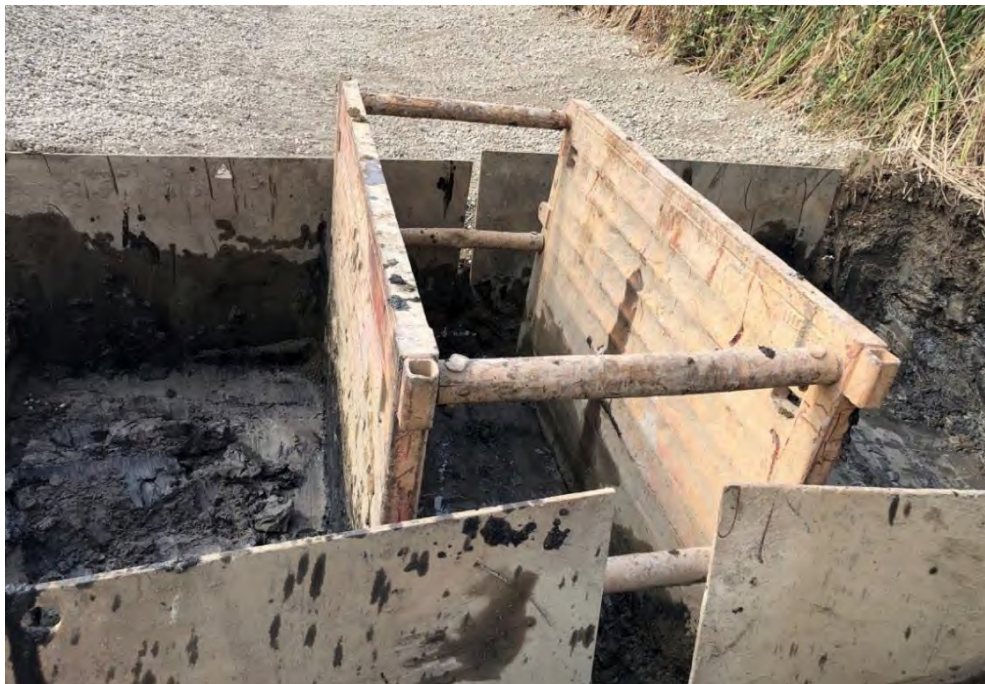
TABLE 11: Analytical Data - Bottom Samples RAU D19					
RAU	EU	DEPTH (ft bgs)	DATE SAMPLED	Arsenic (mg/kg)	Lead (mg/kg)
RAU D19	A1	5.5-6	9/15/2022	ND	20
RAU D19	B1	5.5-6	9/15/2022	8	16
RAU D19	C1	5.5-6	9/15/2022	ND	17
RAU D19	A2	5.5-6	9/15/2022	ND	12
RAU D19	B2	5.5-6	9/15/2022	ND	12
RAU D19	C2	5.5-6	9/15/2022	ND	ND
Average Concentration				2	13

Figure 24: Bottom of RAU D19

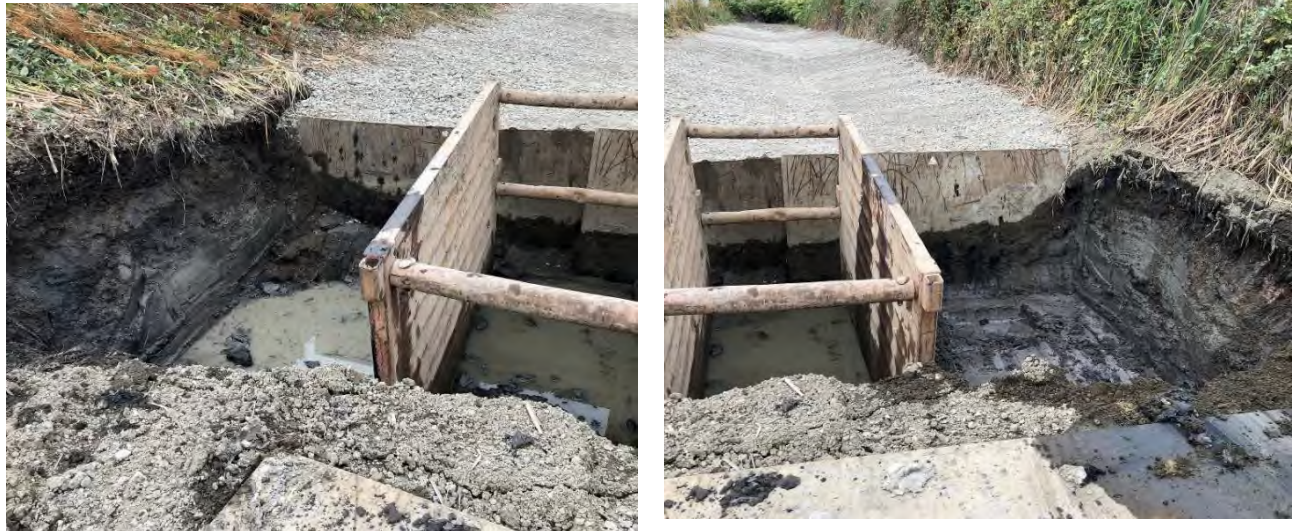
TABLE 12: Analytical Data - Bottom Samples RAU D20					
RAU	EU	DEPTH (ft bgs)	DATE SAMPLED	Arsenic (mg/kg)	Lead (mg/kg)
RAU D20	A1	5.5-6	9/12/2022	ND	15
RAU D20	B1	5.5-6	9/12/2022	ND	20
RAU D20	C1	5.5-6	9/12/2022	7	ND
RAU D20	A2	5.5-6	9/14/2022	ND	12
RAU D20	B2	5.5-6	9/14/2022	14	ND
RAU D20	C2	5.5-6	9/14/2022	ND	21
Average Concentration				4	12

Figure 25: Bottom of RAU D20

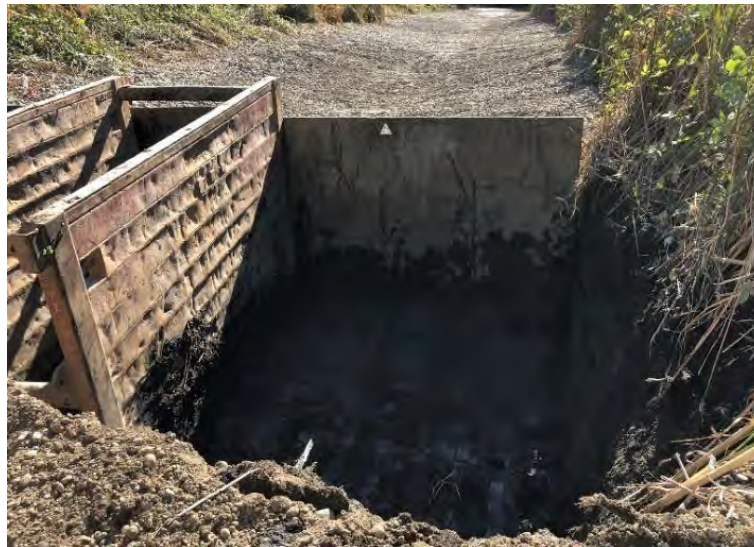
TABLE 13: Analytical Data - Bottom Samples RAU D21					
RAU	EU	DEPTH (ft bgs)	DATE SAMPLED	Arsenic (mg/kg)	Lead (mg/kg)
RAU D21	A1	5.5-6	9/8/2022	7	15
RAU D21	B1	5.5-6	9/8/2022	7	17
RAU D21	C1	5.5-6	9/8/2022	ND	ND
RAU D21	A2	5.5-6	9/9/2022	ND	23
RAU D21	B2	5.5-6	9/9/2022	8	15
RAU D21	C2	5.5-6	9/9/2022	ND	16
Average Concentration				4	15

Figure 26: Bottom of RAU D21

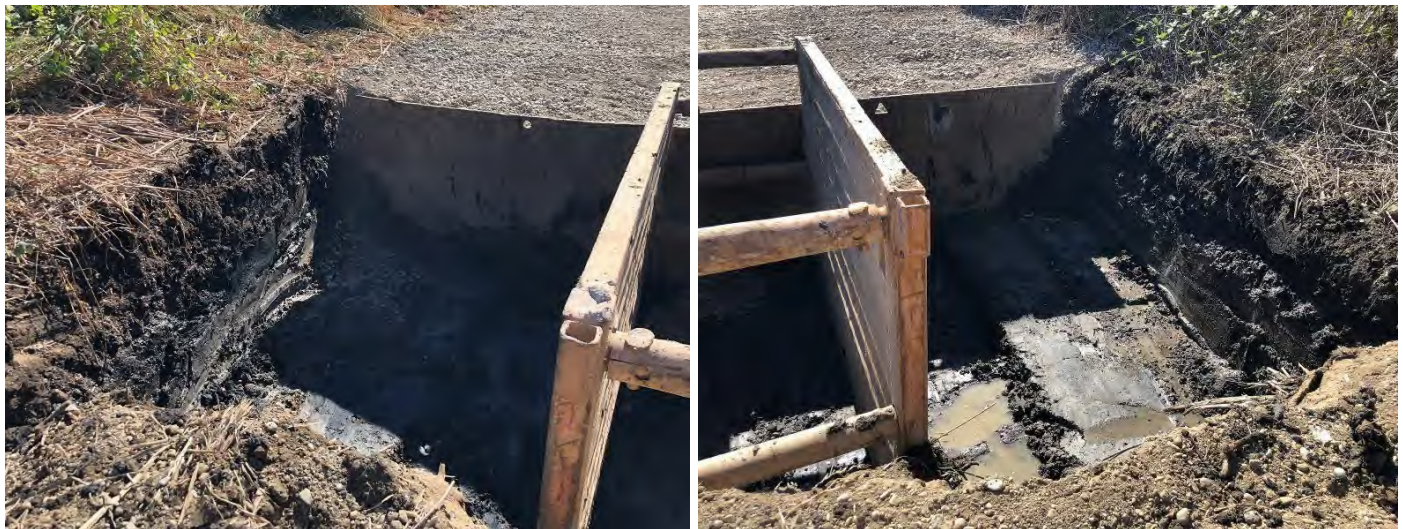
TABLE 14: Analytical Data - Bottom Samples RAU D22					
RAU	EU	DEPTH (ft bgs)	DATE SAMPLE D	Arsenic (mg/kg)	Lead (mg/kg)
RAU D22	A1	5-5.5	9/7/2022	ND	19
RAU D22	B1	5-5.5	9/7/2022	9	12
RAU D22	C1	5-5.5	9/7/2022	ND	10
RAU D22	A2	5.5-6	9/7/2022	8	17
RAU D22	B2	5.5-6	9/7/2022	7	16
RAU D22	C2	5.5-6	9/7/2022	ND	15
Average Concentration				4	15

Figure 27: Bottom and Sidewalls of RAU D22

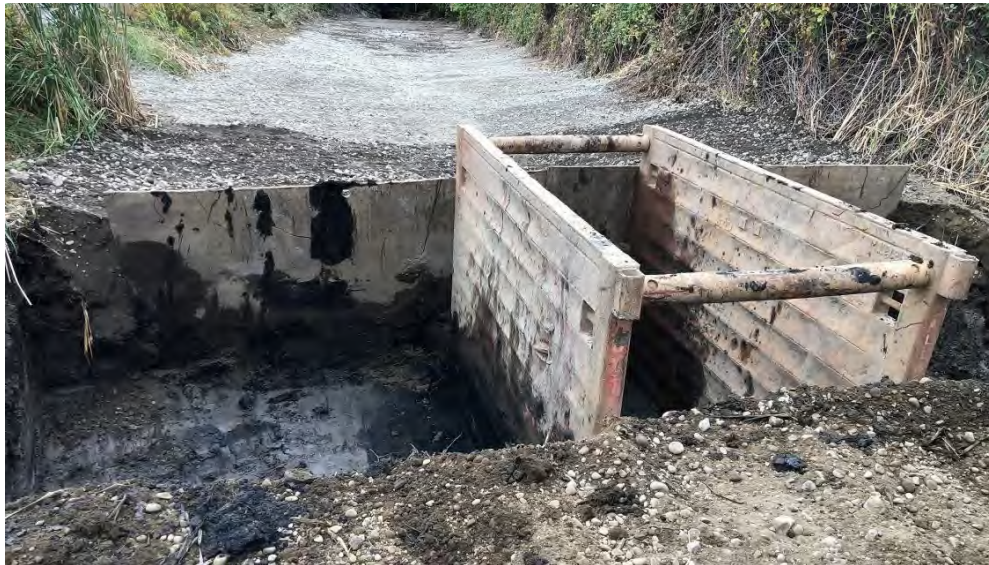
TABLE 15: Analytical Data - Bottom Samples RAU D23					
RAU	EU	DEPTH (ft bgs)	DATE SAMPLED	Arsenic (mg/kg)	Lead (mg/kg)
RAU D23	A1	5-5.5	9/1/2022	7	12
RAU D23	B1	5.5-6	9/1/2022	8	14
RAU D23	C1	5-5.5	9/1/2022	ND	14
RAU D23	A2	5-5.5	9/1/2022	ND	ND
RAU D23	B2	5-5.5	9/1/2022	14	ND
RAU D23	C2	5-5.5	9/1/2022	ND	12
Average Concentration				5	9

Figure 28: Bottom of RAU D23

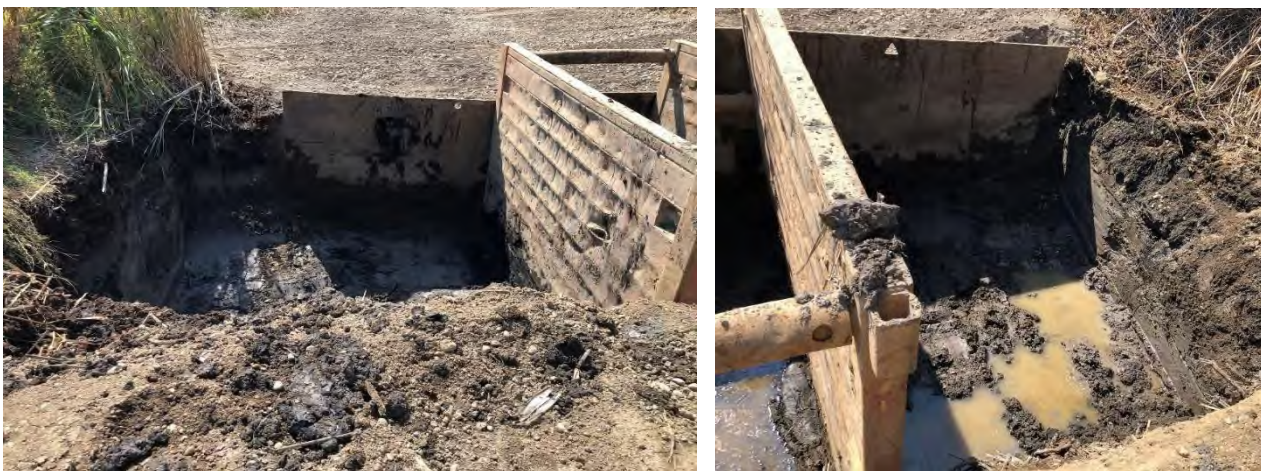
TABLE 16: Analytical Data - Bottom Samples RAU D24					
RAU	EU	DEPTH (ft bgs)	DATE SAMPLED	Arsenic (mg/kg)	Lead (mg/kg)
RAU D24	A1	5-5.5	8/30/2022	ND	13
RAU D24	B1	5-5.5	8/30/2022	19	18
RAU D24	C1	5-5.5	8/30/2022	ND	13
RAU D24	A2	5-5.5	8/31/2022	ND	17
RAU D24	B2	5-5.5	8/31/2022	ND	12
RAU D24	C2	5-5.5	8/31/2022	ND	10
RAU D24	A3	5-5.5	8/31/2022	ND	17
RAU D24	B3	5-5.5	8/31/2022	16	13
RAU D24	C3	5-5.5	8/31/2022	ND	18
Average Concentration				4	15

Figure 29: Bottom and Sidewalls of RAU D24

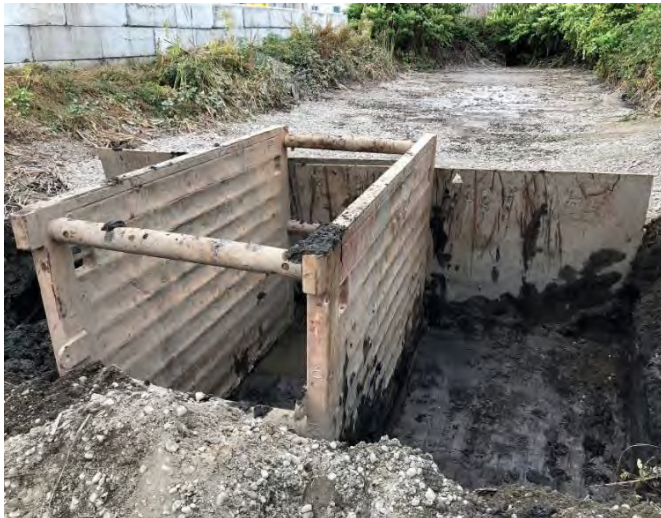
TABLE 17: Analytical Data - Bottom Samples RAU D25					
RAU	EU	DEPTH (ft bgs)	DATE SAMPLED	Arsenic (mg/kg)	Lead (mg/kg)
RAU D25	A1	5-5.5	8/26/2022	ND	10
RAU D25	B1	5-5.5	8/26/2022	19	12
RAU D25	C1	5-5.5	8/26/2022	ND	15
RAU D25	D1	5-5.5	8/26/2022	11	17
RAU D25	E1	5-5.5	8/26/2022	ND	16
RAU D25	A2	5-5.5	8/29/2022	ND	10
RAU D25	B2	5-5.5	8/29/2022	123	25
RAU D25	C2	5-5.5	8/29/2022	ND	19
Average Concentration				20	16

Figure 30: Bottom of RAU D25

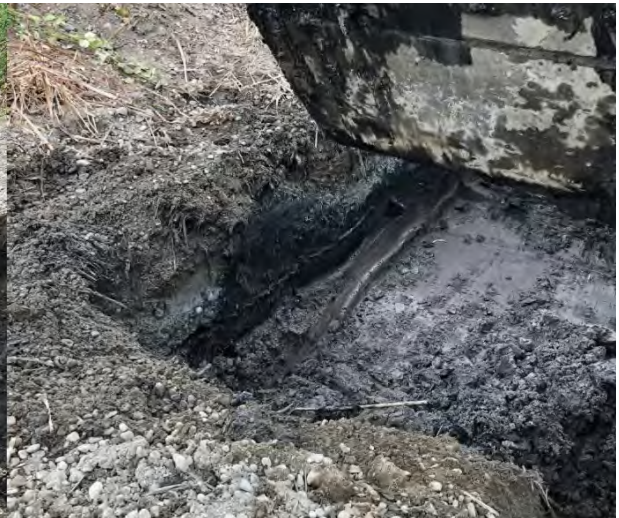
Figure 31: Southwestern Sidewall of RAU D25

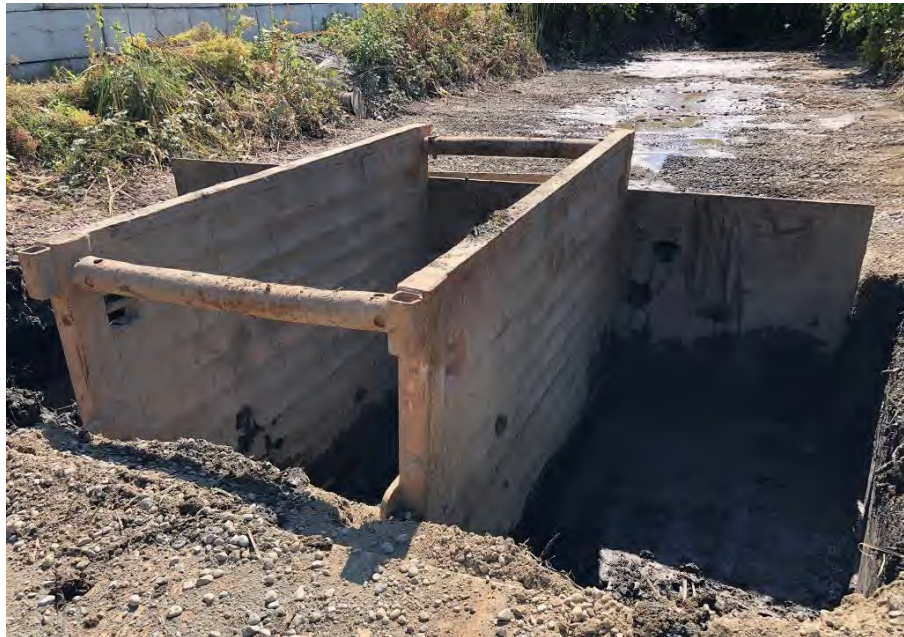
Figure 32: Bottom of RAU D26

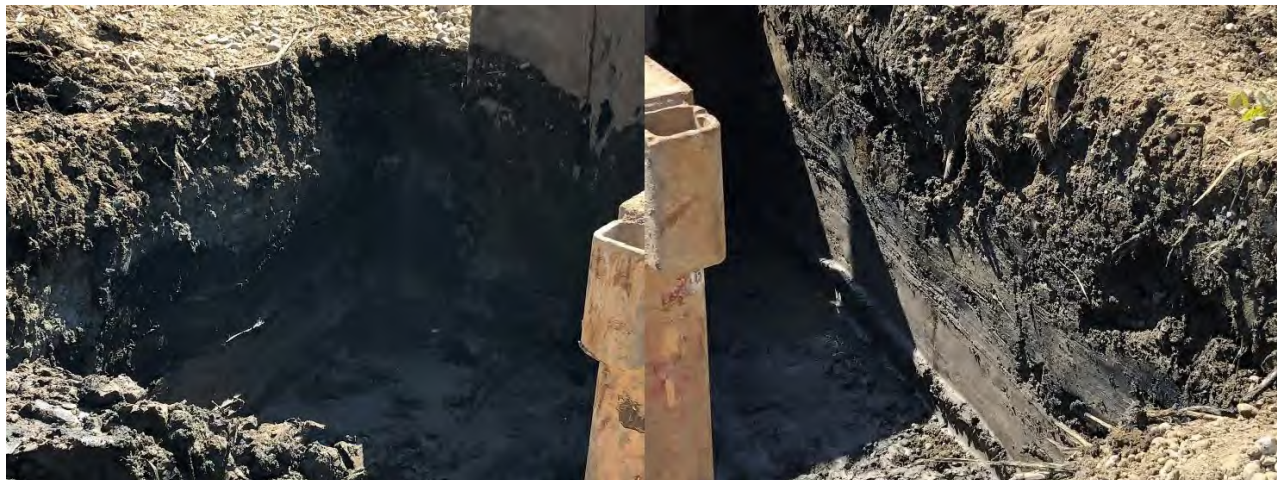
Figure 33: Southwestern and Northeastern Sidewall of RAU D26

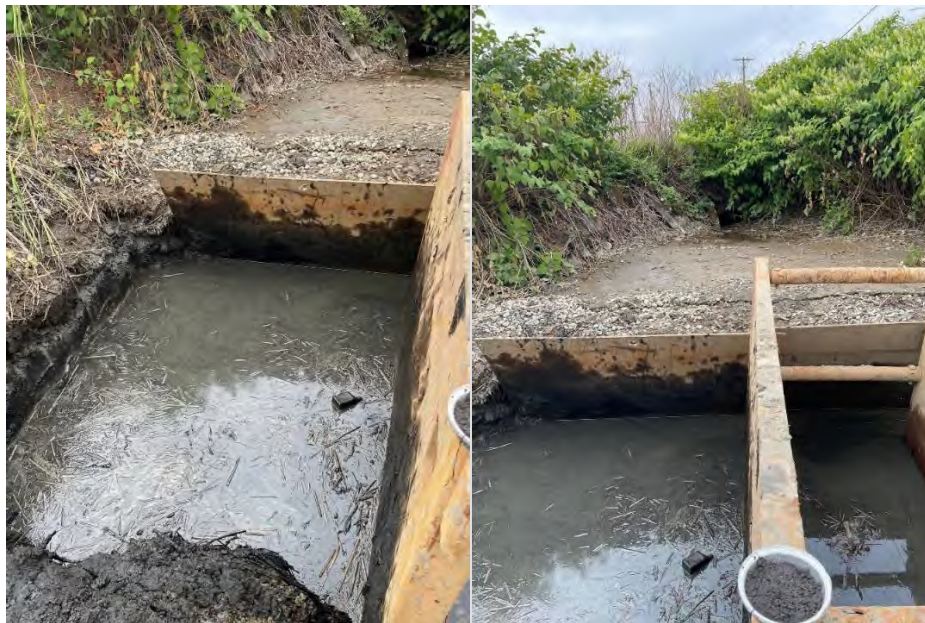
Figure 34: RAU D27

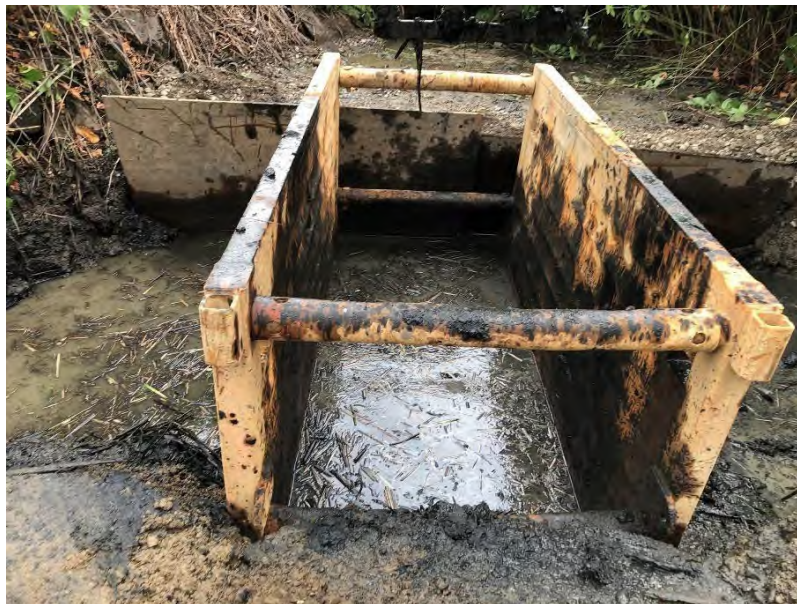
Figure 35: Bottom of RAU D28

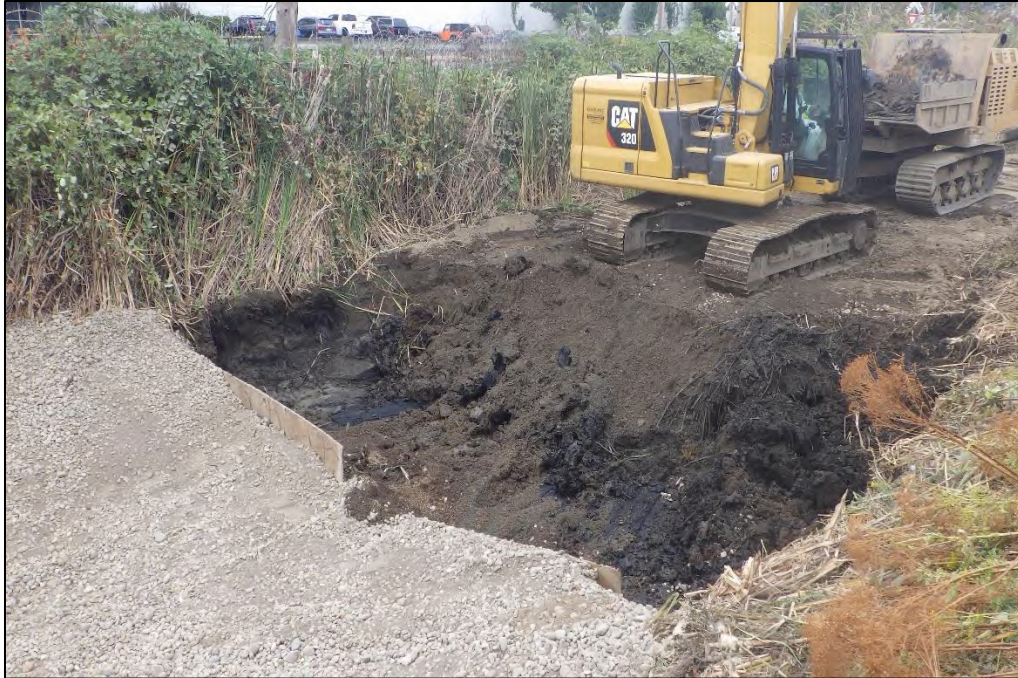
Figure 5-8. Overview of excavation within RAU D-19 during remediation clean up. Blackened sediments visible at bottom of unit, view northwest.

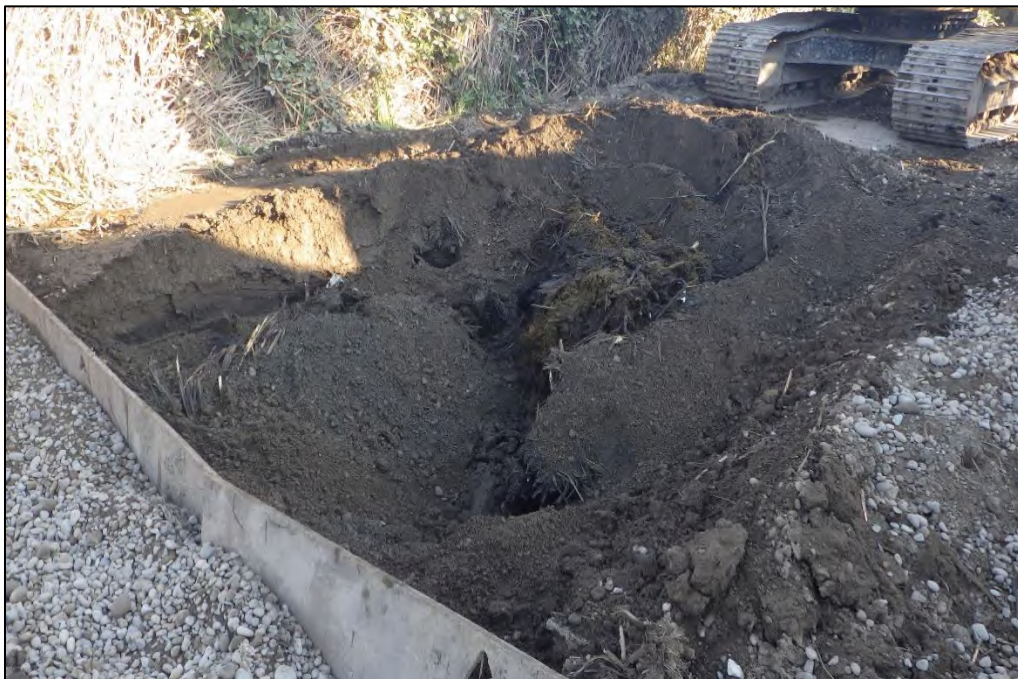
Figure 5-9. Overview of beginning excavations within RAU D-18 during remediation clean up, view northwest.

Ground disturbance included excavation of the soils within the bottom and lower sidewalls of the ditch for remediation in discrete RAU. RAU 28–18 measured on average 37 ft wide and 24 ft long. RAU 17–12 were much more irregular in size, but generally measured 13–37 ft wide and 10–37 ft long. The depth of excavation in each RAU was dependent on the level of contamination recorded in the field and varied from approximately 4 to 6 ft below the surface. Excavations began with the removal of surface vegetation along the sides of the access road and within the current RAU (see Figure 5-8). This was followed by excavation of approximately 2 ft of sediment and then pre-characterization testing (see Figure 5-7). If contamination was present, then another 2 ft of sediment was removed, and testing continued until a depth was reached where minimal contamination was present (see Figure 5-9).

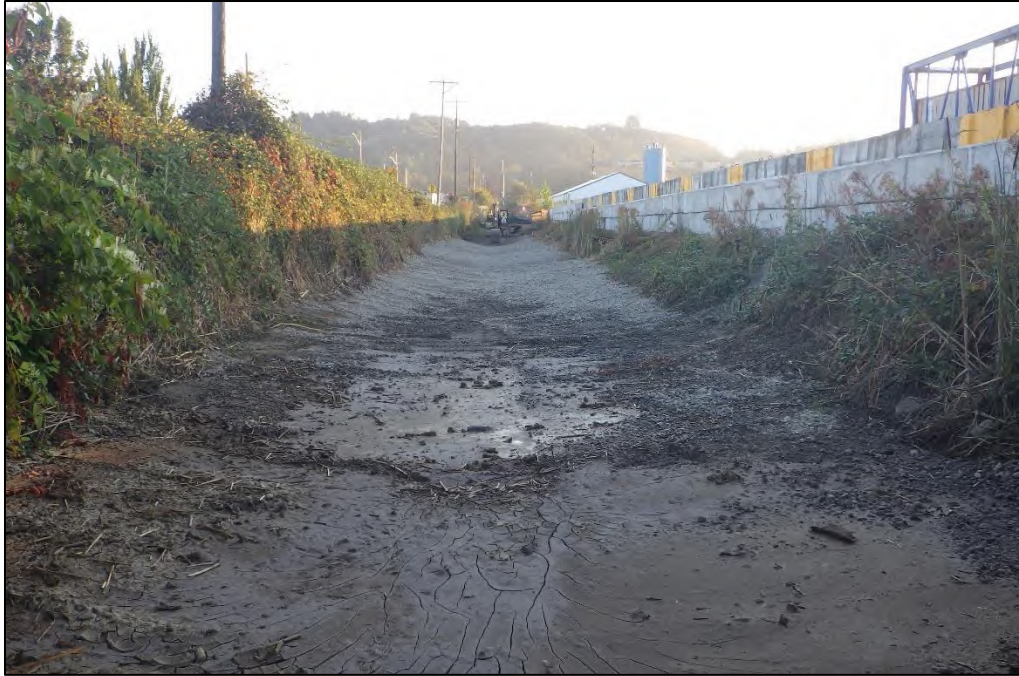
Figure 5-12. Overview of ditch along Lincoln Avenue following remediation and reconstruction, view northeast.
