INITIAL INVESTIGATION FIELD REPORT

<u>Site Name (Name over door):</u> Diablo Dry Dock	<u>Site Address (including City, State and Zip):</u> Diablo Dam Rd, Diablo, WA 98283 north shore of Diablo Lake, adjacent to SCL NCELC	<u>Phone</u> <u>Email</u>
<u>Site Contact, Title, Business:</u> Steve Mitchell National Park Service	<u>Site Contact Address (including City, State and Zip):</u>	<u>Phone</u> <u>Email</u> steve_mitchell@nps.gov
<u>Site Owner, Title, Business:</u> National Park Service, US Dept. of Interior	<u>Site Owner Address (including City, State and Zip):</u>	<u>Phone</u> <u>Email</u>
<u>Site Owner Contact, Title, Business:</u>	<u>Site Owner Contact Address (including City, State and Zip):</u>	<u>Phone</u> <u>Email</u>
<u>Previous Site Owner(s):</u>	<u>Additional Info (for any Site Information Item):</u> Ecology contacted NPS twice to determine if the release had been reported to EPA, but received no response.	
<u>Alternate Site Name(s):</u>

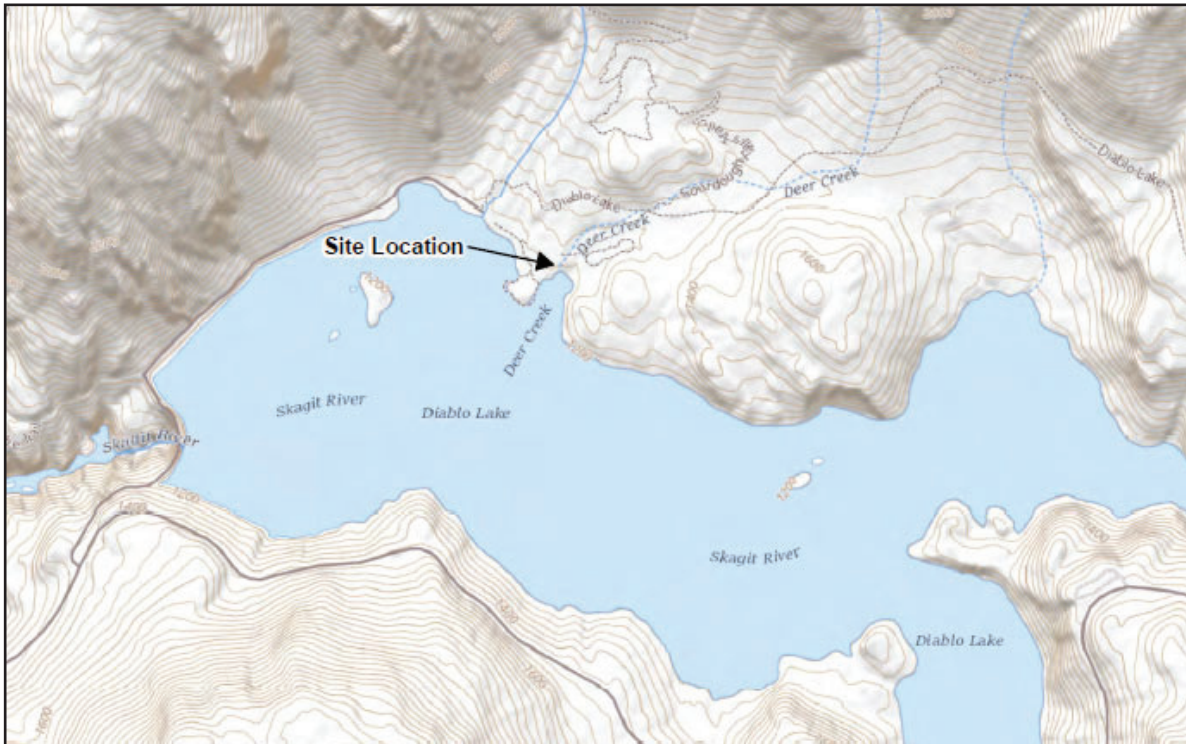
Figure 1: Soil and sediment sampling locations (source: Geosyntec)

Hart Crowser conducted limited upland soil and sediment investigations in 2014 and 2015 to determine if metals, PAHs (polycyclic aromatic hydrocarbons), or petroleum were released to soil and metals or petroleum were released to sediments. Samples were collected around and within the Dry Dock building and from the marine railway (Figure 1).

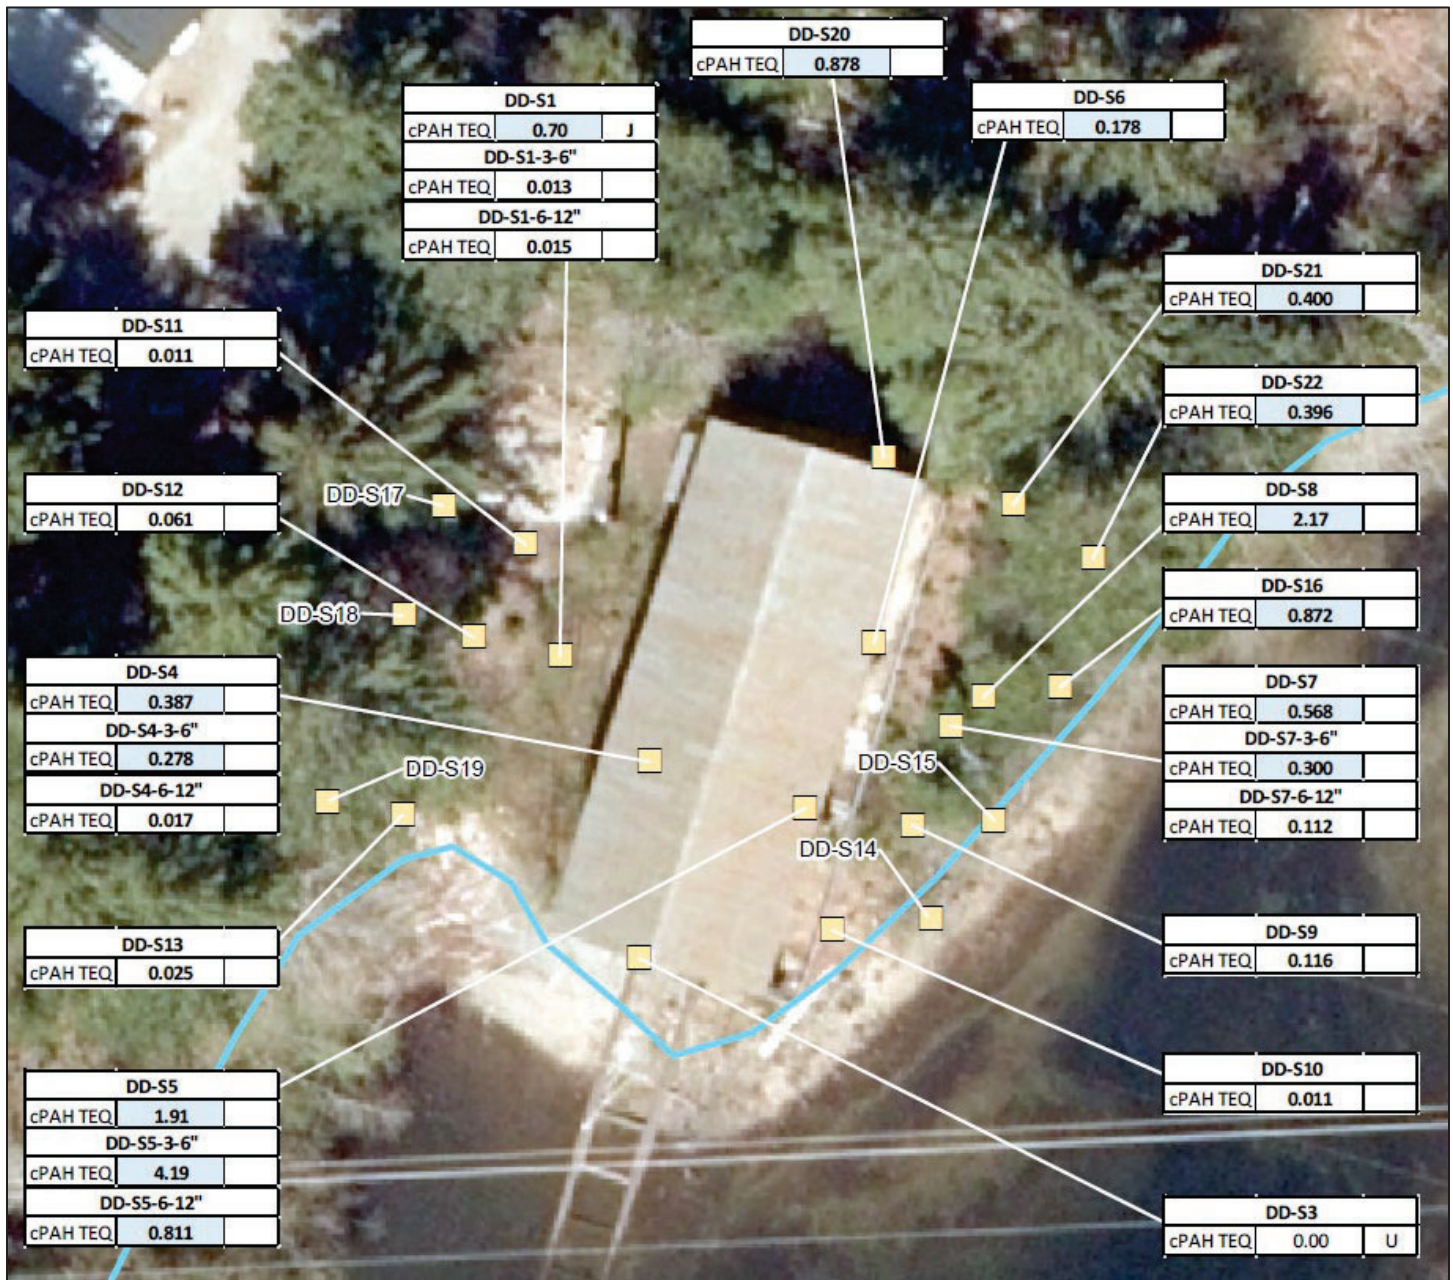
Figure 3: Analytical results for cPAHs in soil samples (source: Geosyntec)

1. Concentrations that exceed MTCA Method A levels are shaded.
2. U = Not detected at the reporting limit indicated.
3. Samples shown with no data were sampled, but were not analyzed for metals.
4. Total cPAH TEQs are calculated by multiplying toxicity equivalency factor (SCUM, 2019) by the detected concentration; non detected are multiplied by half the reporting limit.
5. Total cPAH TEQs calculated using WAC 173-340-708(8) in the historical dataset.

Twenty-two samples were collected from surface and subsurface soils (Figures 2 and 3), eight surface sediment samples were collected south and east of the Dry Dock building, and two subsurface sediment samples were collected immediately below the marine railway close to the building (Figure 4). Hart Crowser compared analytical results to MTCA Method A cleanup levels for all samples, however, Ecology believes a more conservative approach, using Method B cleanup levels, is more appropriate because the location of this site is within a national recreation area and Method A cleanup levels do not consider protection of surface water, sediment, and ecological receptors.
