Go East Landfill Closure  
Construction Quality Assurance Report

Appendix E  
Construction Summary Report  
GeoEngineers, Inc., April 7, 2022

**Construction Summary Report (LDA #1)**

Go East Landfill Closure (PFN 20 118246 LDA)  
Snohomish County, Washington

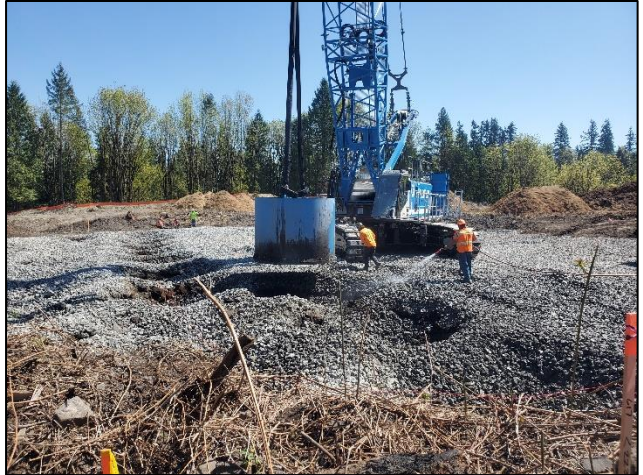
The deep dynamic compaction (DDC) contractor (Malcolm) completed 51 drop points in the northeast area of the detention pond today (see attached site plan). The contractor used a track-mounted crane (Liebherr HS 885 HD) with a 25-ton, 6-foot-high by 8-foot-diameter tamper to complete the dynamic compaction.

Dynamic compaction at northeast end of detention pond. Looking east.

Offset survey hubs were located along the east and west ends of each drop point row. The contractor ran a string between the two survey hubs and measured off them to determine the location of each drop point. The drop points were spaced at 12 feet on center in an equilateral triangular spacing, as specified in the plans and specifications.

The deep dynamic compaction was performed by raising the 25-ton tamper to a height of 40 feet above the working pad (1-foot-thick quarry spalls) and dropping it at the specified drop point. The tamper was dropped at each drop point location at least 4 times as summarized in the table below. Compaction of the drop point craters generally decreased significantly on the final two drops, indicating that the material beneath it was compacting to the extent possible. Crater depths ranged from 3 to 4.5 feet deep. These were based on visual estimates during the compaction process and are estimated to the nearest quarter foot.

Based on our observations, it is our opinion that the deep dynamic compaction was completed in general accordance with the geotechnical aspects of the project plans and specifications, and our recommendations.

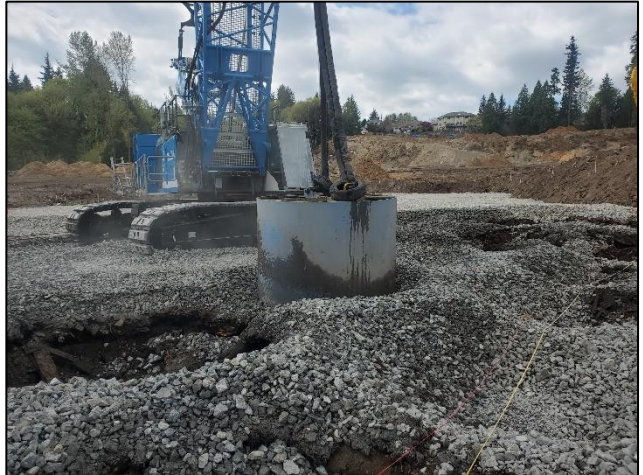
The deep dynamic compaction (DDC) contractor (Malcolm) completed 126 drop points in the detention pond footprint today (see attached site plan). The contractor used a track-mounted crane (Liebherr HS 885 HD) with a 25-ton, 6-foot-high by 8-foot-diameter tamper to complete the dynamic compaction.

Dynamic compaction at north end of detention pond. Looking southwest.

Offset survey hubs were located along the east and west ends of each drop point row. The contractor ran a string between the two survey hubs and measured off them to determine the location of each drop point. The drop points were spaced at 12 feet on center in an equilateral triangular spacing, as specified in the plans and specifications.

The deep dynamic compaction was performed by raising the 25-ton tamper to a height of 40 feet above the working pad (1-foot-thick quarry spalls) and dropping it at the specified drop point. The tamper was dropped at each drop point location at least 4 times as summarized in the table below. Compaction of the drop point craters generally decreased significantly on the final two drops, indicating that the material beneath it was compacting to the extent possible. Crater depths ranged from 3 to 6 feet deep. These were based on visual estimates during the compaction process and are estimated to the nearest quarter foot.

Based on our observations, it is our opinion that the deep dynamic compaction was completed in general accordance with the geotechnical aspects of the project plans and specifications, and our recommendations.

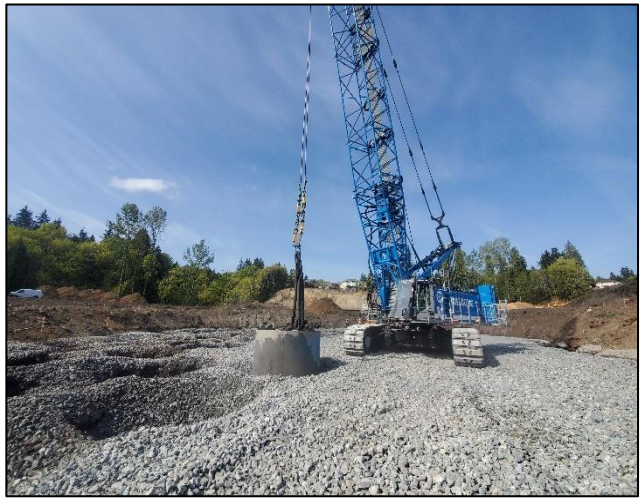
The deep dynamic compaction (DDC) contractor (Malcolm) completed the final 120 drop points in the detention pond footprint today (see attached site plan). The contractor used a track-mounted crane (Liebherr HS 885 HD) with a 25-ton, 6-foot-high by 8-foot-diameter tamper to complete the dynamic compaction.

Dynamic compaction at southeast end of detention pond. Looking northwest.

Offset survey hubs were located along the east and west ends of each drop point row. The contractor ran a string between the two survey hubs and measured off them to determine the location of each drop point. The drop points were spaced at 12 feet on center in an equilateral triangular spacing, as specified in the plans and specifications.

The deep dynamic compaction was performed by raising the 25-ton tamper to a height of 40 feet above the working pad (1-foot-thick quarry spalls) and dropping it at the specified drop point. The tamper was dropped at each drop point location at least 4 times as summarized in the table below. Compaction of the drop point craters generally decreased significantly on the final two drops, indicating that the material beneath it was compacting to the extent possible. Crater depths ranged from 3 to 6 feet deep. These were based on visual estimates during the compaction process and are estimated to the nearest quarter foot.

Based on our observations, it is our opinion that the deep dynamic compaction was completed in general accordance with the geotechnical aspects of the project plans and specifications, and our recommendations.

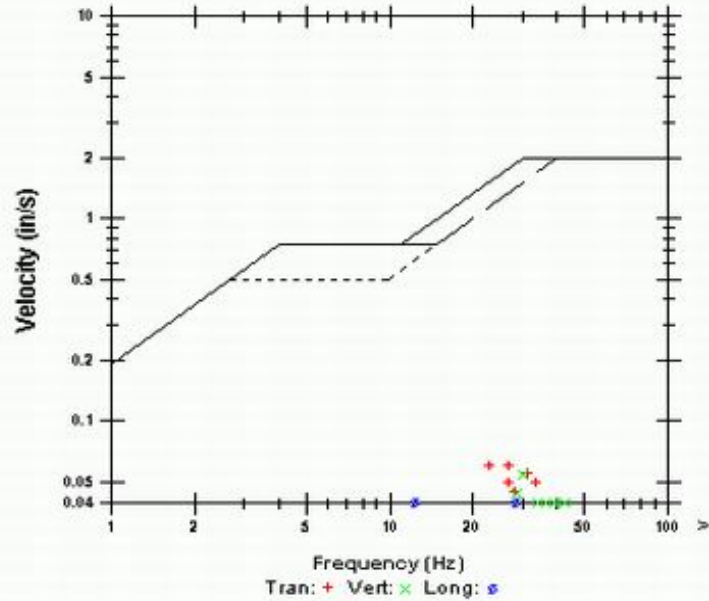
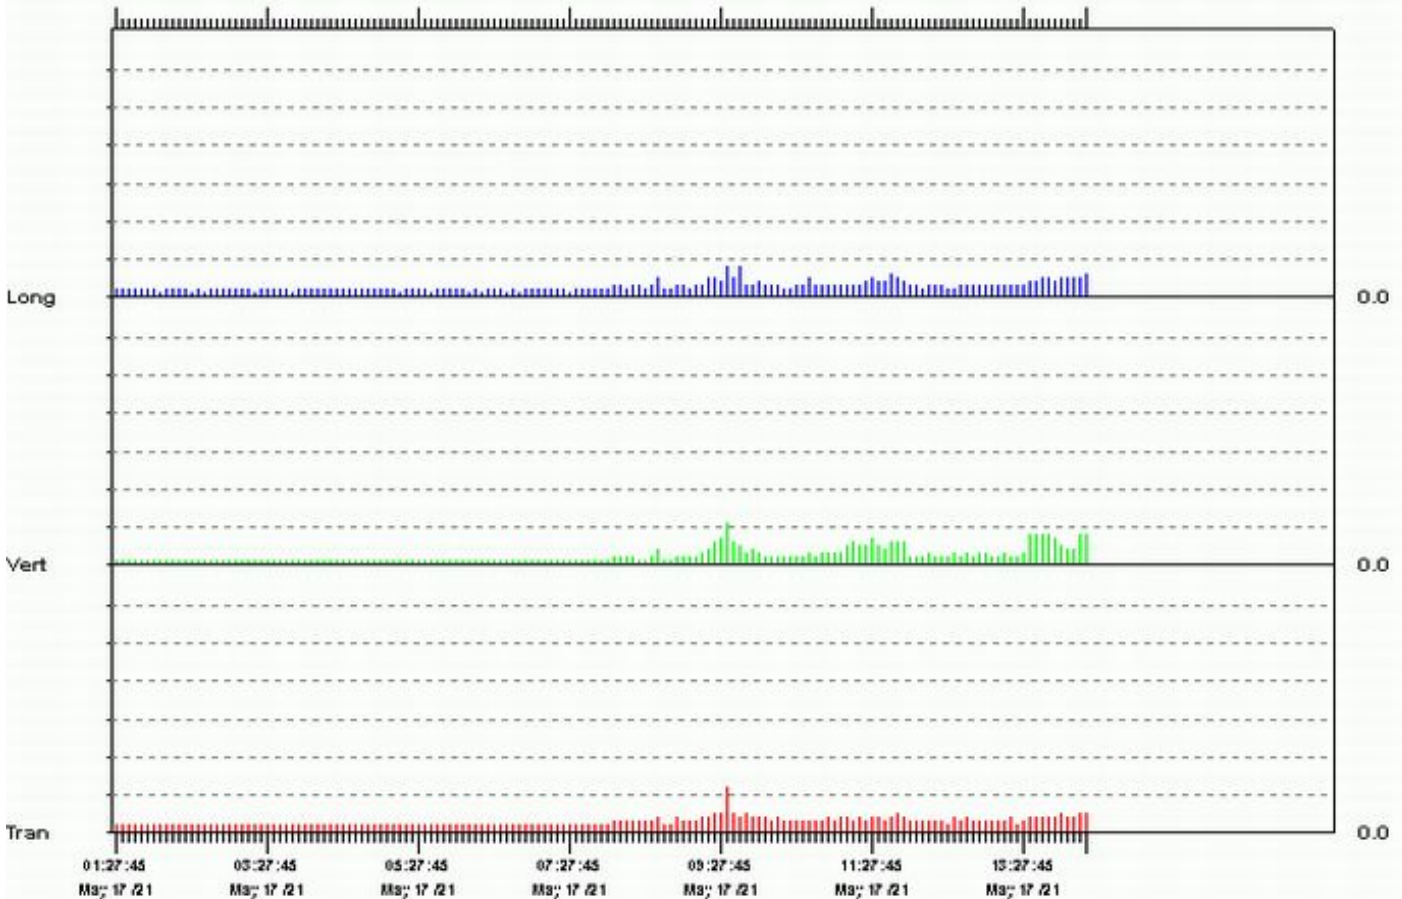
Peak Vector Sum 0.0682 in/s on May 17, 2021 At 09:30:30

USBM R18507 And OSMRE
