## PHASE II SUBSURFACE INVESTIGATION REPORT

Cascade Village  
16950-17060 116th Avenue Southeast  
Renton, Washington 98053

July 6, 2015  
Partner Project Number: 15-139176.2

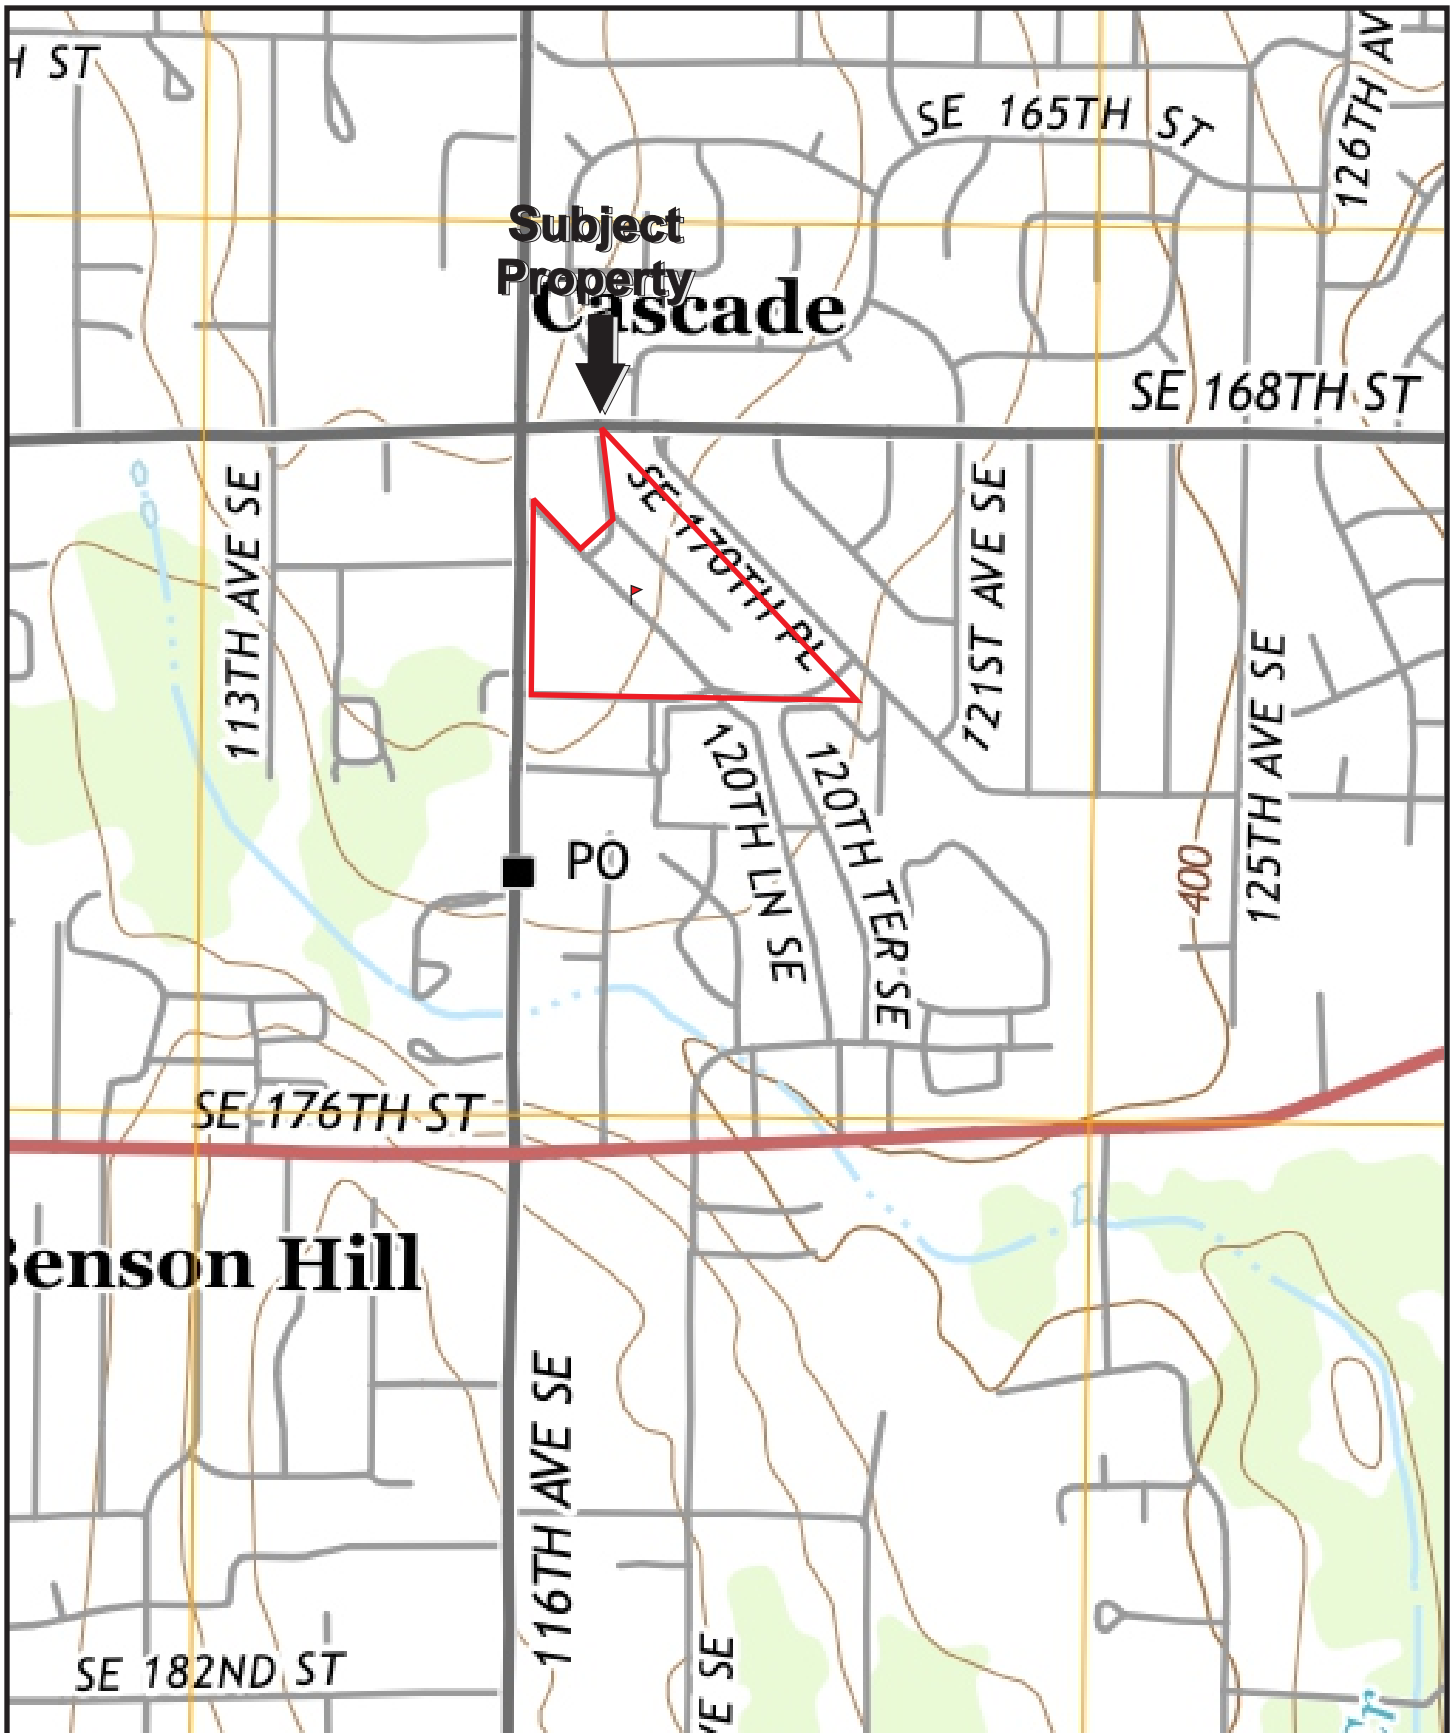
Site Plan		
Figure	Prepared By	Date
1	H. White	June 2015
16950-17060 116th Avenue Southeast Renton, Washington 98058

Subject Site
