DRYWELL DECOMMISSIONING AND CONTAMINATED SOIL REMOVAL REPORT

**HAHN MOTOR COMPANY
1201 SOUTH 1ST STREET
YAKIMA, WASHINGTON 98901**

**Facility Site ID No. 502
Cleanup Site ID No. 4927
VCP Project No. CE0529**

July 28, 2022

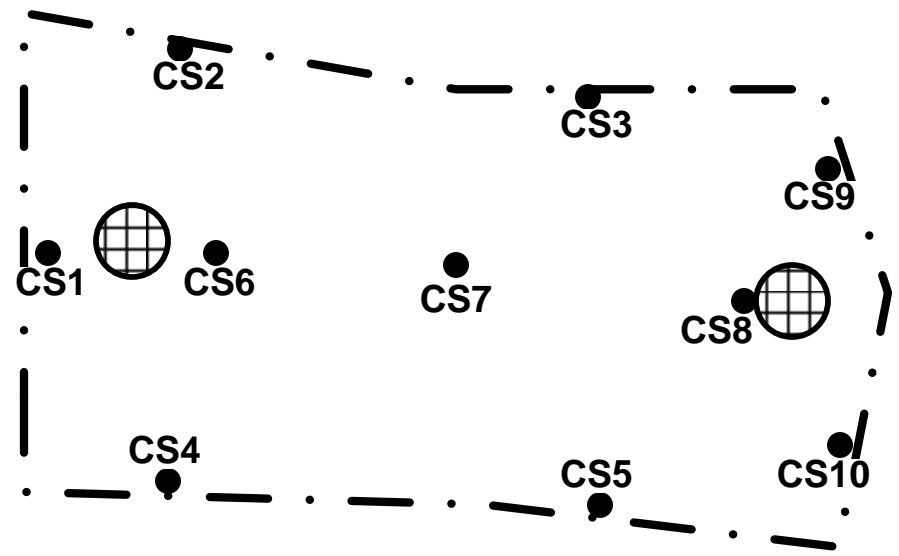
FIGURE 4 – CONFIRMATION SOIL SAMPLE LOCATIONS

NOTE: Depth of all 10 Confirmation Soil Samples = 11 feet bgs

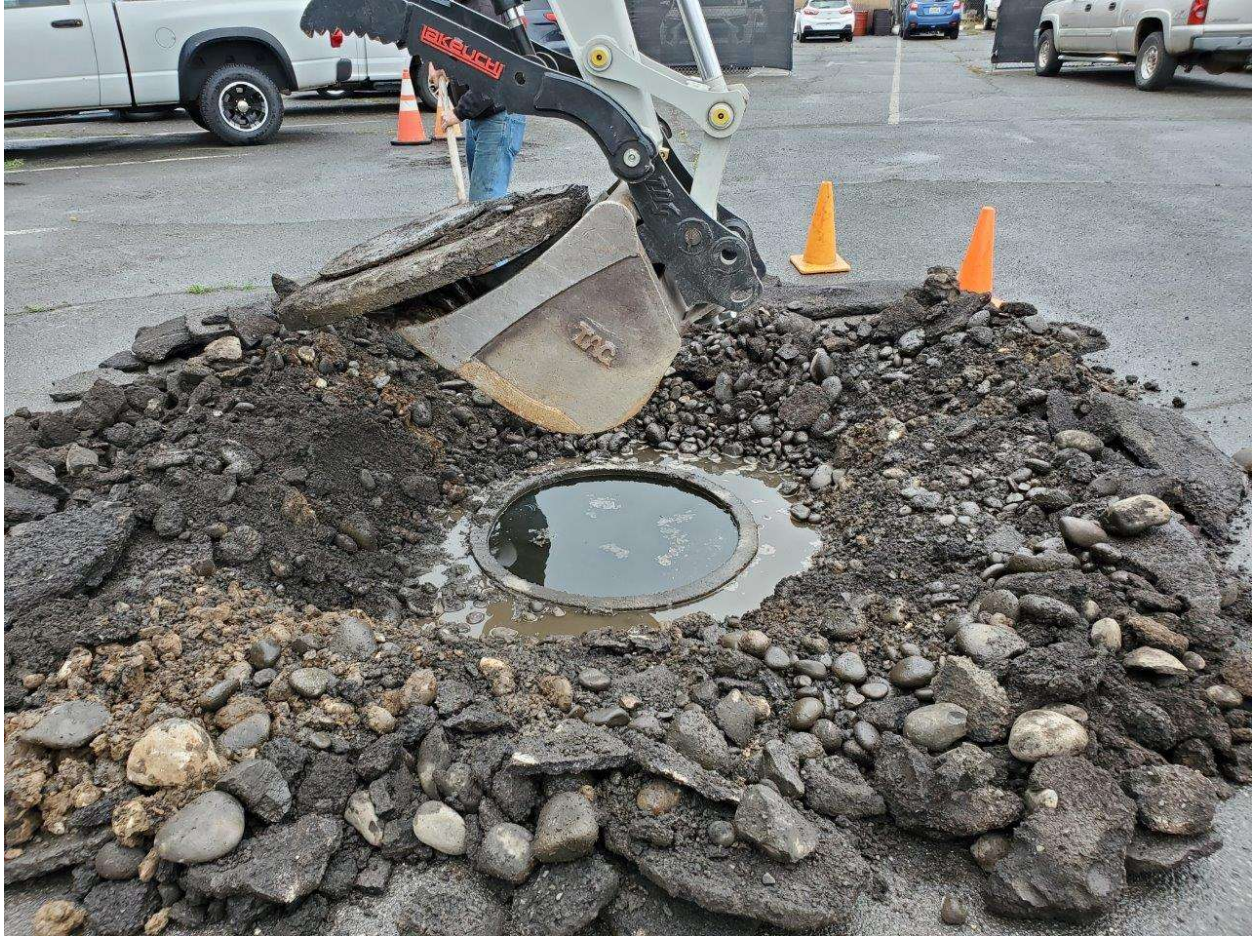
Photograph 1 – Clarke Construction personnel removing lid and assessing Dry Well 2 on July 5, 2022 (facing south).

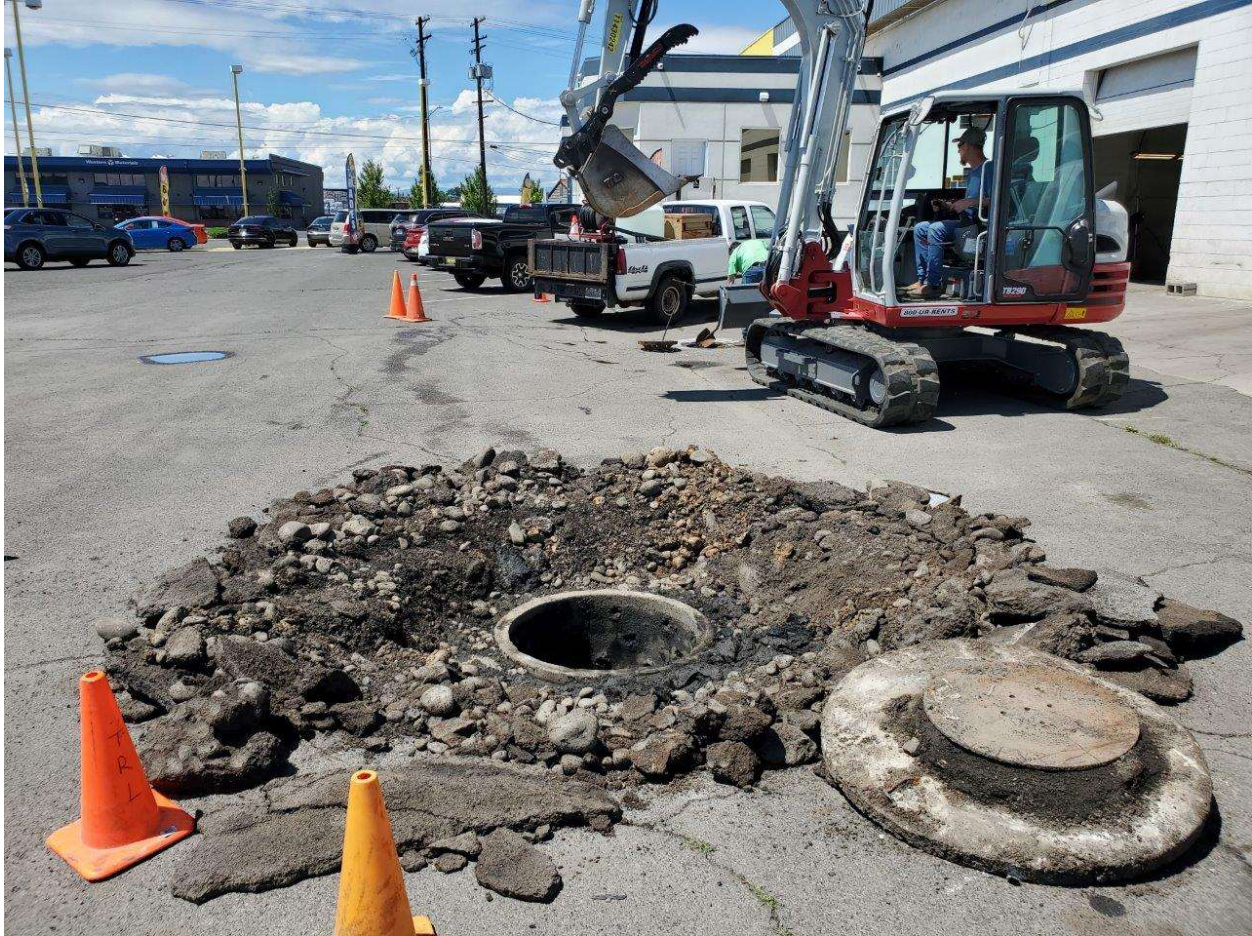
Photograph 2 – Clarke Construction personnel further assessing Dry Well 2 on July 5, 2022 (facing west).

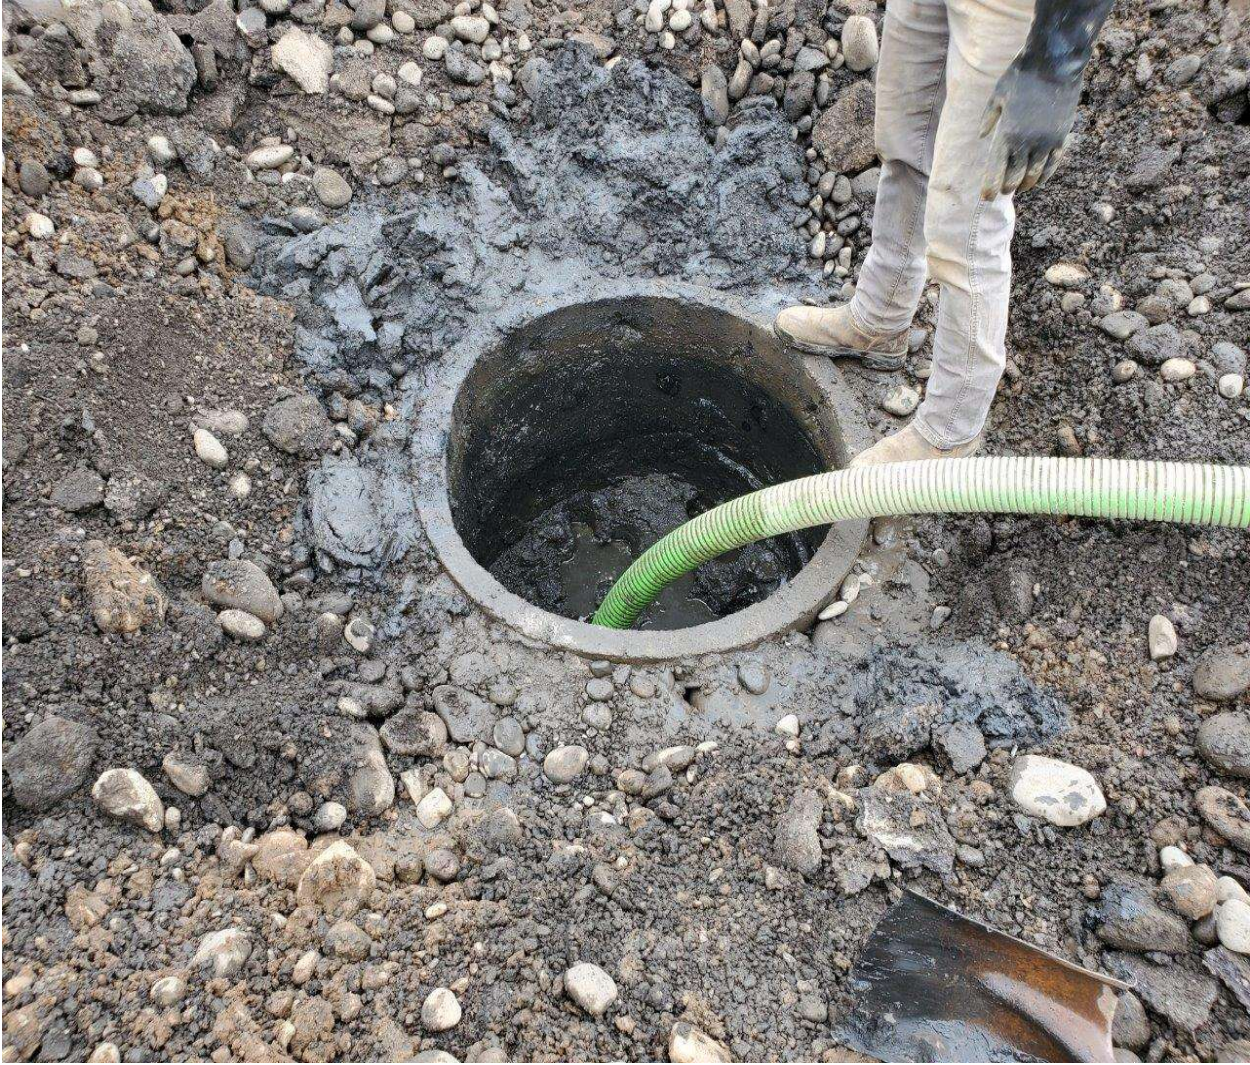
Photograph 4 – Clark Construction personnel removing liquids from Dry Well 2 on July 5, 2022.

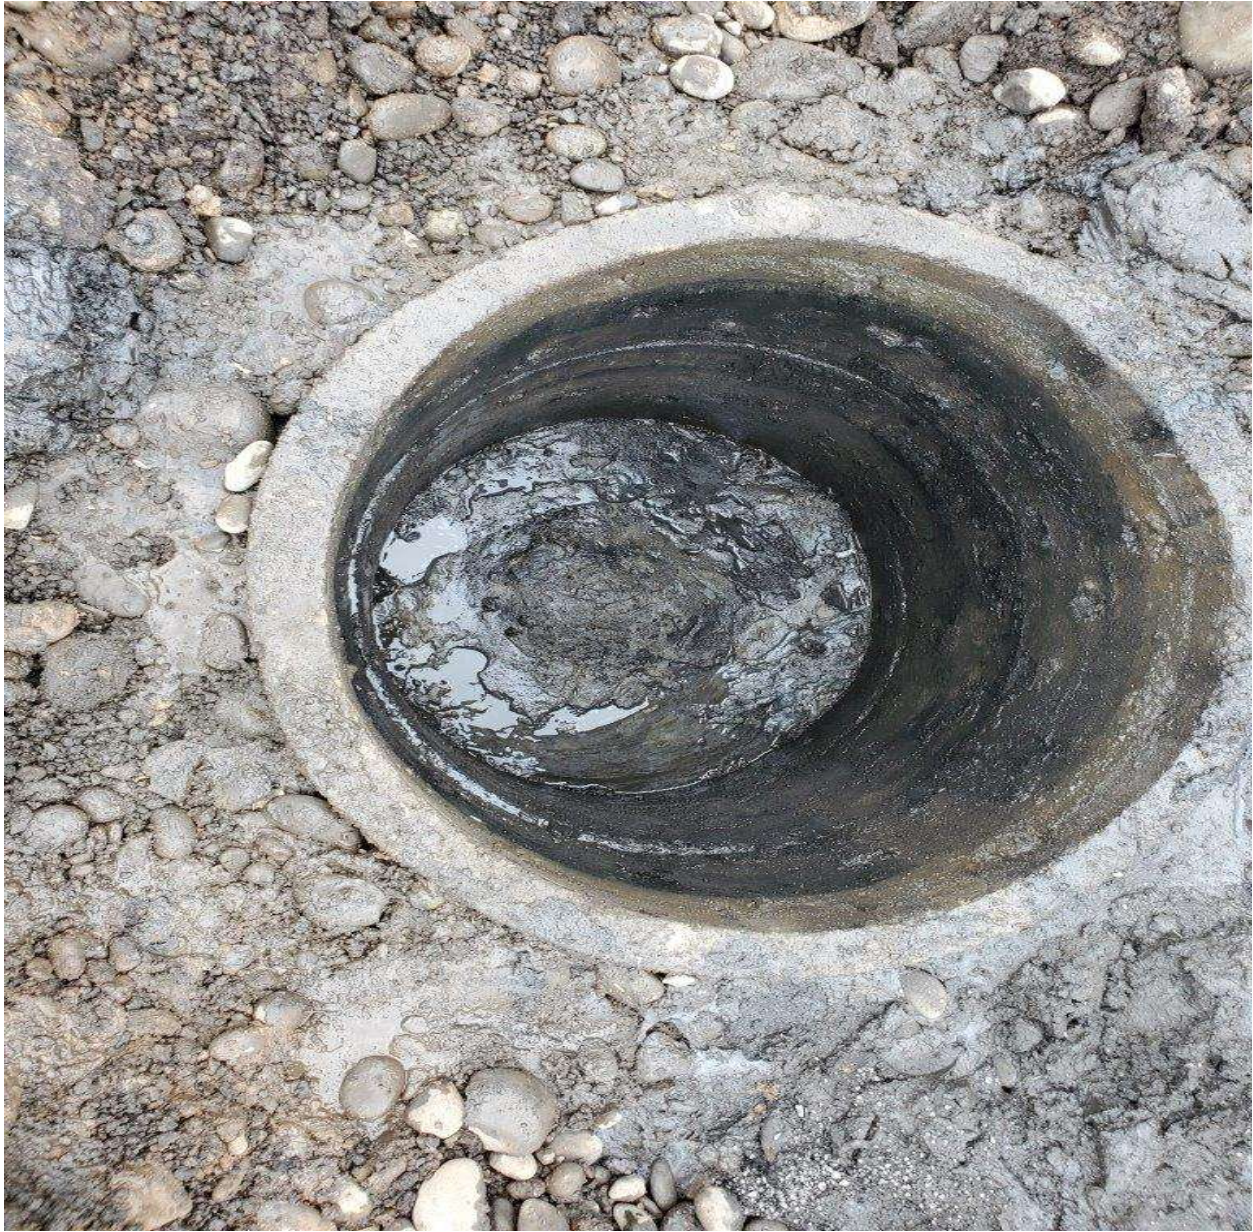
Photograph 5 – Dry Well 2 subsequent to removing liquids and some sediment on July 5, 2022.

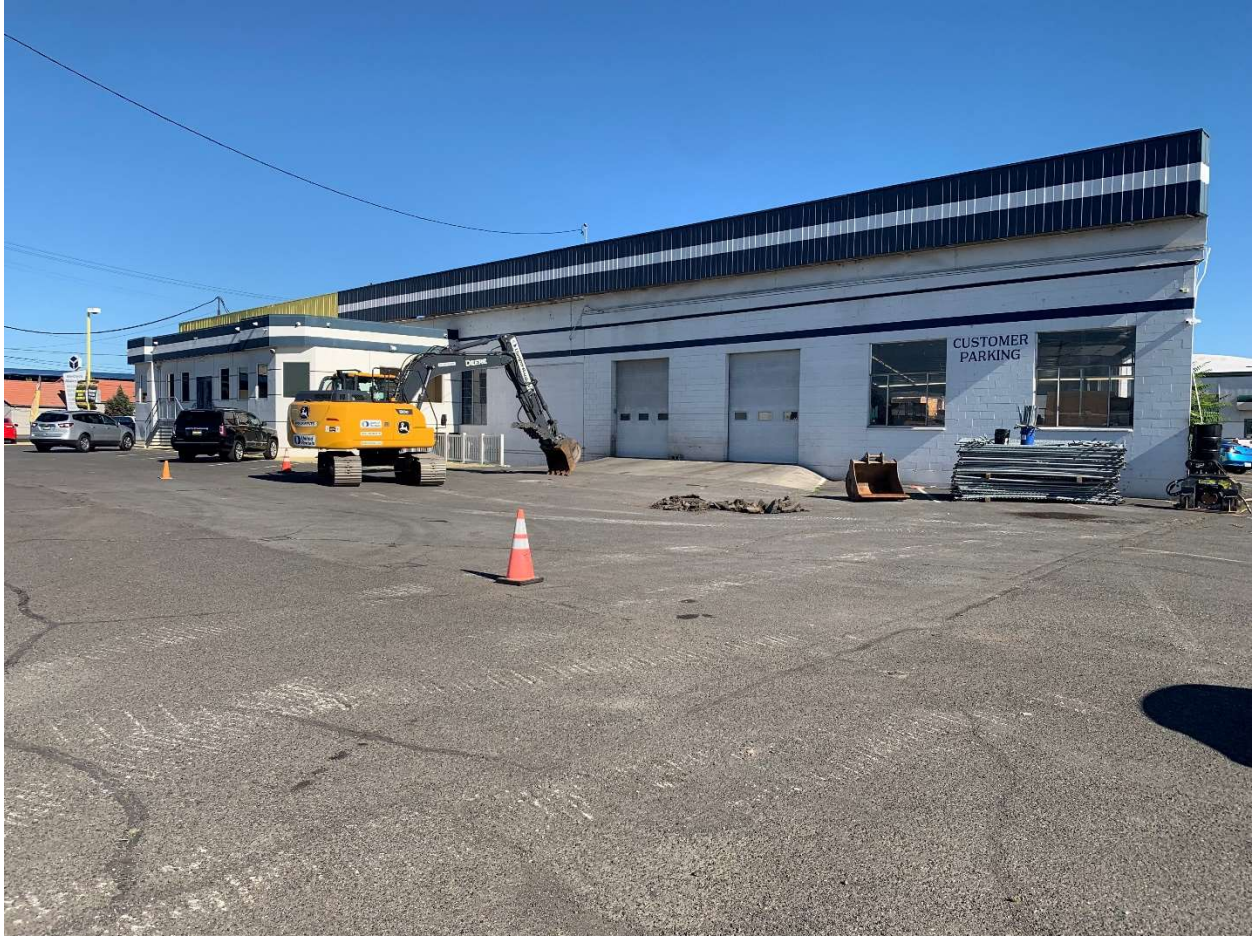
Photograph 6 – Clarke Construction beginning excavation of Dry Well 1 on July 12, 2022 (facing NW).

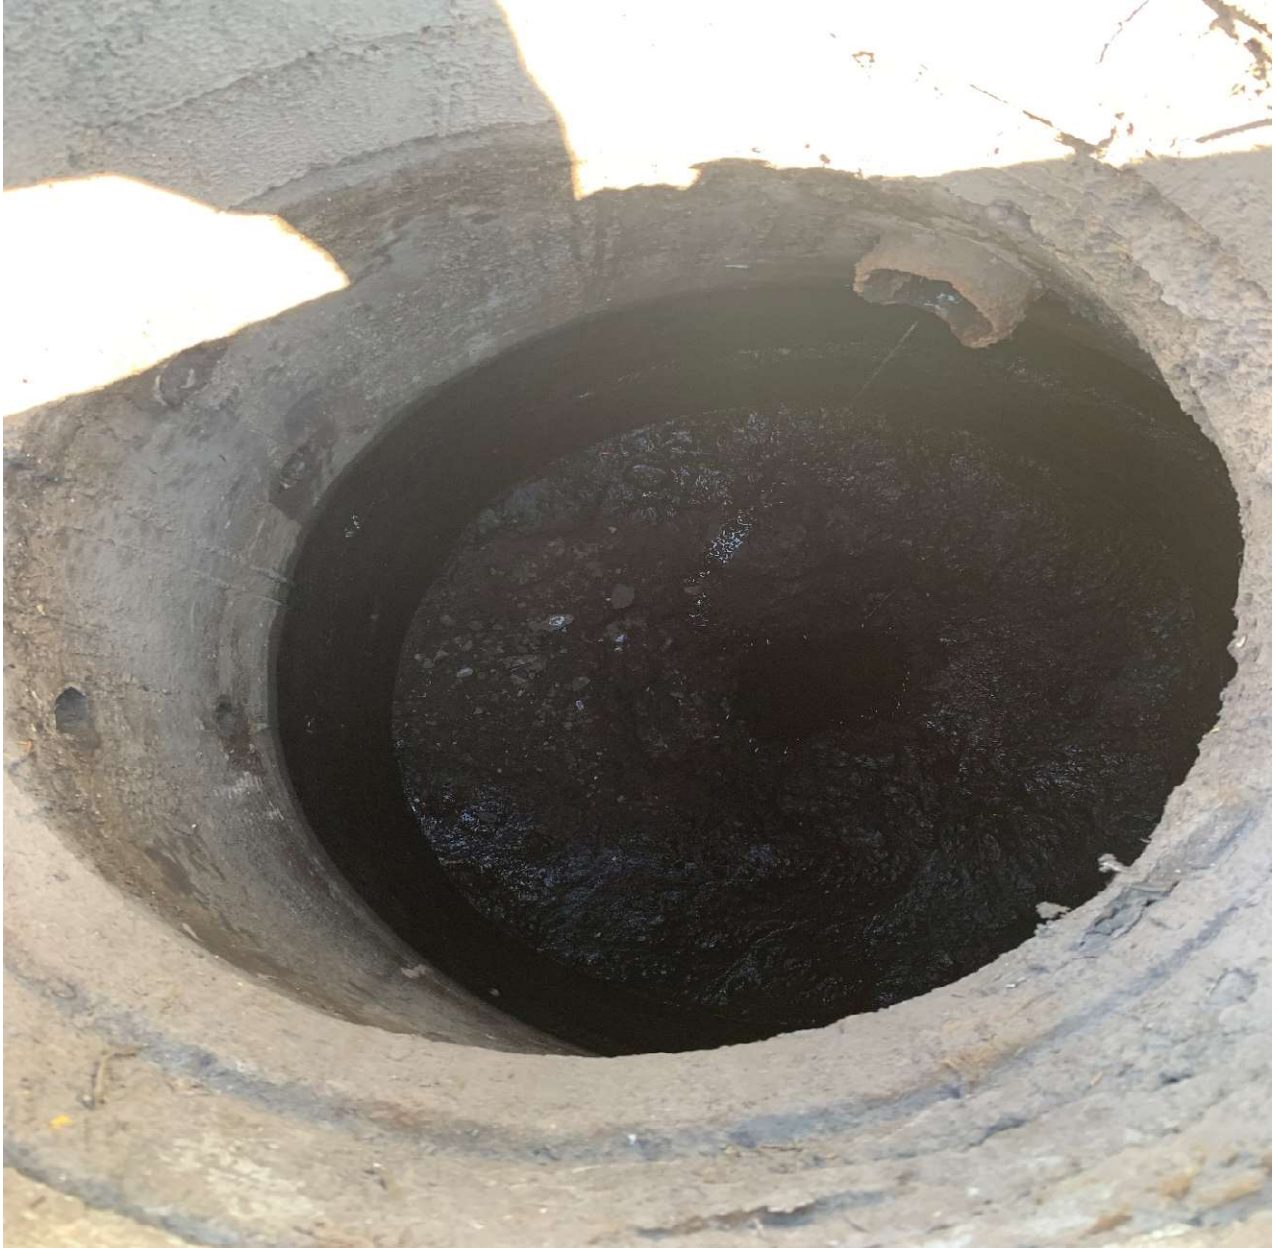
Photograph 7 – View of Dry Well 1 subsequent to liquid removal and before removal.

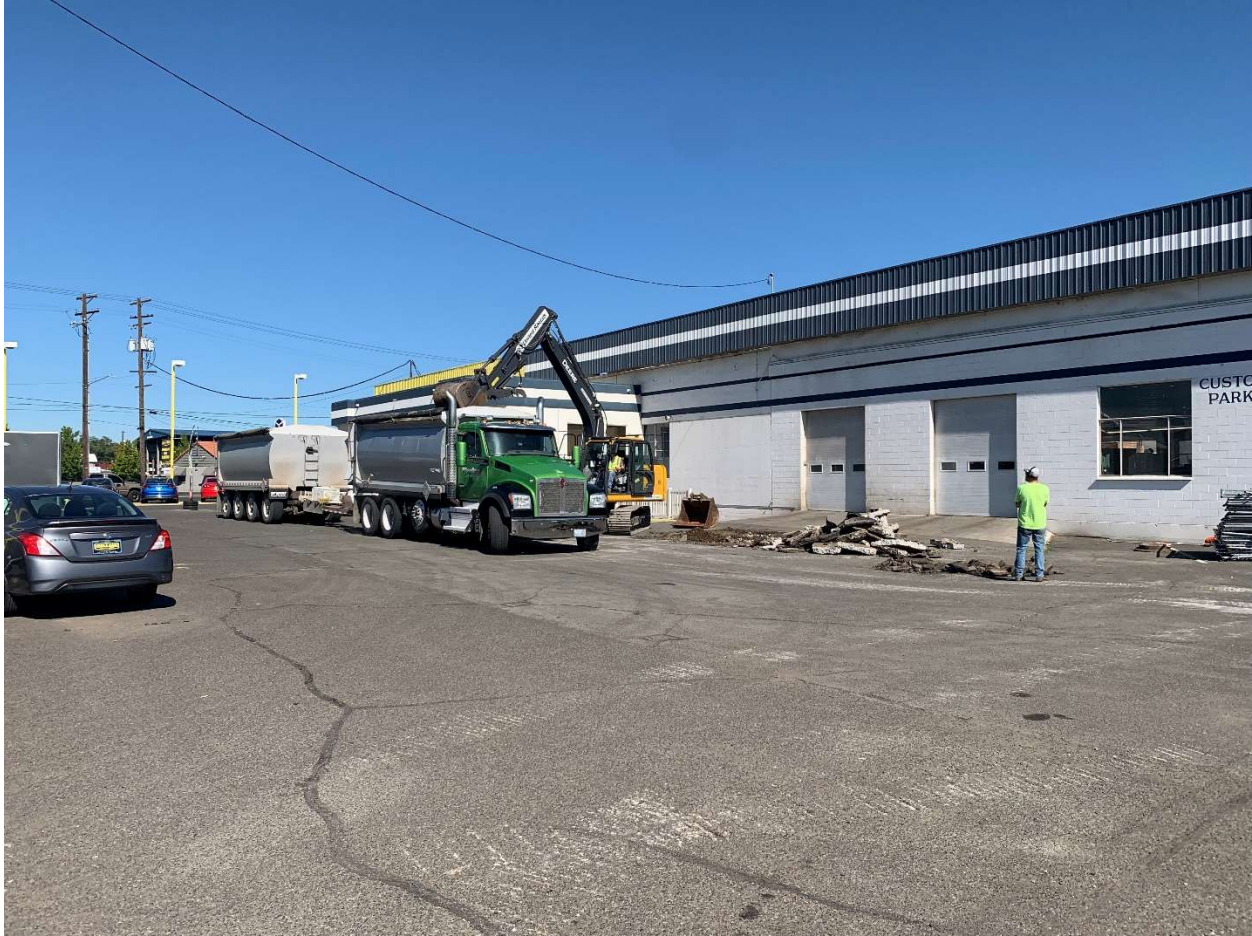
Photograph 8 – Loading contaminated soil in dump truck for disposal on July 12, 2022 (facing NW).

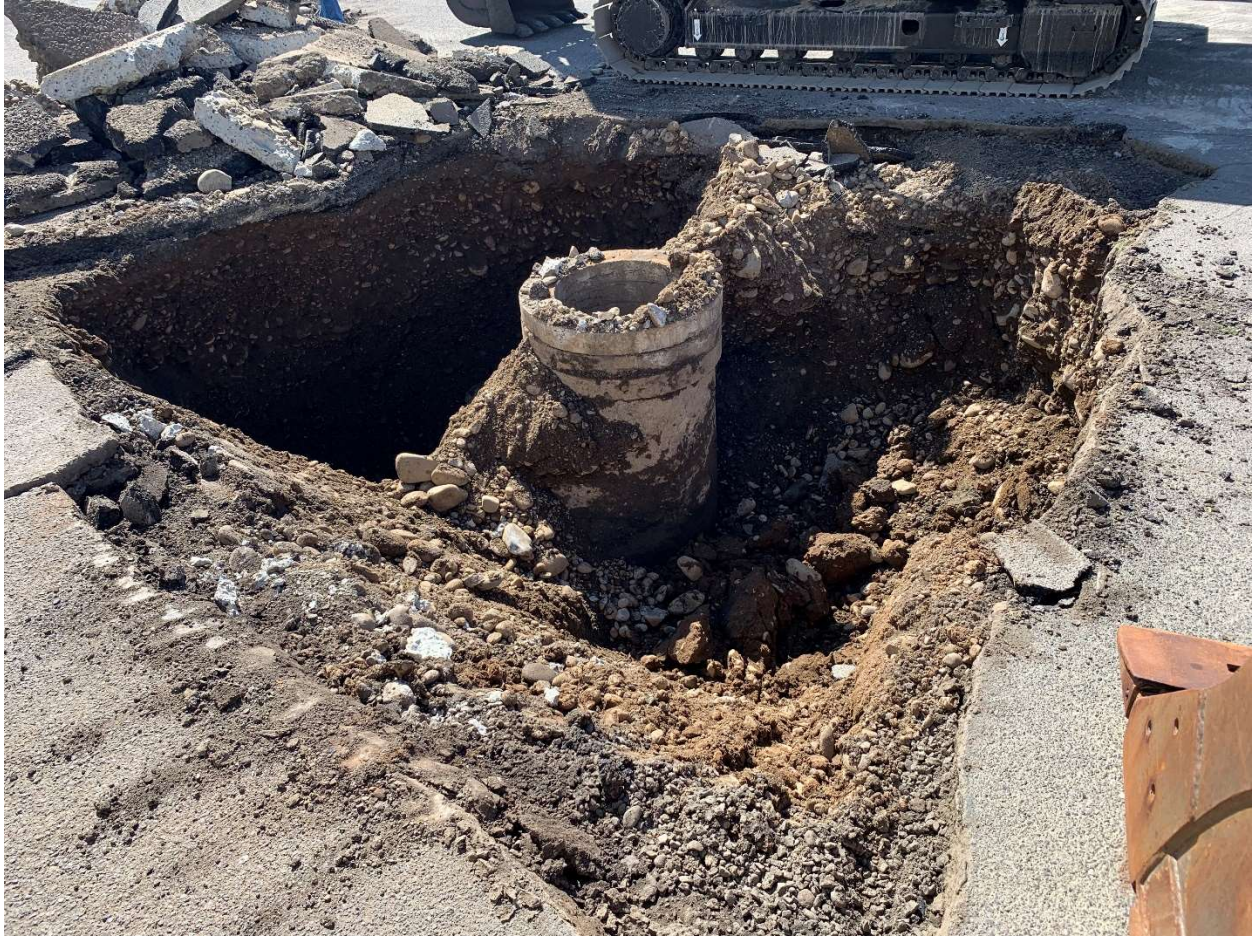
Photograph 9 – Dry well 1 subsequent to soil removal and prior to decommissioning on July 12, 2022 (facing SE).

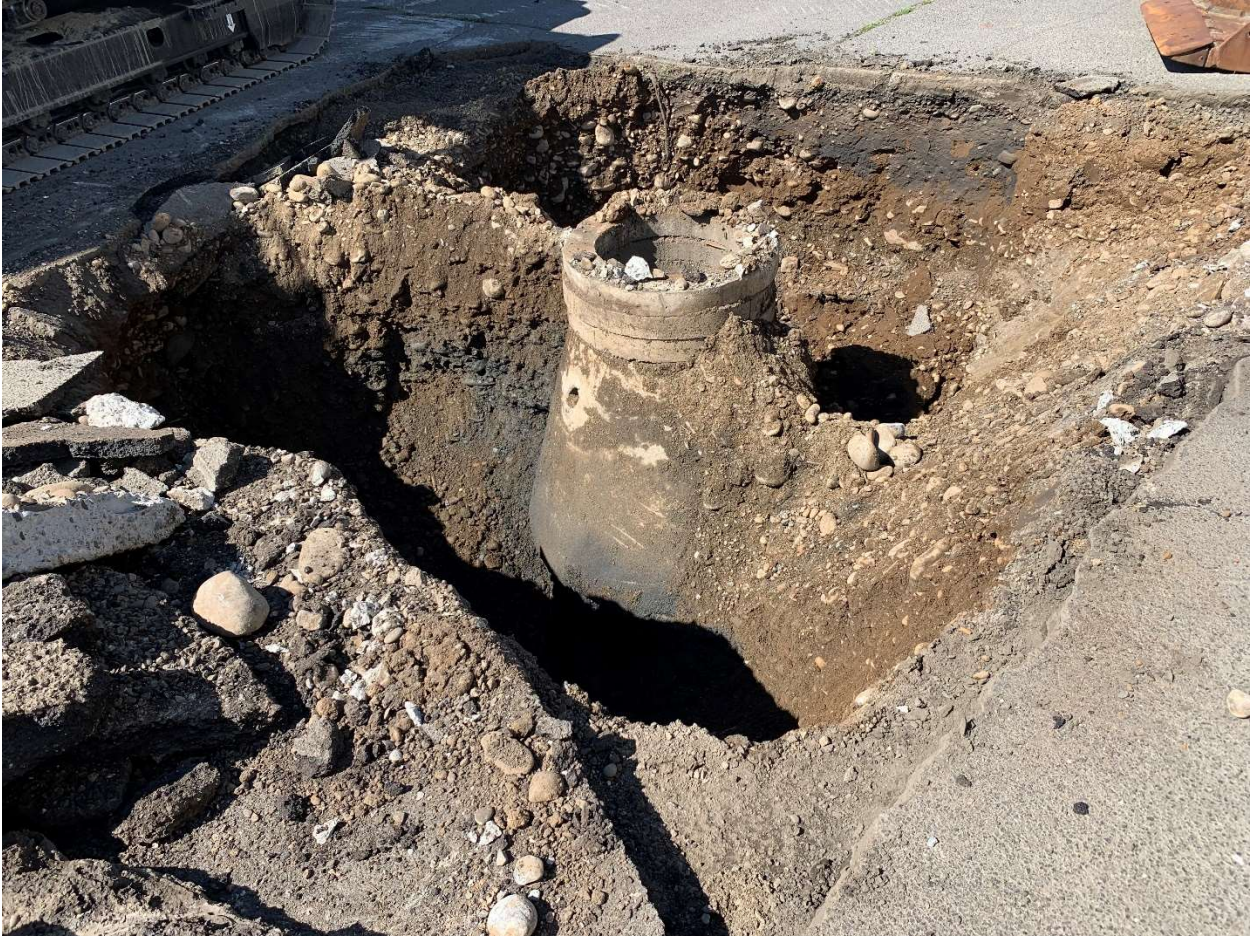
Photograph 10 – Dry well 1 subsequent to soil removal and prior to decommissioning on July 12, 2022 (facing SW). Note dark stained petroleum-contaminated soil (PCS).

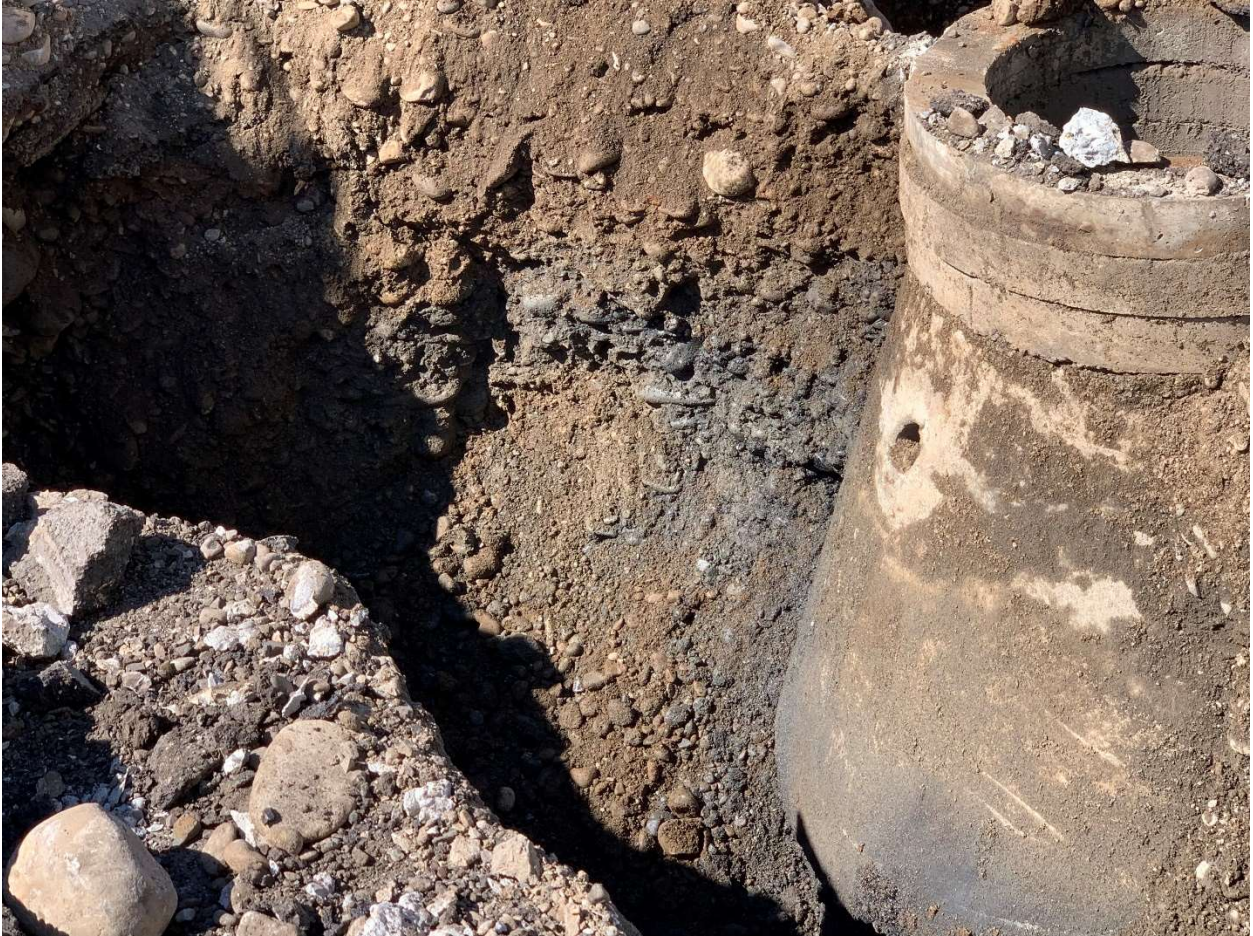
Photograph 11 – Close-up of PCS in vicinity of Dry Well 1.

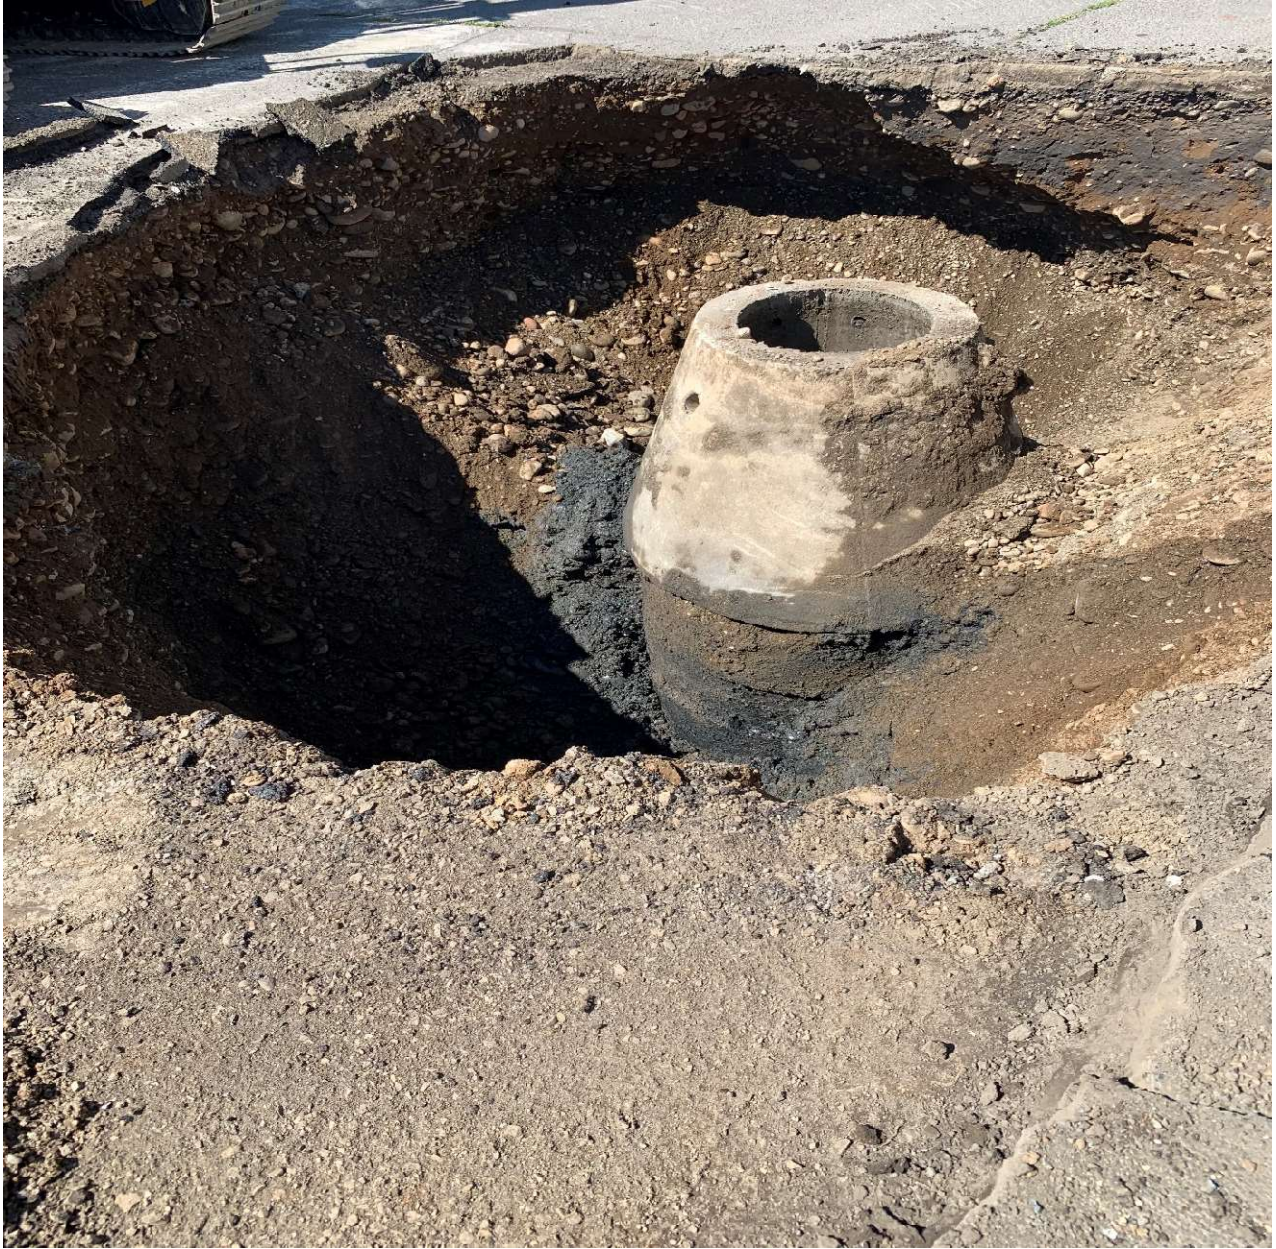
Photograph 12 – PCS depth in vicinity of Dry Well 1 extending to below 5 feet bgs.

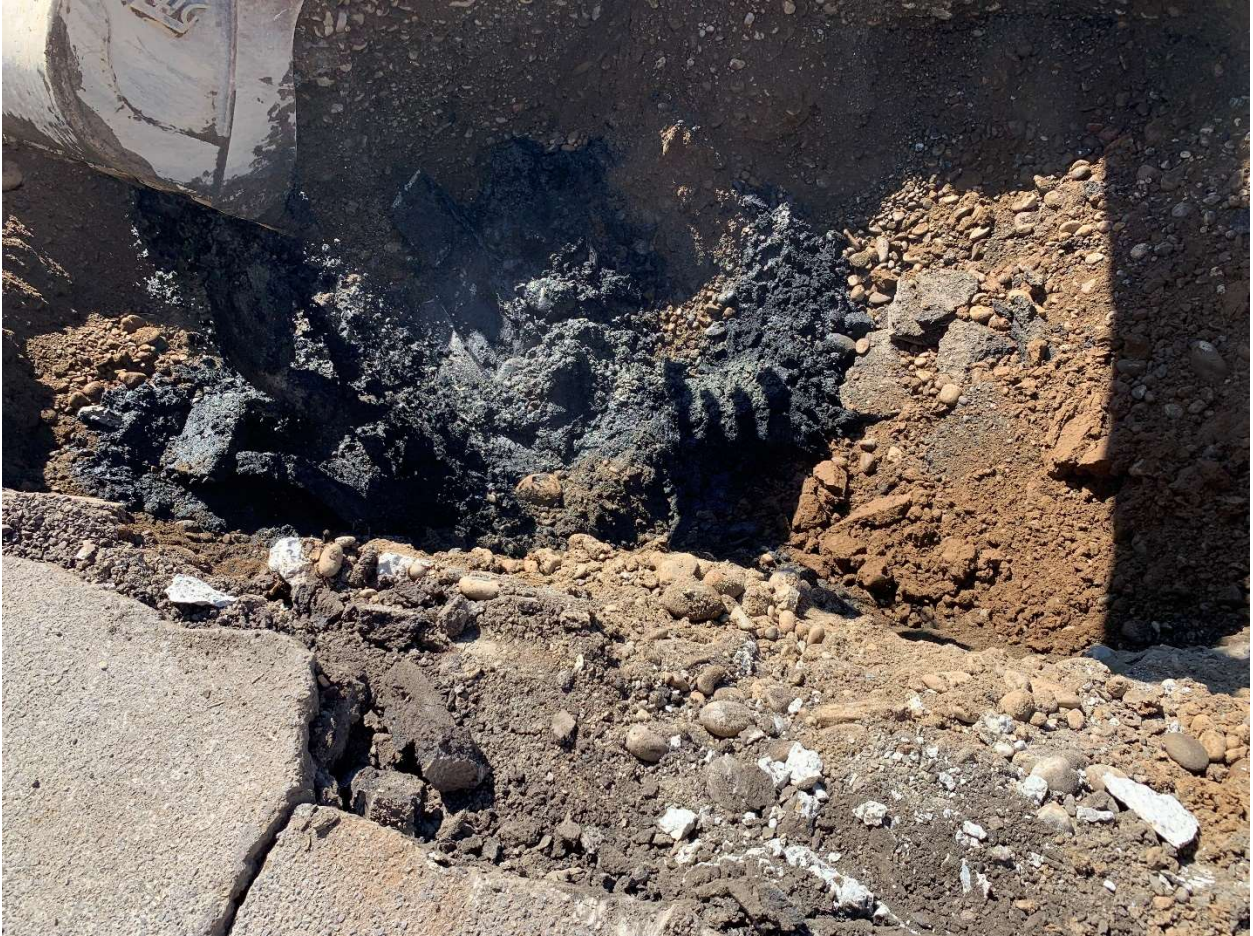
Photograph 13 – Dry Well 1 removed on July 12 2022. Dark stained PCS is evident.

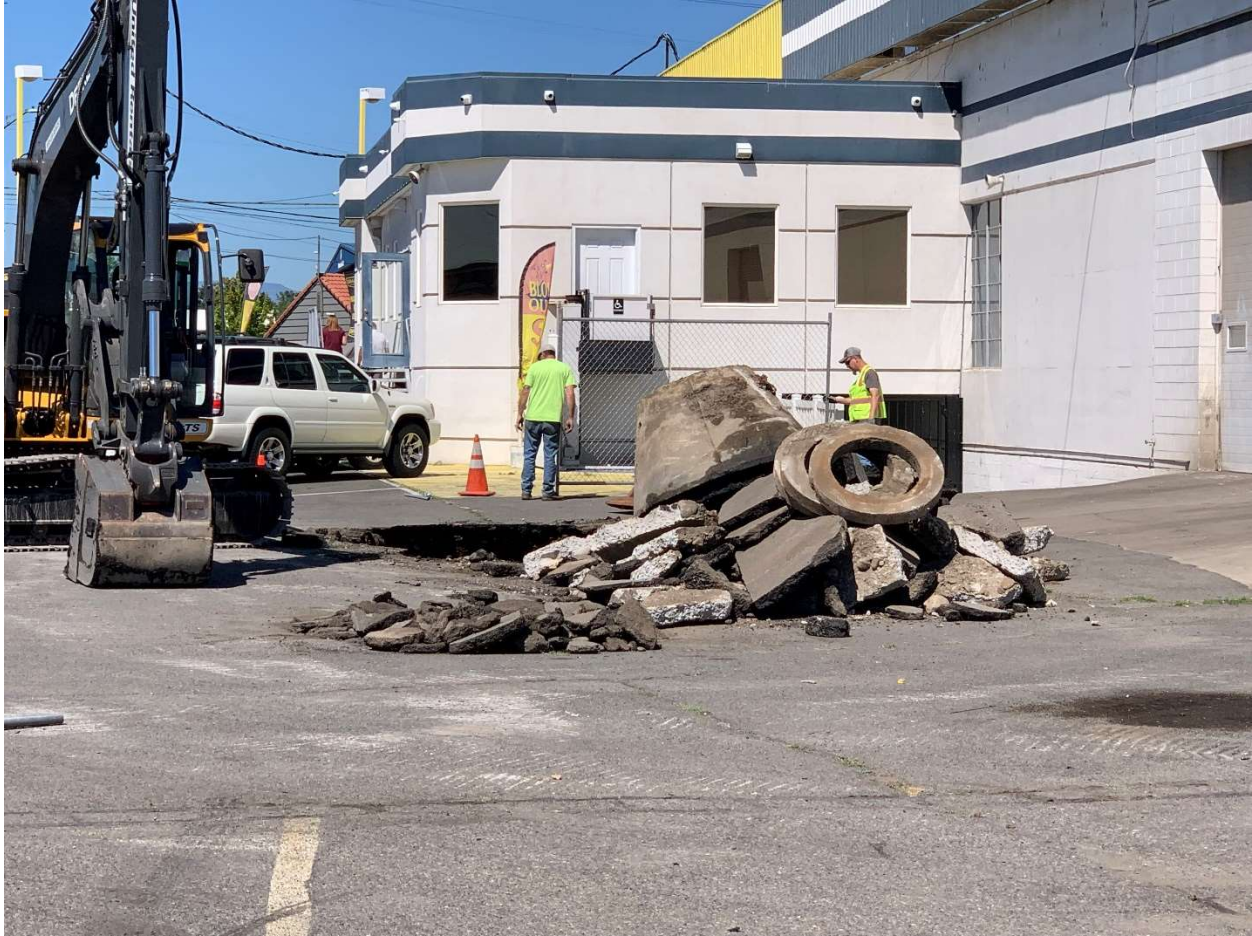
Photograph 14 – Dry Well 1 removed from the ground on July 12, 2022 (facing west).

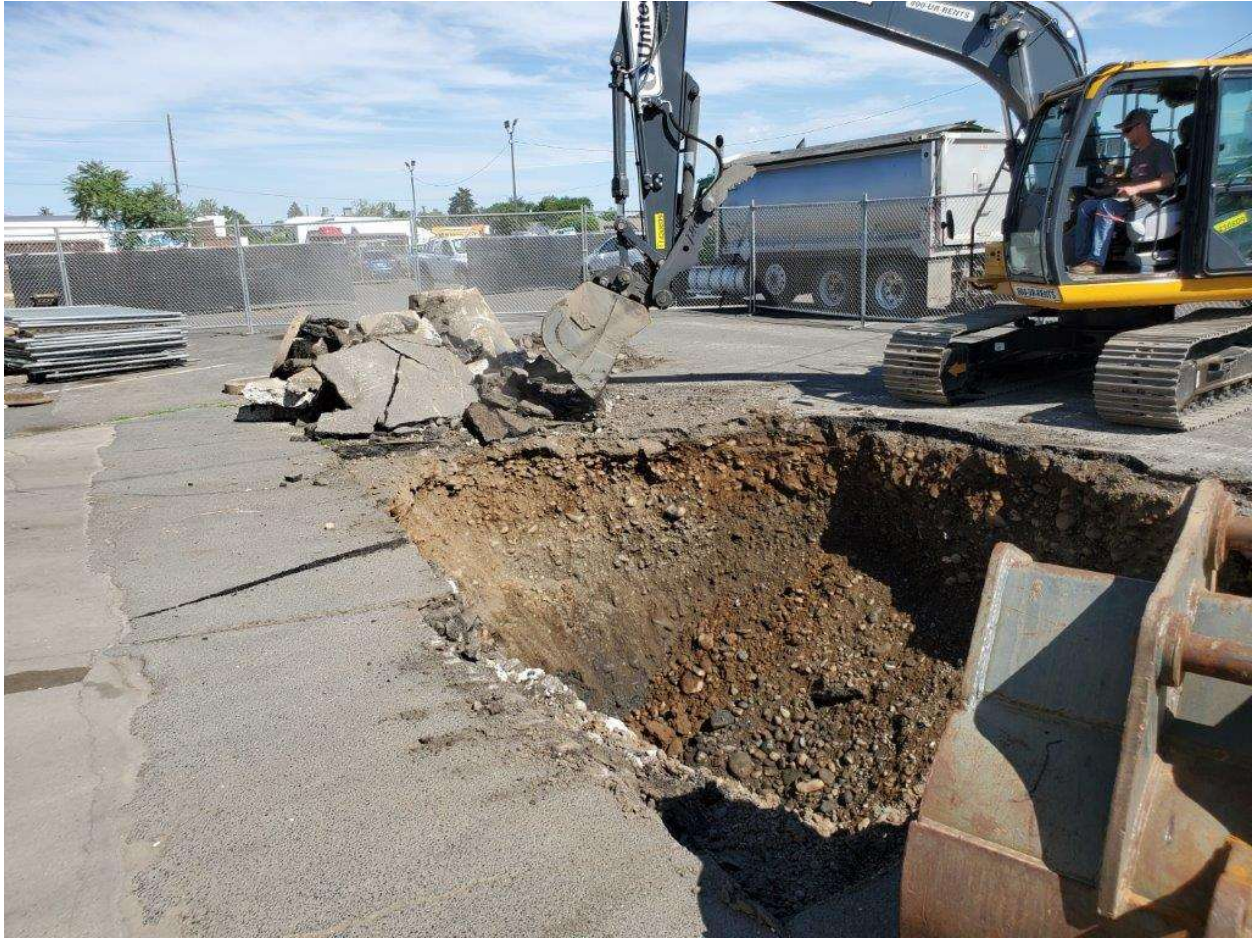
Photogrpah 16 – Clarke Construction continuing excavation to east toward Dry Well 2 on July 12, 2022 (facing east).

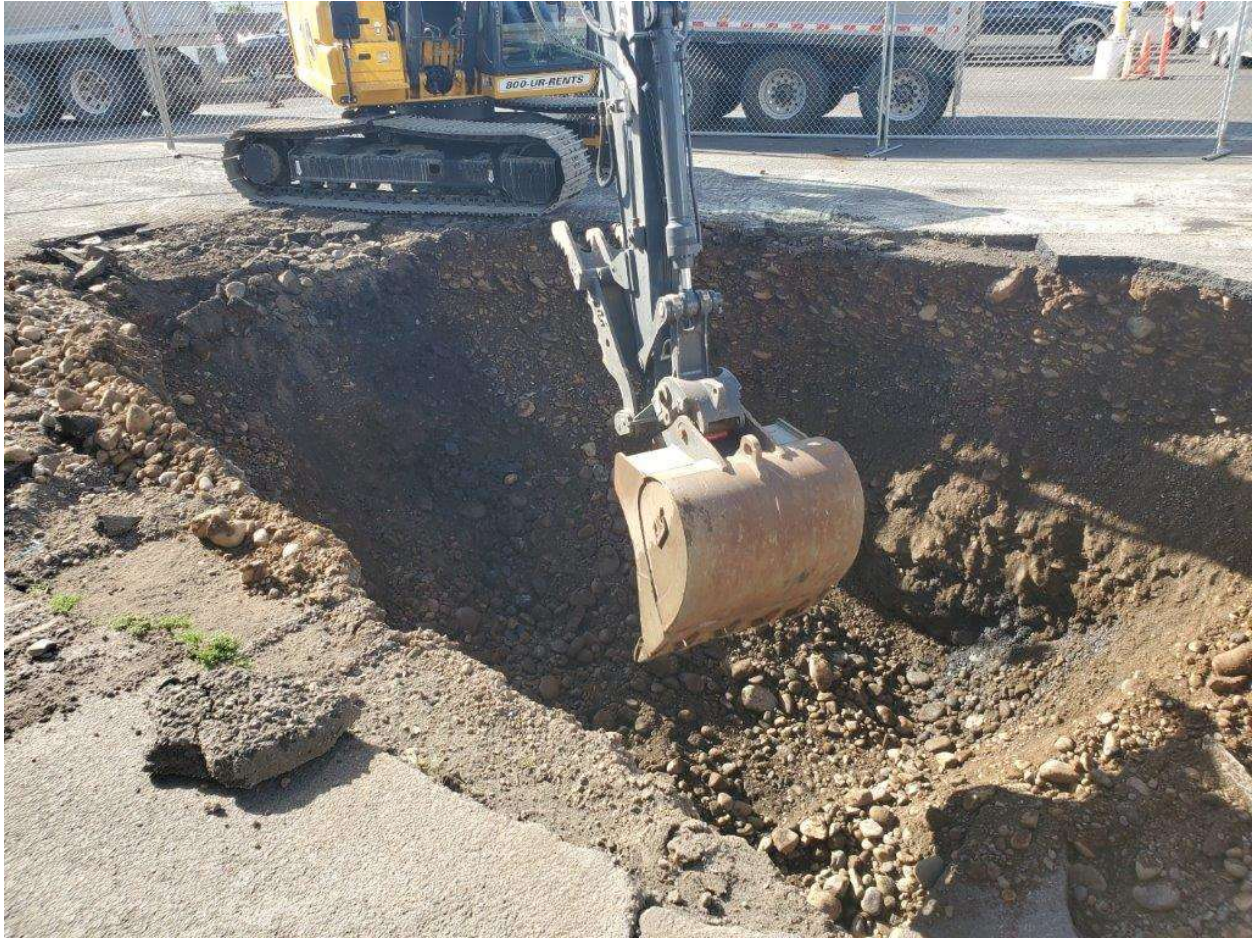
Photograph 17 – Further excavation to east toward Dry Well 2 on July 13, 2022 (facing south).

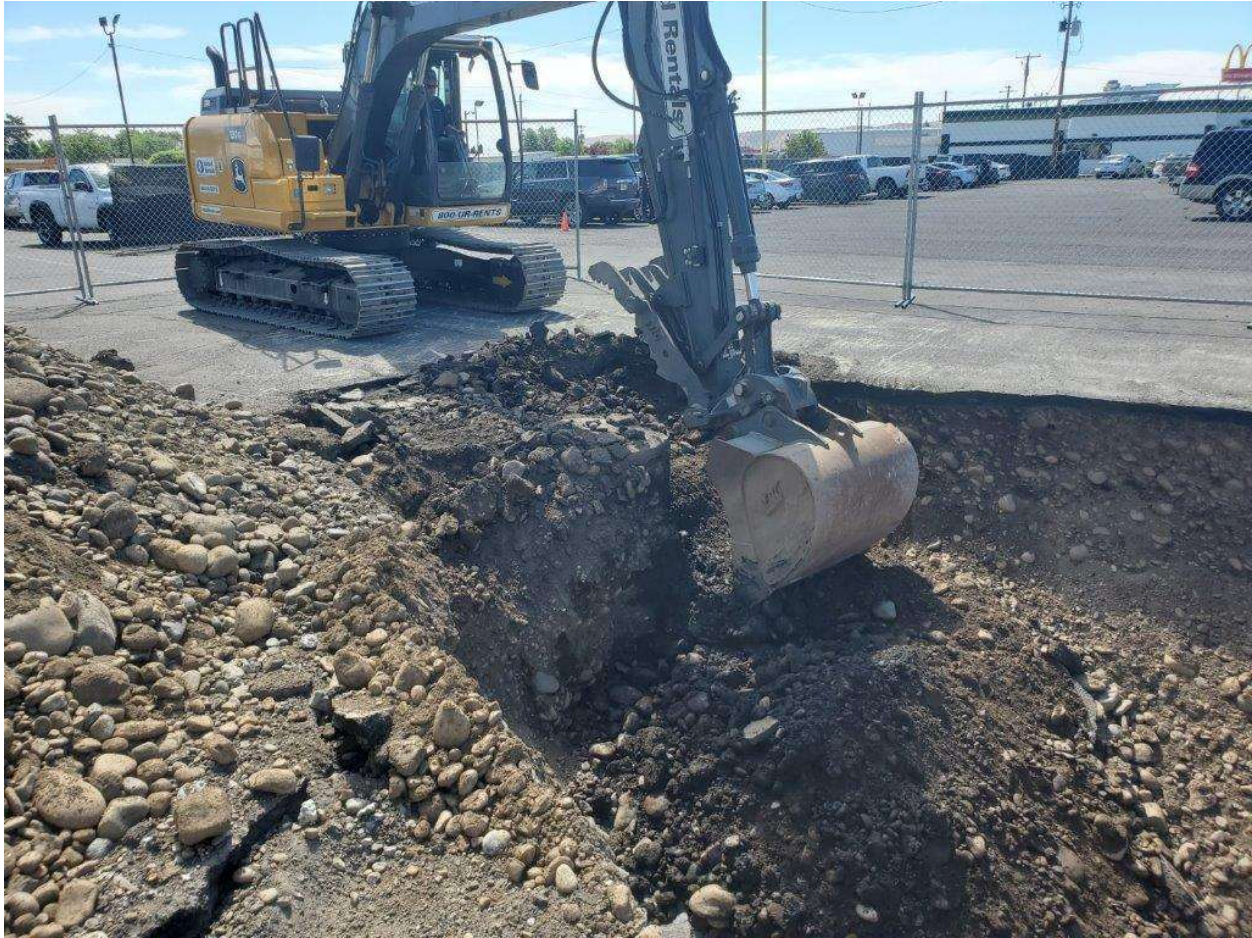
Photograph 18 – Continued excavation toward Dry Well 2 on July 13, 2022 (facing SE).

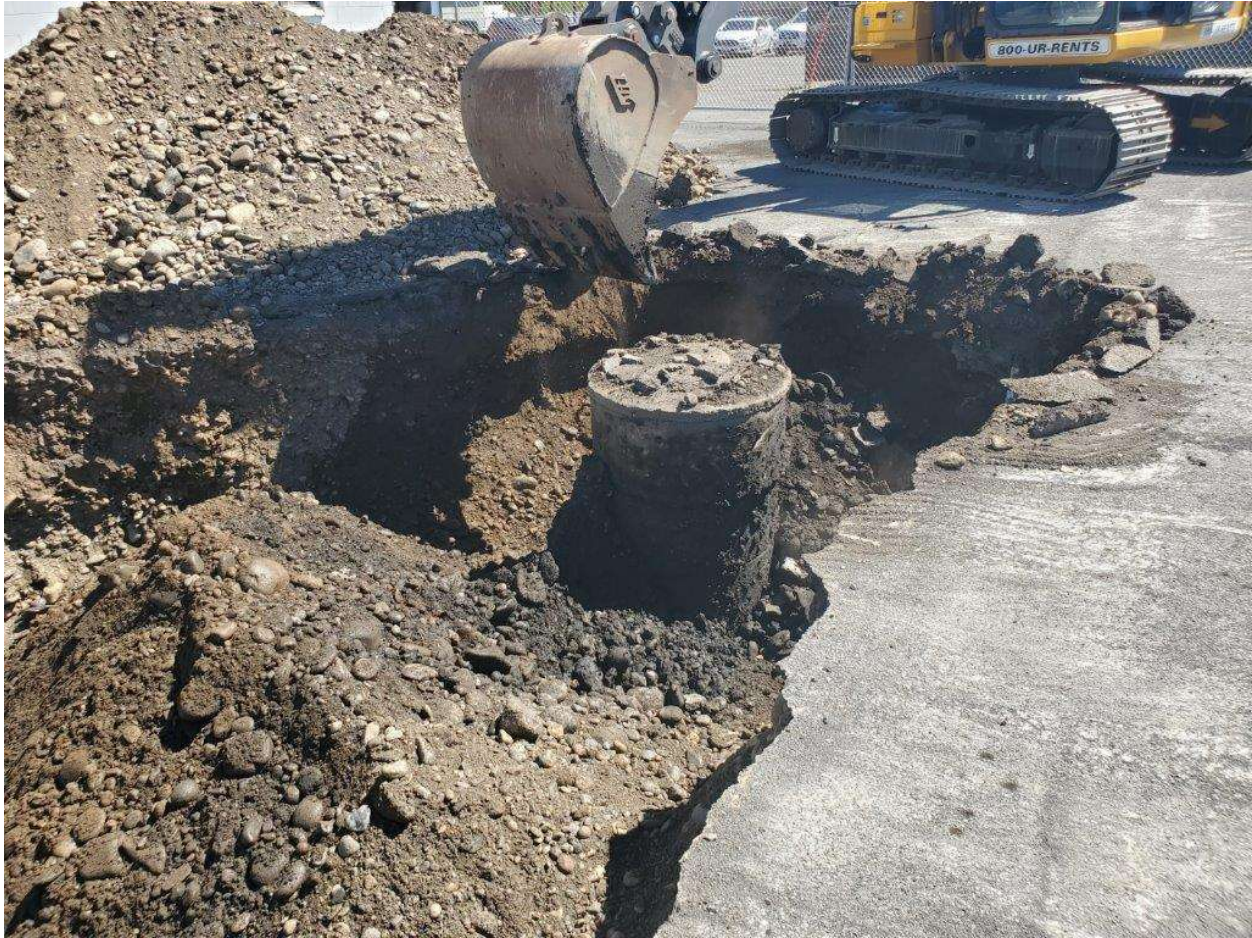
Photograph 15 – Dry Well 2 exposed during PCS excavation on July 13, 2022 (facing SE).
