DRYWELL DECOMMISSIONING AND CONTAMINATED SOIL REMOVAL REPORT

**HAHN MOTOR COMPANY
1201 SOUTH 1ST STREET
YAKIMA, WASHINGTON 98901**

**Facility Site ID No. 502
Cleanup Site ID No. 4927
VCP Project No. CE0529**

July 28, 2022

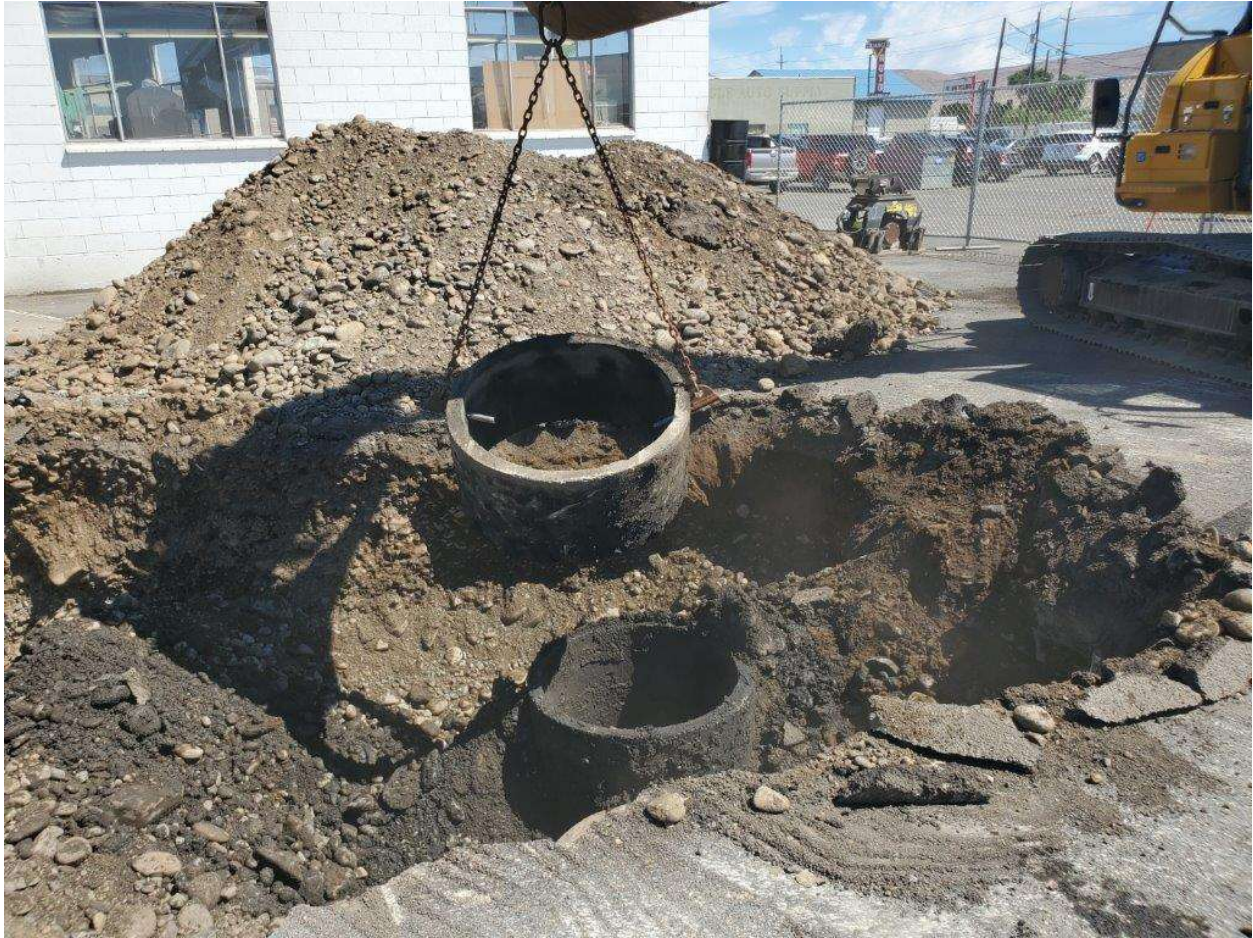
Photograph 16 – Beginning removal of Dry Well 2 on July 13, 2022 (facing NE).

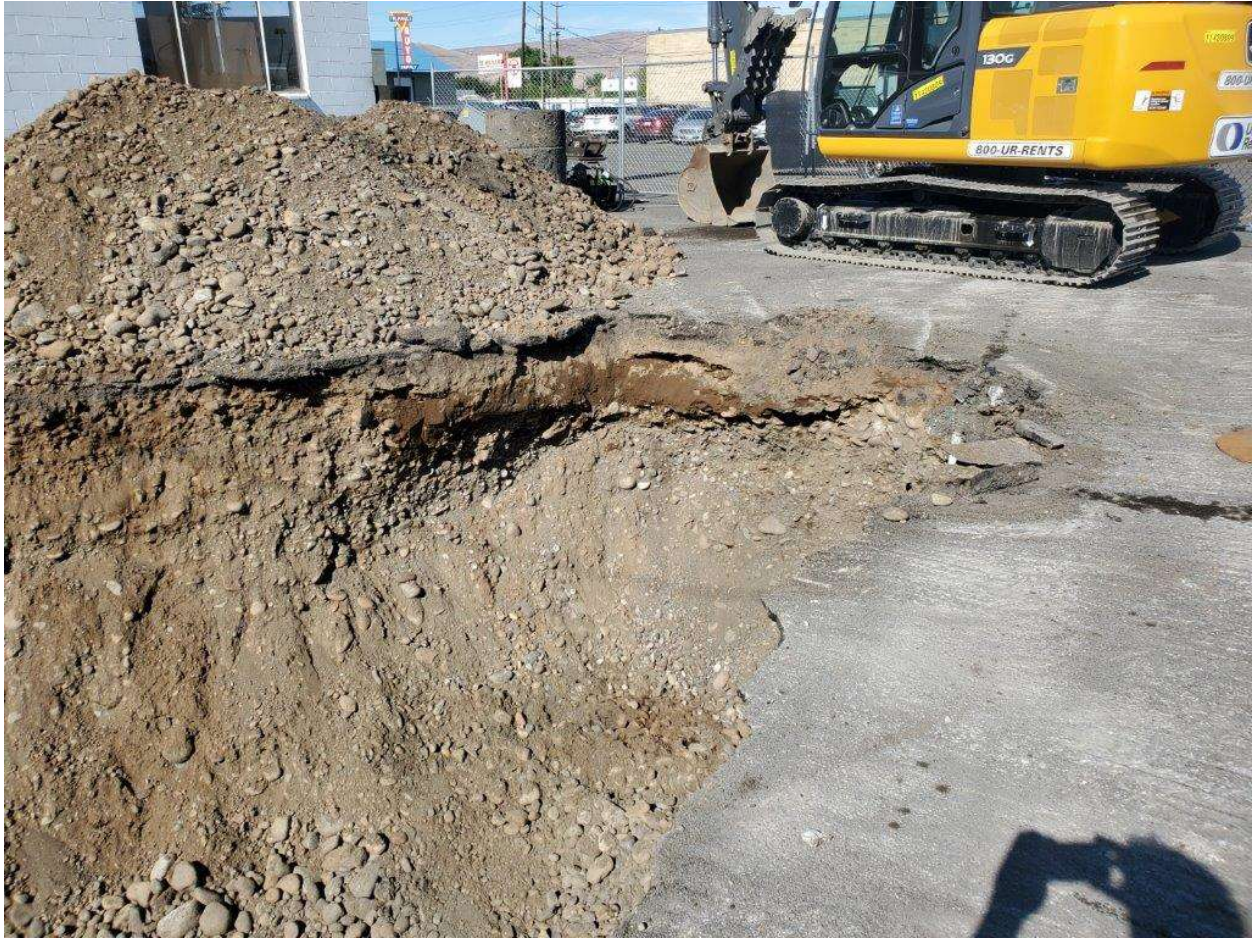
Photograph 17 – Eastern extent of PCS excavation trench on July 13, 2022 (facing NE).

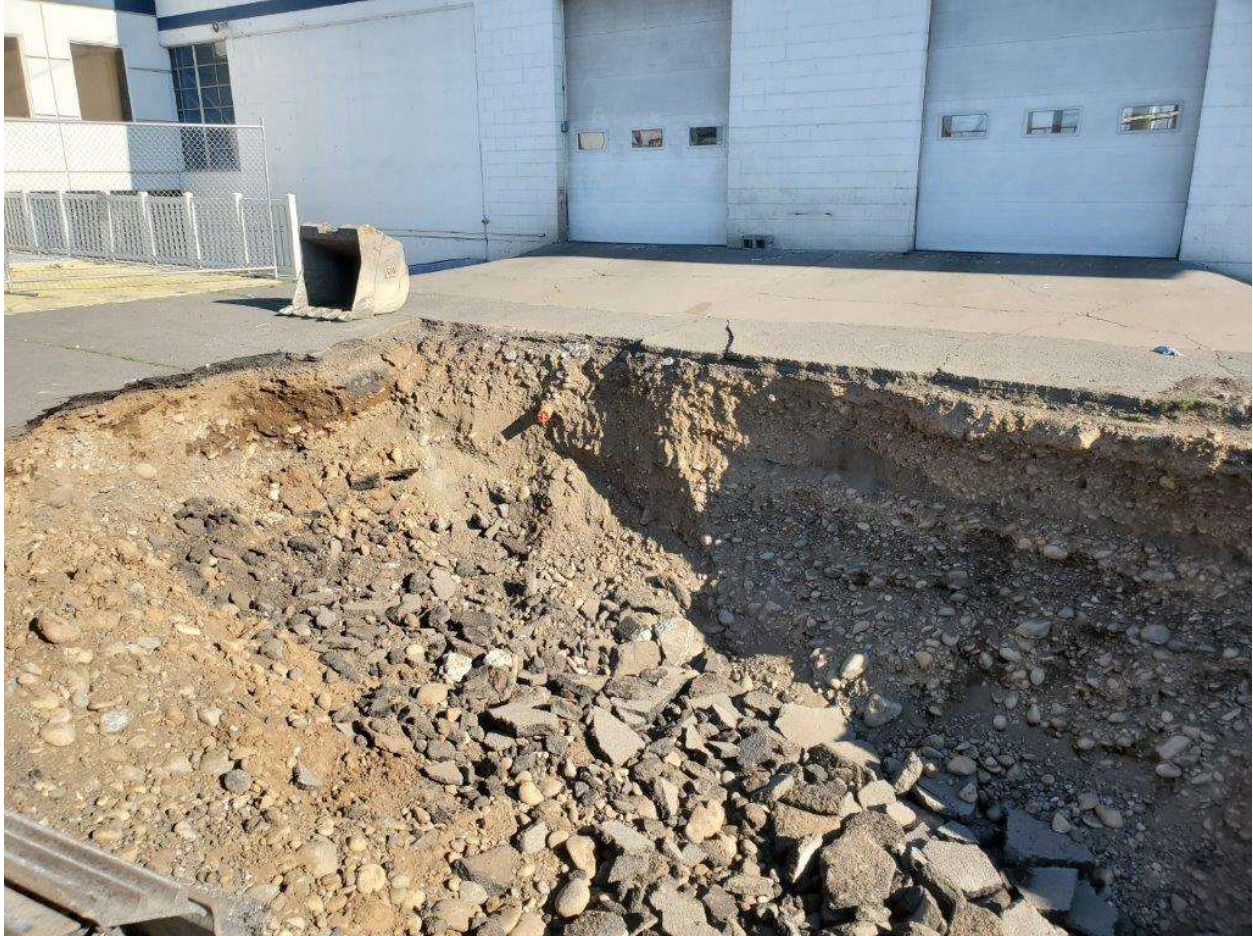
Photograph 18 – Western extent of PCS excavation trench on July 13, 2022 (facing NW).

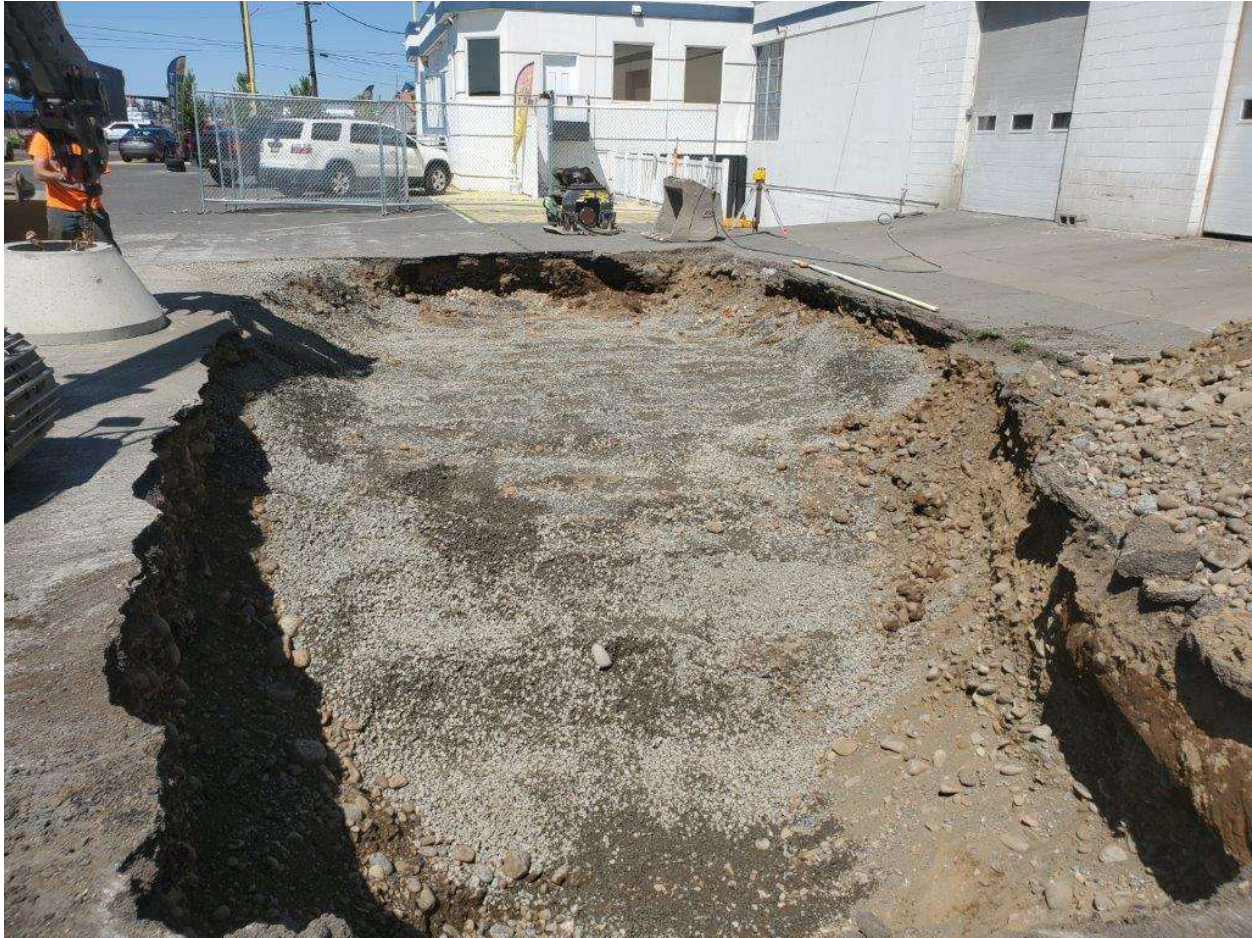
Photograph 19 – Subsequent to receipt of laboratory analysis indicating clean confirmatory soil samples, backfill and compaction on July 14, 2022 (facing west).

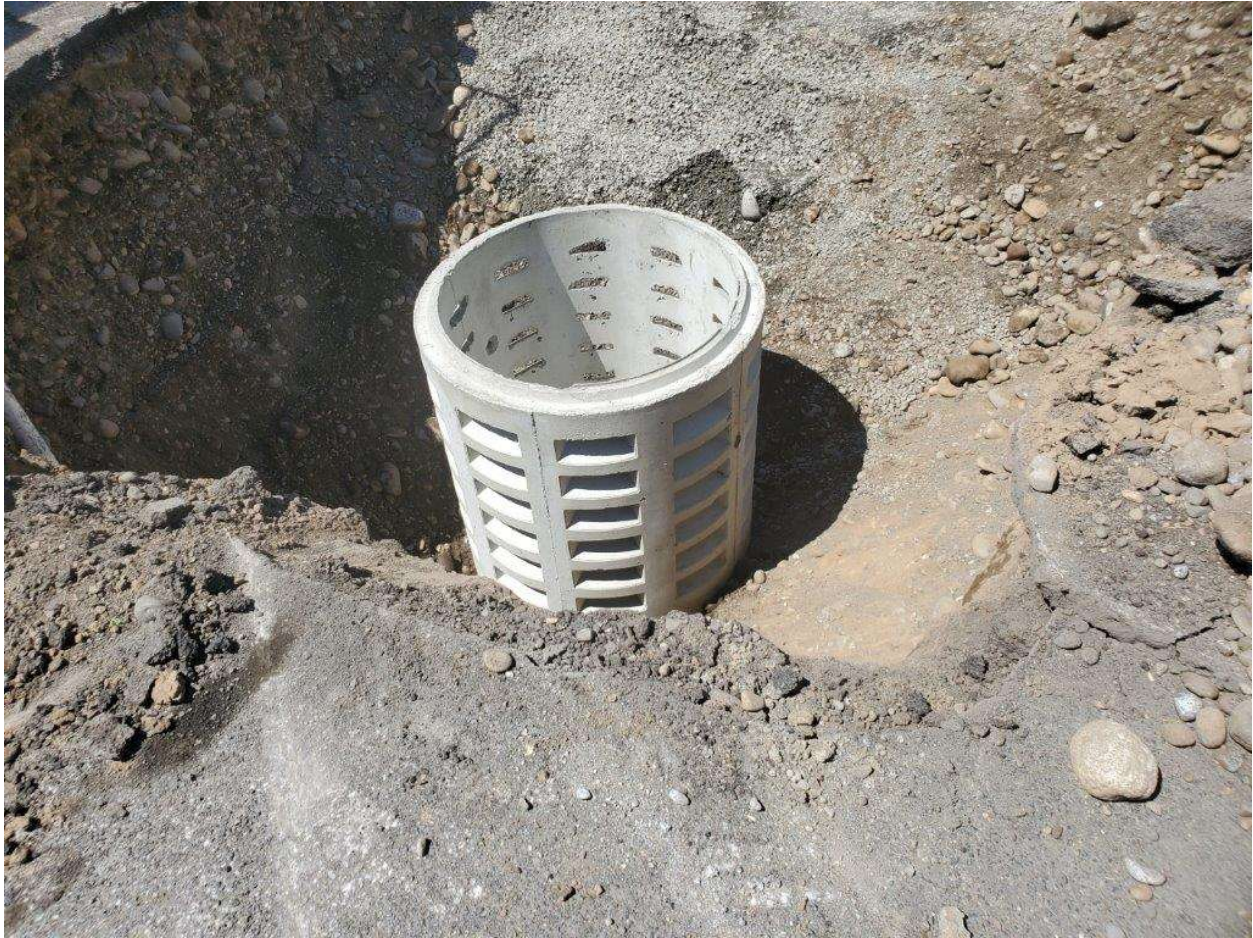
Photograph 20 – New Dry Well being installed near location of former Dry Well 2 on July 14, 2022.

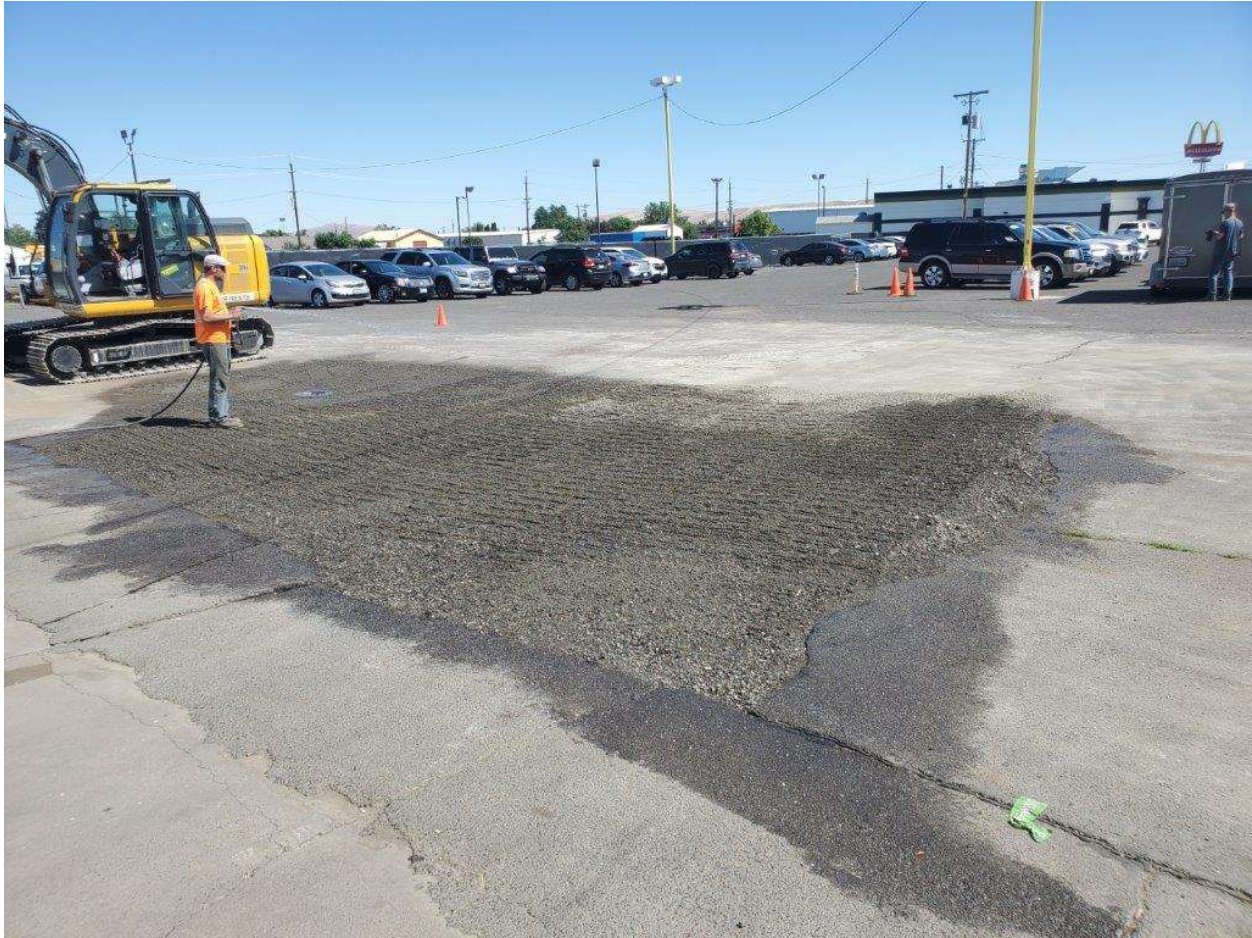
Photograph 21 – View of excavation area after dry well install and backfill, followed by compaction on July 14, 2022 (facing SE).

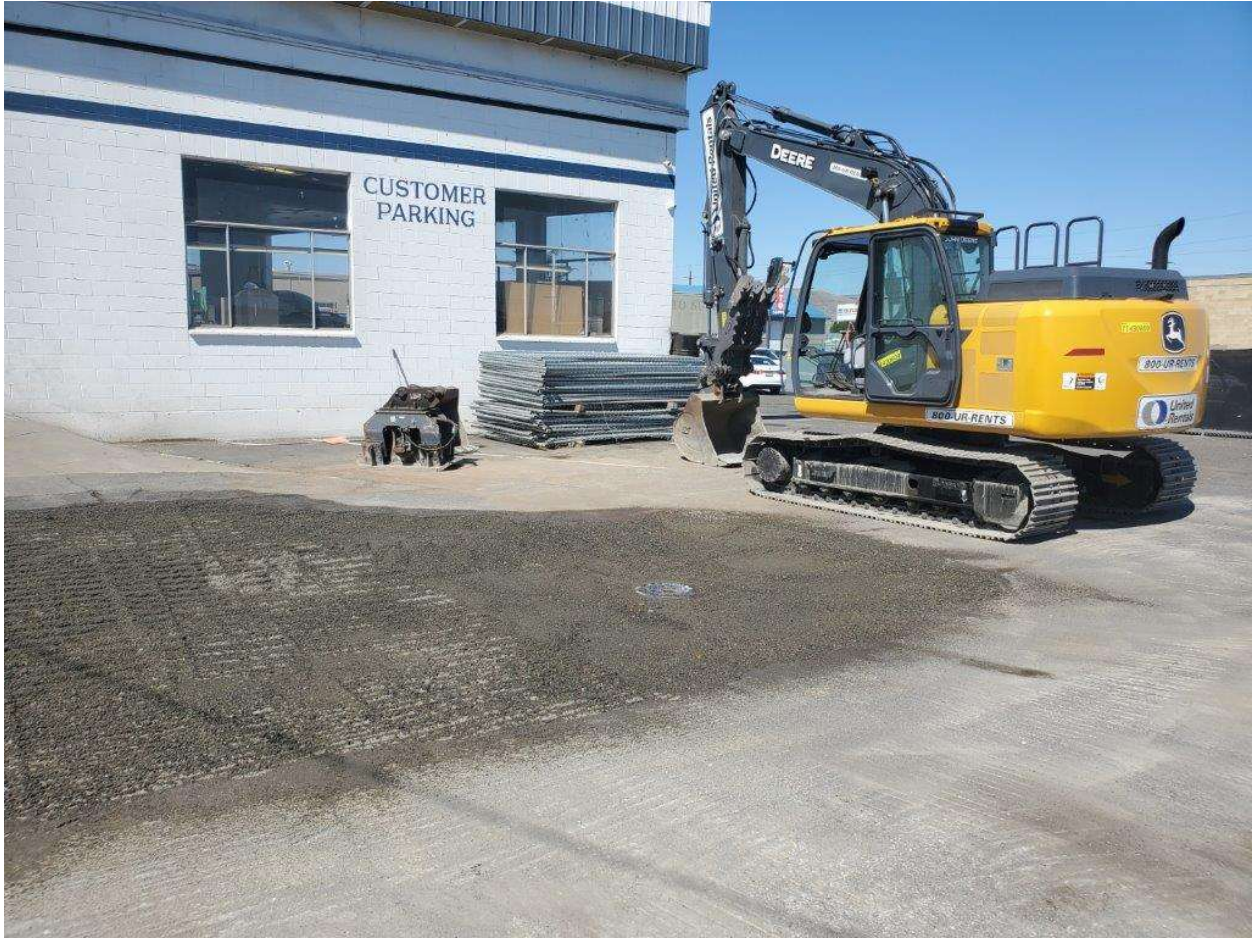
Photograph 22 – View of new dry well installed on July 14, 2022 (facing NE).
