RE: F/V Sundance, Inc. Diesel Fuel Spill Remediation Project
Pacific Marine Center
2601 T Ave., Anacortes, WA 98221

VOLUNTARY CLEANUP REPORT

WDOE ERTS # 712977

Diesel Fuel Spill Remediation Project

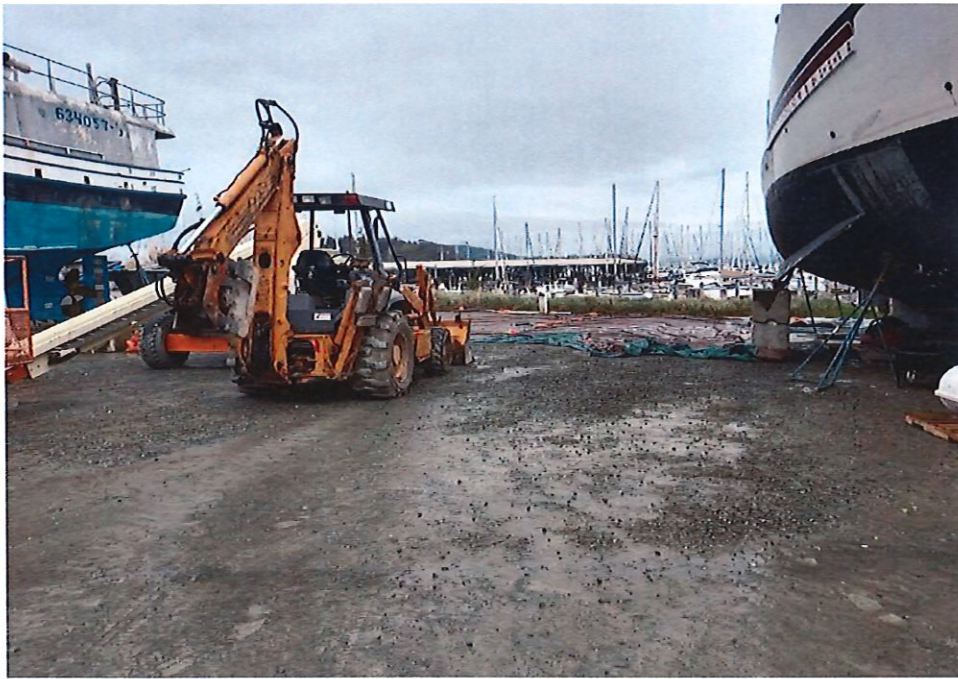
1. Looking east at spill area prior to remediation project. Note the spill area covered with poly sheeting.

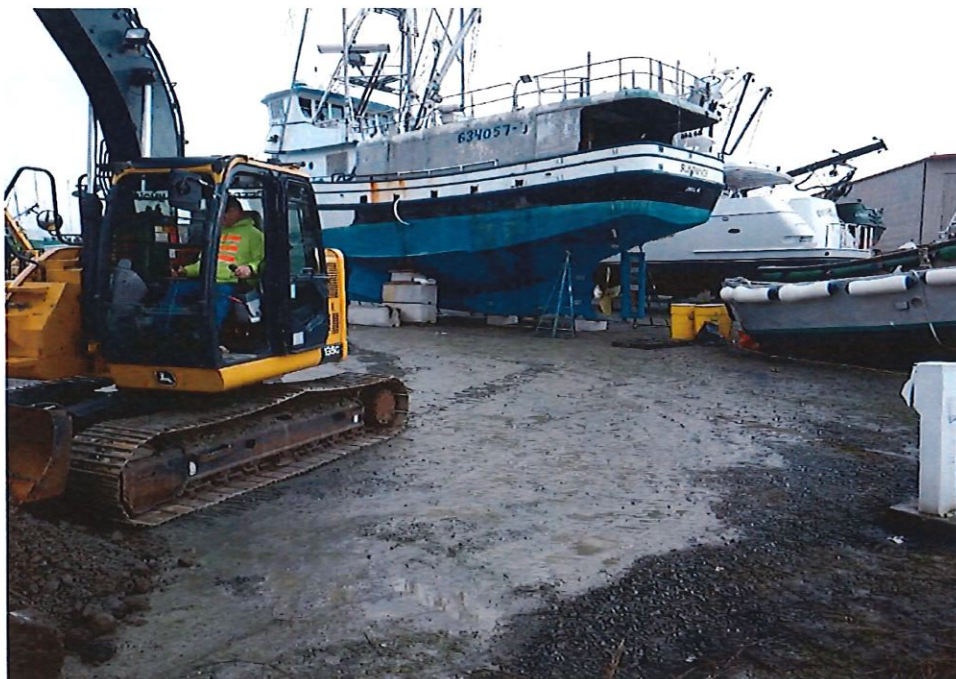
2. Looking north at the start of the PCS excavation in the south end of the spill area. Note the fuel stains on the east end of the Sundance vessel scuppers.

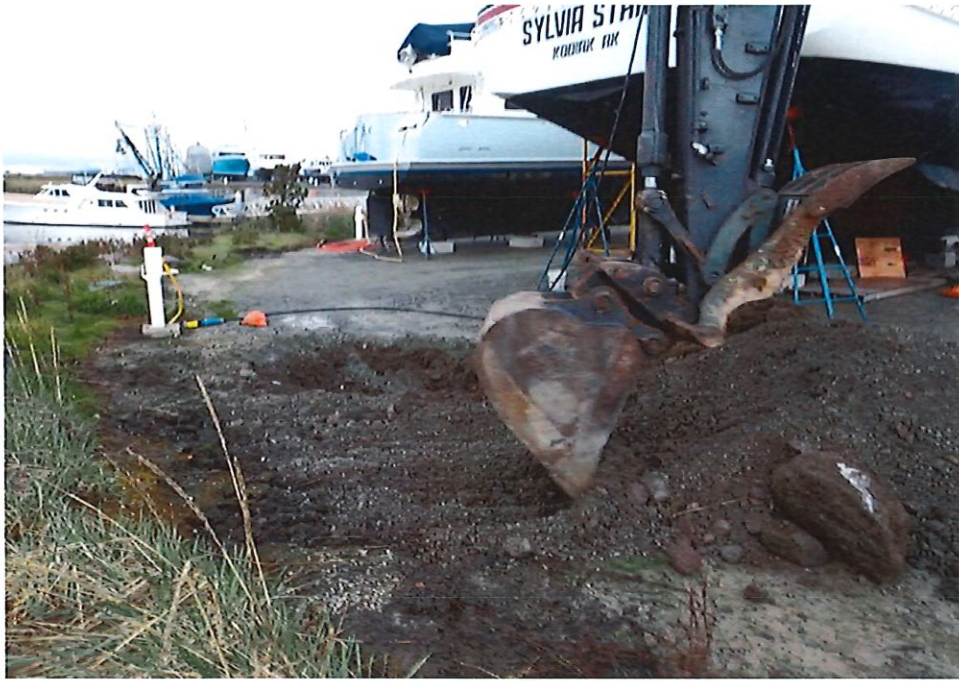
3. Looking south as excavation continues north toward vessel.

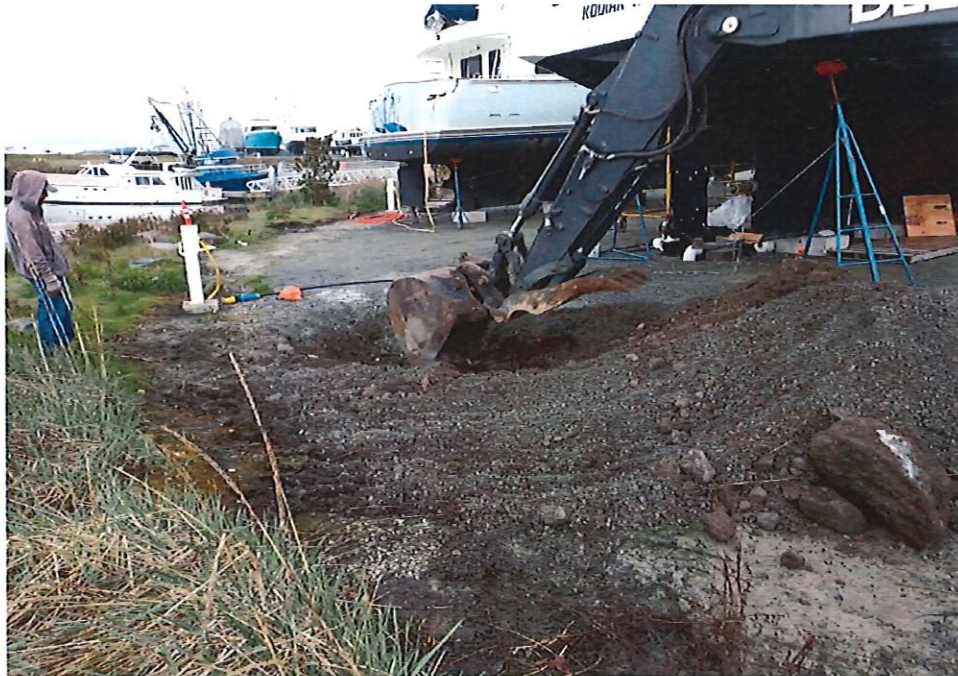
4. Looking south at the approximate middle of remediation area. The southerly 30' dug to an approximate depth of 3 ½'. One area, approximately 16' from south end, excavated to a depth of 6'.

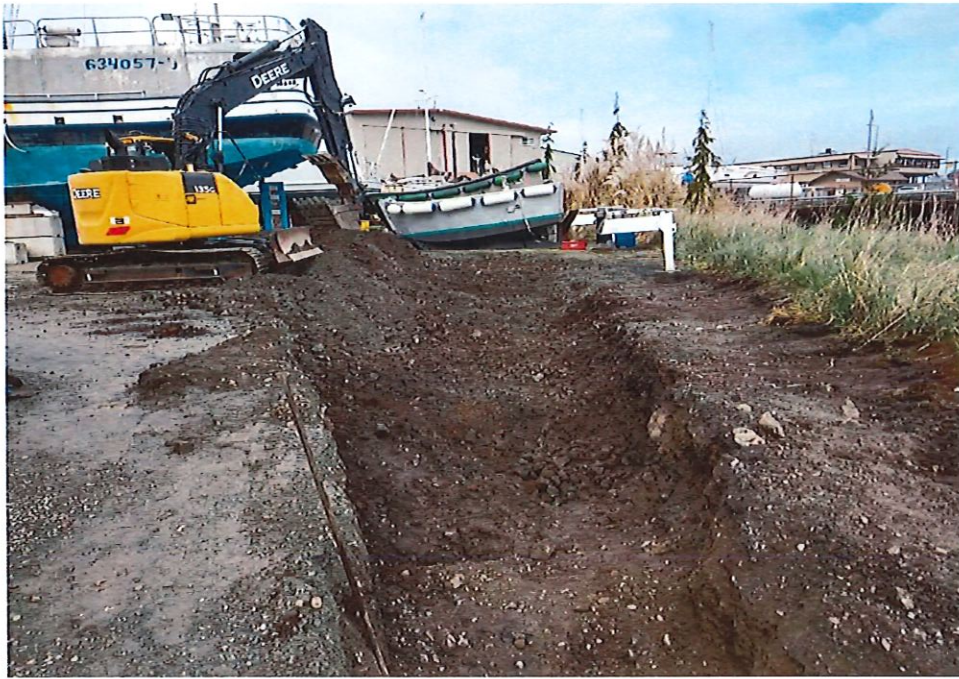
5. Looking north at remediation area. The final northerly 30' of the spill area was limited to an approximate excavation depth of 8" – 12". The original spill occurred during a cold, snowy and frozen February time frame. It is speculated that the spill traveled over the frozen ground. Because of the quick emergency response by Northern Environmental, any fuel puddling was limited to the southern area of the spill.

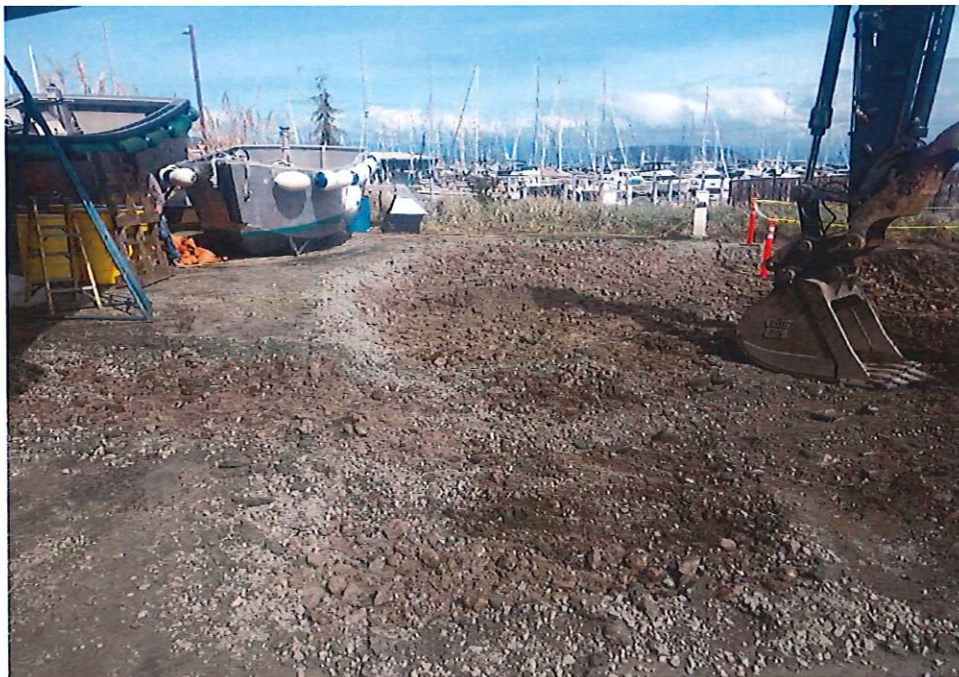
6. Looking east at the final remediation area. Final area measured approximately 61' X 42', in addition to a small 9' X 7' area directly under the spill source.

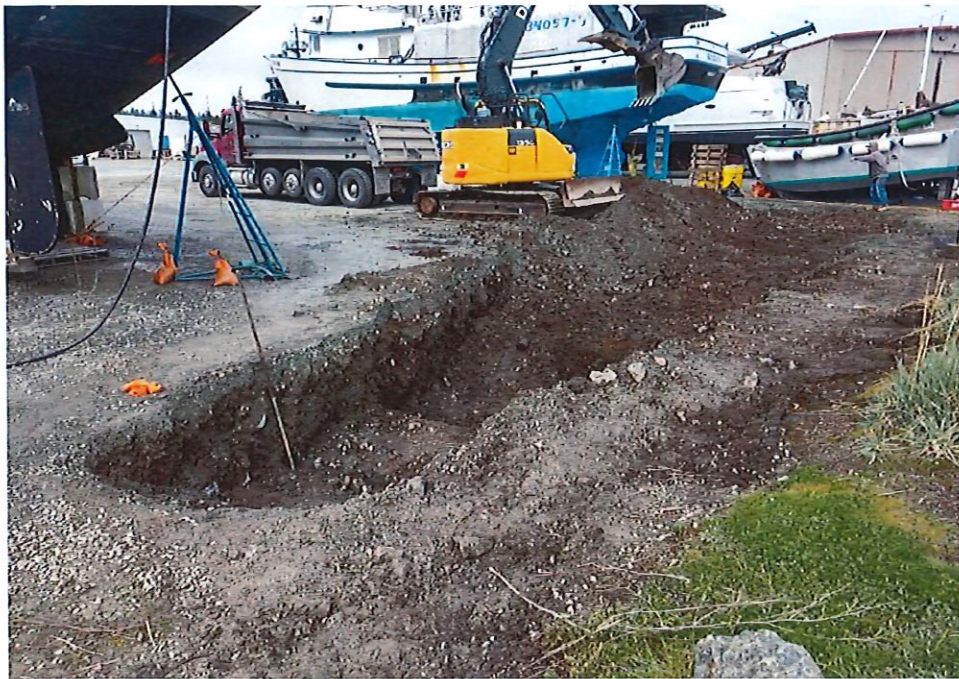
7. All PCS was loaded directly into dump trucks for hauling and disposal at the licensed Cadman thermal desorption facility in Everett, WA.

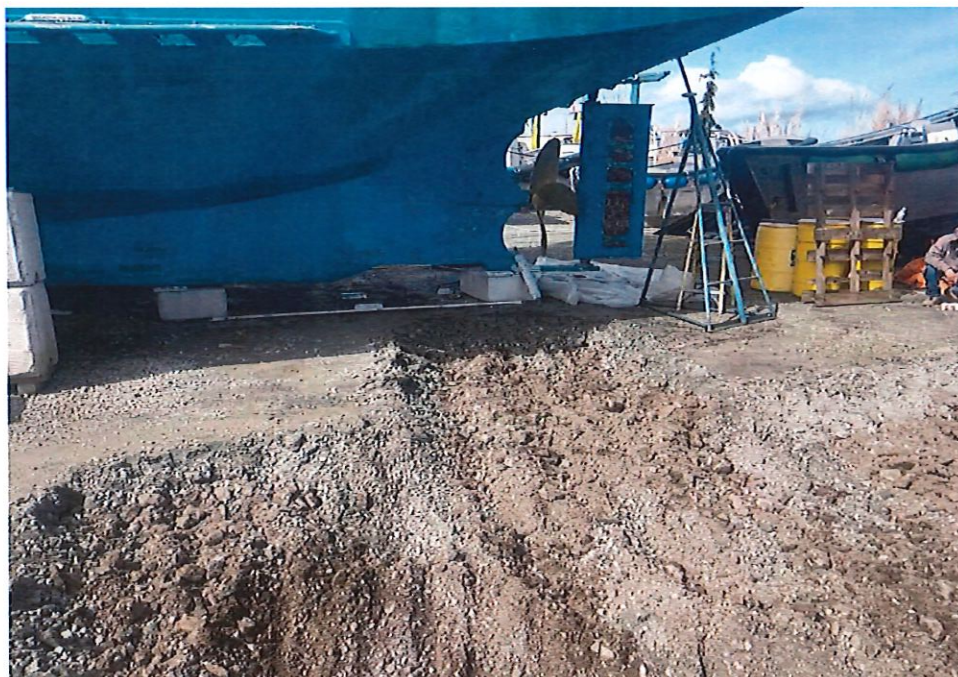
8. Looking north at the excavation area directly under the vessel scuppers (original spill area).

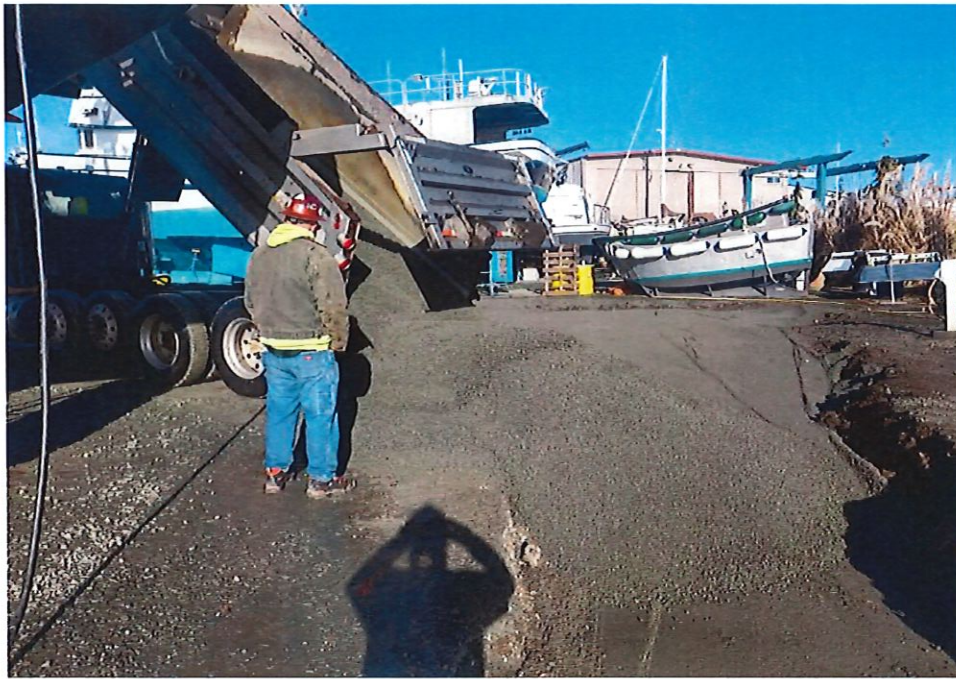
9. Following receipt of confirmation soil sample analytical, the excavation area was backfilled and compacted with clean crushed rock material.
