## INCIDENT REPORT

**Reference:** Incident Report - US Ecology Project No. 180279 – Site Location: 731 F St SE, Quincy, WA

Site Diagram  
for  
Pape Machinery Hydraulic Oil Spill  
USE Project # 180279  
6/30/22

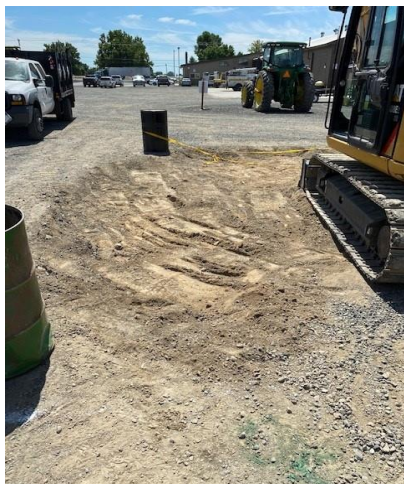
| <b>Photo No.</b> | 1 |

| <b>Description:</b> | Site upon completion of excavation. |

| Start: | | 6/24/2022 | Finish: | 6/30/2022 |
|---|---|---|---|---|
| 6/30/2022 | 0930 | With locates completed, USE returned to the site to conduct excavation operations. USE personnel utilized an excavator and hand tools to remove the hydraulic oil impacted soils. This material was placed into a dump truck for disposal. USE personnel conducted field screening operations to determine that the extent of the impacts had been removed. Confirmation soil samples were then collected. USE personnel then secured the excavation area as requested. | | |

During this response, 15.65-tons of hydraulic oil impacted soil and debris was removed from the site. Upon reviewing the results of confirmation sample data there is no evidence of any hydraulic oil impacted soil that is above the Washington State Department of Ecology MTCA regulations at the time of sampling.

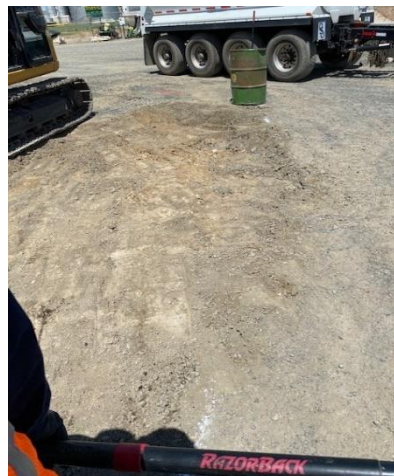
| <b>Photo No.</b> | 2 |

| <b>Description:</b> | Site upon completion of excavation. |

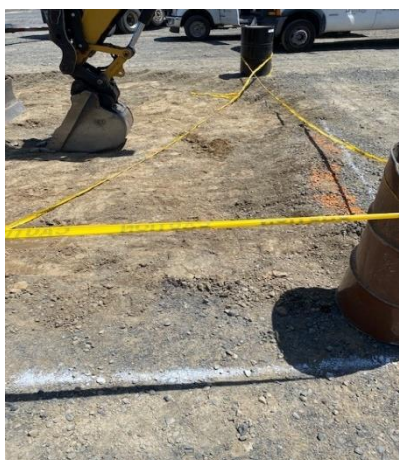
| <b>Photo No.</b> | 3 |

| <b>Description:</b> | Site upon completion of excavation. |

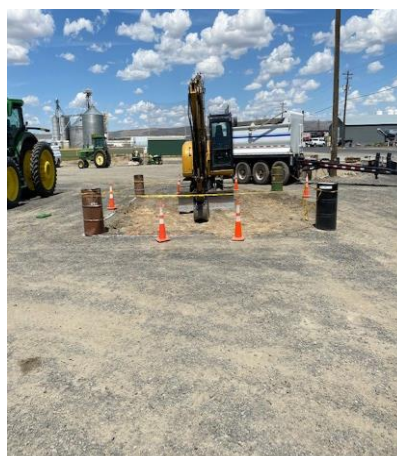
| <b>Photo No.</b> | 4 |

| <b>Description:</b> | Site upon completion of excavation. |
