# REMEDIAL ACTION COMPLETION REPORT PHASE 1 – FINAL

Time Oil Bulk Terminal  
Seattle, Washington

August 8, 2022

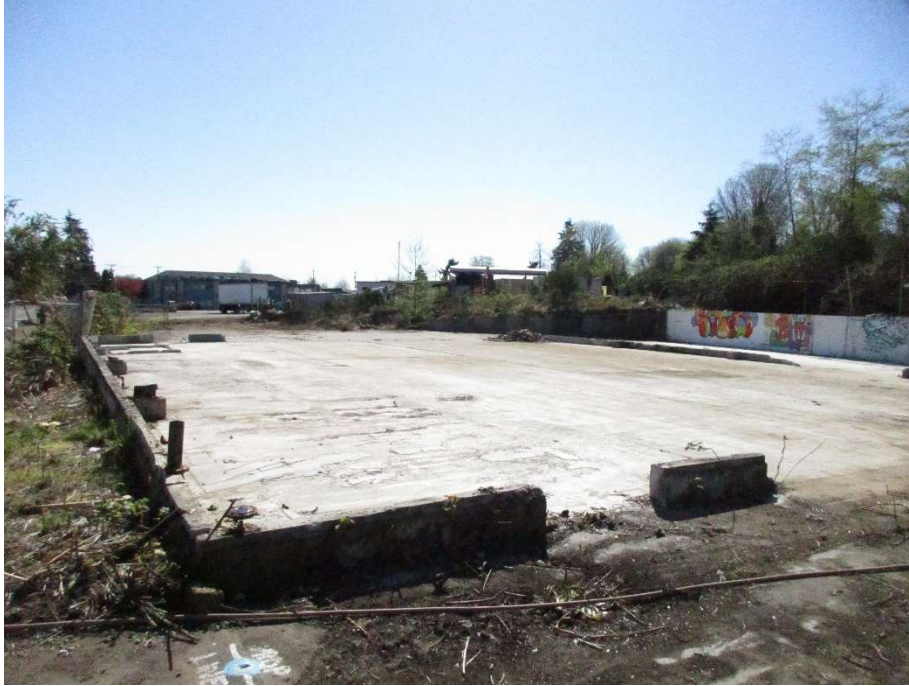
1. ASKO warehouse foundation pad. Warehouse demolition debris and steel hauled off. View to southeast. Photograph from 4/16/21

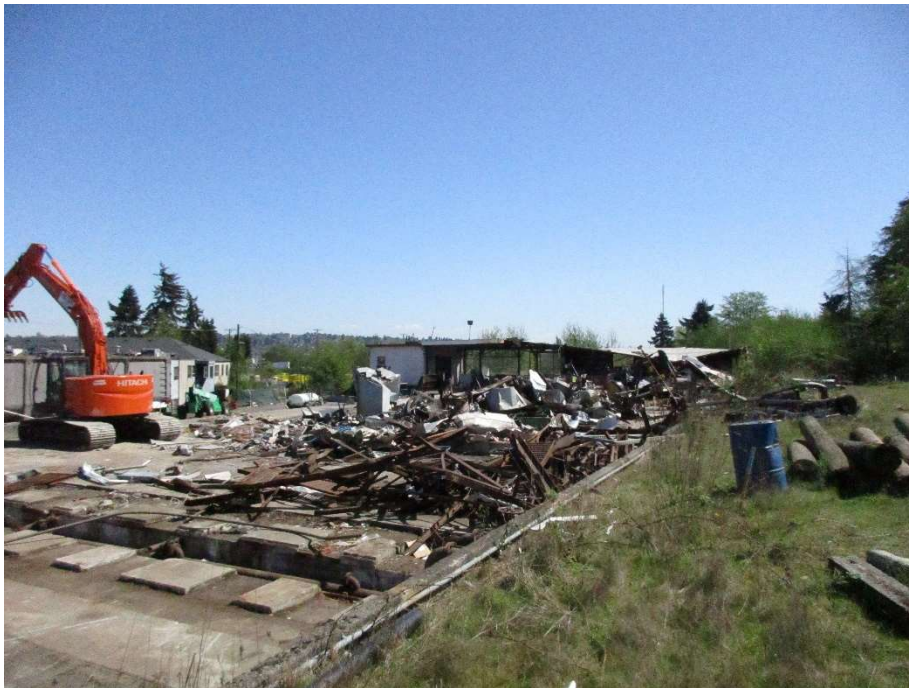
2. Building 2 (Parcel E) demolition underway. View to northeast. Photograph from 4/20/21.

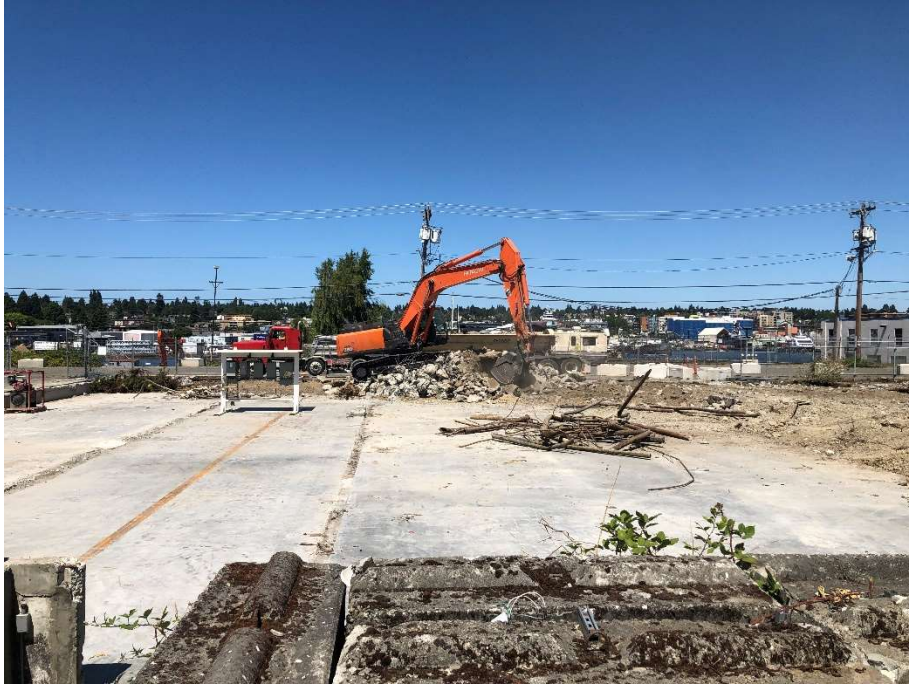
3. Concrete removal at CAA-2 (area preparation).  
View to the north. Photograph taken 7/29/2021.

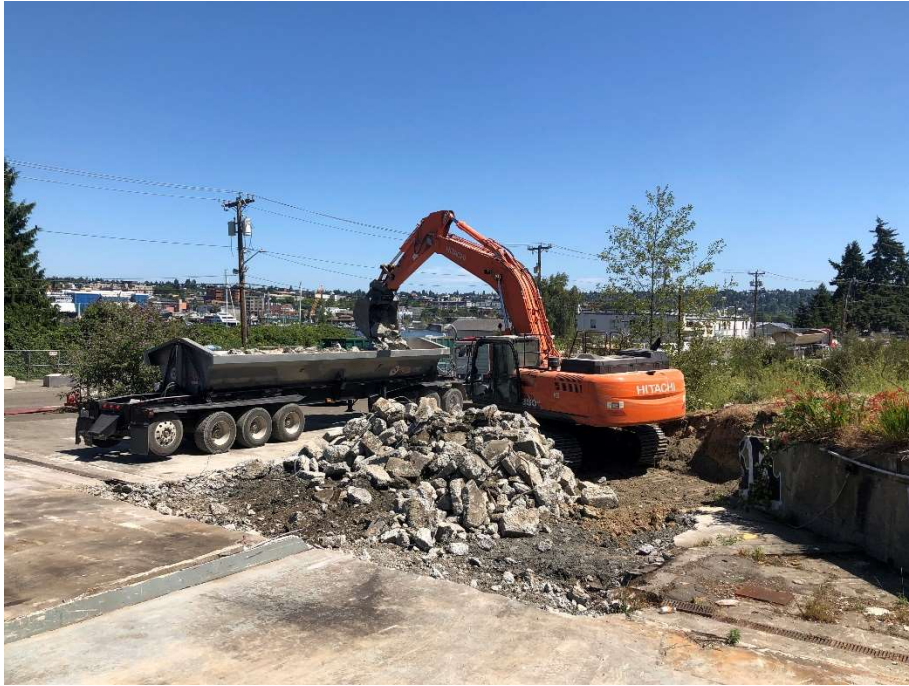
5. Concrete hauling and recycling at CAA-5 (site preparation).  
View to the northeast. Photograph taken 7/29/2021.

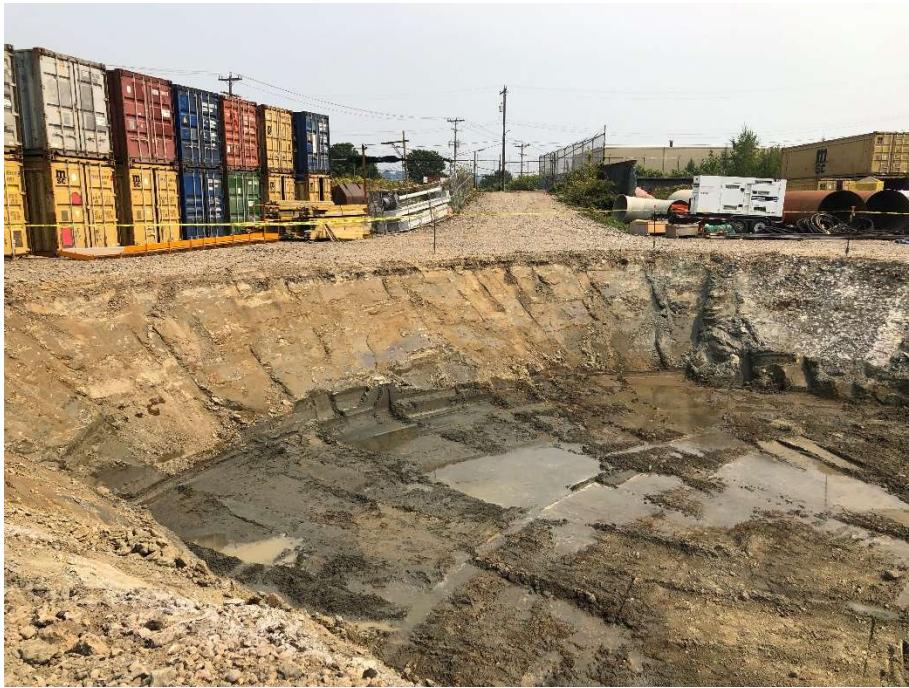
7. CAA-1b excavation. View to the east.  
Photograph taken 8/13/2021.

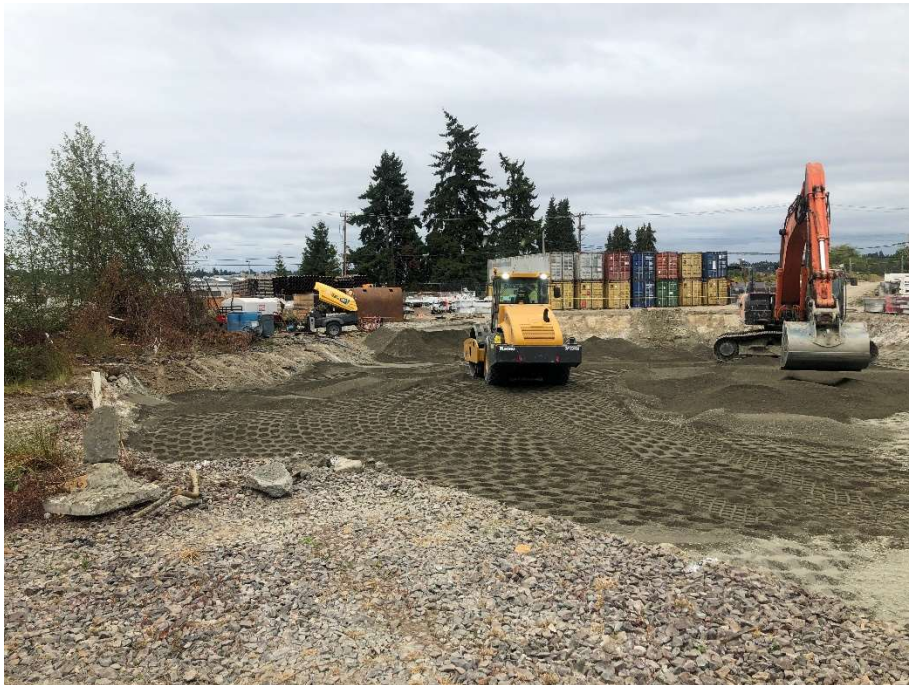
8. CAA-1a - Backfilling and compacting gravel borrow at CAA-1a.  
View to the northeast. Photograph taken 8/20/2021.

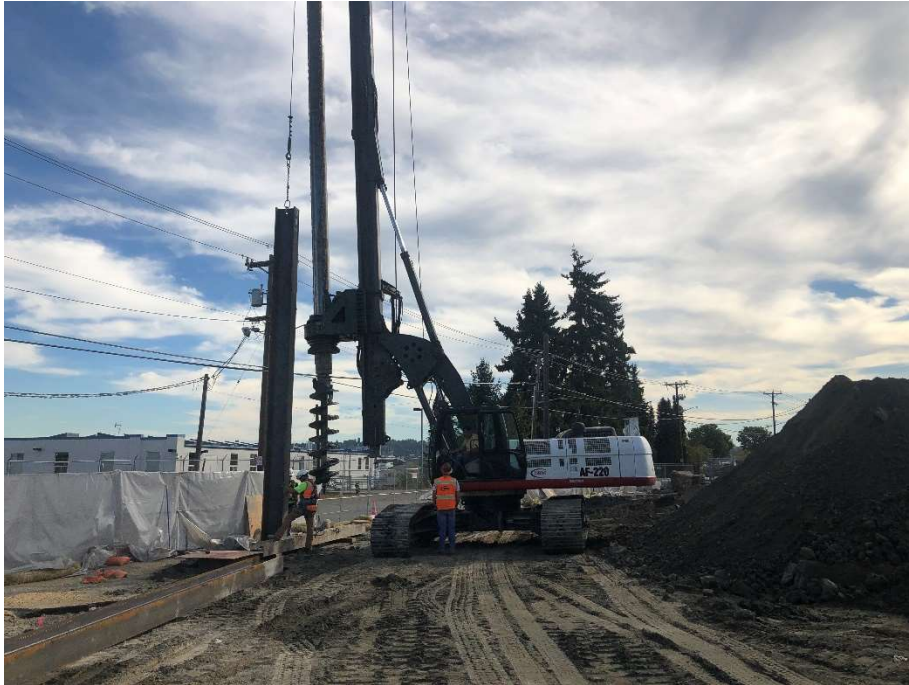
9. Installing soldier pile steel beams at CAA-2b/ROW.  
View to the east. Photograph taken 9/9/2021.

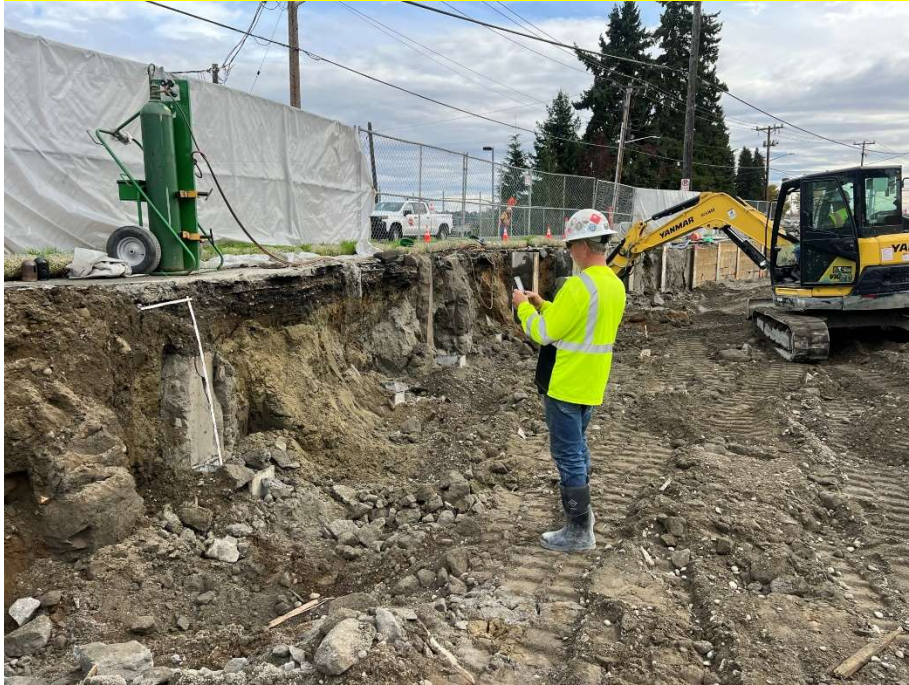
13. CAA-2b ROW area, measuring cut soldier piles for SDOT inspector.  
View to the northeast. Photograph taken 10/21/2021.

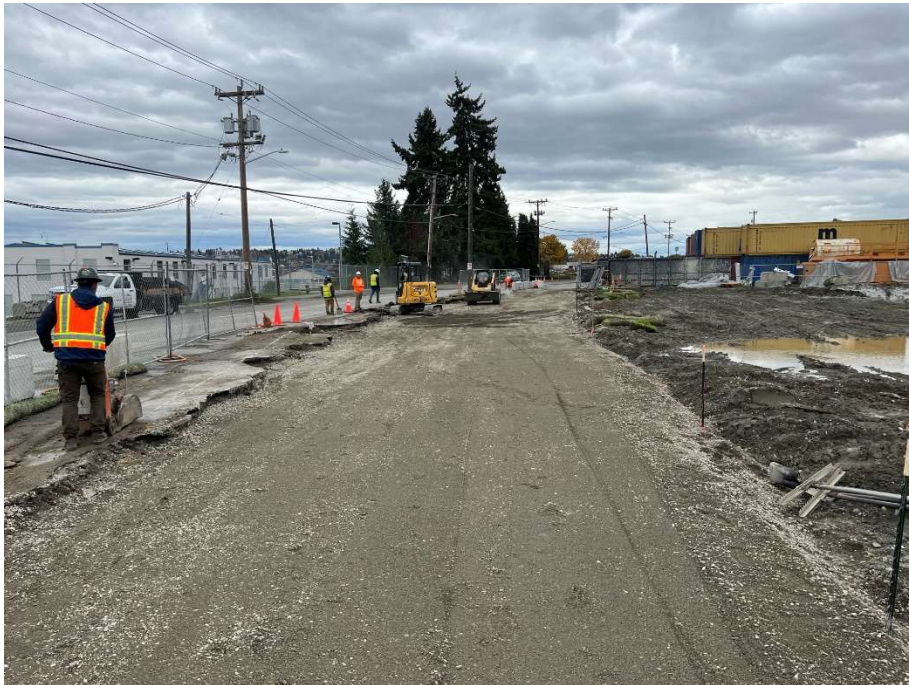
14. CAA-2b ROW area, laying down and grading baserock for asphalt.  
View to the east. Photograph taken 10/25/2021.

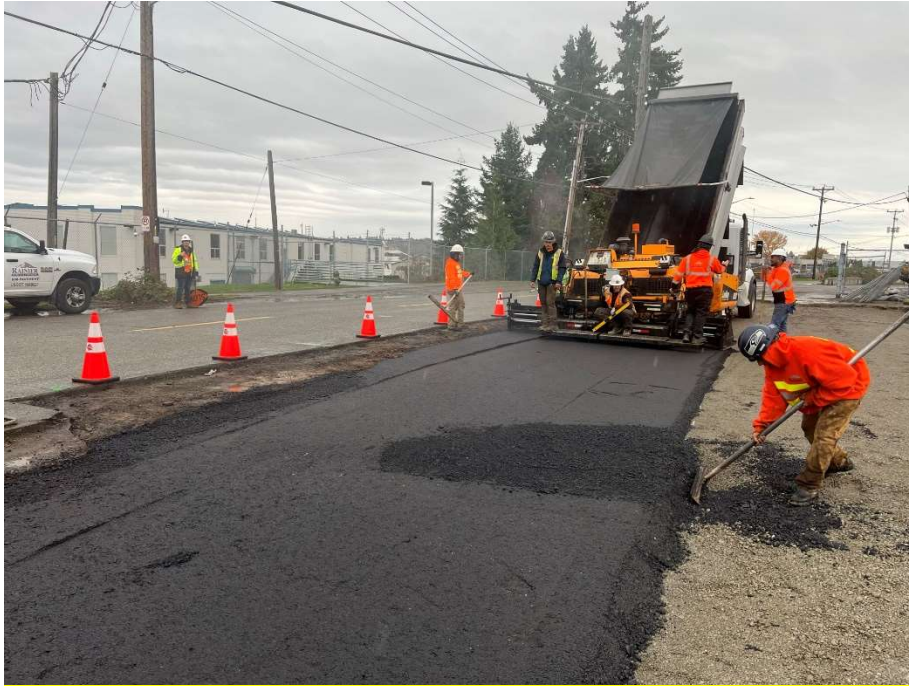
15. Rainer Asphalt & Concrete laying down hot mix asphalt at ROW of CAA-2b.  
View to the east northeast. Photograph taken 10/26/2021.

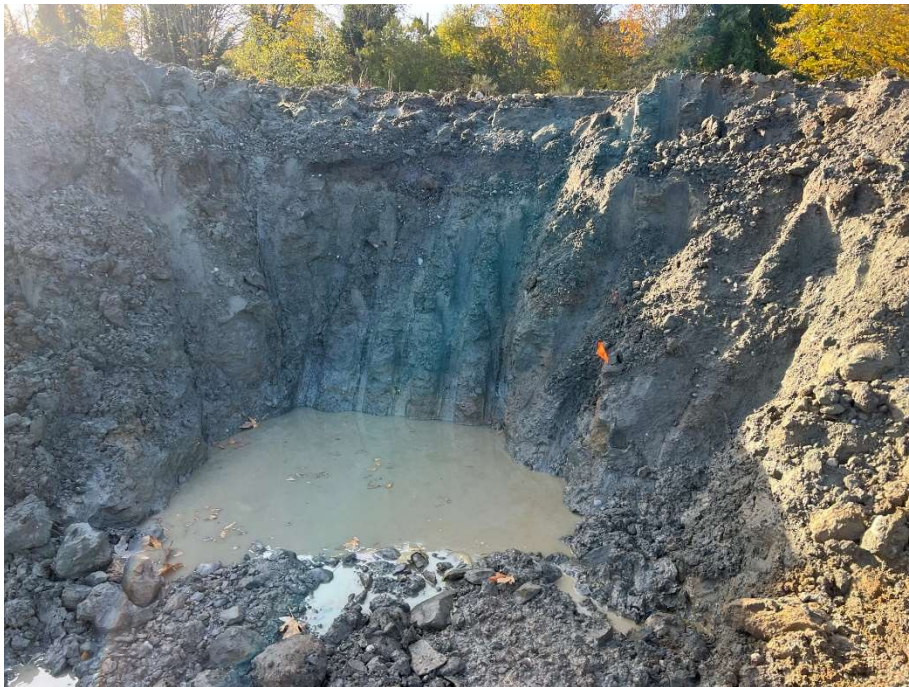
16. CAA-3, pin flag at CAA3-SS-04 confirmation wall sample location (surface water collected at the bottom of the excavation).View to the south. Photograph taken 11/9/2021.

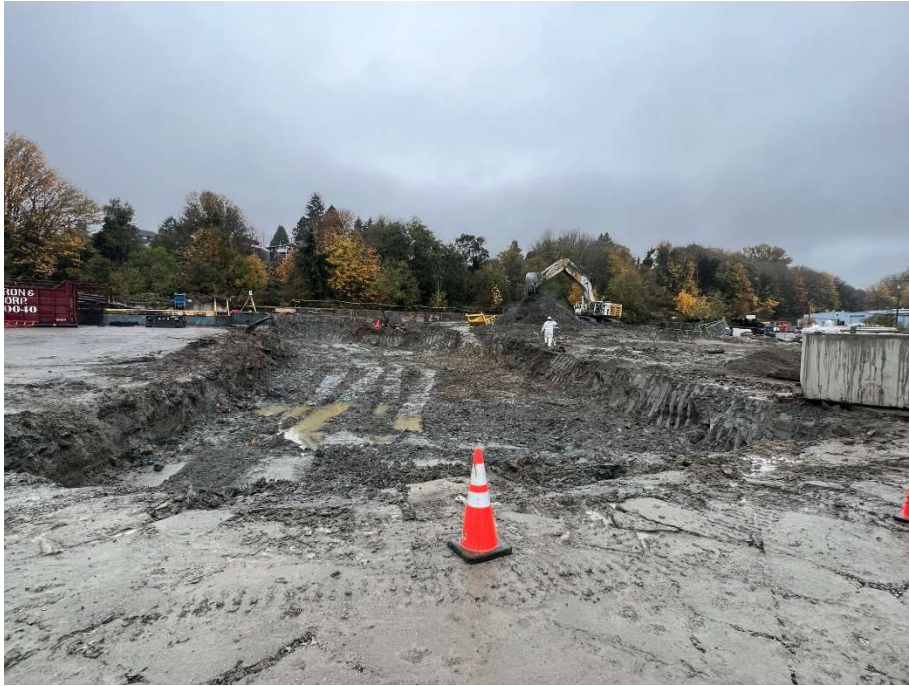
17. CAA-3, excavation completed, post-excitation survey underway.  
View to the south. Photograph taken 11/11/2021.

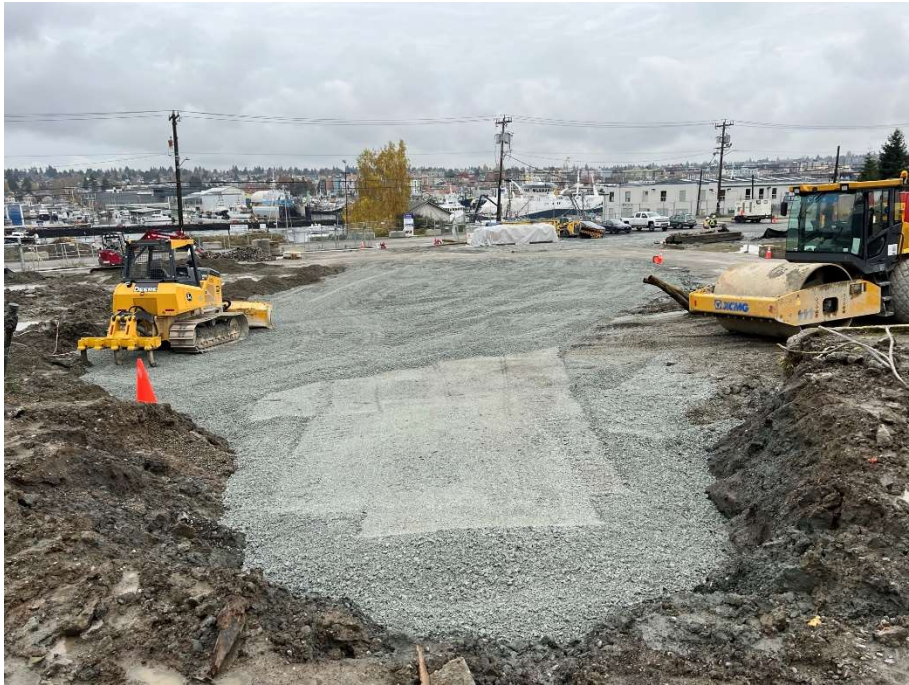
18. CAA-3 largely backfilled, ballast rock at surface.  
View to the north. Photograph taken 11/13/2021.

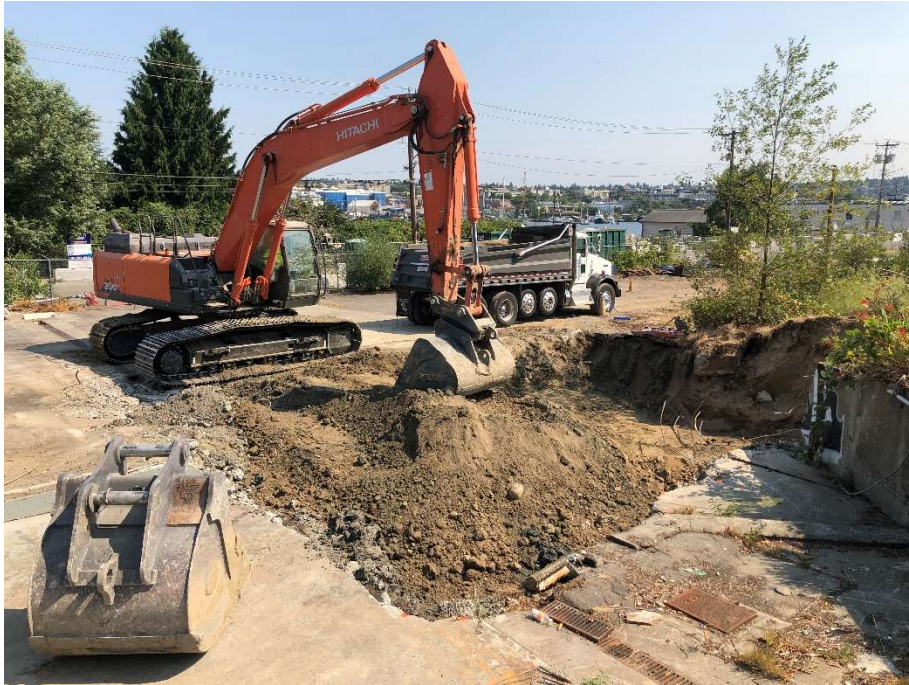
19. Excavating soils at CAA-5. View to the northeast. Photograph taken 8/2/2021.

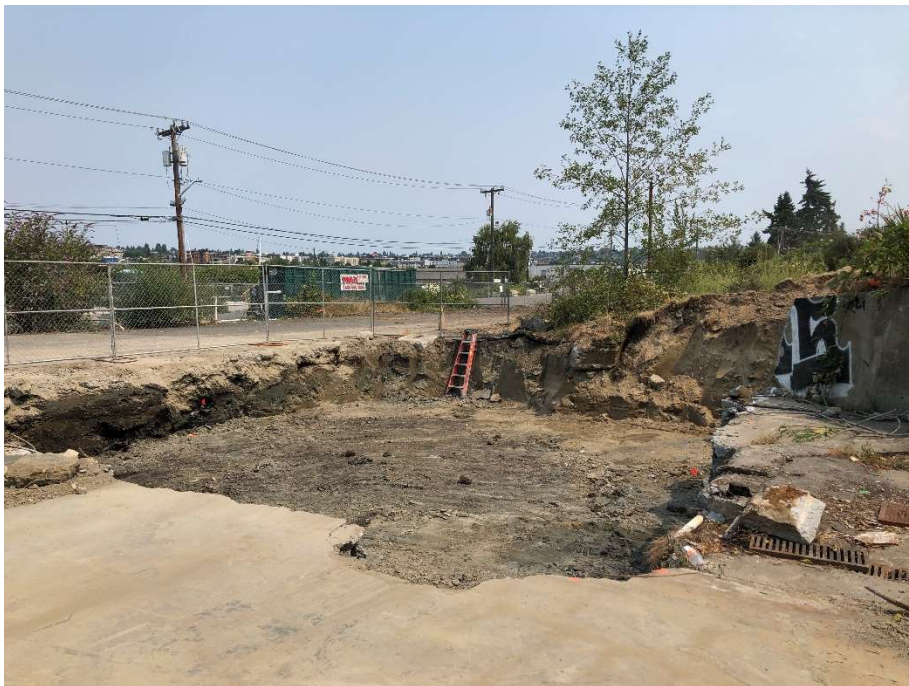
20. CAA-5 excavation complete. View to the northeast. Photograph taken 8/3/2021.

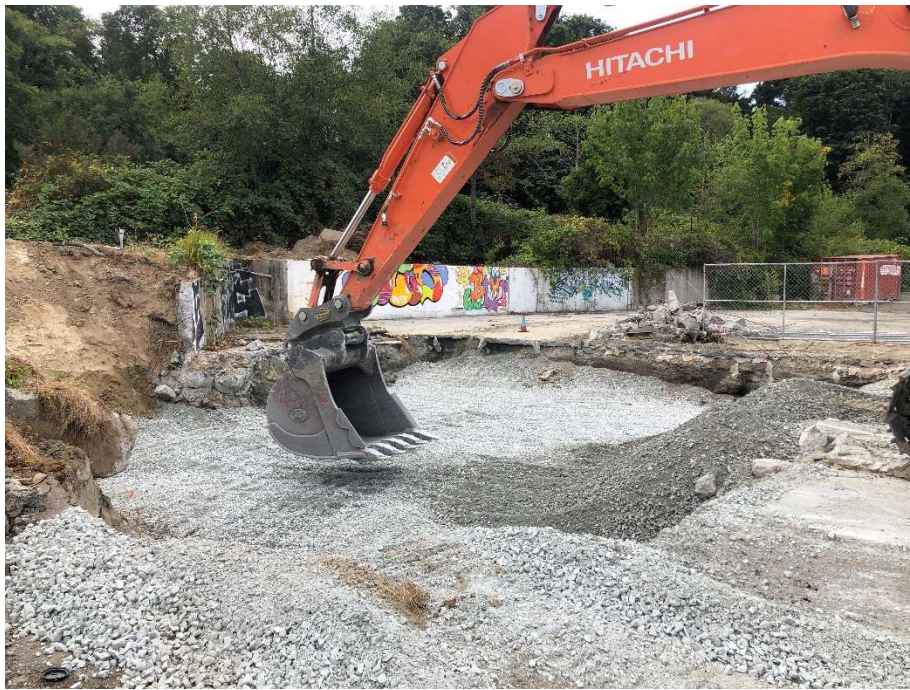
21. Backfilling and compacting CAA-5 with ballast rock. View to the southwest.  
Photograph taken 8/17/2021.

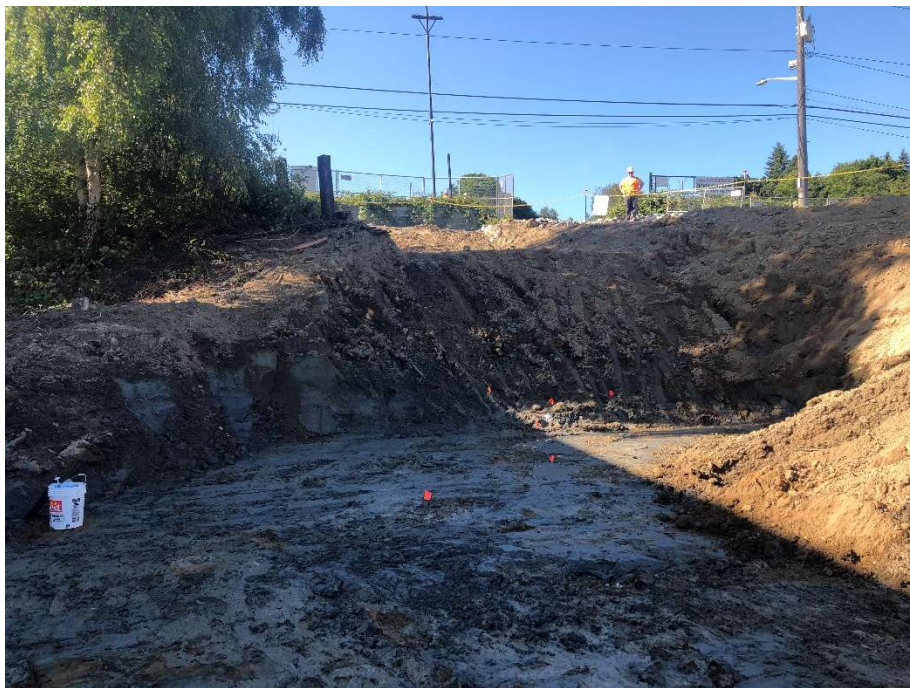
22. CAA-6a floor and south wall PID-screening and sampling (pin flags).  
View to the south. Photograph taken 7/29/2021.

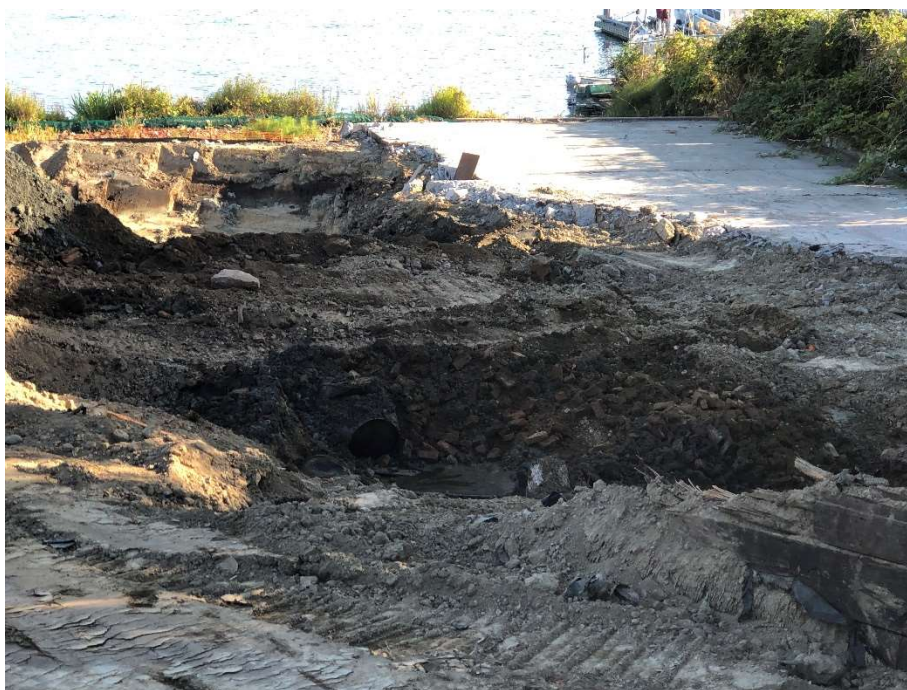
23A. CAA-6a. Two uncovered, buried drums. Shown in-situ.  
View to the north. Photograph taken 7/26/2021.

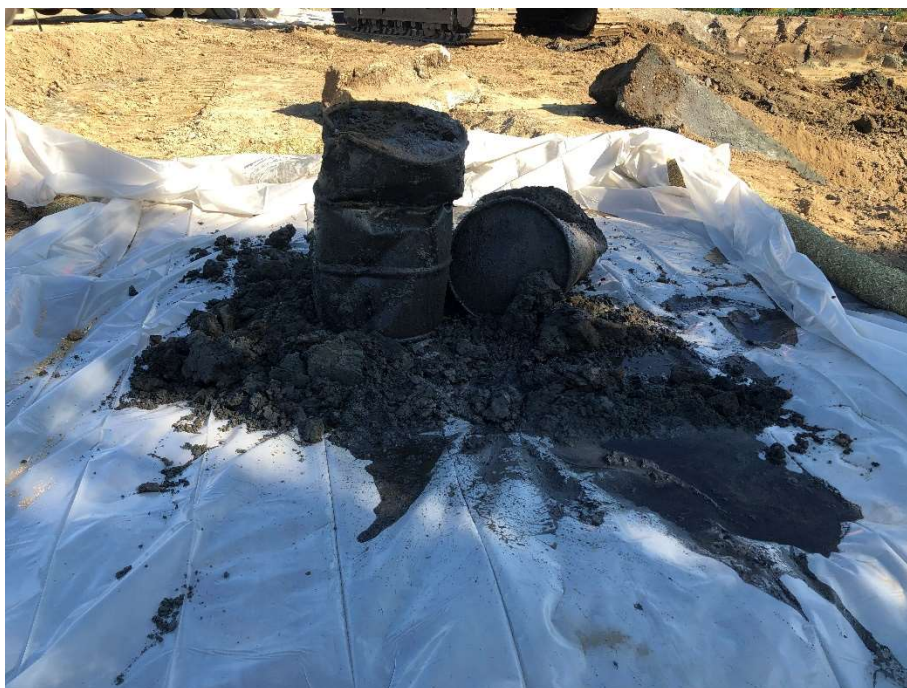
23B. Two 55-gallon drums removed from CAA-6a. Staged on plastic sheeting, bermed, contained in CAA-6a footprint. Photograph taken 7/26/2021.

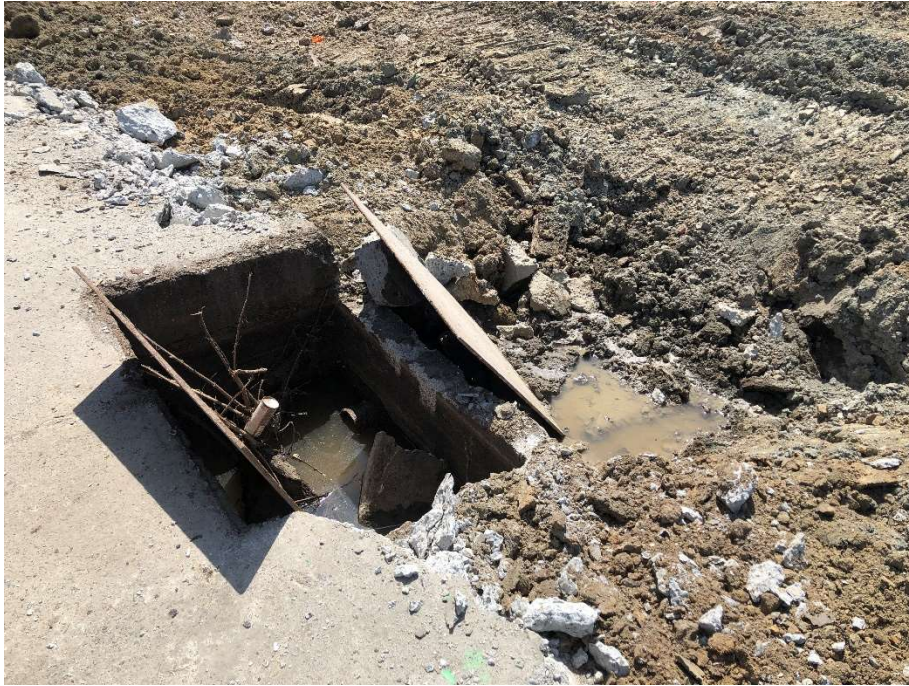
24. Vaults along eastern perimeter of CAA-6a. Inside former building footprint.  
Photograph taken 7/22/2021.

During removal of the concrete pad from CAA-6.a, a floor drain/vault was discovered on July 20, 2021. The vault was opened and standing water was present, no visual staining or oily water was observed on the water or in the vault itself. The vault had 2 separate chambers with piping connecting the 2 chambers. During removal of the sump one additional steel pipe was identified which ran from the sump to the north end of the former building slab. The pipe came in at an upper point in the sump cavity. The location where the pipe exits the building slab on the north end was already broken off prior to the start of the remedial actions. There are no indications of staining on the concrete in the greater area. The sump contained water, organic-rich sediments and roots with no hydrocarbon odors, sheen or other indication of contamination.

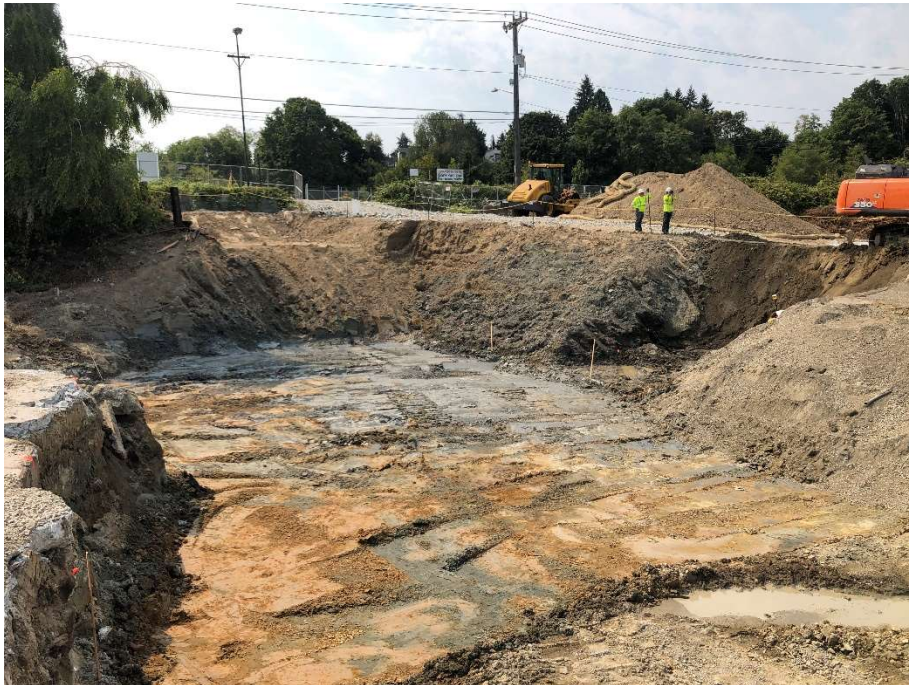
25. CAA-6a excavation underway. View to the south.  
Photograph taken 8/3/2021.

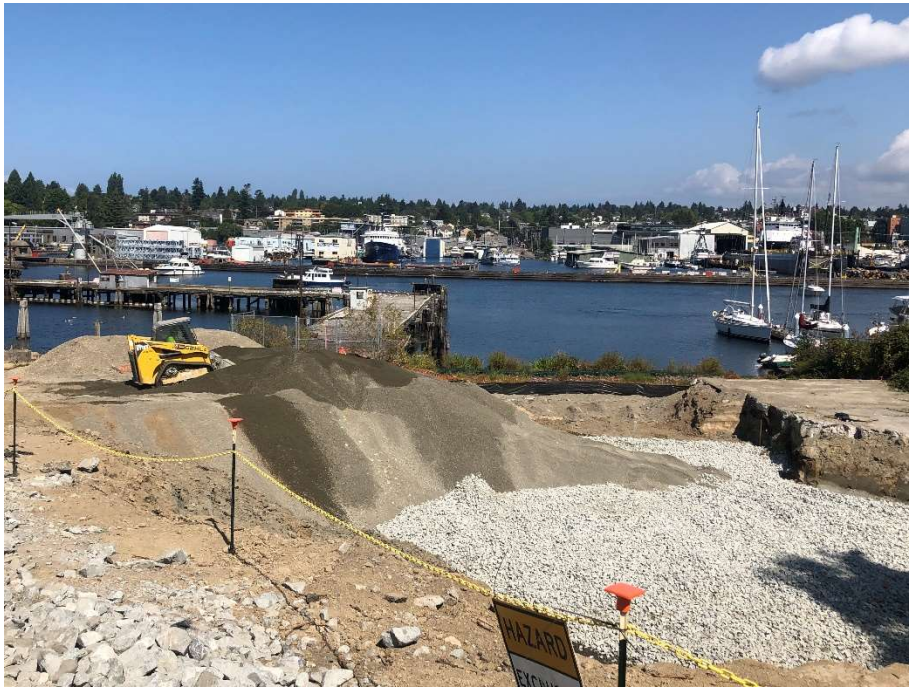
26. CAA-6a. Quarry spall on bottom, adding gravel borrow.  
View to the north. Photograph taken 8/23/2021.

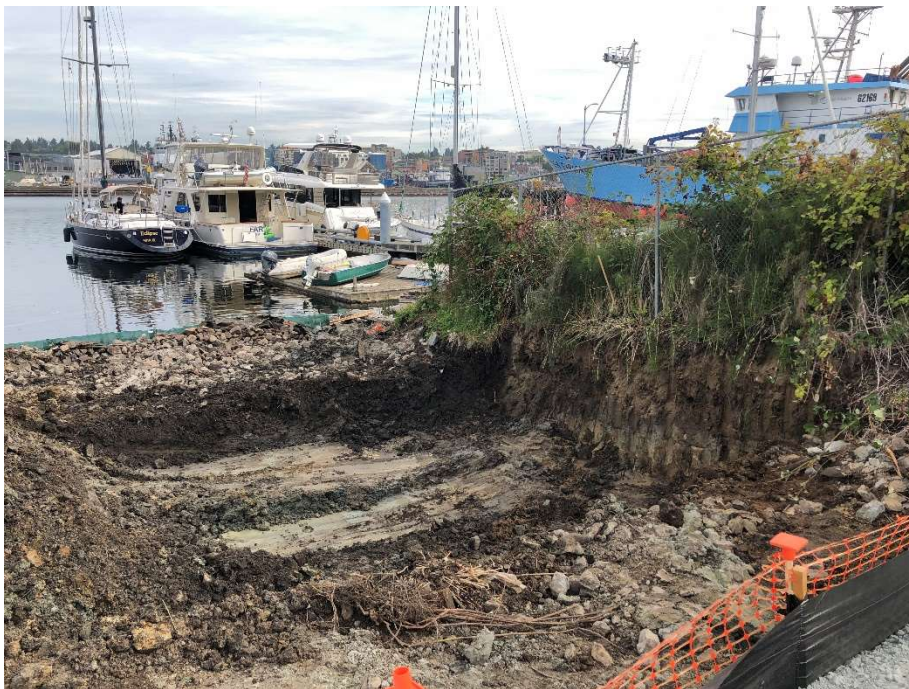
27. Soil excavation at CAA-6b along eastern property line.  
View to the northeast. Photograph taken 9/14/2021.

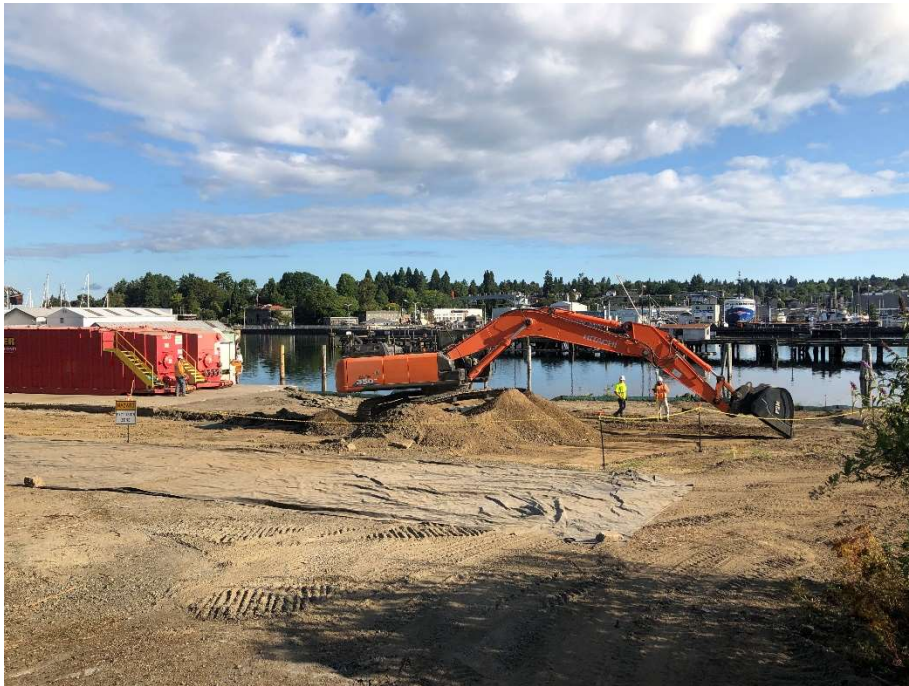
29. Excavating soils at CAA-7. View to the north. Photograph taken 7/22/2021.

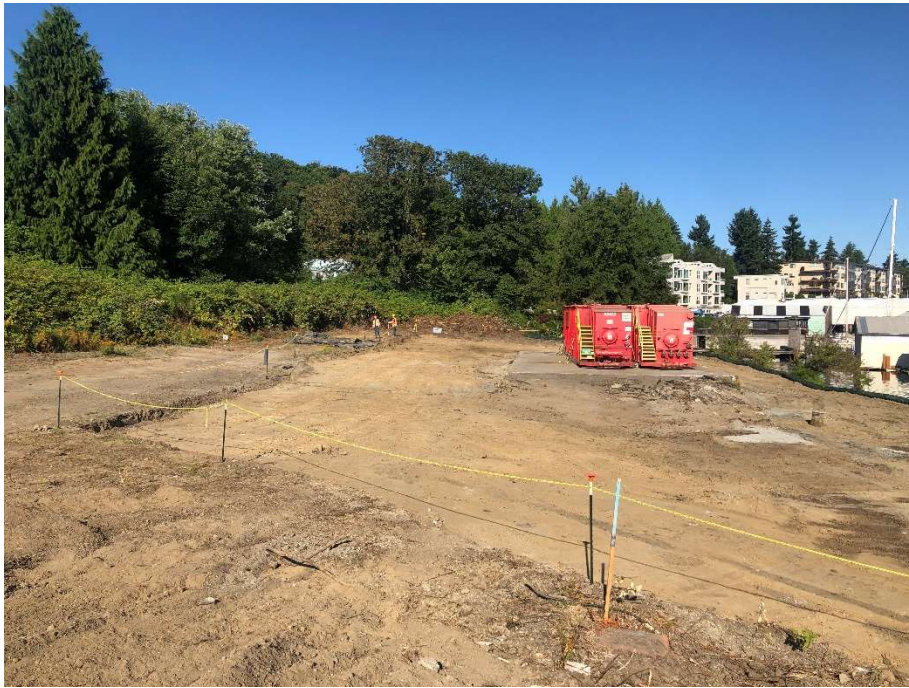
30.CAA-7 post-remedial surfaces. Site conditions at following completion of excavation at CAA-7.  
View to the west. Photograph taken 7/23/2021.

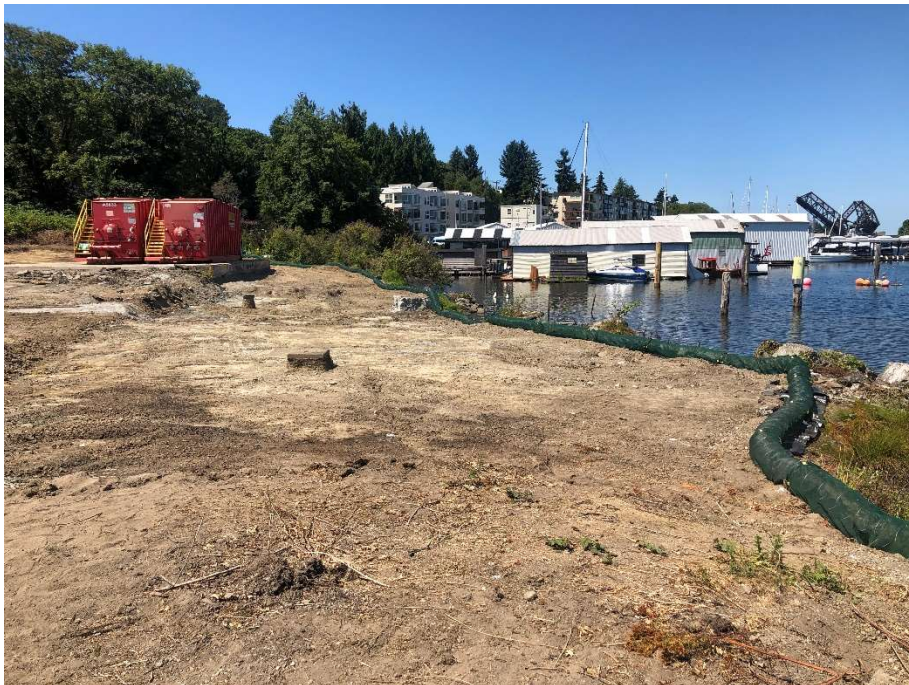
31. CAA-7 post-remedial surfaces. SWPPP BMPs in-place. View to west.  
Photograph taken 7/23/2021.

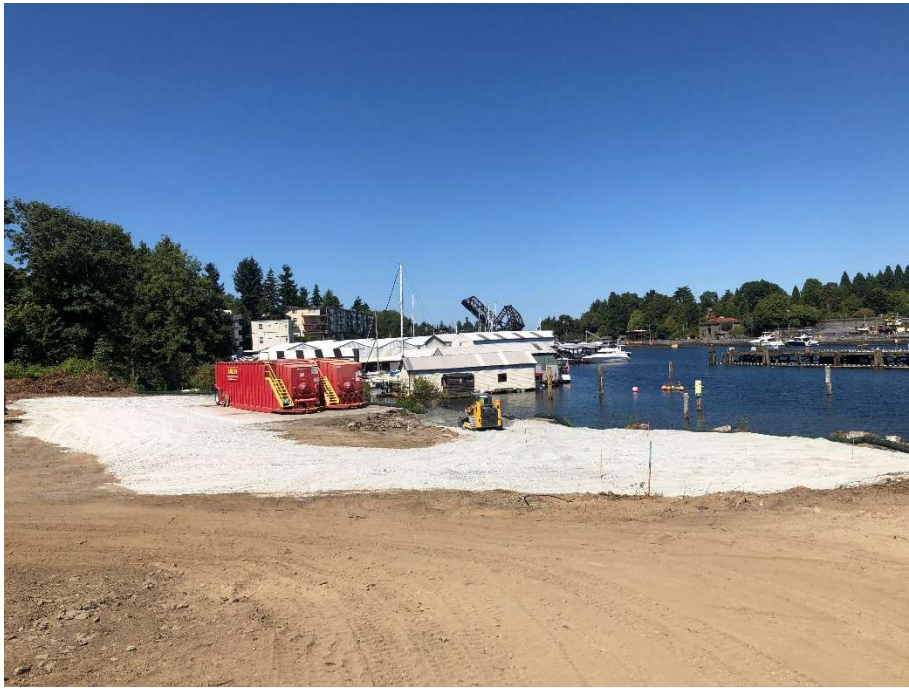
32. Backfilling and grading ballast rock at remediated CAA-7 excavation.  
View to the west. Photograph taken 7/29/2021.

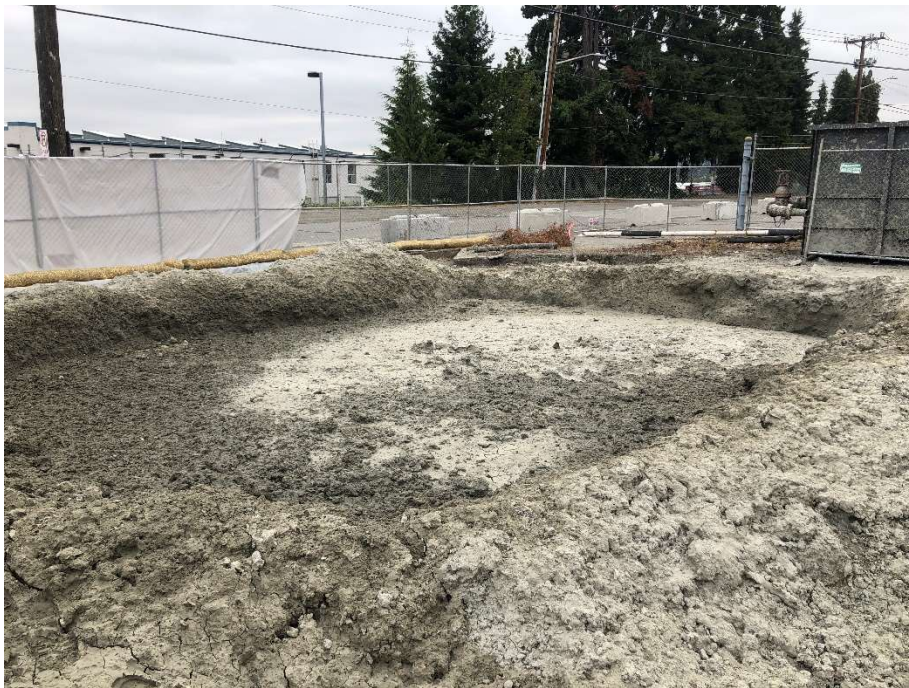
33. CAA-2a, previously mixed ISS Cell 2-42.

View to the northeast. Photograph taken 8/23/2021.

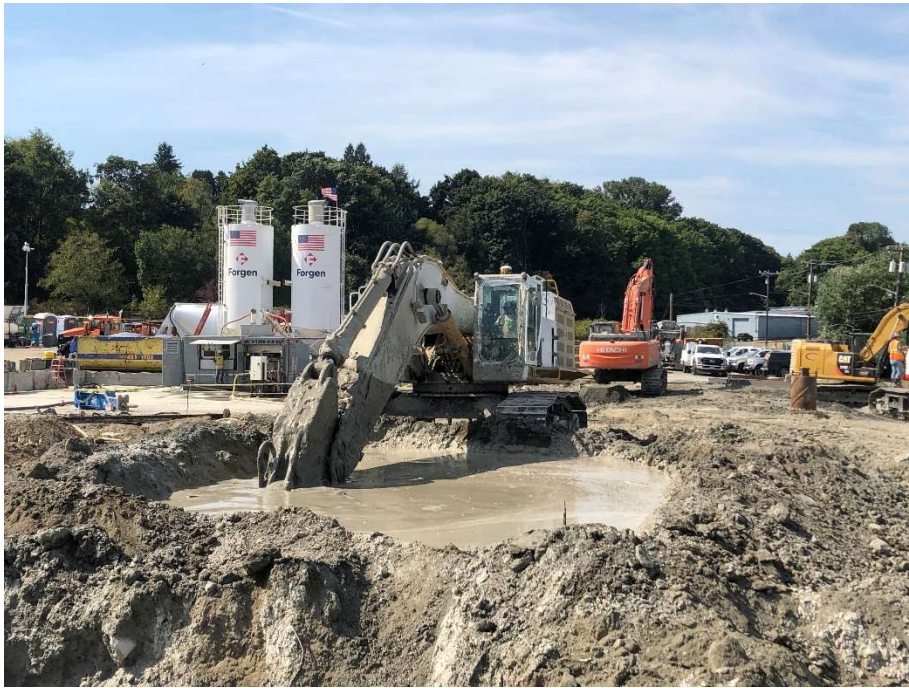
34. Bucket mixing soils and grout at ISS Cell 2-38.  
View to the west. Photograph taken 9/7/2021.

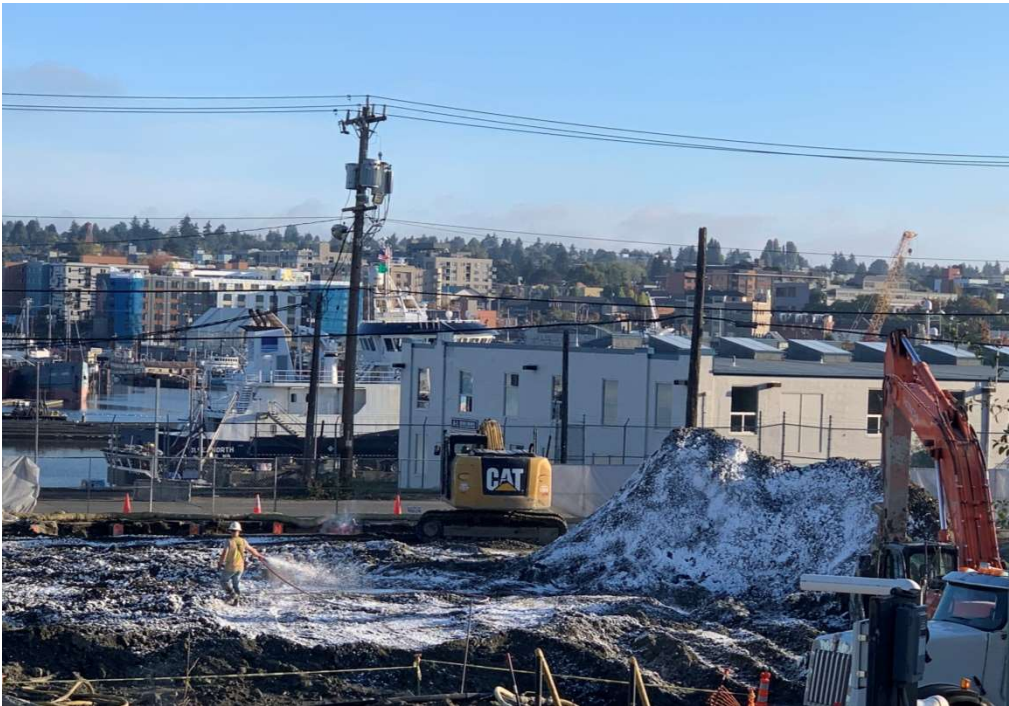
35. CAA-2a odor foam suppressant application (white foam in the photo). View to the south.  
Photograph taken 9/24/2021.

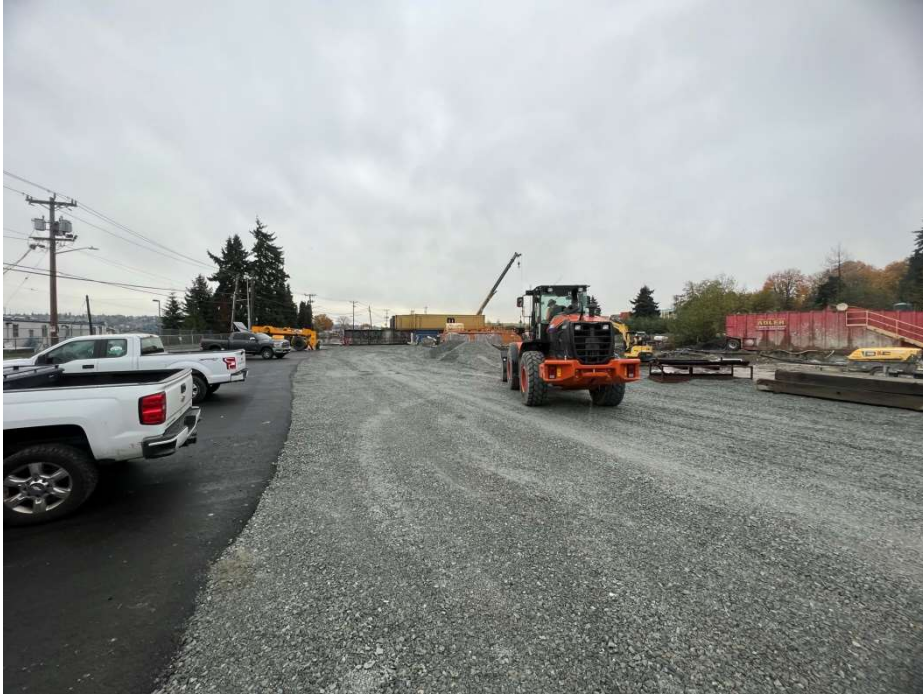
36. CAA-2a completed surface photo. New black asphalt shows CAA-2b ROW. View to the east.  
Photograph taken 11/2/2021.

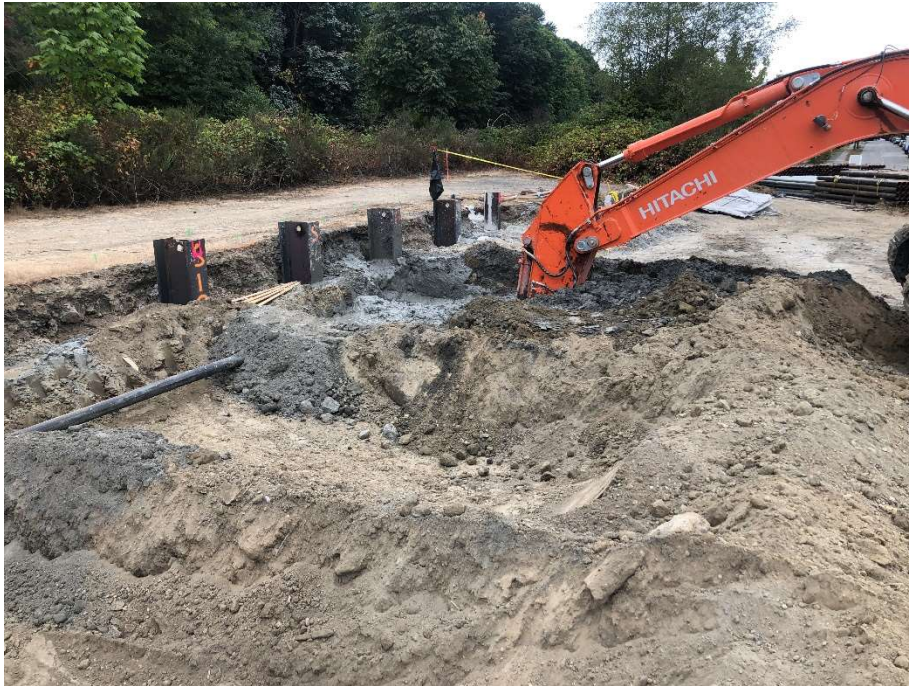
37. Bucket-mixing shallow soils and grout at CAA-4 along southern property line.  
View to the southwest. Photograph taken 9/10/2021.

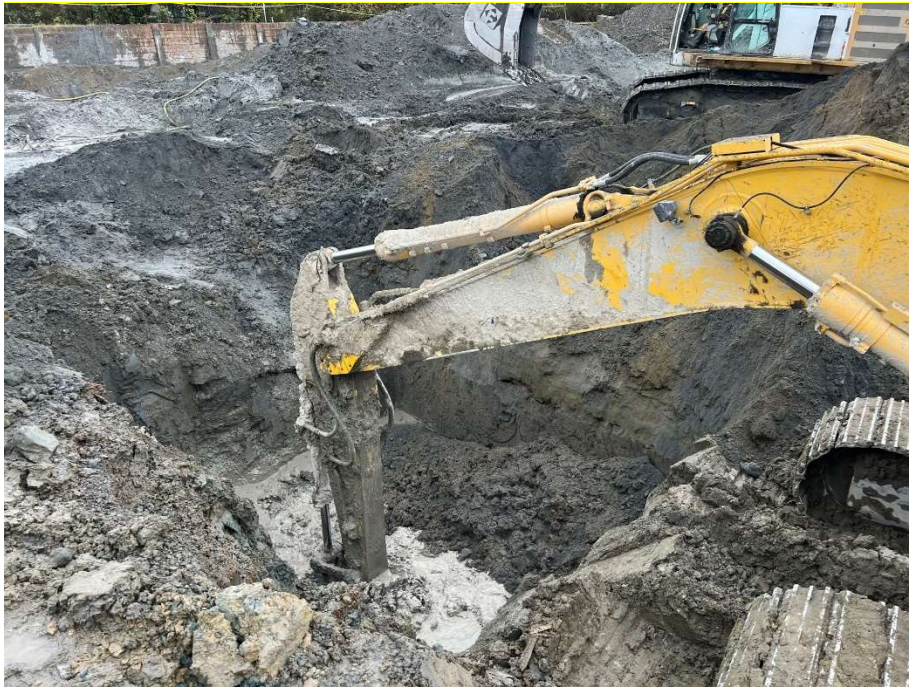
38. CAA-4, ISS bucket-mixing soil and grout at Cell 4-43.  
View to the southwest. Photograph taken 10/26/2021.

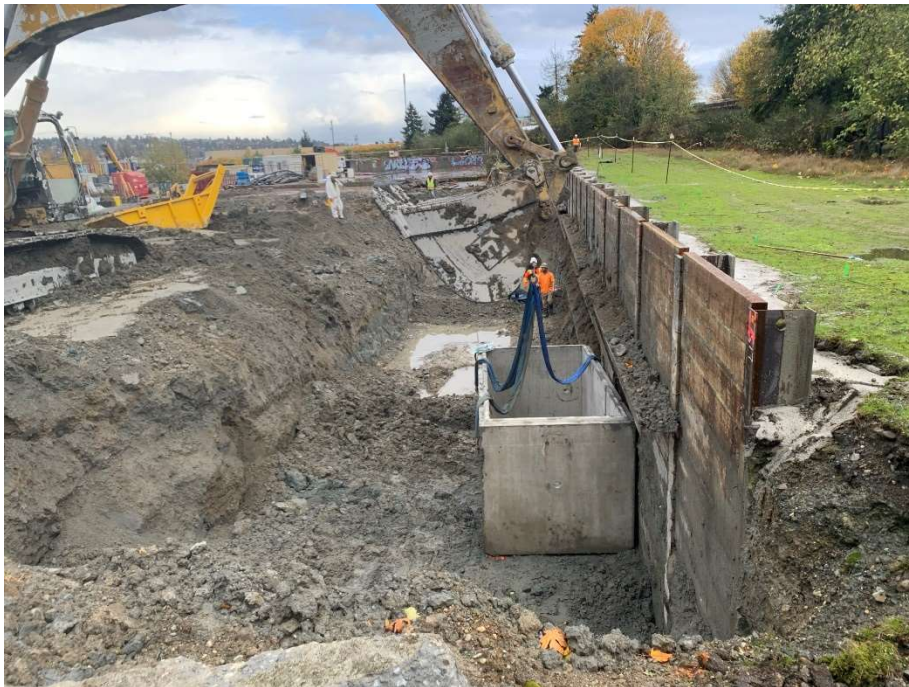
39. CAA-4, positioning concrete vault along interceptor trench.  
View to the east. Photograph taken 11/9/2021.

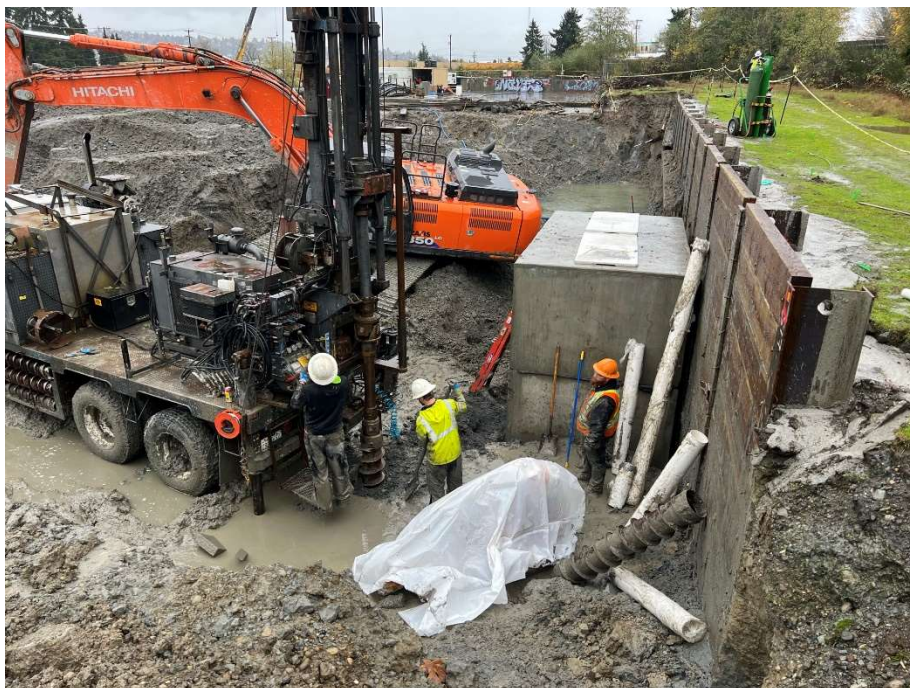
41. CAA-4, hollow stem auger drilling gravity well.  
View to the east. Photograph taken 11/12/2021.
