# REMEDIAL ACTION COMPLETION REPORT PHASE 1 – FINAL

Time Oil Bulk Terminal  
Seattle, Washington

August 8, 2022

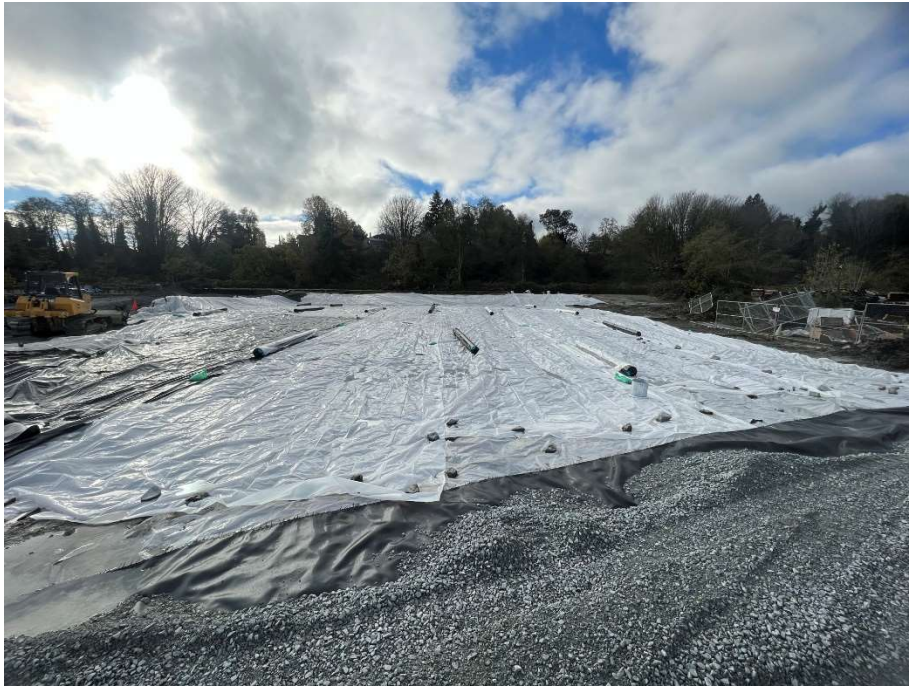
44. CAA-4 ISS material, covered in plastic sheeting.  
View to the south. Photograph taken 11/23/2021.

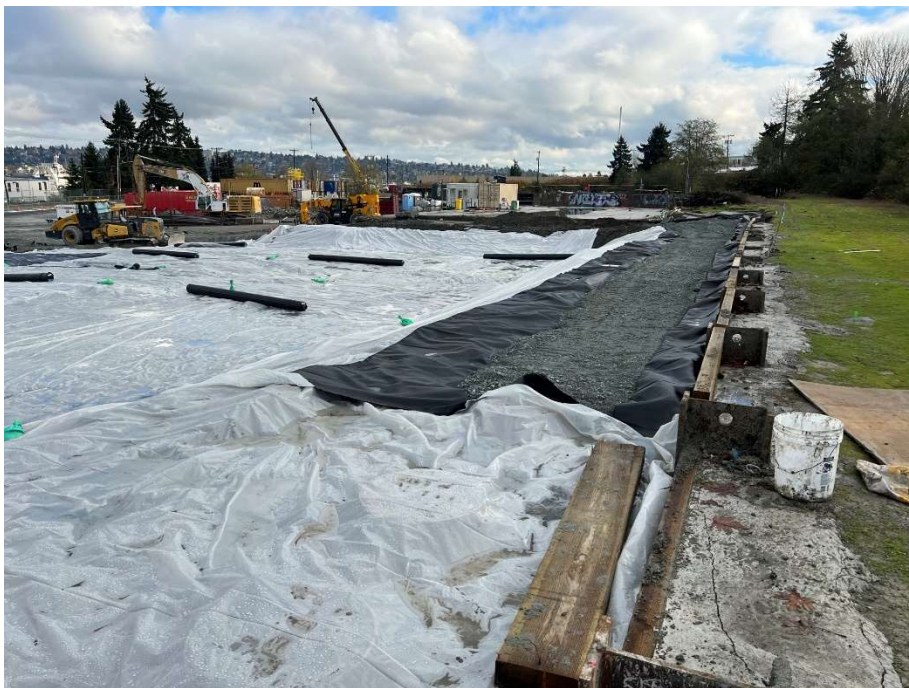
45. CAA-4 interceptor trench area, covered in plastic sheeting as a BMP. Vault in center bottom, trench covered in geotextile and ballast rock. View to the east. Photograph taken 11/23/2021.

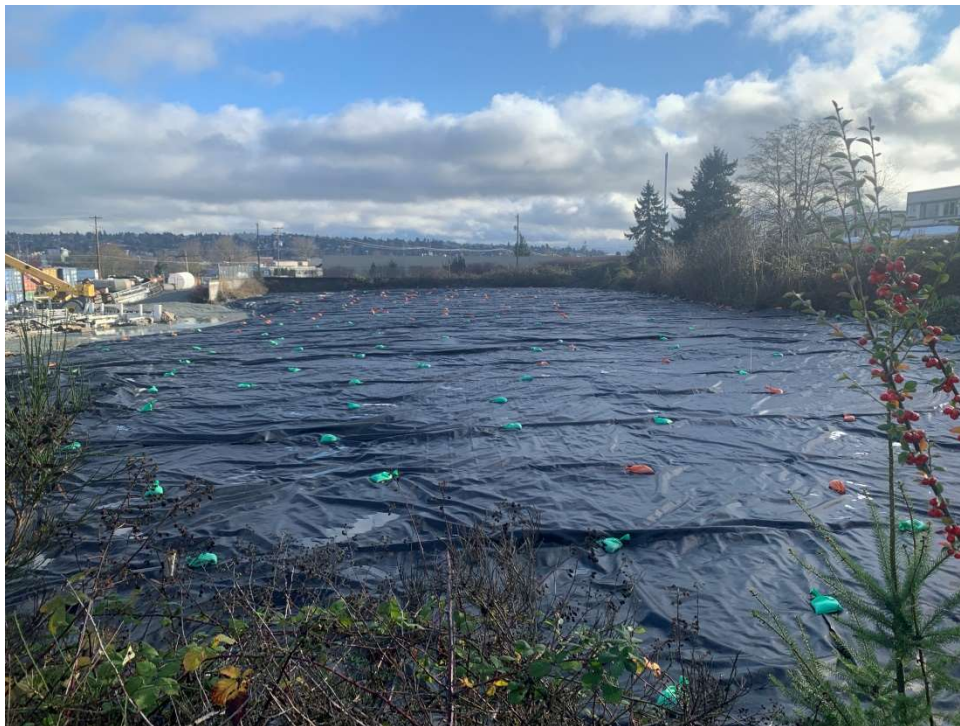
47. Completed SMA Area. View to the east.  
Photograph taken 12/13/2021.

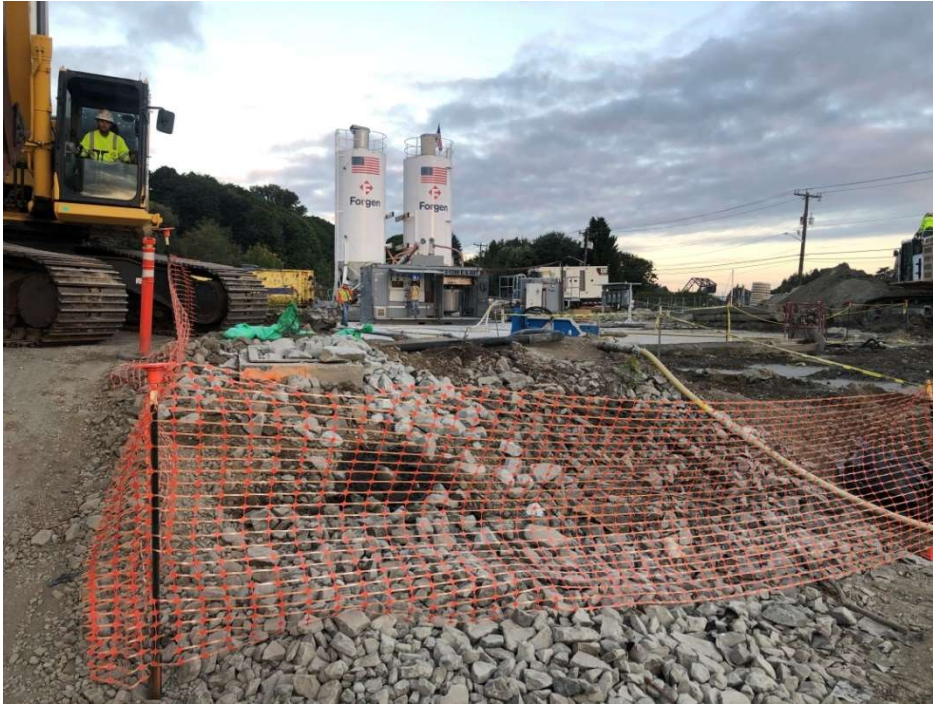
48. Diesel Spill Area – Pre Cleanup. View to the west. Photograph taken 9/13/2021

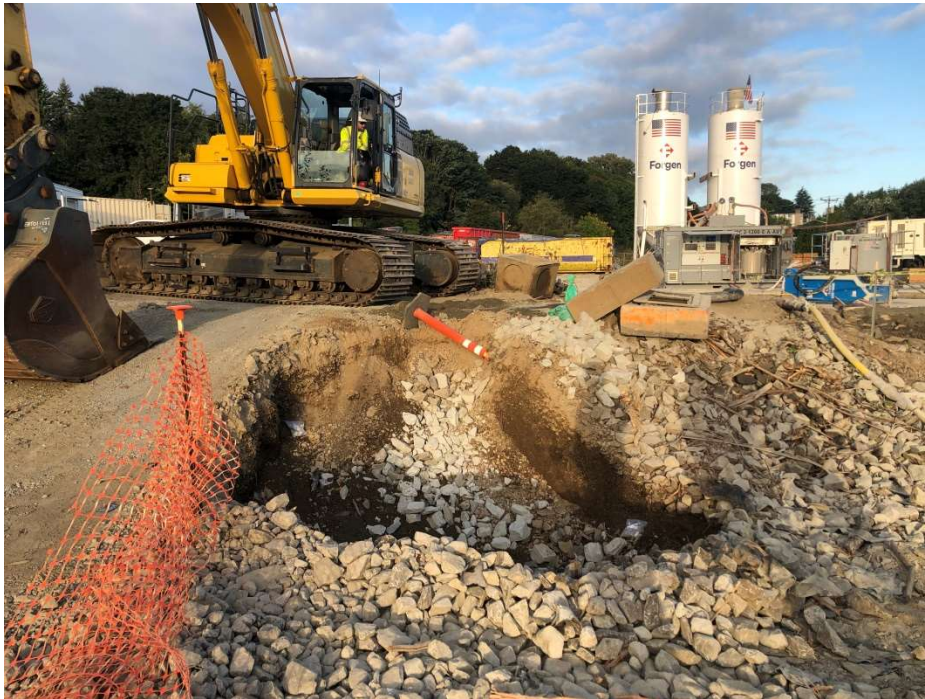
49. Diesel Spill Area – Post Cleanup. View to the west.  
Photograph taken 9/13/2021
