2021 ANNUAL REPORT
Remedy Implementation
Crownhill Elementary School Site
Prepared for: Bremerton School District

Project No. 100094-H-009 • June 14, 2022

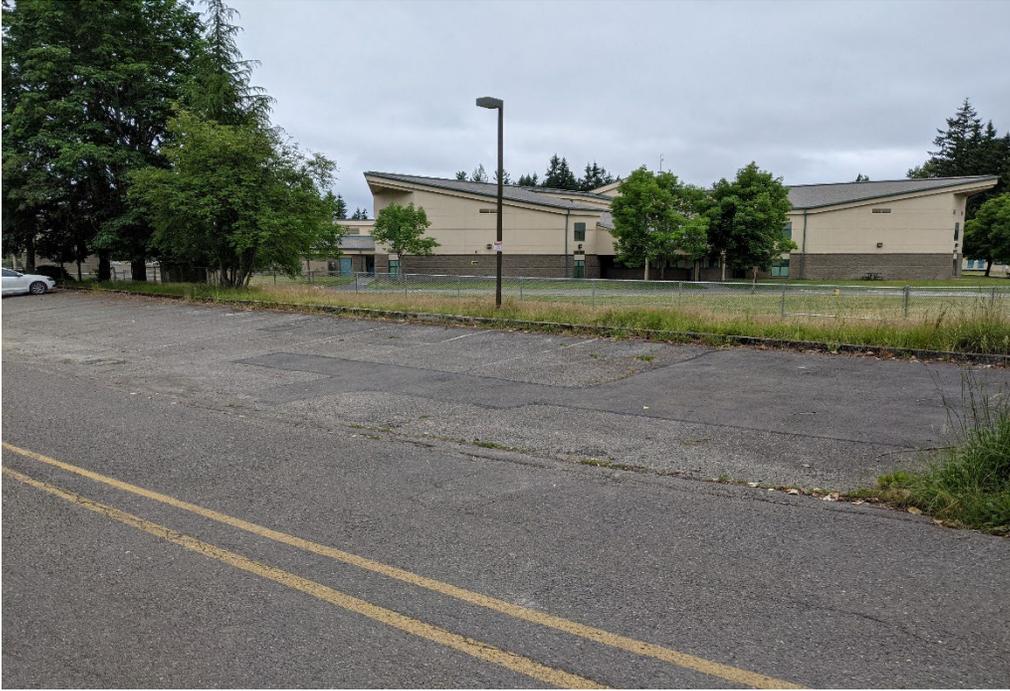
Photo Location 1. 6/23/2021 site inspection

- **Photo Location 1** – Pavement in the parking area along Bertha Avenue NW, where an RI soil sample collected from beneath the pavement (composite sample to 3-foot depth) contained lead at a concentration exceeding the cleanup level.

In July 2018, asphalt repairs were completed at three locations in the Bertha Ave NW parking area (Photo Location 1) after potholes were observed (documented in Aspect, 2019). The parking area appeared to be in excellent condition and the soil/sod cover at Photo Locations 2 through 4 appeared to be in good condition during both 2021 inspection events. The 2021 inspections did not identify any cover system deficiencies in other areas of the Site or other action items.

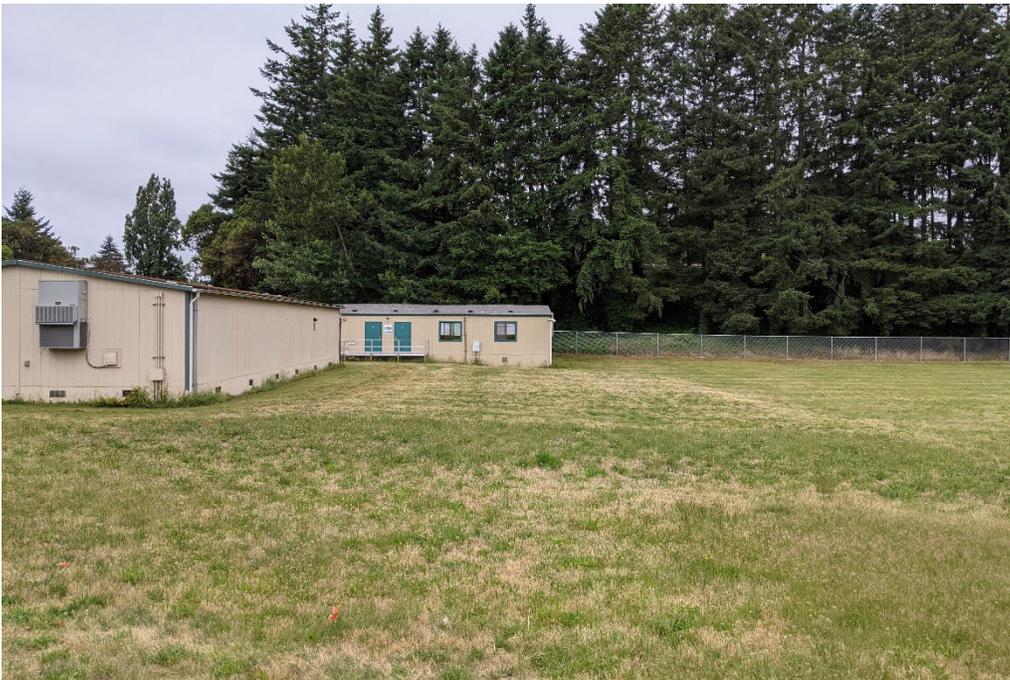
Photo Location 2. 6/23/2021 site inspection

- **Photo Locations 2 and 4** – Soil/sod covers next to the portable classroom building and in the southeast corner of the School property, where lead cleanup level exceedances were identified in soil samples collected from the 1- to 3-foot depth range. In summer 2013, these two areas were covered with a geotextile fabric (placed directly on the undisturbed ground surface) and an additional 1-foot thickness of fill soil was imported and hydroseeded to supplement the pre-existing clean soil cover layer.

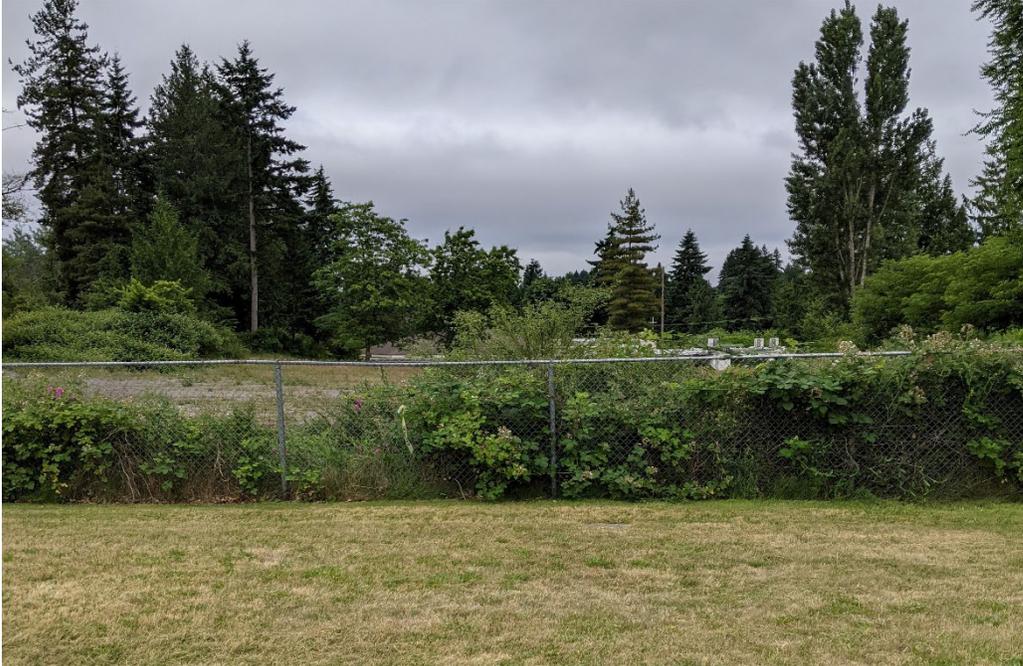
Photo Location 3. 6/23/2021 site inspection

- **Photo Location 3** – A soil/sod cover in the northwest corner of the BUMC property (and extending approximately 10 feet onto the School property), where an interim action was completed in spring 2012 in which contaminated surface soils were removed to a 1-foot depth, a geotextile fabric was placed on remaining contaminated soils, and a 1-foot thickness of fill soil was imported and hydroseeded.
