2021 Operations, Maintenance, and  
Monitoring Annual Report  
South Park Landfill  
Volume I

# 2021 Operations, Maintenance, and Monitoring Annual Report South Park Landfill

**Seattle Public Utilities**

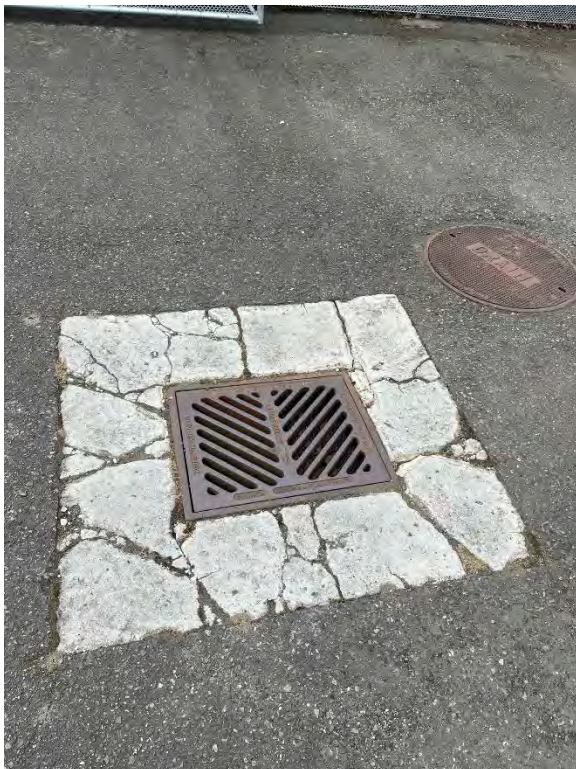
Location 21- 2. Minor Cracking

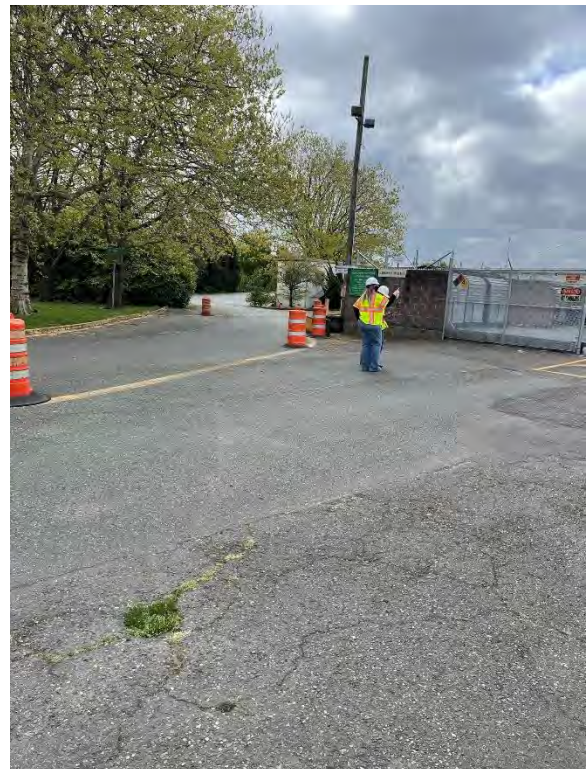
Location 21- 3. Concrete Cracking at Catch Basin

- Repair concrete at catch basin (#21-3).

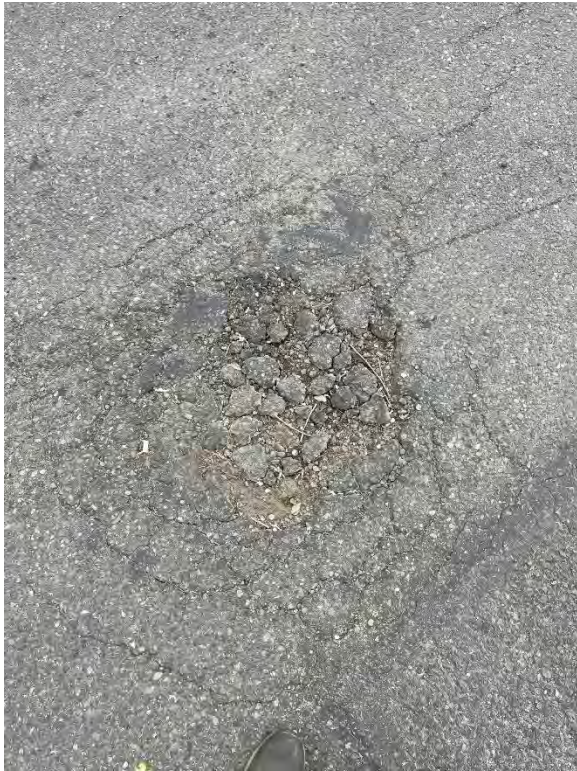
Location 21- 4. Minor Cracking

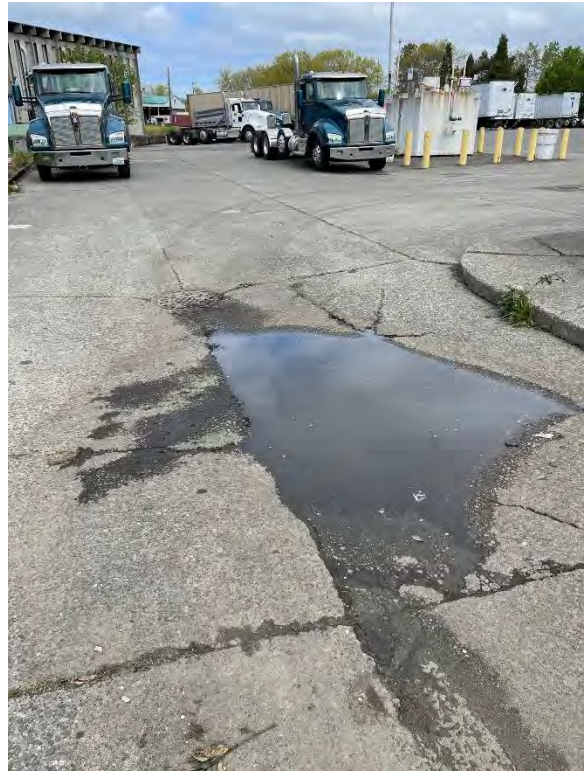
Location 21- 5. Minor Cracking

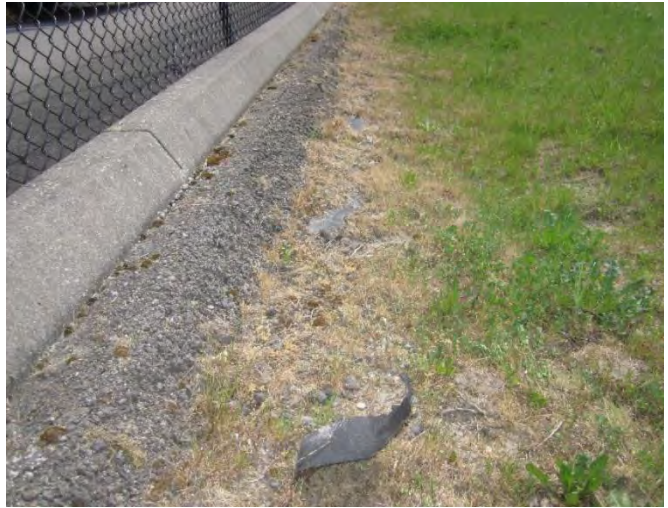
Location 21- 12. Exposed Geomembrane

On November 2, 2021, SPPD conducted additional repair and maintenance work. The repairs corresponded with some of the high priority locations identified in the 2021 Baseline Landfill Cap Inspection including the culvert inlet (#21-12) and areas along the fence line on the south side of the bus parking (#21-13 through 21-15). The Site Coordinator observed repairs being conducted on the exposed geomembrane near the southwest entrance of the SPPD property off Occidental Avenue South. The work was focused on the exposed geomembrane at the culvert headwall and the exposed

geomembrane at the interface with the pavement cap. The culvert headwall was repaired using quarry spalls. After corrective actions were conducted, no geomembrane was exposed, although no cushion material was installed to protect the underlying geomembrane. The other exposed geomembrane areas within the work area were covered with topsoil and erosion control measures were installed on the steep slopes. SPPD also indicated that the exposed geomembrane is not the cap barrier geomembrane. In discussions, SPPD indicated that the geomembrane termination is not as indicated in the design and that this exposed geomembrane is a folded over flap. The exposed geomembrane should be confirmed as sacrificial (non-barrier) by either exposing the leading edge or by excavating below the geomembrane and locating the barrier geomembrane.

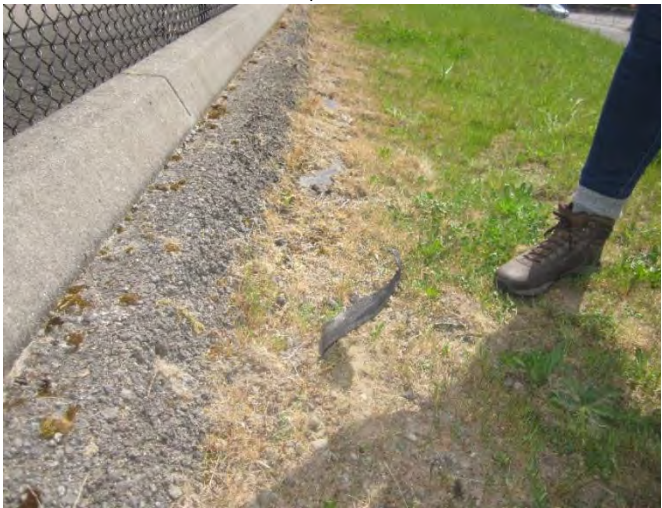
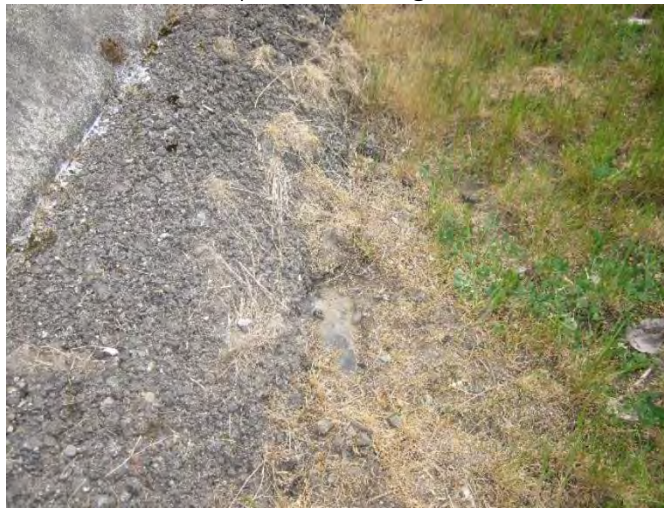
Location 21- 13. Exposed & Damaged Geomembrane

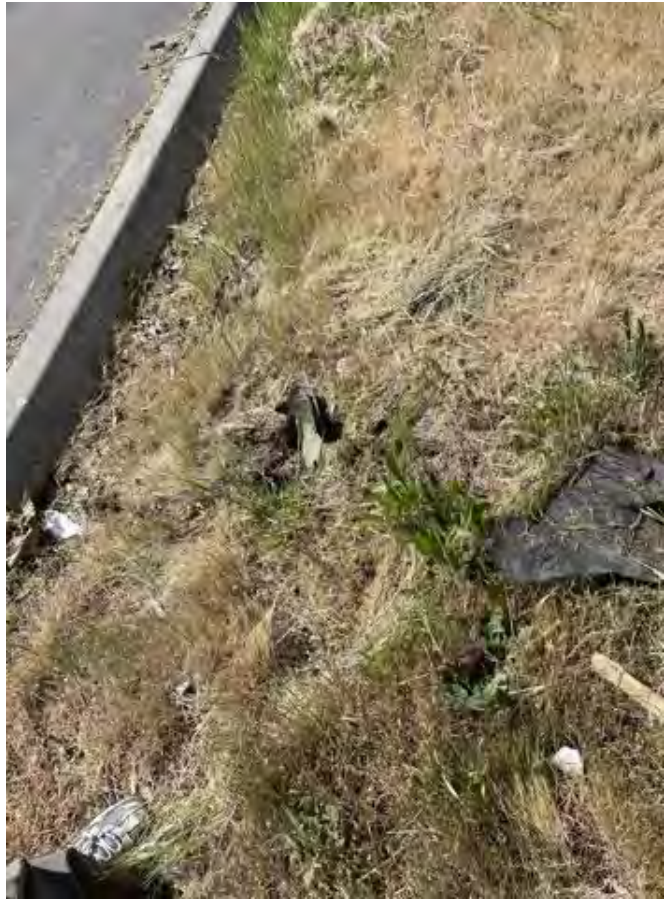
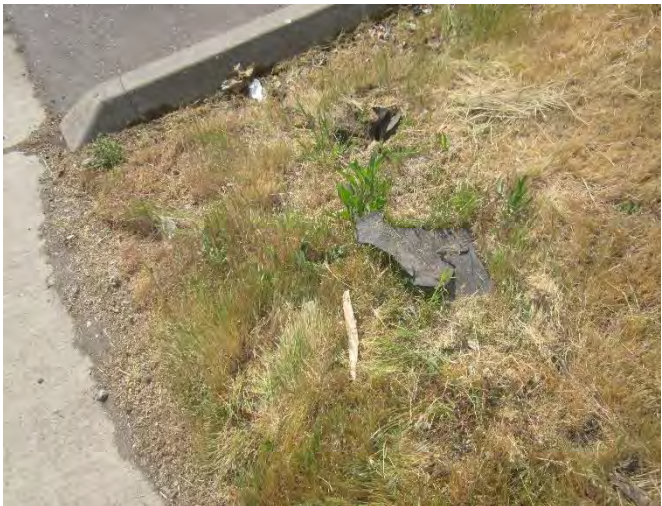
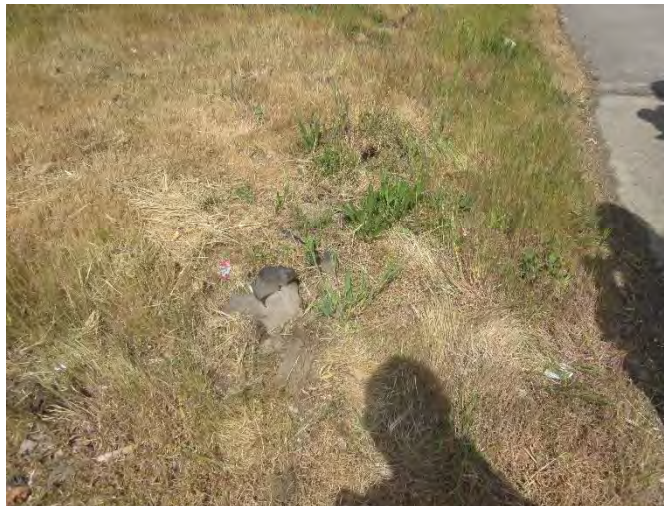
Location 21- 18. Exposed Geomembrane at storm drain structure

Location 21- 18. Exposed & Damaged Geomembrane

Erosion of cover soil and poor vegetative cover continue to be observed at Location #21-9, exposed geomembrane continues to be observed at Location #21-18, and it is recommended to work with the Site Coordinator to prepare a plan to reestablish cover over the geomembrane.

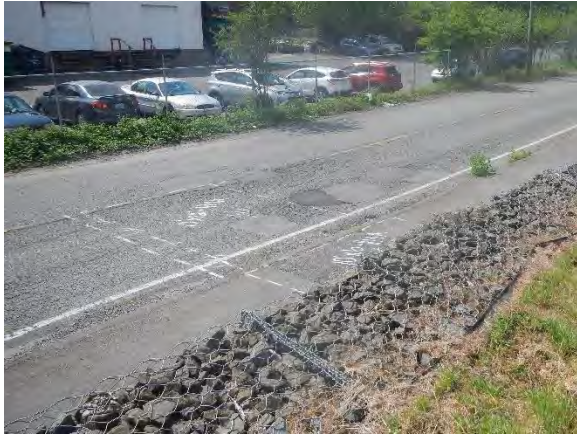
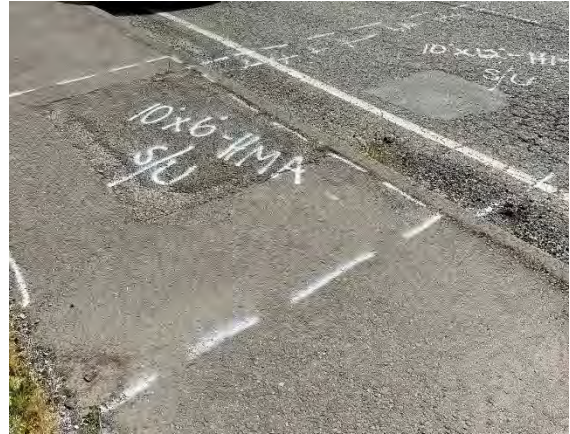
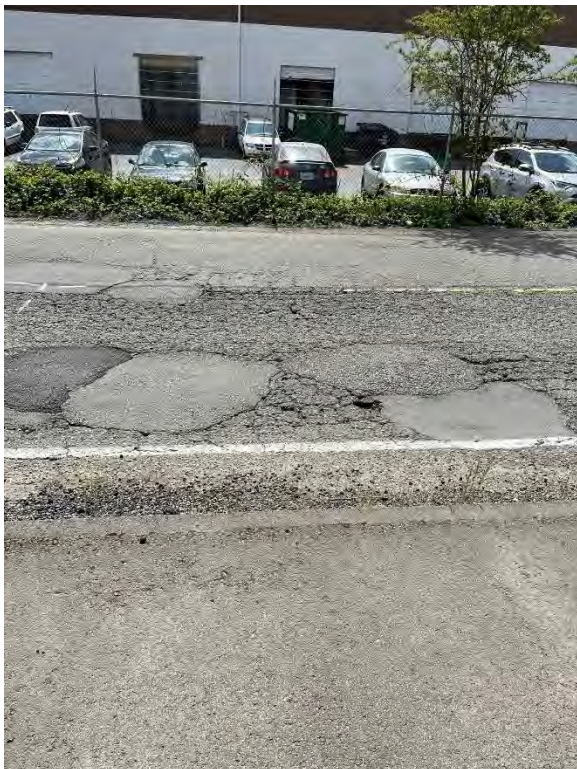
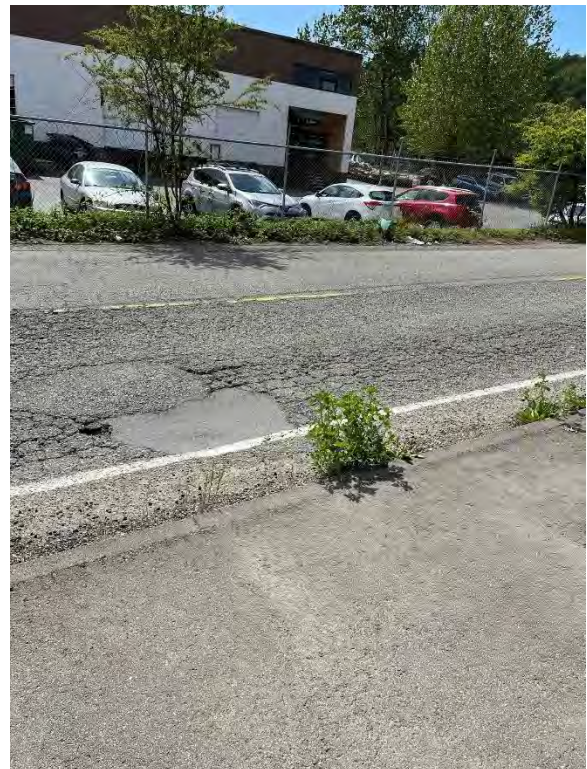
**Right-of-Way.** One location within the Occidental Avenue South right-of-way was identified as a location of concern where cracks and ruts were identified (Point Location #21-20). This location was not identified as a high priority. The 5th Avenue South right-of-way was not reviewed.

Location 21-20. Open Cracks/Ruts

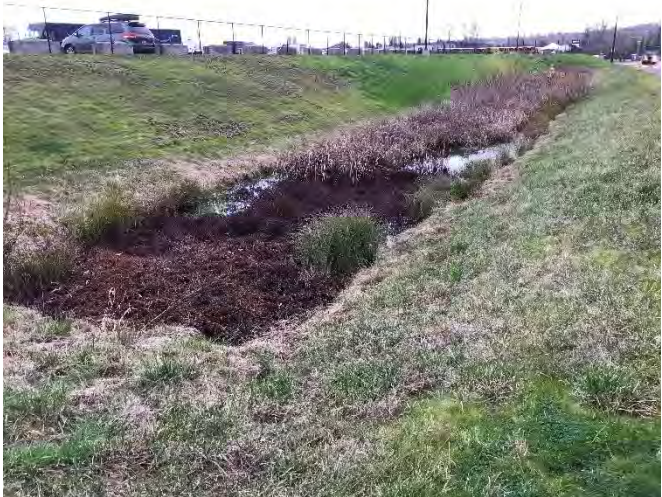
Sparse vegetation as a result of plug aerator

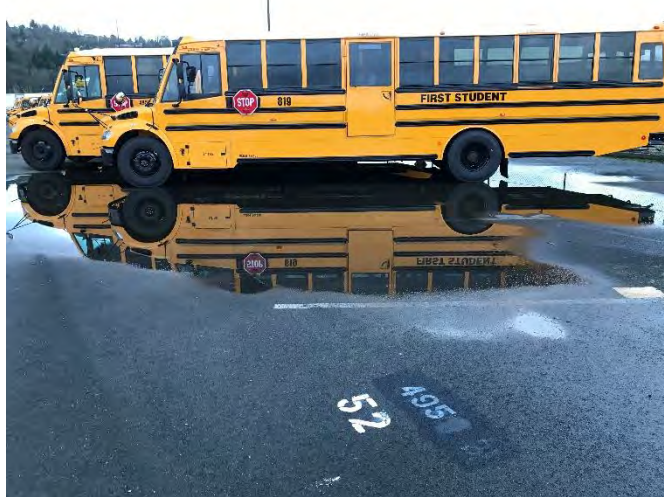
Evidence of swales and conveyance structures flowing as designed. Dredging and removal of sediment accumulation may be recommended. Photographed to the east of GP-11 and MW-12.

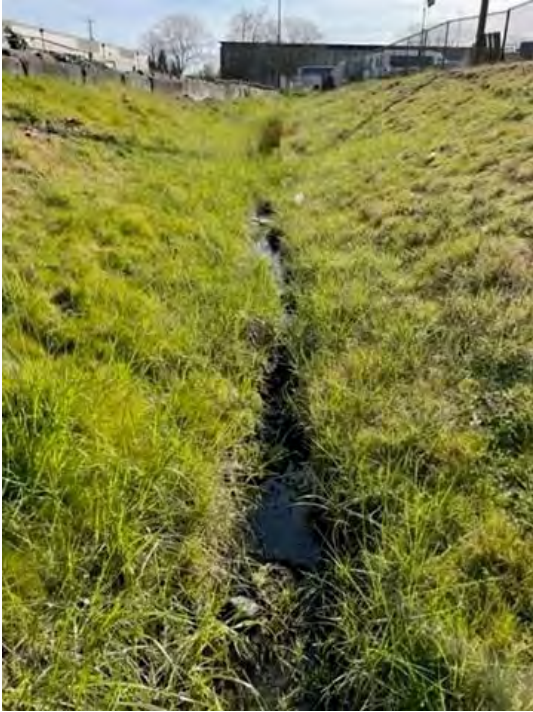
Added topsoil and seed as well as planted plants at basin of swale. In the picture below, plant will begin growing at the base of the ditch.

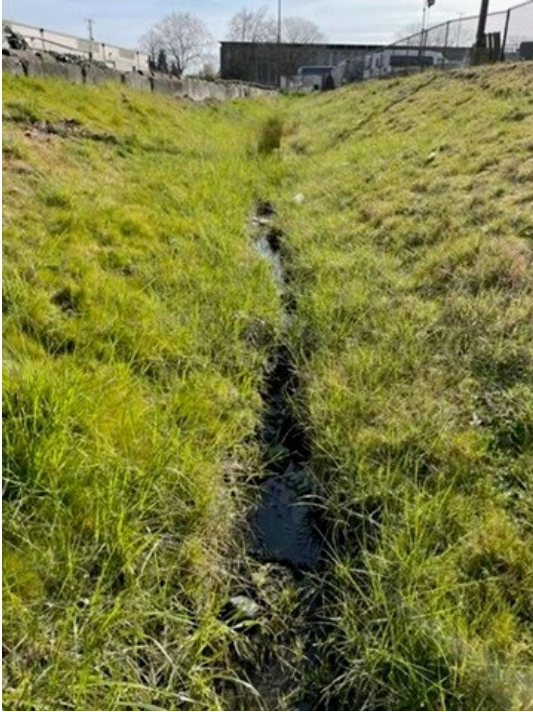
Added topsoil and seed as well as planted plants at basin of swale. In the picture below, plant will begin growing at the base of the ditch.

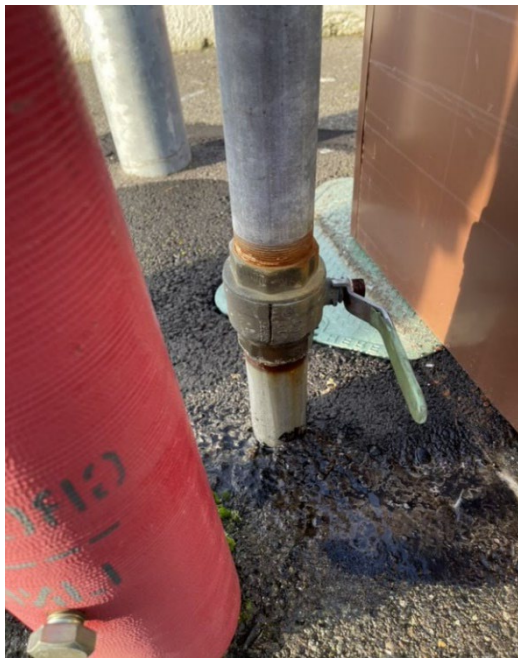
Photograph 1

Three areas were observed on SPPD property that appeared to have recent repairs to the asphalt landfill cap.

1. A crack in a water access pipe was observed in the fire suppression area that was allowing for a low flow but steady stream of water to be released on SPDD property on the landfill cap (Photograph 1). A bollard had been removed and replaced. There was a fresh asphalt edging around the original patch around the bollard (Photograph2). The area of the leaking pipe also had fresh asphalt edging patch around the original patch.
2. A gas extraction well in the NW area of the property appeared to have recent repairs or maintenance to the landfill cap. Safety cones and fresh asphalt were observed at this location (Photograph 4).
3. A gas extraction well in the driveway on the eastern border of the property appeared to have recent repairs or maintenance to the landfill cap. Safety cones and fresh asphalt were observed at this location (Photograph 5).

On January 26, 2022, SPPD raised the well monuments to prevent water intrusion at well head V-7 located in the northwest portion of the property and well head H-5 located at the east main gate entrance. The Site Coordinator observed these repairs on February 9, 2022, as well as an additional repair in the area of a leaking water pipe in the fire suppression area.

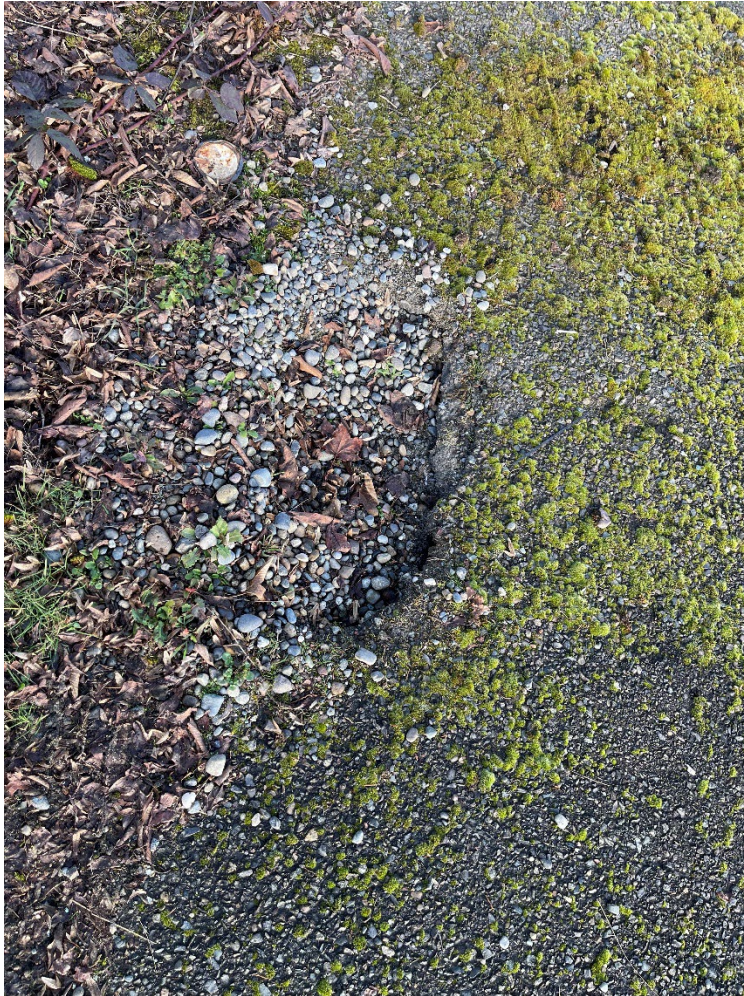
Location of sinkhole was observed. The sink was filled with gravel. We recommend ongoing observations during annual cap inspections until the site is redeveloped in 2024 to verify if the fill remains adequate.

**SRDS Property.** The sinkhole on the SRDS property was repaired by filling with gravel to preclude potential contact with refuse.
