# MEMORANDUM

RE: September and October 2021 Slab Inspection and Vapor Intrusion Priority Monitoring  
Precision Engineering, Inc., Seattle, Washington  
Agreed Order No. DE 18079; Facility Site ID 2056; Cleanup Site ID 4532

Project Name: Precision Engineering, Inc.  
September 20, 2021 Slab Inspection  
Project Number: 1803.01.05  
Location: 1231 S Director Street, Seattle, Washington

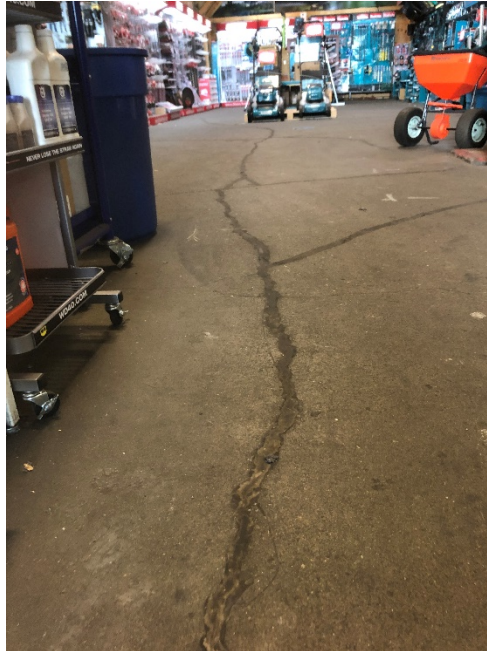
### Photo No. 1.

Typical sealed crack in Warehouse 1. No sealant wear was observed.

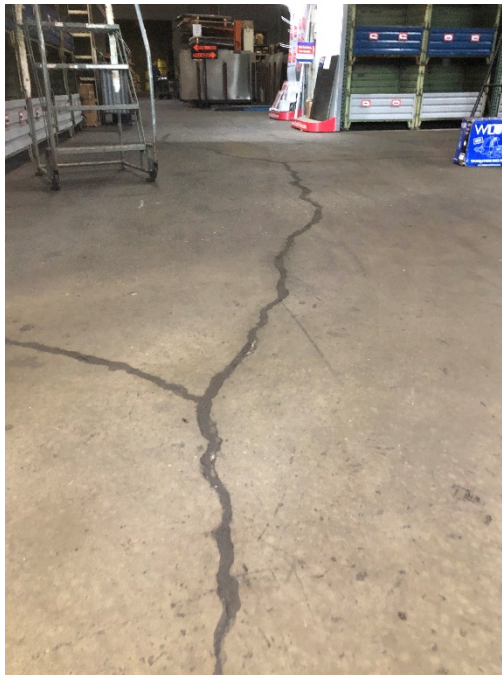
### Photo No. 2.

Typical sealed crack in Warehouse 1. No sealant wear was observed.

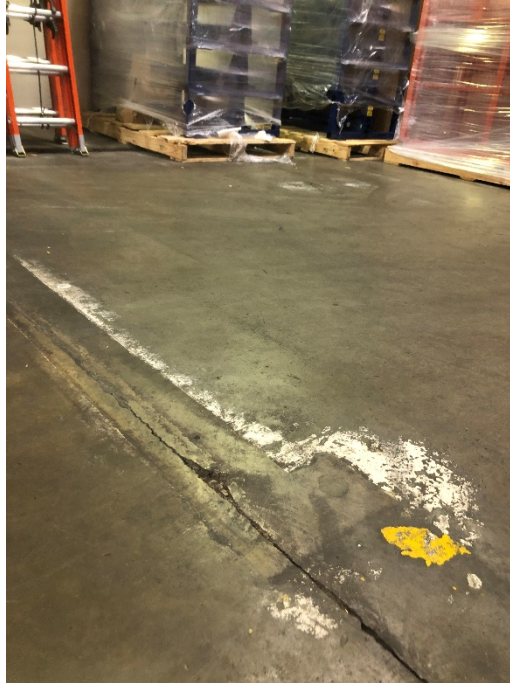
### Photo No. 3.

Crack without sealant in the northwest portion of Warehouse 1. This crack was not observed during previous inspections as it was covered by inventory.

No noticeable changes in conditions from the previous inspection conducted on June 21, 2021 were observed, except for one additional unsealed crack, previously covered with inventory, identified in Warehouse 1.

In Warehouse 1, the sealed cracks are generally in good condition. There is minimal cracking or flaking of sealant. An unsealed crack was identified that had been covered with inventory during the slab sealing work (see the attached figure).

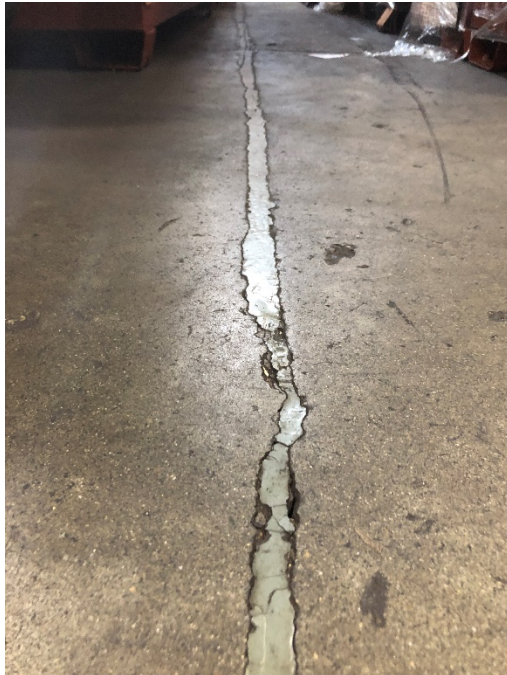
### Photo No. 4.

Minor sealant wear in Warehouse 1. The crack does not appear to extend through the slab.

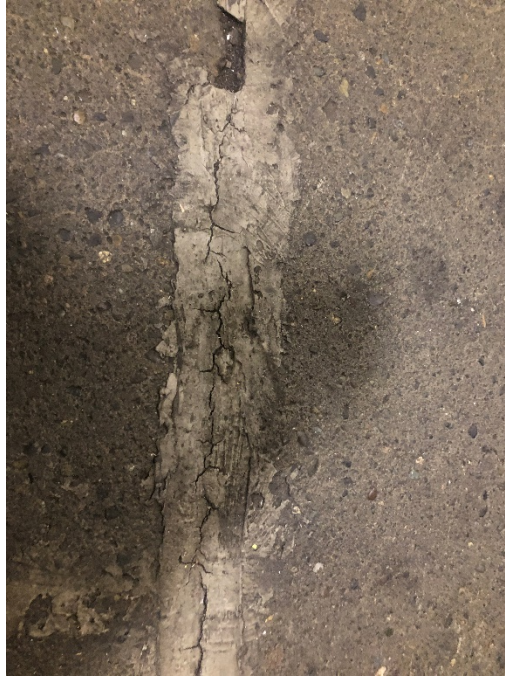
### Photo No. 5.

Typical sealant wear in Warehouse 2.

In Warehouse 2, no significant changes from the previous inspection were observed. A few areas continue to show minor sealant wear, but these appear to be surficial. Areas with the heaviest forklift traffic have the most obvious sealant wear, and in some cases sealant is no longer present(see the attached figure).

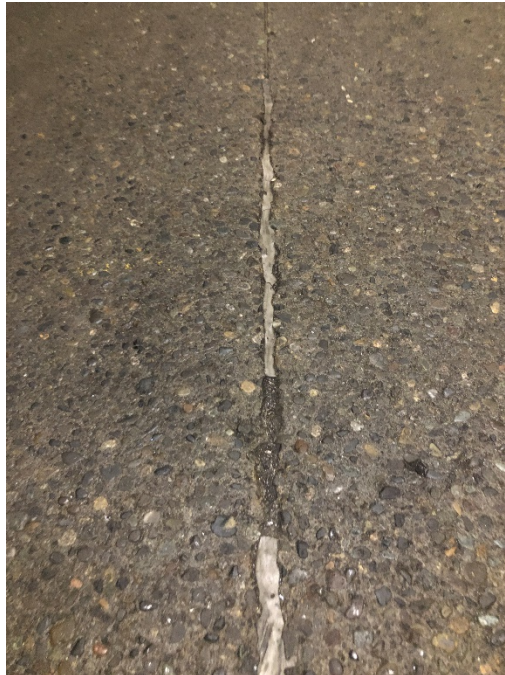
### Photo No. 6.

Example of sealant wear in a crack located in Warehouse 2 in an area of heavy forklift traffic. The crack does not appear to extend into the slab.

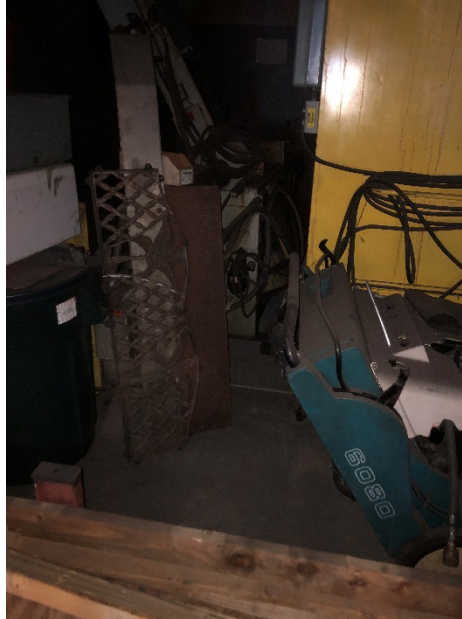
### Photo No. 7.

Former evaporator pit,  
covered by heavy  
equipment and  
inventory.

The former evaporator pit was backfilled with compacted gravel and capped with concrete on April 13, 2020. The cap is currently in good condition.

The former evaporator pit is currently covered with heavy equipment, but the exposed areas appear to be intact, with no visible damage to the concrete.

No settling or bulging was observed.

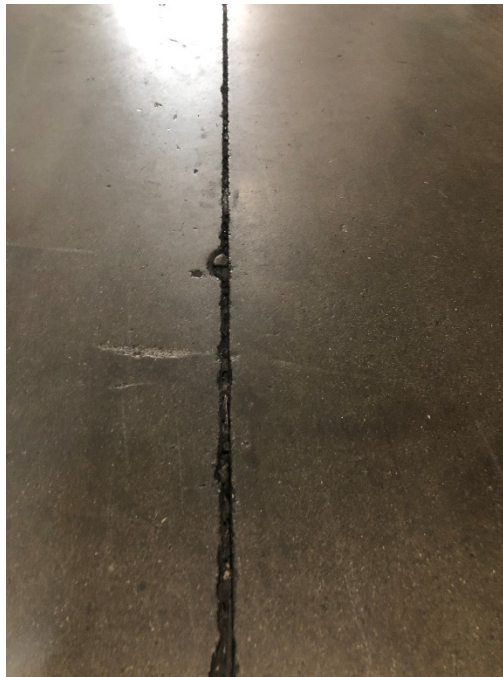
### Photo No. 8.

Example of seam  
without sealant in  
Warehouse 3. Seams are  
approximately 1  
centimeter deep and do  
not appear to extend  
through the slab.

In Warehouse 3, no significant changes from the previous inspection were observed. As the most significant wear has been observed in this area and this area receives the heaviest forklift traffic, this area should continue to be monitored (see the attached figure).

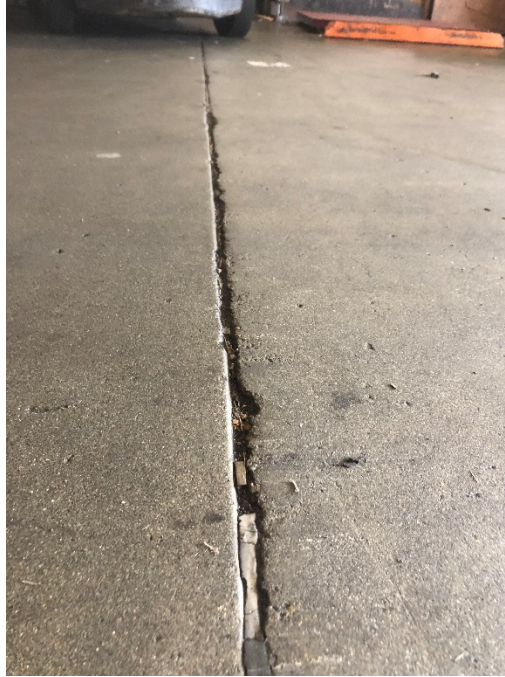
### Photo No. 9.

Example of seam without sealant in Warehouse 3. Seams are approximately 1 centimeter deep and do not appear to extend through the slab.

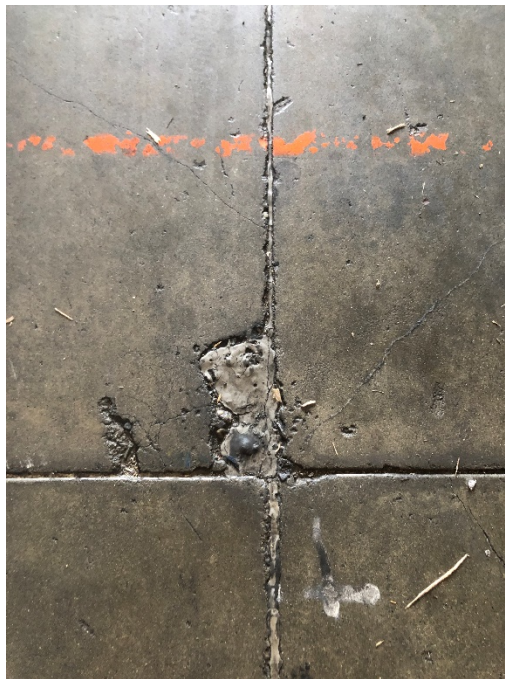
### Photo No. 10.

The slab was observed to be in generally good condition, aside from the minor issues noted in Attachment A. The most significant sealant wear was observed in seams (i.e., expansion joints) that extend only a few centimeters into the concrete slab. Seams do not extend through the entire slab thickness and as such, are not considered to be a vapor intrusion concern. Cracks may extend deeper into the slab. During the interim action, several rounds of concrete mix and sealant were applied to cracks to ensure a complete seal (MFA, 2020a). Sealant wear observed in cracks appears to be surficial and does not appear to penetrate the entire sealed thickness, except for in areas with observed groundwater seepage, as identified in Warehouse 3. Warehouse 3 receives the heaviest forklift traffic, which has contributed to significant sealant wear in those areas. Historical groundwater data from borings in the area suggests that the groundwater seepage does not present an immediate health concern or a vapor intrusion concern (MFA, 2020b). Unsealed cracks were observed in areas previously covered by inventory, but they are narrow or do not appear to extend through the slab and air monitoring results have not identified short-term action limit exceedances. Based on these observations, the slab issues do not appear to present a significant vapor intrusion concern.

Typical sealant wear in seams in Warehouse 3. Seams are approximately 1 centimeter deep and do not appear to extend through the slab.

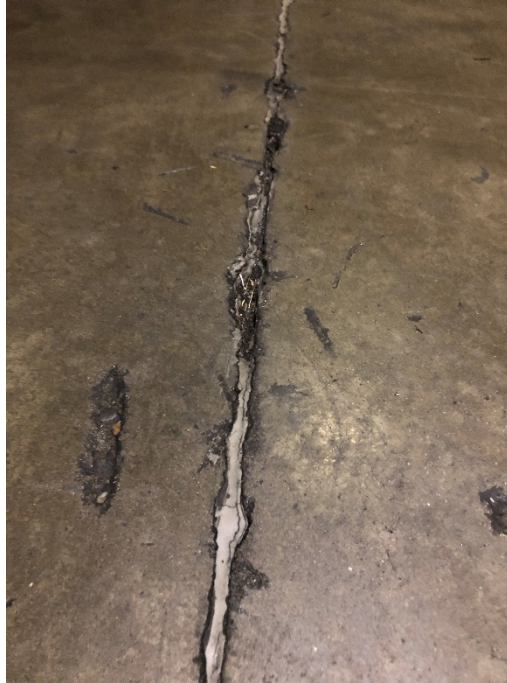
### Photo No. 11.

Typical sealant wear in seams in Warehouse 3. Seams are approximately 1 centimeter deep and do not appear to extend through the slab.

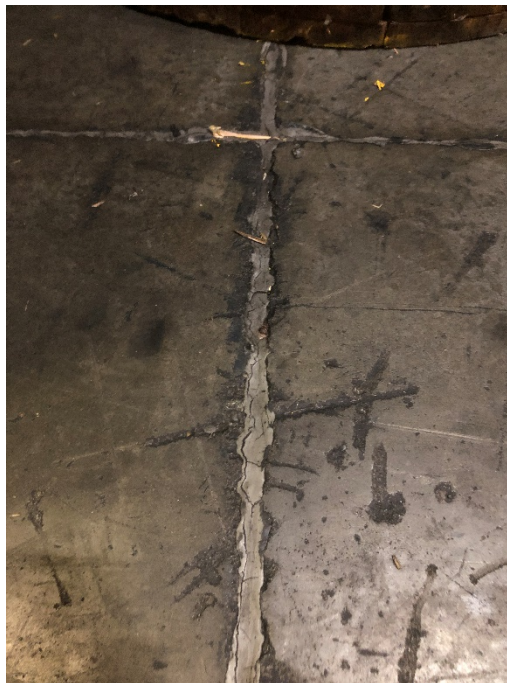
### Photo No. 12.

Typical sealant wear in seams in Warehouse 3. Seams are approximately 1 centimeter deep and do not appear to extend through the slab.
