TECHNICAL MEMORANDUM

Project No. GL152030402

**REMEDIAL INVESTIGATION SOIL AND INFILTRATION POND SEDIMENT SAMPLING RESULTS
RESERVE SILICA RECLAMATION SITE
FACILITY ID NO.: 2041; CLEANUP SITE NO.: 4728**

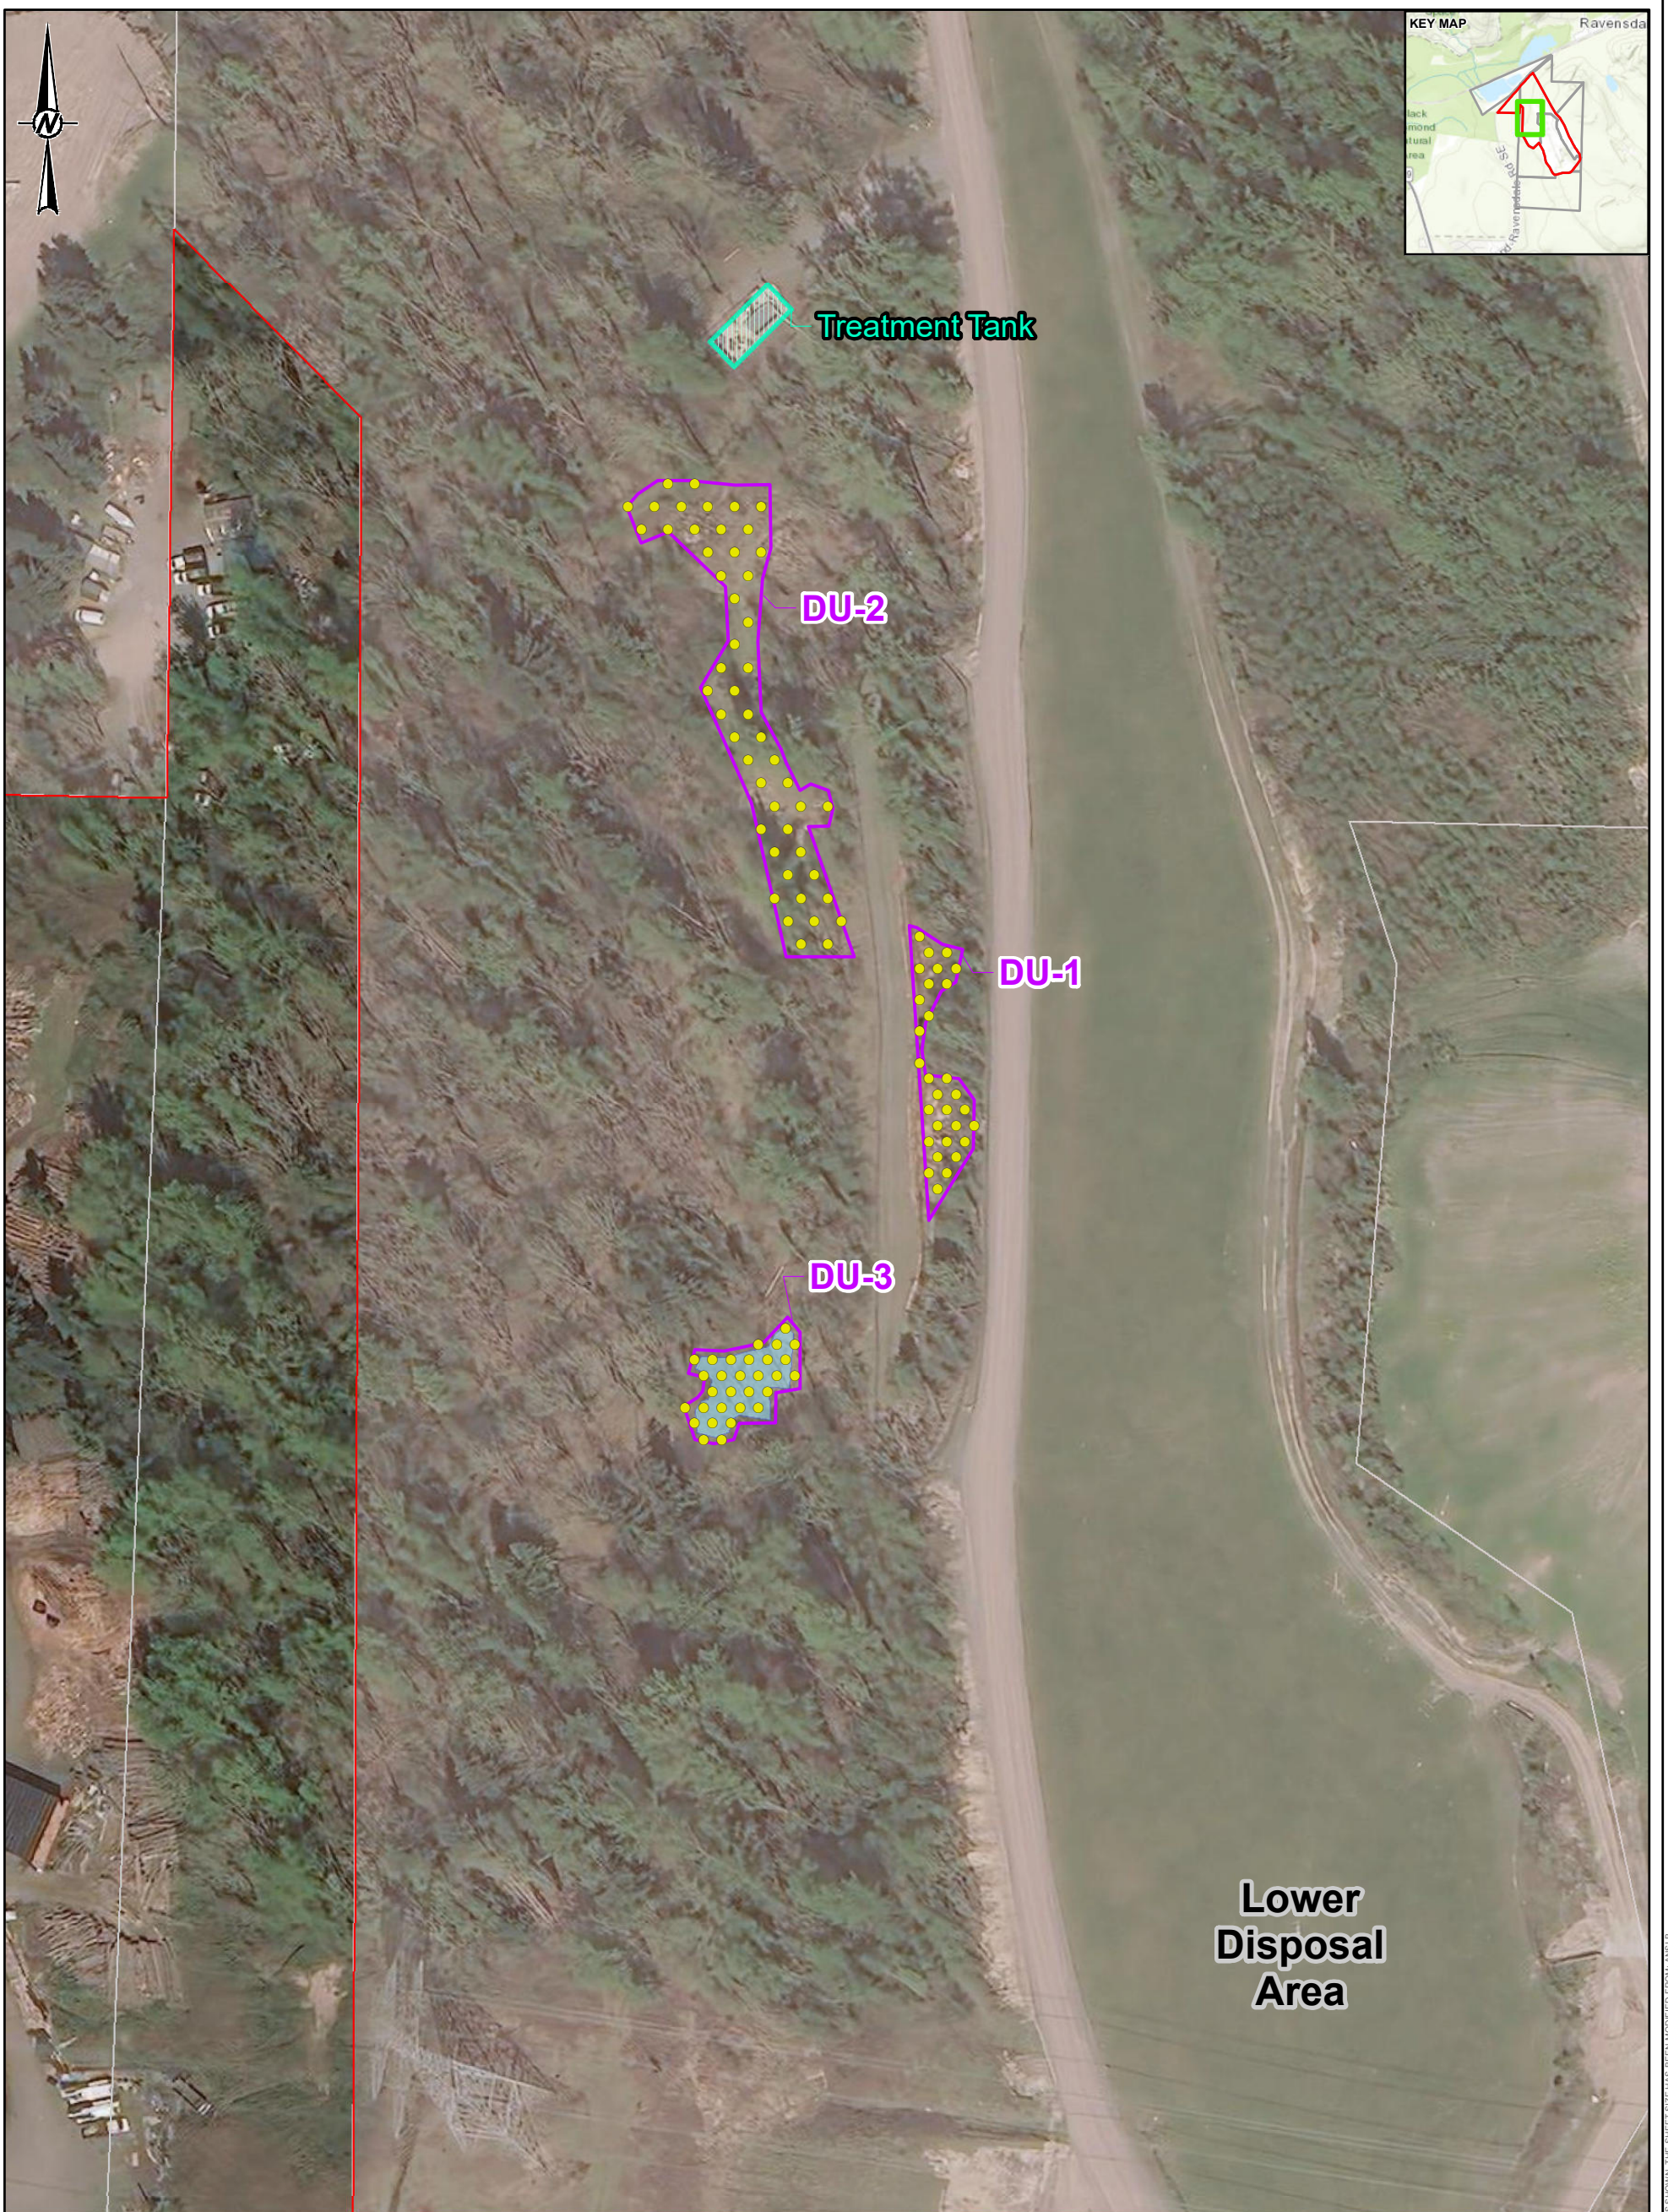
TITLE
ISM DECISION UNITS AND SAMPLING LOCATIONS

The locations of these three DUs are shown in Figure 3.

Each DU's boundary was established before the field sampling began. The boundaries were primarily based on visual observations and Site historical knowledge, and included the following:

- DU-1 Seepage precipitation area – this area is readily delineated by the presence of carbonate precipitates that have accumulated along the bench west of the Lower Haul Road and the known areas where high pH groundwater discharges to the surface along the bench. High pH seepage is not uniform across this area, but discharges at clearly visible locations. DU-1 was established to target the areas where the high pH seepage water is or historically has discharged and flowed overland to the seepage collection ditch, and therefore these samples represent the areas of likely highest impact along the bench immediately west of the Lower Haul Road.

- DU-2 Historical overland flow area – Prior to construction of the seepage collection ditch, the high pH groundwater discharging along the bench flowed west and then northwest towards the “constructed wetlands”. The topography in this area, the clear presence of former flow paths, and the historical knowledge of personnel who historically observed the overland flow in this area allowed for relatively accurate delineation of the boundaries where the high pH water historically flowed. Historical infiltration of high pH water in this area potentially resulted in dissolution and adsorption of metals into the surficial soils. DU-2 samples targeted the surficial soils in this area to evaluate the concentration of metals present.

- DU-3 South Pond – The South Pond is a man-made depression in the wooded area west of the south end of the seepage bench. Seasonally, when groundwater elevations are elevated during wet periods, high pH groundwater daylight in the South Pond. Visual observations for the last five years indicate that water seldom extends beyond the margins of the South Pond. When standing water is present within the pond, it results from rising and lowering groundwater, with minimal surface inflow or outflow of stormwater. Most of the year the pond does not contain standing water, as the groundwater is lower than the ground surface.

Triplicate ISM samples were collected within each DU, meaning three replicate ISM samples per DU were collected and shipped to ALS Environmental Laboratory located in Kelso, Washington for processing and analysis. Each ISM sample in DU-1 and DU-3 was an aggregate of 30 increments. Each ISM sample in DU-2 was an aggregate of 50 increments. ISM samples from DU-2 include a greater number of increments because the DU-2 area is larger than DU-1 and DU-3. The increments were collected along a systematic local grid within each DU. Under the systematic grid sampling design, the second replicate increment locations were collected approximately 3 feet west of the first replicate increment locations, and the third replicate increment locations were collected approximately 3 feet south of the first replicate increments. Different colored flagging was used to
