January 9, 2020

**RE: BLOCK 37 SUBSURFACE INVESTIGATION
SOUTH LAKE UNION BLOCK 37 PROPERTY
SEATTLE, WASHINGTON
FARALLON PN: 397-065**

BLOCK 37 SUBSURFACE INVESTIGATION South Lake Union Block 37 Property Seattle, Washington

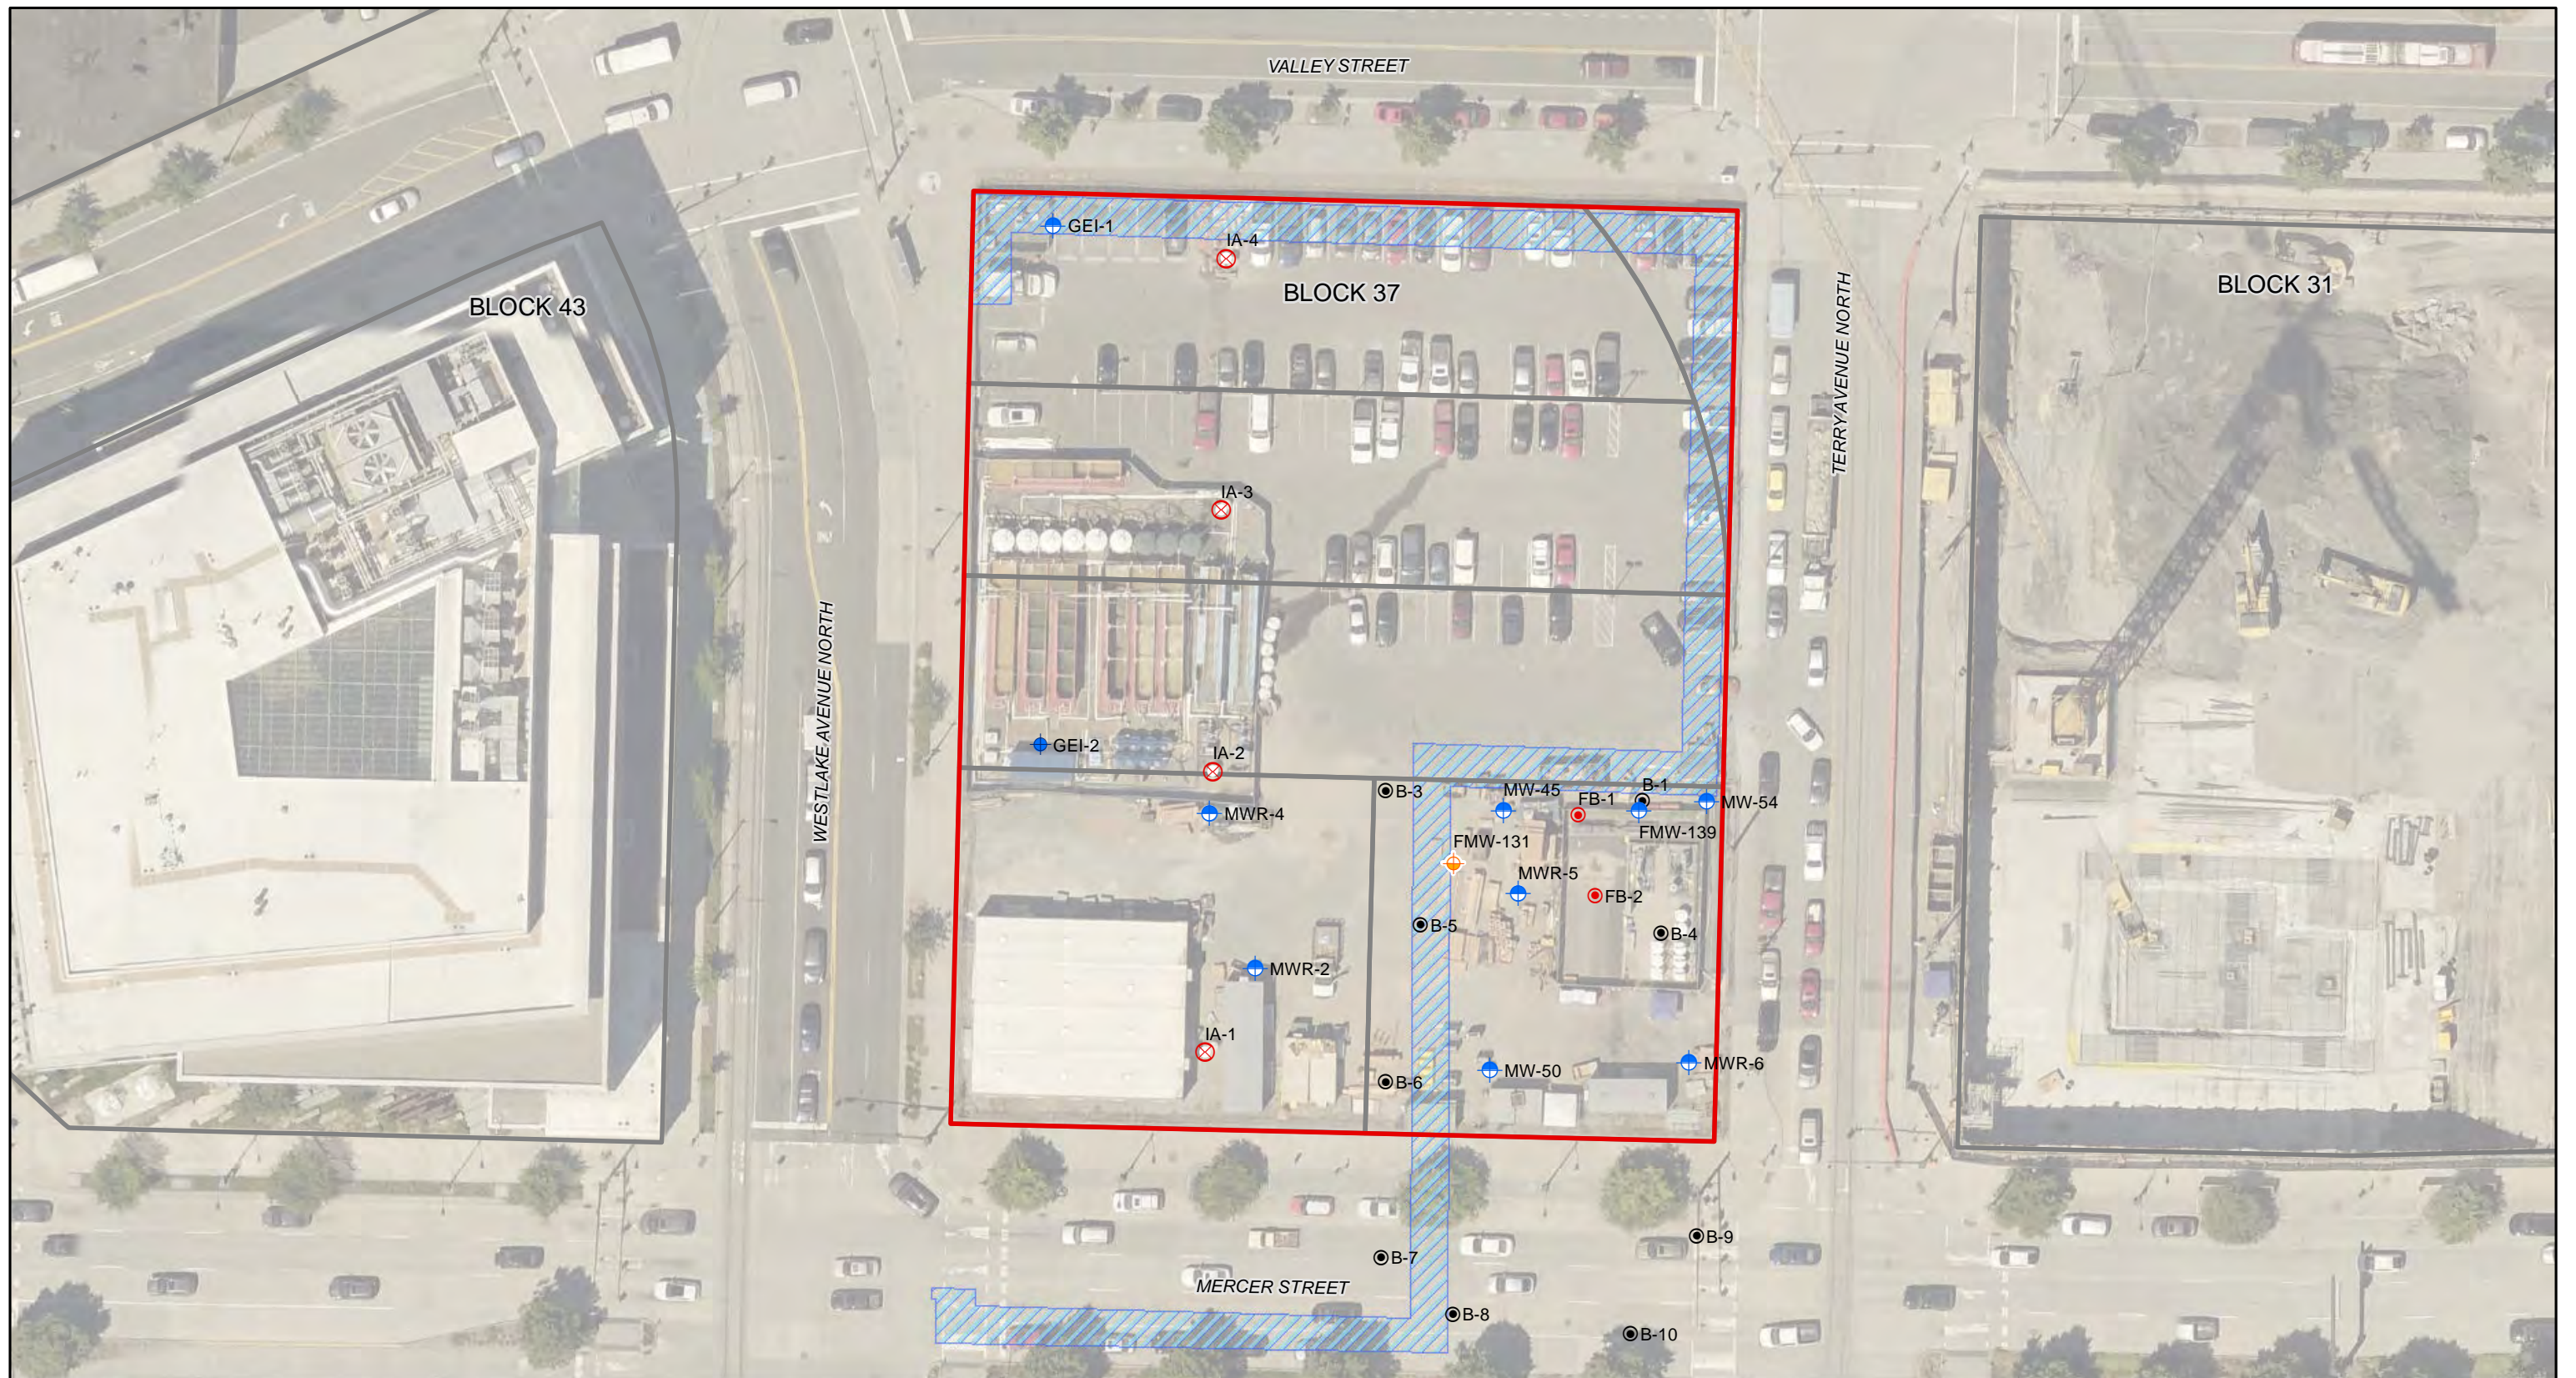
FIGURE 2
PROPERTY PLAN
SOUTH LAKE UNION BLOCK 37 PROPERTY
SEATTLE, WASHINGTON

Block 37 is a rectangular city block that comprises King County Parcel Nos. 408880323501, 408880323600, 4088803240, 4088803345, 4088803355, and 1987200015, totaling approximately 1.6 acres of land. Block 37 is bordered by Mercer Street to the south, Valley Street to the north, Terry Avenue North to the east, and Westlake Avenue North to the west, in a commercial and light industrial area of Seattle, Washington (Figure 2).

Borings FB-1 and FB-2 were installed at their respective locations to further evaluate potential CVOC impacts to shallow soil proximate to boring B-1 (Figure 2). Monitoring well FMW-139 was installed to collect shallow groundwater samples from a permanent monitoring well that would be considered representative of shallow groundwater water-quality conditions (Figure 2), in the same area where PCE was previously reported to be present in a reconnaissance shallow groundwater sample. Prior to conducting the field work, Farallon prepared a site-specific Health and Safety Plan as required by Part 1910 of Title 29 of the Code of Federal Regulations and Section 810 of Chapter 173-340 of the Washington Administrative Code.

Monitoring well FMW-139 was installed by Cascade Drilling, Inc. at or immediately adjacent to the reported location of boring B-1 location (Figure 2) using a direct-push drill rig. The monitoring well was constructed using 2-inch diameter Schedule 40 polyvinyl chloride casing and 0.010-inch slotted screen with a pre-packed 10/20 Monterey sand filter pack set from 7 to 17 feet bgs. 10/20 sand was placed in the annulus surrounding the monitoring well to approximately 1 foot above the pre-packed screen. A hydrated bentonite seal was placed from 2 to 6 feet bgs, followed by a surface seal of concrete from the ground surface to 2 feet bgs. Monitoring well FMW-139 was completed with a flush-mounted monument at the ground surface.

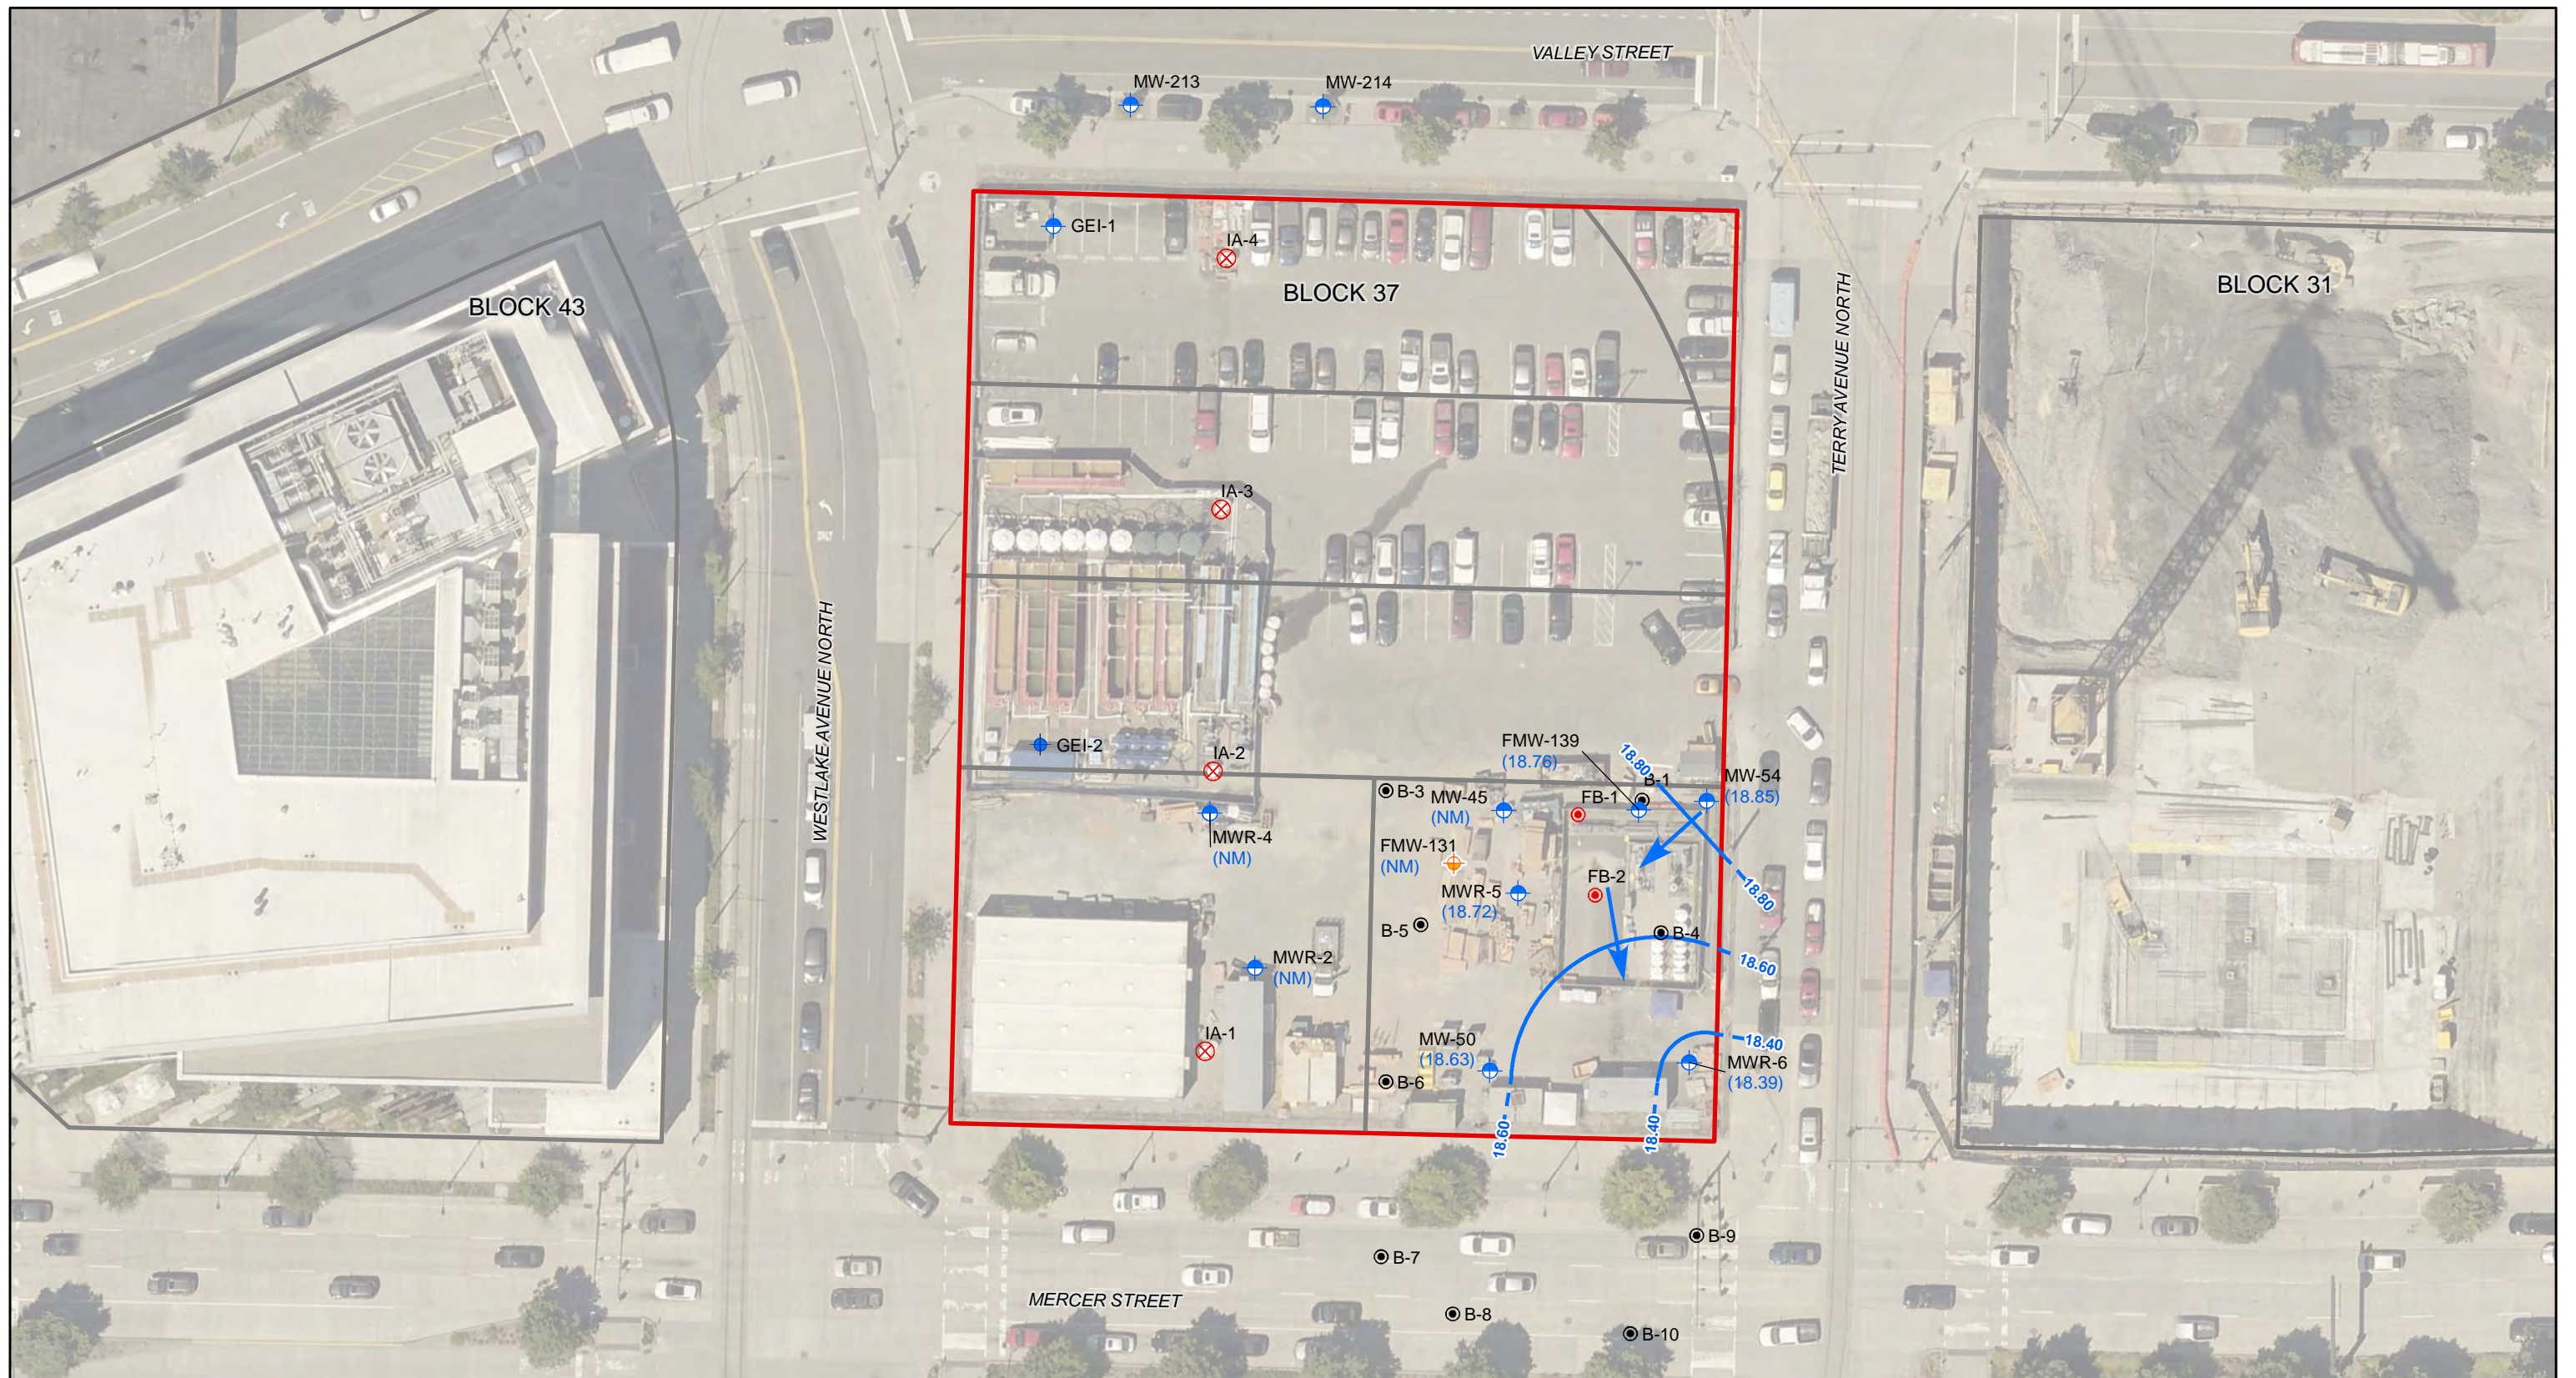
FIGURE 4
GROUNDWATER ELEVATION CONTOURS FOR MAY 6, 2019
SOUTH LAKE UNION BLOCK 37 PROPERTY SEATTLE, WASHINGTON

Based on the reported groundwater elevations, groundwater flow was north to northeast during the March, July, and September 2019 monitoring events. Groundwater contours for the March 2019 monitoring event are presented in Figure 3; the average gradient for the area measured was 0.015 feet per foot. Groundwater flow was south to southwest during the May 6, 2019 monitoring event with an approximate gradient of 0.005 feet per foot (Figure 4). In recent years, groundwater on Block 37 has periodically been affected by construction dewatering activities in the South Lake Union area that may have temporarily changed shallow groundwater flow direction or gradient from those reported based on the monitoring performed by Farallon in 2019.

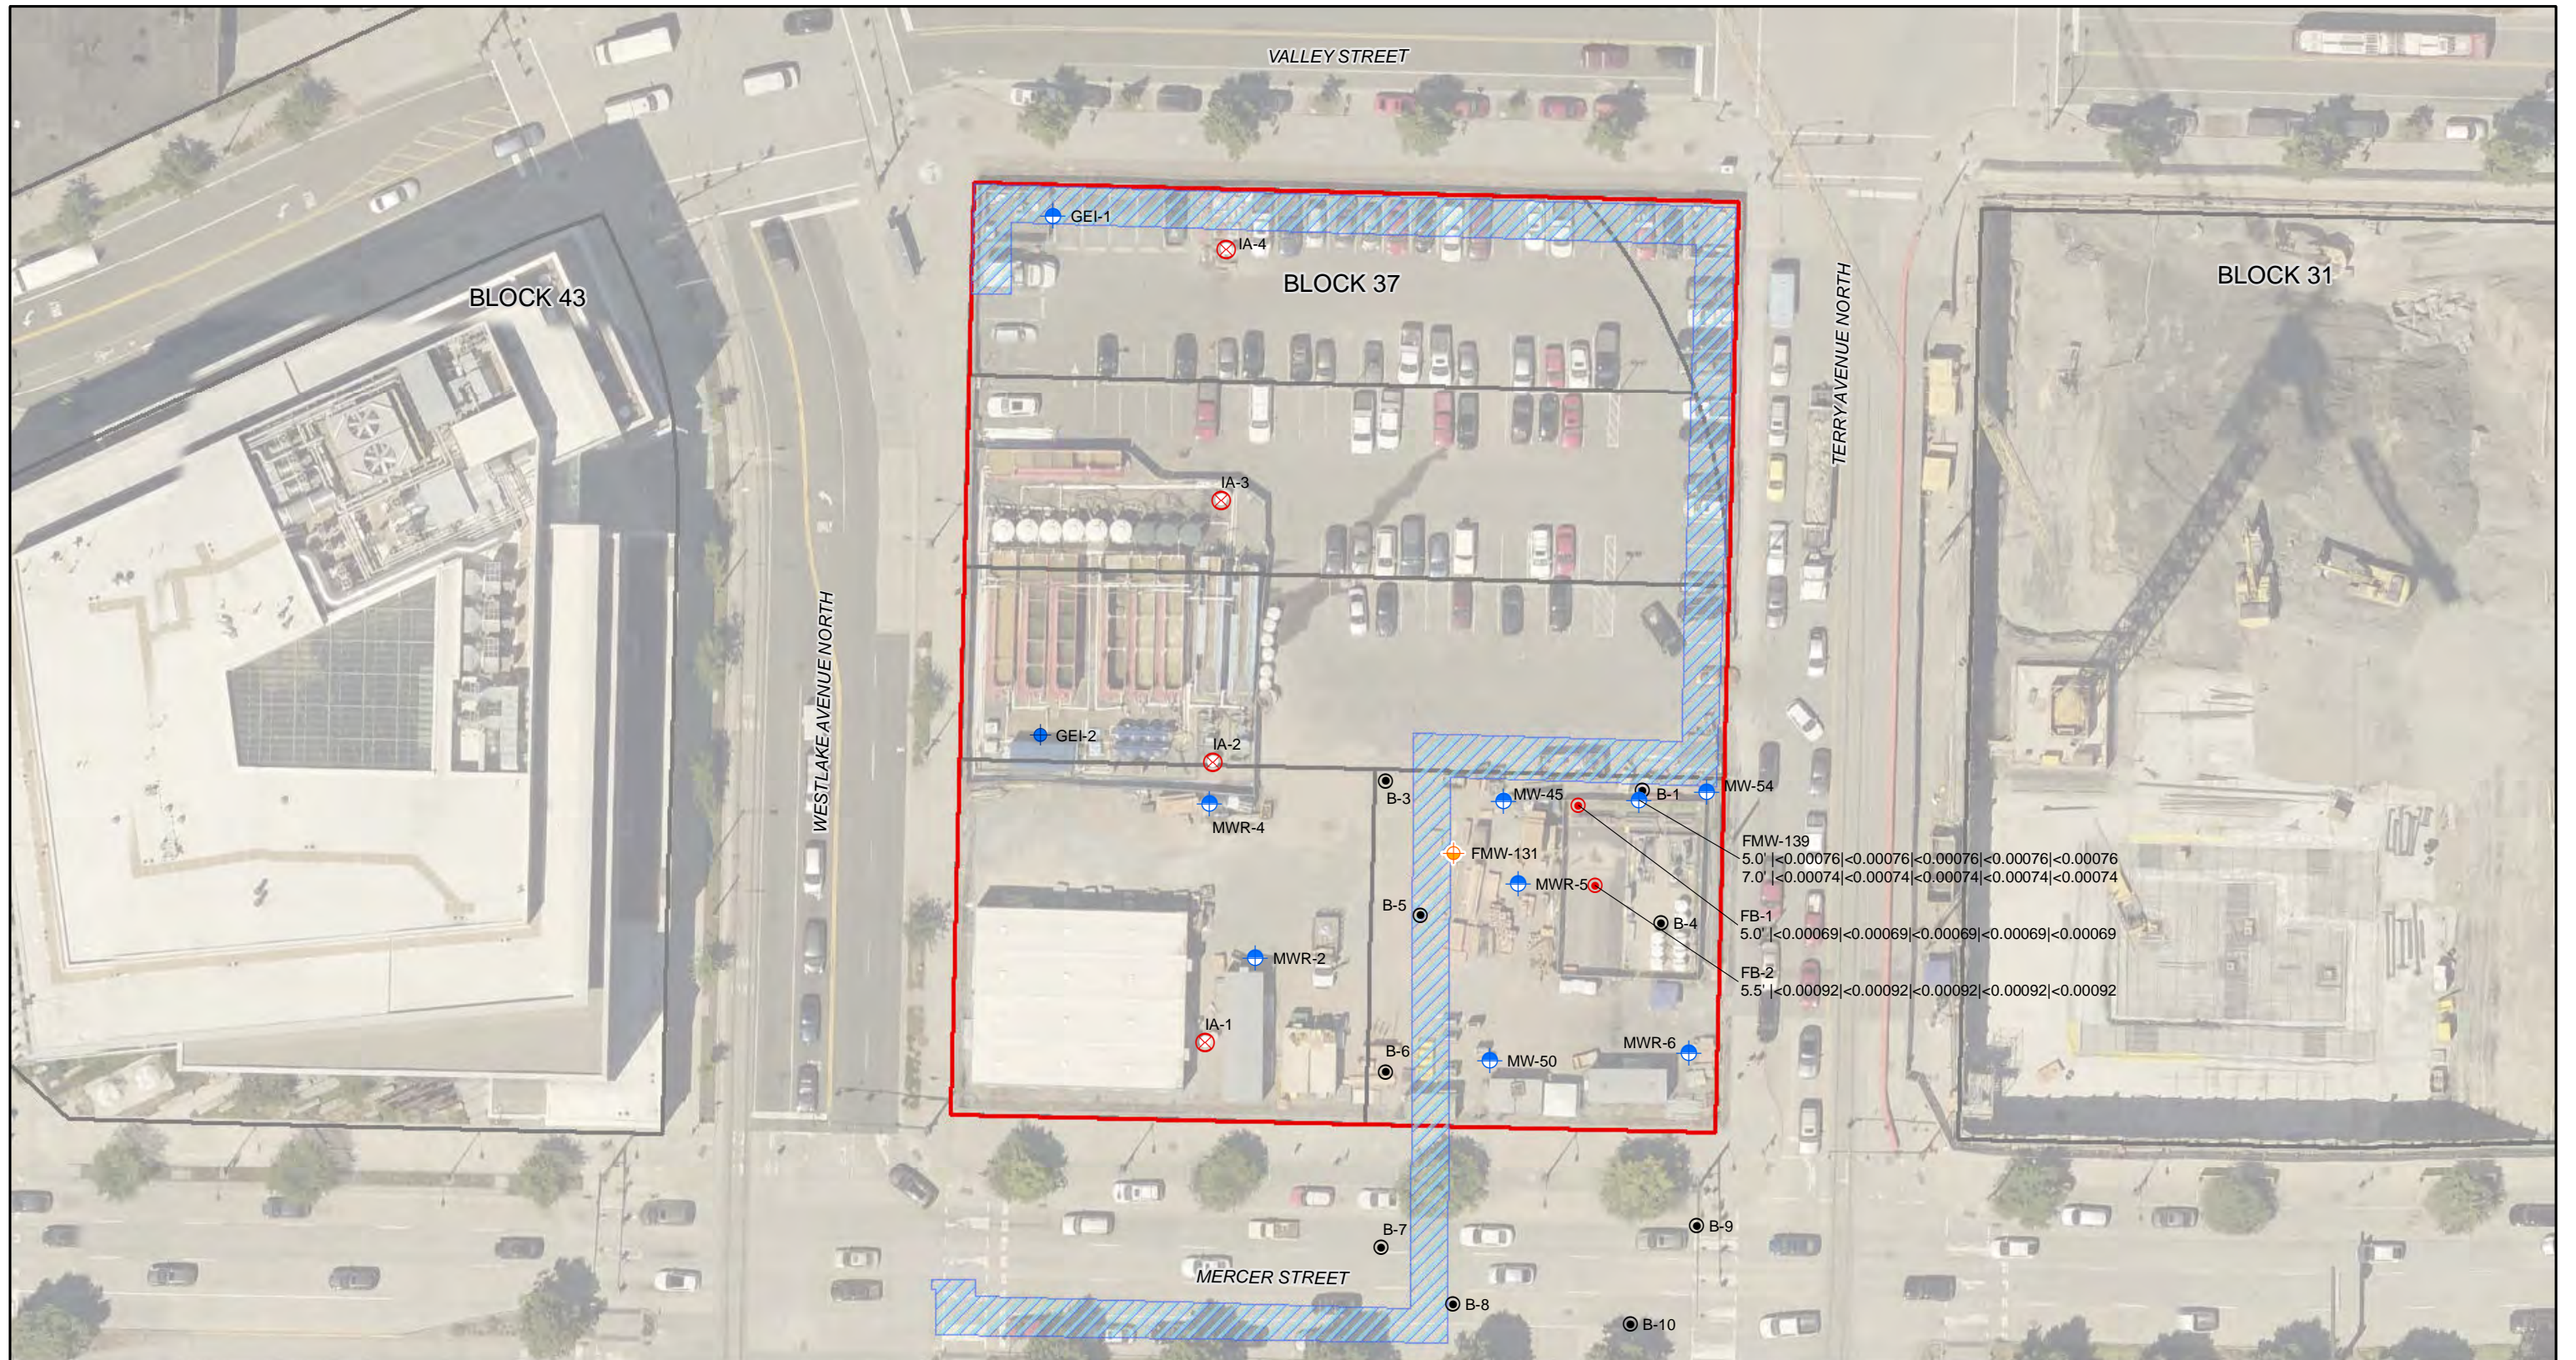
FIGURE 5
 SOIL ANALYTICAL RESULTS FOR CVOCs
 SOUTH LAKE UNION BLOCK 37 PROPERTY
 SEATTLE, WASHINGTON

Farallon analyzed the soil samples collected at depths of 5 feet and 7 feet bgs (approximately 24 to 22 feet NAVD88) to further evaluate the potential for a shallow release of CVOCs to vadose zone soil that could potentially act as a source to groundwater. Farallon did not observe any field indications of contamination – including odor, staining, or elevated photoionization detector readings – in the recovered soil cores or samples retained for analysis (Attachment B). The highest photoionization detector reading reported was 23 parts per million for the soil sample collected from boring FB-2 at a depth of 7 feet bgs (approximately 22 feet NAVD88); the sample was analyzed for CVOCs. CVOCs were reported non-detect at the laboratory PQL for all soil samples collected from borings FB-1 and FB-2 and monitoring well FMW-139 at depths between 5 and 7 feet bgs (approximately 24 to 22 feet NAVD88) (Table 2; Figure 5).

PCE was reported to have been detected at a concentration exceeding the MTCA Method A cleanup level in a reconnaissance shallow groundwater sample collected from boring B-1 by Hart Crowser, Inc. on Block 37 in September 2000. To further evaluate whether Hart Crowser, Inc.'s reported detection was evidence of a release of PCE to the subsurface, additional subsurface assessment was conducted by Farallon that used sampling and analytical methods currently recommended and approved by Ecology^{10,11} to evaluate potential CVOC impacts to soil and the Shallow Water-Bearing Zone on Block 37. Farallon advanced two additional borings proximate to historical boring B-1; installed one new shallow groundwater monitoring well at the location of boring B-1; and sampled six existing shallow groundwater monitoring wells and the new monitoring well FMW-139 four times over a period of 5 months (Figure 2). CVOCs were reported non-detect at the laboratory PQL in all soil and groundwater samples analyzed (Tables 2 and 3; Figures 5 and 6).

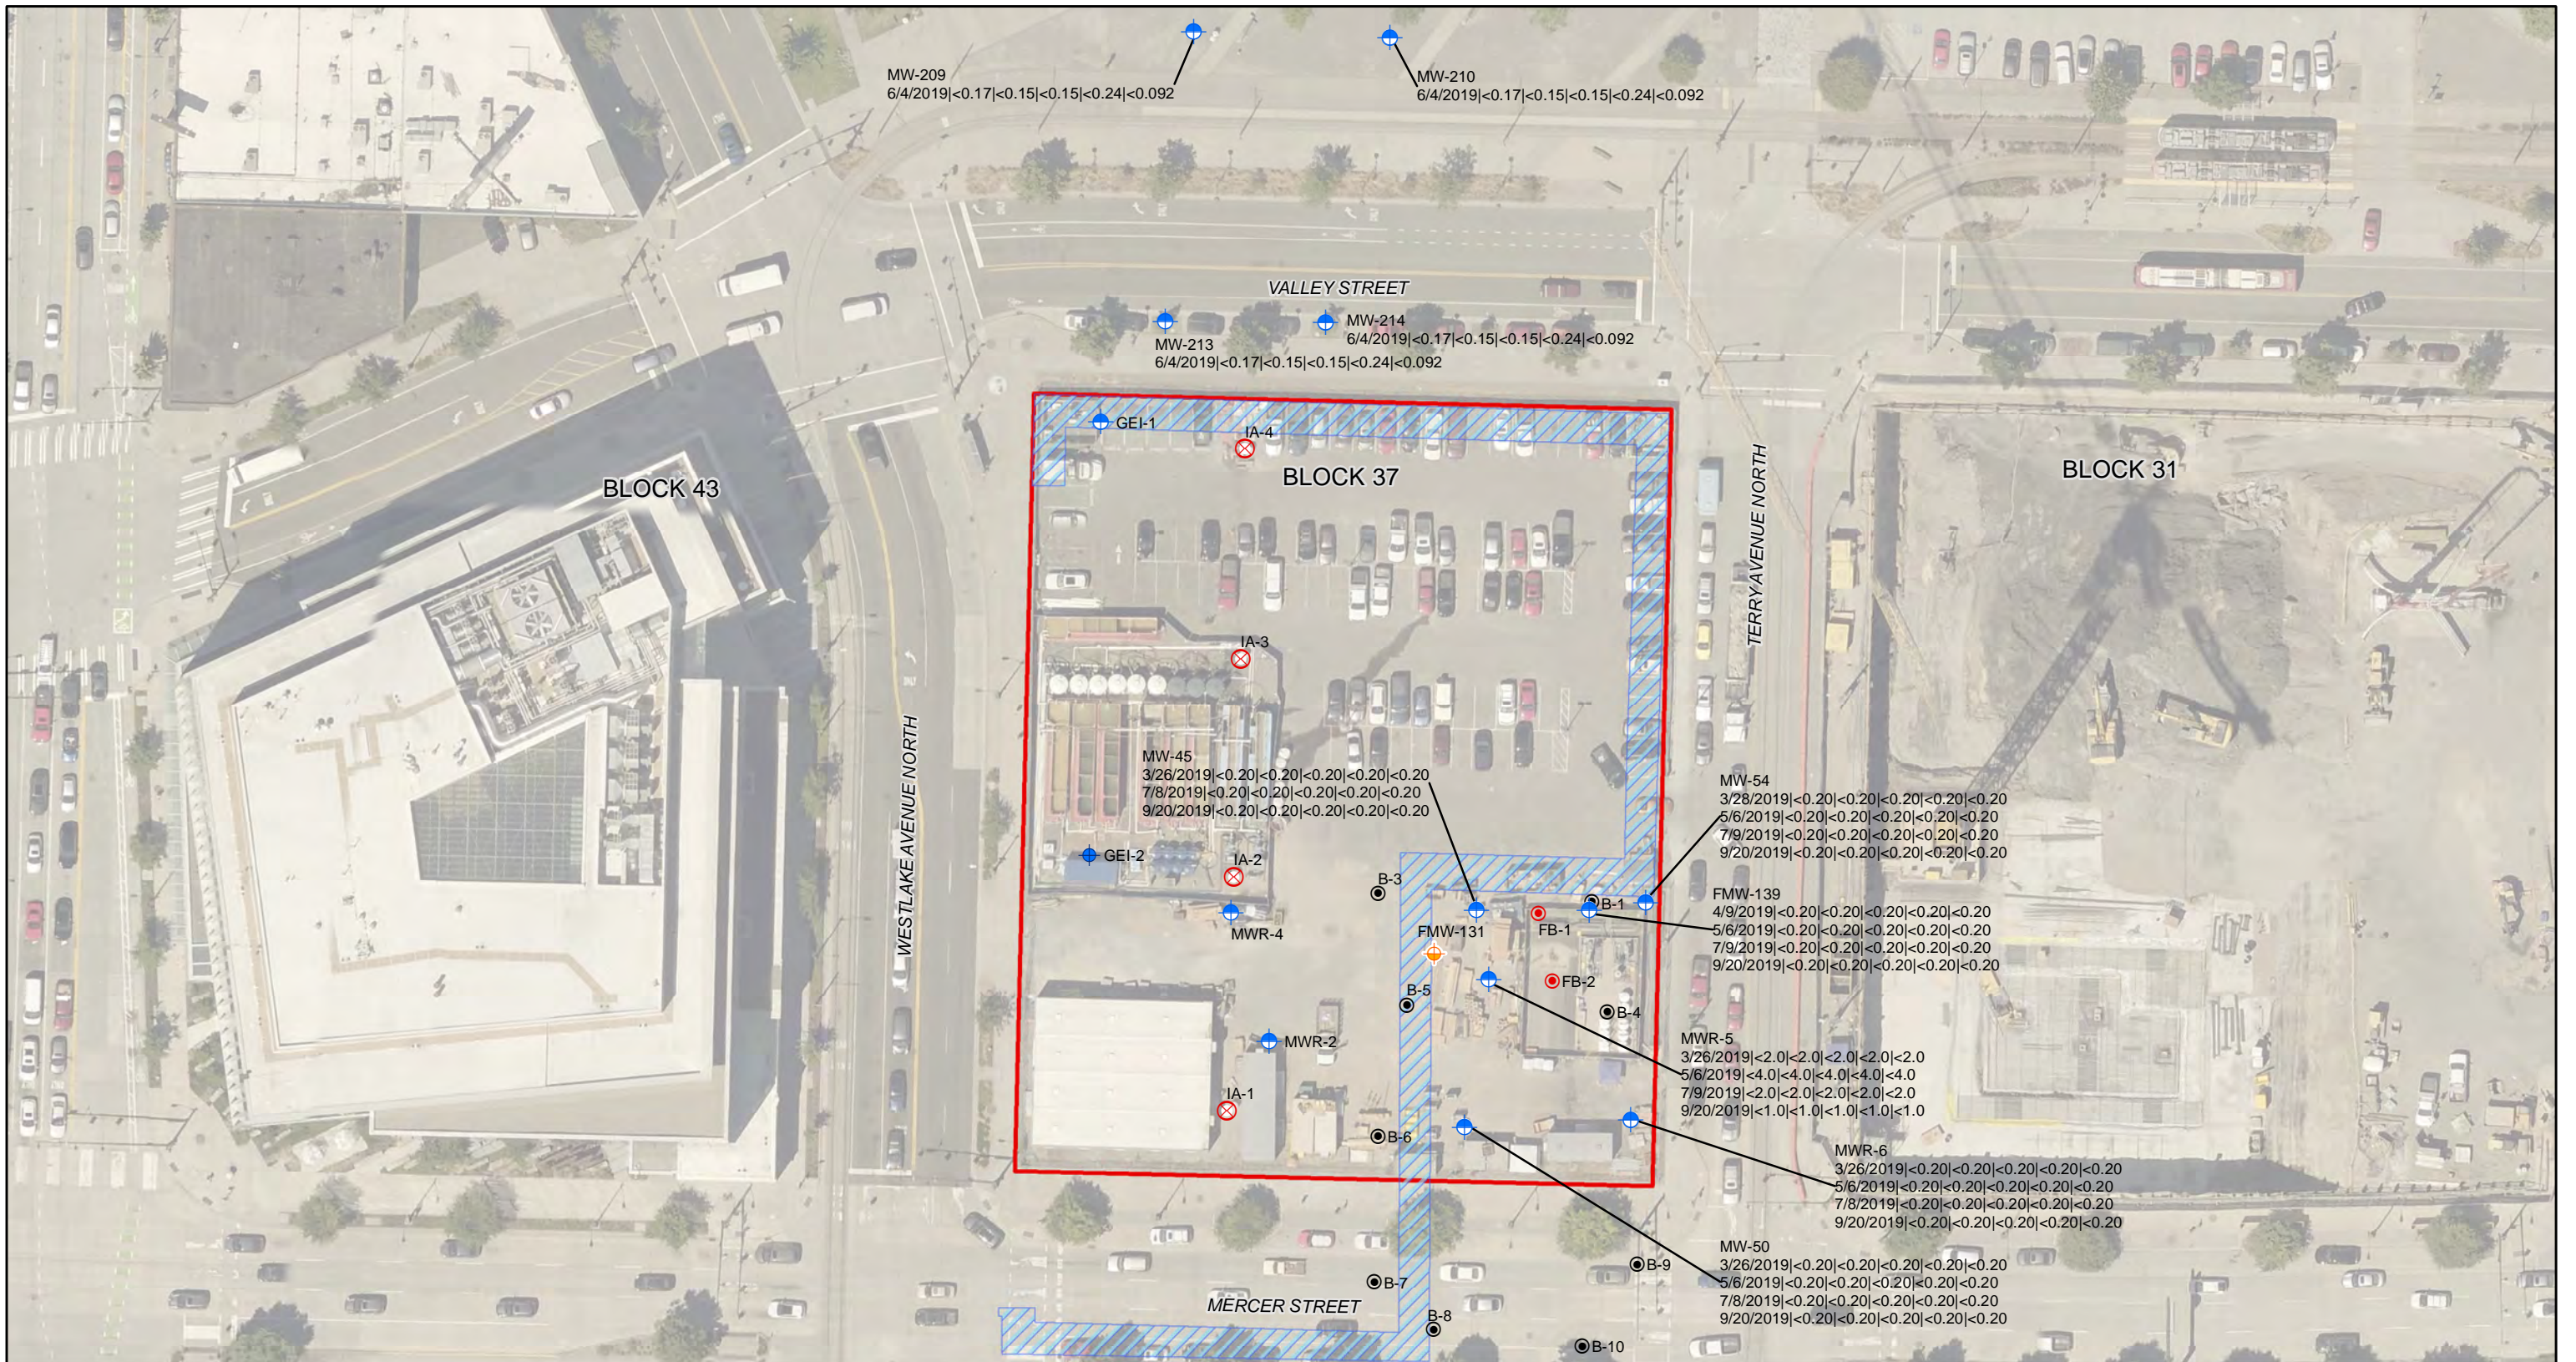
A summary of the results for soil and shallow groundwater sampling conducted by Farallon is presented below. Summary tables for soil and shallow groundwater analytical results are provided in Tables 2 and 3, respectively. Soil analytical results for CVOCs are presented on Figure 5. Shallow groundwater analytical results for CVOCs are presented on Figure 6. The complete laboratory analytical reports for soil and shallow groundwater samples are provided in Attachment C.
