**PHASE II ENVIRONMENTAL
SITE ASSESSMENT
QUALITY 4x4 TRUCK SUPPLY
2509 E EDDY LANE
PORT ANGELES, WASHINGTON**

Project No. 104-22002
February 21, 2022

Prepared for:
Estate of Burt Senf
1120 West 6th Street
Port Angeles, Washington 98363

Prepared by:
Krazan & Associates, Inc.
1230 Finn Hill Road NW, Ste A
Poulsbo, Washington 98370
(360) 598-2126

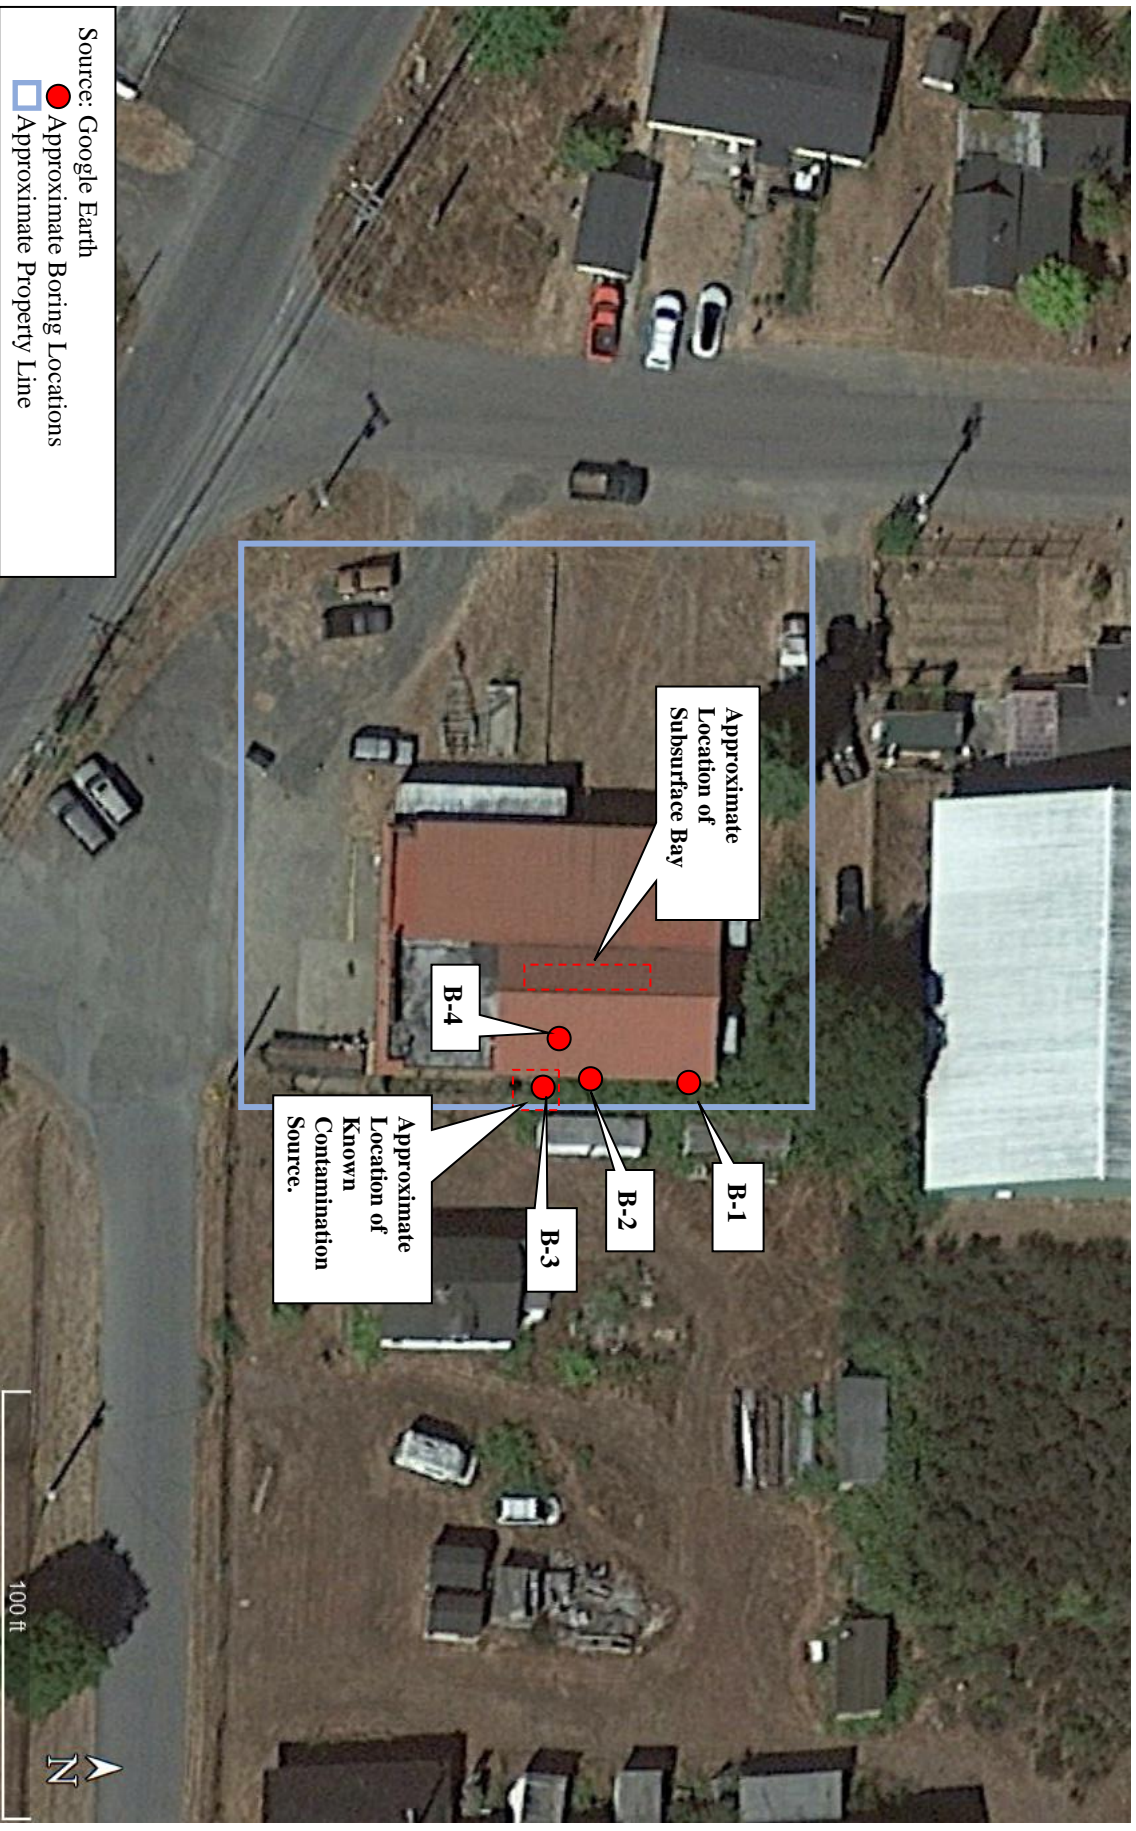
SITE MAP		Scale:	See Scale	Date:	February 2022
Quality 4x4 Phase II ESA 2509 E. Eddy Lane Port Angeles, Washington	Drawn by:	AG	Project No. 104-22002	Approved by:	SEW
	Figure No. 2

A representative of Krazan observed the drilling of soil borings and obtained soil samples on February 2nd, 2022, at Quality 4x4. Four soil borings were drilled with a Geoprobe 57LT Mini, limited access, direct-push drill. Attempts were made to drill 15 feet at each boresite. However, due to a layer of very dense gravels, the maximum depth achieved was 6.5 feet. The following location descriptions of soil borings are shown on Figure 2 and in greater detail on Figure 3:

- Boring B-1 was located outside the eastern most exterior wall near the northeast corner of the building;
- Boring B-2 was located outside the eastern most exterior wall directly south of boring B-1, and directly north of boring B-3;
- Boring B-3 was located outside the eastern most exterior wall directly south of boring B-2, along the northern edge of the concrete slab adjacent to the side garage door;
- Boring B-4 was located within the garage near the door along the eastern exterior wall and was drilled through the concrete slab-on-grade floor.

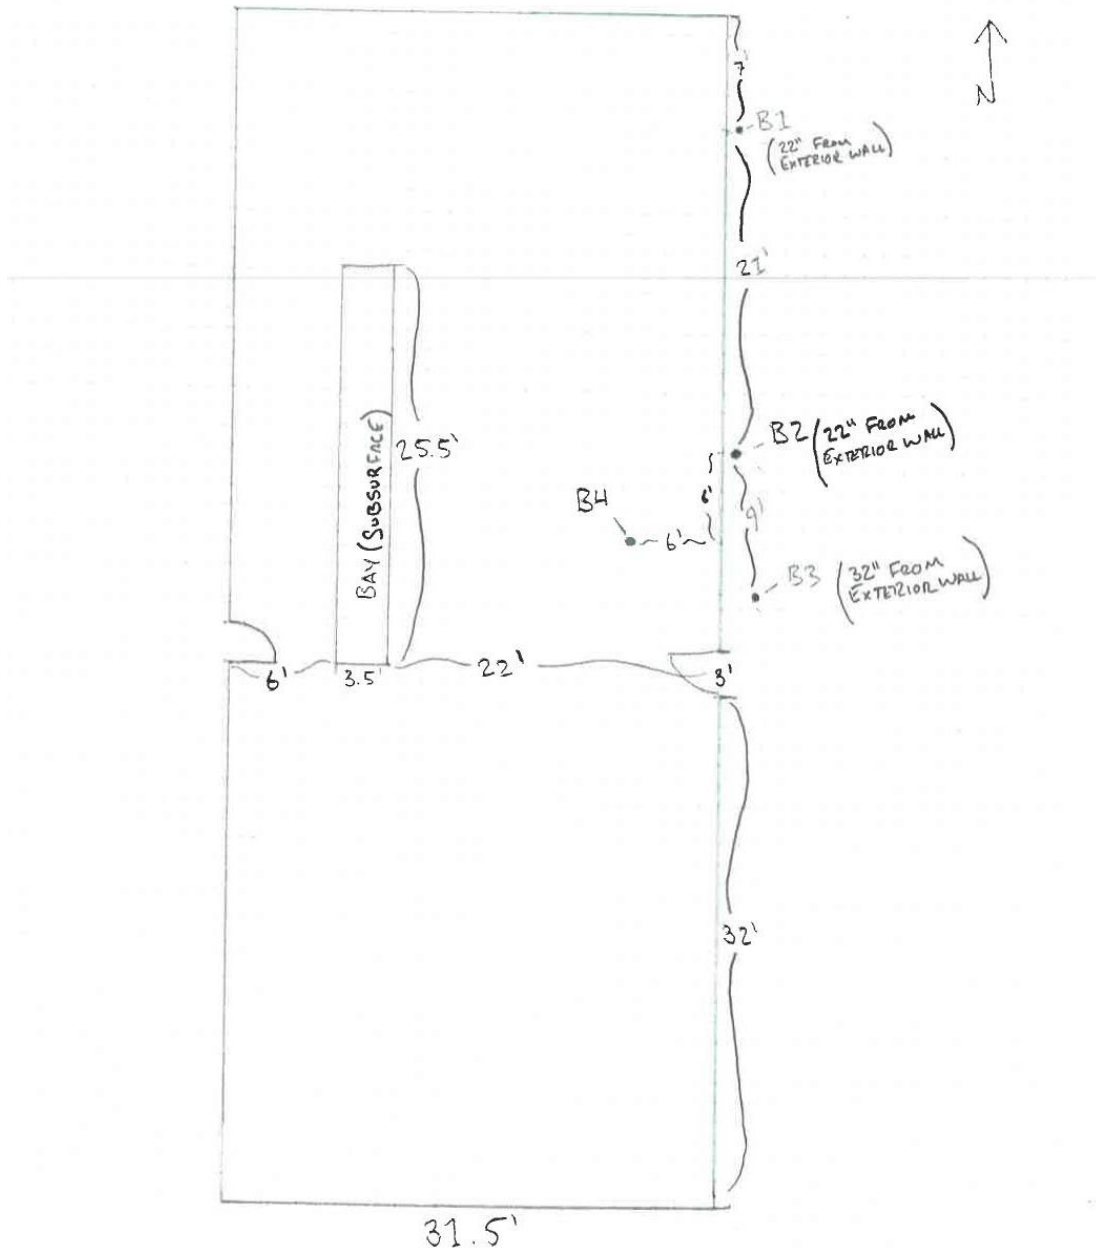
SITE DEVELOPMENT ENGINEERS <i>Offices Serving the Western United States</i>
Quality 4x4 Phase II ESA 2509 E. Eddy Lane Port Angeles, Washington	Drawn by: AG	Approved by: SEW	
	Project No. 104- 22002	Figure No. 3

SKETCH OF GARAGE ATTACHED TO EAST-SIDE OF BUILDING

Site Sketch	Scale: 1:120	Date: February 2022

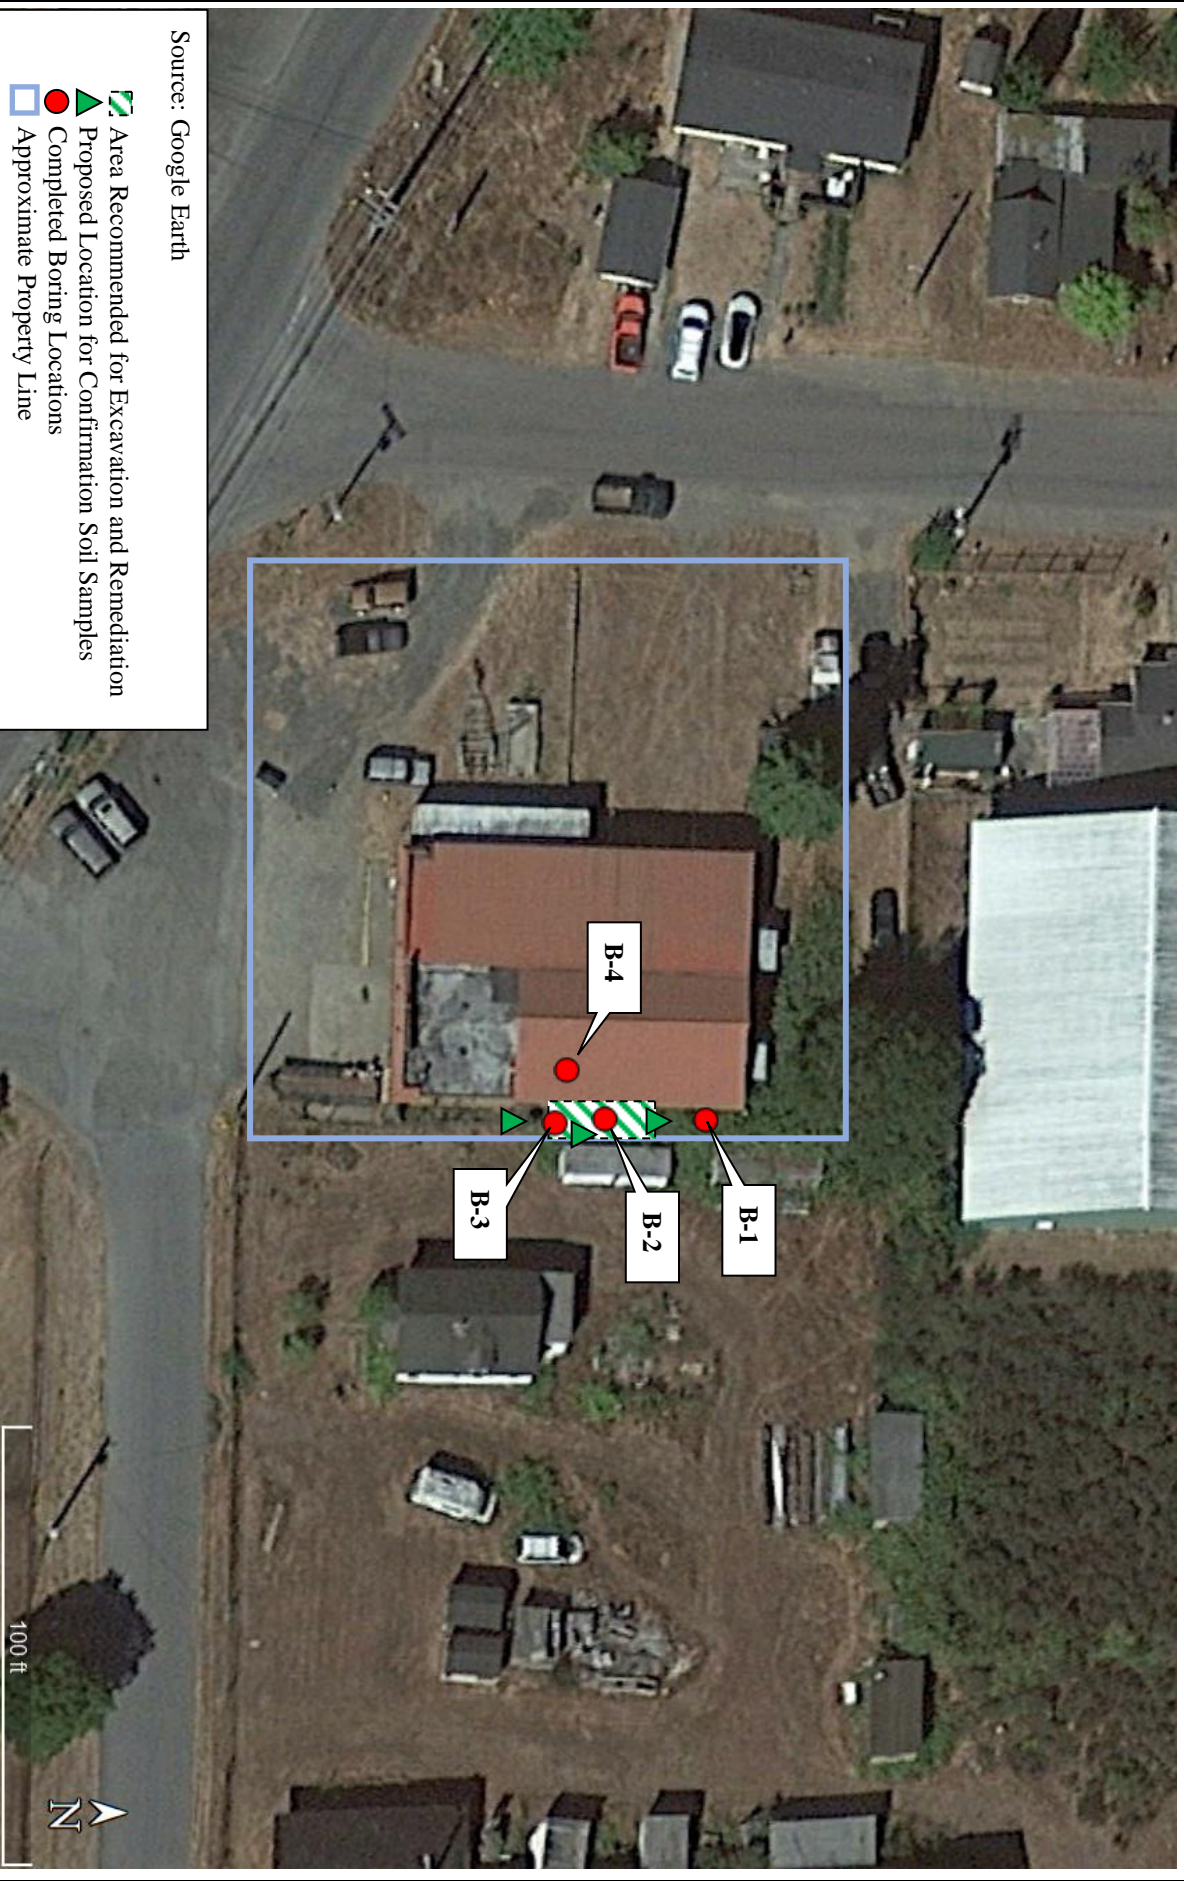
<p>Quality 4x4 Phase II ESA 2509 E. Eddy Lane Port Angeles, Washington</p>		<p>Scale: See Scale</p>	<p>Date: February 2022</p>
<p>Drawn by: AG</p>		<p>Approved by: SEW</p>	
<p>Project No. 104-22002</p>		<p>Figure No. 4</p>

Area Recommended for Excavation and Remediation
-

Proposed Location for Confirmation Soil Samples
-

Completed Boring Locations
-

Recommendations for Excavation and Remediation

- We recommend excavation of near surface soils for remediation of the contaminated area (Figure 4). The contaminated area is approximately 100 square feet in size and should be

excavated to a depth of at least 1.5 feet. The total volume of material to be excavated is estimated to be approximately 5.5 cubic yards.

- At the time of the excavation of contaminated soils, confirmation samples will be collected to confirm all contamination has been removed. The proposed locations of these additional samples can be found on Figure 4.

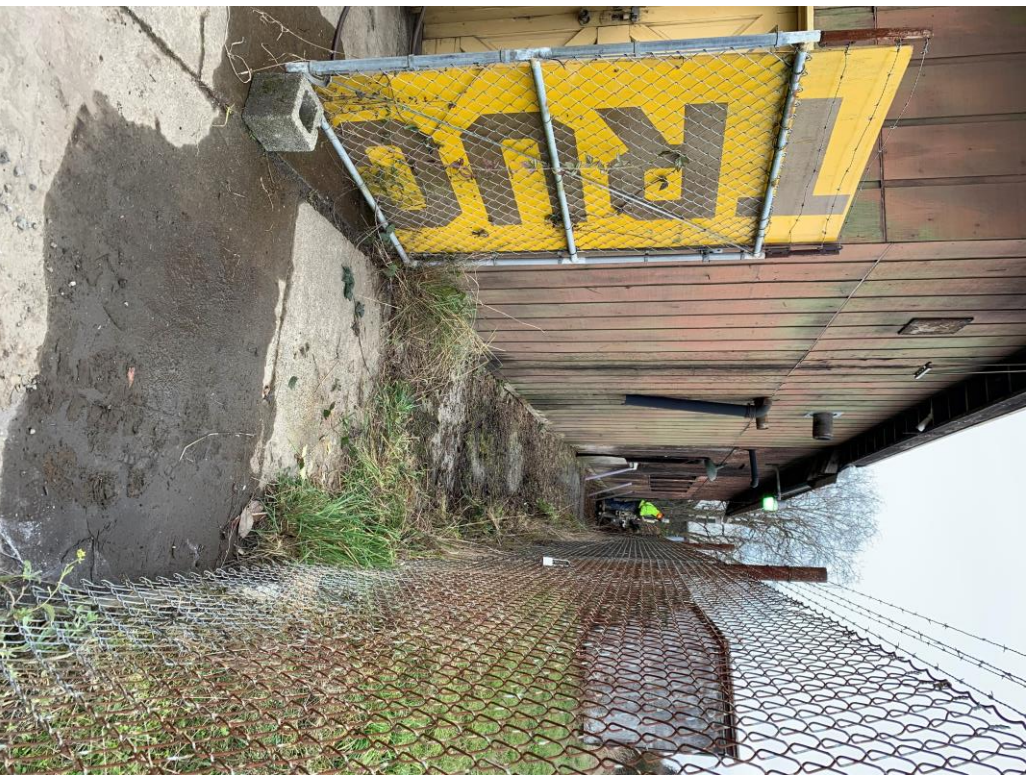
Photo 1: Positioned facing north along the east side of the site. Drilling of boring B-1.

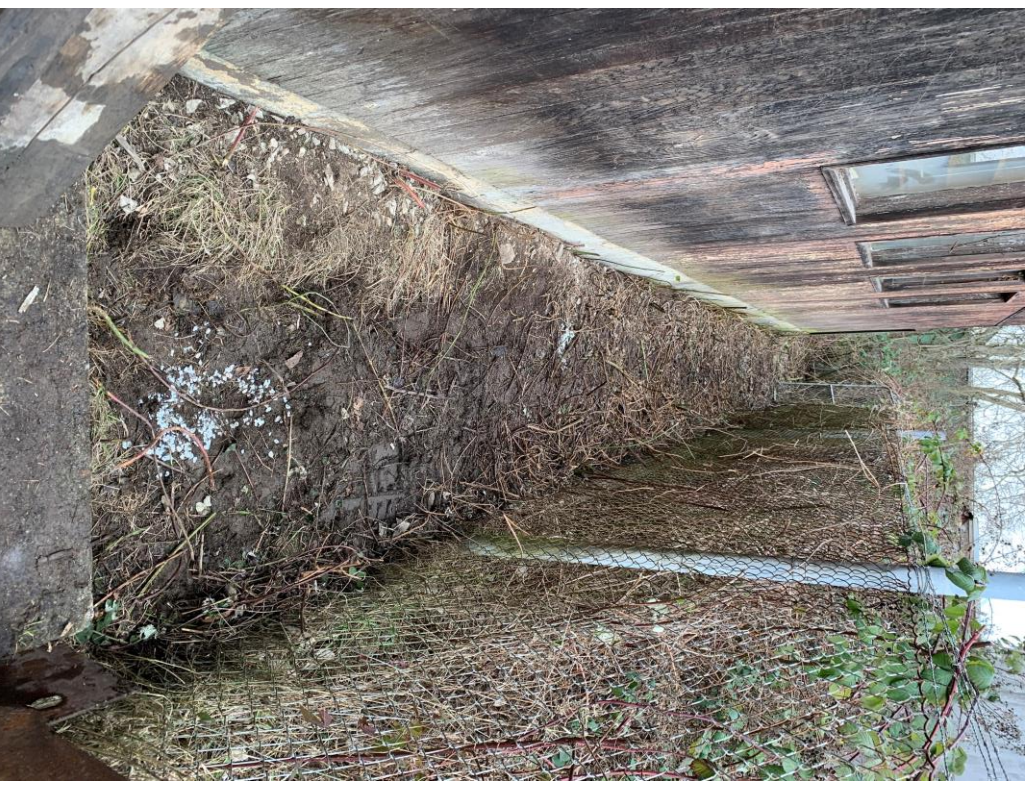
Photo 2: Positioned facing north along the east side of the site. Boring B-3 Located at bottom of image; Boring B-1 located at the top of image.

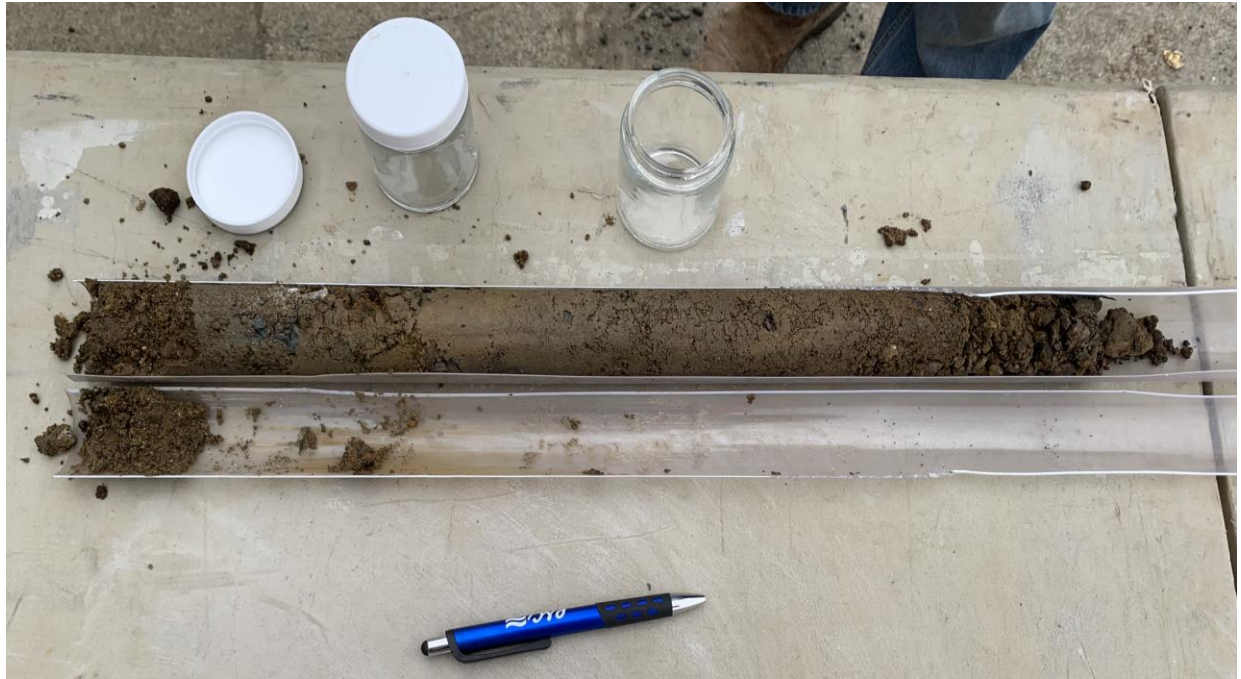
Photo 3: Boring from B-1 at 0-2 feet.

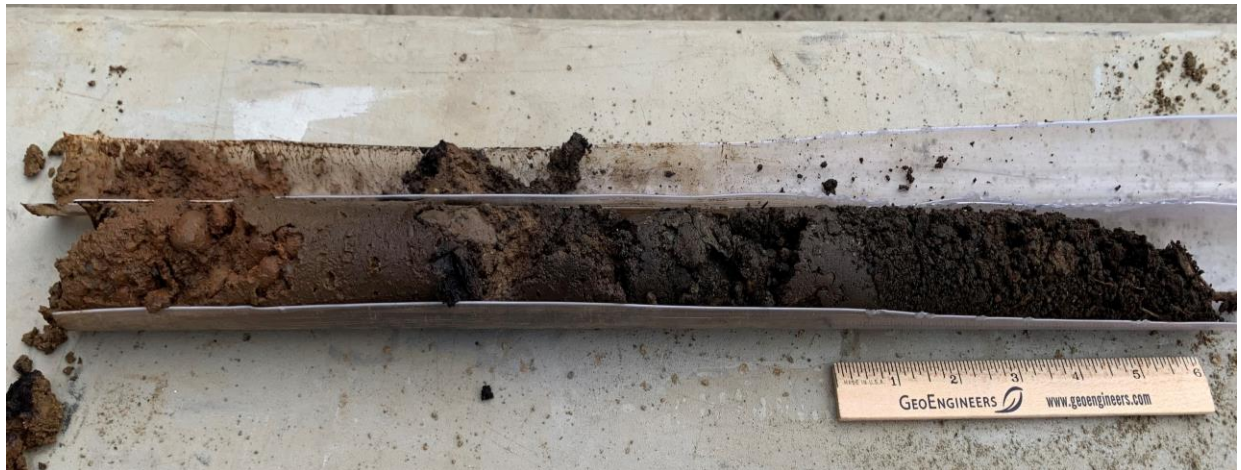
Seven soil samples were collected for analysis of the target compounds. Only one sample, B2-S1 at 1.0 feet, exceeded MTCA Method A cleanup levels for oil, arsenic, cadmium, and lead. Sample B3-S1 at 0.5 feet contained detectable concentrations of diesel and oil, but did not exceed MTCA Method A cleanup levels. Deeper samples in boring B-3 and samples from borings B-1 and B-4 contained no detectable diesel and oil concentrations. The results from samples analyzed for MTCA 5 metals from borings B-1, B-3, and B-4 were all below MTCA Method A cleanup levels. Samples analyzed from borings B-1, B-3, and B-4 contained no detectable concentrations of PCBs or PAHs.

- Soil samples collected and analyzed at boring B-2, located 28 feet south from the northeast corner of the building at a depth of 1 foot, contained concentrations of contaminants exceeding MTCA Method A Industrial Land Use Cleanup Levels, including total petroleum hydrocarbons in the heavy oil range, lead, cadmium, and arsenic. Samples from all other boring sites did not contain concentrations exceeding MTCA Method A Cleanup Levels, although the near-surface sample from boring B-3 did contain detectable concentrations of diesel and oil.

Photo 4: Boring from B-2 at 0-2 feet.

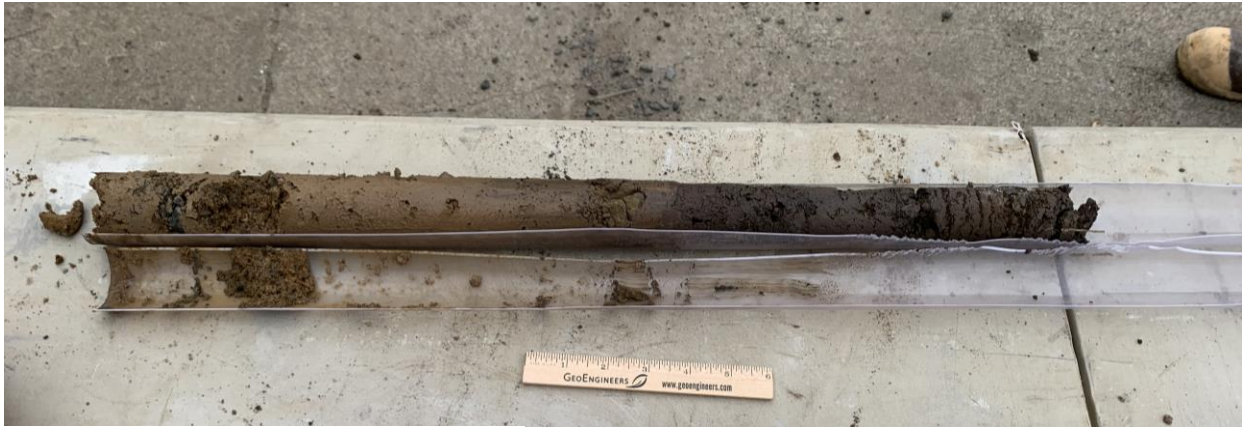
Photo 5: Boring from B-3 at 0-2 feet.

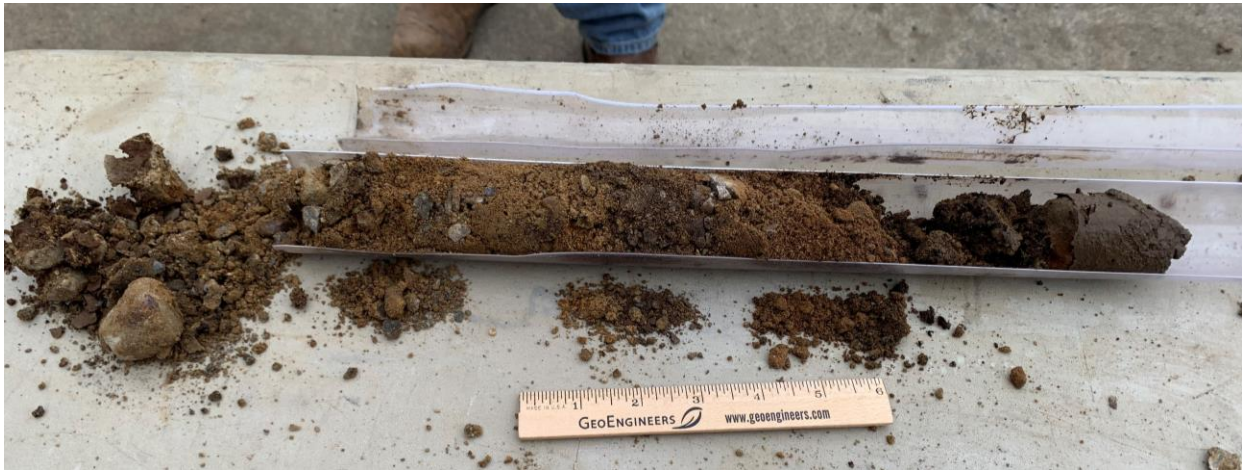
Photo 6: Boring from B-4 at 0-1 feet.

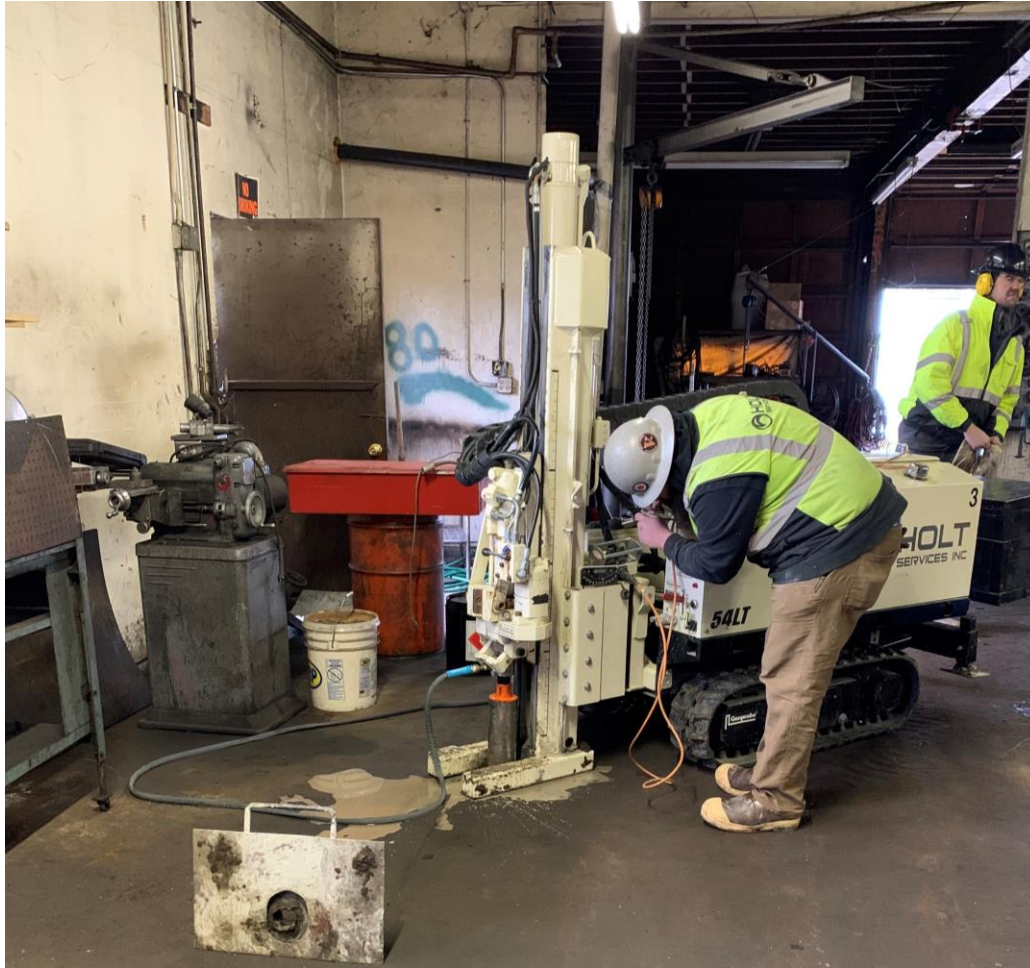
Photo 7: Positioned facing south inside the garage. Drilling of boring B-4.
