**REMOVAL ACTION AND  
CONFIRMATION SAMPLING  
QUALITY 4x4 TRUCK SUPPLY  
2509 E EDDY LANE  
PORT ANGELES, WASHINGTON**

Project No. 104-22002  
July 25, 2022

Prepared for:  
Estate of Burt Senf  
1120 West 6<sup>th</sup> Street  
Port Angeles, Washington 98363

Prepared by:  
Krazan & Associates, Inc.  
1230 Finn Hill Road NW, Ste A  
Poulsbo, Washington 98370  
(360) 598-2126

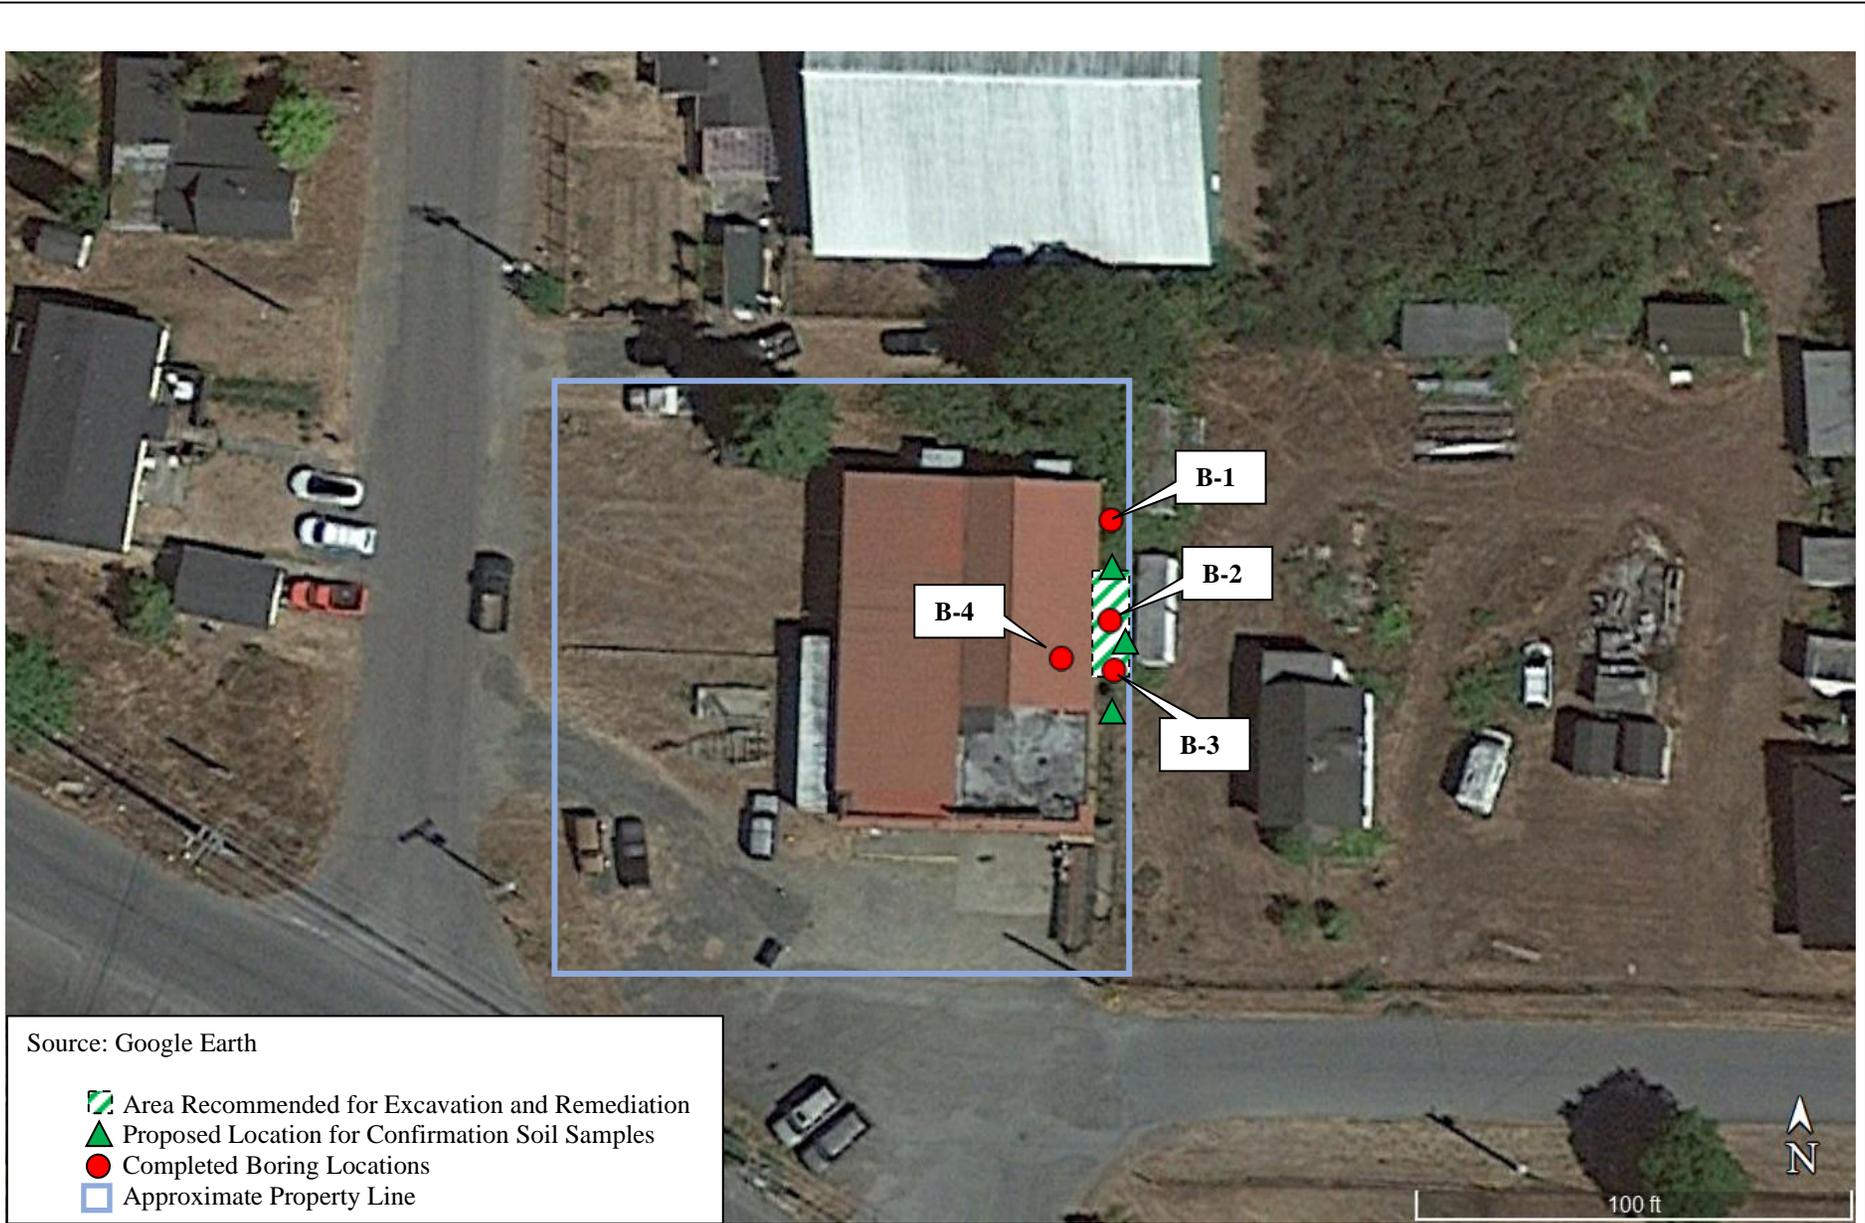
<b>Recommendations for Excavation and Remediation</b>  <b>Quality 4x4 Truck Supply</b> <b>Removal Action and Confirmation Sampling</b> <b>2509 E. Eddy Lane</b> <b>Port Angeles, Washington</b>	Scale: NTS	Date: July 2022
	Drawn by: AG	Approved by: SEW
	Project No. 104-22002	Figure No. 3

- We recommend excavation of near surface soils for remediation of the contaminated area (Figure 3). The contaminated area is approximately 100 square feet in size and should be excavated to a depth of at least 1.5 feet. The total volume of material to be excavated is estimated to be approximately 5.5 cubic yards.
- At the time of the excavation of contaminated soils, confirmation samples will be collected to confirm all contamination has been removed. The proposed locations of these additional samples can be found on Figure 3.

The near surface soil in the designated area on the east side of the Quality 4x4 building was excavated to at least 1.5 feet below ground surface on May 22, 2022. A total of 5.83 tons of soil was excavated and transported to the City of Port Angeles Transfer Station in Port Angeles, Washington. The excavation area was 4.5 by 30 feet (Figure 3). Three confirmation soil samples were collected by Krazan within the excavation bottom (1.5 feet below ground surface [bgs]) on June 15, 2022. During the confirmation sampling, each soil sample collected was screened using a photoionization detector (PID) to assess for the presence of volatile organic constituents. No detectable PID measurements were recorded from samples from any of the sampling locations. The excavation was not backfilled.

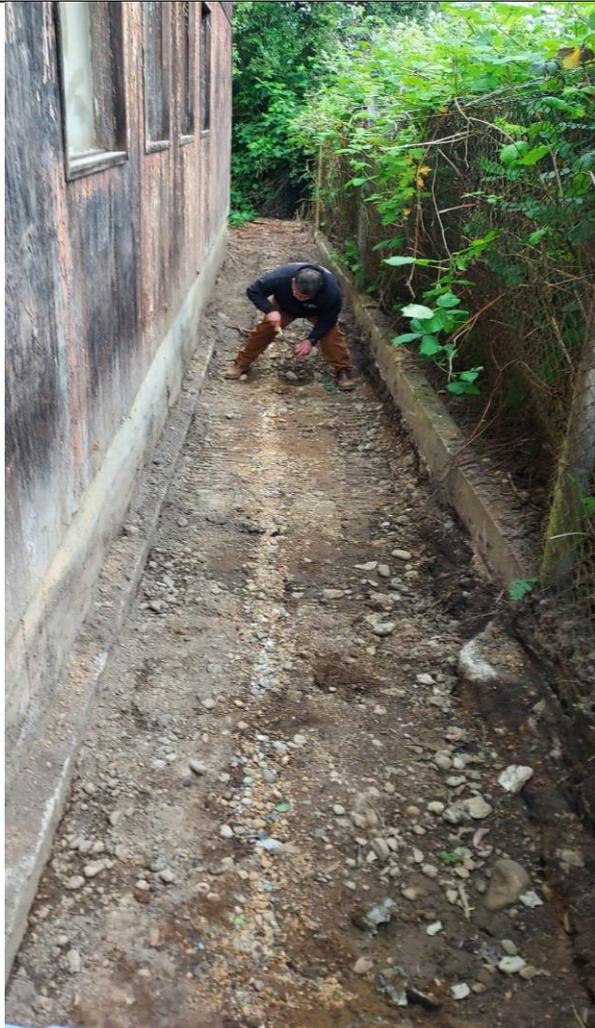
**Photo 1:** Image showing confirmation sampling after initial excavation.

See Table 1 for confirmation sample results. Confirmation sample KA-CS-02-SL from the center of the excavation contained cadmium and lead concentrations exceeding the MTCA Method A Industrial Land Use Cleanup Levels. Confirmation sample KA-CS-03-SL from the north end of the excavation contained TPH in the oil range, cadmium, and lead concentrations exceeding the MTCA Method A Industrial Land Use Cleanup Levels. Analysis results of the remaining target compounds in Sample-02 and Sample-03 were either below the MTCA Method A Industrial Land Use cleanup levels or were below laboratory detection levels. All concentrations of the target compounds from Sample-01, sampled discretely from the bottom of the south end of the excavation area, were either below the MTCA Method A Industrial Land Use cleanup levels or were below laboratory detection levels.

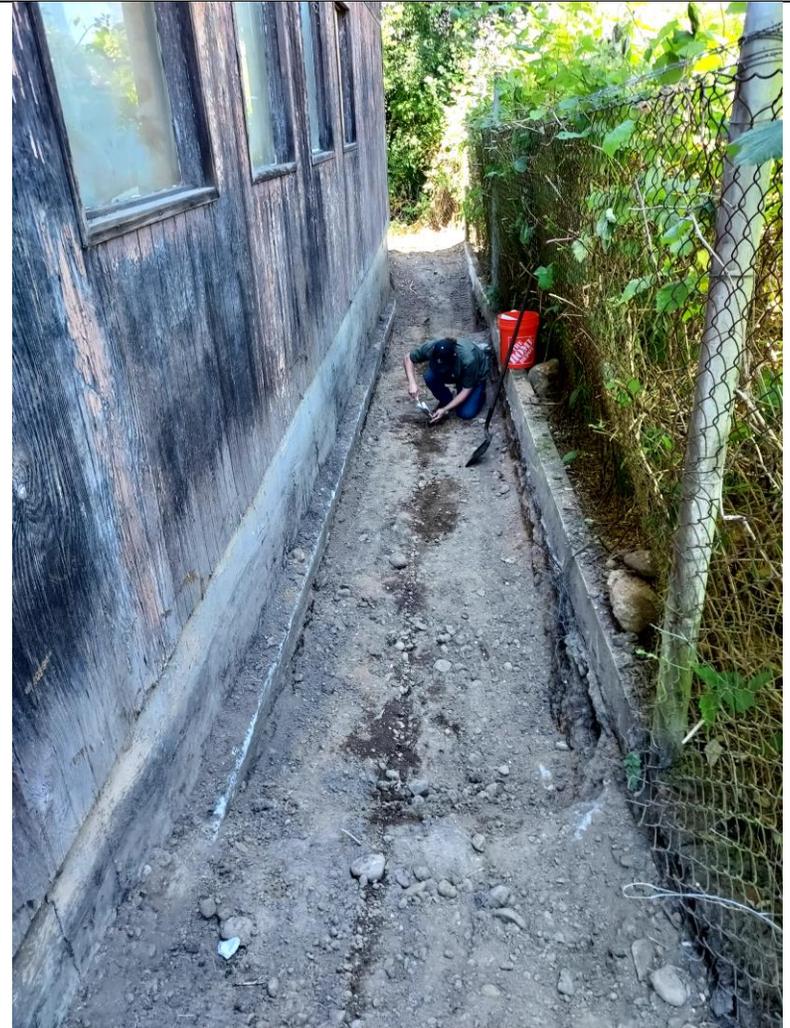
**Photo 2:** Image showing confirmation sampling after second excavation.

On July 11, 2022, following the second excavation, two soil samples from the bottom of the excavated area (2.5 feet bgs), were collected for analysis of the target compounds. The sampling and analytical procedures utilized during the June 15, 2022, confirmation sampling were used during the July 8, 2022 sampling. Samples were taken from approximately the same location as Sample-01 and Sample-02 during the June 15, 2022, confirmation sampling. Sample-04 and Sample-05, discretely sampled from the center and north end of the pit respectively, were submitted for analysis of the target compounds. Concentrations of all the target compounds were reported either below the MTCA Method A Industrial Land Use cleanup levels or were below laboratory detection levels. See Figure 3 and Table 1 for all sampling locations and a summary of the results. The laboratory reports are provided in Appendix A and photo copies of the transfer station receipts are provided in Appendix B.
