## **Monitoring, Sampling and Analysis Report**

### **Spokane River Shoreline Sediment Sites Heavy Metals (As, Cd, Pb, Zn) Post-Remediation Monitoring**

April 2015

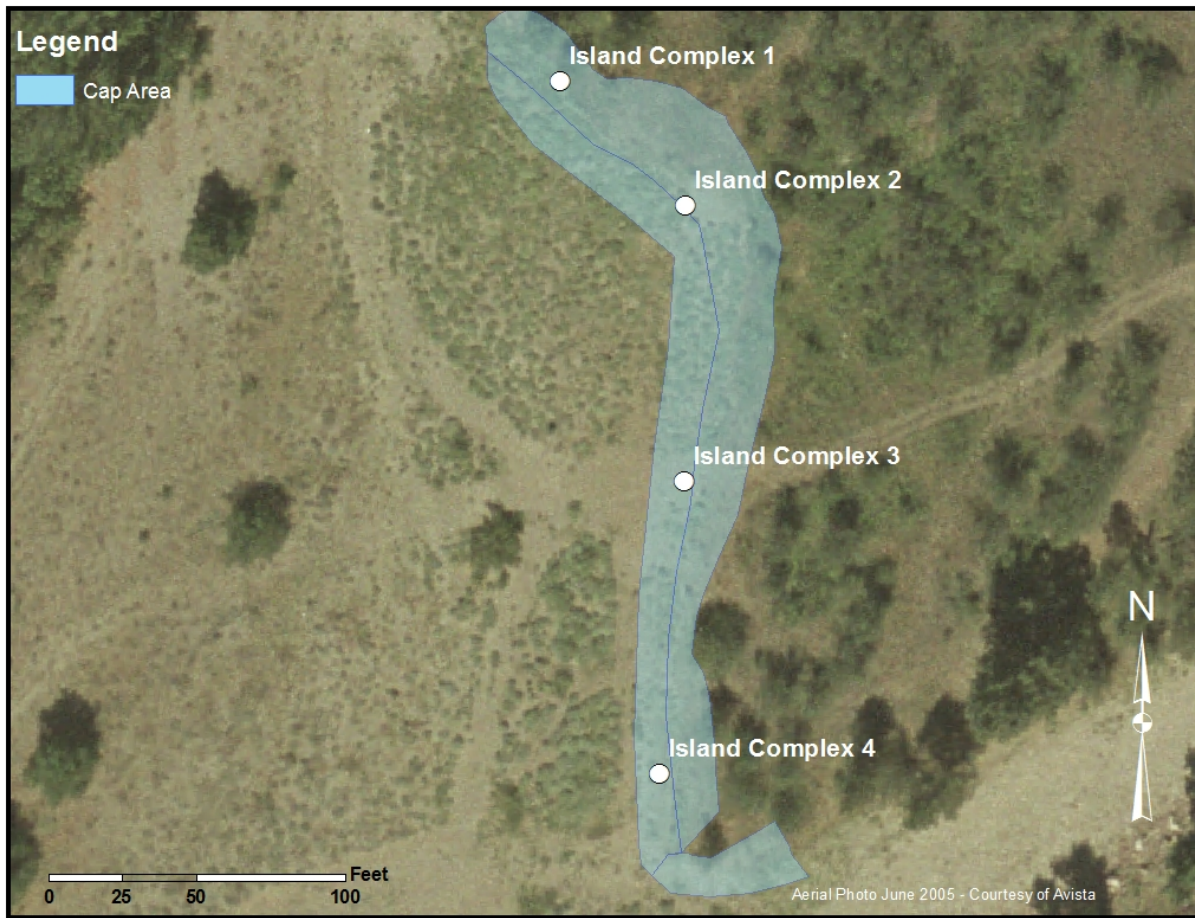
Figure A-1. Island Complex

An aerial photograph of each site that depicts the area that was remediated and also the locations of samples collected during the 2013 sampling event can be found in Appendix A.

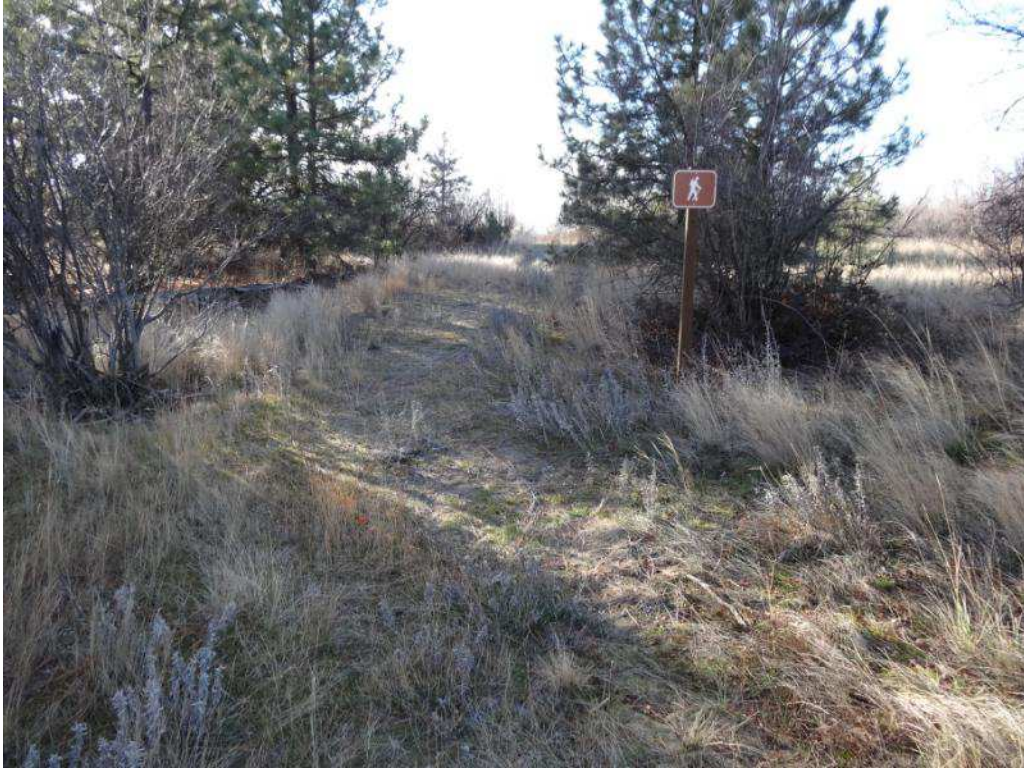
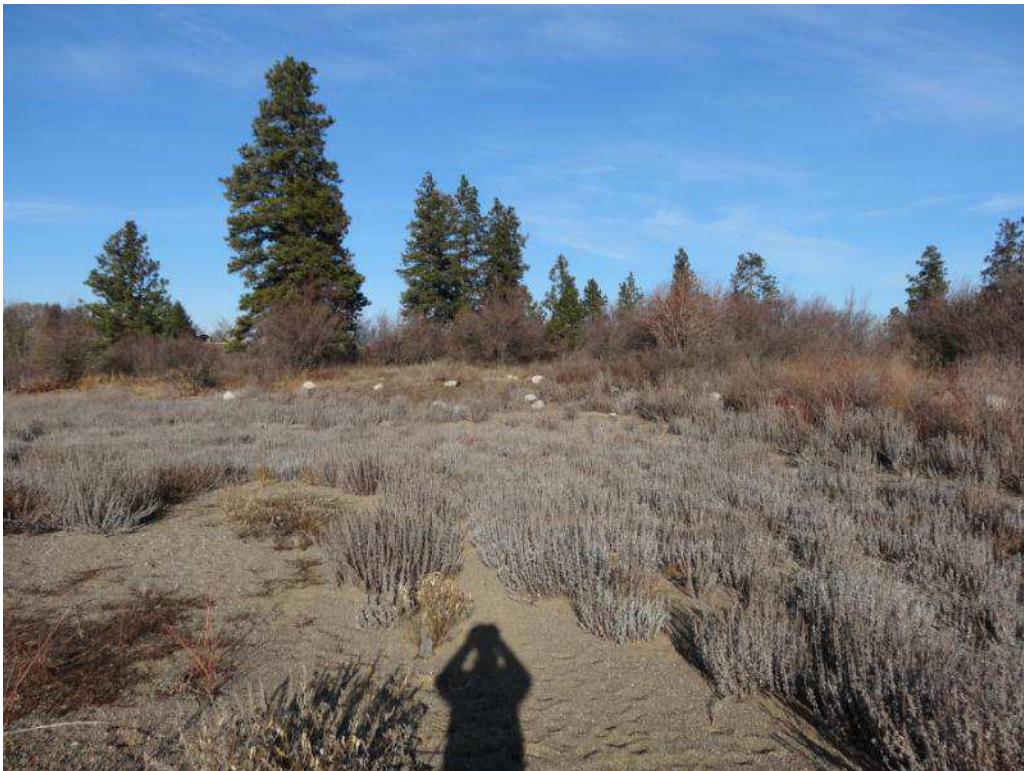
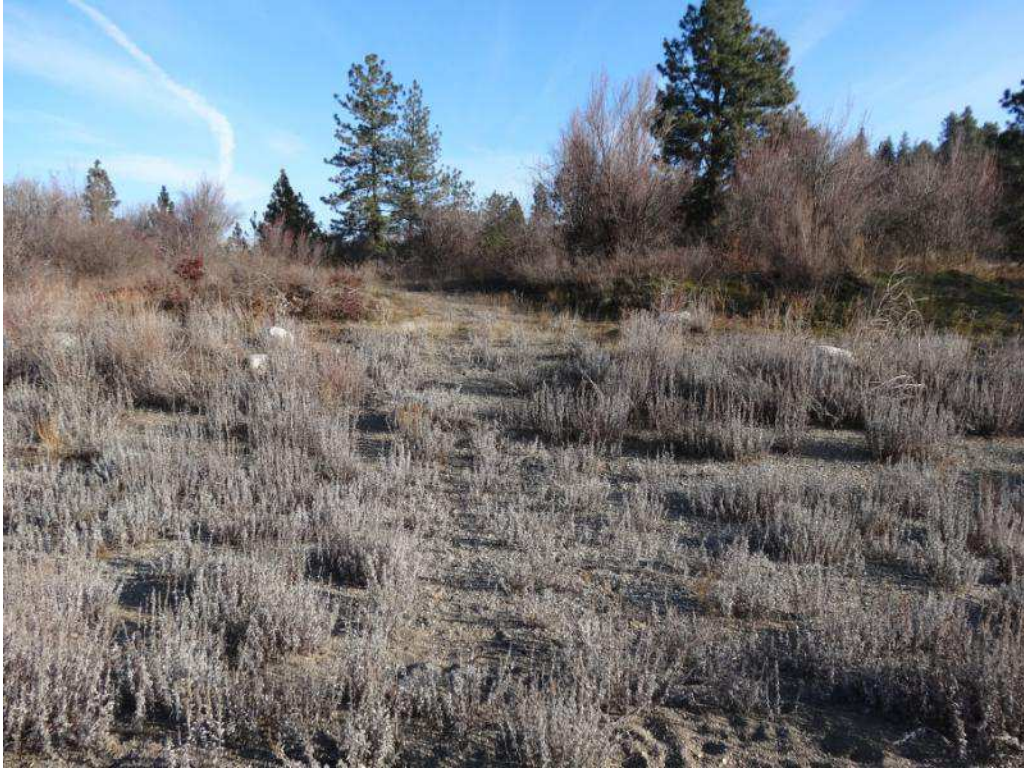
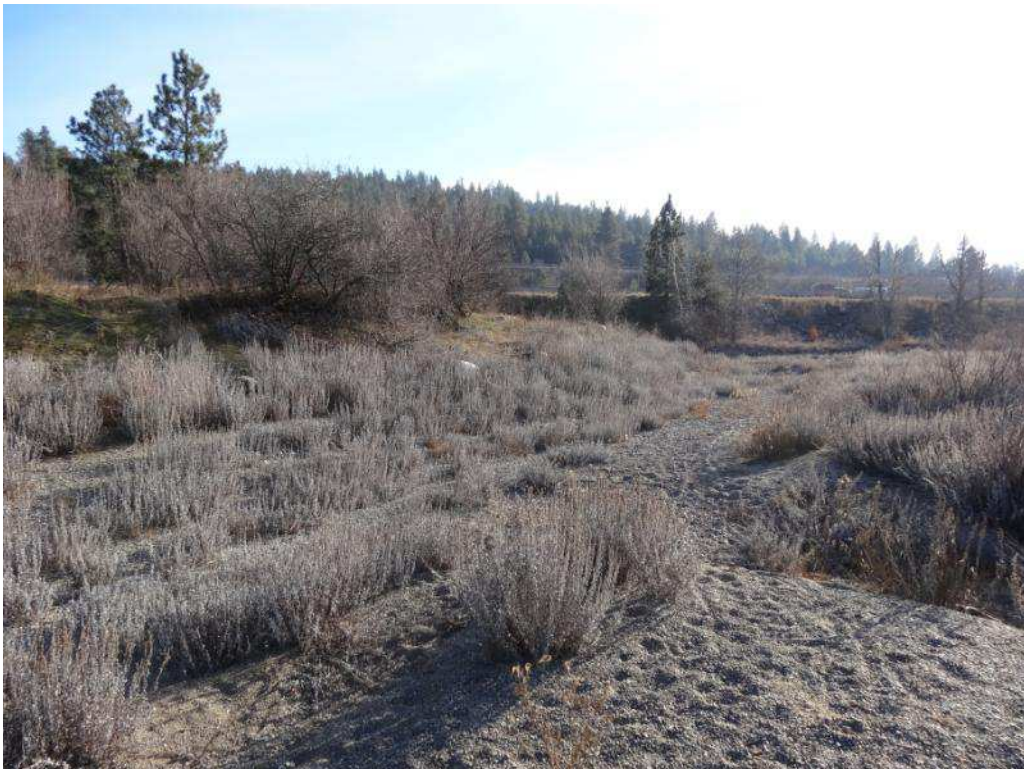
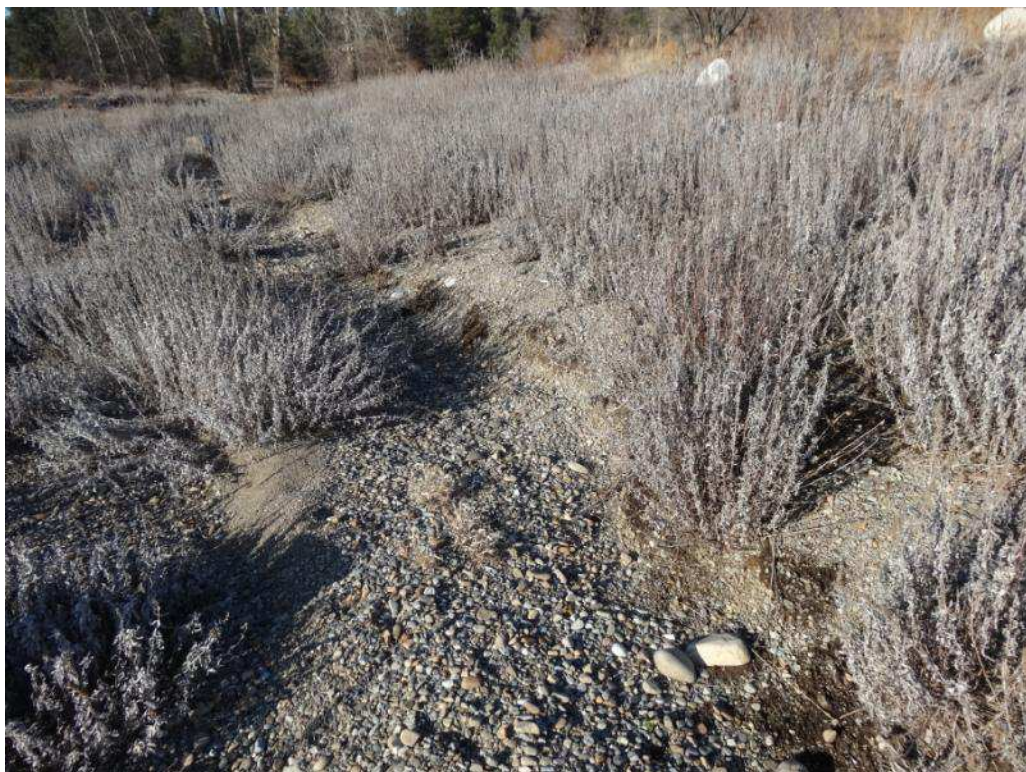
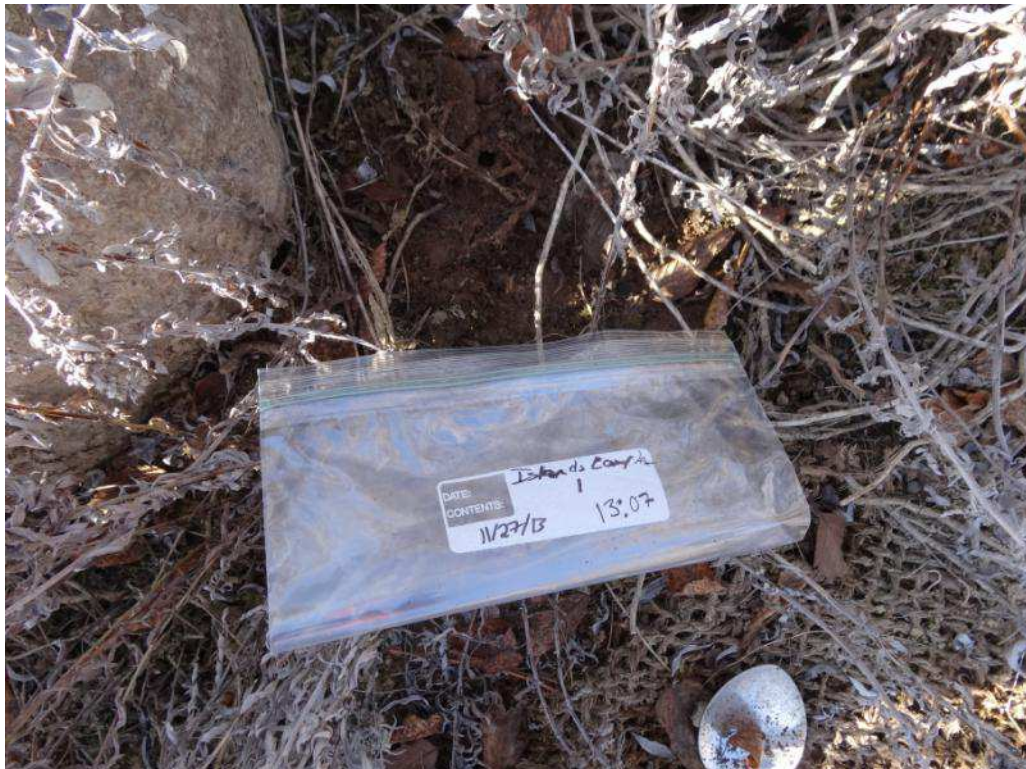
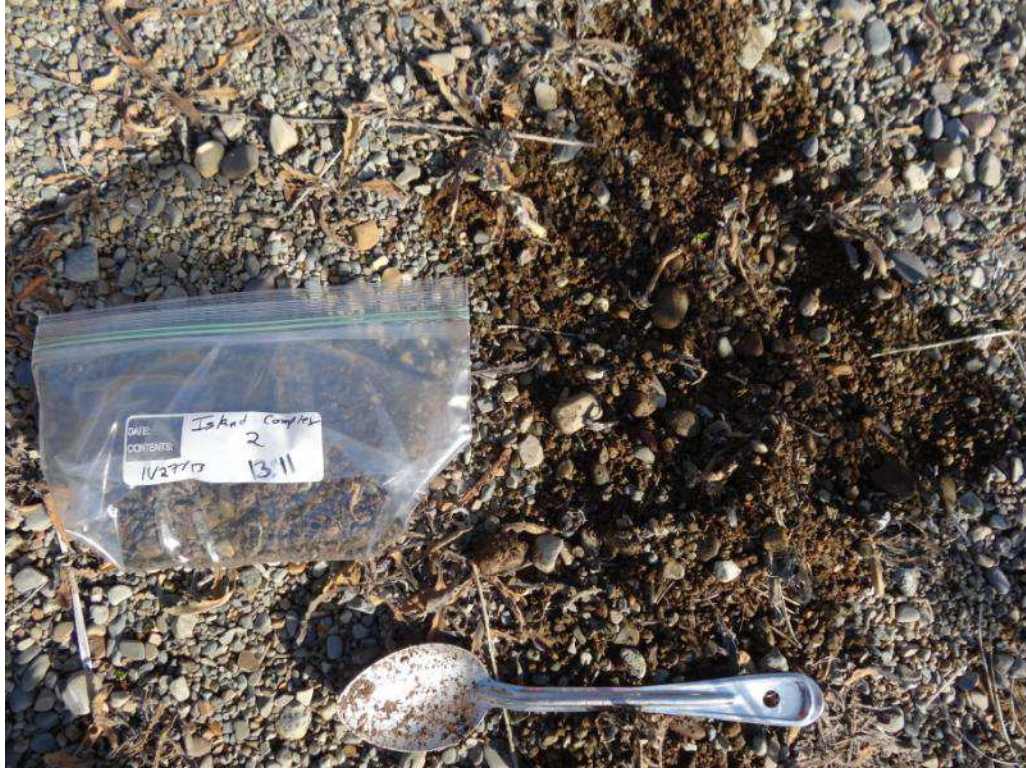
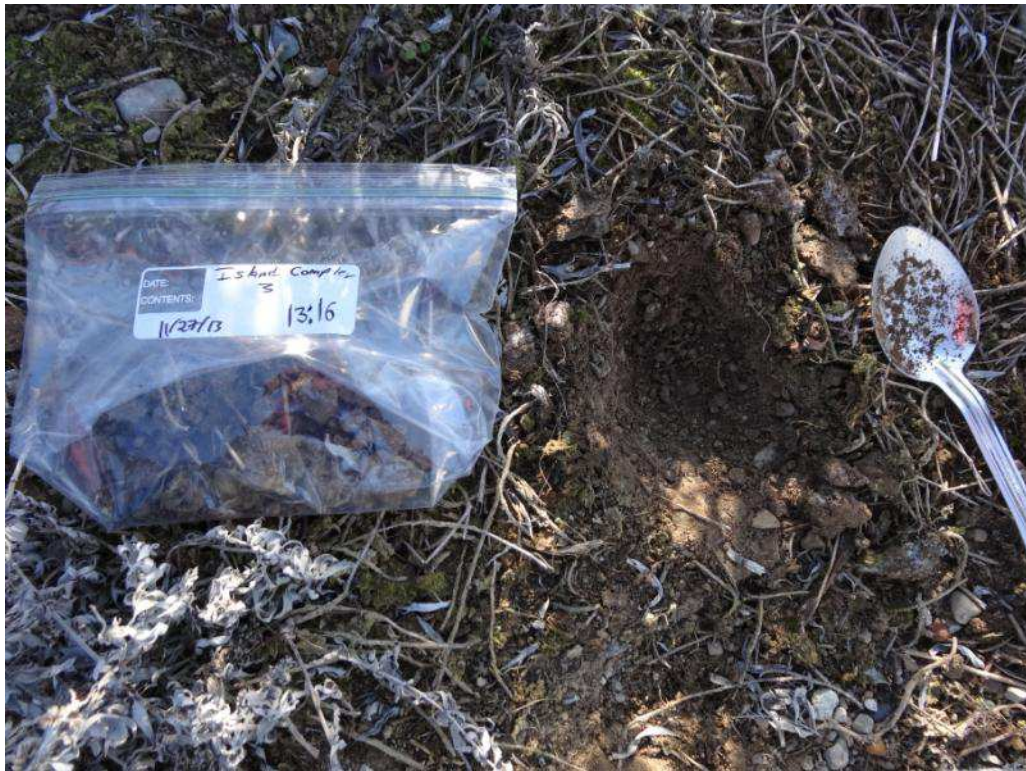
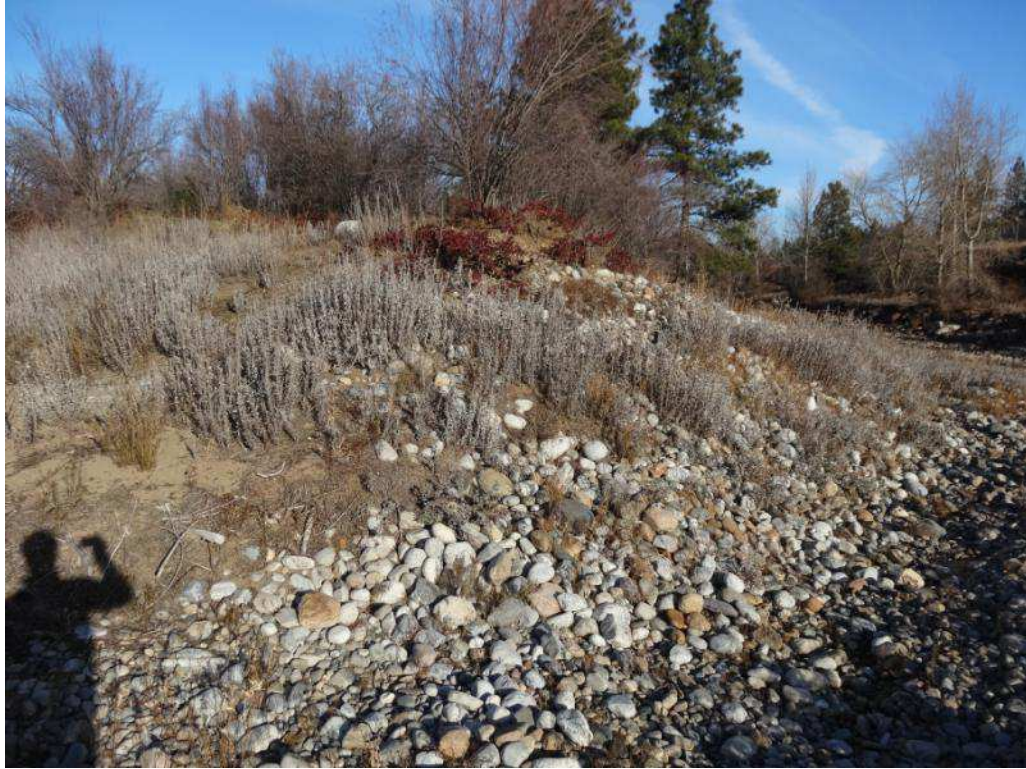
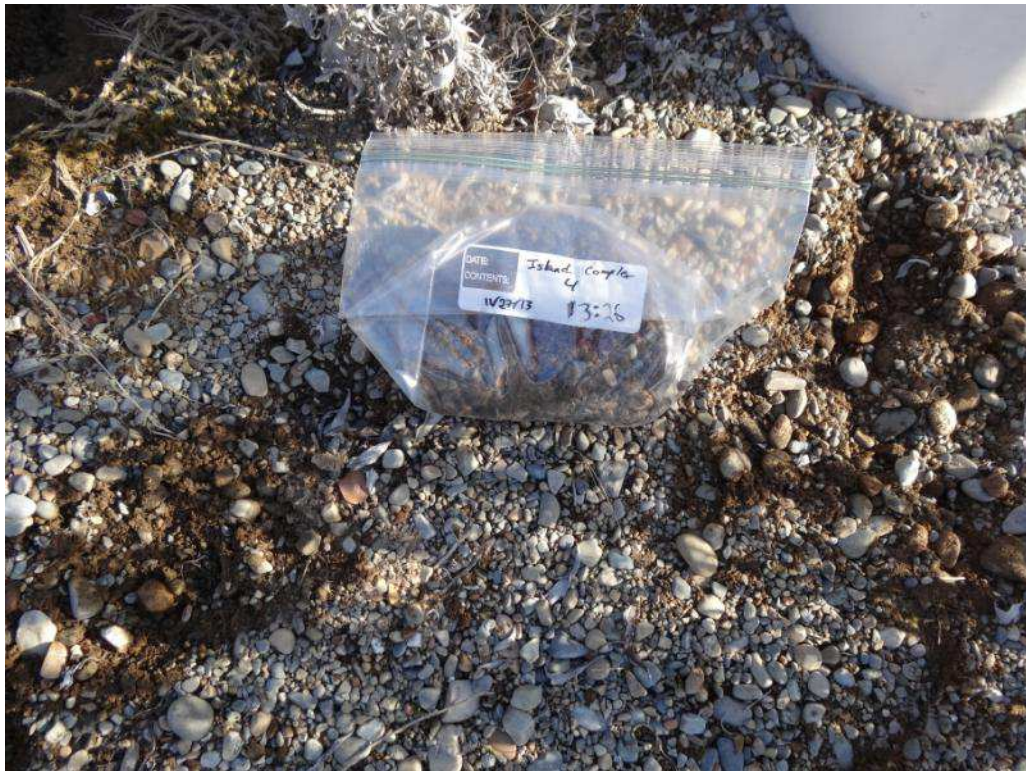
- Sand and fine-grained particles intermixed in the cap fabric
- Significant amounts of new sand/gravel in the chevron area adjacent to the cap

- most areas the coir fabric is intact. some places it has been cut or pulled back
- material placed with the coir fabric is predominantly still present

Photo Log	
Photo ID	Description
DSC\pp\156.JPG	-view of trail to site w/ s.gage
" " 157	-looking north of the site
" " 158	- looking to the east in middle of site
" " 159	- looking towards the southeast portion of the site
" " 160	-looking to the north end of the site
" " 161	-sample 1
" " 162	-Sample 2.
" " 163	-Sample 3
" " 164	-armored area of the site - southern most extent
" " 165	-Sample 4

Due to the little to no change in the contaminant concentrations at Island Complex, it is recommended that additional sampling occurs at the site as a part of the 2014 sampling event of the further downstream sediment sites.

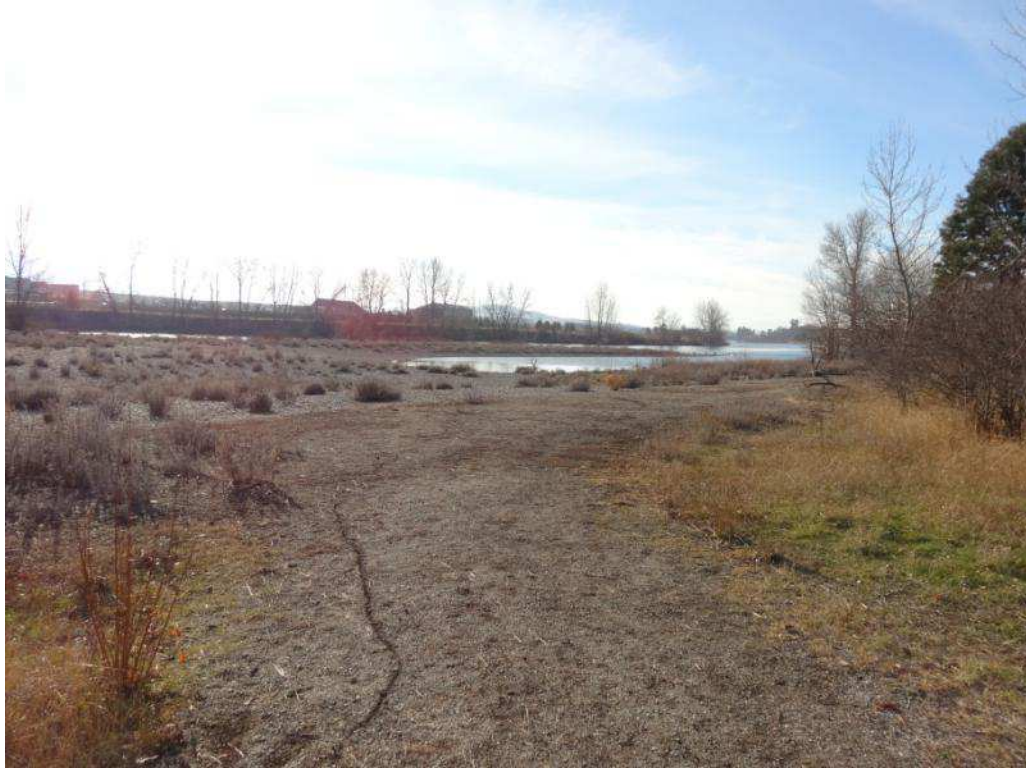
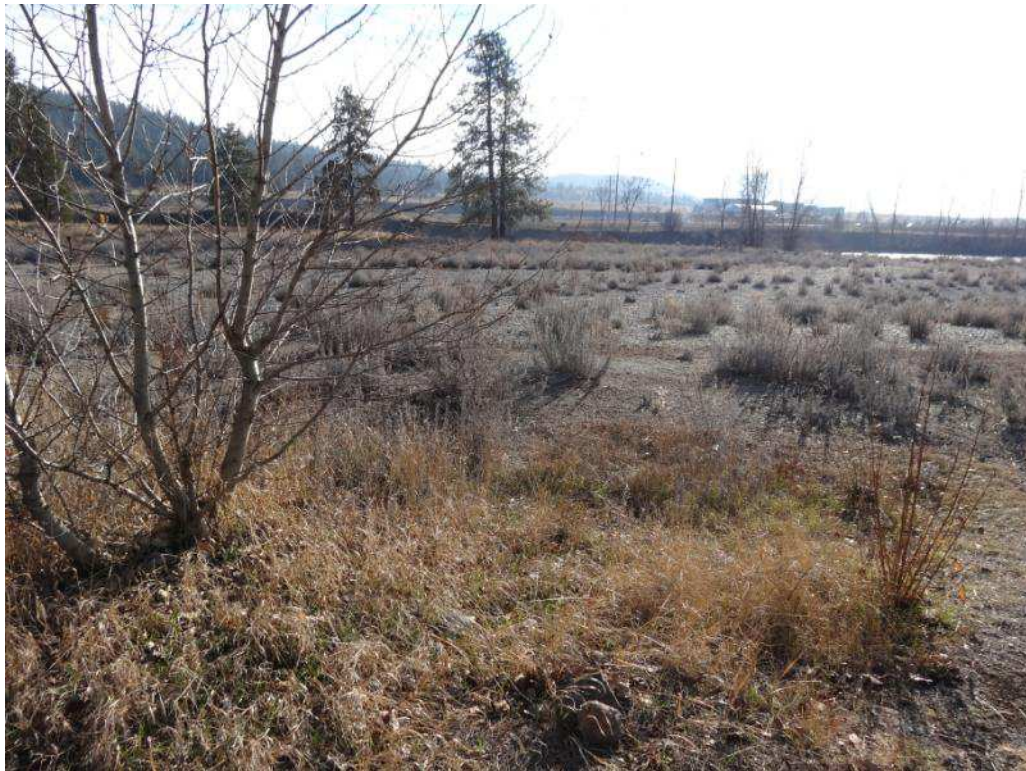
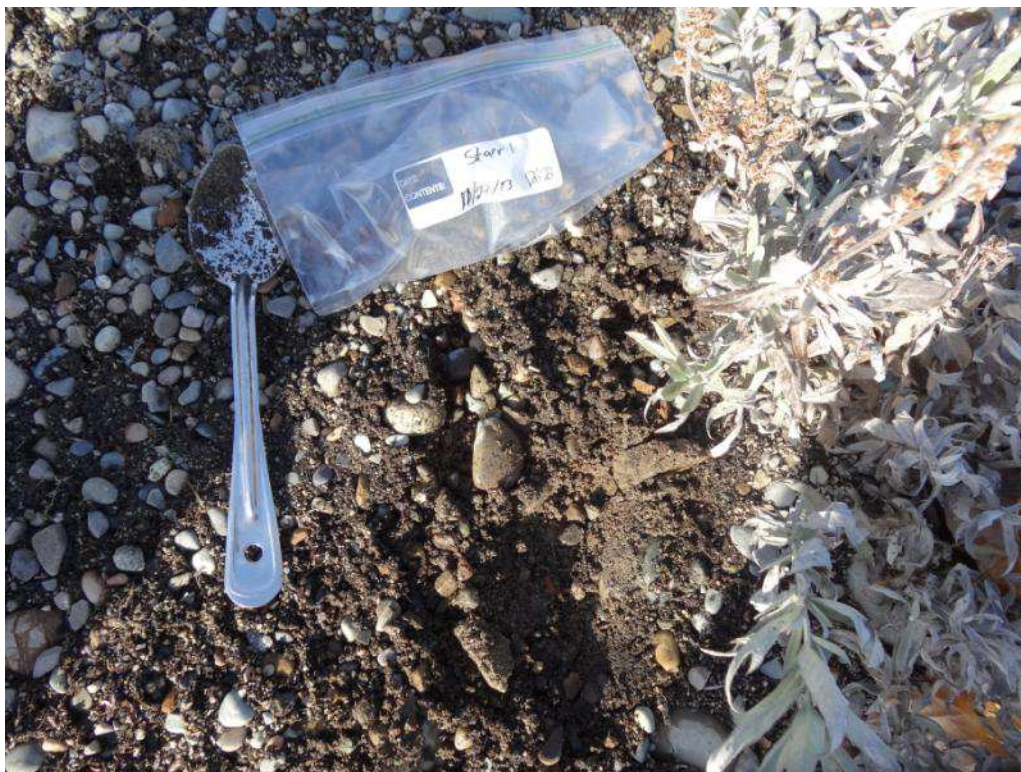
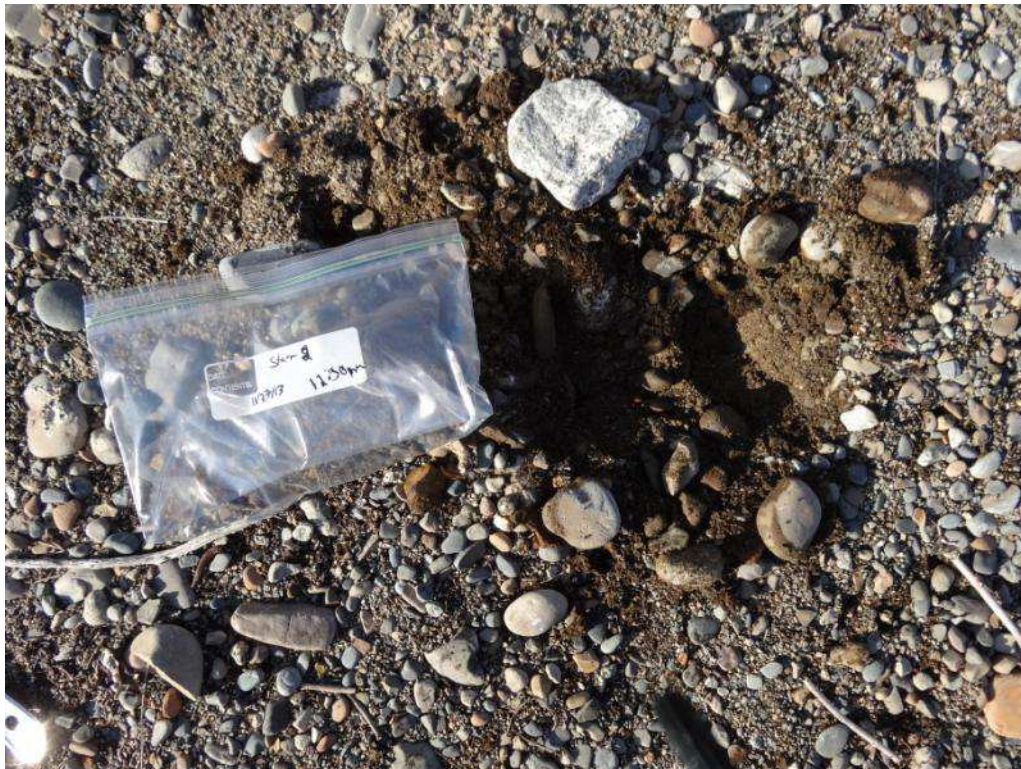
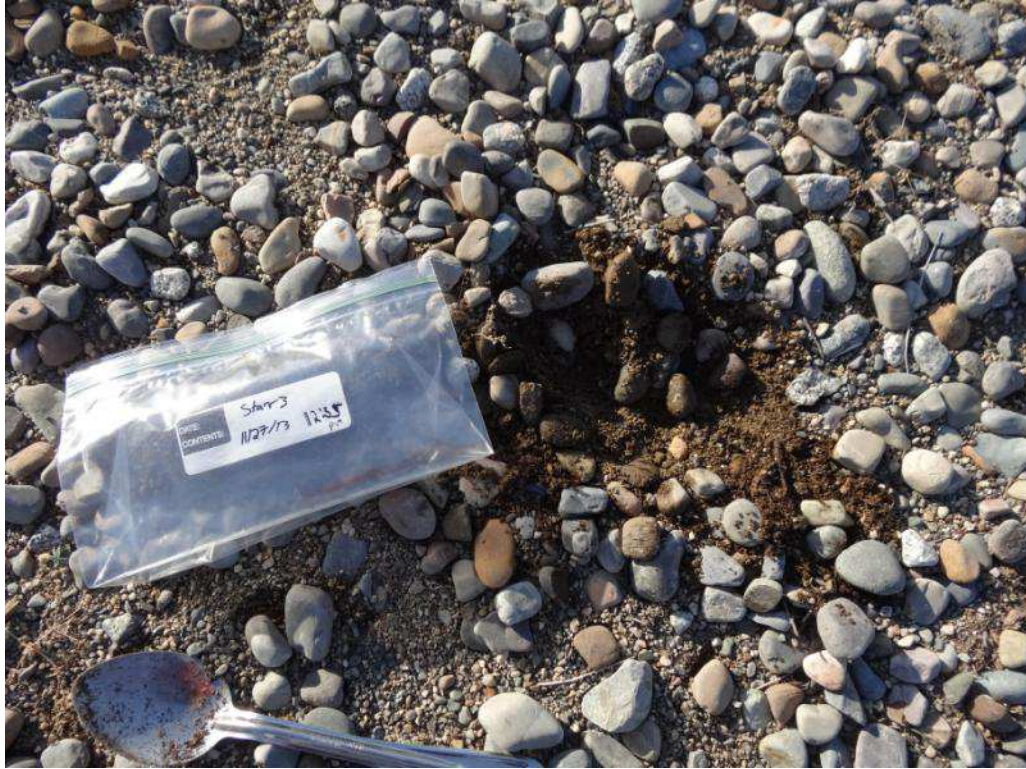
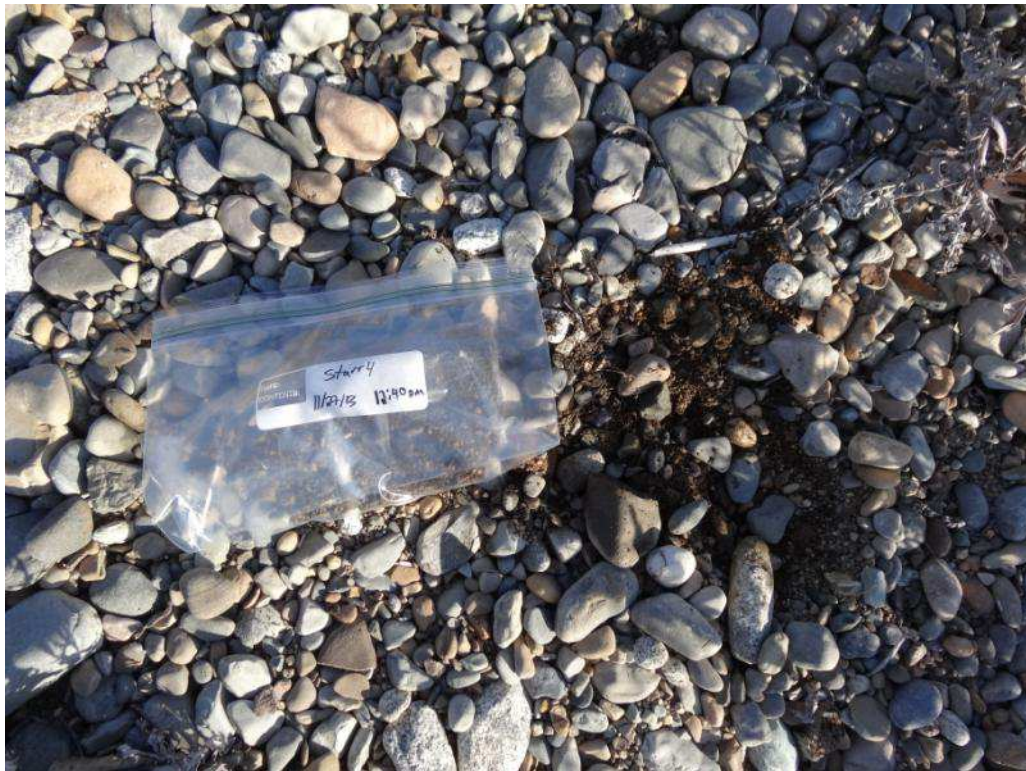
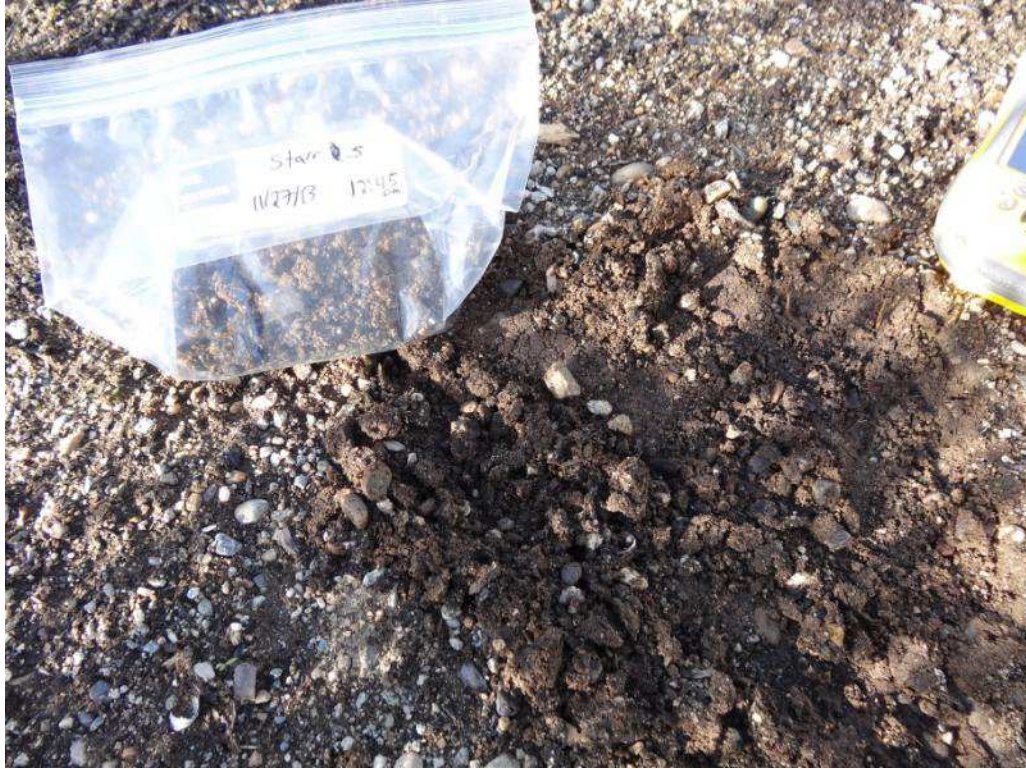
Fine grained material intermixed with the gravel  
layer of the cap.

Photo ID	Description
DSC00148.JPG	- Full view looking downstream of the site from the access trail
" " 149	- view looking on the upstream area of the site towards the south
" " 150	Sample 1
" " 151	- sample 2
" " 153	- sample 3
" " 154	- sample 4
" " 155	- sample 5

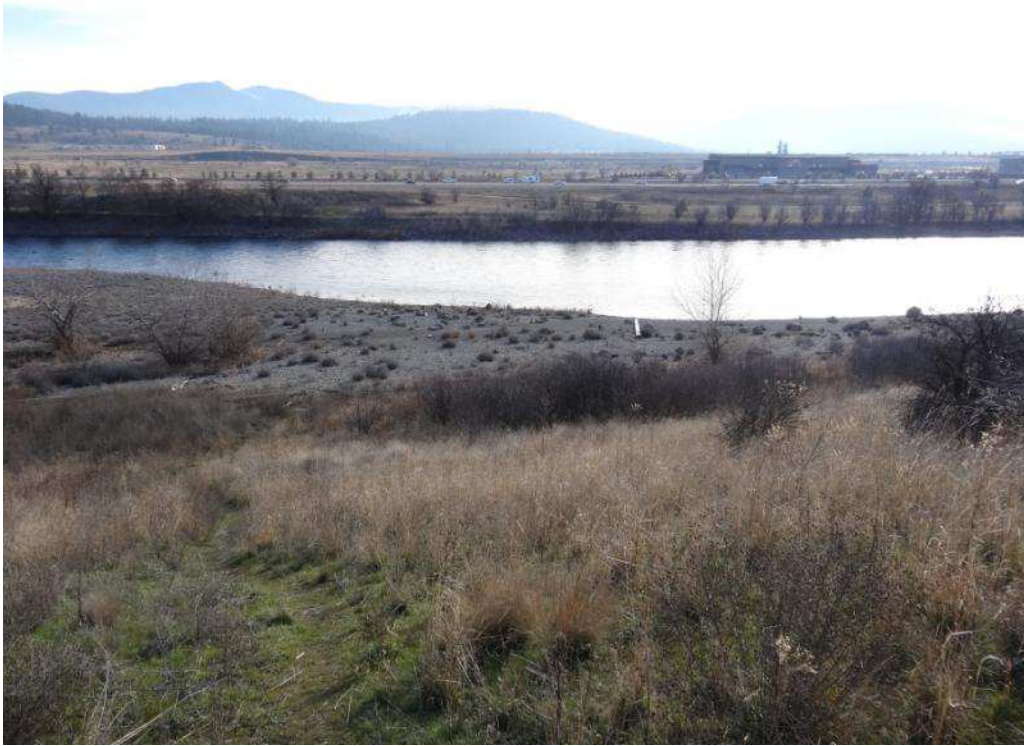
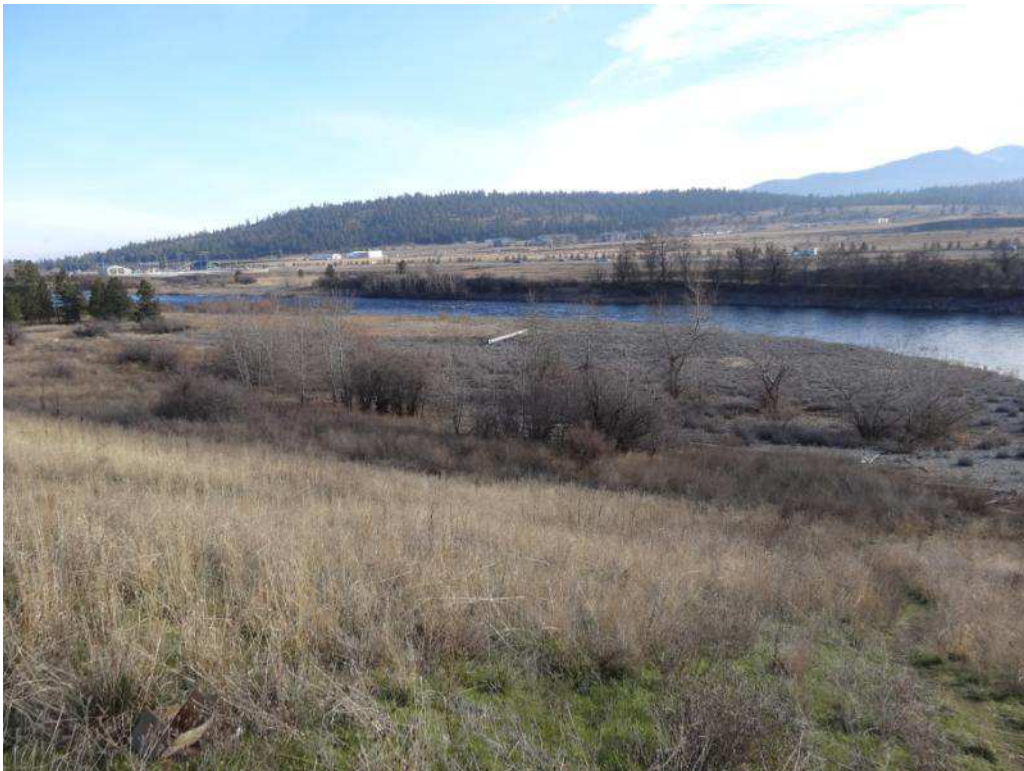
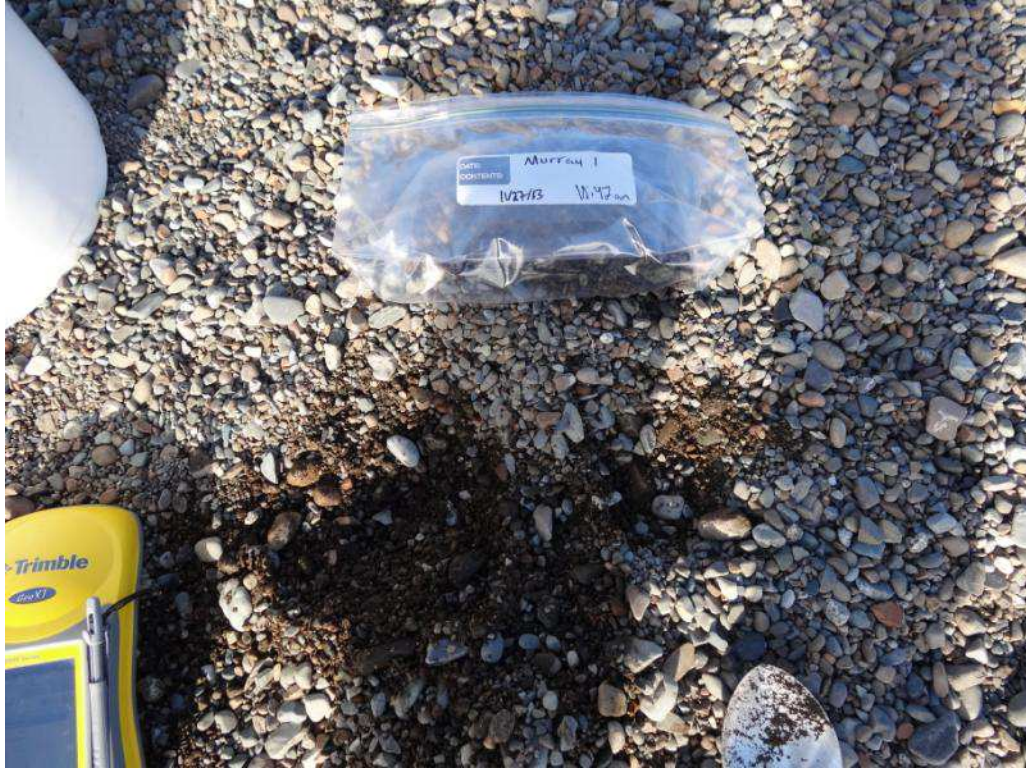
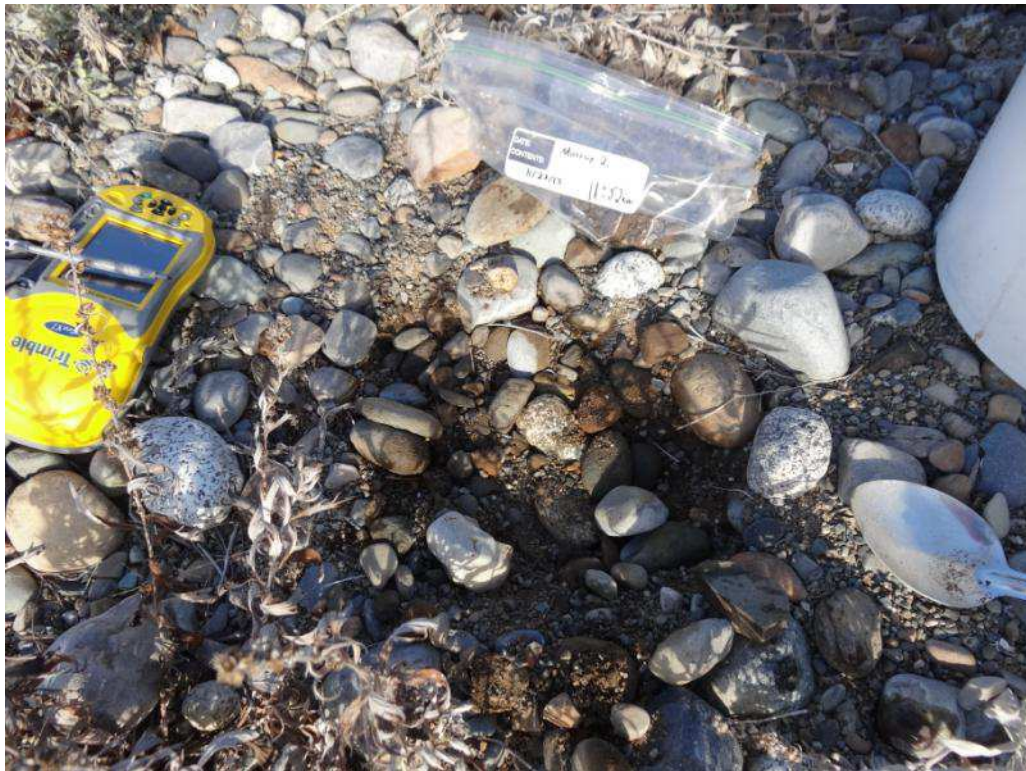
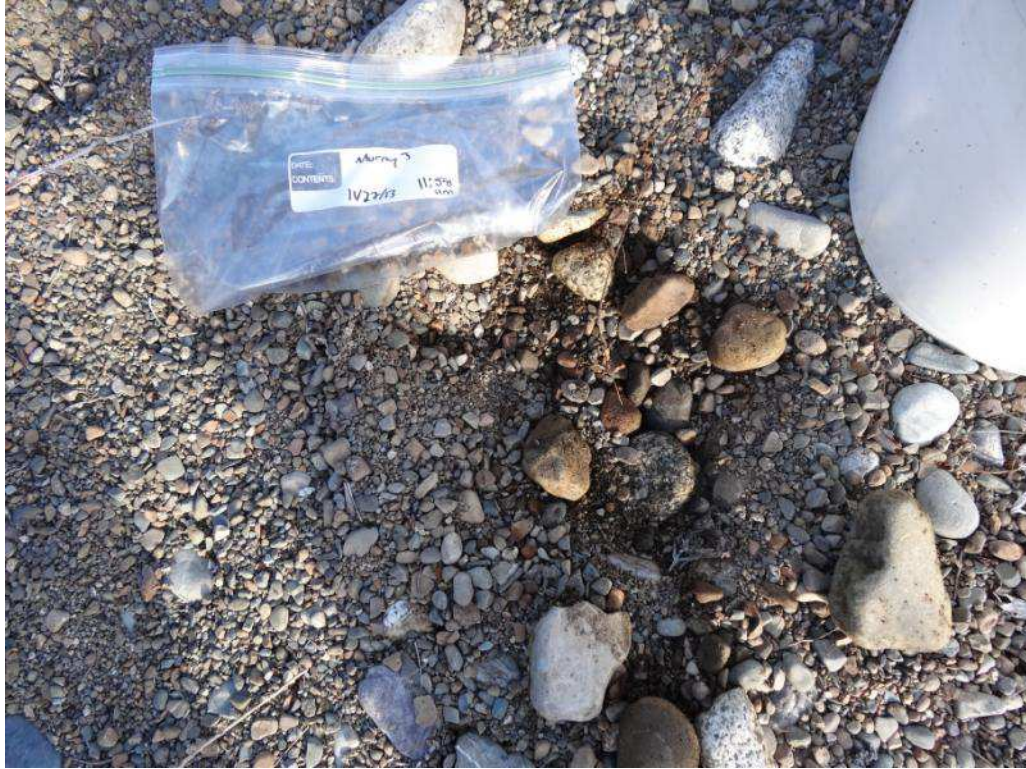
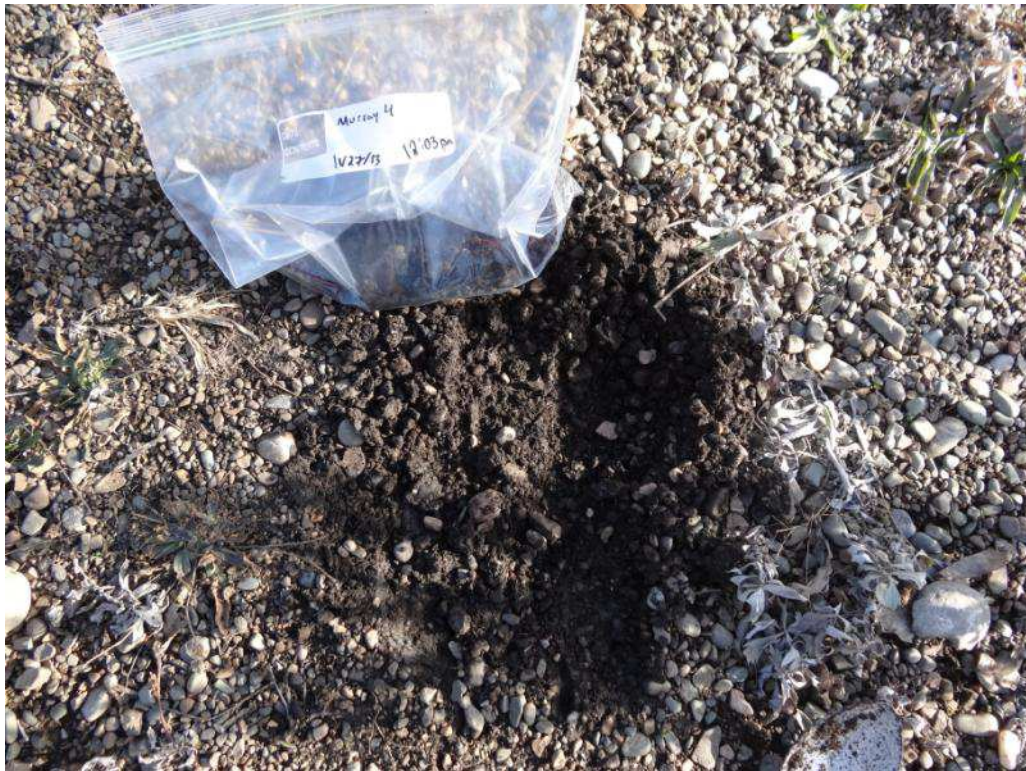
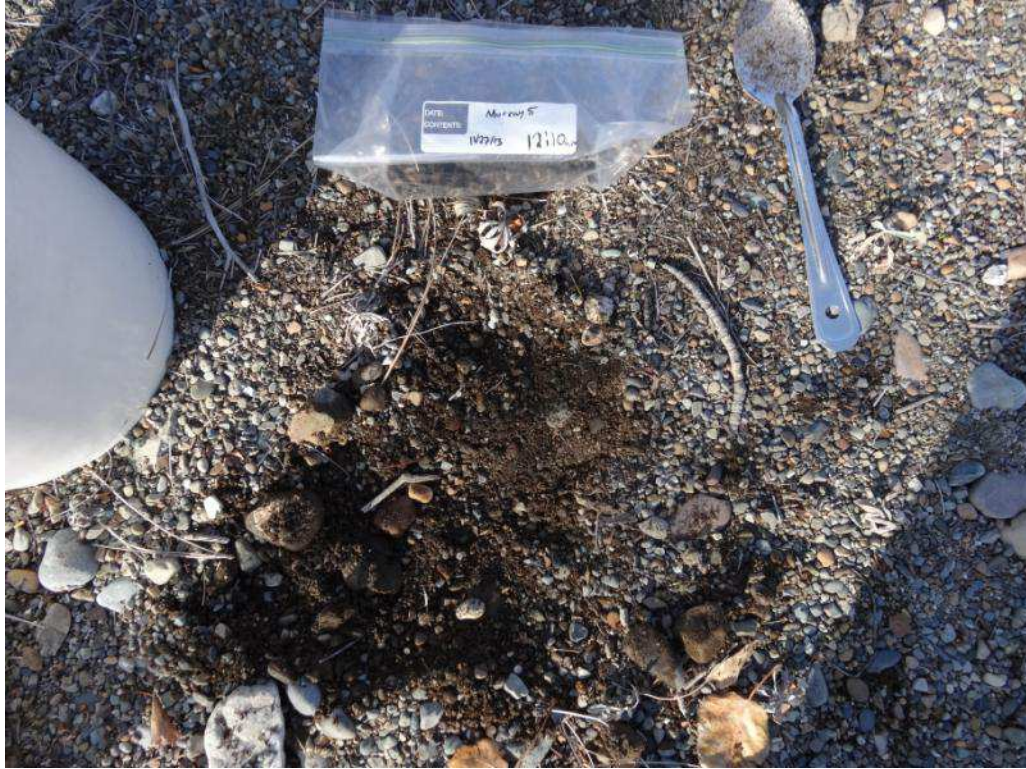
- most areas is intact (Cap A/B areas)  
- Some areas of Cap C are damaged (washed away)  
as a result of highwater flows

Photo ID	Description
DSC <del>141</del> 141.5PG	-view to the south overlooking the western (downstream) end of the site
" <del>142</del> 142	-view to the southeast overlooking the upstream end of the site
" 143	-sample 1
" " 144	-sample 2
" " 145	sample 3
" " 146	-sample 4
" " 147	-sample 5

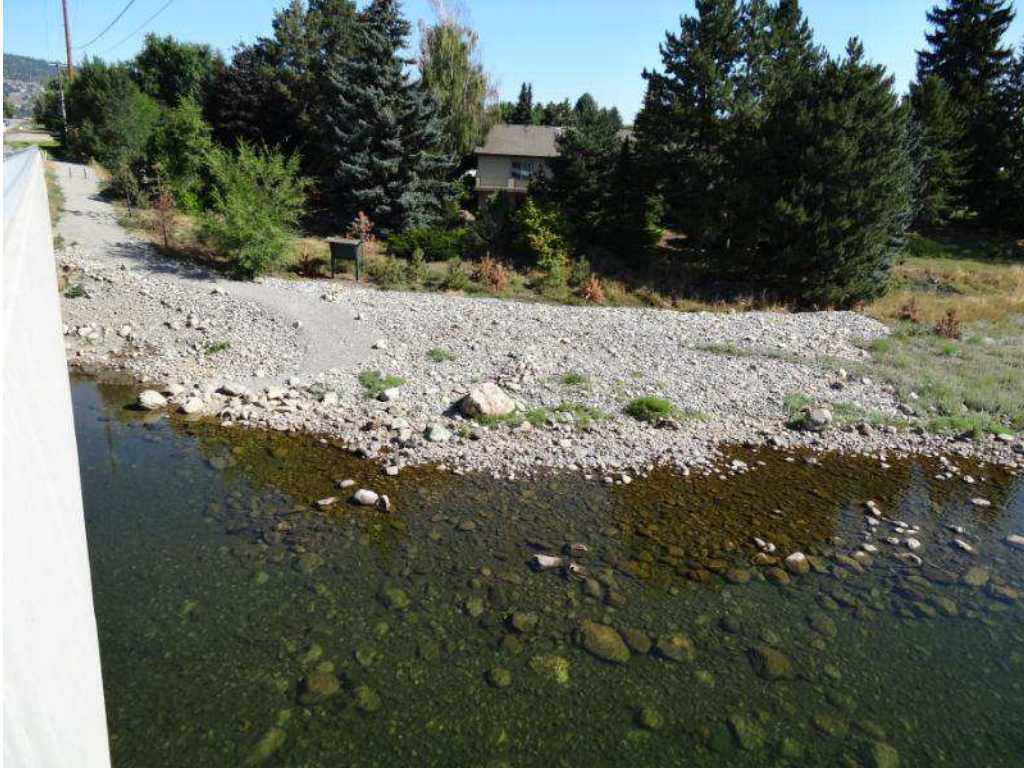
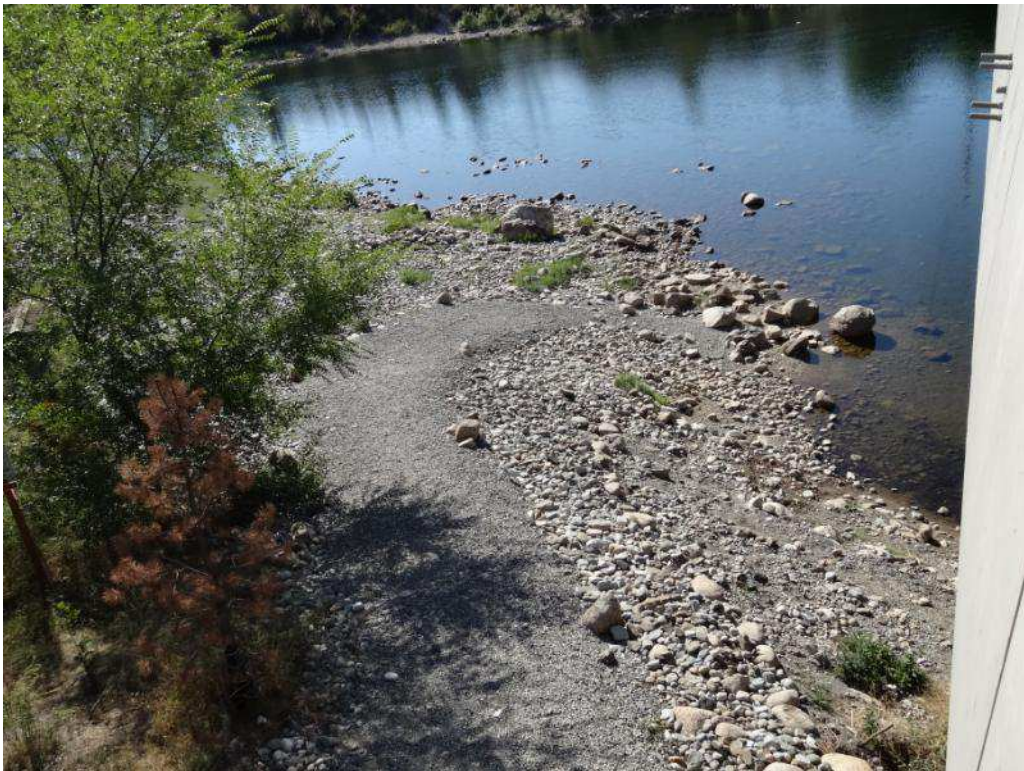
- minor erosion of the cap directly upstream and under Barker Rd.  
Bridge noted → cap material still present and covering native soils

Photo ID	Description
DSC00052.JPG	-Standing on Barker Road Bridge (approx 1/2 across) looking down on the site to the north
DSC00083.JPG	-standing on Barker Road Bridge (directly adjacent to the site) looking down on the site to the east.
