## **Monitoring, Sampling and Analysis Report**

### **Spokane River Shoreline Sediment Sites Heavy Metals (As, Cd, Pb, Zn) Post-Remediation Monitoring**

April 2015

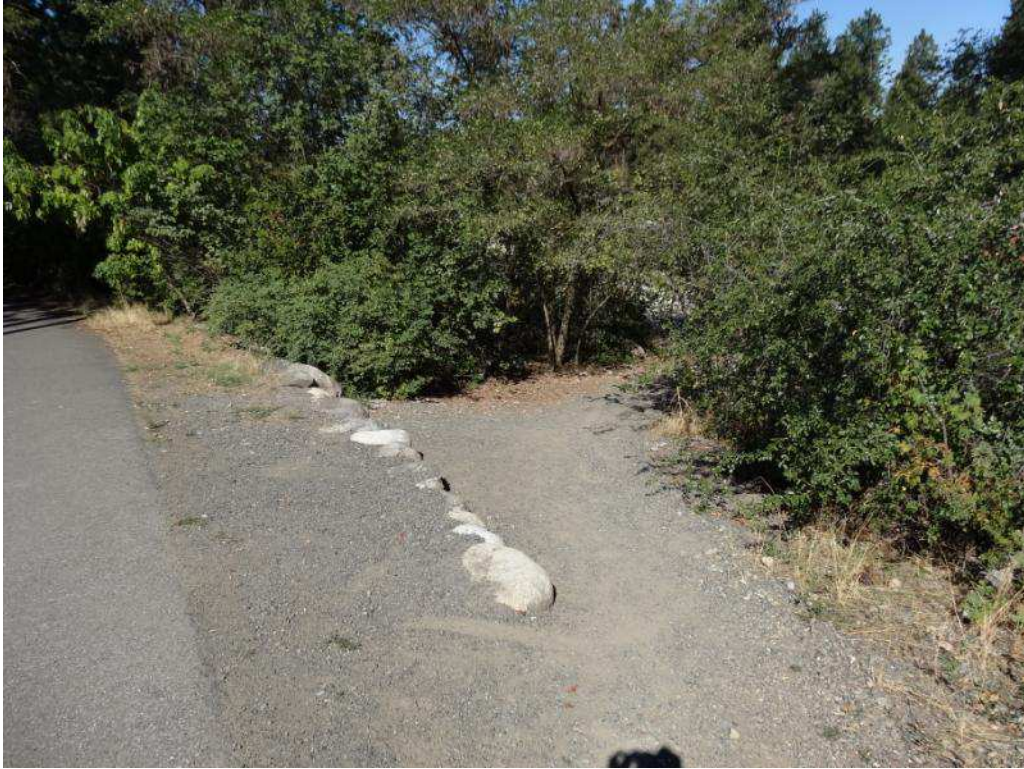
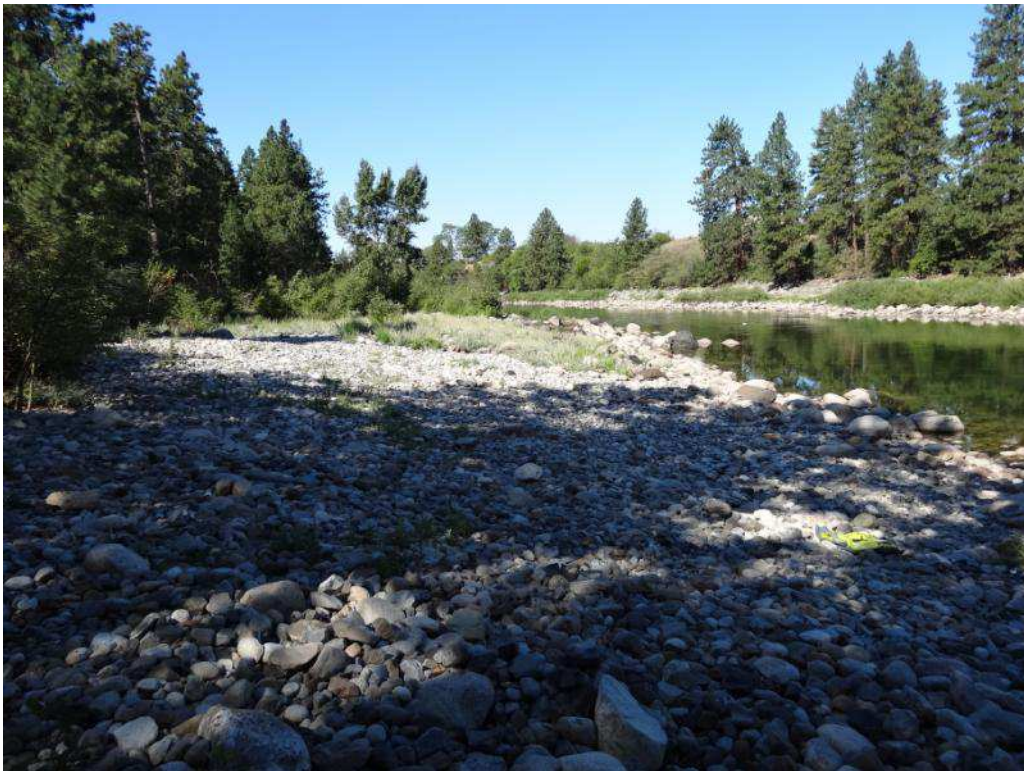
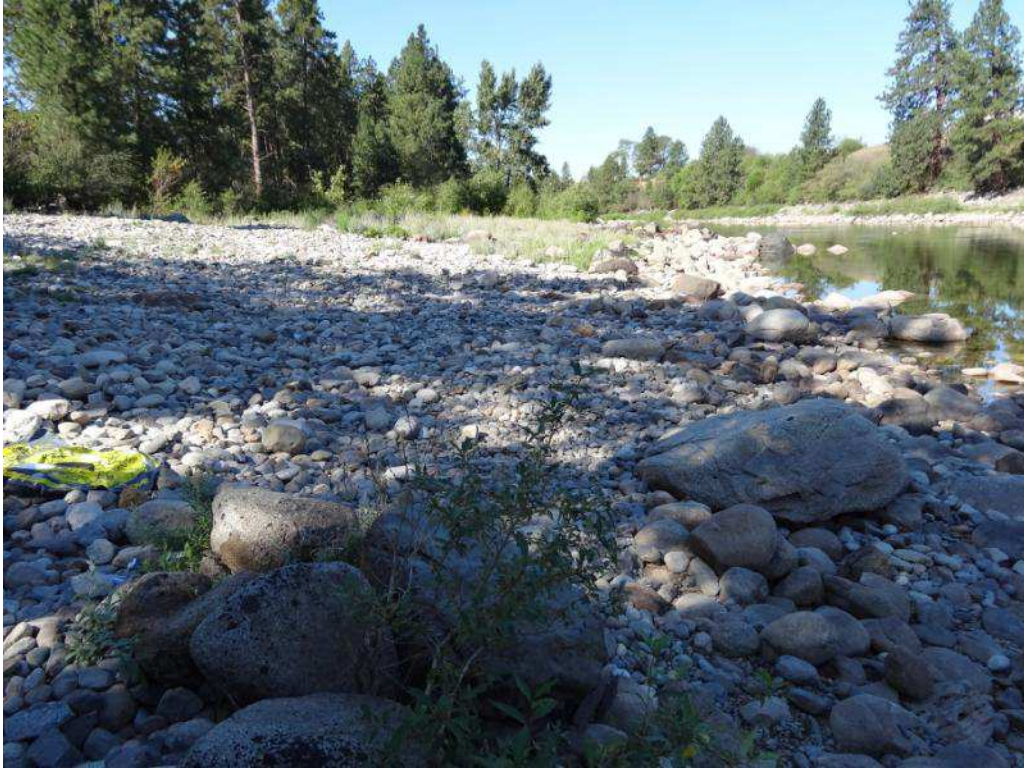
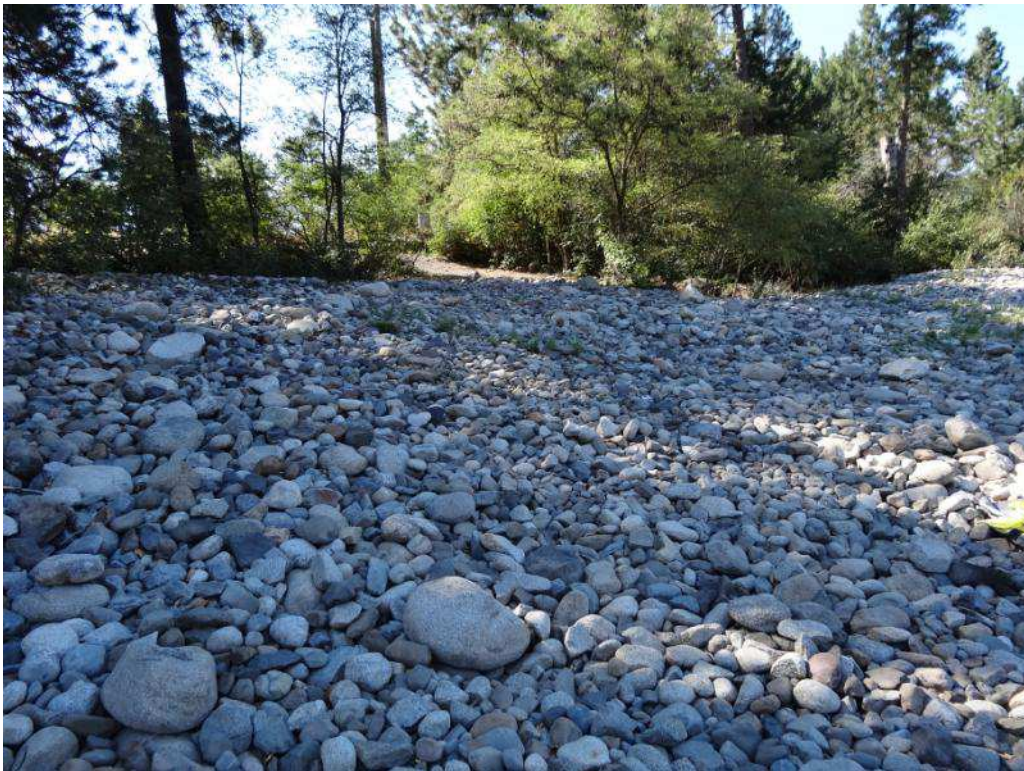
- Interact with some usage of access noted
- minor erosion at the trail but overall in good condition

Photo ID	Description
DSC00085.JPG	- standing on Centennial Trail at access trail to the site
" " 86.JPG	- standing in middle of the site looking downstream (west) onto the rest of the site
" " 87.JPG	- standing towards riveredge part of the site looking downstream onto the site (west)
" " 88.JPG	- standing towards riveredge part of the site looking towards access trail (south)

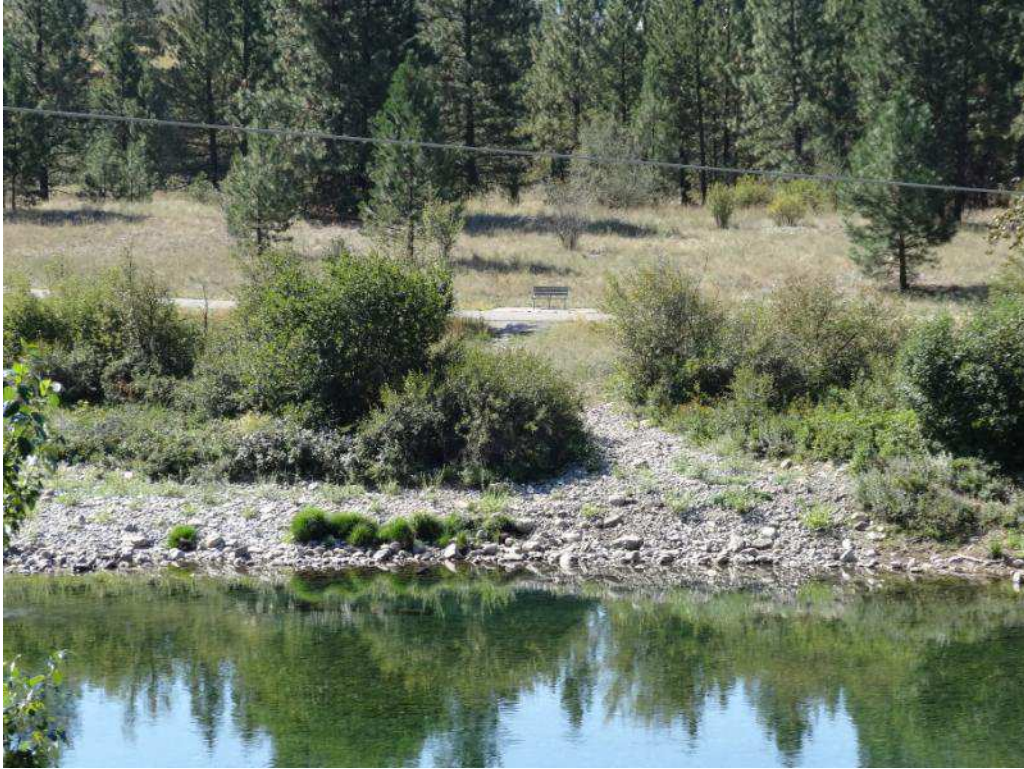
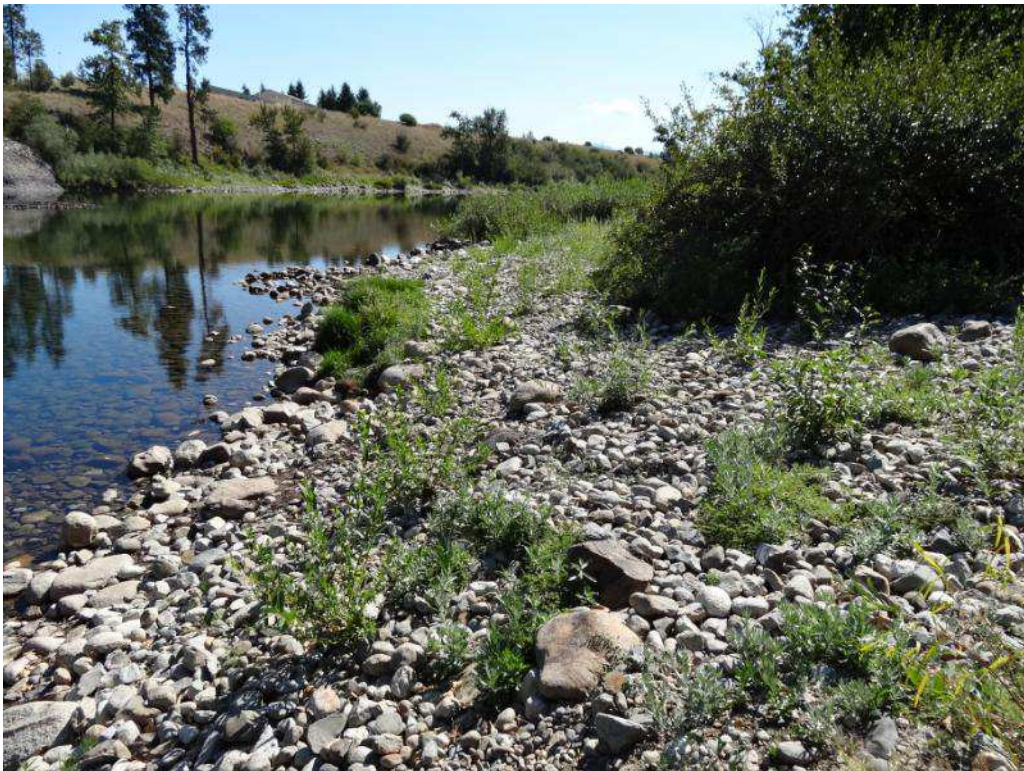
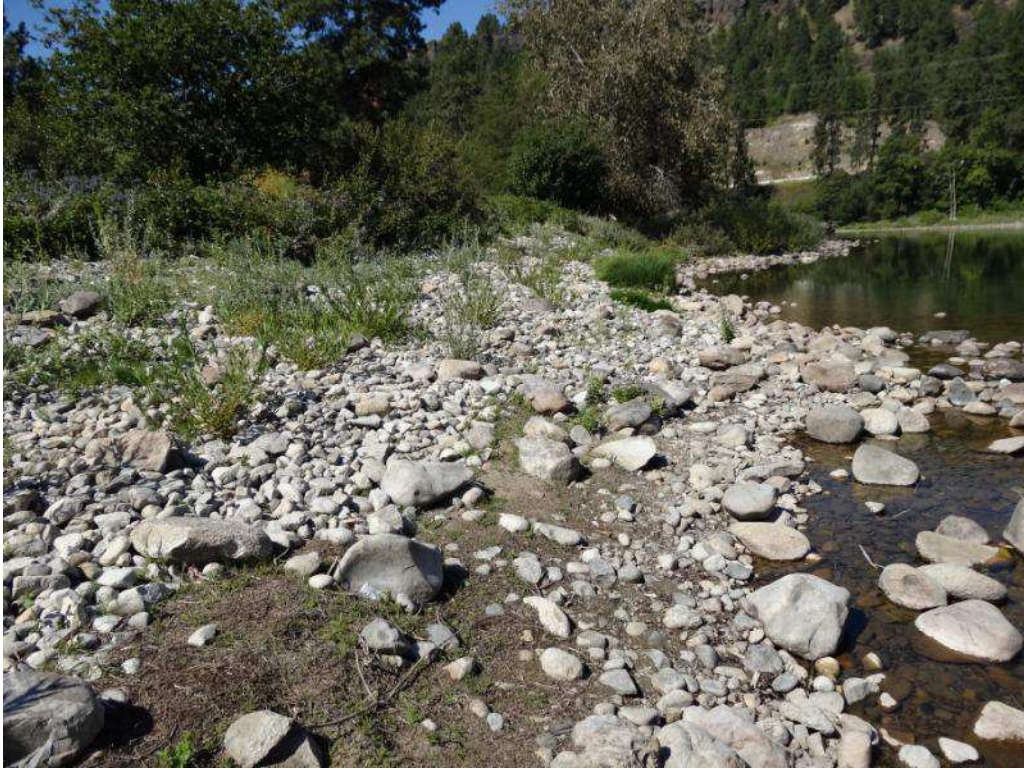
Photo ID	Description
DSC00090.JPG	standing on opposite side of the bank looking across the river onto the site
DSC00095.JPG	standing in middle of site by river edge looking upstream (SE)
DSC00097.JPG	standing in middle of site by river edge looking downstream (NW)

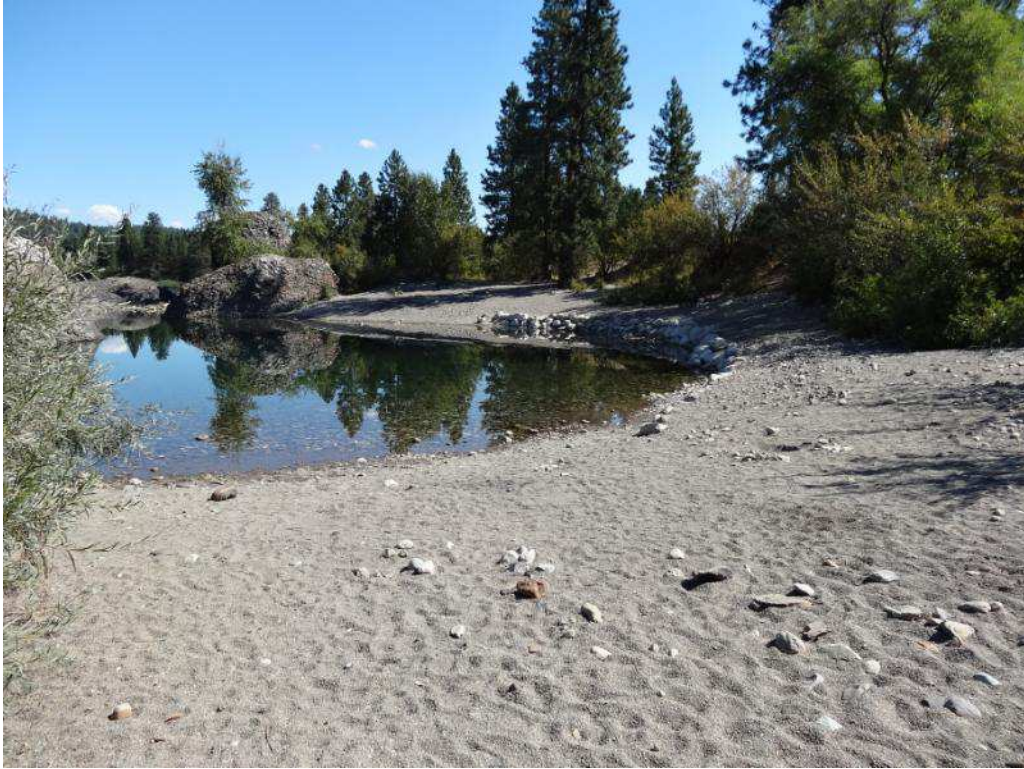
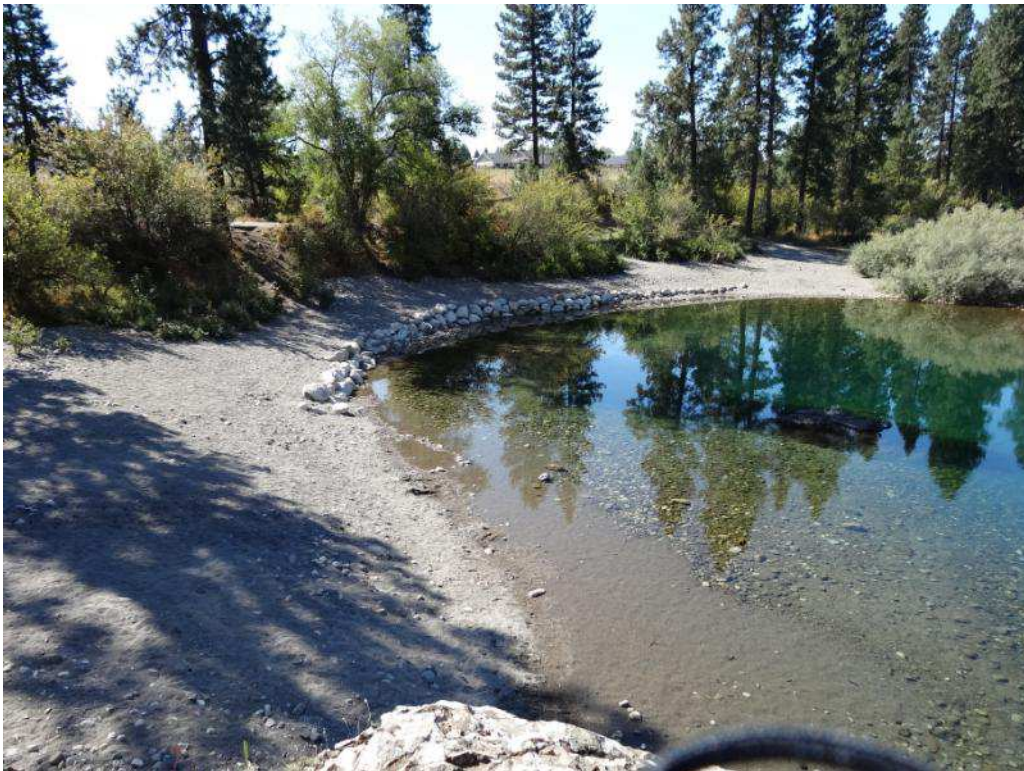
- rocks placed in some areas of the cap
- most likely due to beach users / no damage caused

Photo ID	Description
D500092.JPG	Standing on downstream (west) end of the site looking upstream
" "0094.JPG	Standing on boulder on upstream (east) end of the site looking to west
