Phase I Environmental Site Assessment Report

**6901 Fox Avenue South
Seattle, Washington**

Project Number: 033-009

January 31, 2020

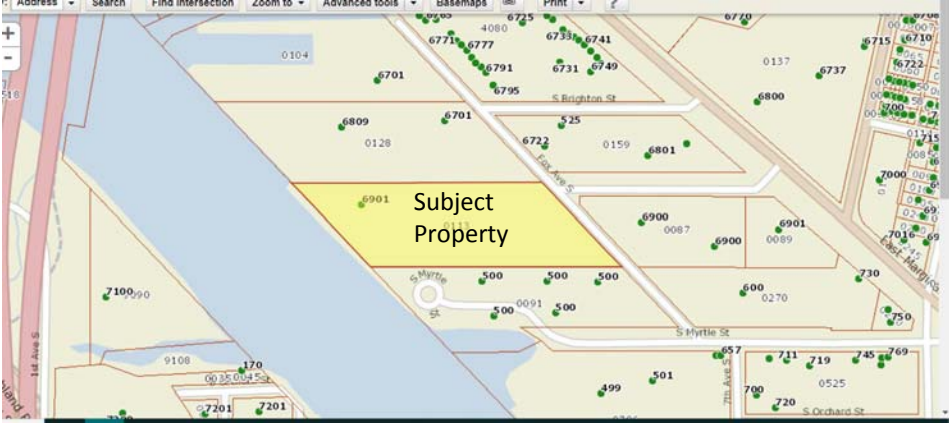
Figure 1 6901 Fox Ave South Property Parcel Viewer

Parcel numbers start with '000180'.
