**Preliminary Assessment for
Per- and Polyfluoroalkyl Substances (PFAS)**

Manchester Fuel Depot
Kitsap County, Washington

May 2021

Prepared for NAVFAC Northwest
by CH2M HILL, Inc.
Seattle, Washington
Contract N62470-16-D-9000
CTO N4425518F4117 (4117)

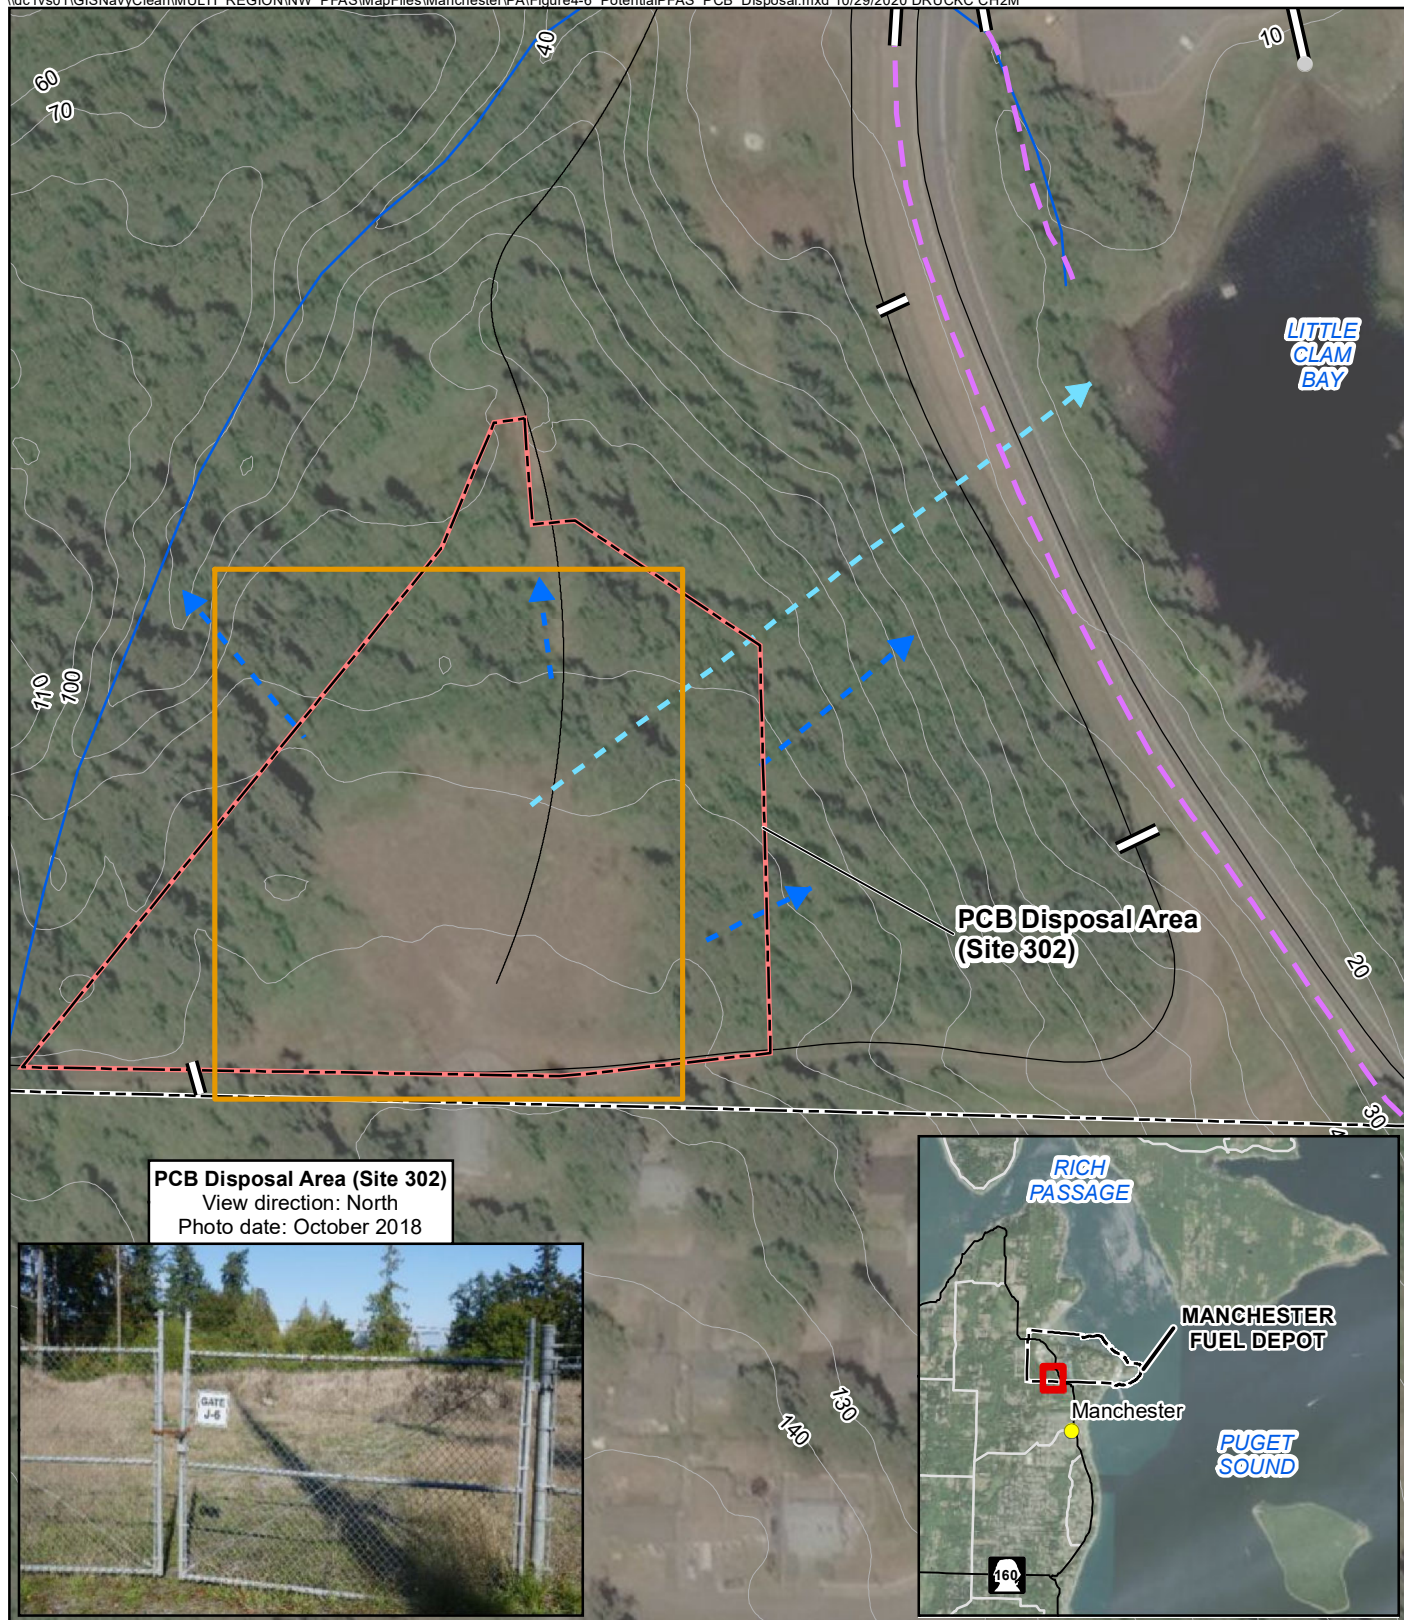
Figure 4-6

Area	Potential PFAS Source Area (Y/N)	Rationale
Polychlorinated Biphenyl (PCB) Disposal Area (Site 302)	Y	Site 302 (PCB Disposal Area) was used as a dump for ship bilge waste, transformer oil, and other petroleum waste from MFD operations and Regional Naval facilities in the Puget Sound from 1955 through 1976 (Figure 4-6). Bilge waste disposed at this location may contain PFAS as a result of AFFF use aboard ships during training or emergency response (Navy, 2014). See Section 4.3.6 for additional information and Section 5 for the recommended path forward.
Specialty Paint, Cleaner, or Pesticide Use or Release		
No use or release of PFAS-containing specialty paints, cleaners, or pesticides was identified at MFD	NA	NA
Chrome Plating Shops		
No chromium plating shops were identified at MFD.	NA	NA
Potential PFAS Storage Areas		
Fuel Pump House (Building 12)	Y	Fuel Pump House (Building 12) houses the emergency generator for MFD, the pumps for transferring fuel between storage tanks, and the manifold equipment where all the piping contained in Tunnels B, C, and D and pipes from the USTs 16-21 converge (Figure 4-3). Building 12 is the current storage location of AFFF drums and may have been the historical storage location of AFFF. Additionally, AFFF may have been transferred to deployment equipment at this building. See Section 4.3.7 for additional information and Section 5 for the recommended path forward.

Potential PFAS Source Area:
PCB Disposal Area (Site 302), MFD
Preliminary Assessment for PFAS
Manchester Fuel Depot, Kitsap County, Washington

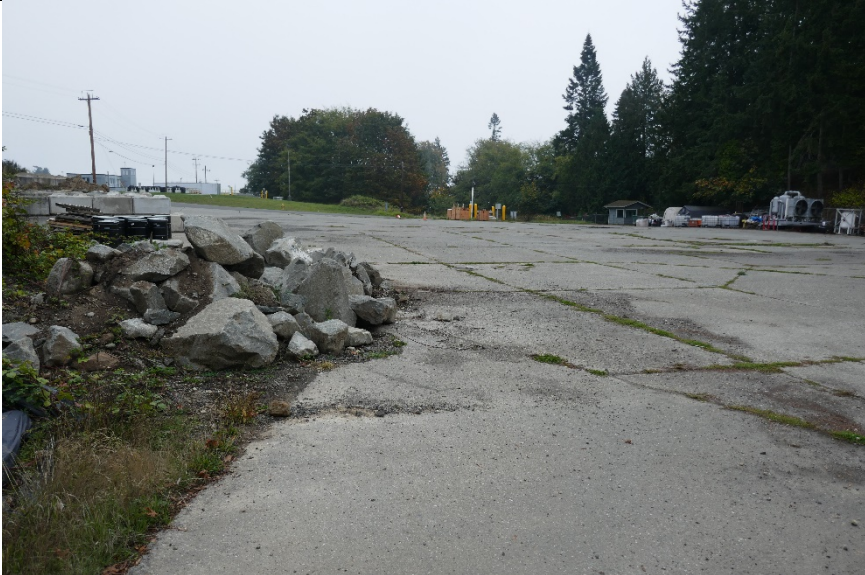
Photo 1 (Above)	10:58	Standing on the western portion of the laydown yard looking East	View of the laydown yard located on the middle-southern edge of the Base. This area is considered a small peninsula with view of the Fire Station to the east-northeast and Puget Sound in the distance. The Base uses the area for laydown of bulk materials and the waste disposition.

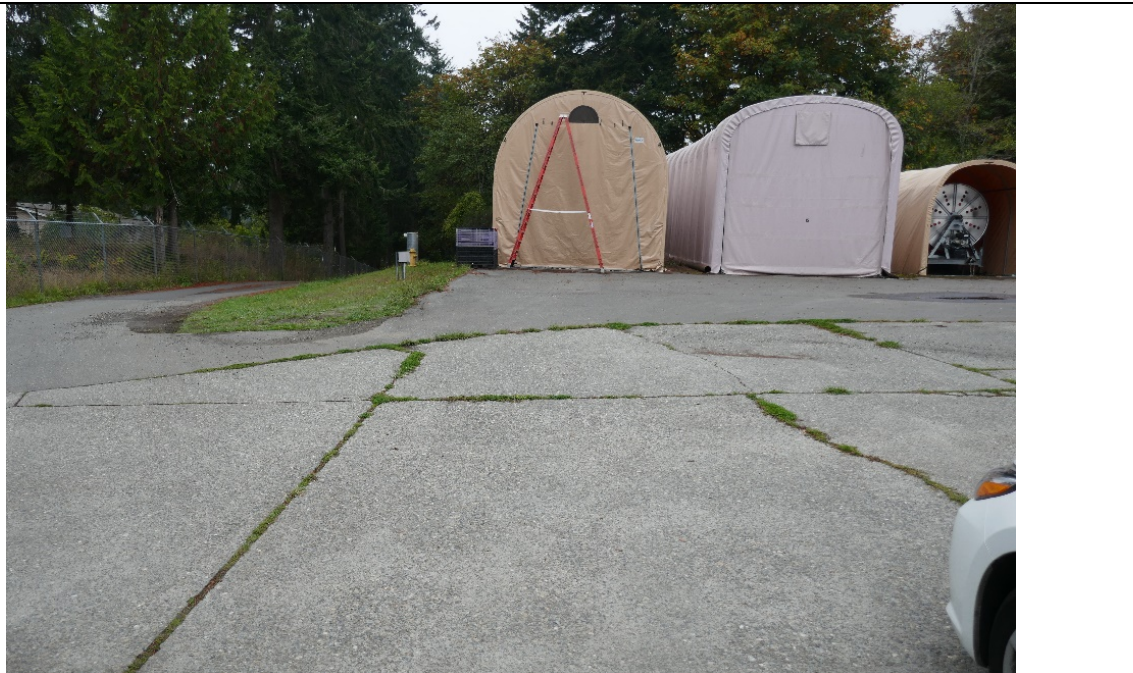
Photo 3 (Above)	12:01	Standing in the middle of the laydown area looking west along South Dike Road.	View of the covered laydown structure, fire hydrant, and water conveyance station.

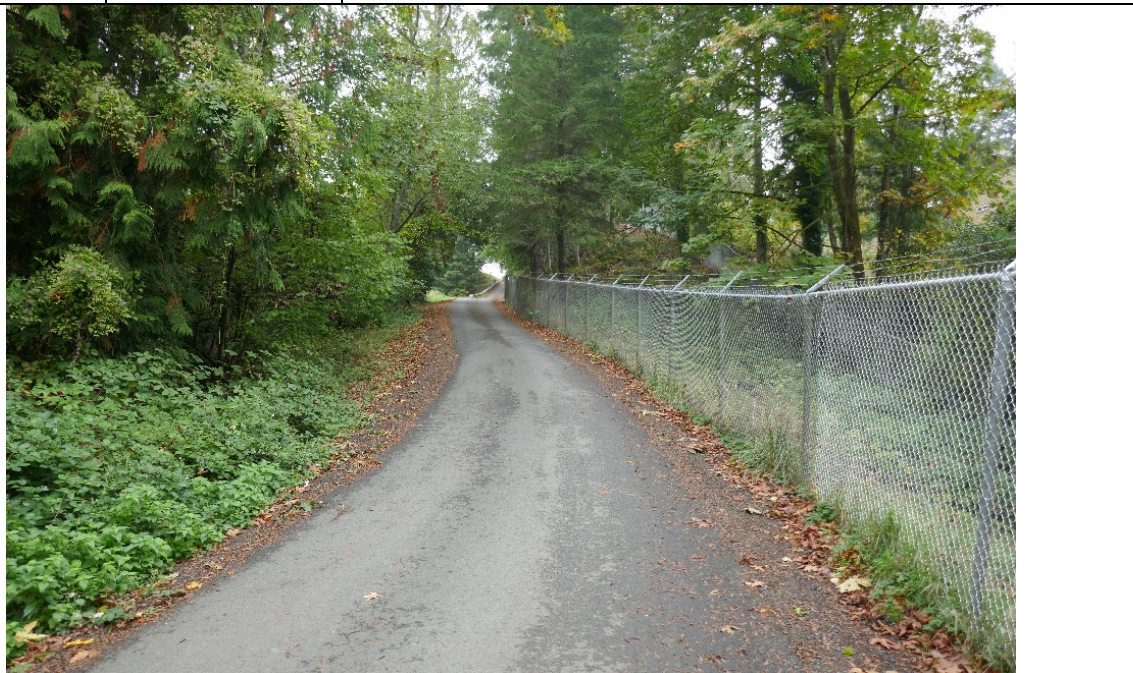
Photo 4 (Above)	12:05	View looking east up South Dike Road	Photo taken near "SLOMO" structure, which stands for Slow Moving equipment area. Also known as the Covered Equipment Storage (CES) area. The SLOMO area is in the southwestern corner of the western half of the property, west of the contractor laydown area.

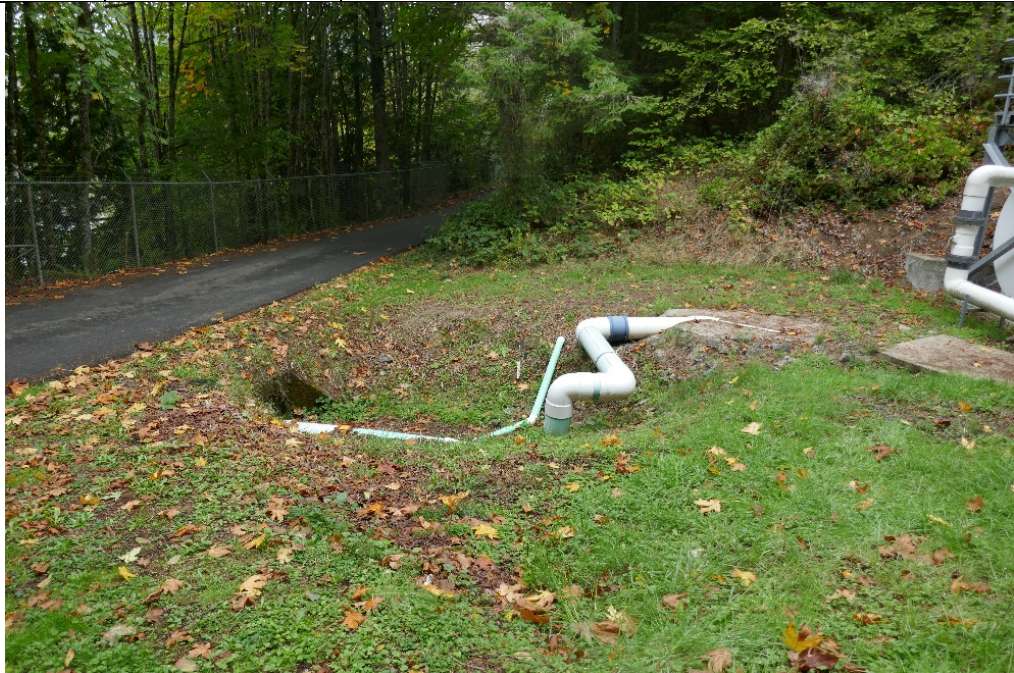
Photo 6 (Above)	12:08	View looking north-northwest along Clam Bay Road	View of discharge pipe from Oil/Water Separators (OWSs) Nos. 8, No. 8A, and 8B. The discharge pipe empties into Little Clam Bay under an NPDES permit.

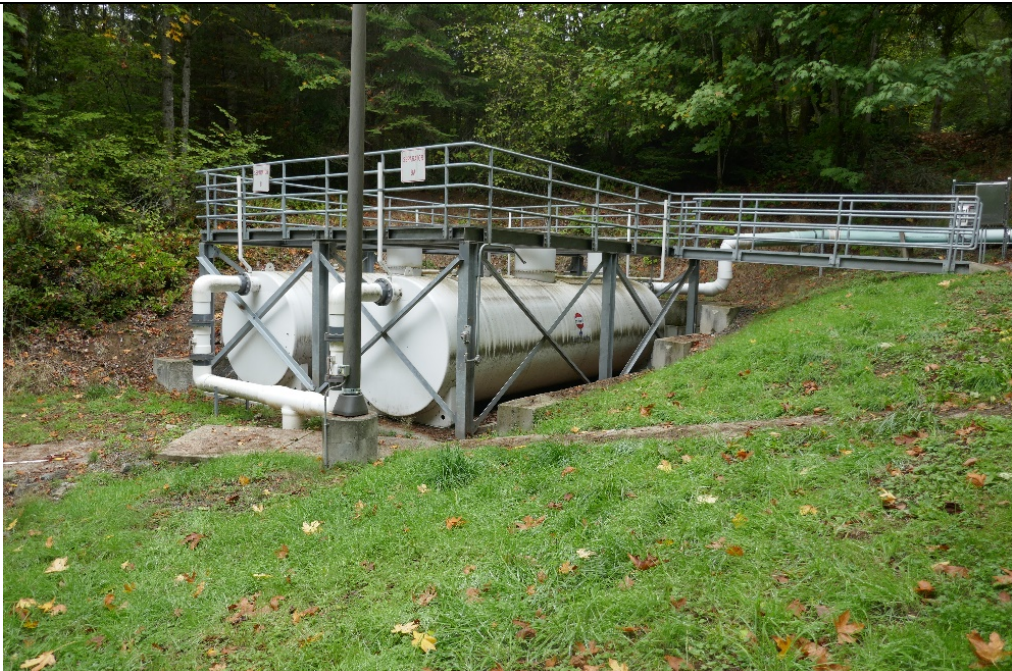
Photo 7 (Above)	12:08 through 12:10	View looking primarily north.	Various views of OWS No. 8, 8A, and 8B.

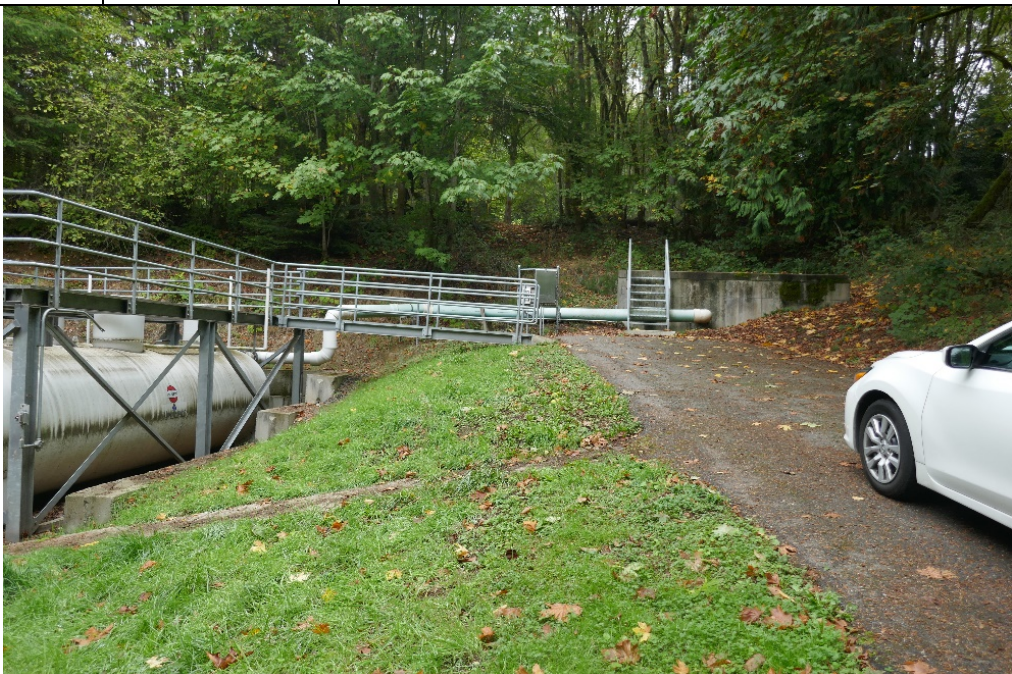
Photo 8 (Above)	12:08 through 12:10	View looking primarily north.	Various views of OWS No. 8, 8A, and 8B.

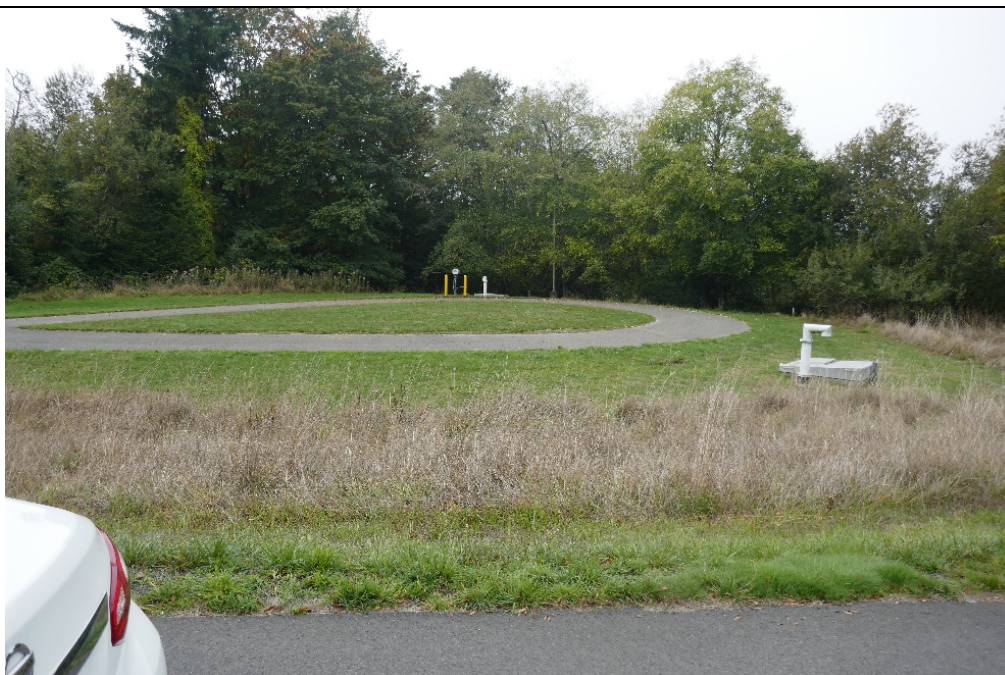
Photo 13 (Above)	12:14 – 12:15	Various views.	Views of various underground storage tank (UST) locations. Based on staff interviews and recon, no evidence of fires or usage of PFAS-based chemicals as part of UST maintenance.
-----------------------------	------------------	----------------	---

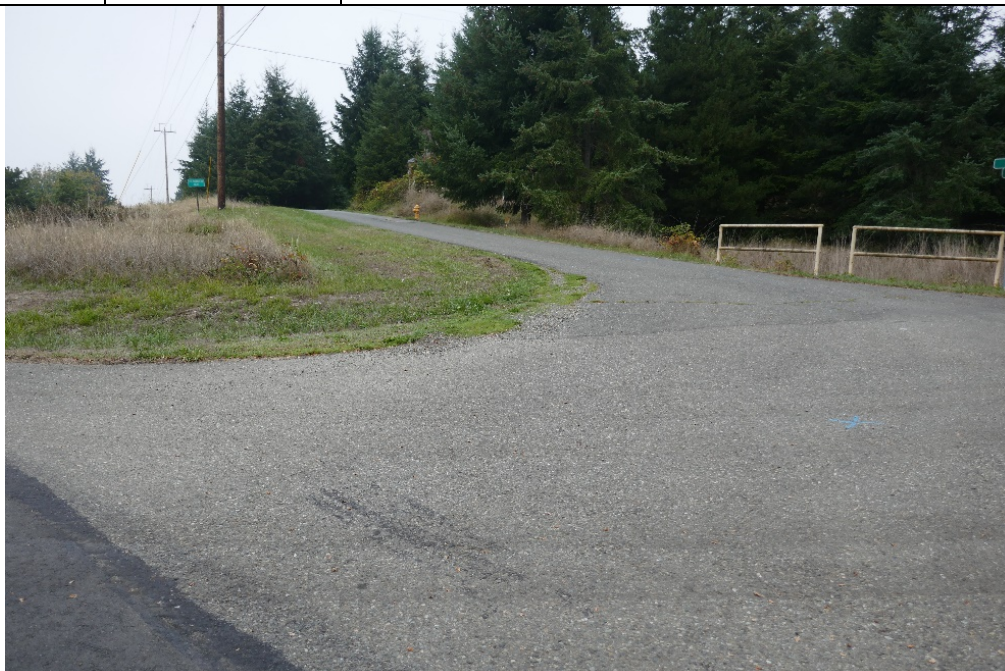
Photo 14 (Above)	12:14 – 12:15	Various views.	Views of various UST locations. Based on staff interviews and recon, no evidence of fires or usage of PFAS-based chemicals as part of UST tank maintenance.
-----------------------------	------------------	----------------	---

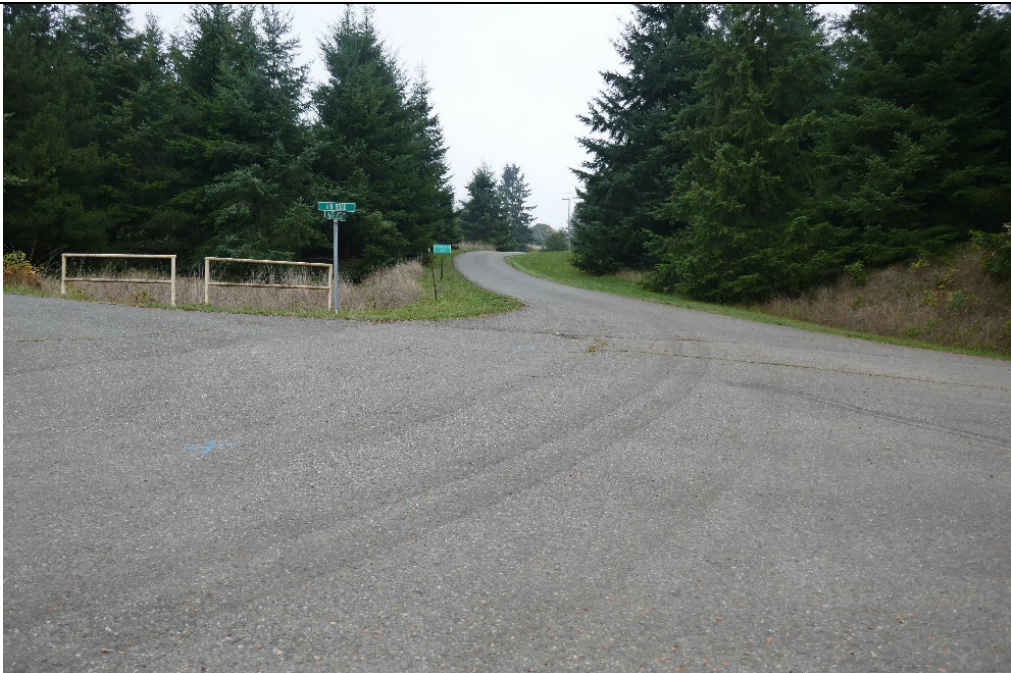
Photo 15 (Above)	12:14 – 12:15	Various views.	Views of various UST locations. Based on staff interviews and recon, no evidence of fires or usage of PFAS based chemicals as part of UST tank maintenance.

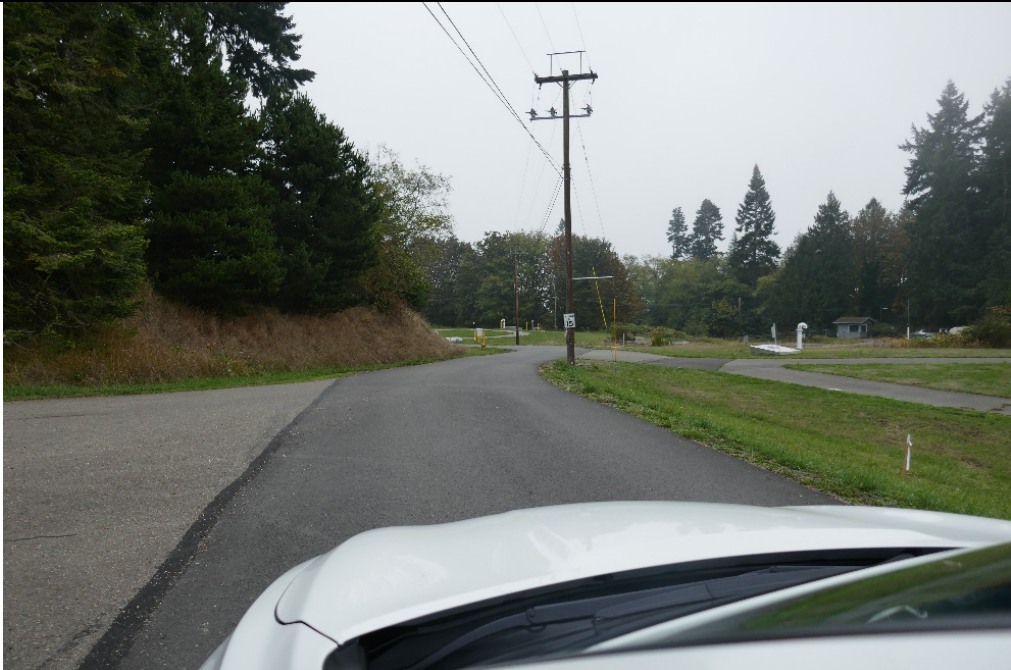
Photo 16 (Above)	12:14 – 12:15	Various views.	Views of various UST locations. Based on staff interviews and recon, no evidence of fires or usage of PFAS-based chemicals as part of UST tank maintenance.

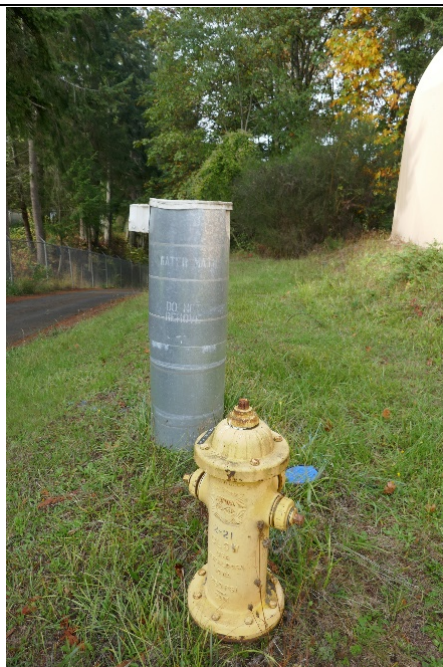
Photo 17 (Above)	12:58	View to the west along South Dike Road	View of water main access port. Fleet Logistics Center Puget Sound Manchester Fuel Depot (MFD) staff Deputy Environmental Director and Environmental Engineer did not know exactly who installed it. It is most likely associated with the City of Manchester Water Utility.
-----------------------------	-------	--	--

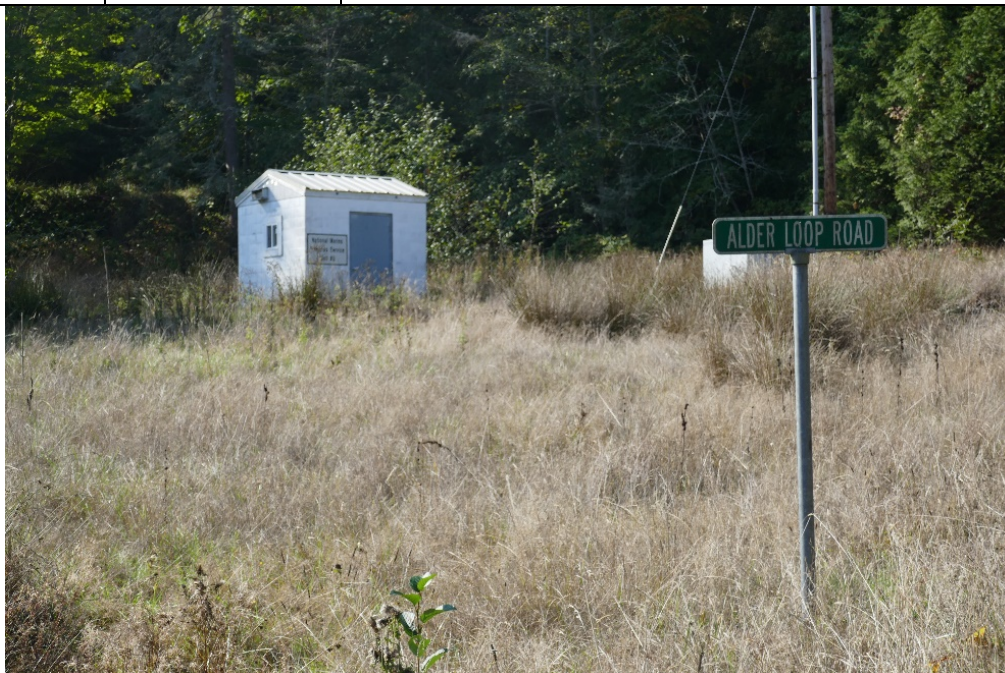
Photo 18 (Above)	13:11	View to the southwest along Alder Loop Road.	View of National Oceanic and Atmospheric Administration (NOAA) Well.
-----------------------------	-------	--	--

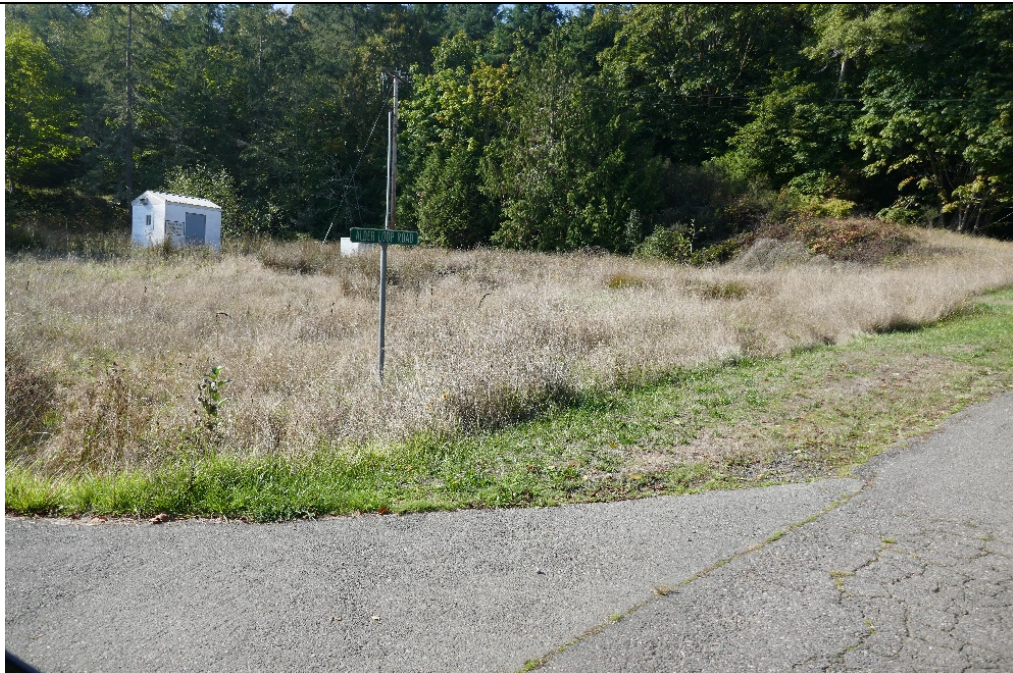
Photo 19 (Above)	13:11	View to the southwest along Alder Loop Road.	View of NOAA Well.

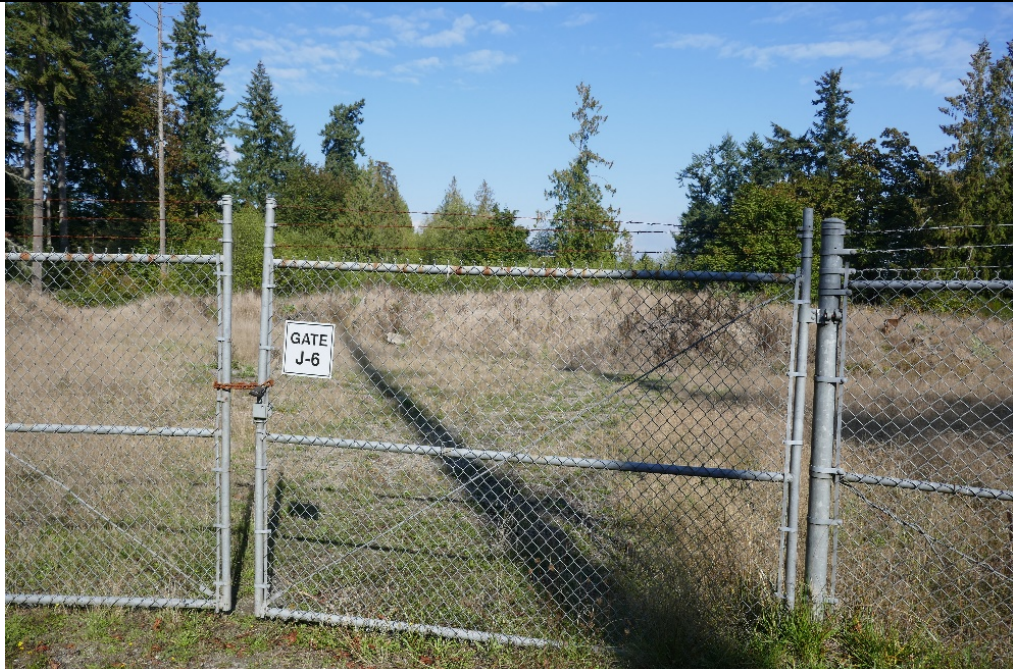
Photo 20 (Above)	13:14	View looking to the north.	View of the former PCB Site 302. The site is gated off with access prohibited. The site was remediated in the 1990s and is highly vegetated. It would be difficult to identify the previous burn areas and there is no direct evidence to suggest that AFFF was used to extinguish fires.

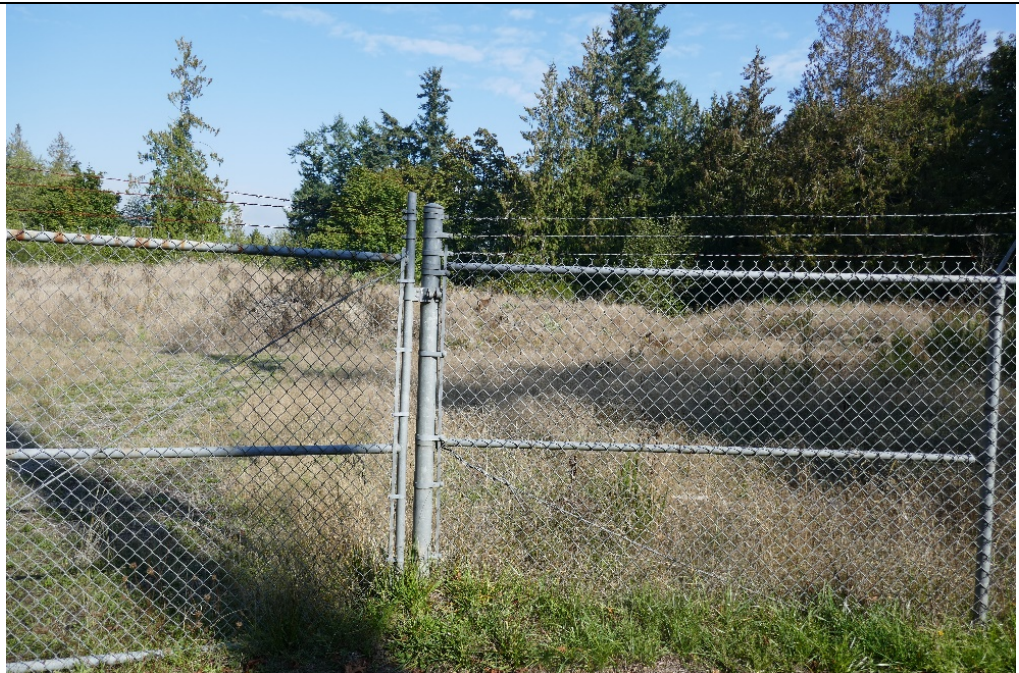
Photo 21 (Above)	13:14	View looking to the north. View of the former PCB Site 302. The site is gated off with access prohibited. The site was remediated in the 1990s and is highly vegetated. It would be difficult to identify the previous burn areas and there is no direct evidence to suggest that AFFF was used to extinguish fires.

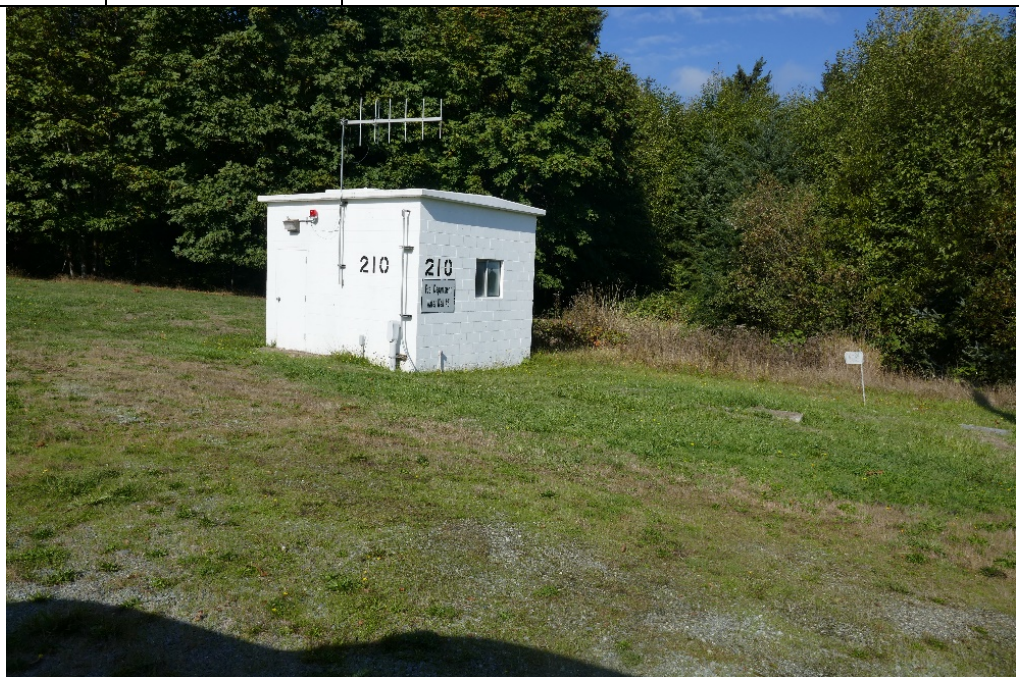
Photo 22 (Above)	13:24	View looking to the northwest View of Well Pump House 210.

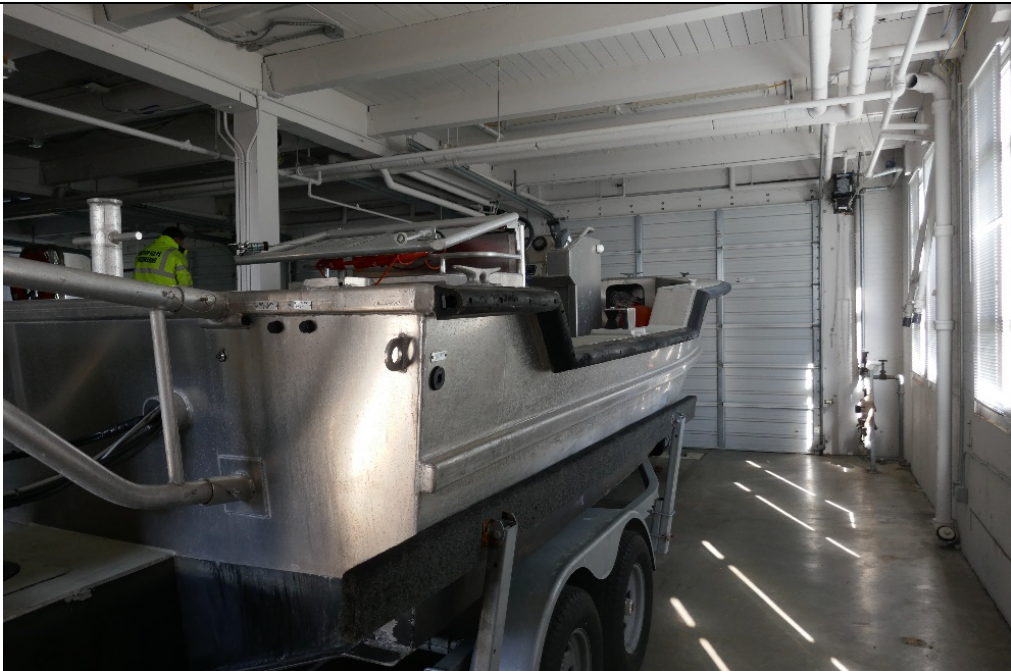
Photo 25 (Above)	13:35- 13:38	Interior photos of Building 85	Interior photos of Building 85. Note there is no floor drains in the building. Any wash waters from truck or equipment washing would have drained in the front of the building.

Because of the operational history of this area as a former Fire Station, further investigation is recommended at Building 85 as part of an SI. The SI should evaluate human health risk for PFAS-impacted media where complete pathways exist. If formal regulatory-based ESVs are available for PFAS compounds in the future, evaluation of ecological risk as part of a future investigation is recommended.

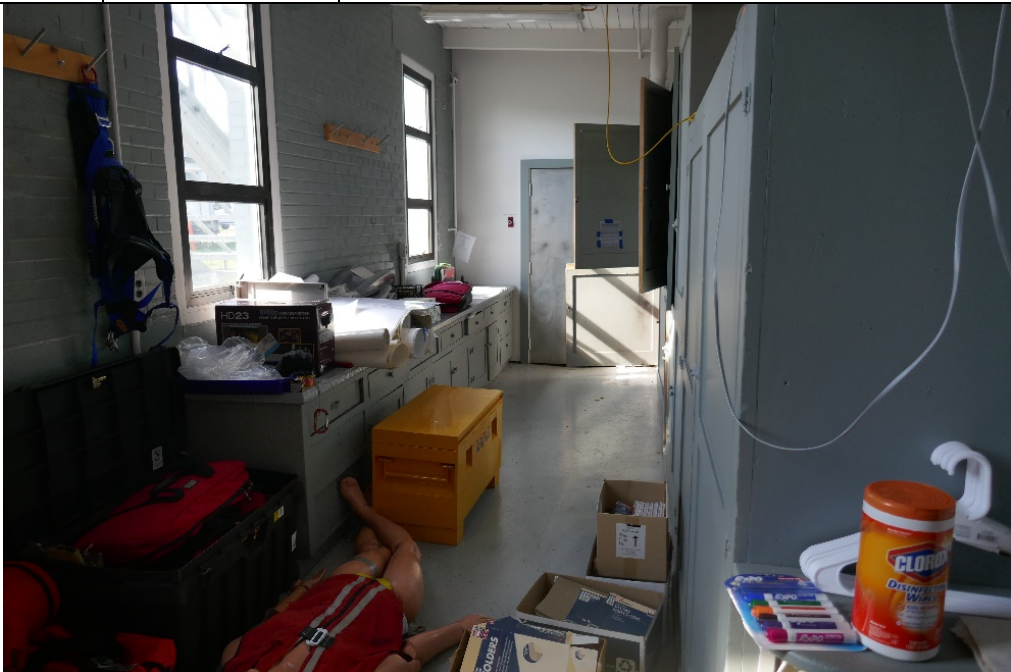
Photo 26 (Above)	13:35- 13:38	Interior photos of Building 85	Interior photos of Building 85. Note there is no floor drains in the building. Any wash waters from truck or equipment washing would have drained in front of the building.

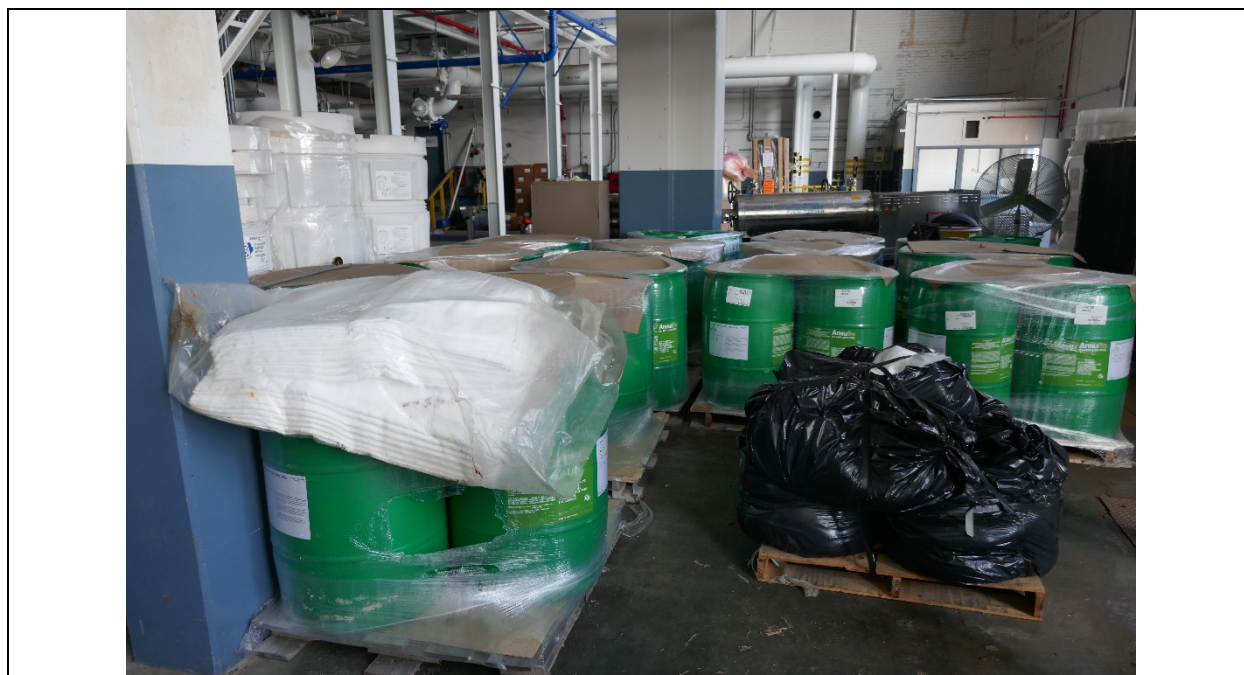
Photo 27 (Above)	13:47 through 13:51	Interior photos of Building 12 showing containers of AFFF.	Photos of AFFF stored in Building 12. Note there is 44 containers shown with 1 missing.
-----------------------------	---------------------------	--	--

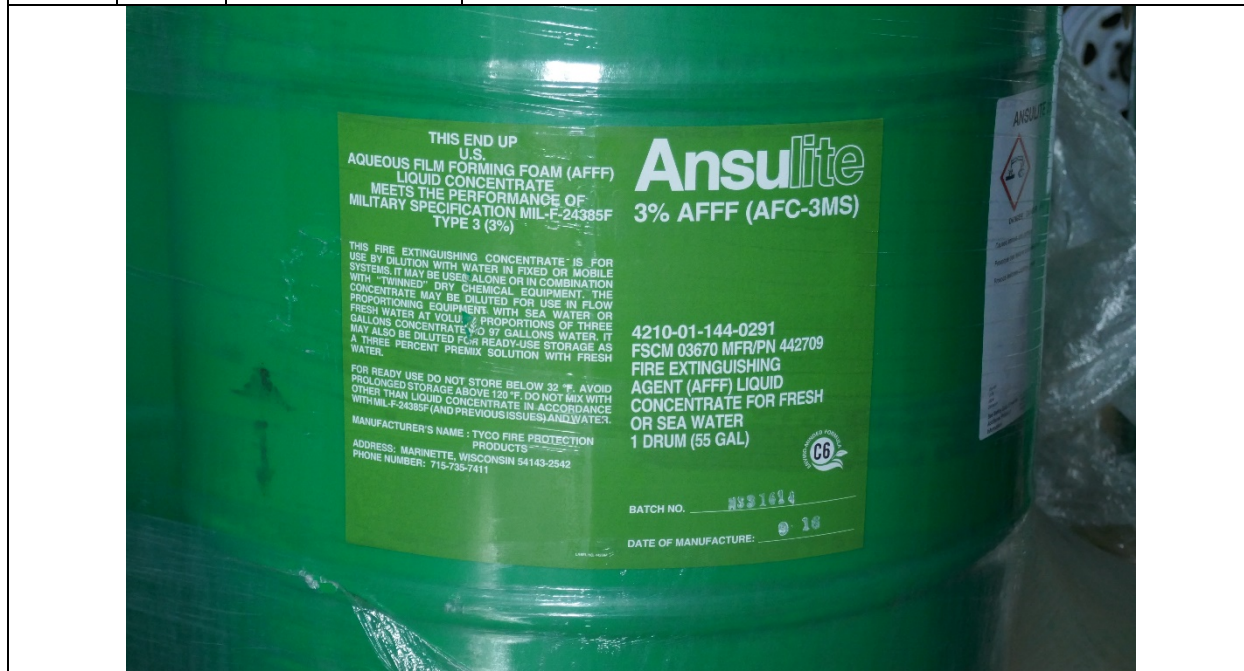
Photo 28 (Above)	13:47 through 13:51	Interior photos of Building 12 showing containers of AFFF.	Photos of AFFF stored in Building 12. Note there is 44 containers shown with 1 missing.
-----------------------------	---------------------------	--	--

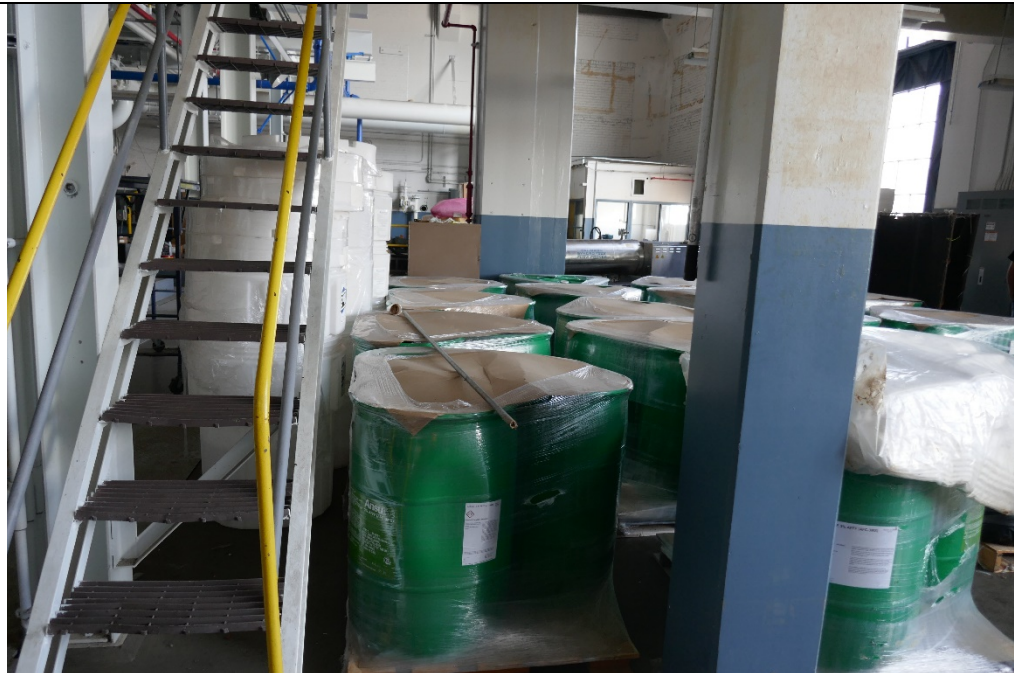
Photo 31 (Above)	13:47 through 13:51	Interior photos of Building 12 showing containers of AFFF. Photos of AFFF stored in Building 12. Note there is 44 containers shown with 1 missing.

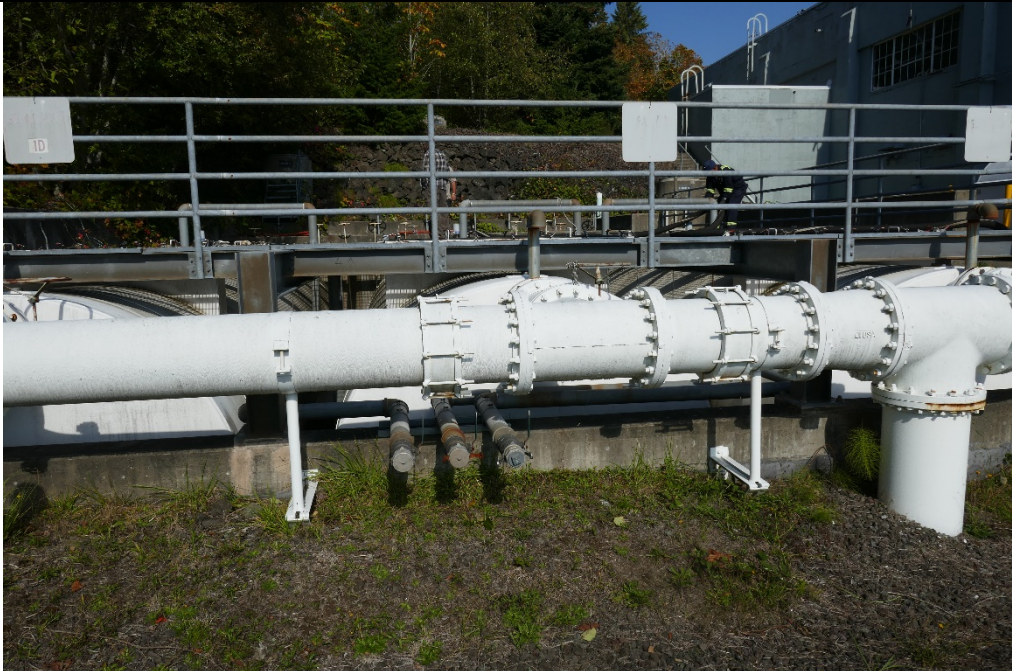
Photo 33 (Above)	14:00	View looking north	OWS 1B, 1C, and 1D.

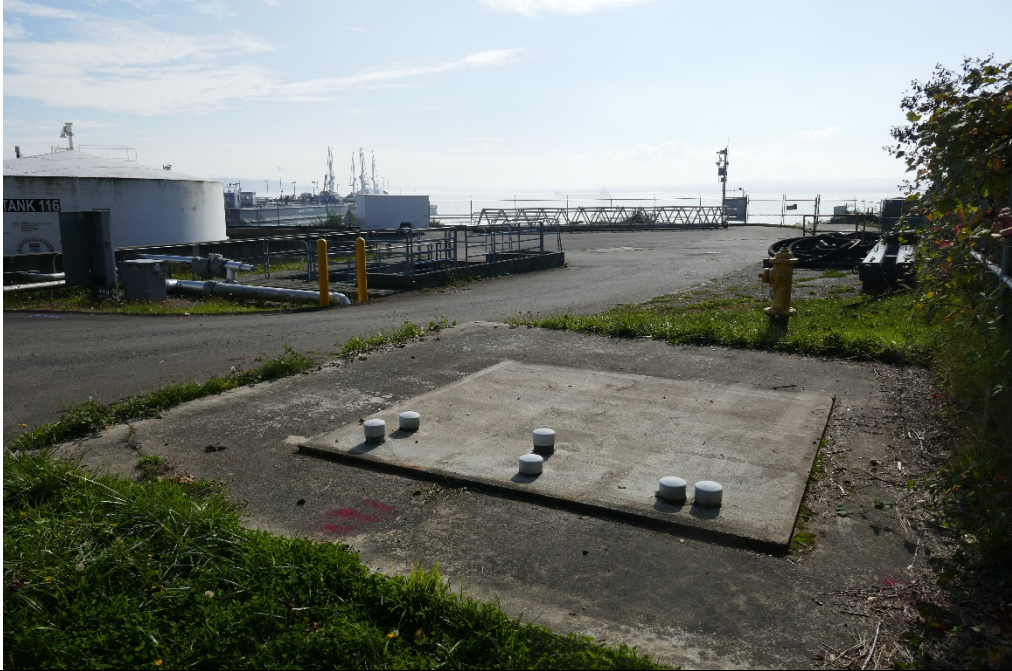
Photo 34 (Above)	14:00	View looking south-southeast	Primary Electrical Switchgear

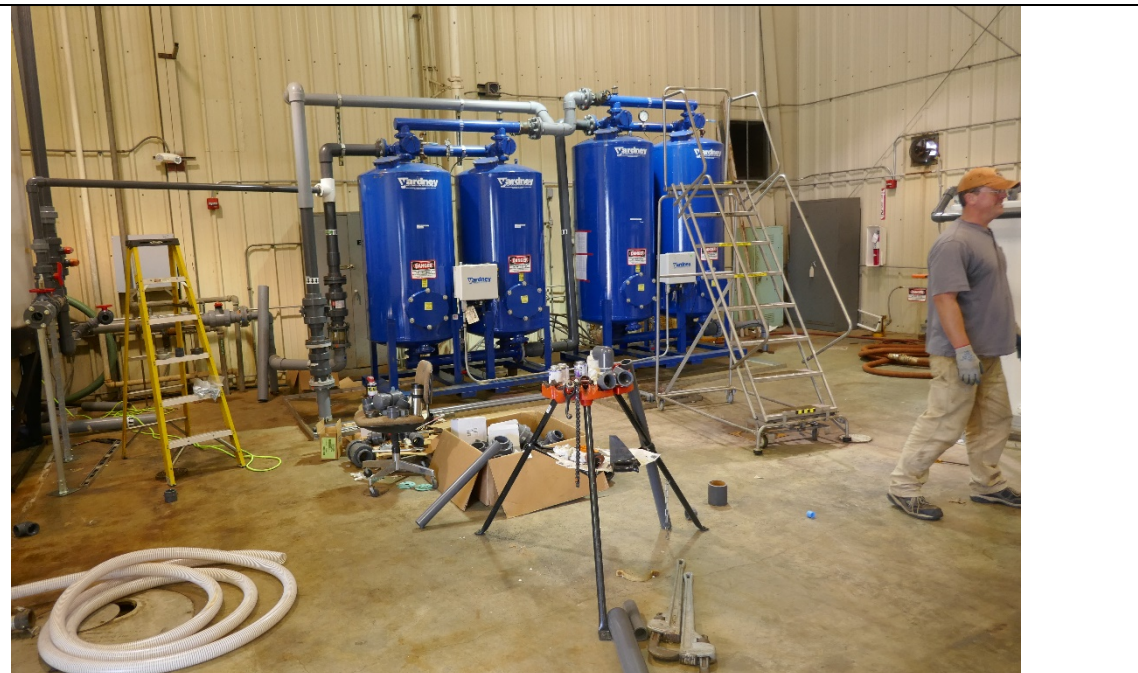
Photo 35 (Above)	14:07	Interior photos of Building 178	Interior photos of equipment and tanks in the Oily Water Treatment Plant, Building 178.

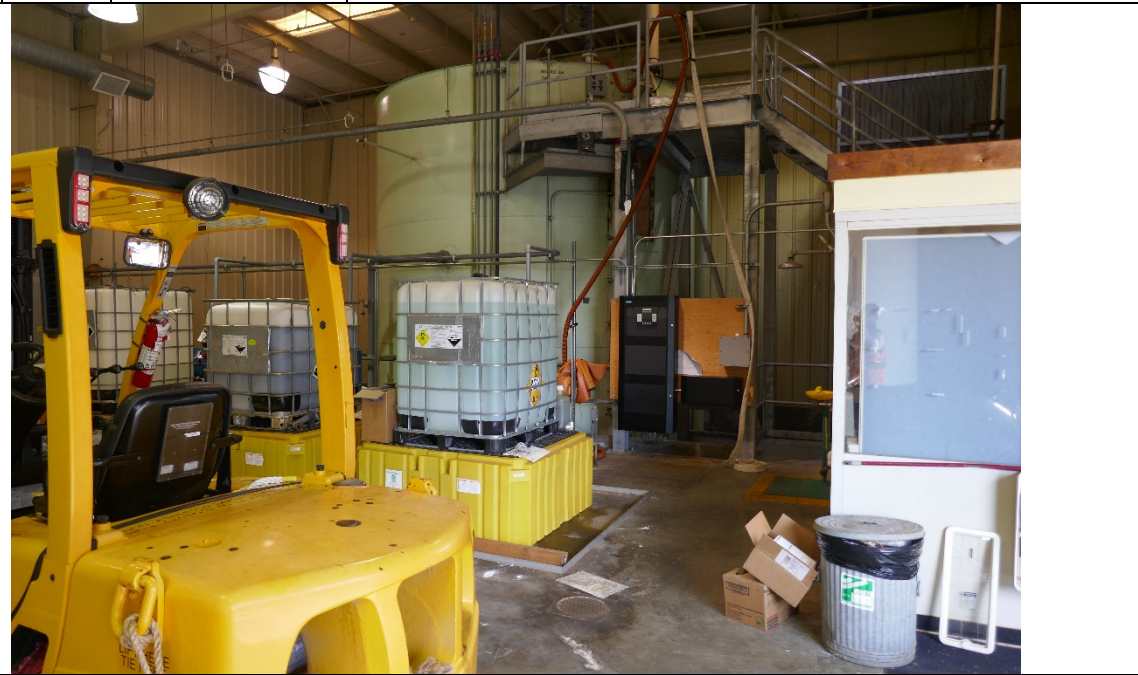
Photo 36 (Above)	14:07	Interior photos of Building 178	Interior photos of equipment and tanks in the Oily Water Treatment Plant, Building 178.

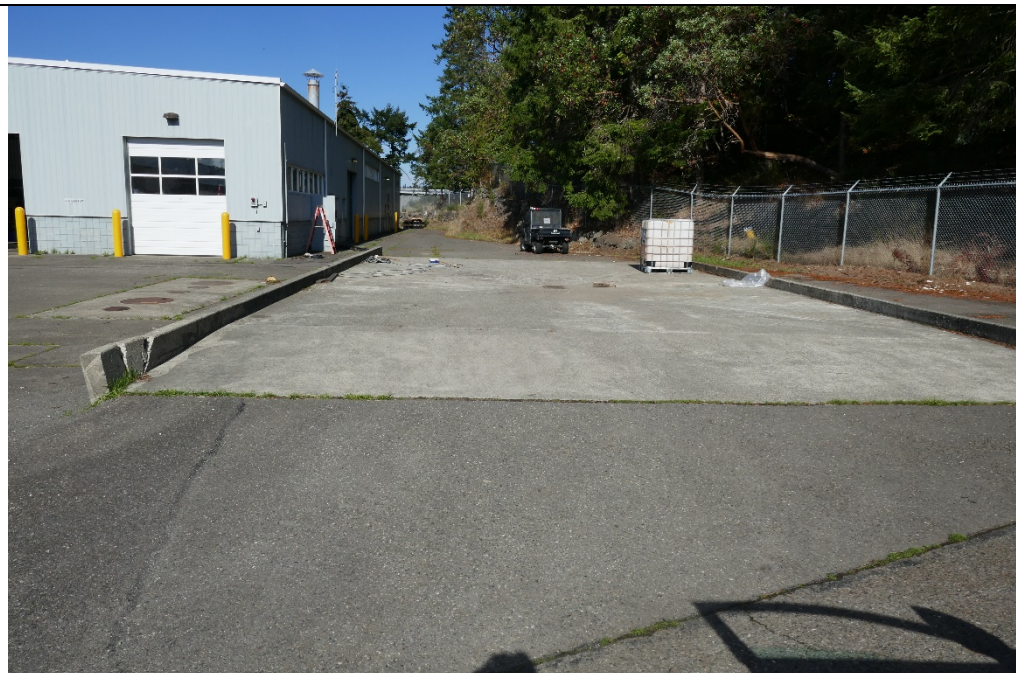
Photo 37 (Above)	15:24	View looking north-northwest	Vehicle wash rack. Per Base protocol, Fire Station staff were instructed to wash Fire Engines and Equipment at this wash rack.

Based on the uncertainty regarding whether this area was used to wash fire trucks with AFFF residue, further investigation is recommended at the VWR as part of an SI. The SI should evaluate human health risk for PFAS-impacted media where complete pathways exist. If formal regulatory-based ESVs are available for PFAS compounds in the future, evaluation of ecological risk as part of a future investigation is recommended.

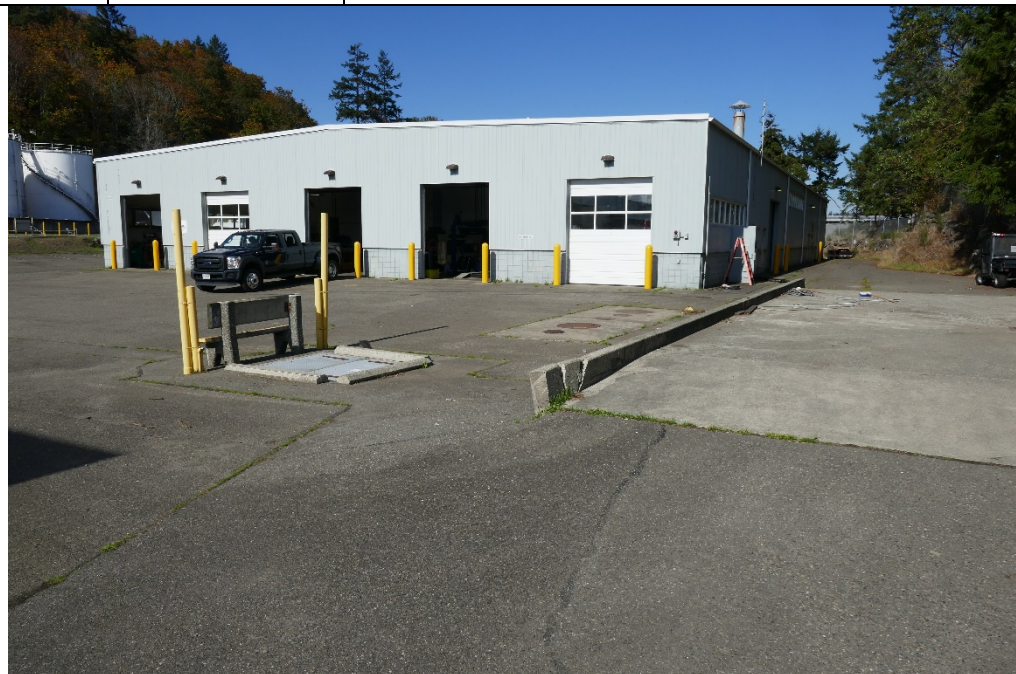
Photo 38 (Above)	15:24	View looking north-northwest	Vehicle wash rack. Per Base protocol, Fire Station staff were instructed to wash Fire Engines and Equipment at this wash rack.
