**Preliminary Assessment for
Per- and Polyfluoroalkyl Substances (PFAS)**

Manchester Fuel Depot
Kitsap County, Washington

May 2021

Prepared for NAVFAC Northwest
by CH2M HILL, Inc.
Seattle, Washington
Contract N62470-16-D-9000
CTO N4425518F4117 (4117)

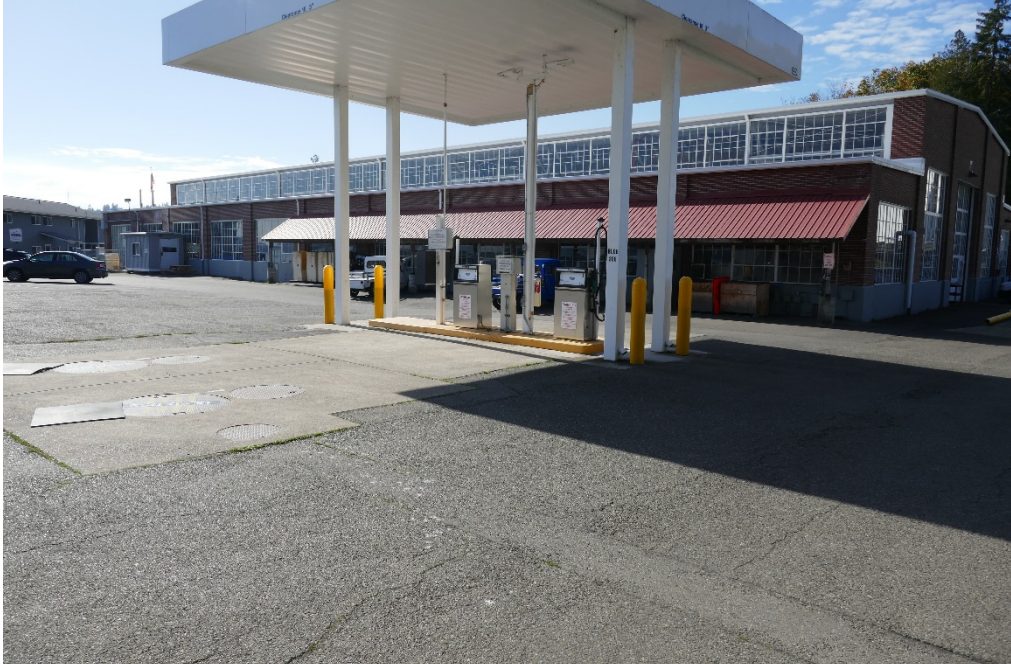
Photo 39 (Above)	15:24	View looking southwest.	Pump Island and Building No. 1.
