October 17, 2022

**RE: UST Decommissioning Report Addendum**

*Naches Pit Stop*  
10121 Highway 12  
Naches, Washington 98937-9785  
VCP ID No.: CE0449

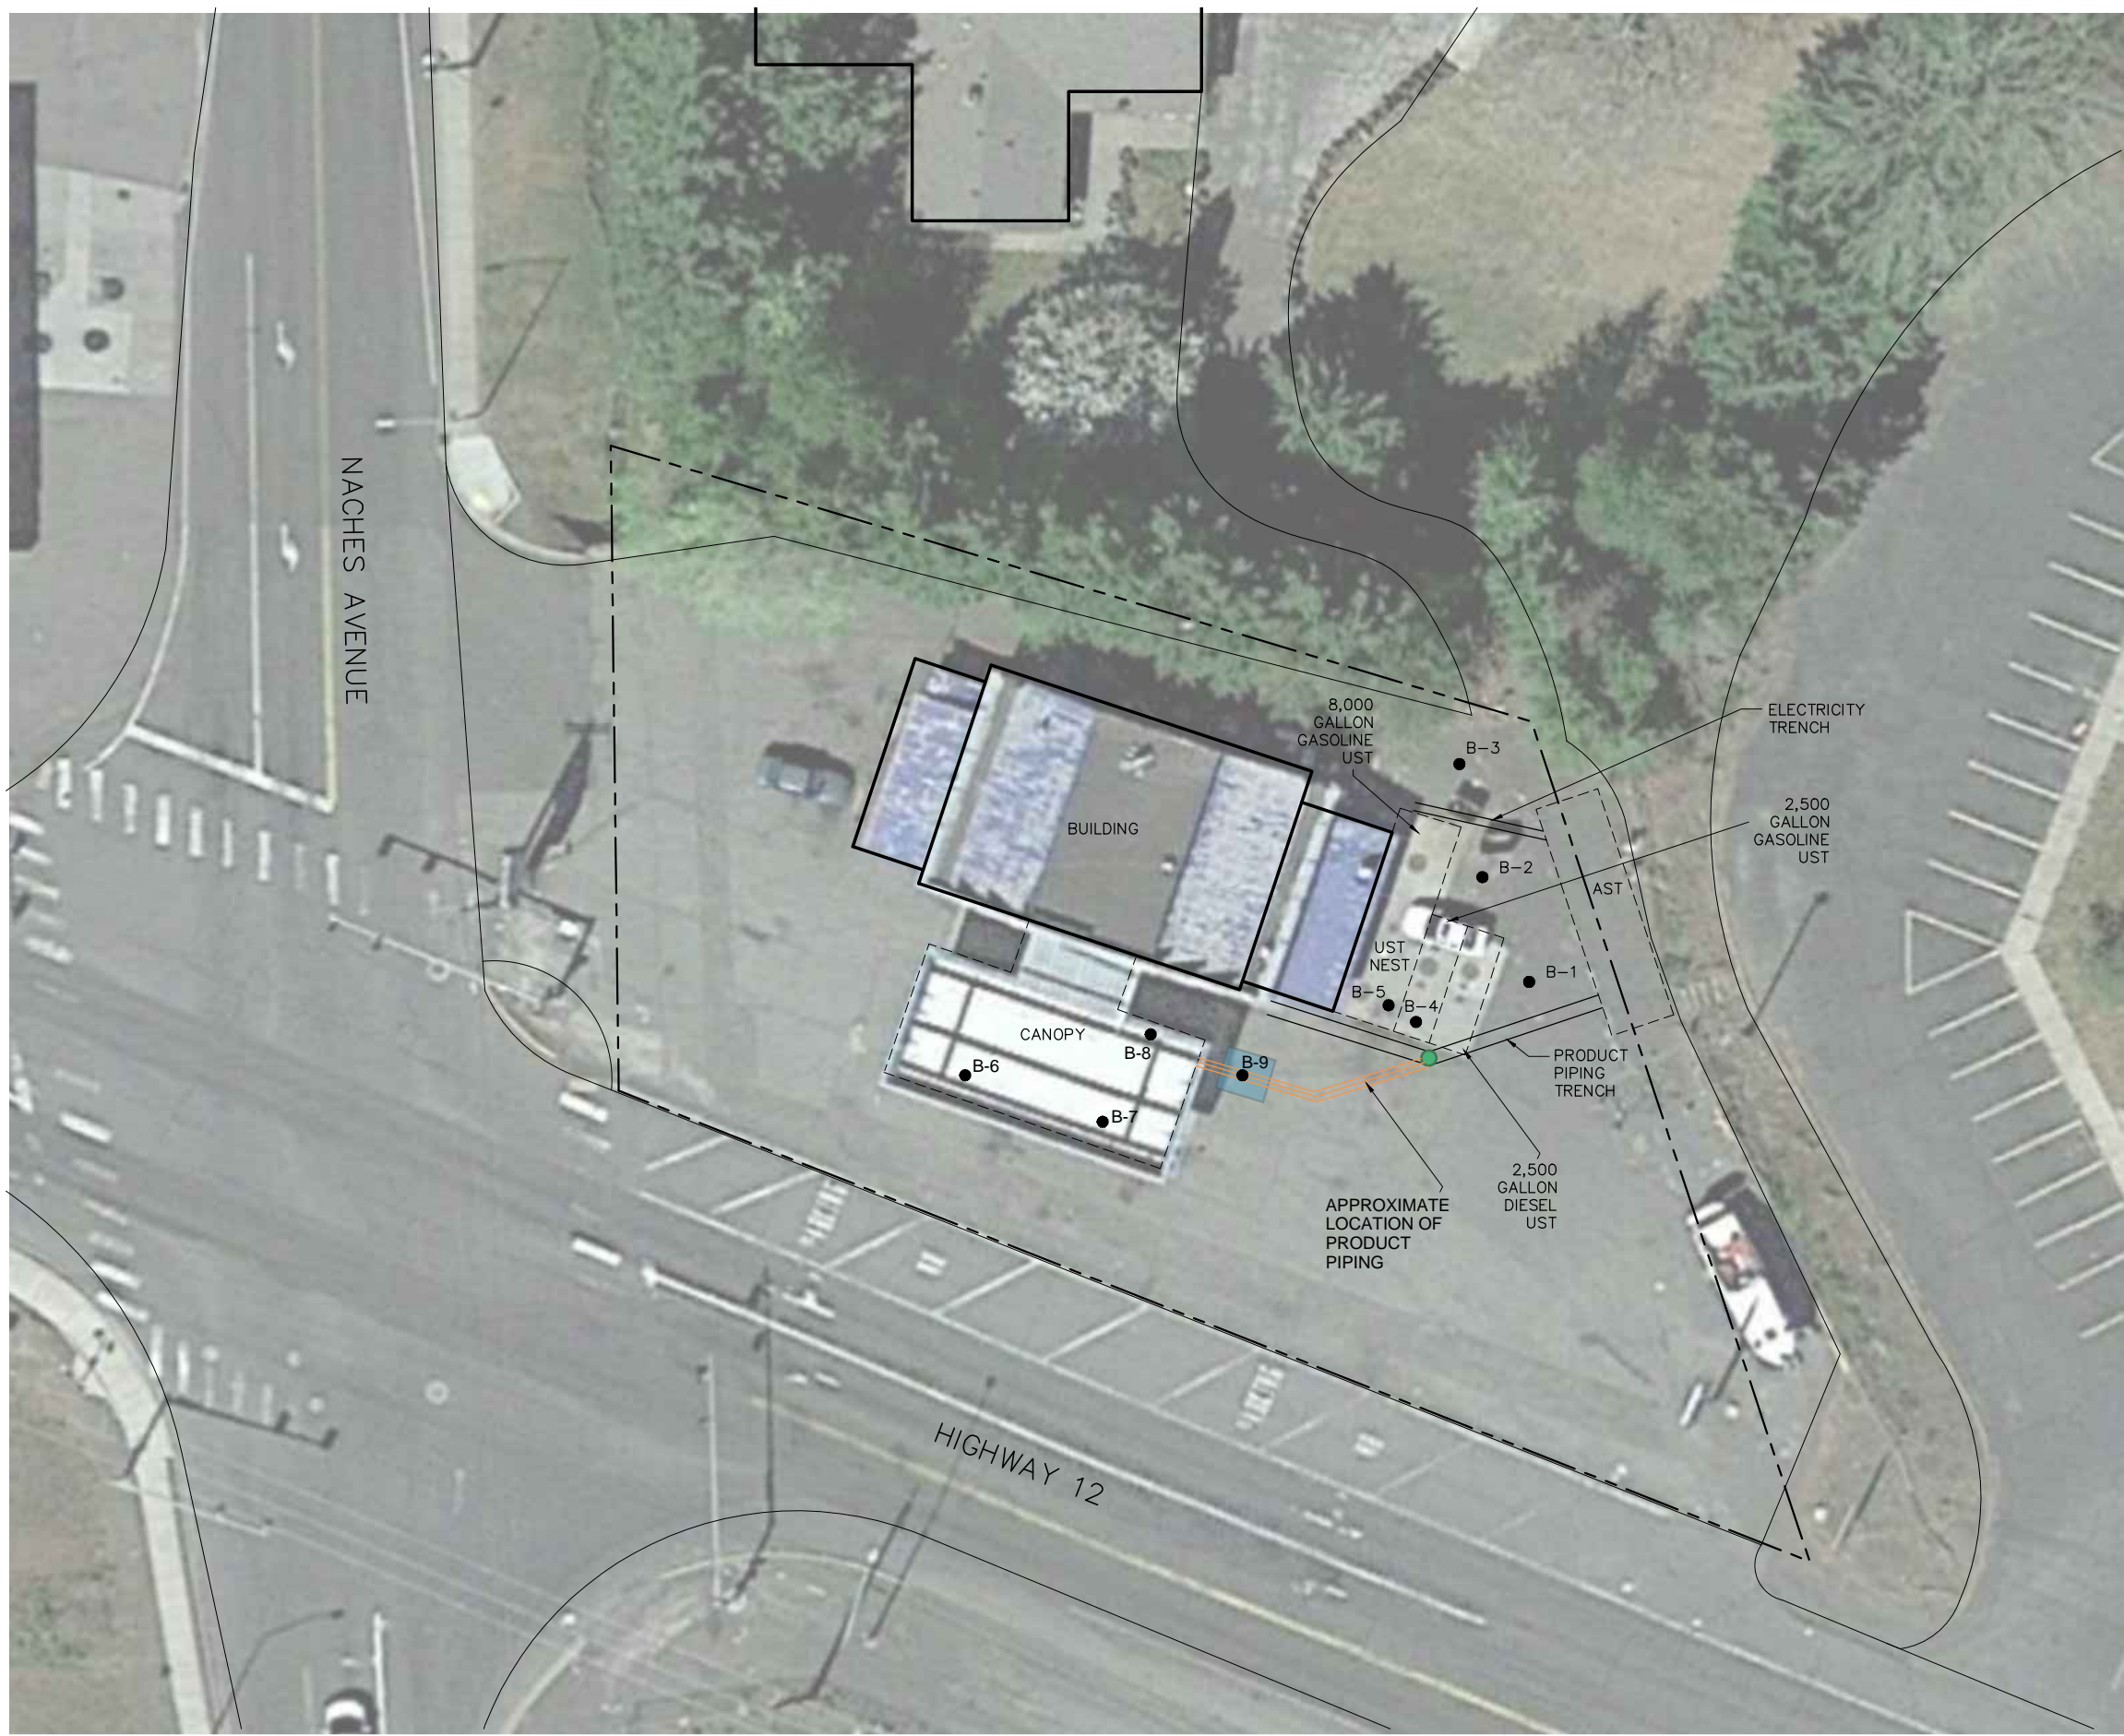
FIGURE 2  
 SITE MAP

AEG returned to the Site on May 16, 2022, and advanced four borings (B-6, B-7, B-8, and B-9) adjacent the product lines and dispensers. As was the case with borings B-1 through B-5, groundwater was not encountered in any of the borings. Boring locations are illustrated in Figure 2, *Site Map*, and boring logs are included in Appendix B, Supporting Documents, *Boring Logs*. The Ecology UST Inspector was on Site during drilling. For the final boring (B-9), Ecology requested AEG field staff move the planned boring location about 1.5 feet closer to the where the product line markings were drawn by the utility locator. While advancing the boring, the drilling rods punctured one of the product lines, and the UST system immediately shut off. Luckily, most

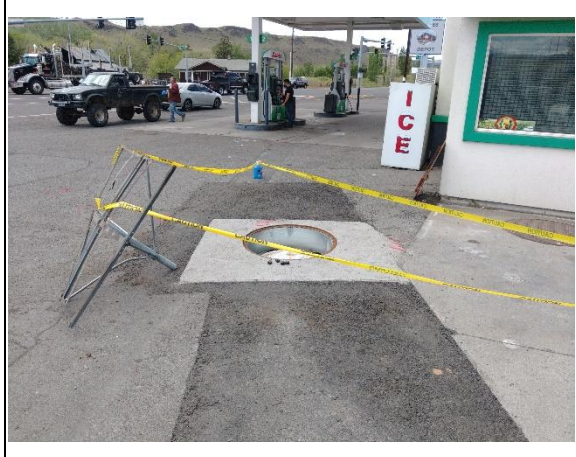
Photo # 7	Sump where most of the gas in the piping was captured

of the gasoline in the piping flowed backwards into a sump location between the aboveground tank and the dispensers, and was pumped out.
