Subject: Addressing Ecology's RI Data Gaps
Hardel Mutual Plywood Corporation Site
1210 West Bay Drive NW, Olympia, Washington
VCP ID SW1757, Formerly Agreed Order DE 4108, Cleanup Site ID No. 3704, Facility/Site ID No. 75128579

To: Joe Hunt, L.HG. (Ecology)
From: Troy Bussey Jr., P.E., L.G., L.HG. (PIONEER)
Cc: Brandon Smith (Milestone), Kim Seely (Coastline), Heather Burgess (Phillips Burgess)
Date: October 25, 2022
Subject: Responses to Nick Acklam's January 11, 2022 Verbal Comments on the August 2021 RI Data Gap Report
Hardel Mutual Plywood Corporation Site
1210 West Bay Drive NW, Olympia, Washington
VCP ID SW1757, Formerly Agreed Order DE 4108, Cleanup Site ID No. 3704, Facility/Site ID No. 75128579

Work Plan to Address Ecology's RI Data Gaps

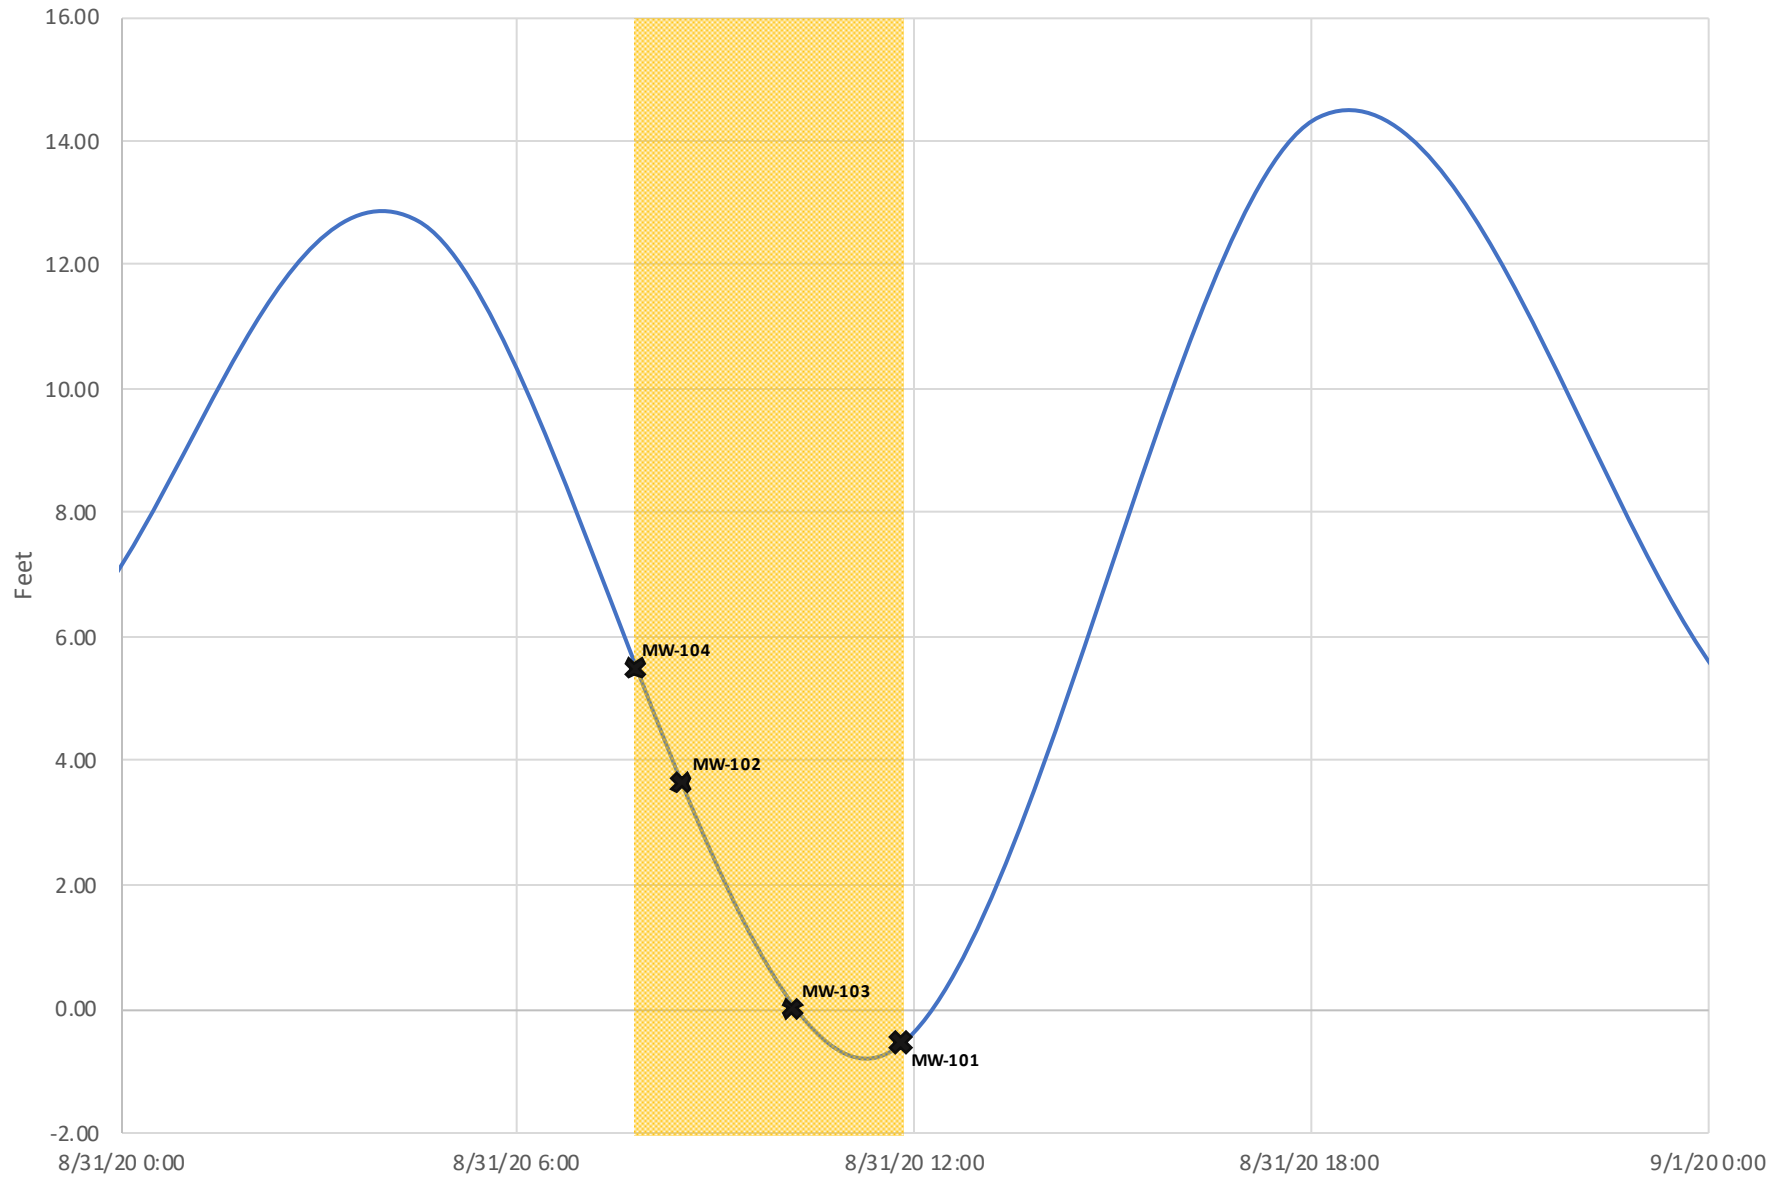
Chart 1: Groundwater Sampling Times Relative to Tidal Stage for 3Q20
(August 31, 2020)

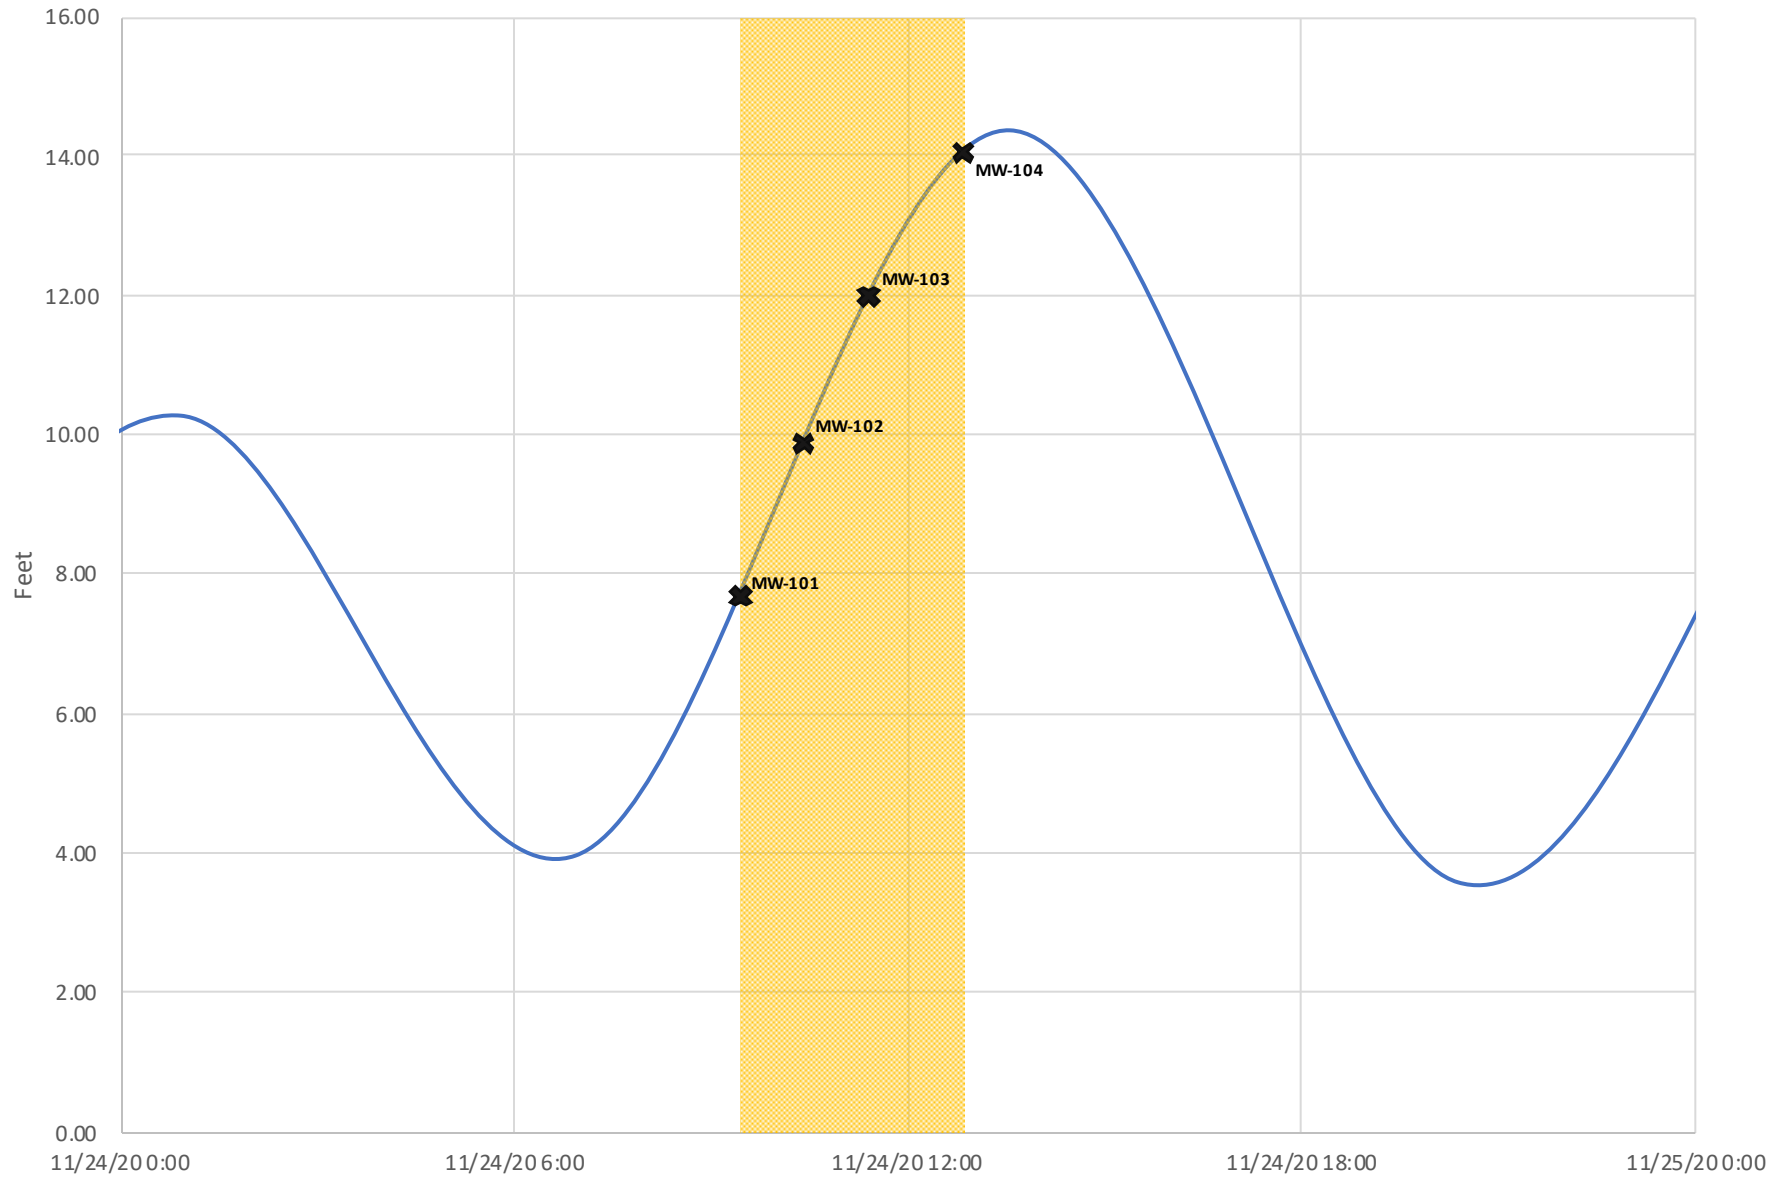
Chart 2: Groundwater Sampling Times Relative to Tidal Stage for 4Q20
(November 24, 2020)

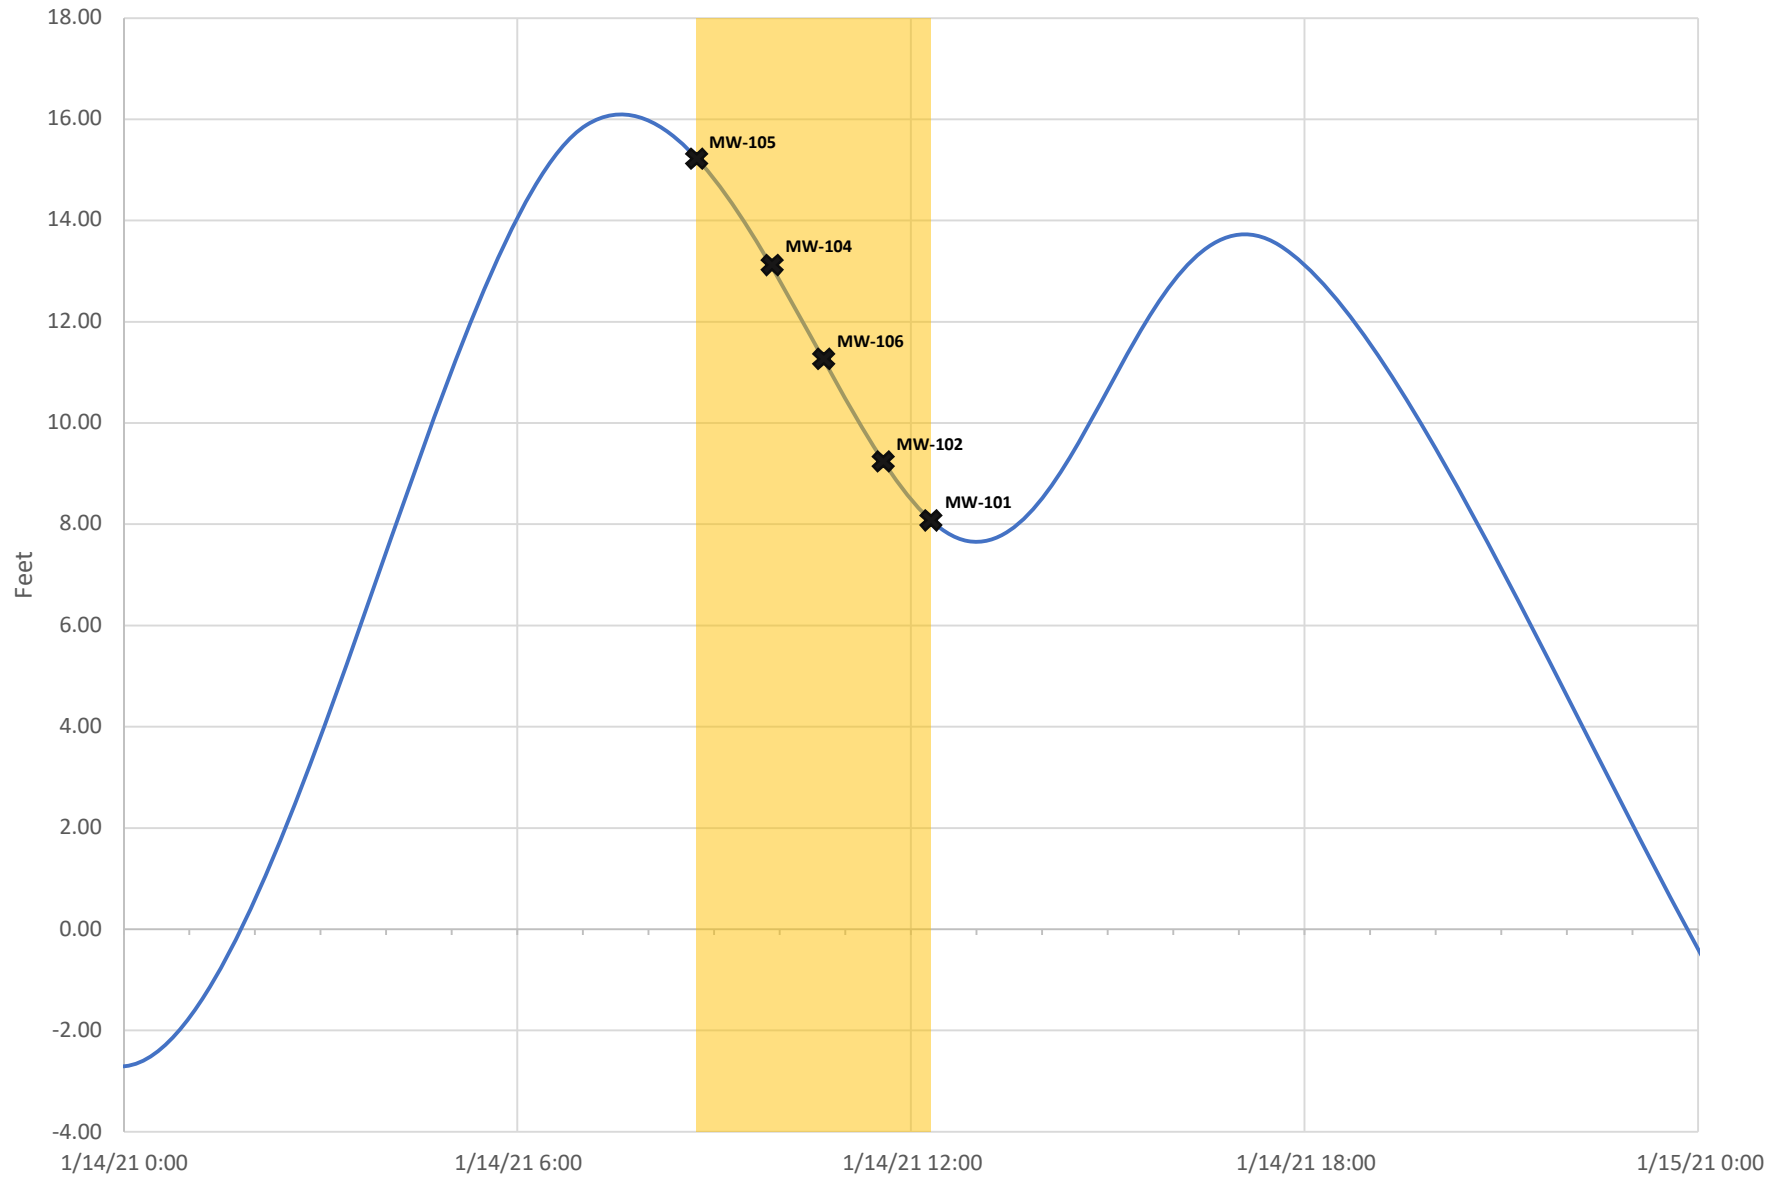
Chart 3: Groundwater Sampling Times Relative to Tidal Stage for 1Q21
(January 14, 2021)

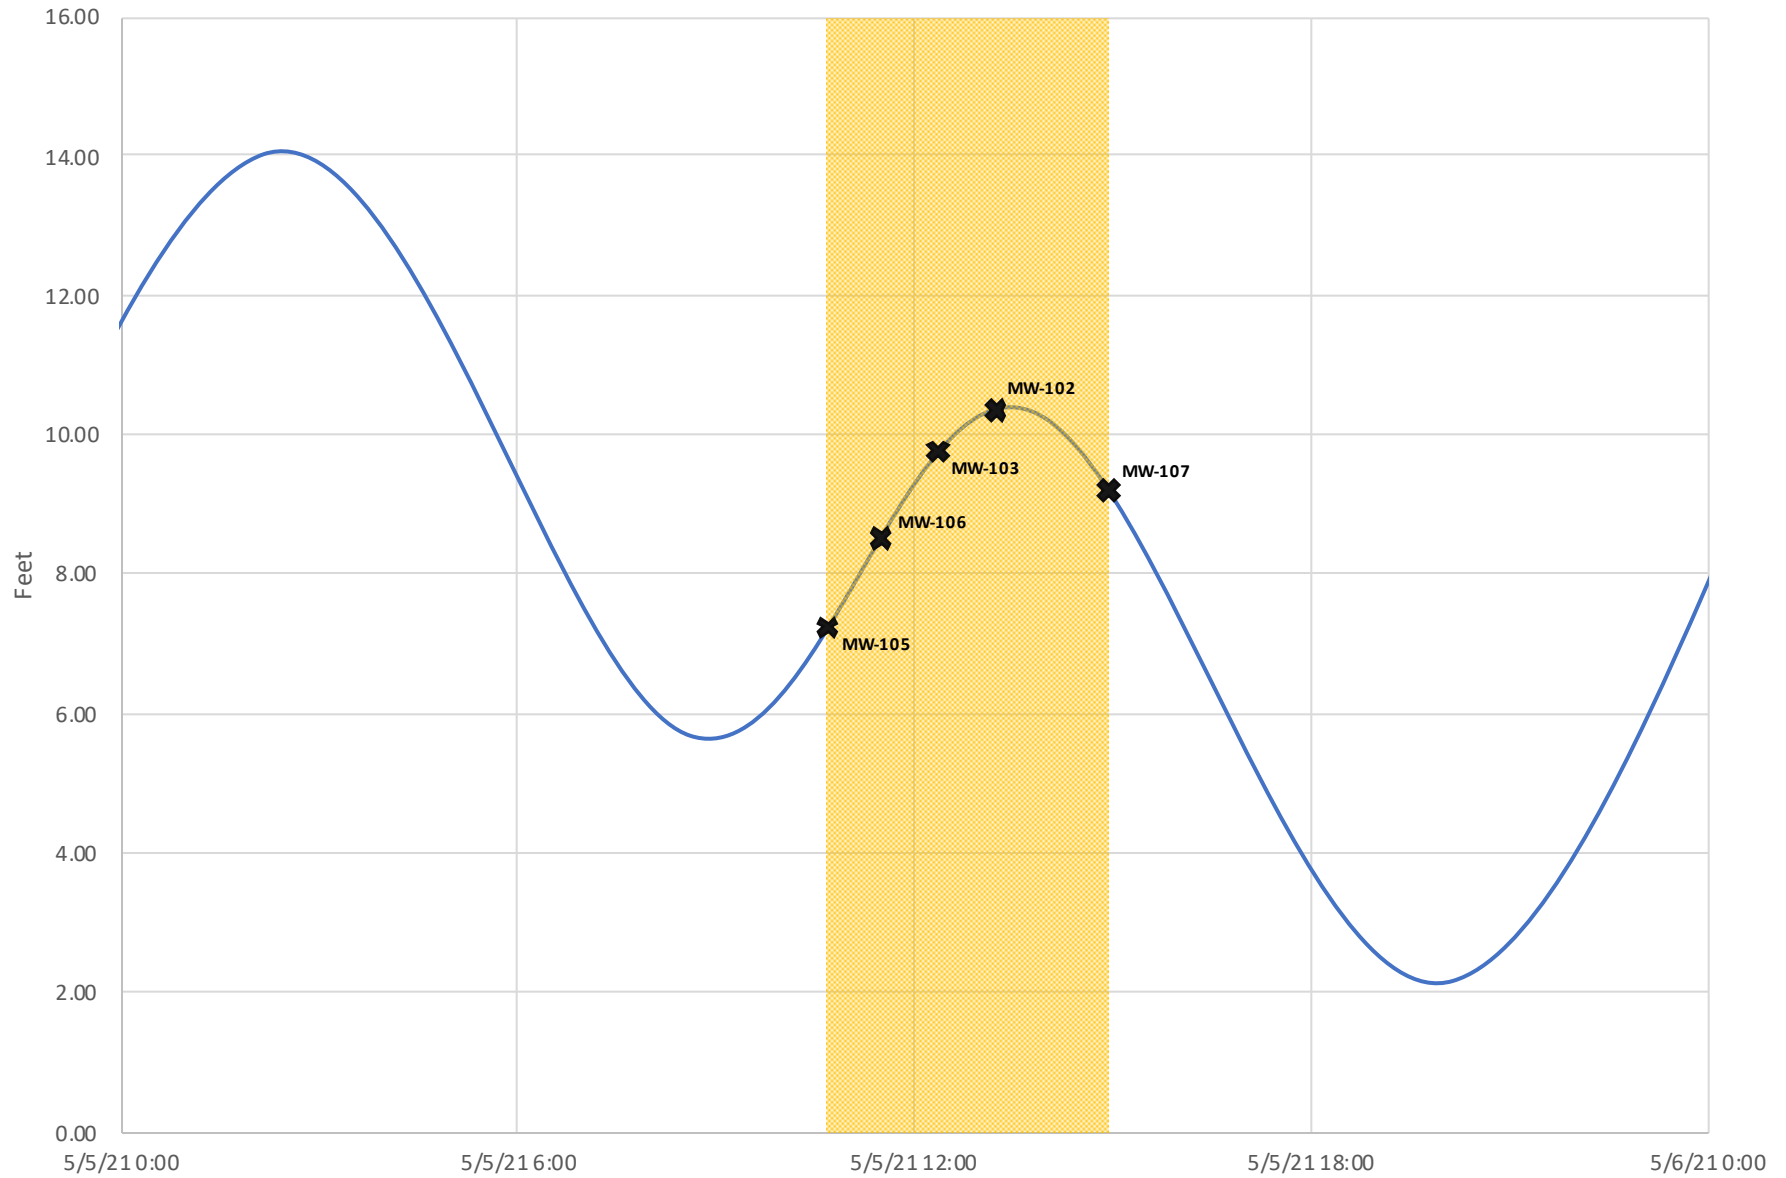
Chart 4: Groundwater Sampling Times Relative to Tidal Stage for 2Q21
(May 5, 2021)

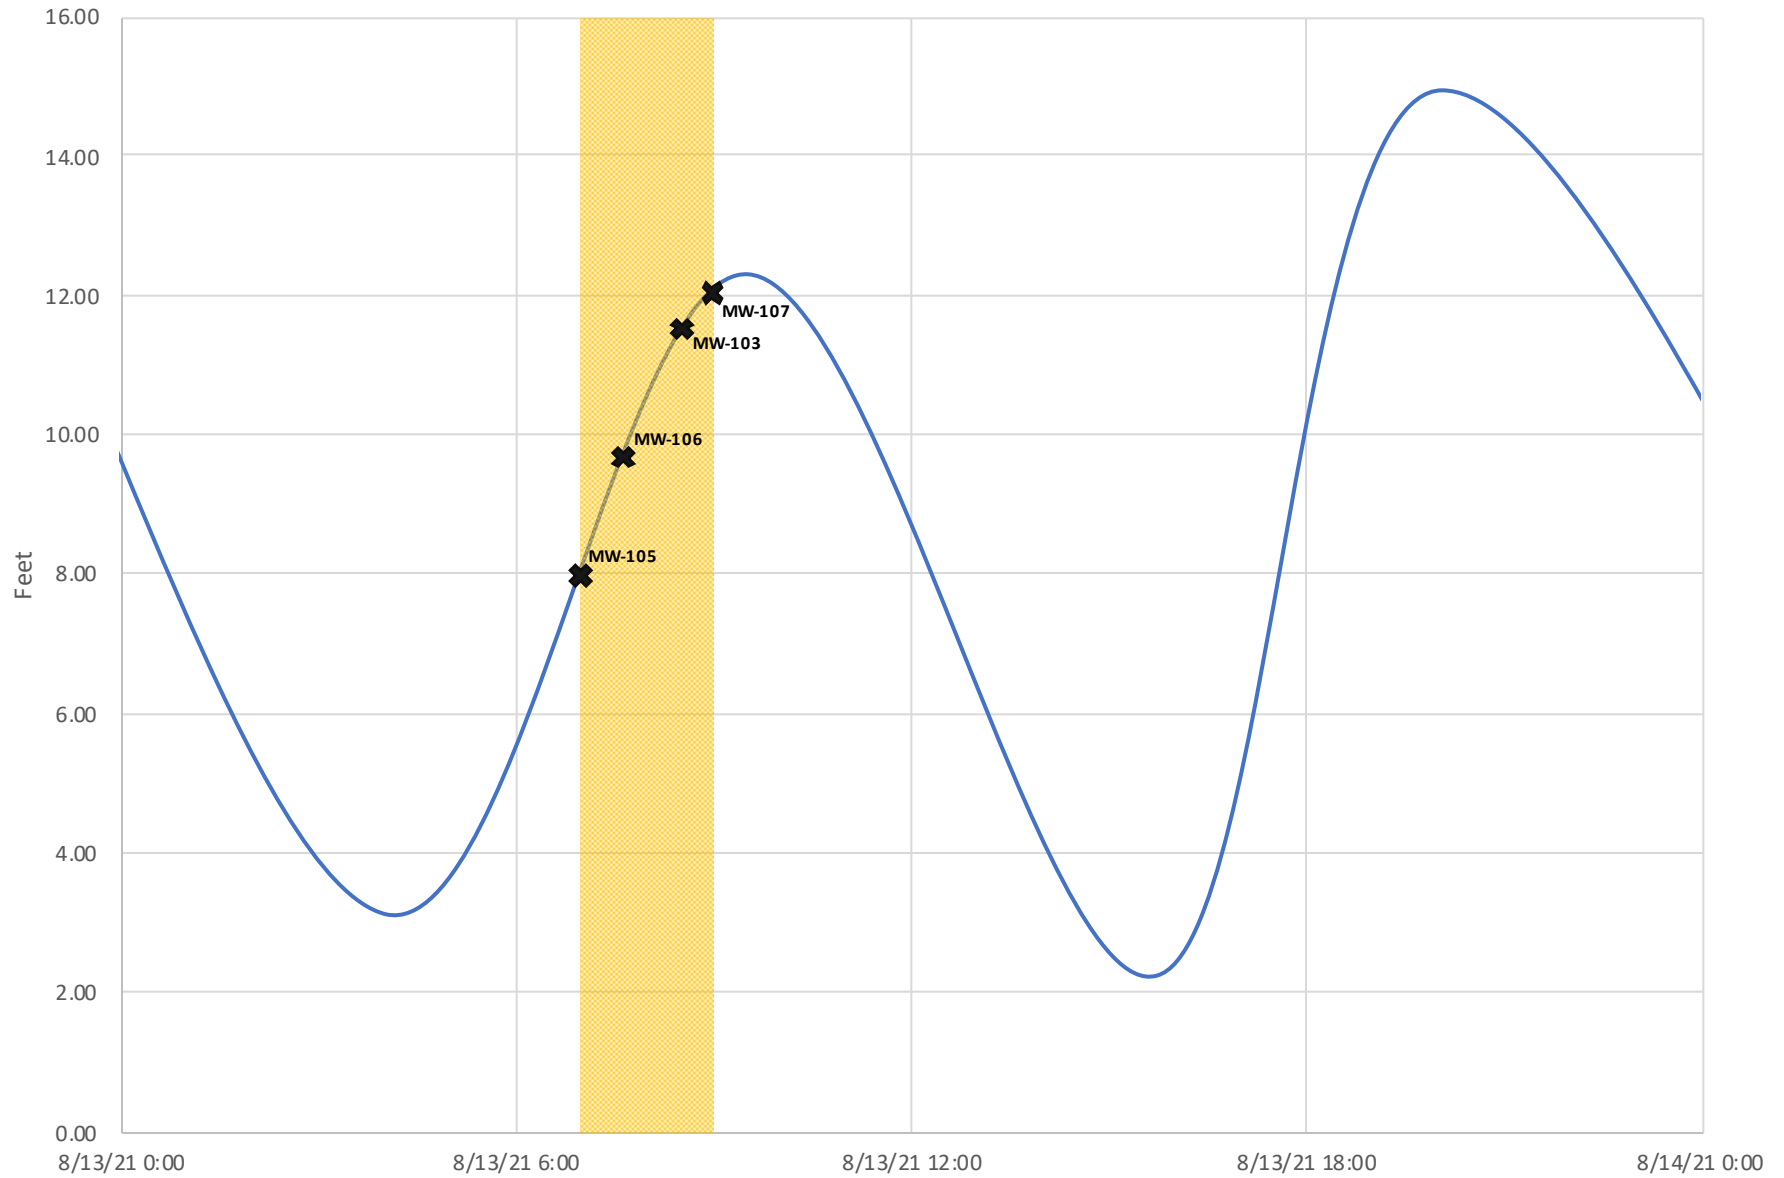
Chart 5: Groundwater Sampling Times Relative to Tidal Stage for 3Q21
(August 13, 2021)

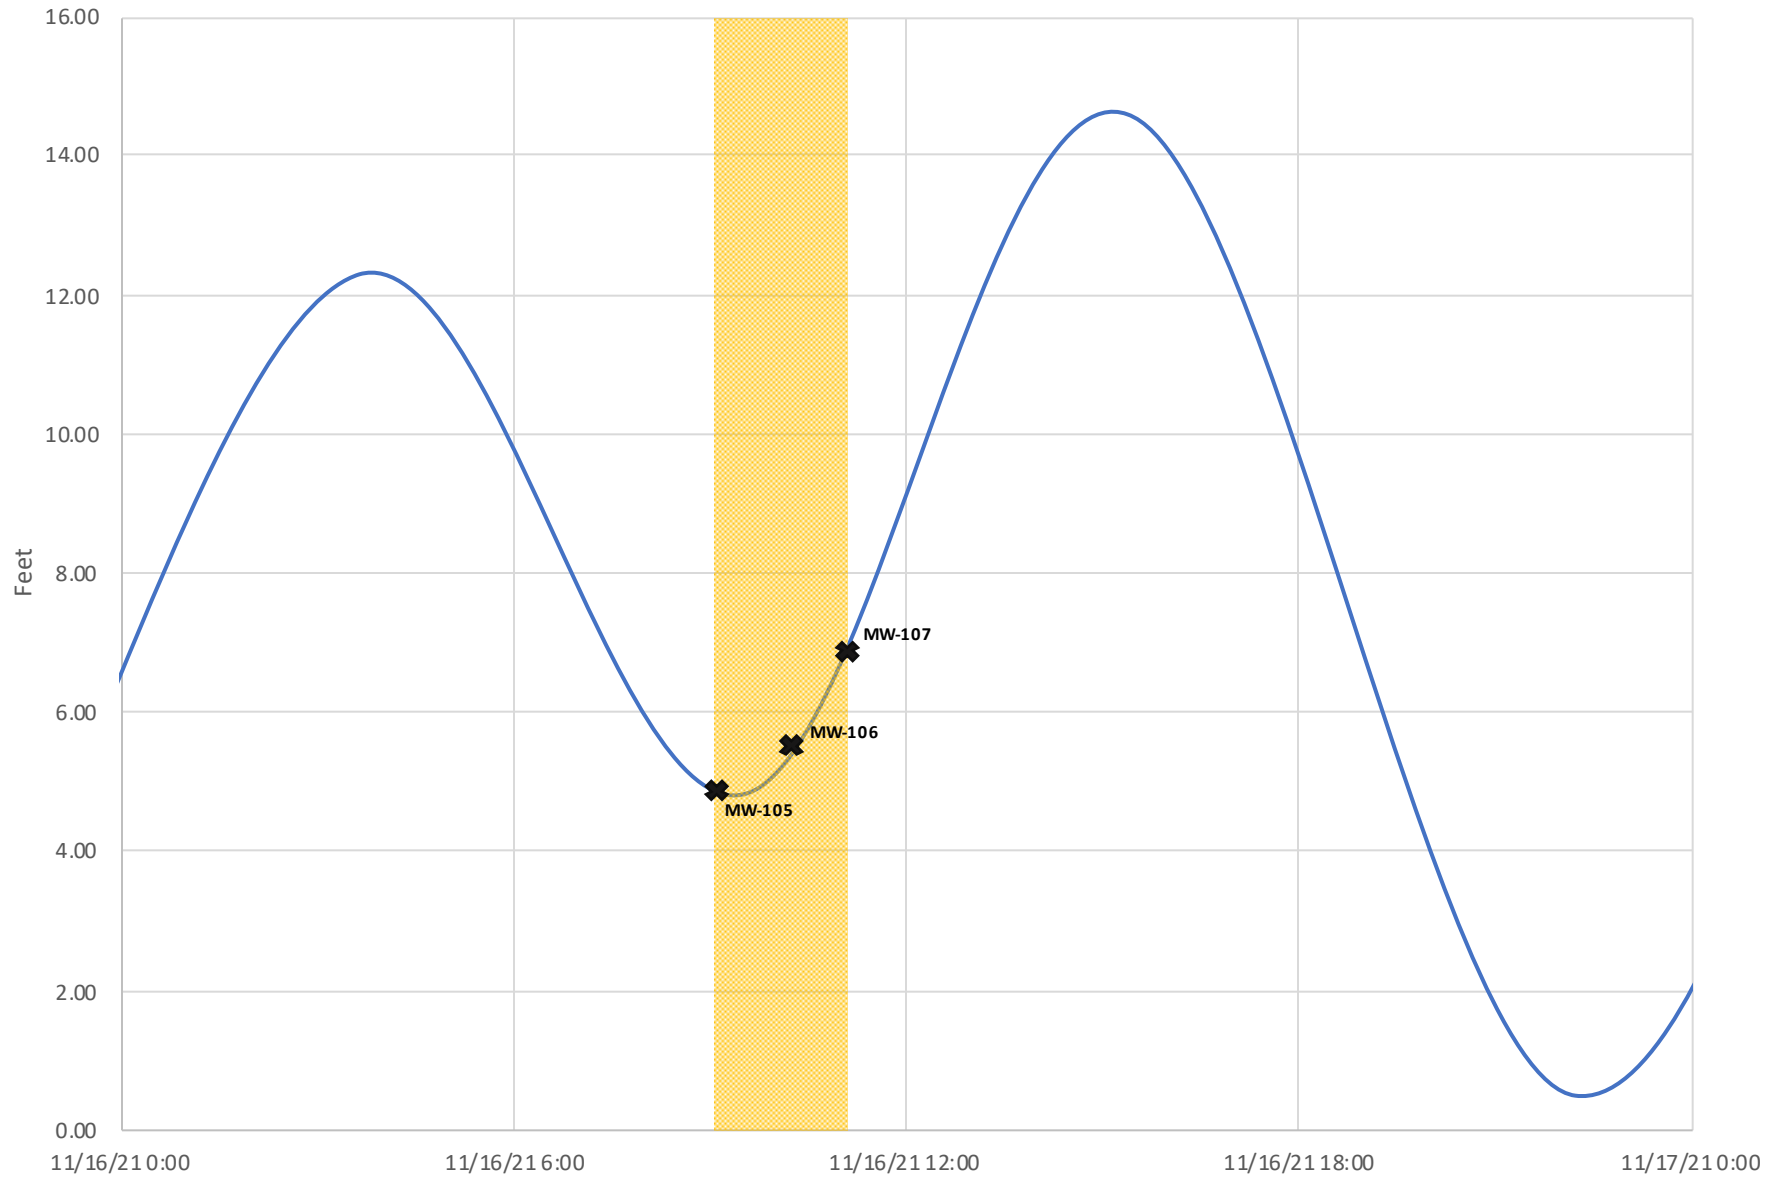
Chart 6: Groundwater Sampling Times Relative to Tidal Stage for 4Q21
(November 16, 2021)

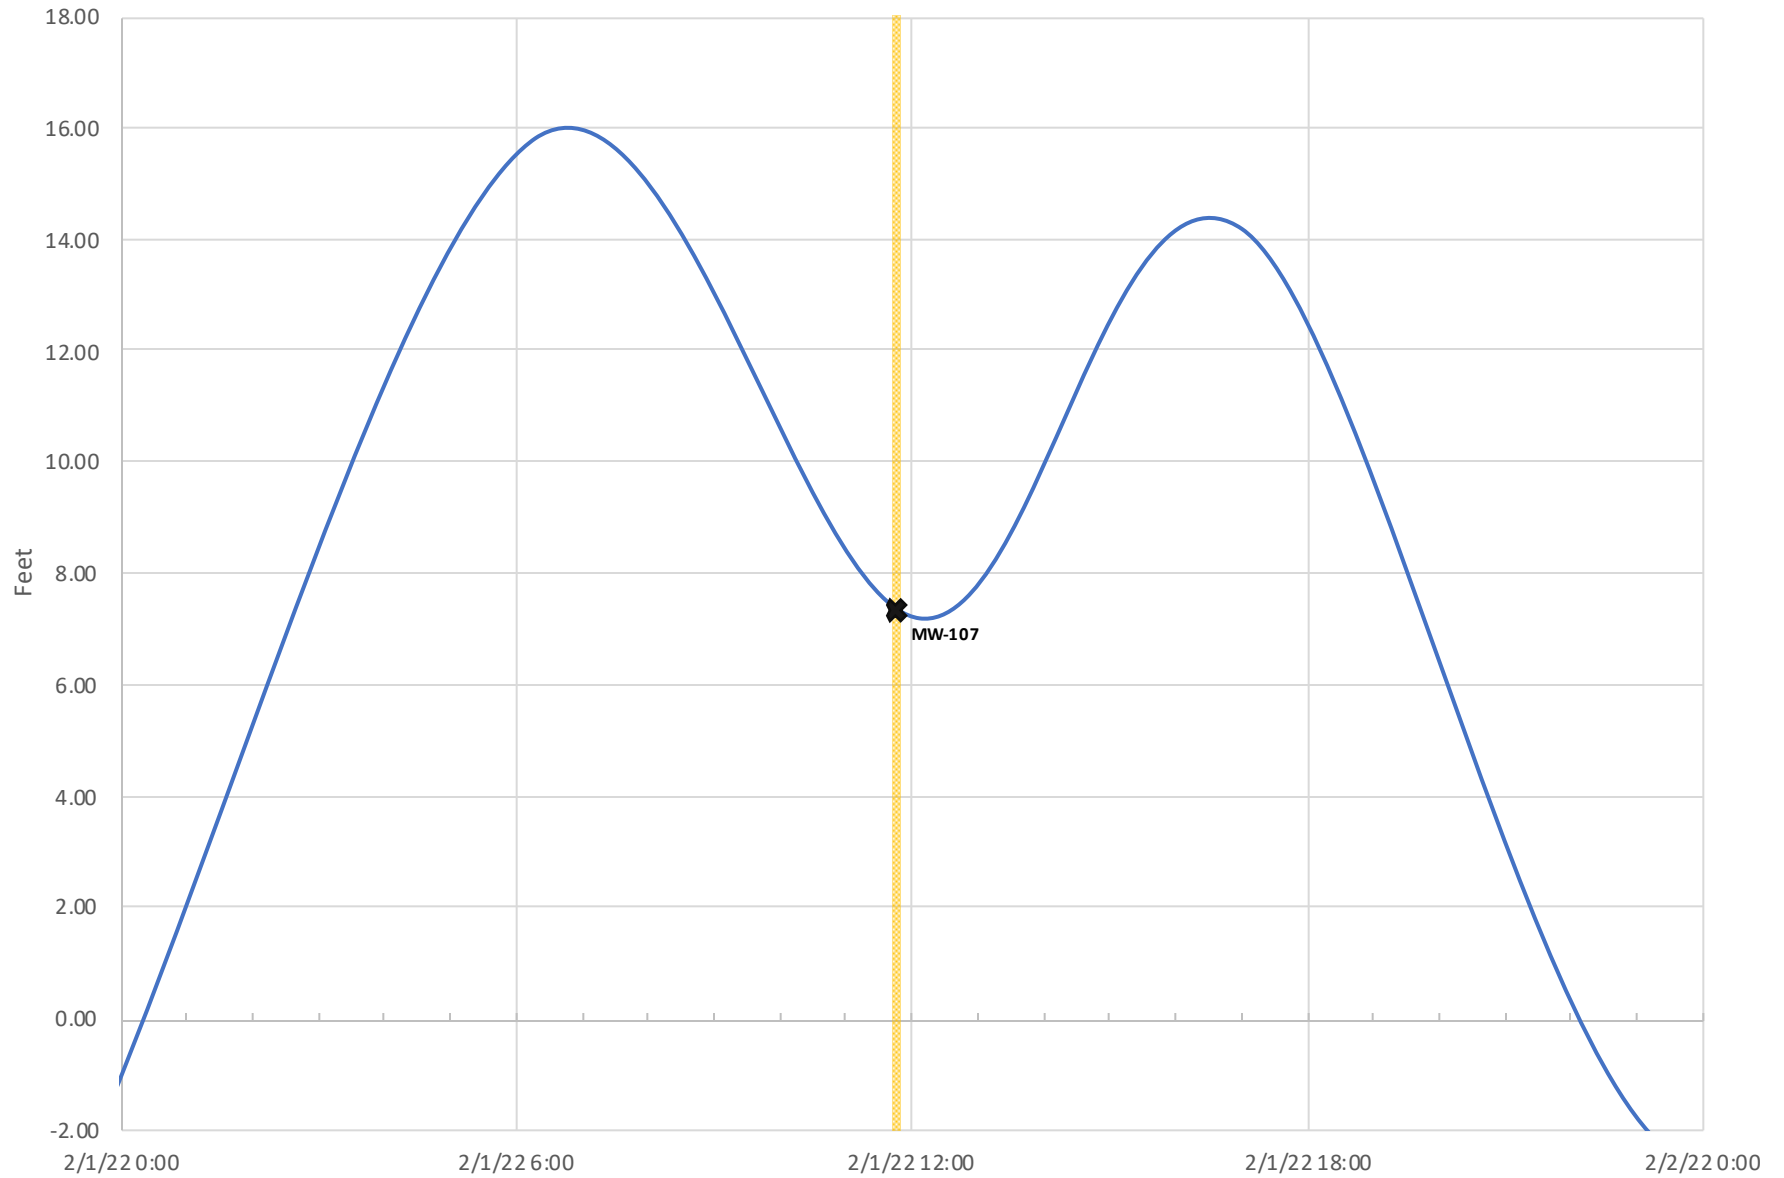
Chart 7: Groundwater Sampling Times Relative to Tidal Stage for 1Q22
(February 1, 2022)

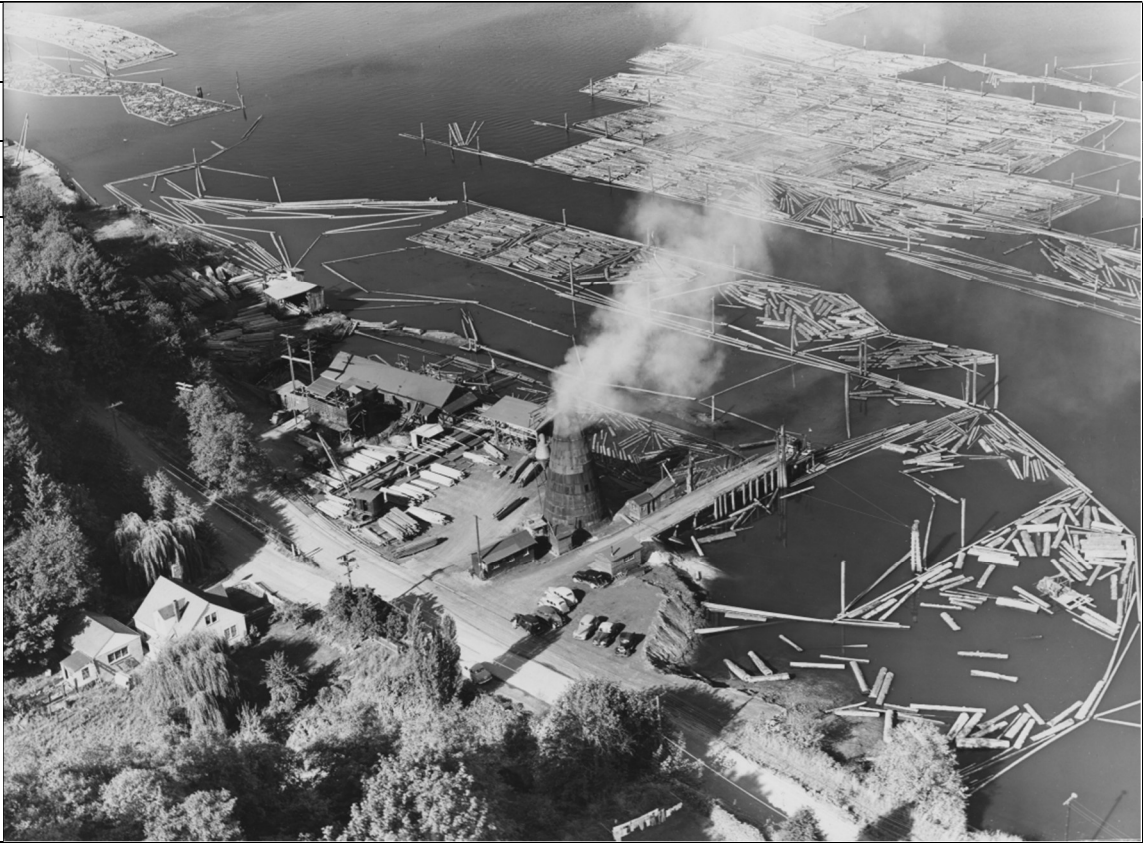
Description: Emissions from Delson Lumber HFB (center portion of photo). It is expected that this HFB burned salt-laden wood waste.

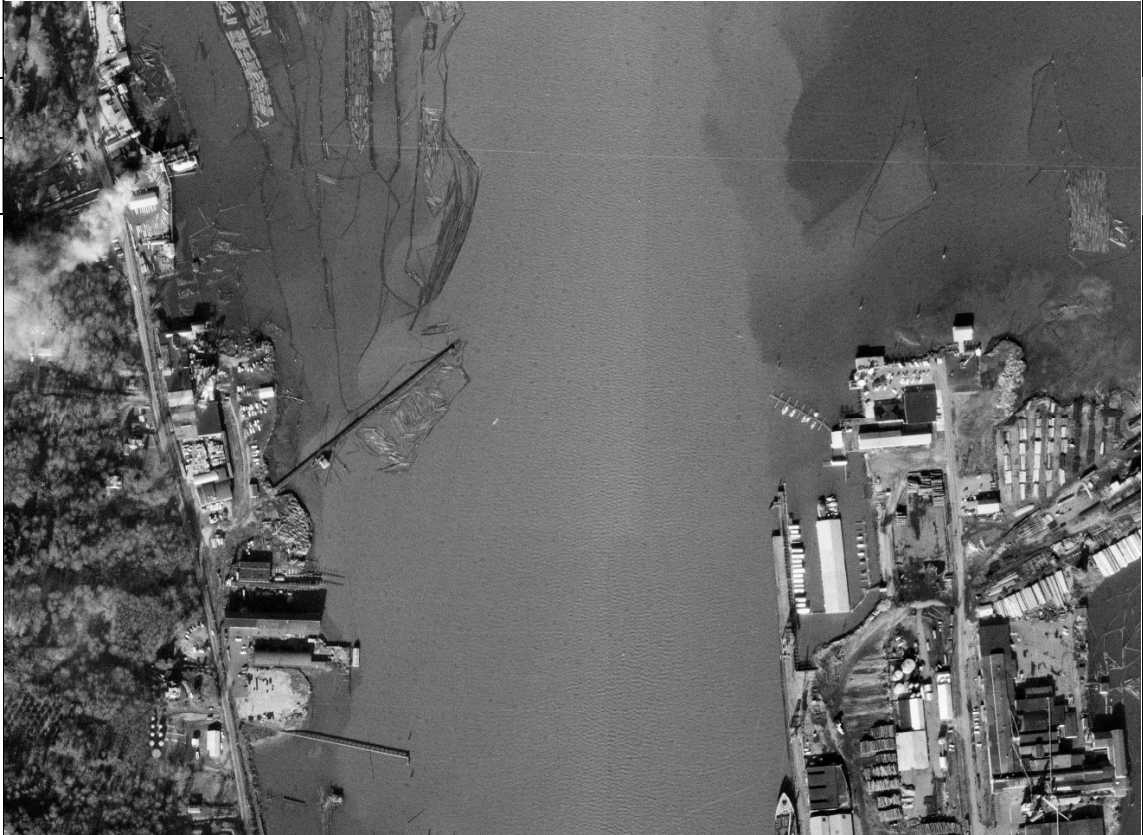
Photo No. 8: Delson Lumber HFB #2

Description: Emissions from Delson Lumber HFB (upper left portion of photo). Note the substantially larger quantity of Delson Lumber HFB emissions compared to emissions from the side-by-side Hardel smokestacks (center left portion of photo).

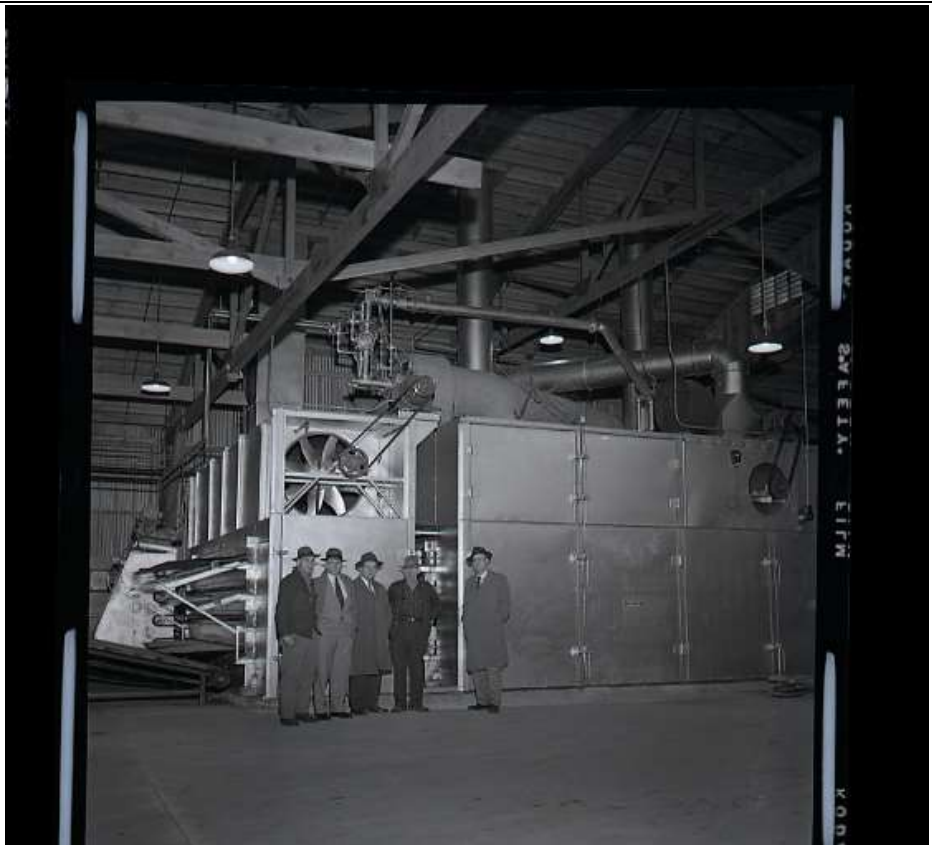
Photo No. 9: Butane-Fired Hardel Boiler

Description: Posing before the Hardel butane-fired boiler following installation. Note the side-by-side smokestacks extending through the roof of the boiler house (upper center portion of photo).

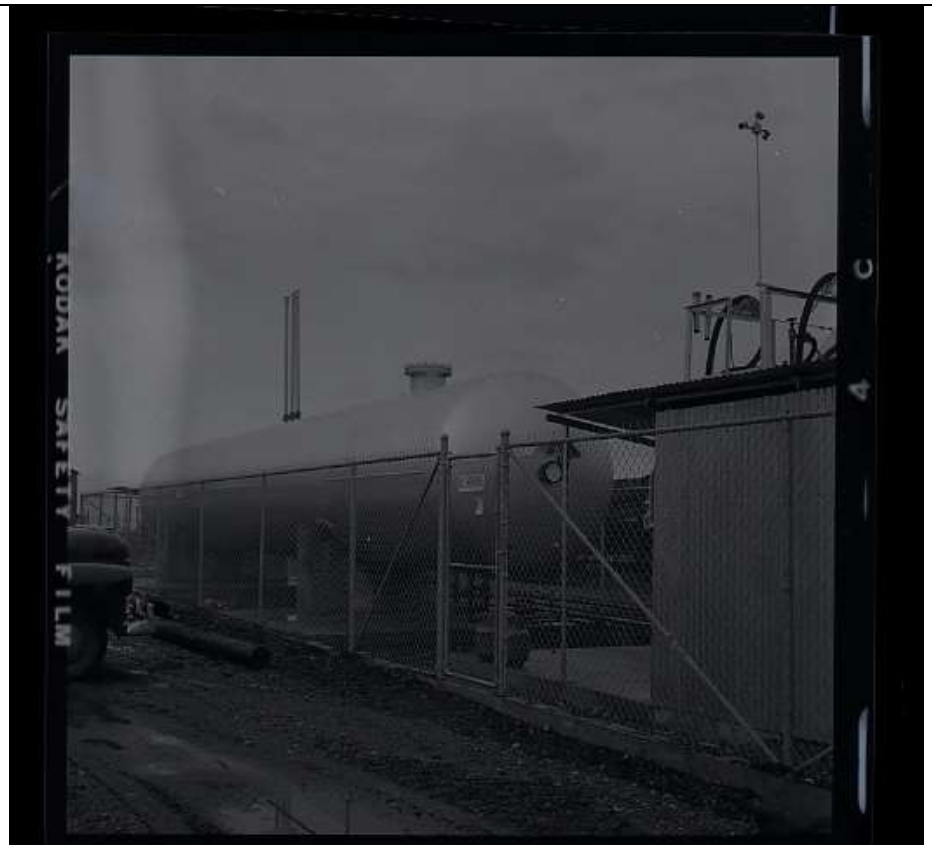
Photo No. 10: Butane Storage Tank

Description: Hardel butane storage tank following installation of butane-fired boiler.

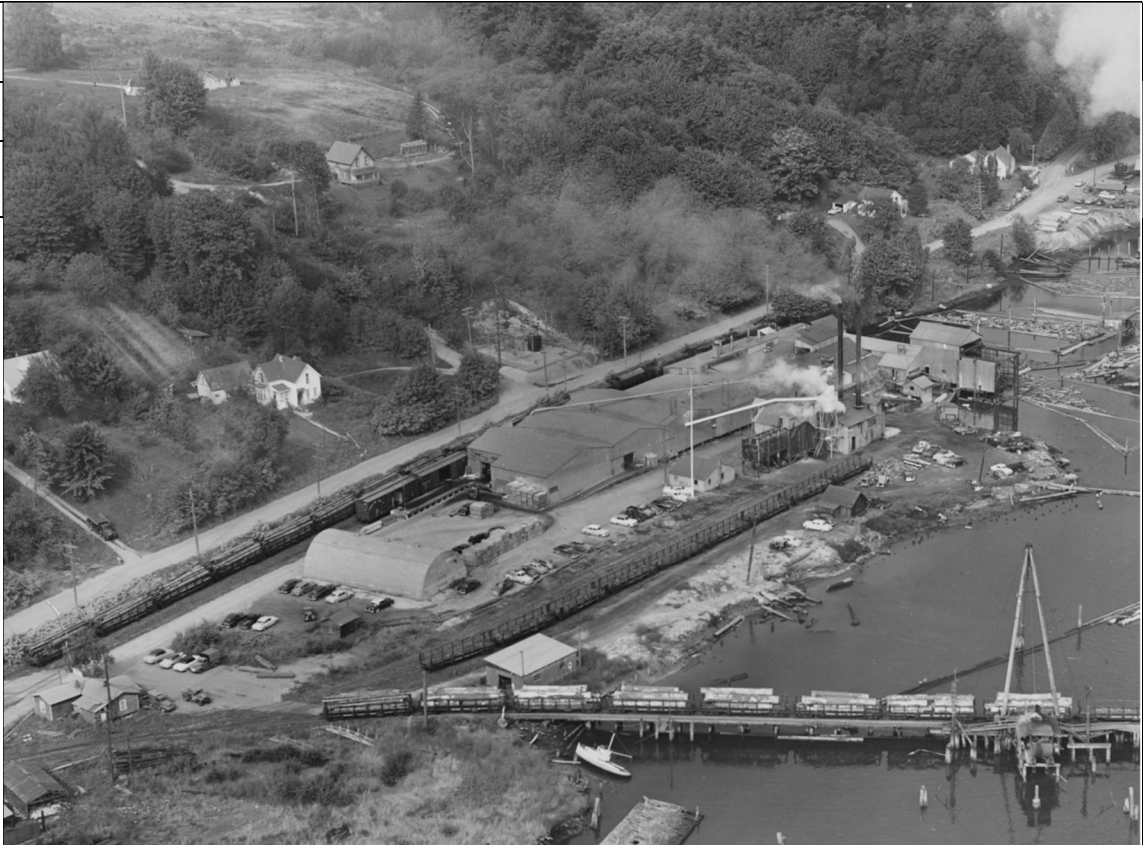
Photo No. 11: Early Hardel Operations

Description:
 Hardel Plant circa 1950. Note minimal emissions from side-by-side smokestacks (center right portion of photo), emissions form Delson Lumber HFB (upper right portion of photo), and logway (center right portion of photo).

¹ The possibility that some salt-laden wood waste might have been burned in the boiler is based solely on the presence of a logway on the northeastern end of Hardel operations (see Photos #6, #11, and #12 in Appendix A). This logway may have been installed for pre-1953 operations (before Hardel bought raw veneer from local manufacturers) or it may have been used for some ancillary non-manufacturing purpose. Based on a review of aerial photographs, the logway was removed when the current shoreline armoring was installed circa 1977-1980.
