Subject: Addressing Ecology's RI Data Gaps
Hardel Mutual Plywood Corporation Site
1210 West Bay Drive NW, Olympia, Washington
VCP ID SW1757, Formerly Agreed Order DE 4108, Cleanup Site ID No. 3704, Facility/Site ID No. 75128579

To: Joe Hunt, L.HG. (Ecology)
From: Troy Bussey Jr., P.E., L.G., L.HG. (PIONEER)
Cc: Brandon Smith (Milestone), Kim Seely (Coastline), Heather Burgess (Phillips Burgess)
Date: October 25, 2022
Subject: Responses to Nick Acklam's January 11, 2022 Verbal Comments on the August 2021 RI Data Gap Report
Hardel Mutual Plywood Corporation Site
1210 West Bay Drive NW, Olympia, Washington
VCP ID SW1757, Formerly Agreed Order DE 4108, Cleanup Site ID No. 3704, Facility/Site ID No. 75128579

Work Plan to Address Ecology's RI Data Gaps

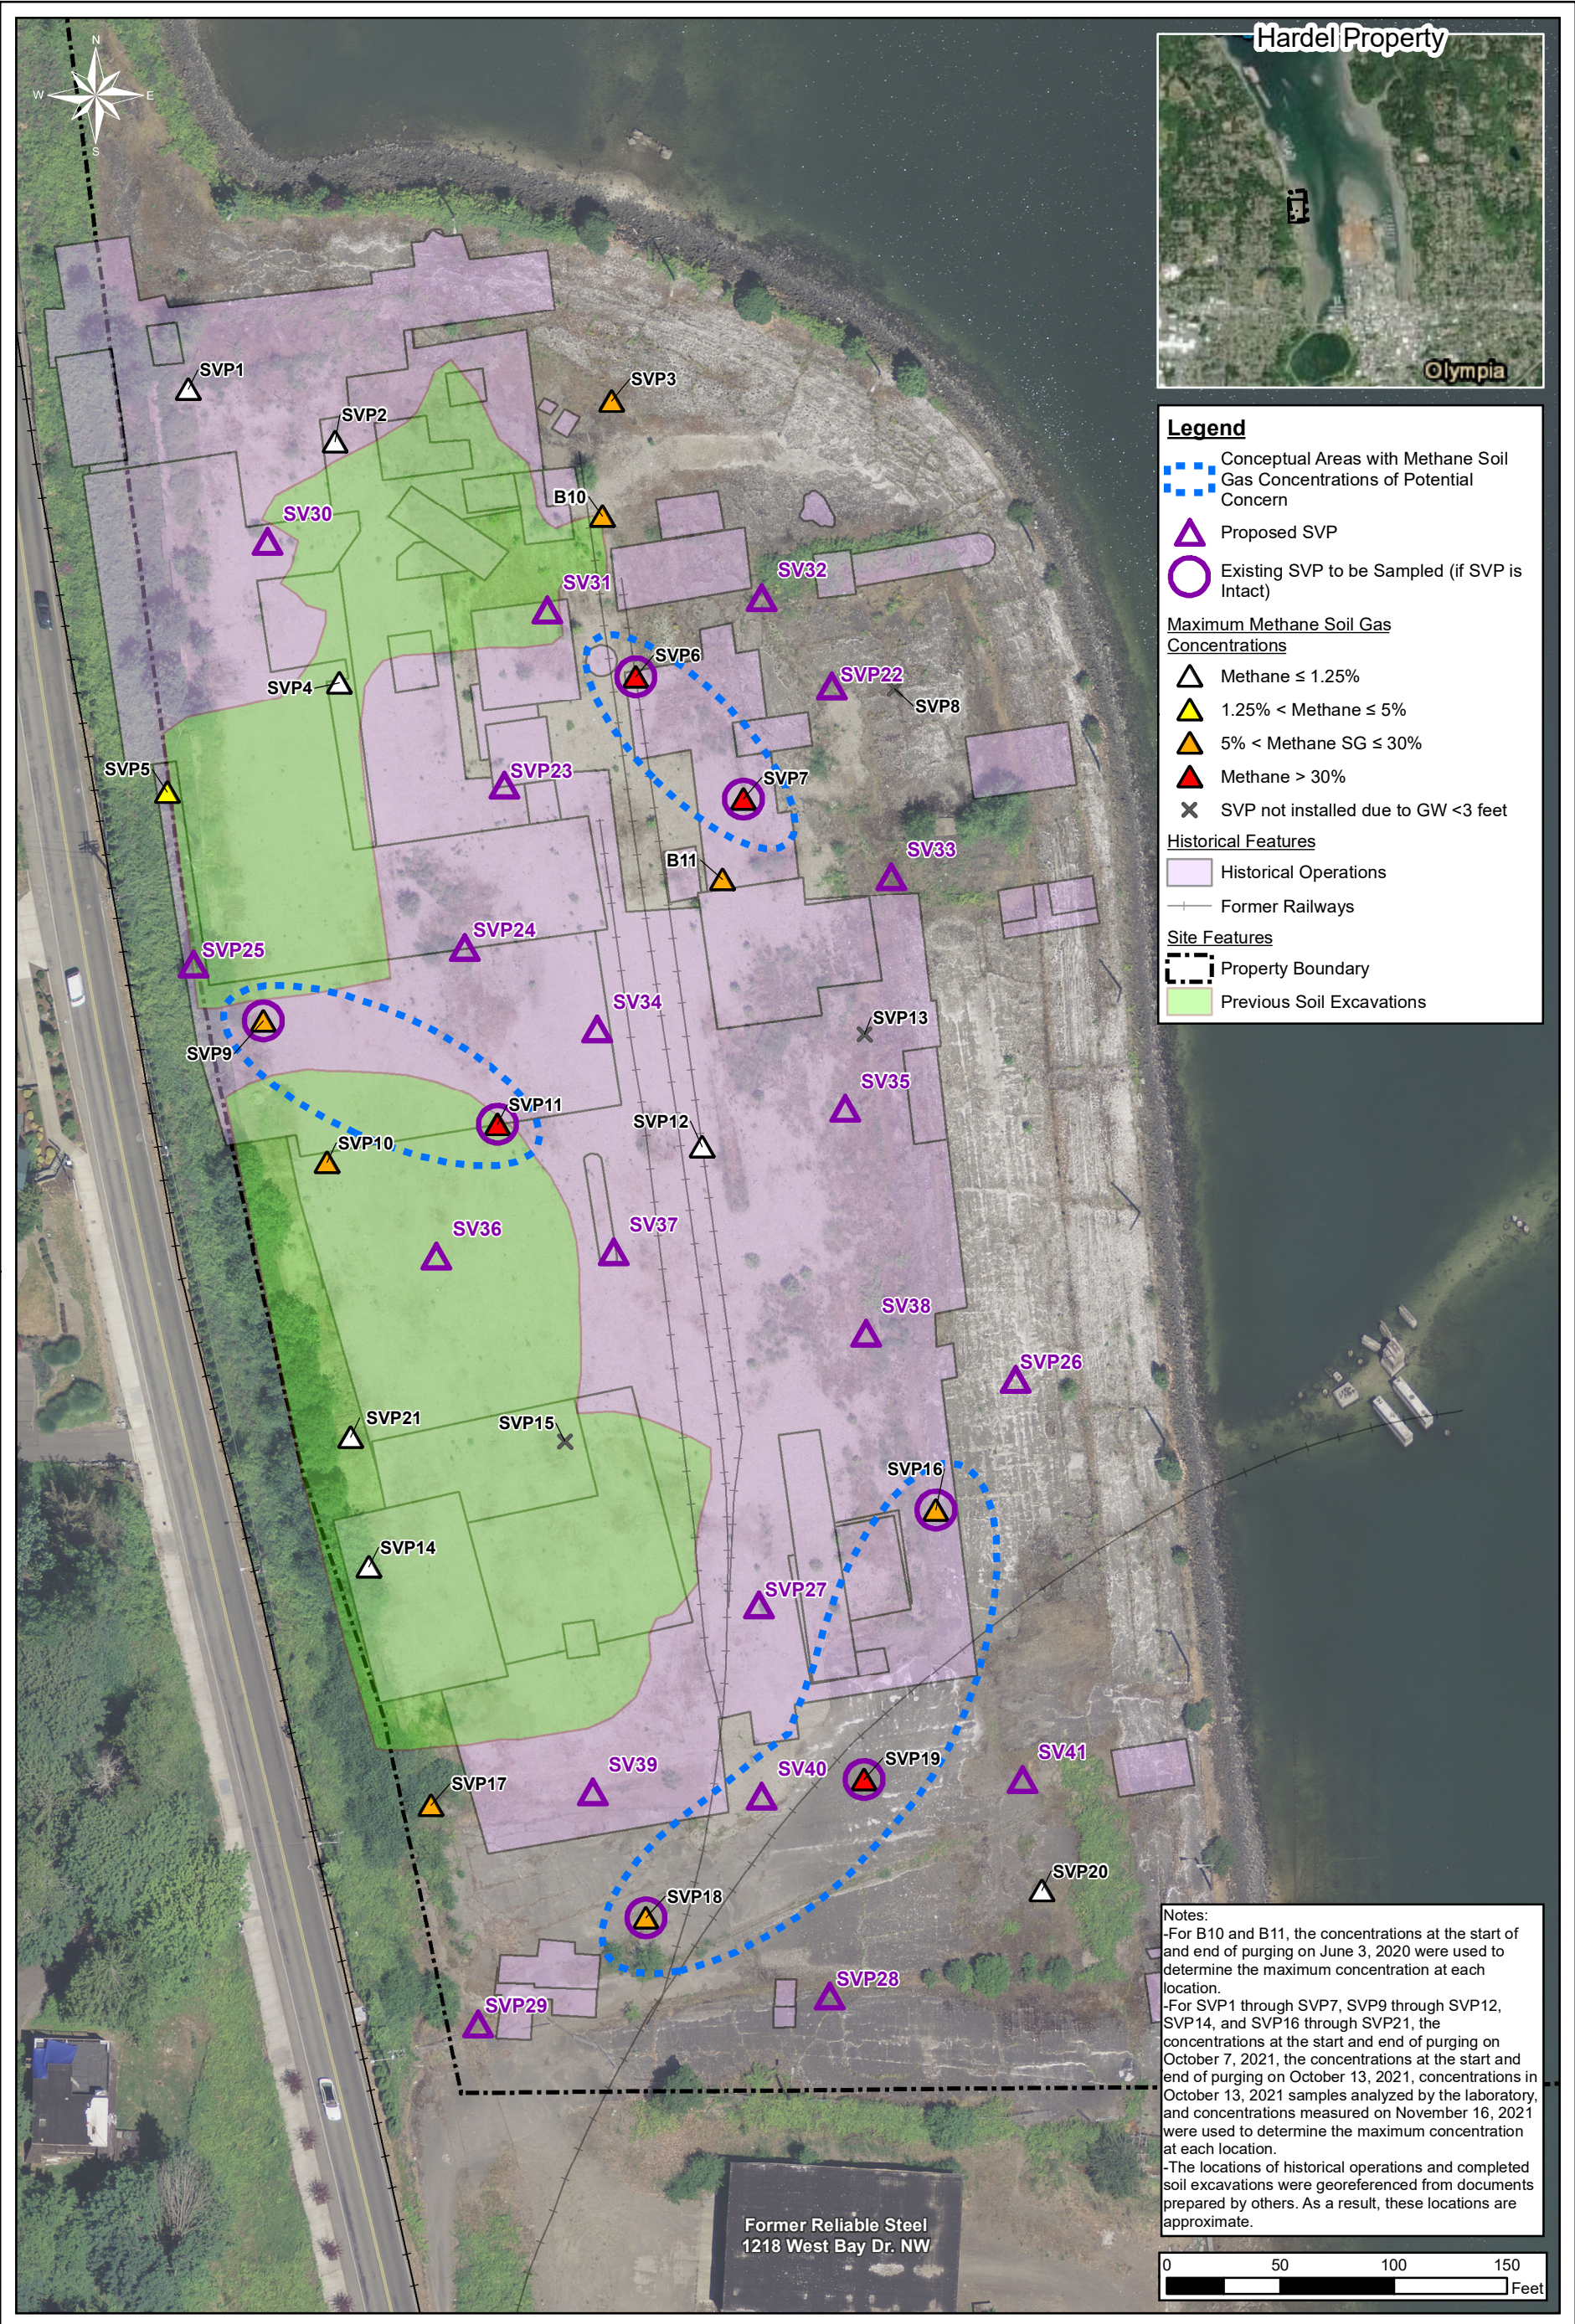
Proposed Sampling Locations for Data Gap #3
Work Plan to Address Ecology's RI Data Gaps
Hardel Mutual Plywood Corporation Site

During the 2020 Phase II ESA, PIONEER installed and sampled two soil vapor probes (SVPs; B10 and B11) (see Figure 4). Methane soil gas concentrations (i.e., less than 30%) and pressure differentials (i.e., less than 500 pascals) in these two SVPs indicated that no further action was necessary regarding a potential methane hazard in accordance with ASTM International Designation E2993-16 (Standard Guide for Evaluating Potential Methane Hazards as a Result of Methane in the Vadose Zone). However, additional methane investigation activities were conducted because of the amount of subsurface wood debris at

Although methane soil gas concentrations at seven locations either exceeded 30% or have the potential to exceed 30% in the future (i.e., SVP6, SVP7, SVP9, SVP11, SVP16, SVP18, and SVP19 - collectively referred to as conceptual areas with methane soil gas concentrations of potential concern in Figure 4 of this Work Plan), the potential for subsurface methane to cause an indoor air hazard at this Site is low for several key reasons. First, there are no current buildings on the Site. Second, the proposed development includes the addition of clean soil fill material, which will raise the ground surface of the upland area from the current elevations of 13 to 16 feet North American Vertical Datum of 1988 (NAVD88) to a final elevation of 17 feet NAVD88 (PIONEER 2021b). For instance, approximately two feet of clean fill will be added during the planned development in the vicinity of the four SVPs with maximum methane soil gas concentrations exceeding 30% (PIONEER 2021b). This added soil will provide additional attenuation of methane between subsurface soil gas and indoor air. Third, the only indoor air space in the proposed development below an elevation of 26 feet NAVD88 will be a large subsurface parking garage underneath the buildings. In other words, there is a limited indoor air space for potential methane transport. Finally, in accordance with building, mechanical, and fire code requirements, the subsurface parking garage will have a mechanical ventilation system that satisfies code-required air exchange
