September 22, 2022
Project No. M0615.17.002

Re: Groundwater Monitoring Report
Former Cascade Timber No. 3 Log Sort Yard Site
Consent Decree No. 94-2-03590-3
Facility Site ID: 1206
Monitoring Date: August 21, 2022

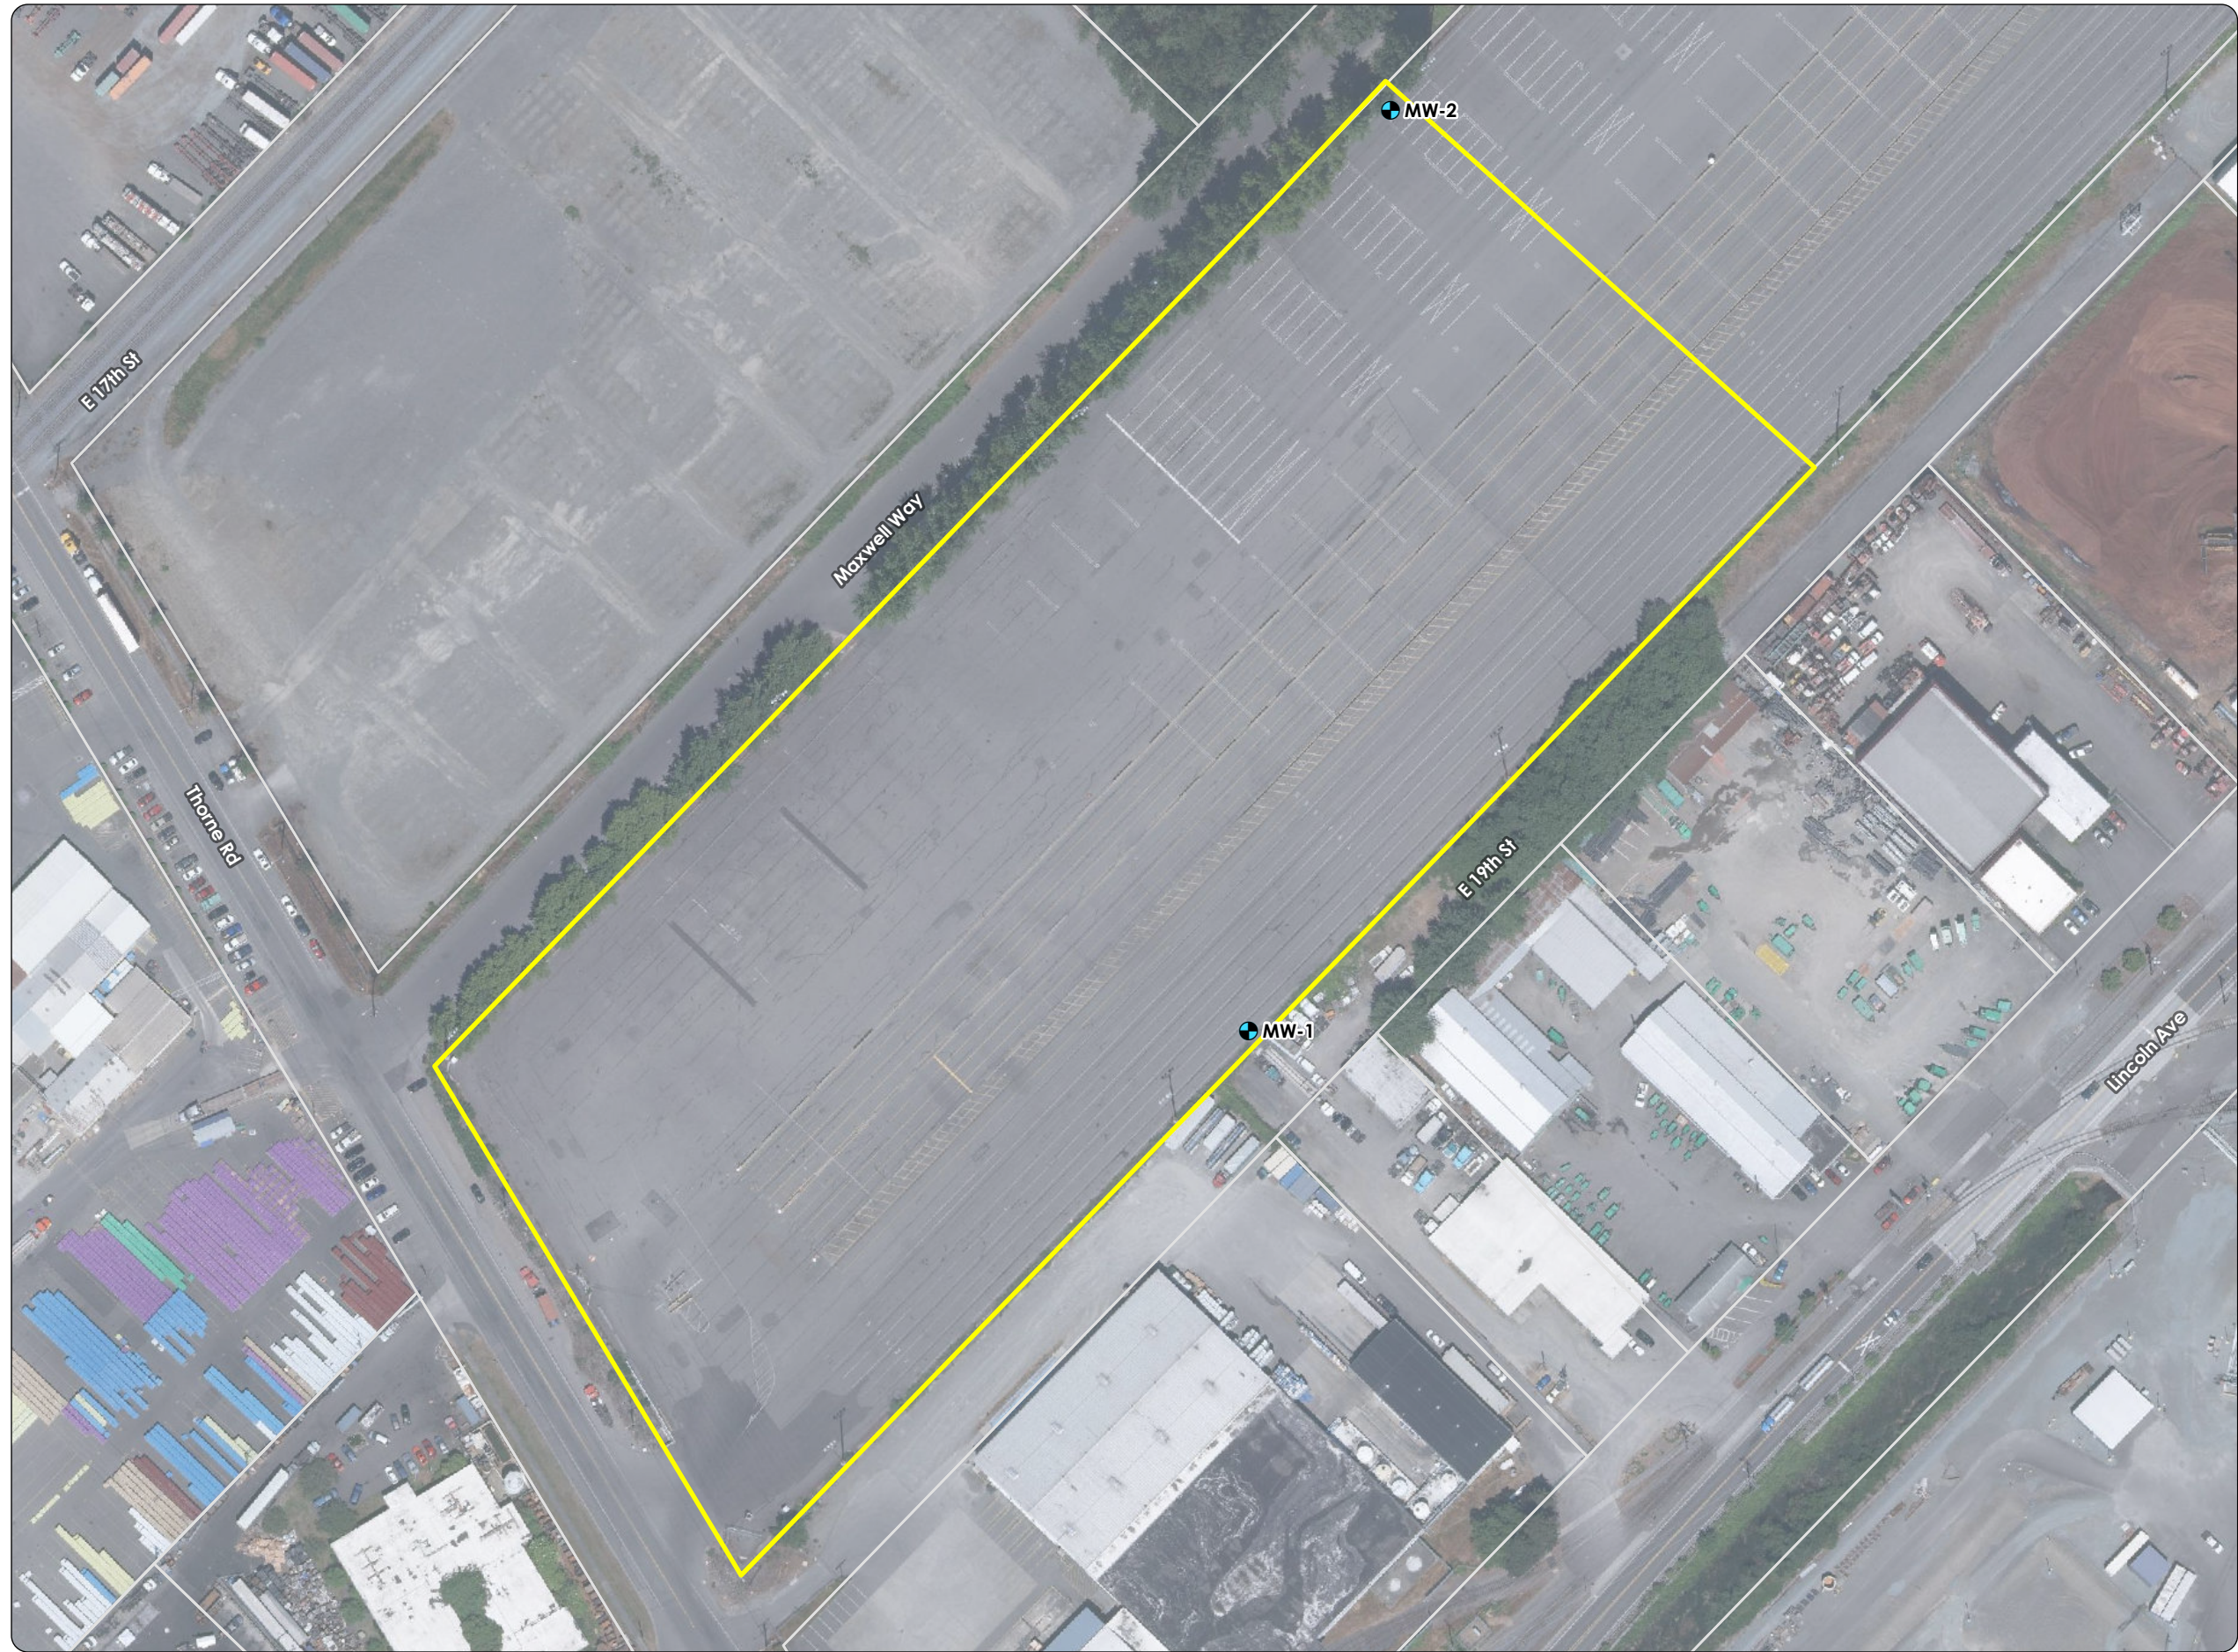
Figure 2 Site Features

Groundwater monitoring has been conducted at monitoring wells MW-1 and MW-2 since 1994 to monitor groundwater quality on the Site (Figure 2). Groundwater monitoring is conducted every 18 months consistent with a 2011 memorandum of understanding between Ecology and the Port (Ecology 2011).
