Re: Quarterly Groundwater Monitoring and Remedial Operations Report – September 2022, Former Provisioner’s Express, Inc. Facility, 2102 West Valley Highway North, Auburn, Washington, Ecology Facility ID 91612121, Cleanup Site ID 6847, VCP Project No. 3206

SITE MAP
 QUARTERLY GROUNDWATER MONITORING REPORT - SEPTEMBER 2022
 FORMER PROVISIONERS EXPRESS FACILITY
 2102 WEST VALLEY HIGHWAY NORTH, AUBURN, WASHINGTON

GROUNDWATER CONTOUR - SEPTEMBER 14, 2022
 QUARTERLY GROUNDWATER MONITORING REPORT - SEPTEMBER 2022
 FORMER PROVISIONERS EXPRESS FACILITY
 2102 WEST VALLEY HIGHWAY NORTH, AUBURN, WASHINGTON

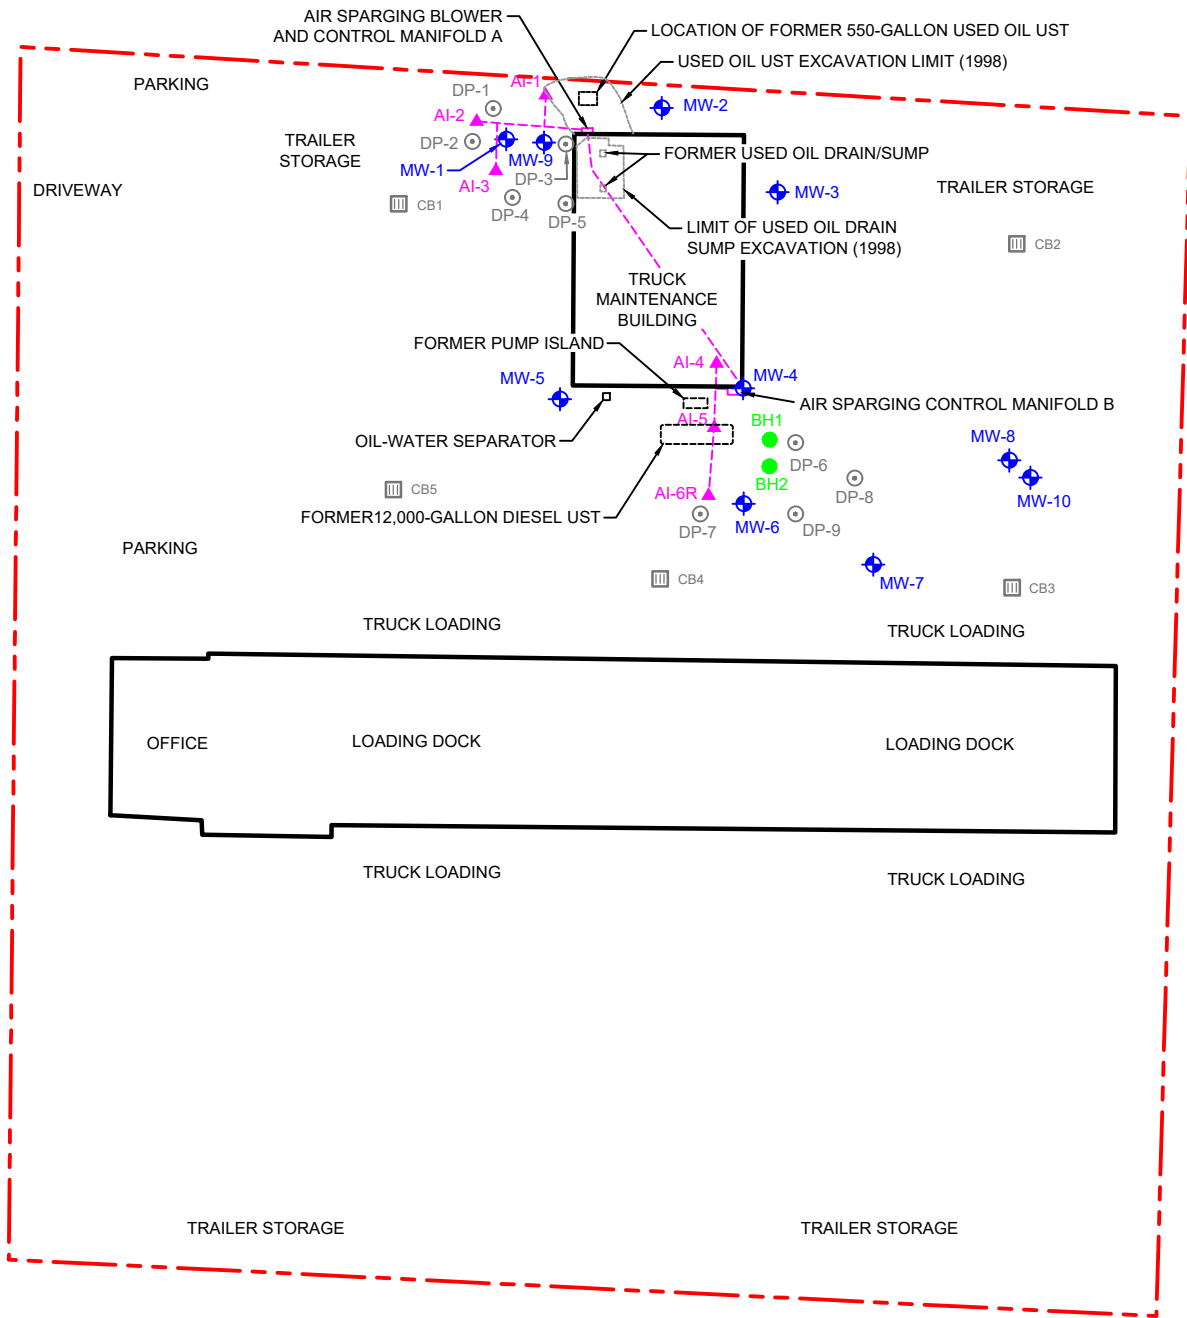
SCALE: AS SHOWN	DATE: 9/30/22	FIGURE NO. 2
APPROVED BY: DJL	DRAWN BY: SRM	PROJECT NO. 2004-0003

On November 28, 2012, a 12,000-gallon diesel fuel UST was decommissioned by removal south of the truck maintenance building (Figure 2). According to available information, the UST was emptied and removed from service in 1998 when the 550-gallon waste oil UST was decommissioned and had not been operated between 1998 and 2012. EPI personnel oversaw the UST decommissioning activities and collected nine (9) soil samples and a water sample from the excavation. The diesel contaminated water was reported in the water from the excavation and was reportedly rinseate from the UST that was spilled as the UST was removed from the excavation due to improper rigging and hoisting. EPI prepared the *Underground Storage Tank Site Assessment Report* (EPI, 2013a), dated January 4, 2013, for submittal to Ecology's Underground Storage Tank Division.

On August 26, 2016, EPI directed the advancement of two soil borings, designated BH-1 and BH-2 for soil sample collection, and construction of two conditional point of compliance (POC) monitoring wells, designated MW-7 and MW-8. BH-1 and BH-2 were advanced east of the former 12,000-gallon diesel UST to evaluate subsurface conditions immediately downgradient of the former UST. Well MW-7 was installed southeast and downgradient of the former 12,000-gallon diesel UST and existing well MW-6. Well MW-8 was installed northeast of MW-7, also downgradient of the former 12,000-gallon diesel UST and existing well MW-6. The purpose of the POC monitoring wells was to monitor groundwater conditions downgradient of the former 12,000-gallon diesel UST (EPI, 2017a). The soil boring and monitoring wells locations are presented on Figure 2.

On August 11, 2017, monitoring well MW-9 was installed by Holt Services near the northwest corner of the truck maintenance building (Figure 2). The additional well was requested by CRT as part of their environmental due diligence prior to their purchase of the property. Historical direct-push sampling data from this location indicated TPH-d and TPH-o was above MTCA Method A in a groundwater sample collected from the boring (EPI, 2017b).

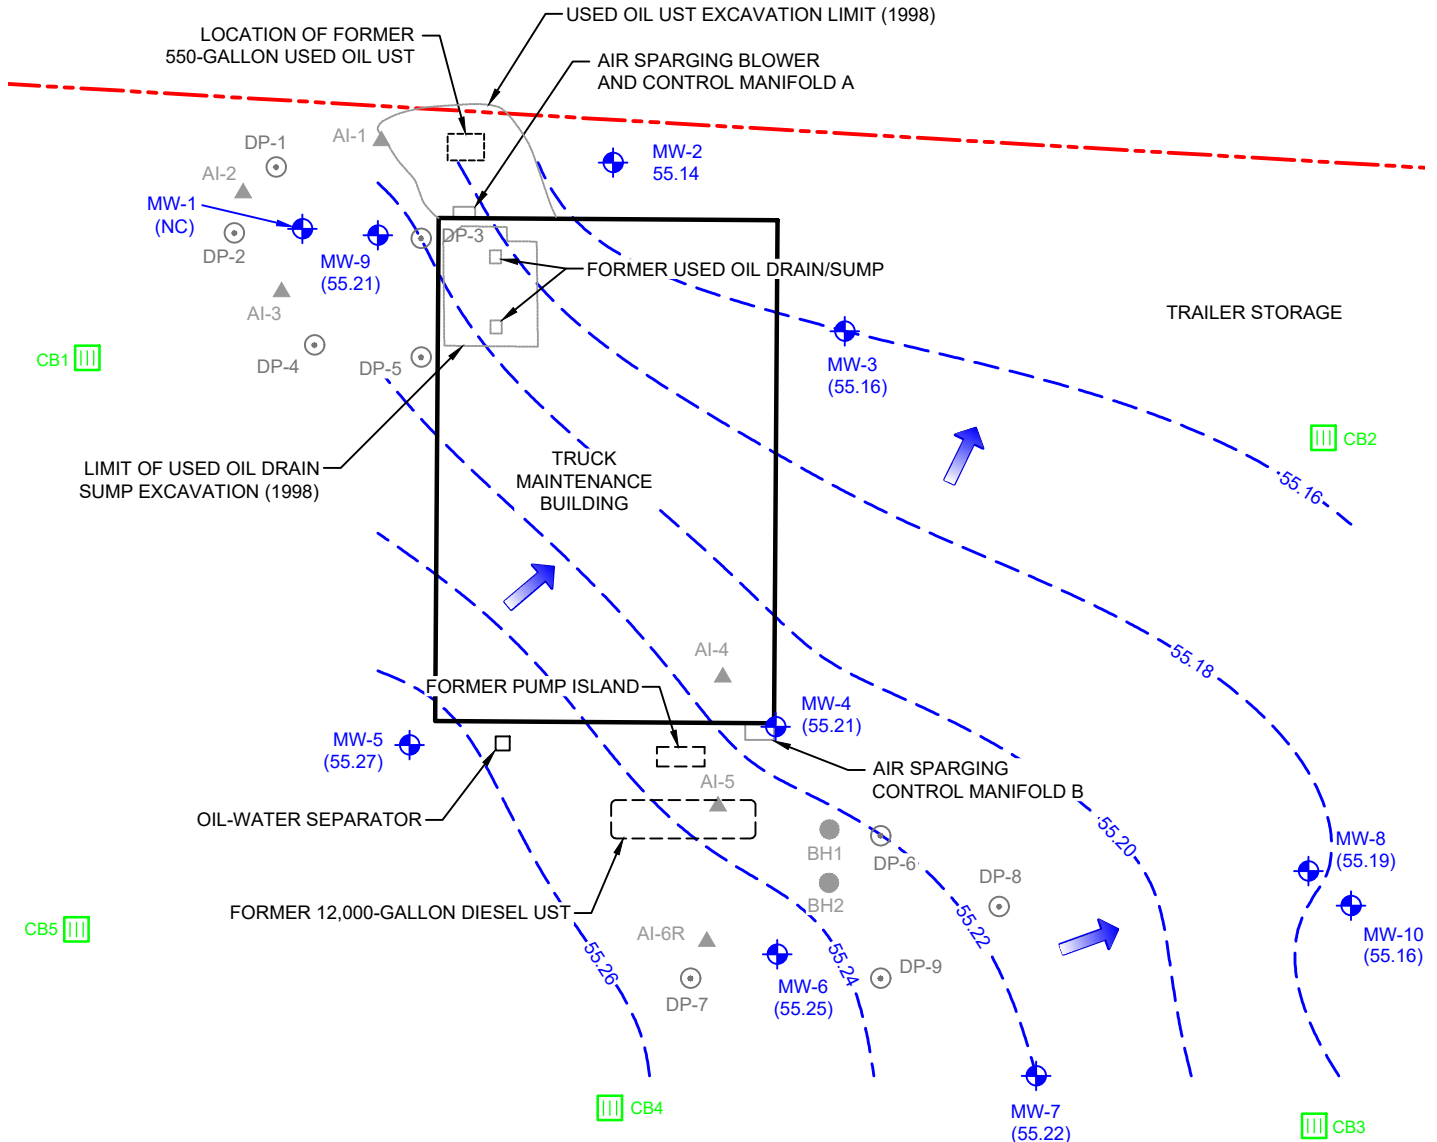
SCALE: AS SHOWN	DATE: 9/30/22	FIGURE NO. 3
APPROVED BY: DJL	DRAWN BY: SRM	PROJECT NO. 2004-0003

Based on the depth-to-water measurements collected on September 14, 2022, from the nine (9) monitoring wells, a groundwater elevation contour map was generated for the Site (Figure 3) using field measurements and data from well surveys completed on September 19, 2017 (MW-1 through MW-9) and February 5, 2019 (MW-10). Groundwater elevation data indicated a predominantly east-northeast groundwater flow direction, consistent with prior monitoring events. The horizontal groundwater gradient was relatively flat during the September 14, 2022 groundwater monitoring event.

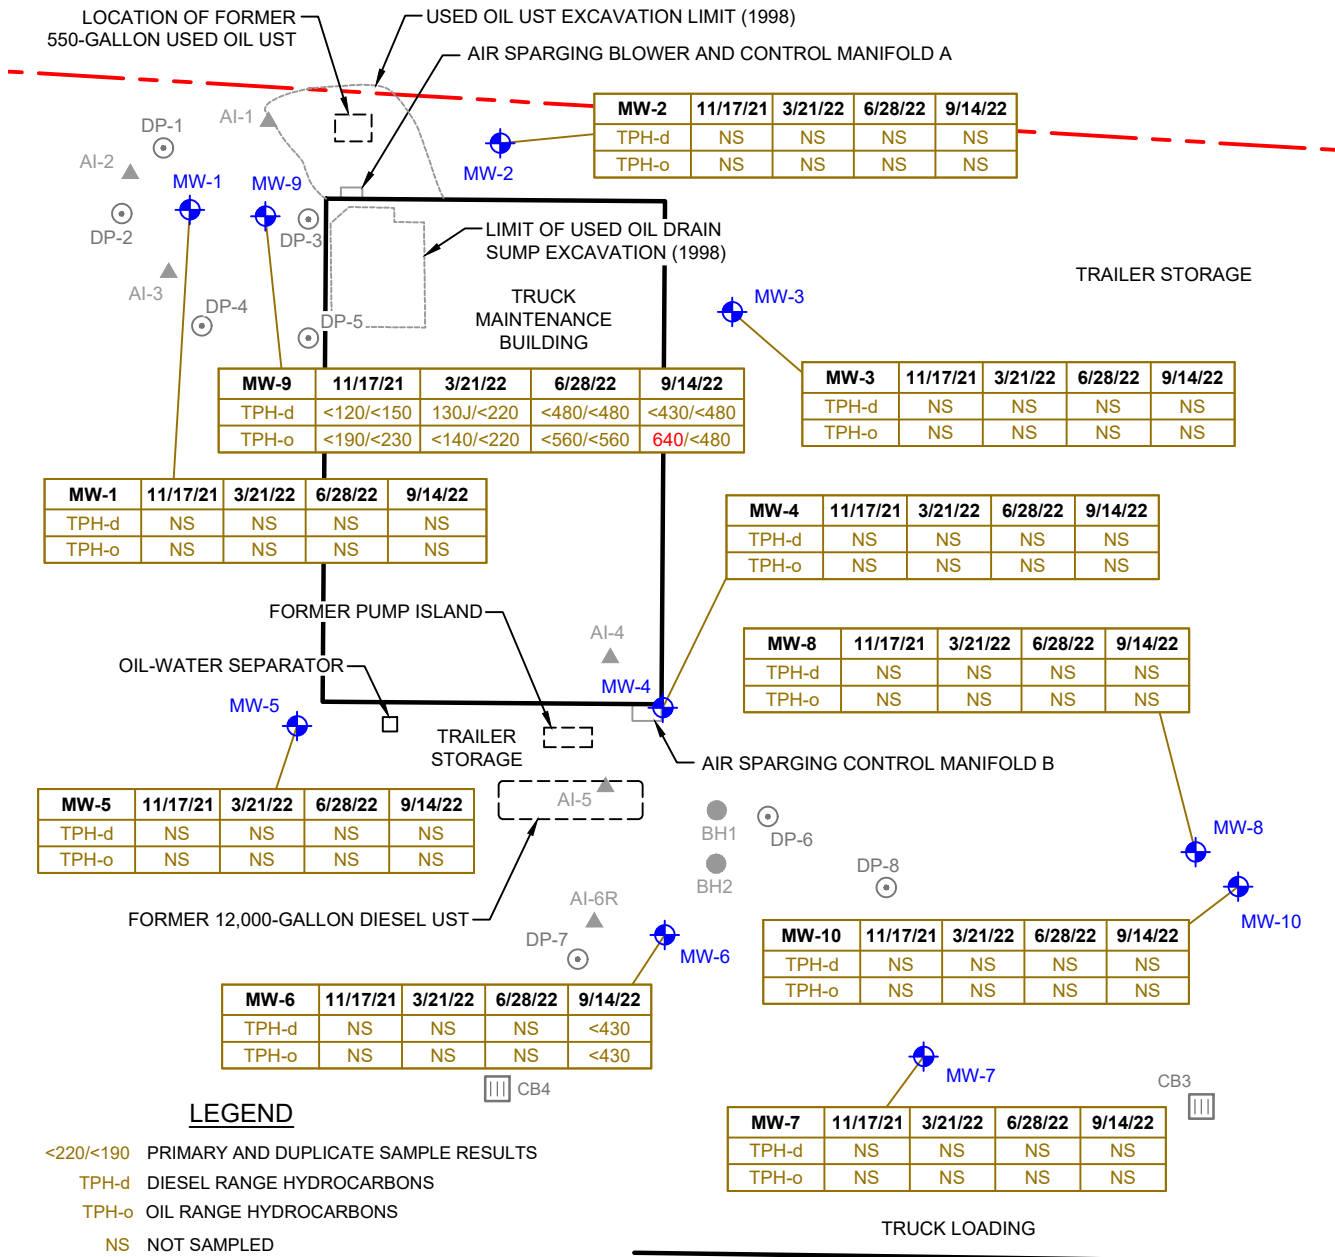
A summary of the laboratory analytical results for the samples collected on September 14, 2022, from monitoring wells MW-6 and MW-9 are provided in Table 2 along with Ecology MTCA Method A CULs for comparison. TPH-d and TPH-o analytical results are also presented on Figure 4. A copy of the laboratory analytical report is provided as Attachment B.

- TPH-d was not reported at, or above, the laboratory method reporting limit (MRL) in the sample collected from MW-6 and the primary and duplicate groundwater sample collected from monitoring well MW-9.

- TPH-o was reported above the laboratory MRL in the primary groundwater sample collected from monitoring well MW-9 at a concentration of 640 micrograms per liter ($\mu\text{g/L}$), above MTCA Method A CUL of 500 $\mu\text{g/L}$. TPH-o was not reported at, or above, the MRL in the sample collected from MW-6 and the duplicate sample collected from MW-9.

- Total TPH was reported above the laboratory MRL in the primary groundwater sample collected from monitoring well MW-9 at a concentration of 640 $\mu\text{g/L}$, above MTCA Method A CUL of 500 $\mu\text{g/L}$. Total TPH was not reported at, or above, the MRL in the sample collected from MW-6 and the duplicate sample collected from MW-9.

- <220/<190 PRIMARY AND DUPLICATE SAMPLE RESULTS
 - TPH-d DIESEL RANGE HYDROCARBONS
 - TPH-o OIL RANGE HYDROCARBONS
 - NS NOT SAMPLED
 - < NOT REPORTED AT OR ABOVE LABORATORY METHOD REPORTING LIMITS
 - RED** VALUE EXCEEDS MTCA METHOD A CLEANUP LEVEL
 - ▲ AIR SPARGING WELL
 - ◆ MONITORING WELL
 - HOLLOW STEM AUGER BORING
 - ⊙ DIRECT-PUSH BORING (OCTOBER 2013)
 - ▤ CATCH BASIN
 - UST UNDERGROUND STORAGE TANK
 - APPROXIMATE SITE PROPERTY BOUNDARY
 - J ESTIMATED CONCENTRATION, BELOW METHOD REPORTING LIMIT, ABOVE METHOD DETECTION LIMIT
- ALL ANALYTICAL RESULTS ARE IN MICROGRAMS PER LITER (µg/L)

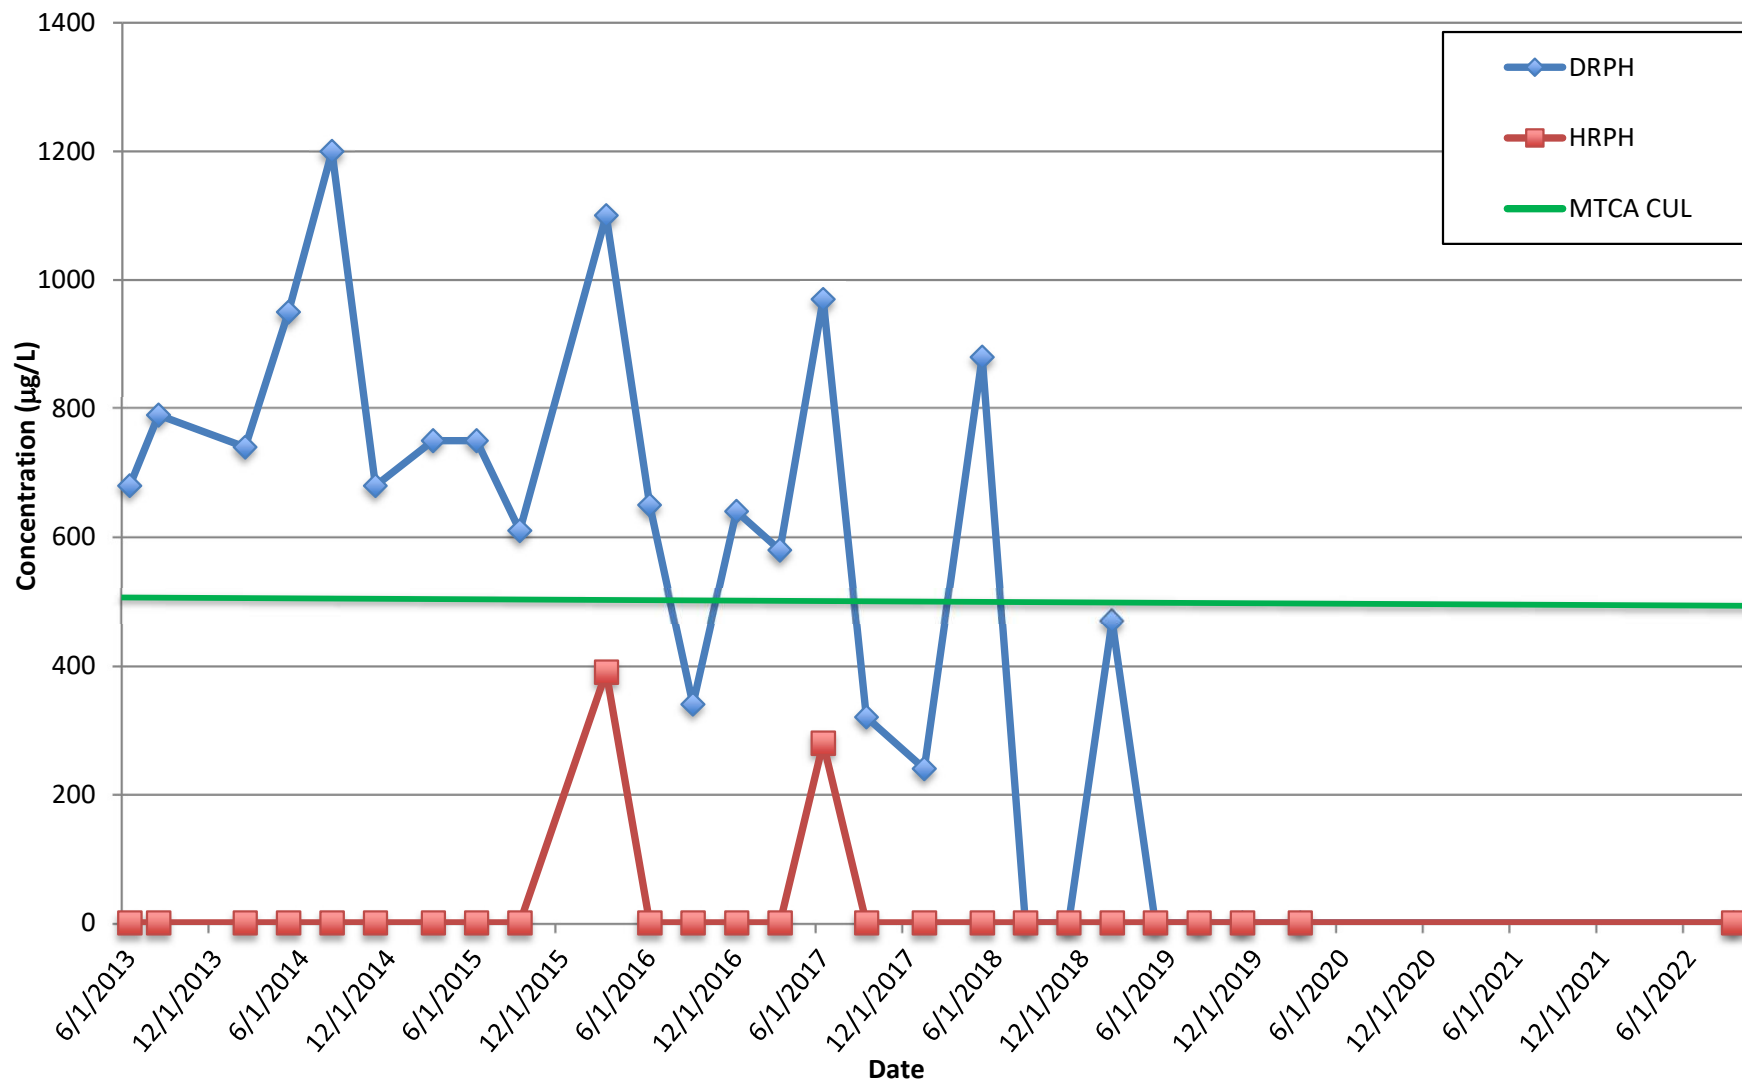
MW-6 DRPH and HRPH Concentration Time Series

- Laboratory analyses for samples collected from MW-6 indicate the declining trend observed in May 2019 has continued in the area downgradient of the former diesel UST. TPH-d and TPH-o were not reported at, or above, laboratory MRLs in the September 2022 sample collected from MW-6, confirming the four quarters of compliance observed for the period of September 2018 through May 2019.

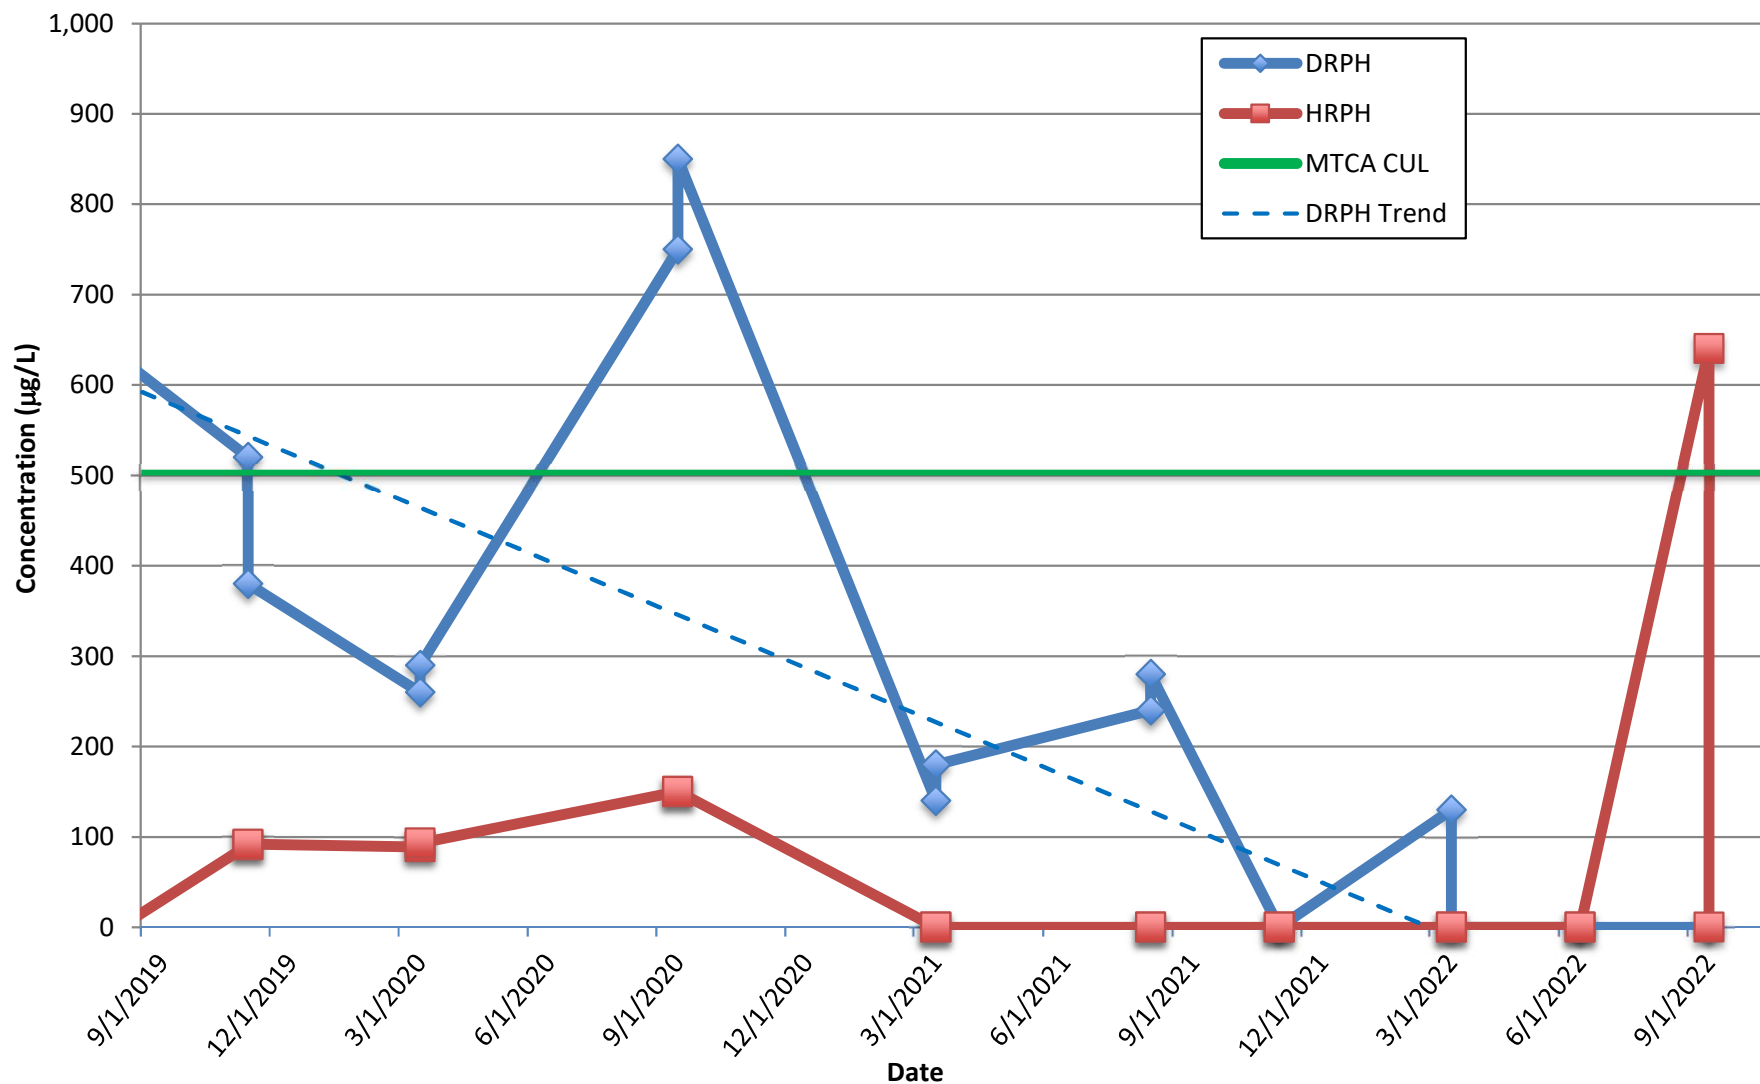
MW-9 DRPH and HRPD Concentration Time Series

- Laboratory analyses for samples collected from MW-9 indicate a declining trend during the past 3-year monitoring period. Groundwater quality data for TPH-d were compliant with Ecology MTCA Method A for the fifth consecutive quarter since suspending remedial operation in August 2021. TPH-d has not been reported above the MRL in groundwater samples collected from MW-9 since September 2020. Until the primary groundwater sample collected in September 2022, TPH-o had never been reported in groundwater samples collected from MW-9 at concentrations above the MRL in twenty-nine samples. The historical data strongly indicates the primary sample from September 2022 is an anomalous sample and does not reflect actual groundwater quality.
