## DRAFT FEASIBILITY STUDY REPORT

Troy Laundry Seattle Site  
300 Boren Avenue North and  
399 Fairview Avenue North  
Seattle, Washington  
Ecology Facility ID: 19135499

January 24, 2022

Project No.: 0731-004-07

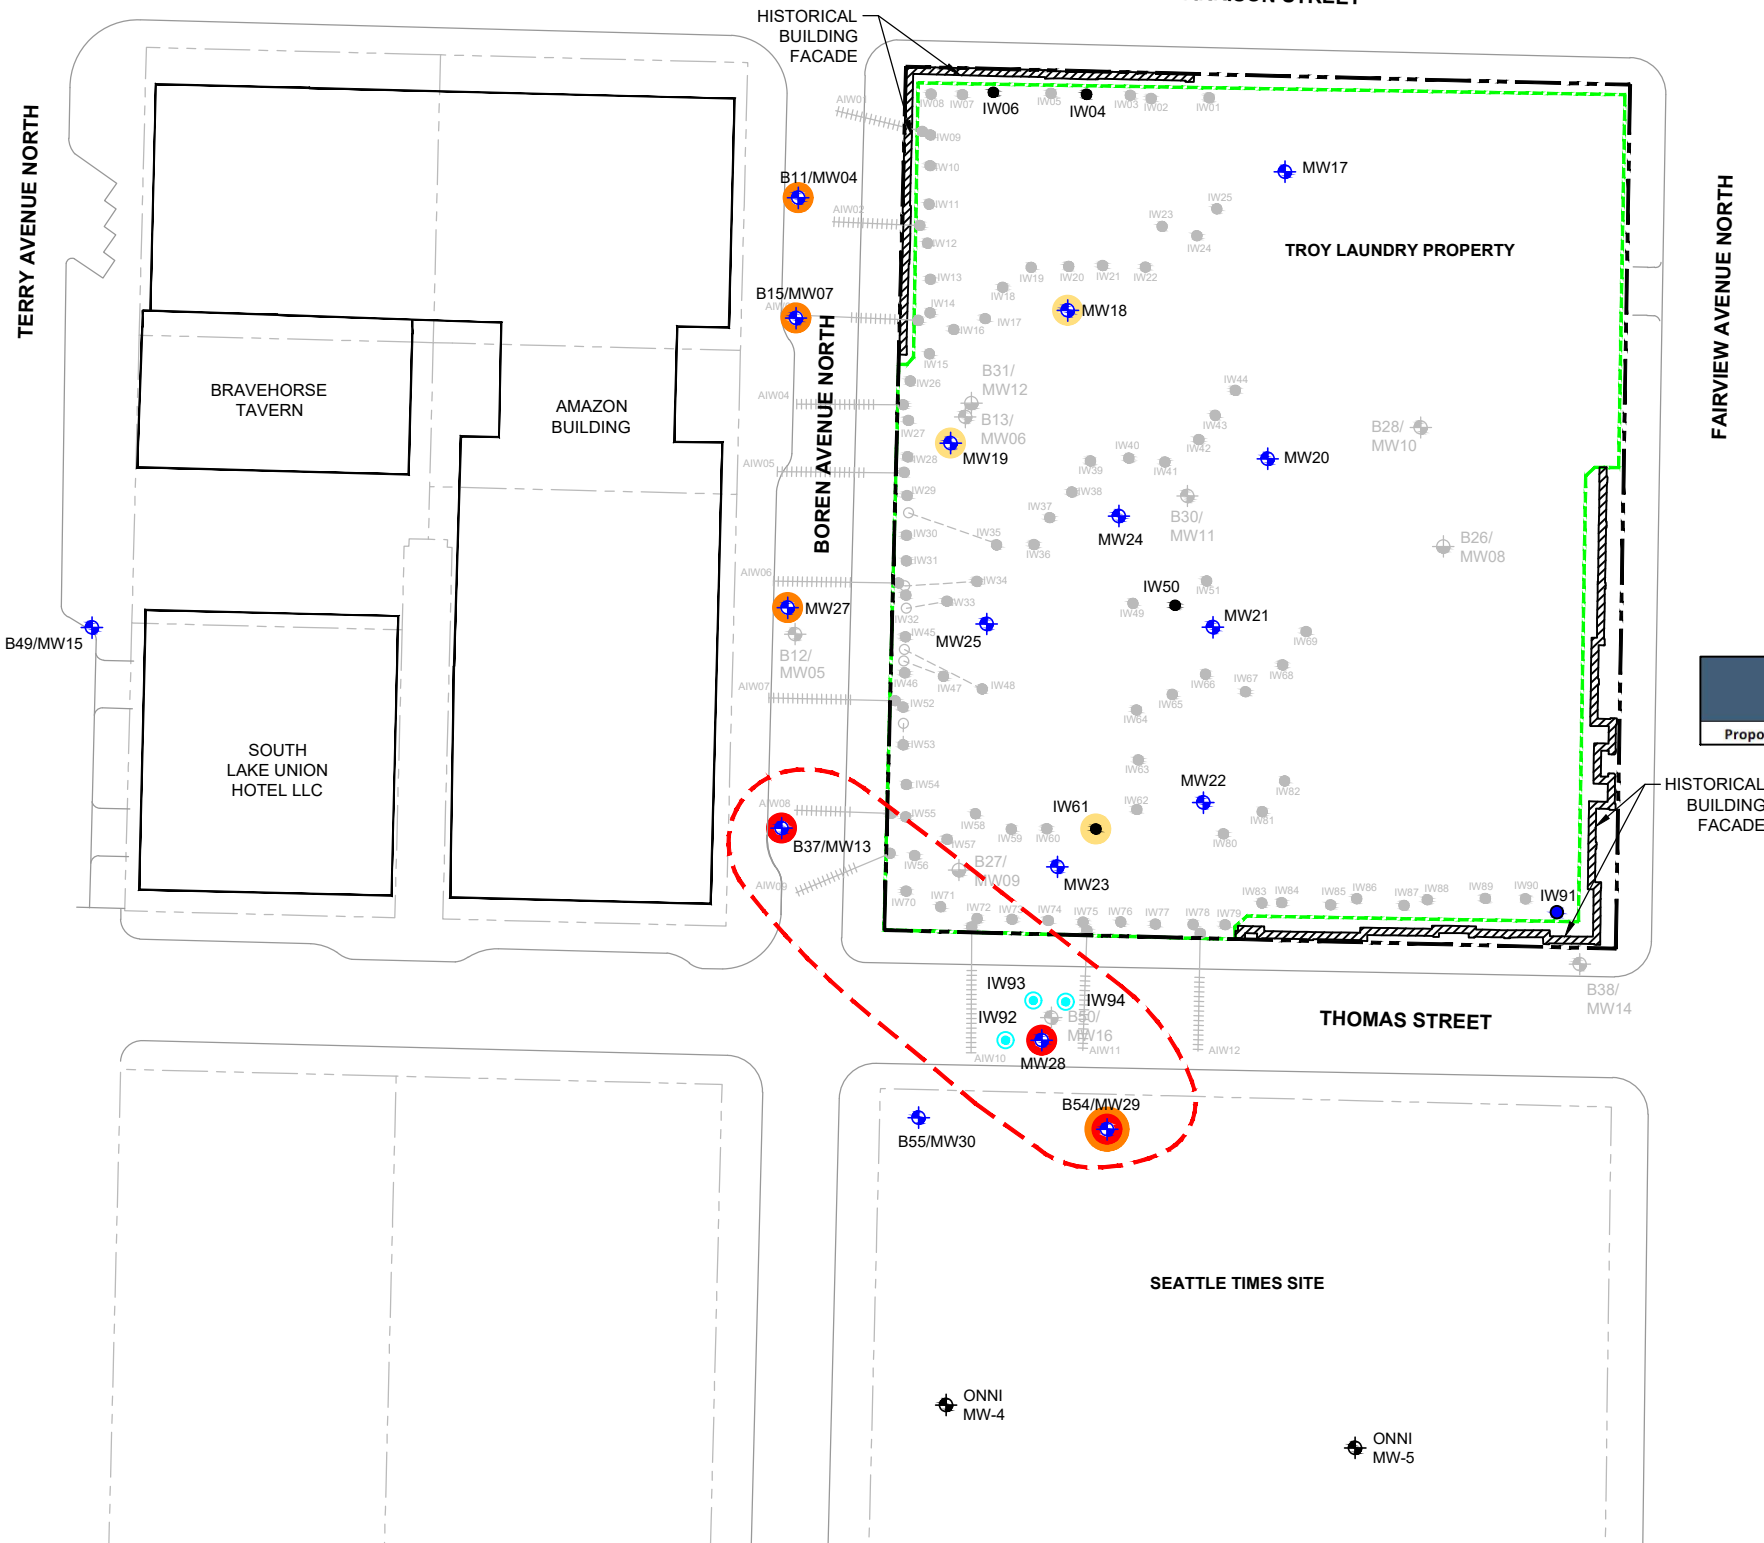
**FIGURE 18**  
 REGIONAL GROUNDWATER FLOW  
 DIRECTIONS - SOUTH LAKE UNION

Construction dewatering at Block 38 West, located to the northwest of the Property, has influenced the groundwater gradient at the Site, which has caused groundwater to flow to the west and northwest across the Boren Avenue North and Harrison Street ROWs. The construction dewatering system at Block 38 West was shut down in March 2021, although dewatering continued to occur beyond that date in connection with the development of the property located at 400 Westlake Avenue. South of the Property, the groundwater direction was not influenced by construction dewatering and has continued to flow to the south-southeast, which is the historical groundwater flow direction for the Site.

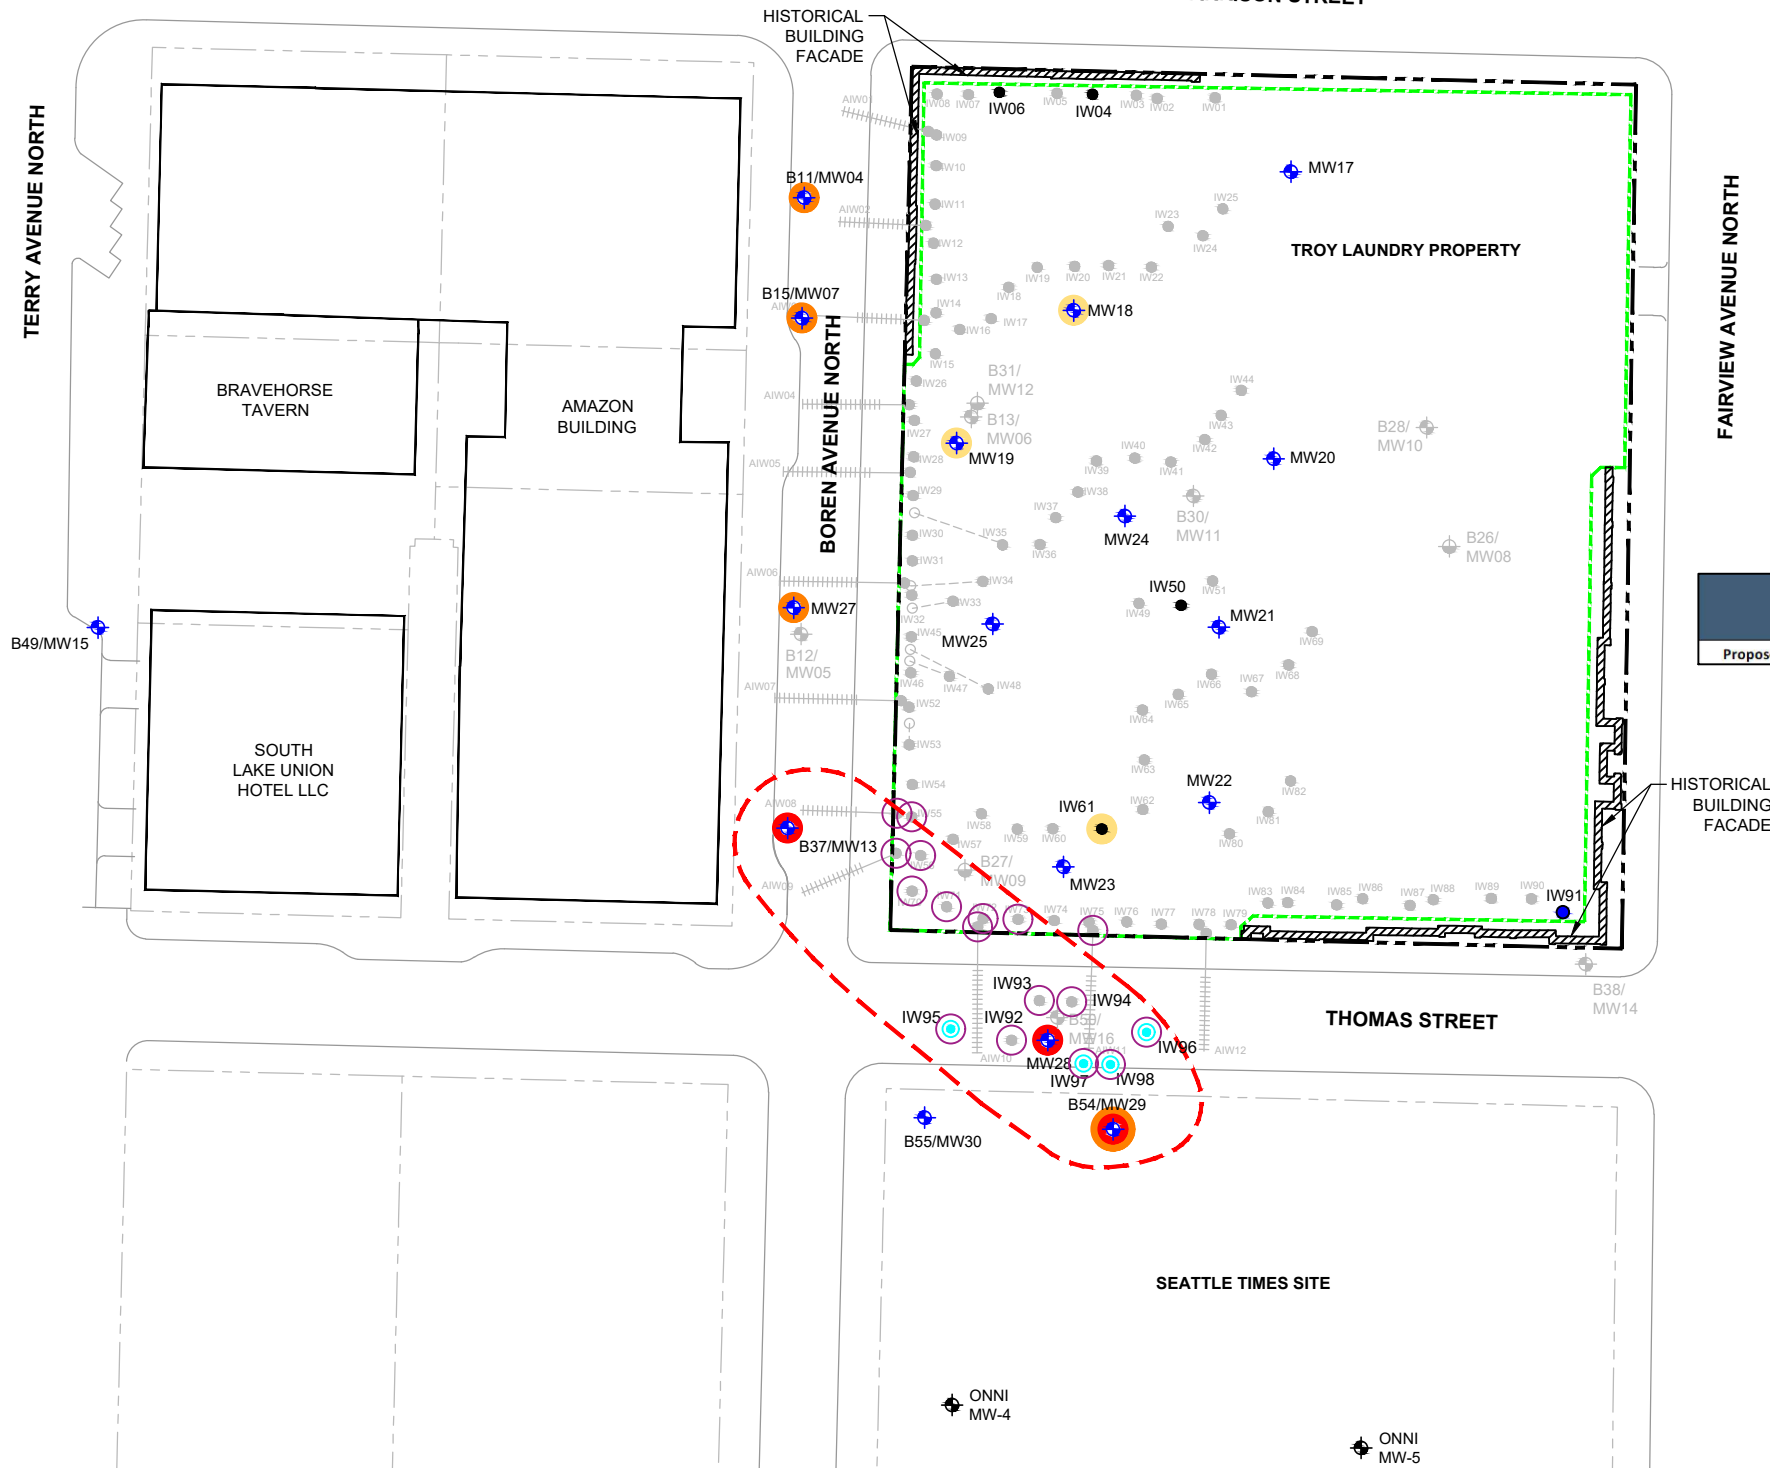
**FIGURE 20**  
CLEANUP ACTION ALTERNATIVE 2,  
IN SITU REDUCTIVE DECHLORINATION AND  
ENVIRONMENTAL COVENANT WITH MNA

Figure 20 provides an illustration of the conceptual implementation of this cleanup action alternative, including the layout of the injection program. Cleanup Action Alternative 2 would consist of the following:

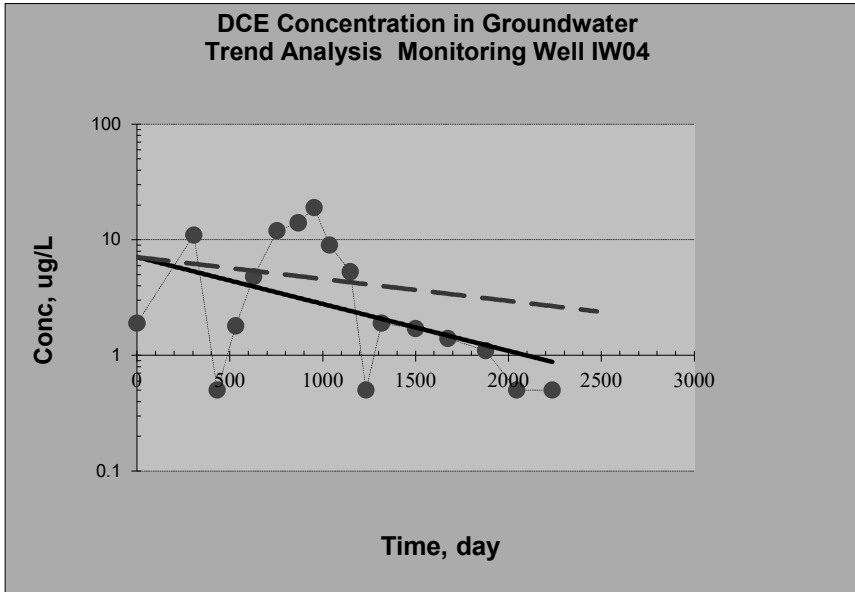
Hazardous Substance: cis-1,2-DCE

Name of Sampling Well?	IW04	Confidence Level (Decision Criteria)?	85.0%
Confidence Level calculated with log-linear regression is?	93.739%		
Plume Stability?	Shrinking	; Decision Criteria is 85%.	
Slope: Point decay rate constant ( $k_{point}$ ), yr <sup>-1</sup>	0.341 @50% C.L.;	0.159 @85% C.L.	
Half Life for $k_{point}$ , yr	2.034 @50% C.L.;	4.351 @85% C.L.

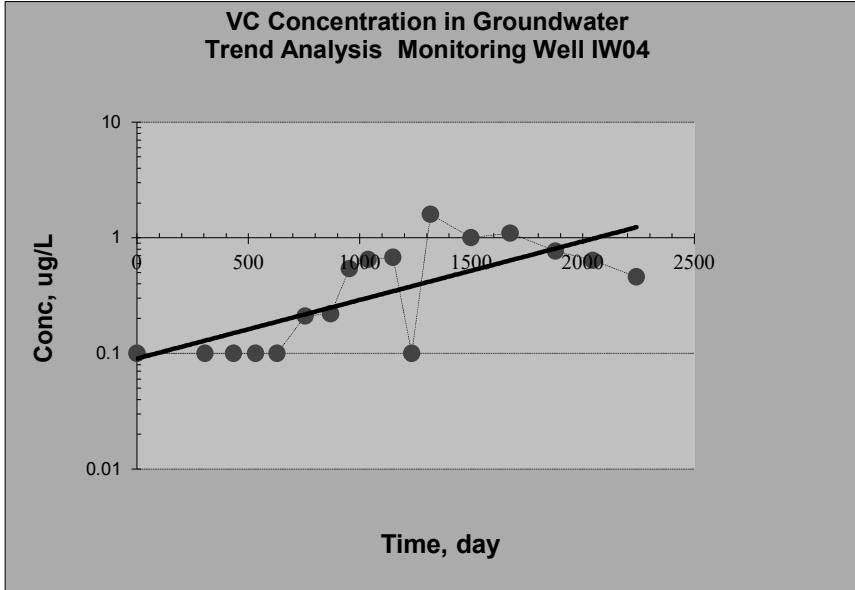
Name of Sampling Well?	IW04	Confidence Level (Decision Criteria)?	85.0%
Confidence Level calculated with log-linear regression is?	99.898%		
Plume Stability?	Expanding ; Decision Criteria is 85%.		
Slope: Point decay rate constant ( $k_{point}$ ), yr <sup>-1</sup>	NA @50% C.L.;	NA @85% C.L.	
Half Life for $k_{point}$ , yr	NA @50% C.L.;	NA @85% C.L.

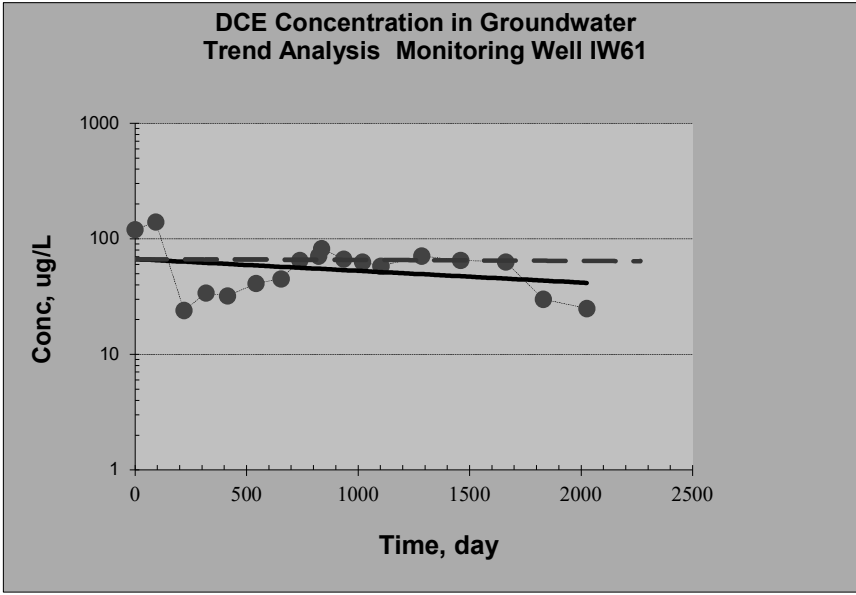
Name of Sampling Well?	IW61	Confidence Level (Decision Criteria)?	85.0%
Confidence Level calculated with log-linear regression is?	73.537%		
Plume Stability?	Stable	; Decision Criteria is 85%.	
Slope: Point decay rate constant ( $k_{point}$ ), yr <sup>-1</sup>	0.085 @50% C.L.;	0.006 @85% C.L.	
Half Life for $k_{point}$ , yr	8.116 @50% C.L.;	107.811 @85% C.L.

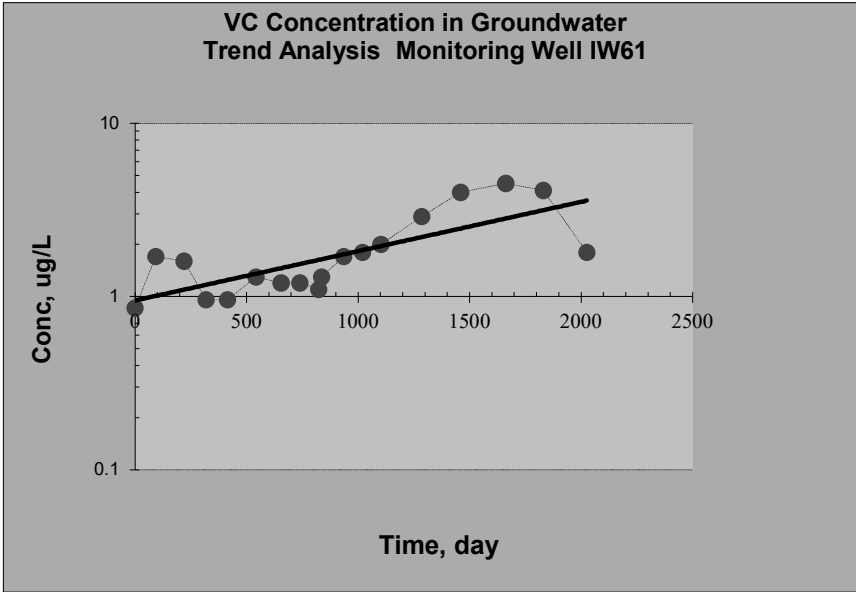
Name of Sampling Well?	IW61	Confidence Level (Decision Criteria)?	85.0%
Confidence Level calculated with log-linear regression is?	99.972%		
Plume Stability?	Expanding	; Decision Criteria is 85%.	
Slope: Point decay rate constant ( $k_{point}$ ), yr <sup>-1</sup>	NA @50% C.L.;	NA @85% C.L.	
Half Life for $k_{point}$ , yr	NA @50% C.L.;	NA @85% C.L.

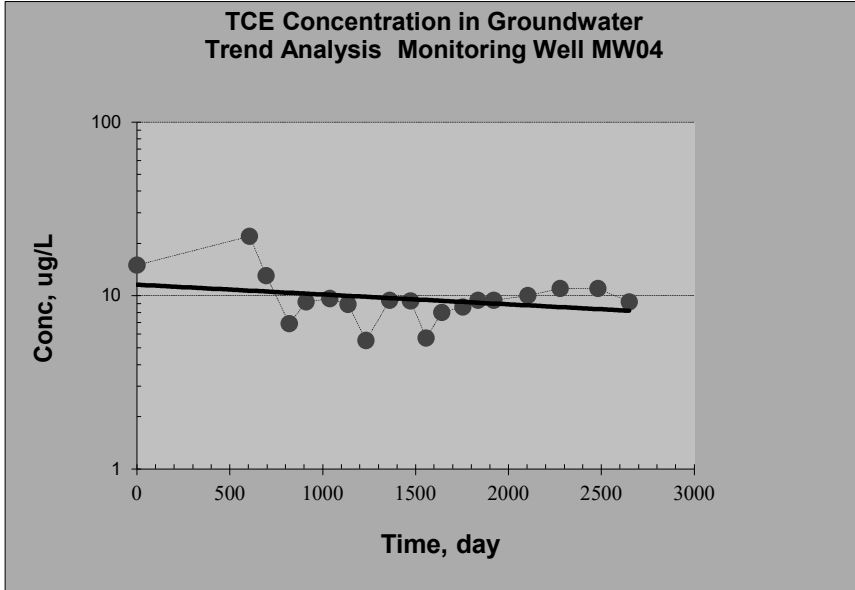
Name of Sampling Well?	MW04	Confidence Level (Decision Criteria)?	85.0%
Confidence Level calculated with log-linear regression is?	63.871%		
Plume Stability?	Stable	; Decision Criteria is 85%.	
Slope: Point decay rate constant ( $k_{point}$ ), yr <sup>-1</sup>	0.033 @50% C.L.;	NA @85% C.L.	
Half Life for $k_{point}$ , yr	21.245 @50% C.L.;	NA @85% C.L.
