Remedial Action Completion Report

Big B Mini Mart Site

Prepared for
Big B LLC

November 2022

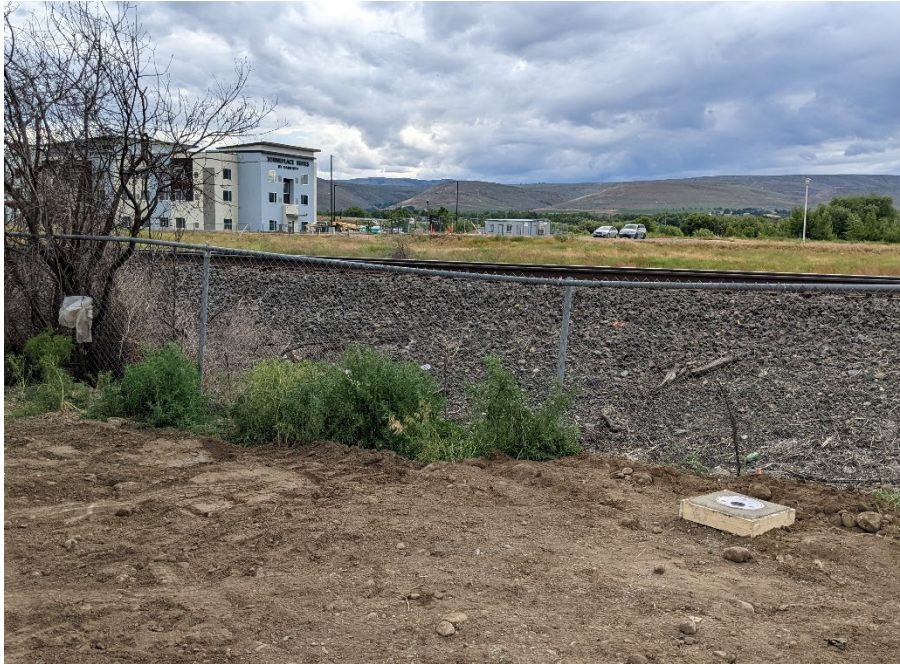
Photograph 53. Monument replacement of MW-3. View SW.

Attempts were made to locate MW-7, which had been buried and damaged during backfill of the 2021 excavation area, but it was not located or reinstalled. MW-3 was also buried during the Phase I excavation activities, but it was located and repaired in July 2022. MW-3 was redeveloped, and a new monument was installed to protect the well from further damage during redevelopment activities.

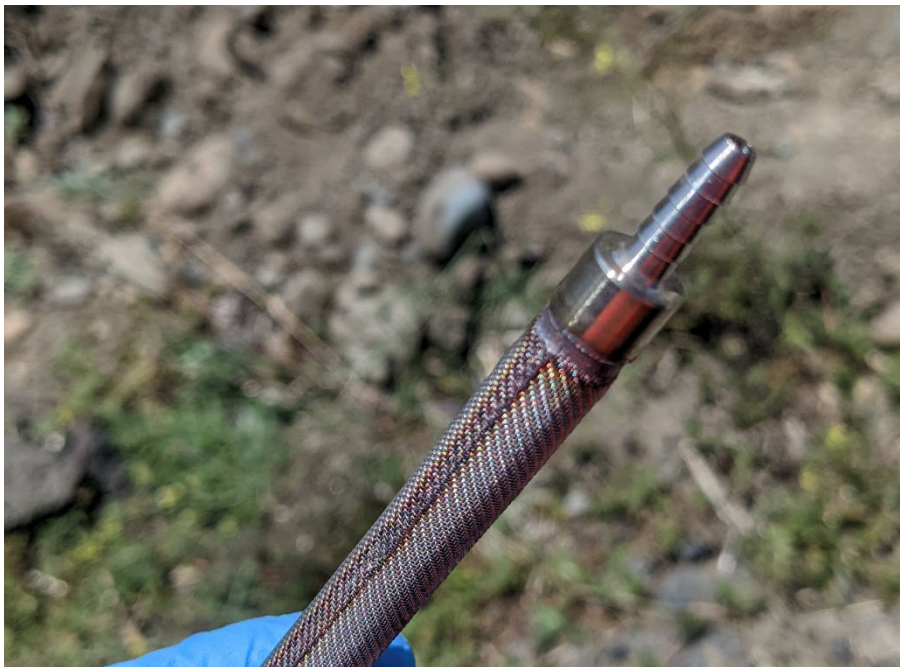
Photograph 56. Three-inch-long, stainless steel soil vapor screen. The screen was attached to tubing and installed at 3 feet bgs.

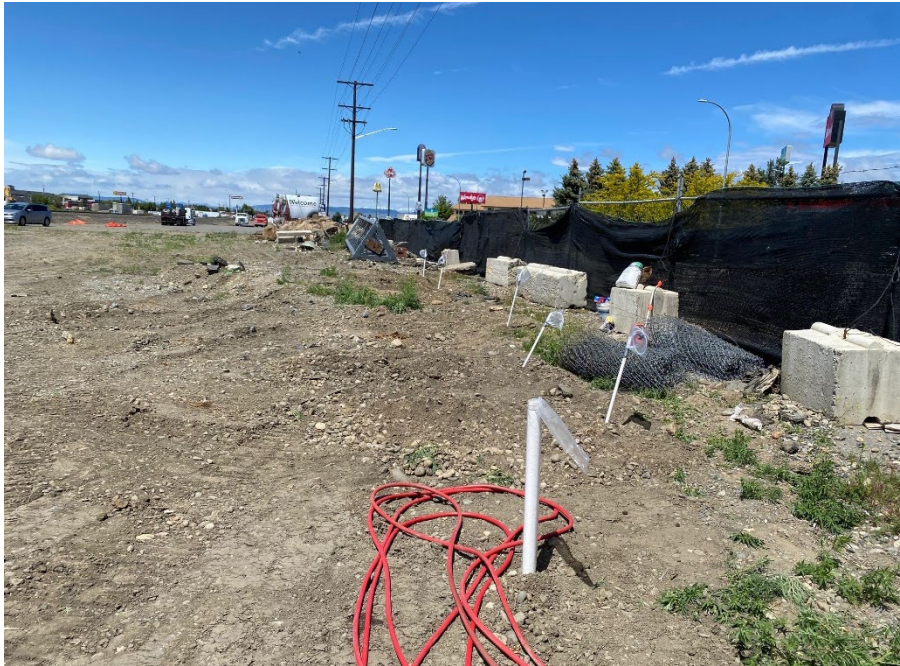
Photograph 57. Final locations of injection point (foreground) and soil vapor monitoring points.
View N.
