**PLANT 1 WATERFRONT PROBING SUMMARY REPORT
SITE: FORMER BP HARBOR ISLAND TERMINAL
CLEANUP SITE ID: 4426**

**SEAPORT MIDSTREAM PARTNERS LLC. SEATTLE TERMINAL
1652 SW LANDER STREET
SEATTLE, WASHINGTON**

CONSENT DECREE NO. 00-2-05714-8SEA

FEBRUARY 2020

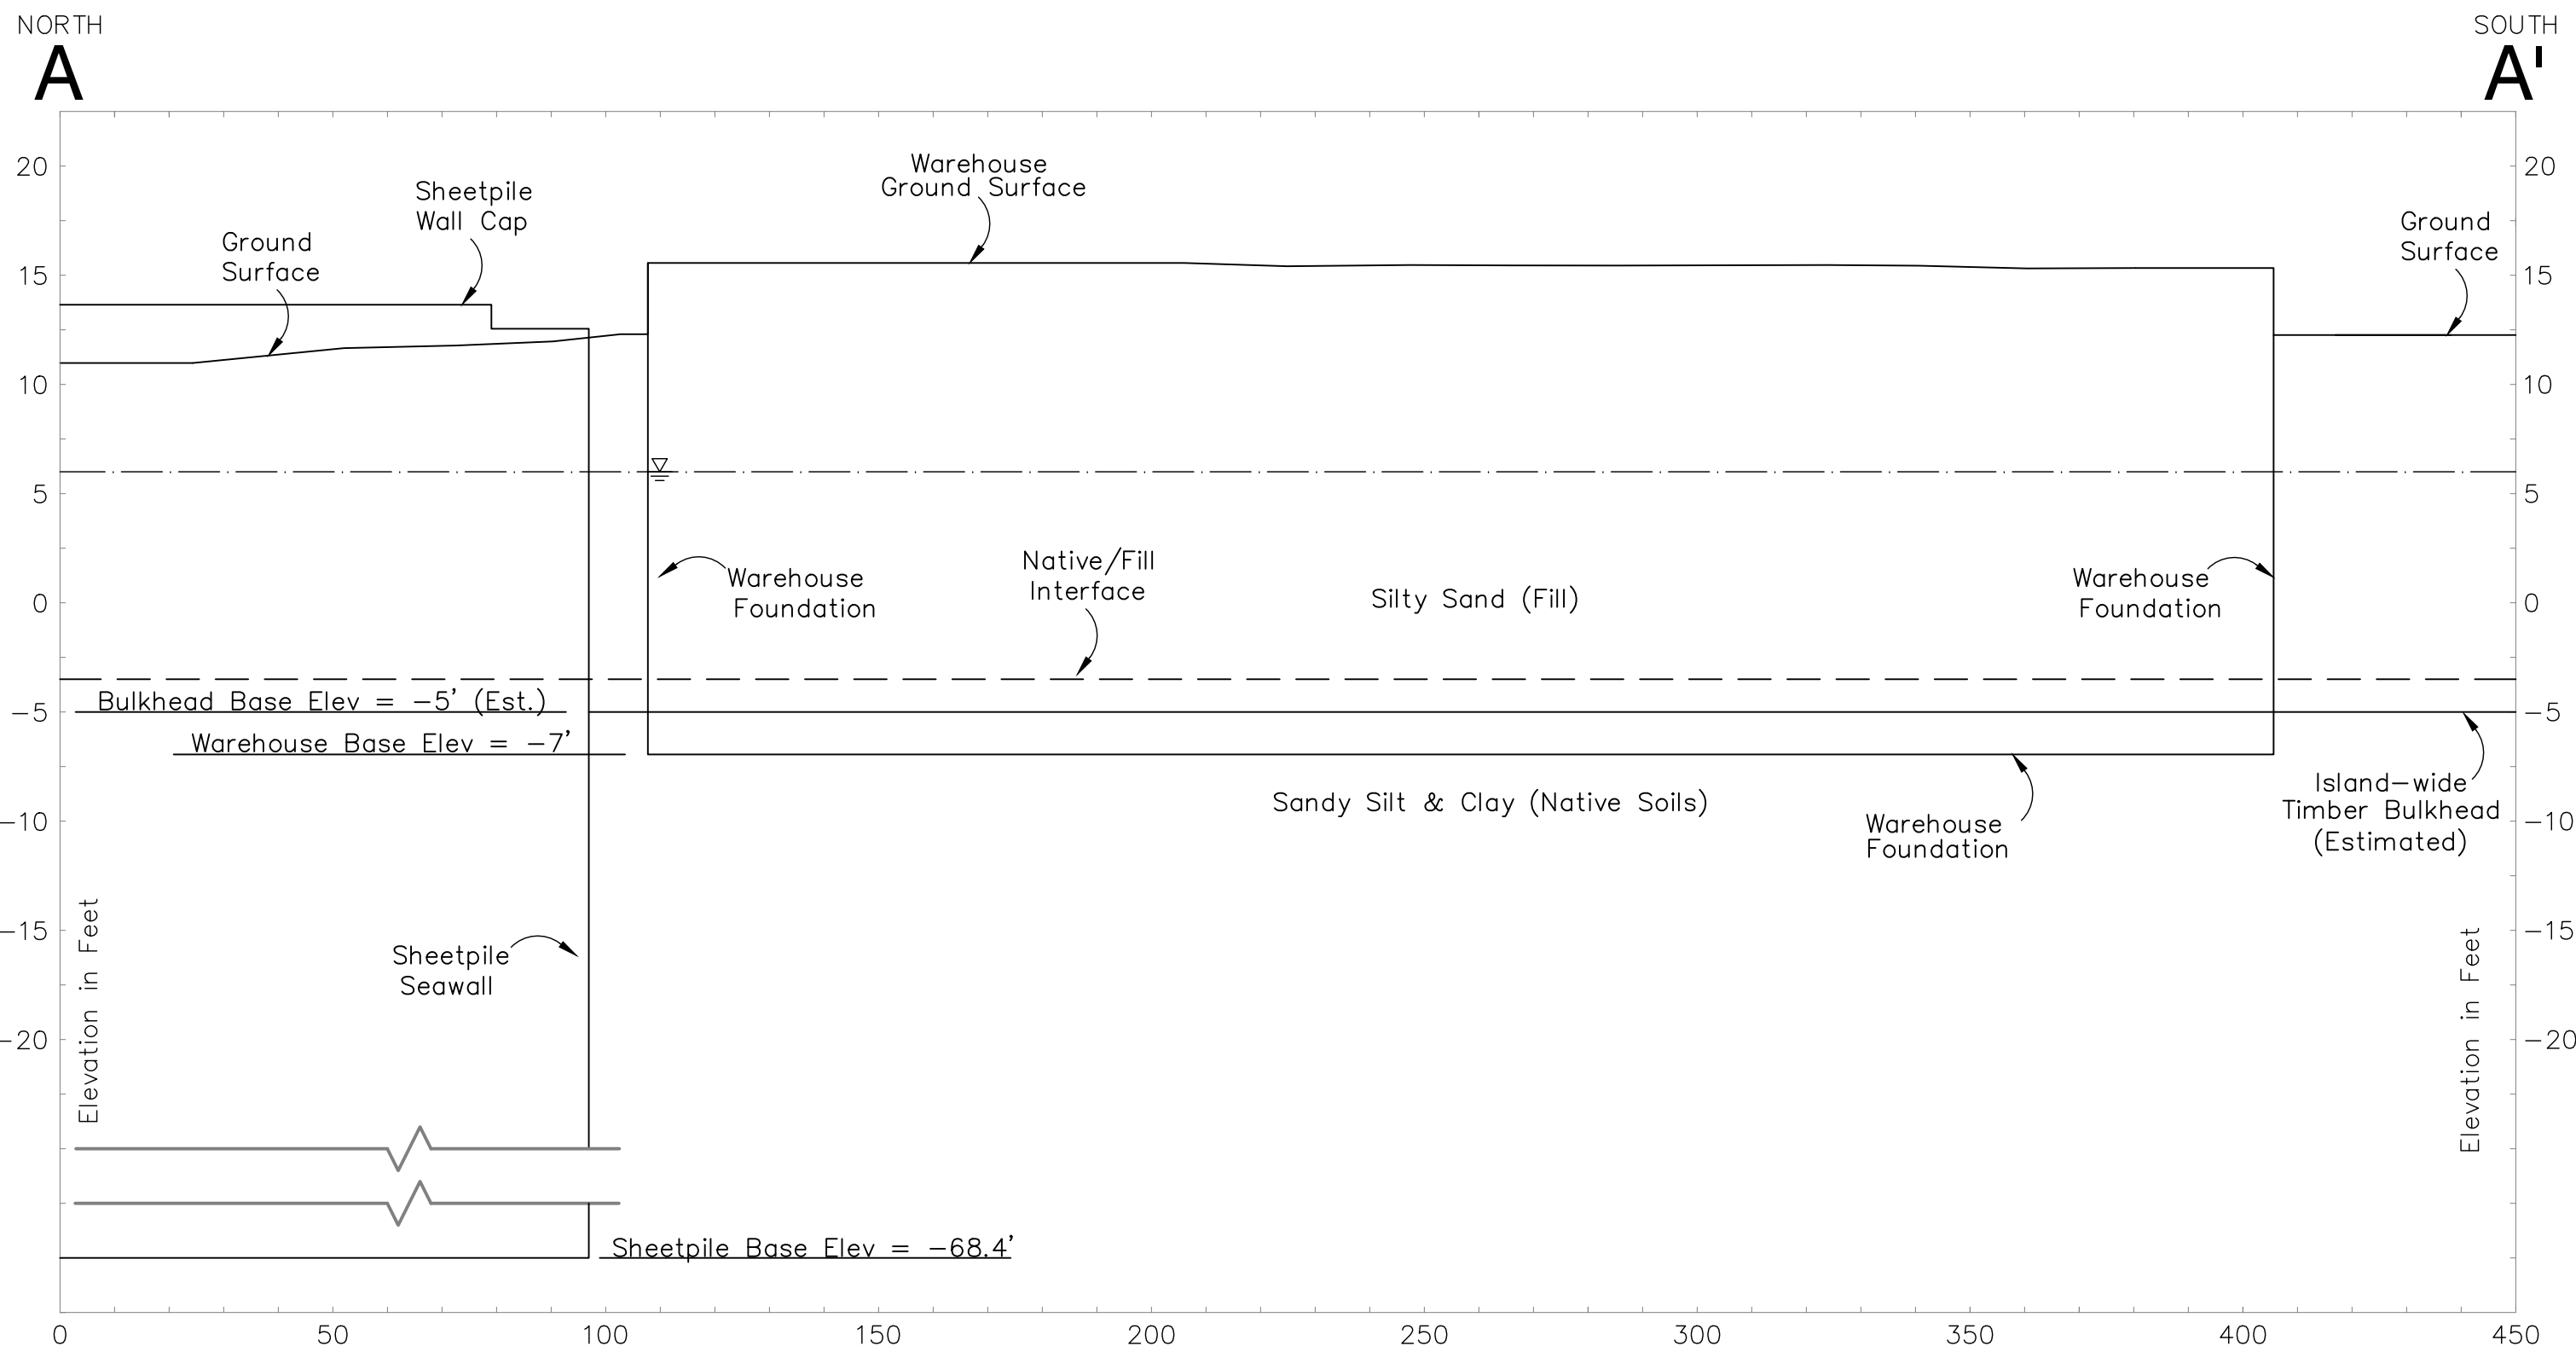
FIGURE
7

Approximate Groundwater Surface
	Approximate Fill/Native Soil Interface

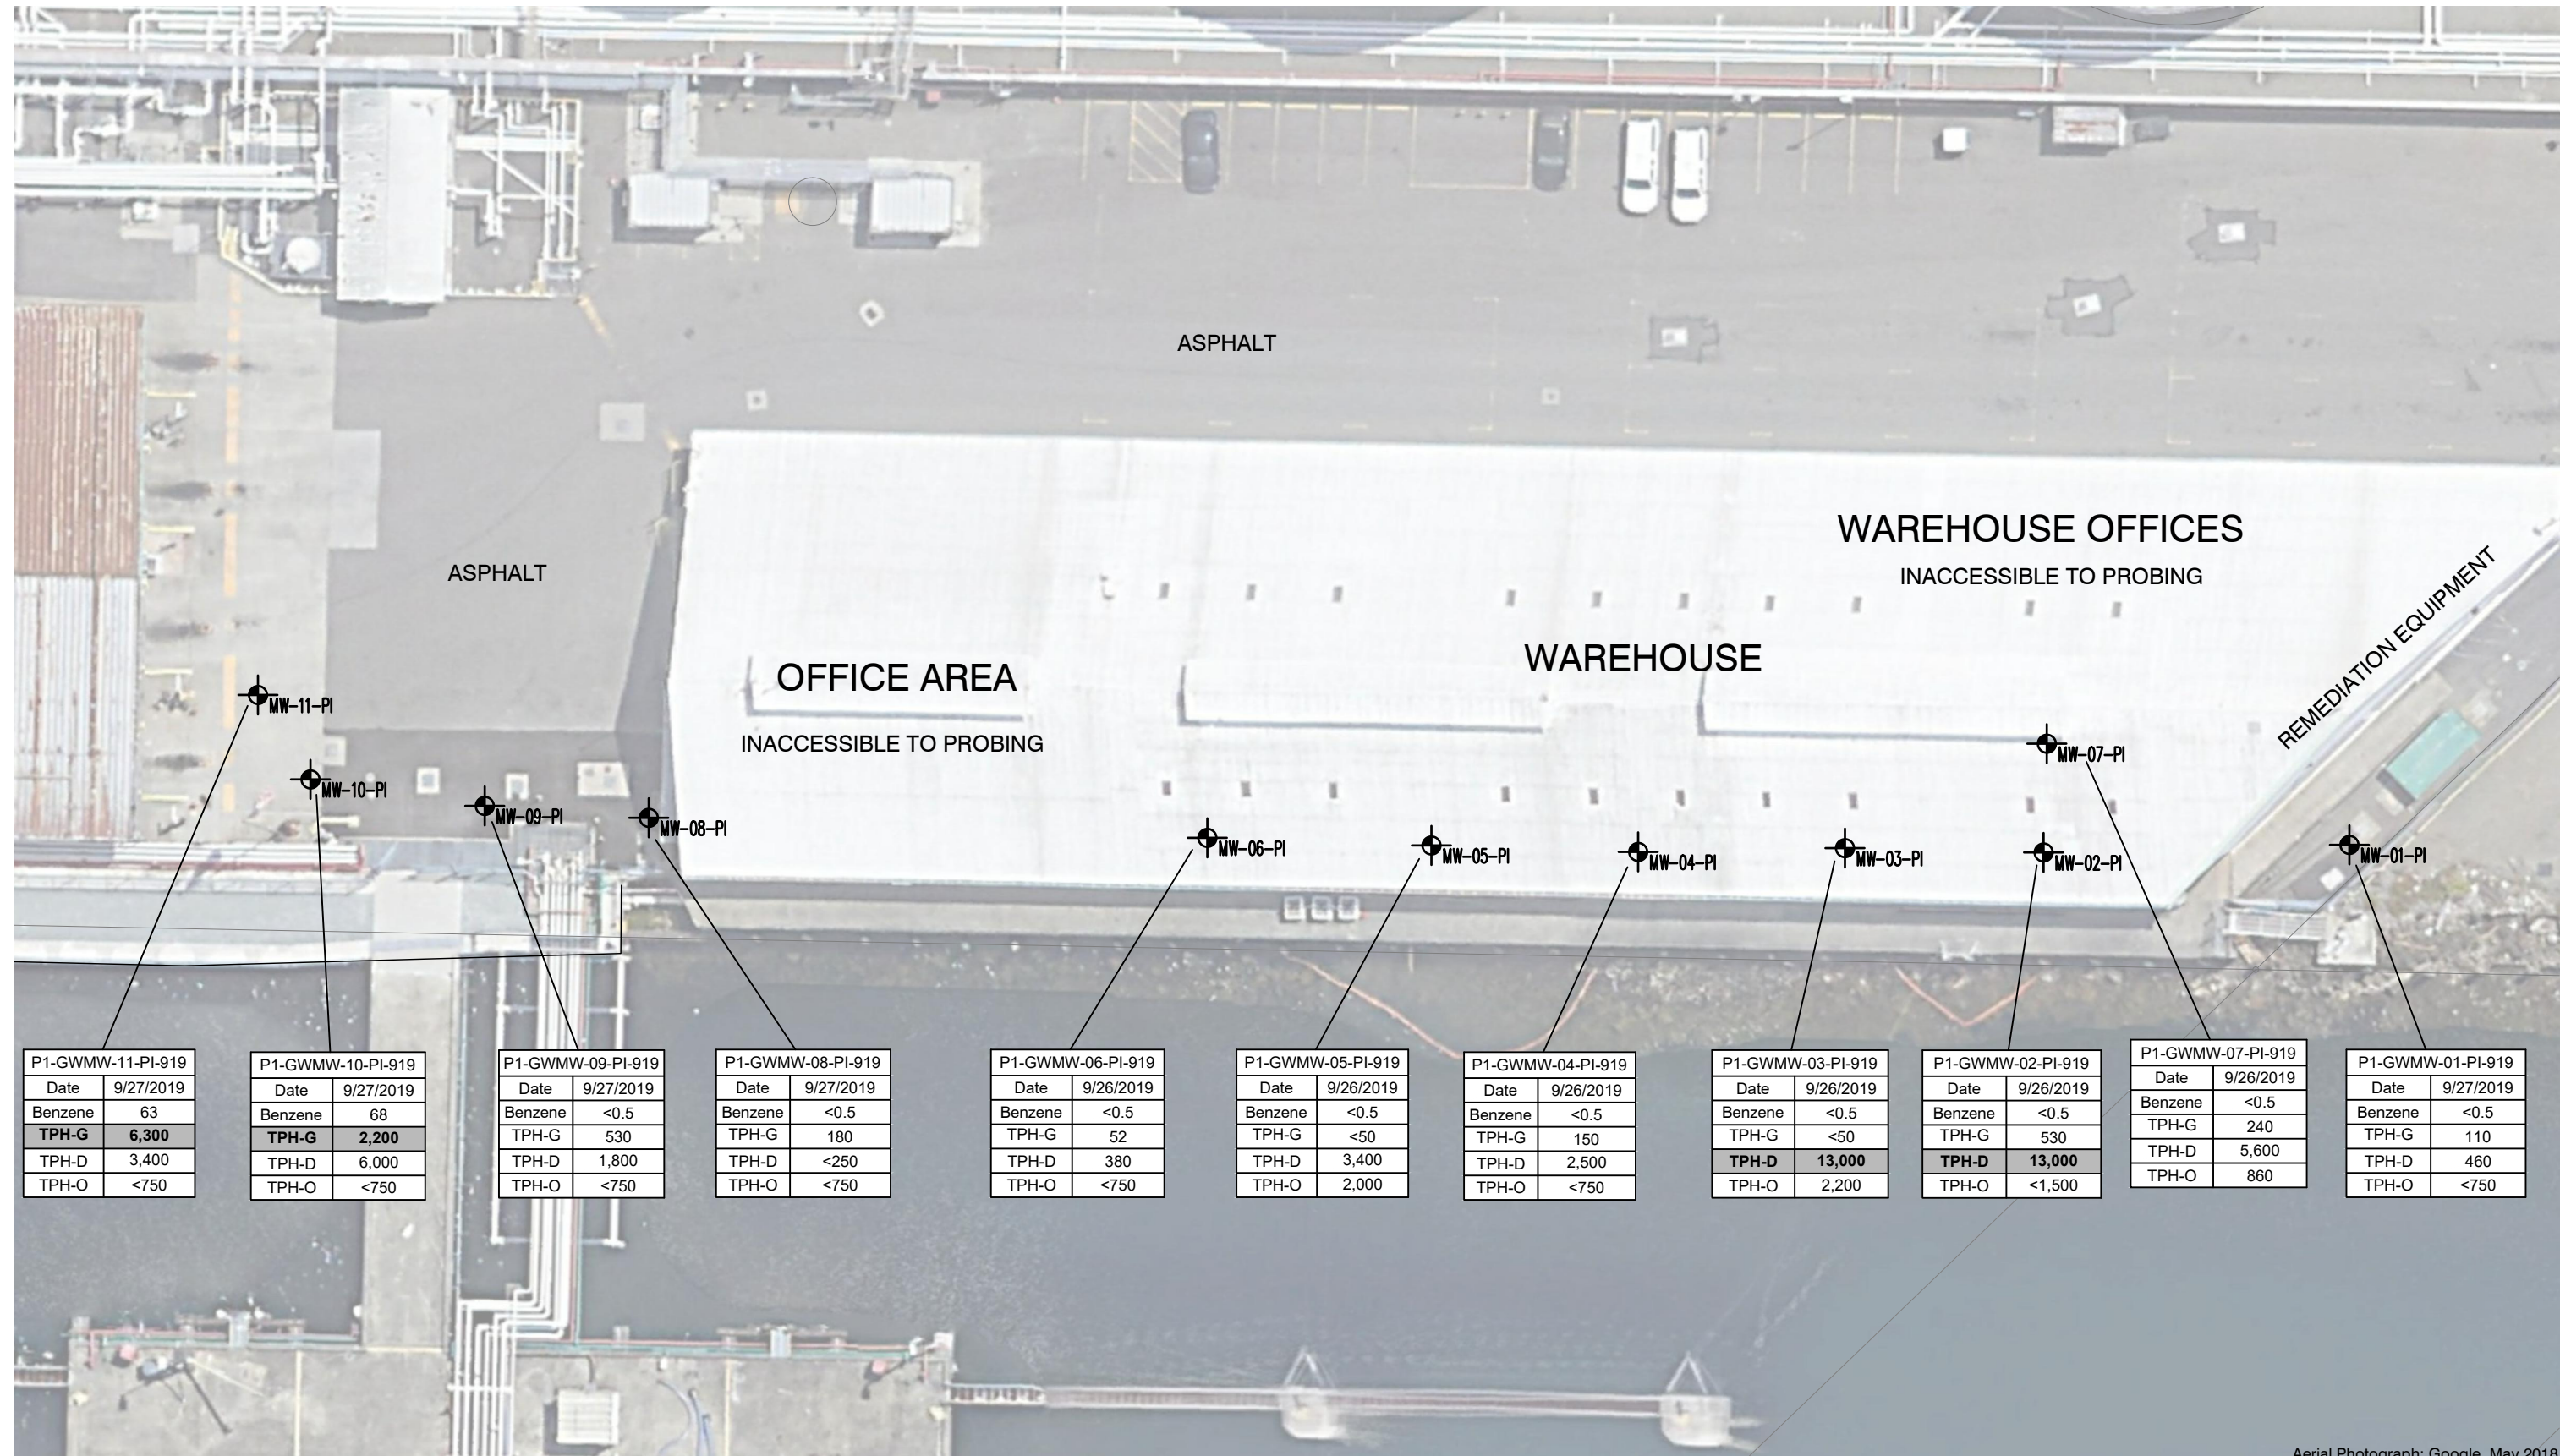
Figure 7 – Plant 1 Probing Investigation, A-A' Plant 1 Waterfront Cross Section Map

approximately -3 feet. Deeper soils transitioned to sands, silt, and clay. The shallower and deeper soils are representative of soils encountered during the RI, discussed in Section 2.1. The approximate soil boundaries and interfaces are shown on Figure 7. Soil boring logs detailing soil lithology are included in Appendix B.

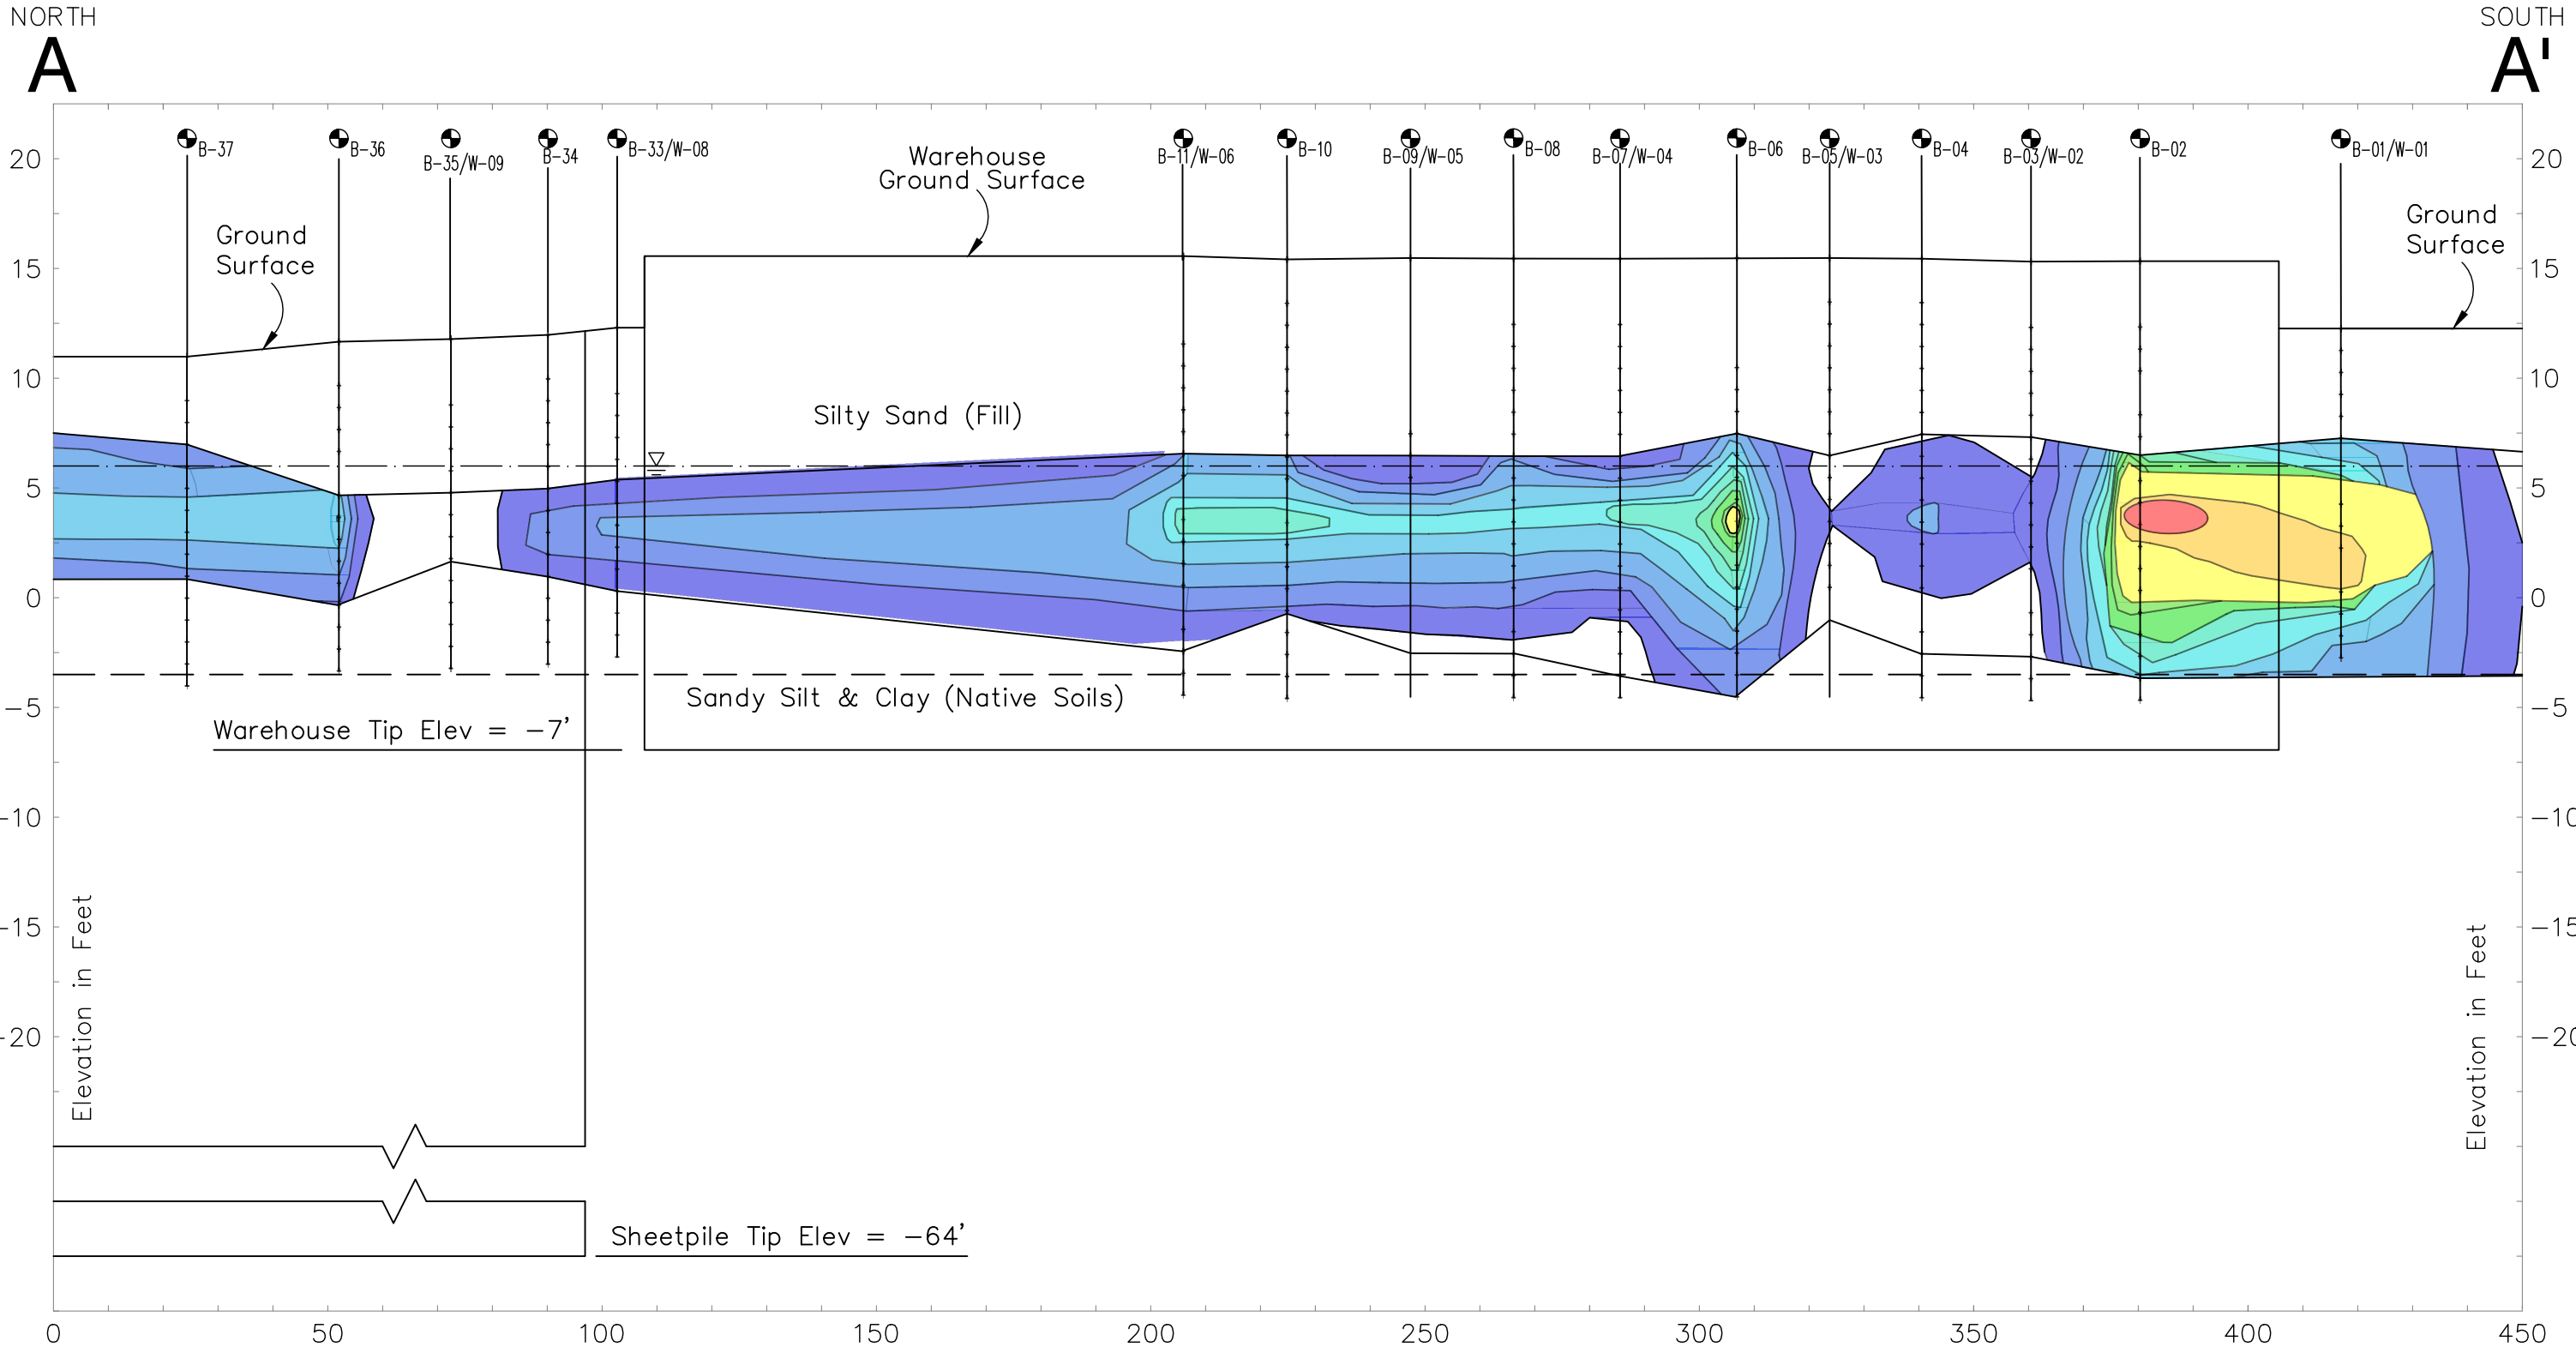
FIGURE
10

- B-01 Probing Boring Location
- Approximate Groundwater Surface
- Approximate Fill/Native Soil Interface

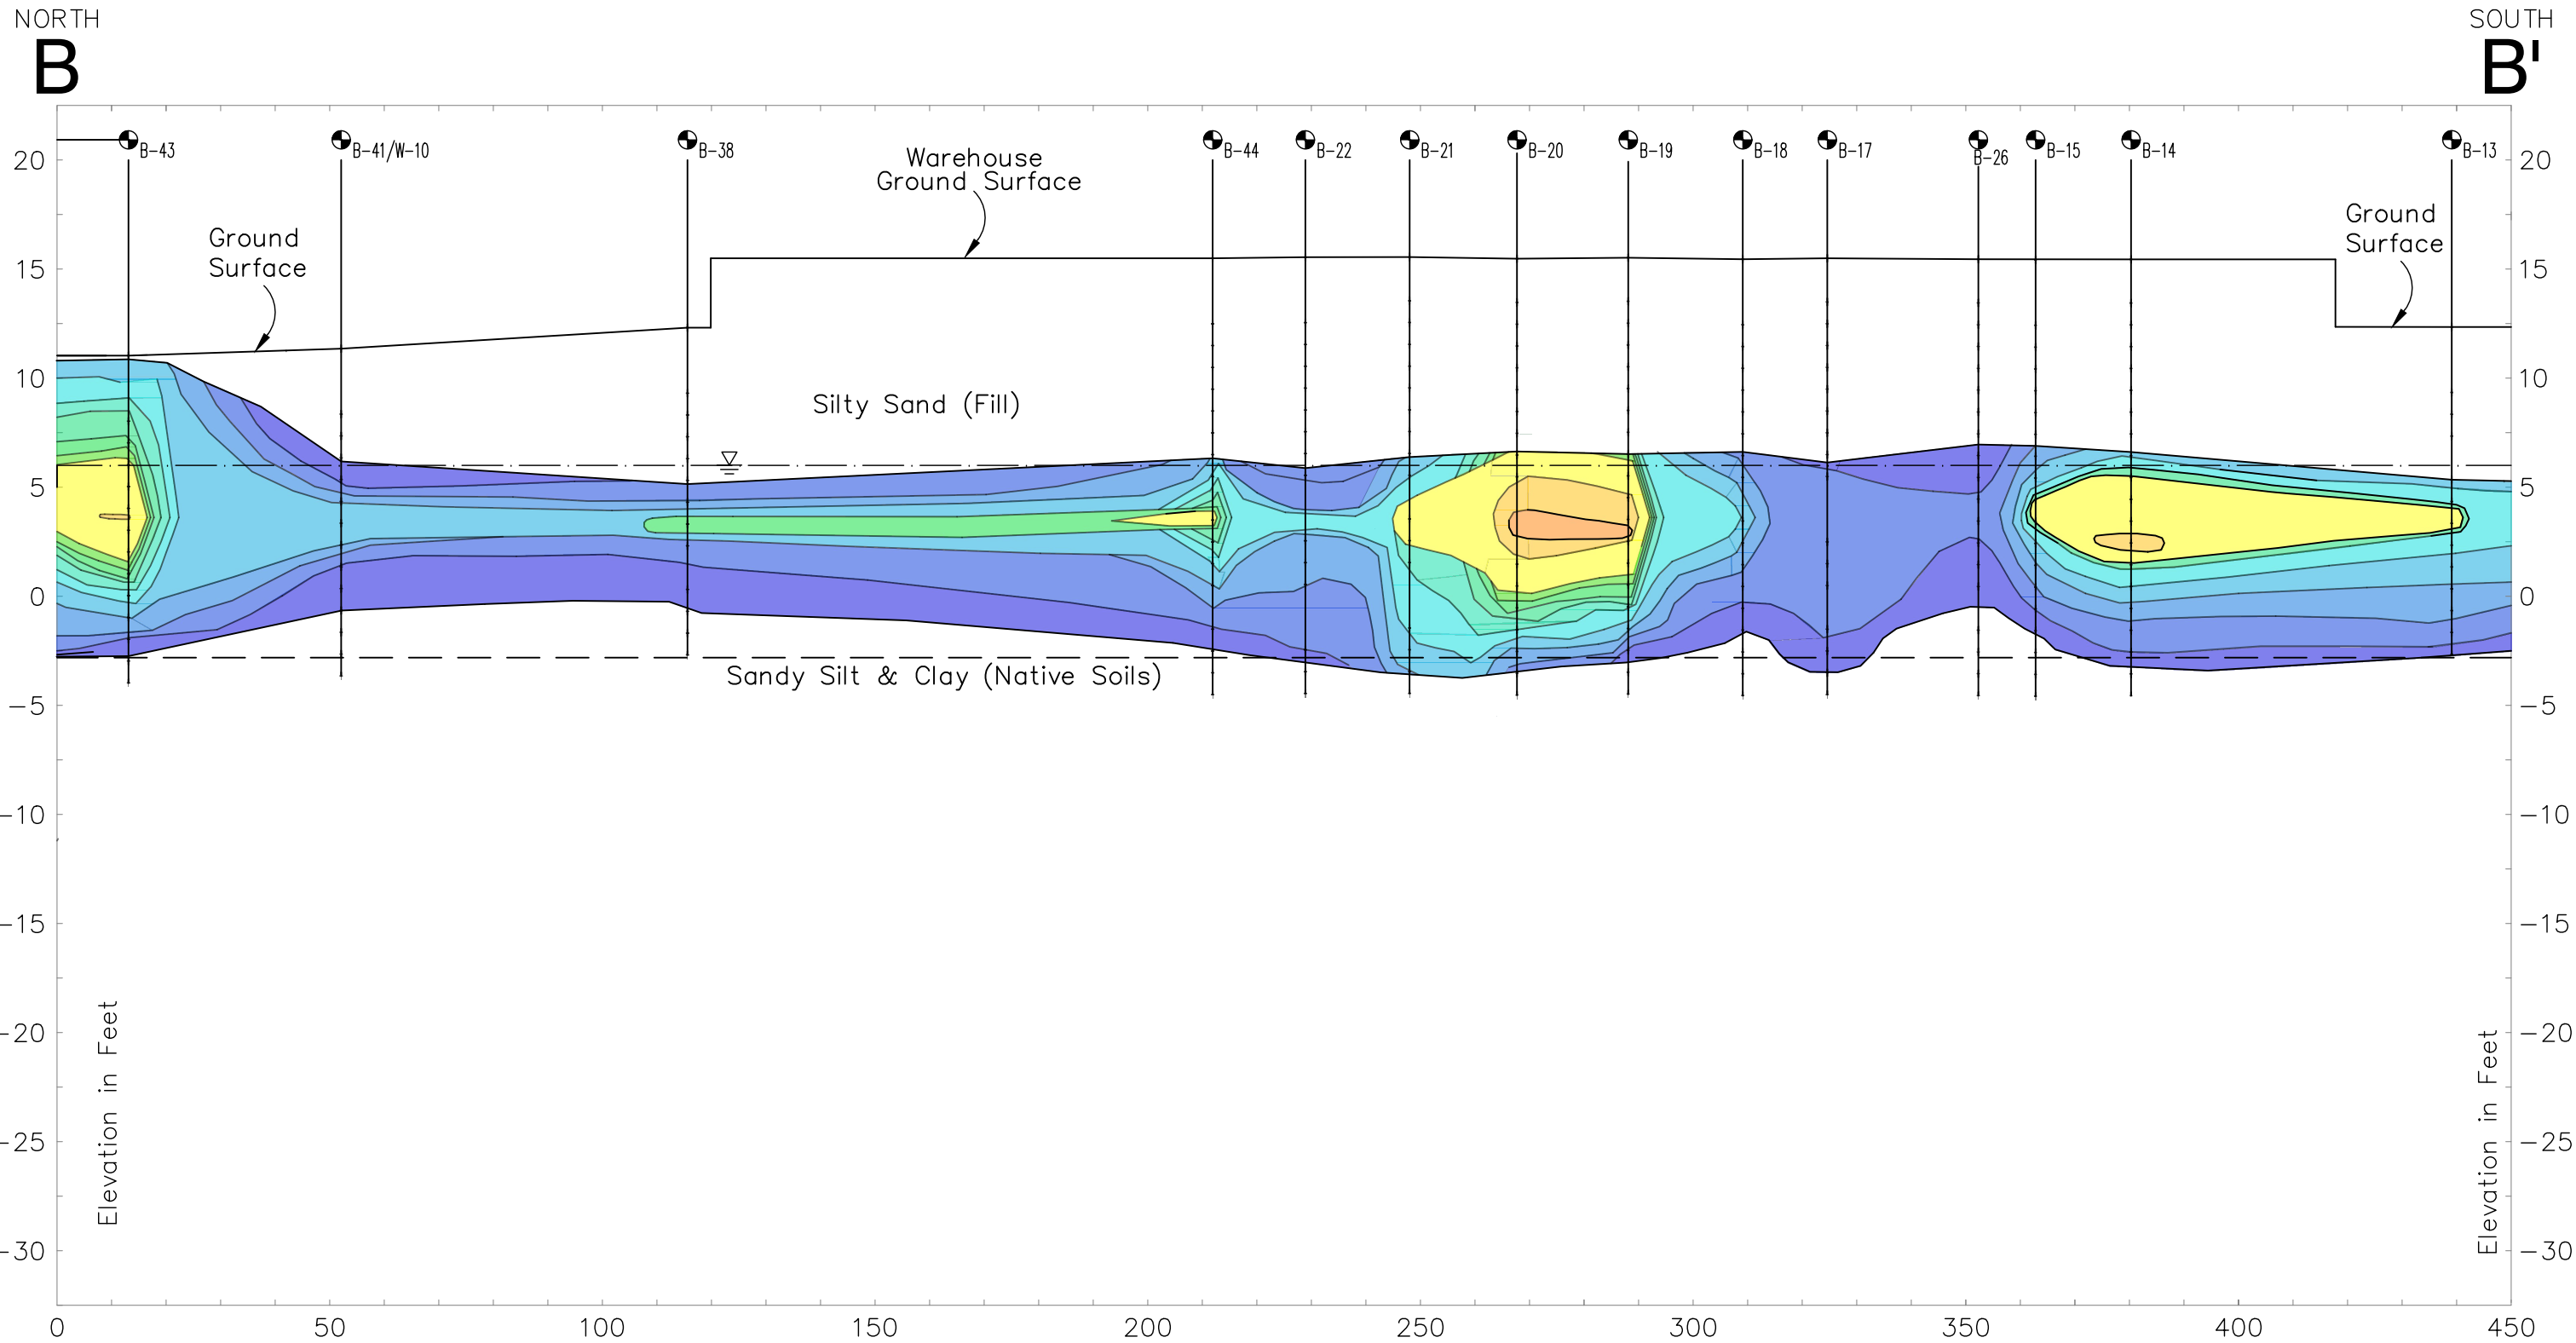
Figure 11 – Plant 1 Probing Investigation, B-B' TPH Contour Cross Section Map

- B-01 Probing Boring Location
- Approximate Groundwater Surface
- Approximate Fill/Native Soil Interface
