**2021 ANNUAL SITE REPORT
SITE: FORMER BP HARBOR ISLAND TERMINAL
CLEANUP SITE ID: 4426
1652 SW LANDER STREET
SEATTLE, WASHINGTON**

CONSENT DECREE NO. 00-2-05714-8SEA

APRIL 2022

Prepared by
TechSolve Environmental, Inc.
7518 NE 169th Street
Kenmore, Washington 98028
www.techsolveinc.com

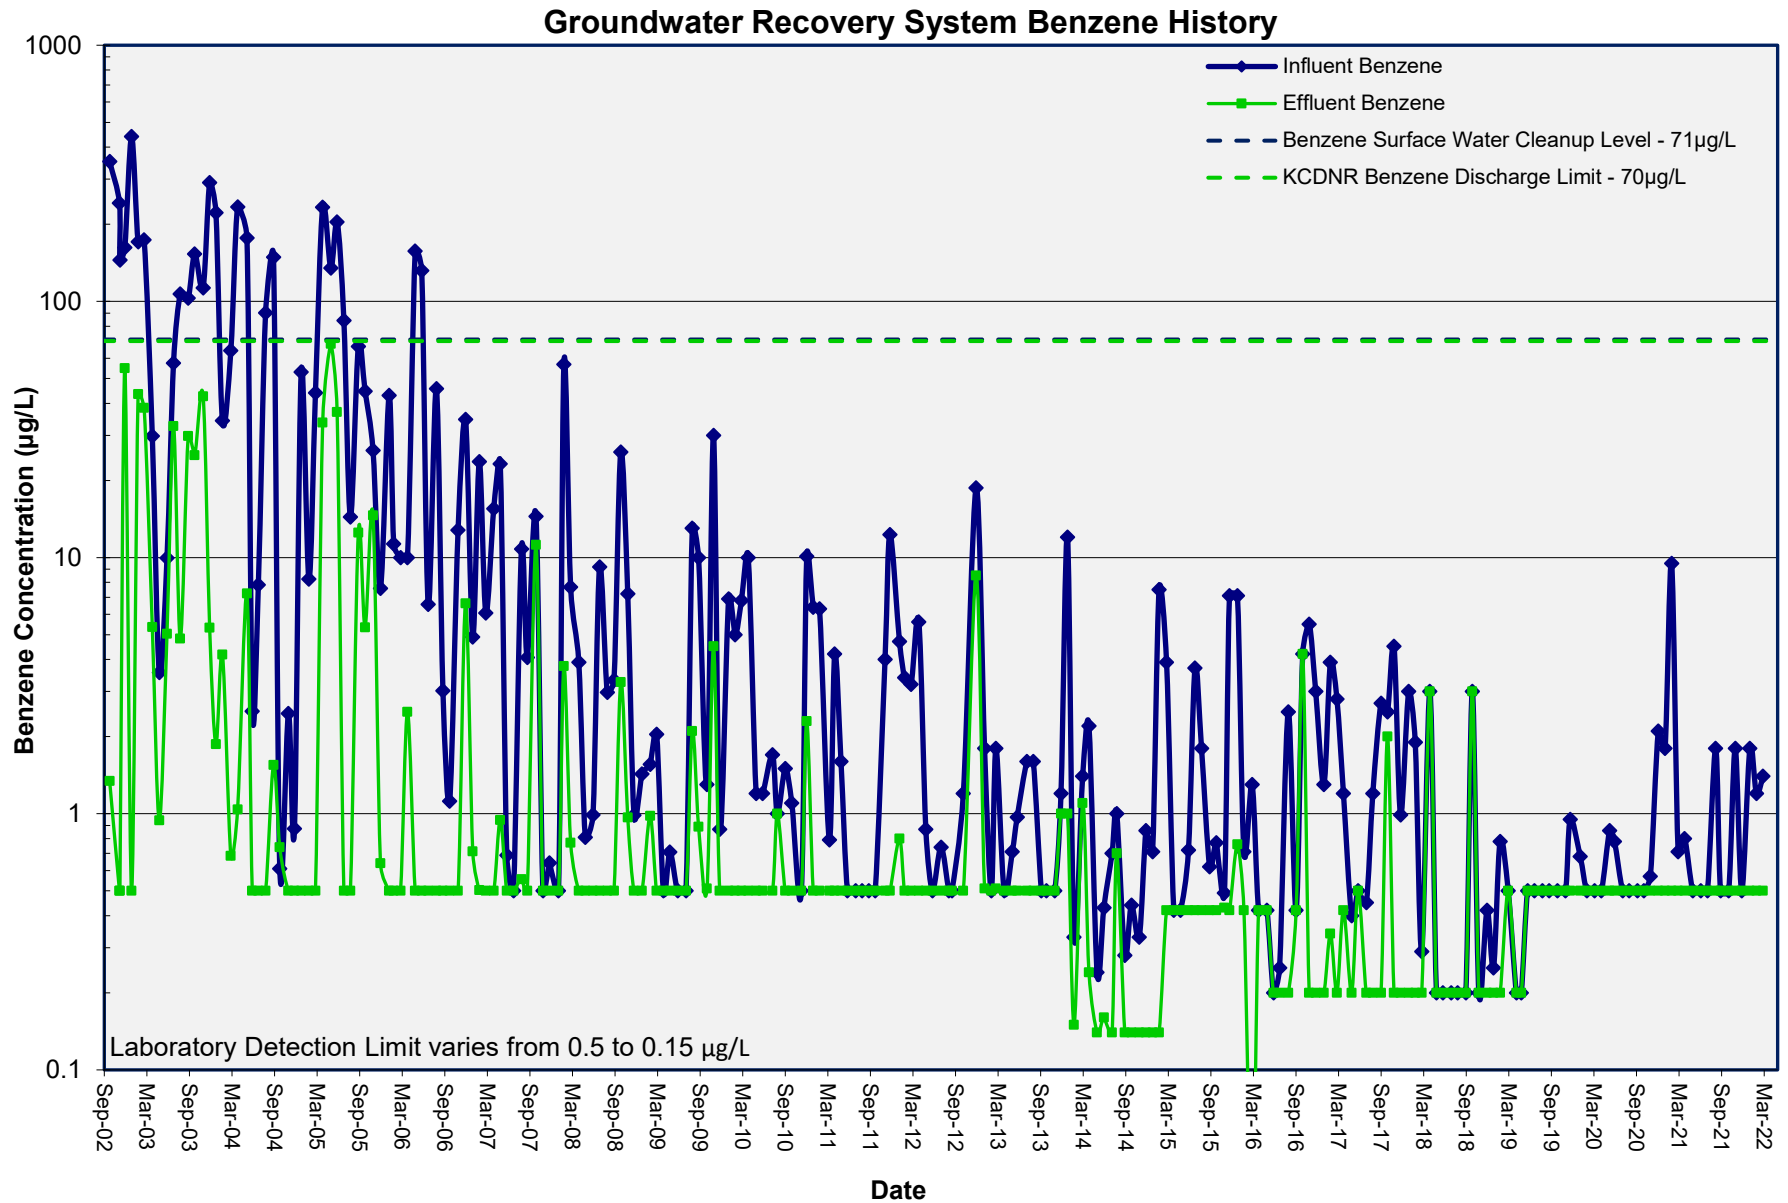
Figure 6. Final System Influent vs. Effluent Benzene Concentrations
October 2002 through March 2022
Site: Former BP Harbor Island Terminal

Note: Data is included since startup of the final groundwater and product recovery system in 2002.

recovered 395 gallons of LNAPL from October 2002 through December 2021, and 417 gallons of dissolved hydrocarbons (Tables 1 and 3). The total combined recovery including recovered LNAPL, dissolved hydrocarbons, historical SVE recovery, and biodegradation processes (discussed in Section 3.1.2.), is about 29,781 gallons to date (Tables 1 and 3). Influent concentrations of IHSs in recovered groundwater for 2021 are shown on Figures 5 through 7, and listed in Table 1.

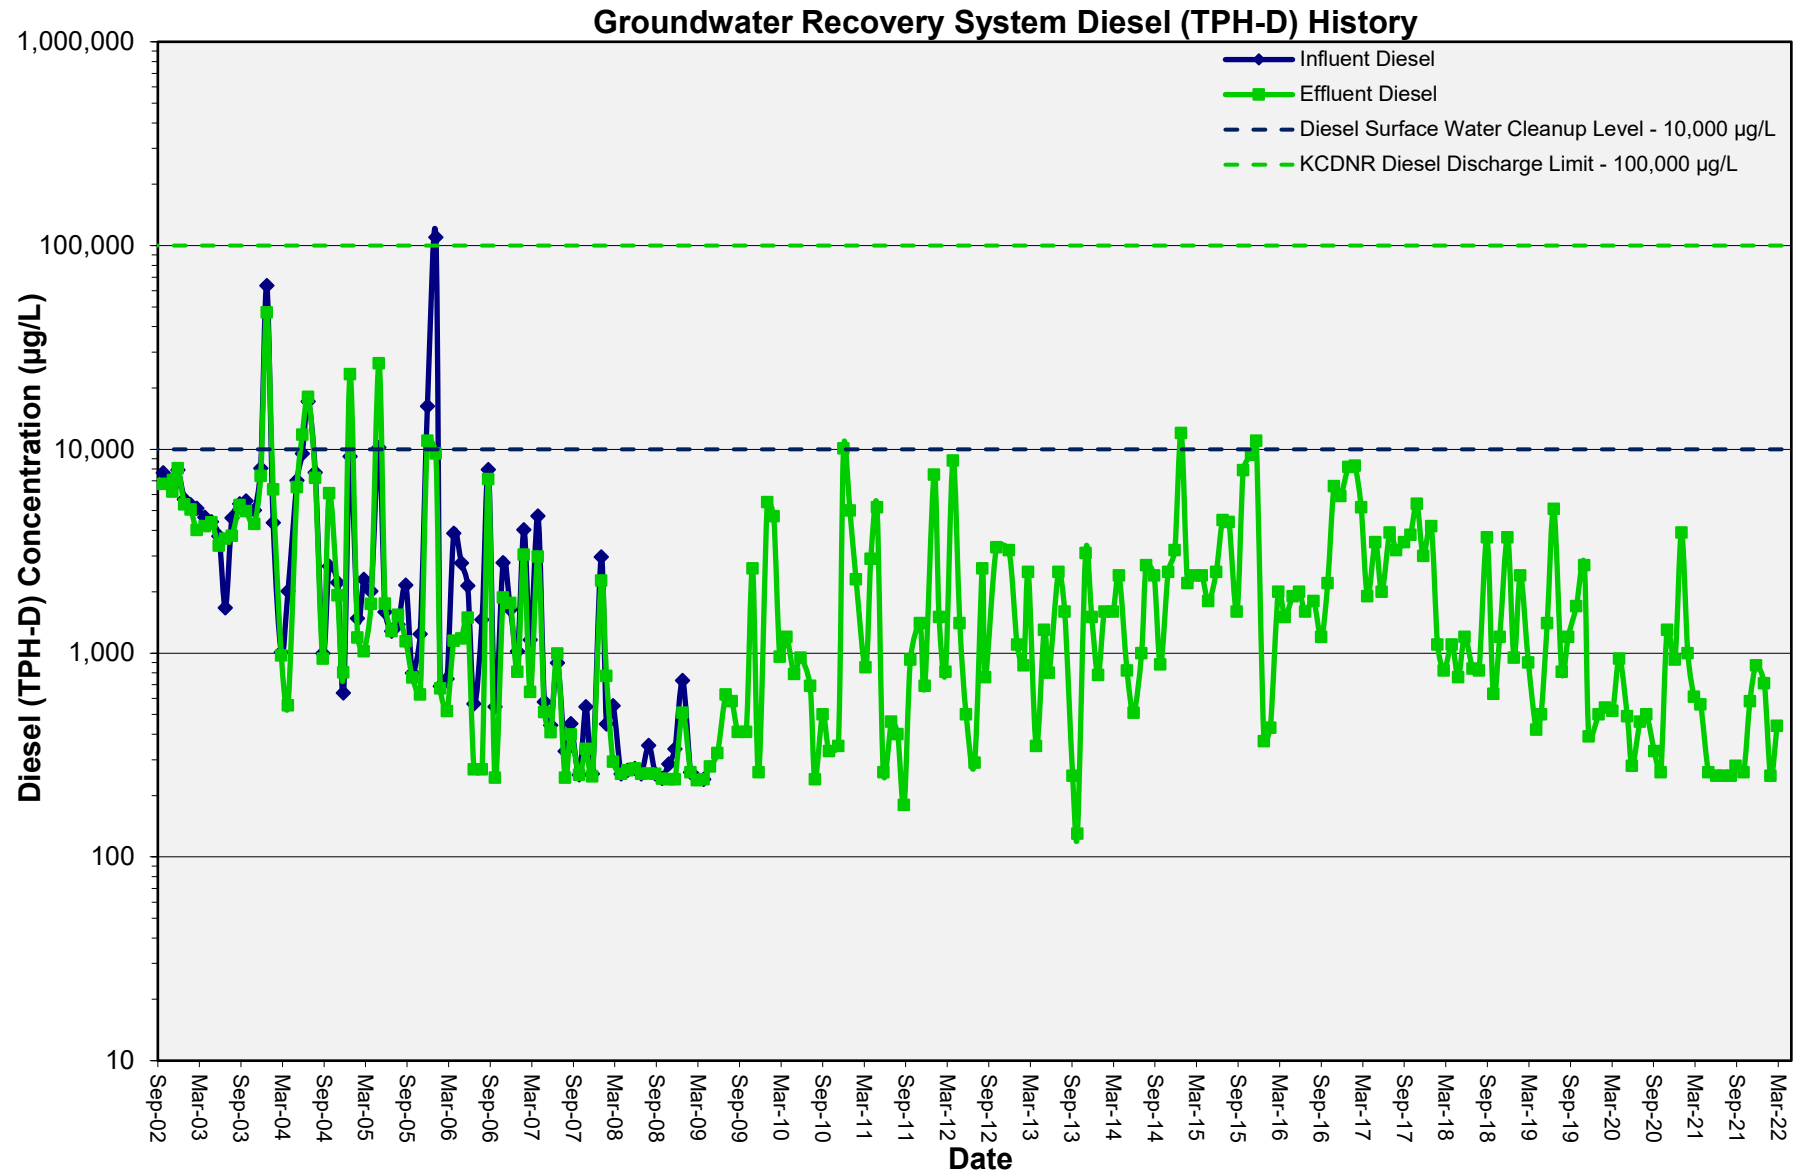
Figure 7. Final System Influent vs. Effluent Diesel Concentrations
October 2002 through March 2022
Site: Former BP Harbor Island Terminal

Note: Data is included since startup of the final groundwater and product recovery system in 2002.

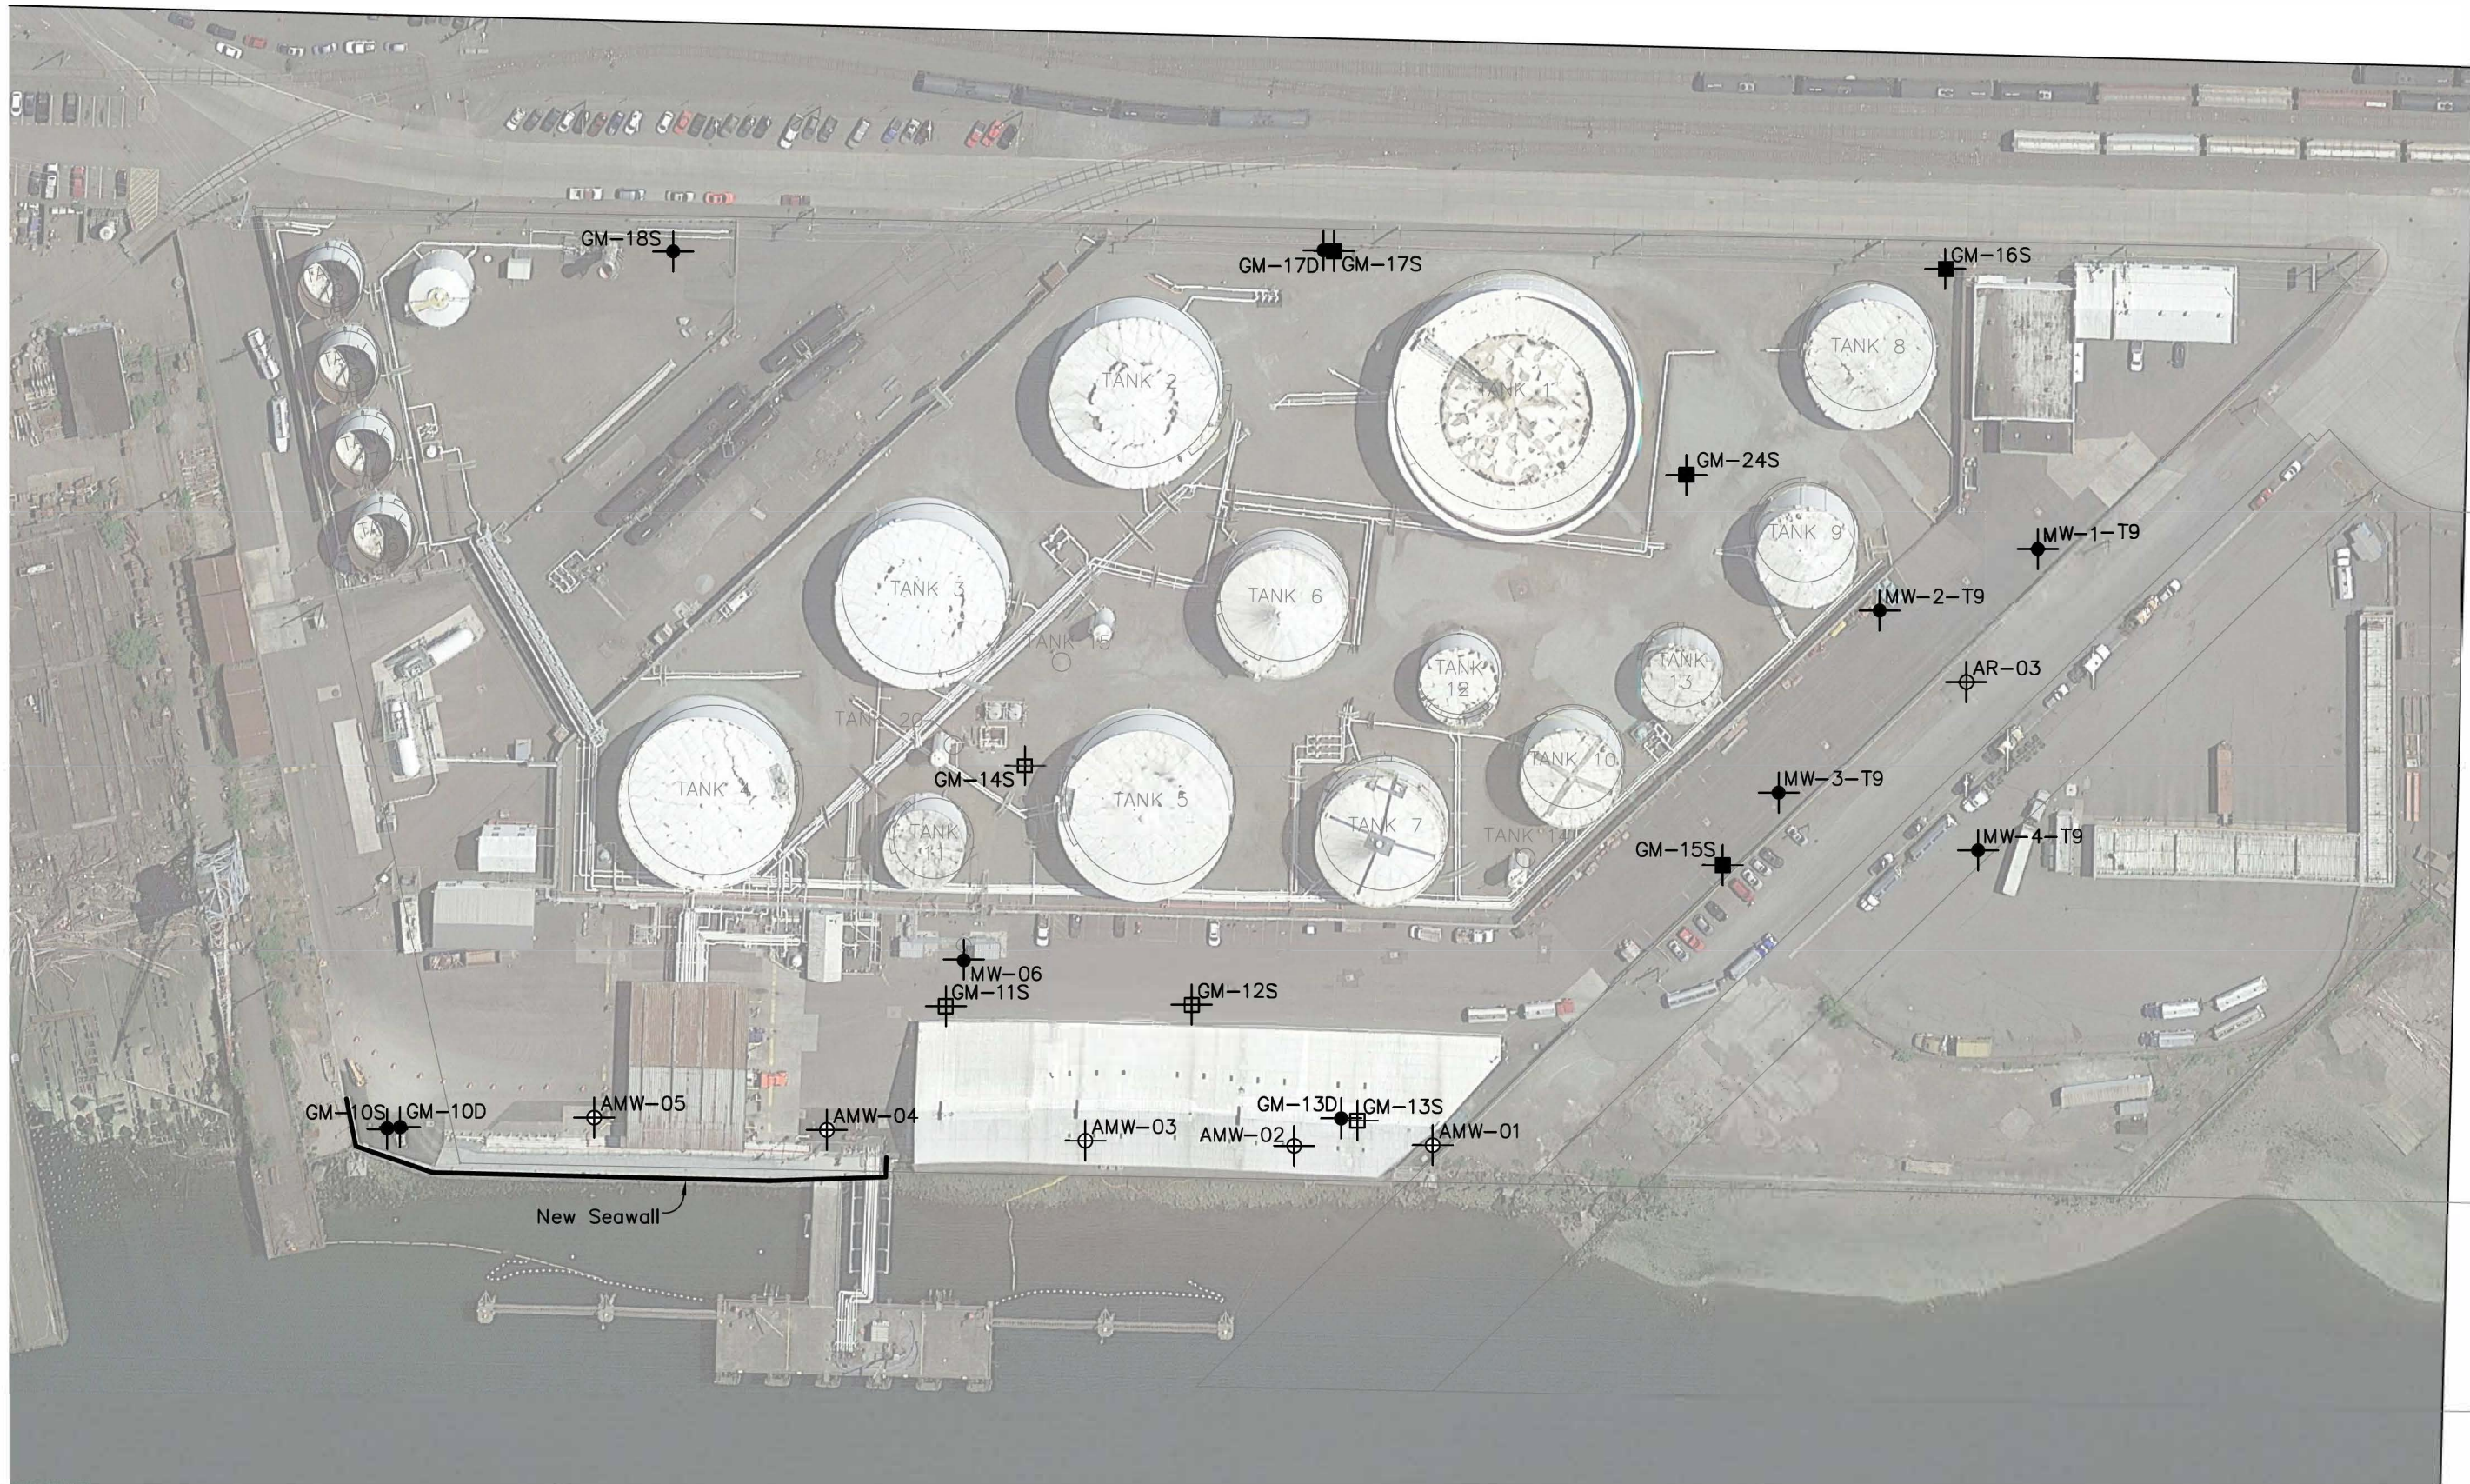
Plant 1 Monitoring Well Network

●	GM-16S	MONITORING WELL
○	IAMW-01	PERFORMANCE/CONFIRMATION WELL
■	GM-13D	PERFORMANCE WELL
□	GM-13S	PRODUCT PERFORMANCE WELL
