Technical Memorandum

RE: **Burnt Ridge Closure Summary**
Emerald Kalama Chemical/Fire Mountain Farms
Fire Mountain Farms Storage Units
Onalaska, Washington
Landau Project No. 0066045.110.114

This technical memorandum provides a summary of closure activities for the Burnt Ridge storage facility (Burnt Ridge) operated by FMF. From June 23, 2020 through November 28, 2022, FMF completed the facility's closure in accordance with the Final Closure Plan (Landau 2020), which was prepared for all three facilities as stipulated in the Agreement. Closure activities for Burnt Ridge are described in the following sections and consisted of water removal; mixed-material solids dewatering, removal, and disposal; decontamination; and collection of confirmation samples.

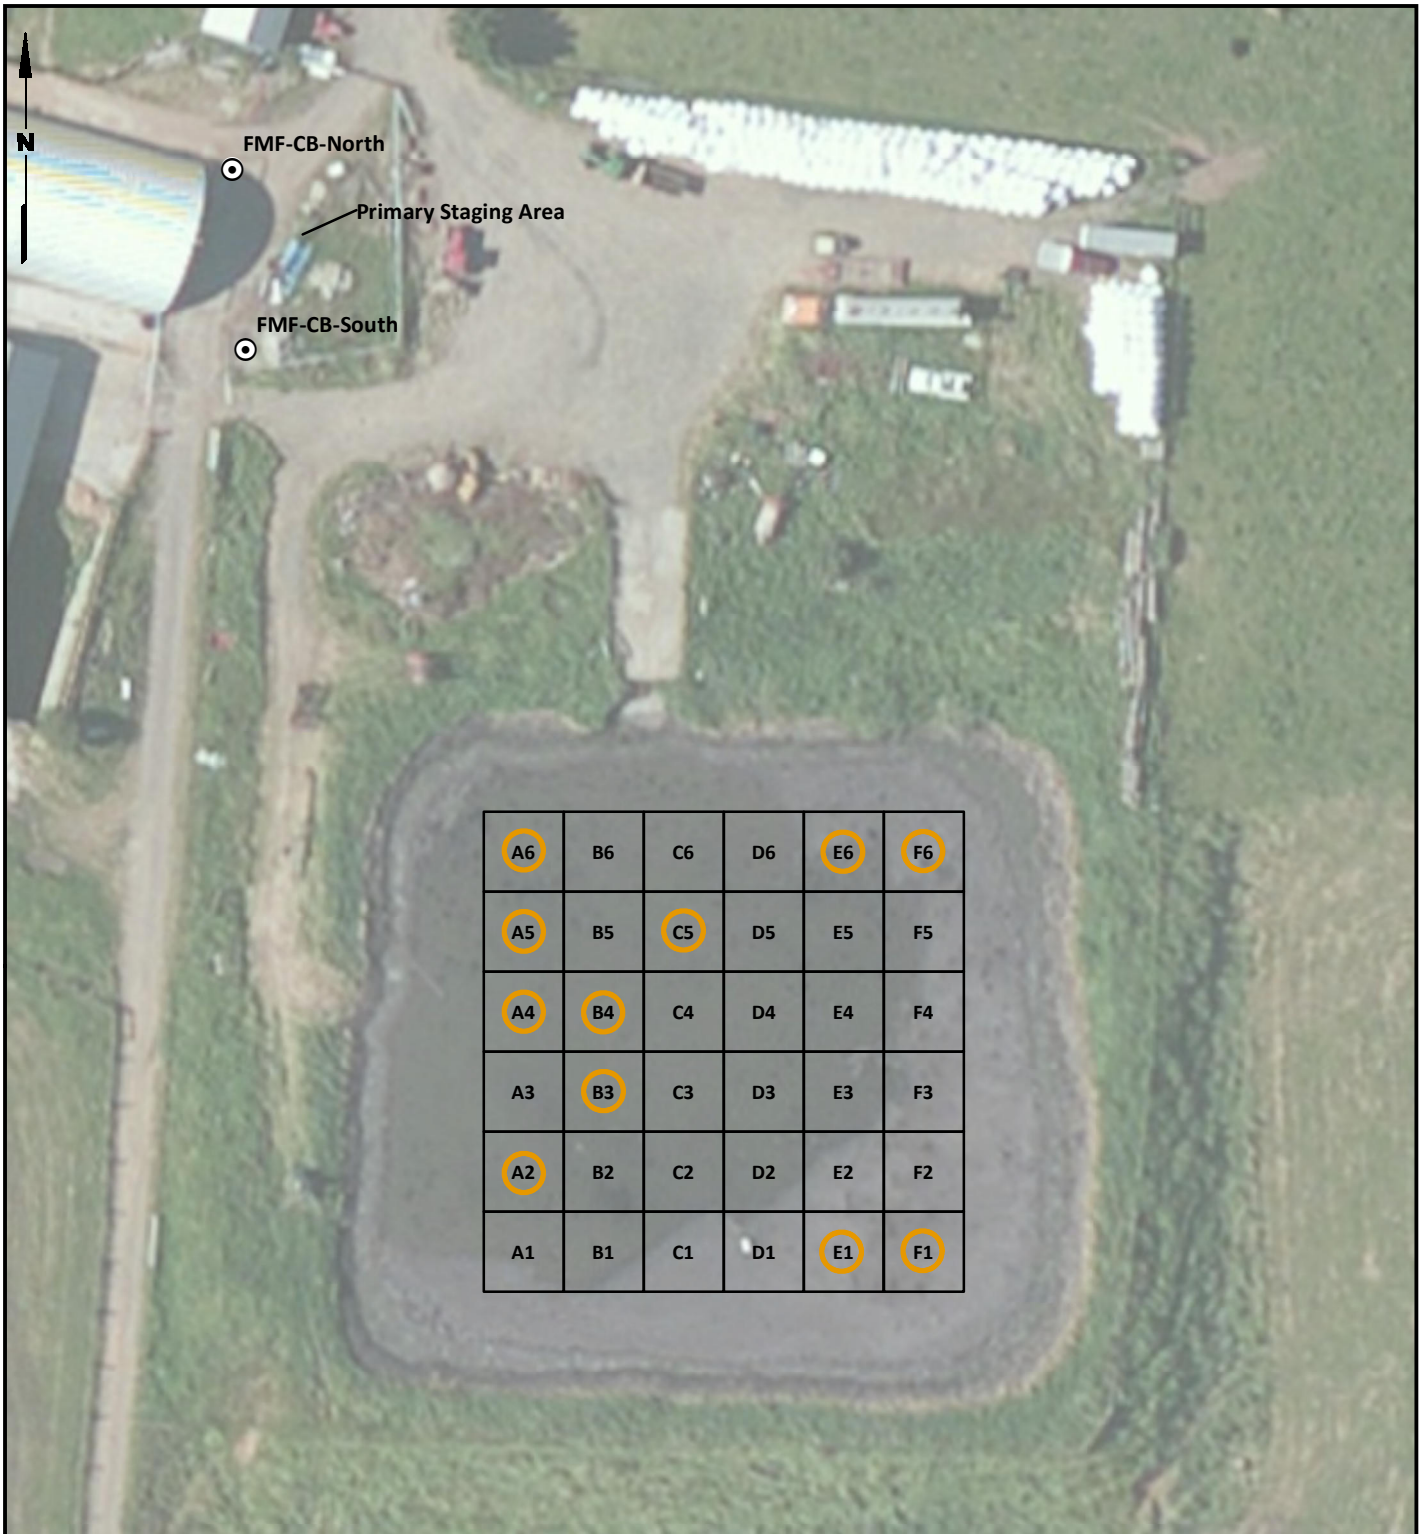
During the third phase of manual mixed-material removal, most of the soil cap throughout the central portion of the storage unit (Figure 3; columns B, C, D, and E, rows 2 through 5) could not easily be segregated from the mixed material by the manual means employed and, as a result, was removed and incorporated into the material hauled to landfill. Portions of the geosynthetic liner in this central area of the storage unit were damaged such that the underlying soil was exposed. The damaged liner was pointed out to and observed by Ecology and, following discussion of the confirmation sampling process, the exposed subgrade below the liner was specifically identified for confirmation sample collection, as discussed below.

Landau collected 11 soil samples from the bottom of the Burnt Ridge storage unit on September 16, 2022. As shown on Figure 3 and as discussed in Section 2.2.1 of the Closure Plan (Landau 2020), these 11 confirmation sampling locations were determined using the same methods described in the Waste Characterization Plan for sampling mixed material (Landau 2017a). The specific portion of the subgrade material sampled within each of the 11 cells was selected in the field following Ecology concurrence.

Analytical results for the 11 soil confirmation samples collected from the base of the storage unit (Figure 3) were below the MTCA Method A soil cleanup levels for both benzene and toluene (Table 1). Toluene was detected in six of the 11 samples at concentrations significantly below the MTCA Method A soil cleanup level and benzene was not detected above the laboratory reporting limit. The benzene reporting limit for 1 of the 11 samples (FMF-BR-C5) was slightly elevated due to matrix interference encountered by the laboratory while running the analysis, which required a dilution. The required dilution resulted in an elevated reporting limit slightly above the MTCA Method A cleanup level for benzene; however, based on results from the other 10 samples in which benzene was not detected and reporting limits were below the MTCA Method A cleanup level, the sampling results collectively demonstrate that neither benzene nor toluene was present at concentrations exceeding MTCA Method A soil cleanup levels.

Analytical results for the two water samples collected from the catch basins located in the temporary upland solids staging area (Figure 3) are provided in Table 2. Benzene and toluene were not detected above their respective laboratory reporting limits. These sampling results support the conclusion that the staging area controls were effective at preventing the release of liquids into the stormwater system.

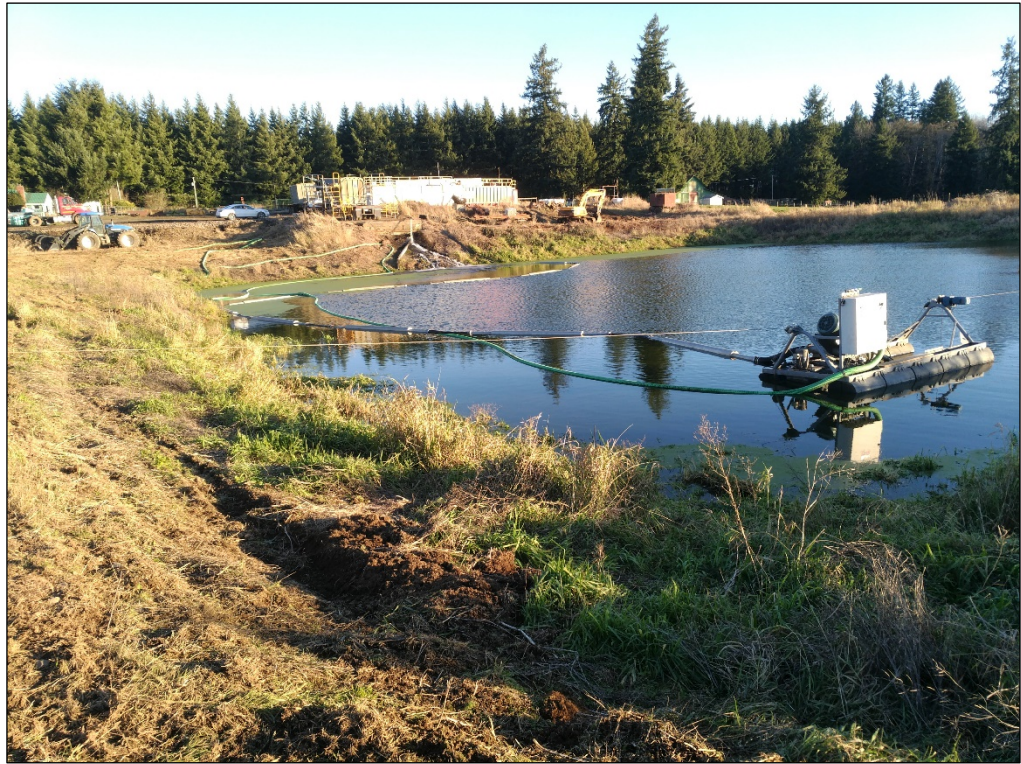
parallel at rates up to 200 gallons per minute each. Filtrate water from the centrifuge was recirculated back to the unit. A photograph of the dredge and centrifuge is provided in Attachment 1. The centrifuge was stopped once the influent mixed-material solids content was less than 3 percent, which is the limit of the operable range for that equipment. A total of 1,516 tons (approximately 1,799 cy) of dewatered mixed material was removed during this first phase of dewatering with a significant amount of mixed material remaining in the storage unit.

1. 2020: FMF dredge in foreground, centrifuge in background, looking north.

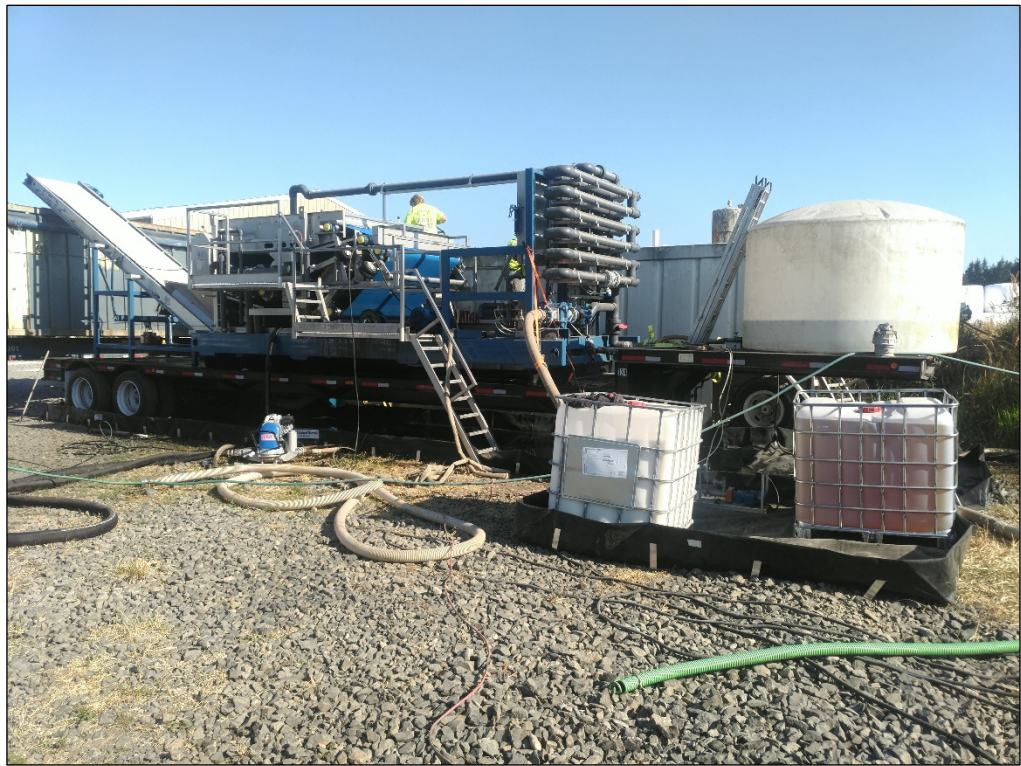
2. 2021: Belt filter press setup.

The second phase of water and mixed-material removal work occurred in 2021 and, in accordance with the Closure Plan, 1,732,362 gallons of accumulated precipitation was trucked from the storage unit to the Emerald Kalama plant for treatment between March 8, 2021 and August 12, 2021. Once the storage unit was drained to the desired level, mixed-material removal commenced by means of a large-scale BFP. Between September 2, 2021 and October 14, 2021, mixed material was removed using FMF-operated pumps to a polymer mix tank where coagulants and flocculants were added, and then processed through the BFP at rates up to 105 gallons per minute. Filtrate water from the BFP was pumped through a series of frac and weir tanks to remove suspended sediment and the clarified water was sent to the Emerald Kalama plant for treatment. The BFP work was stopped when the mixed material remaining in the unit became too coarse to be pumped; a review and approval of final material removal alternatives would be required before the third and final phase of closure work could be conducted in 2022. A total of 715 tons (approximately 848 cy) of dewatered mixed material was removed during the second phase of dewatering. A total of 363,843 gallons of BFP process water was trucked to the Emerald Kalama plant for treatment. Photographs of the belt filter press are provided in Attachment 1.

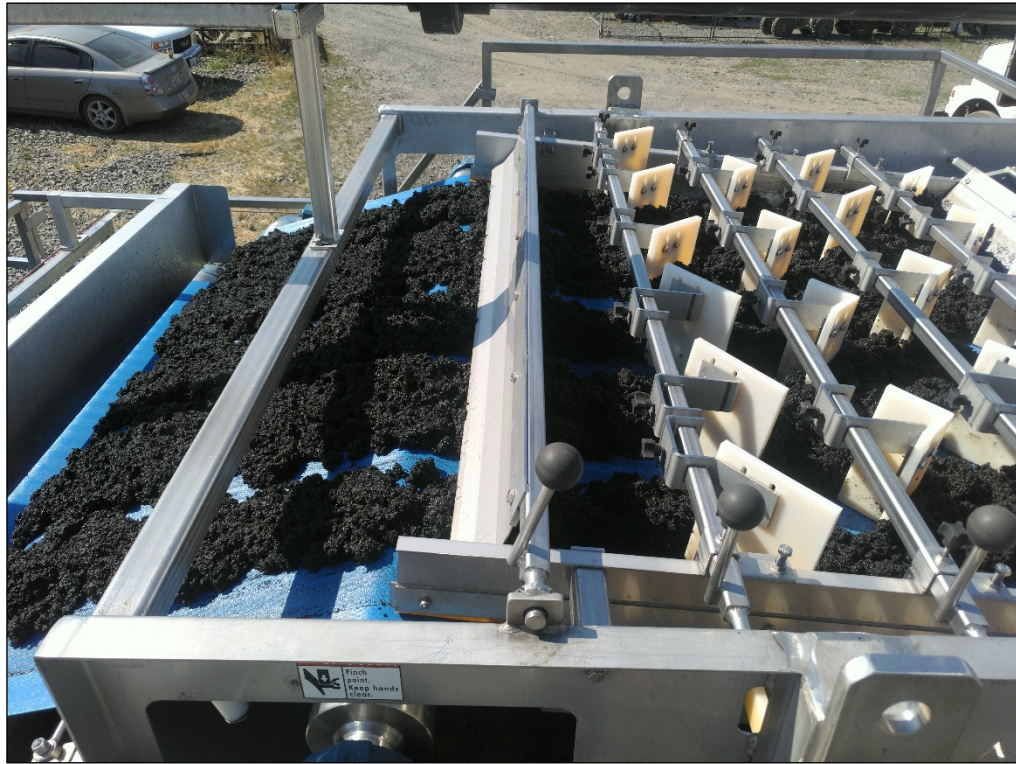
3. 2021: Belt filter press in operation.

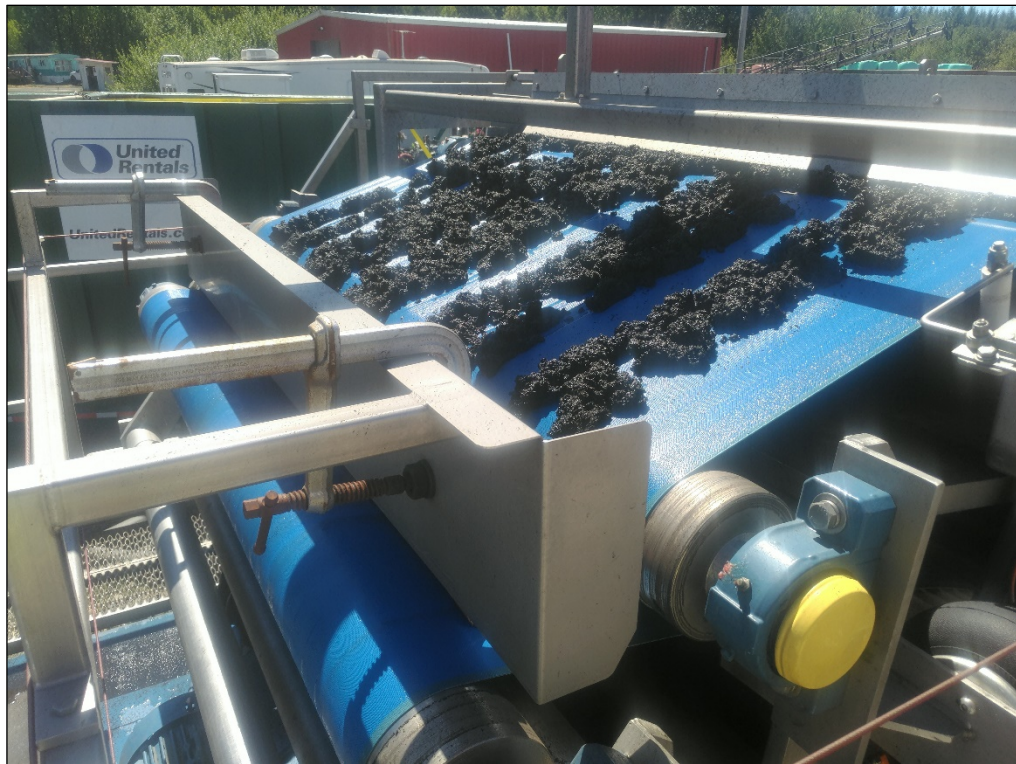
4. 2021: Belt filter press in operation.

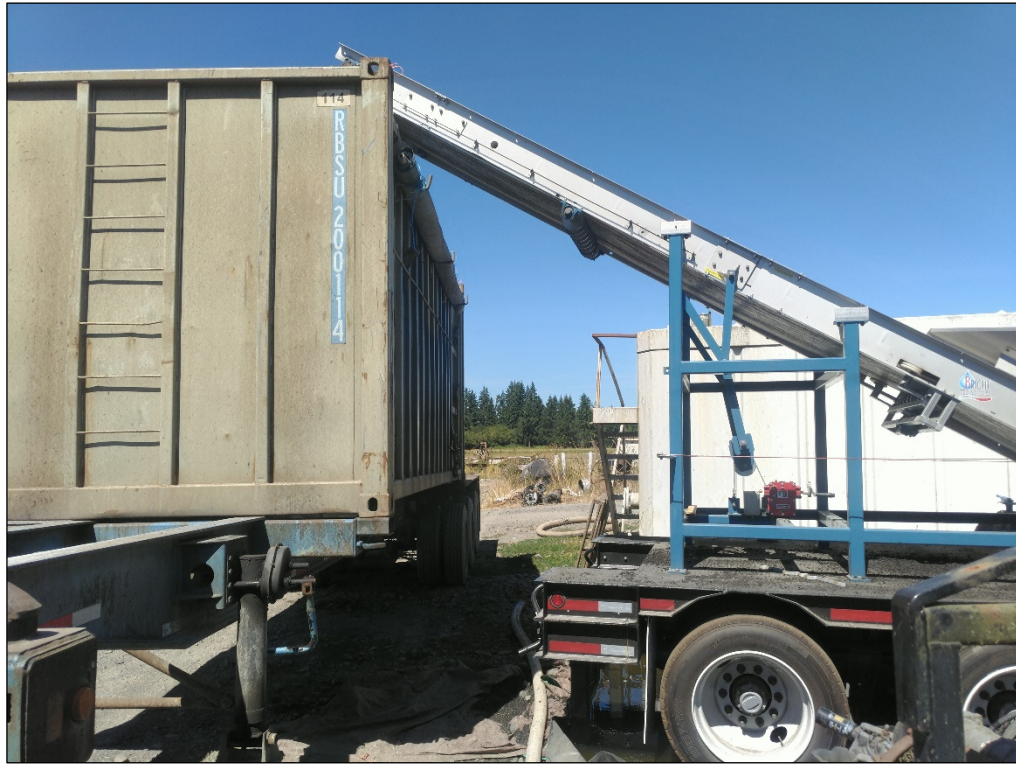
5. 2021: Belt filter press – loading LeMay container.

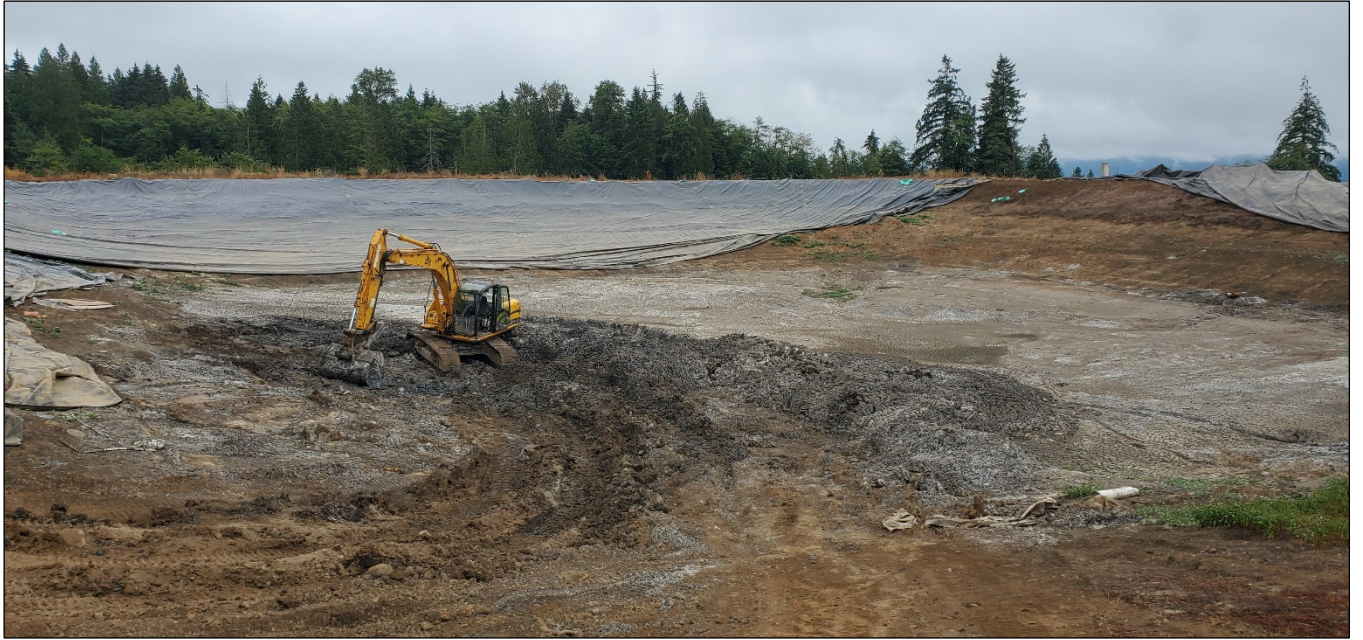
7. 2022: Mixed-material dig excavation, looking southwest.

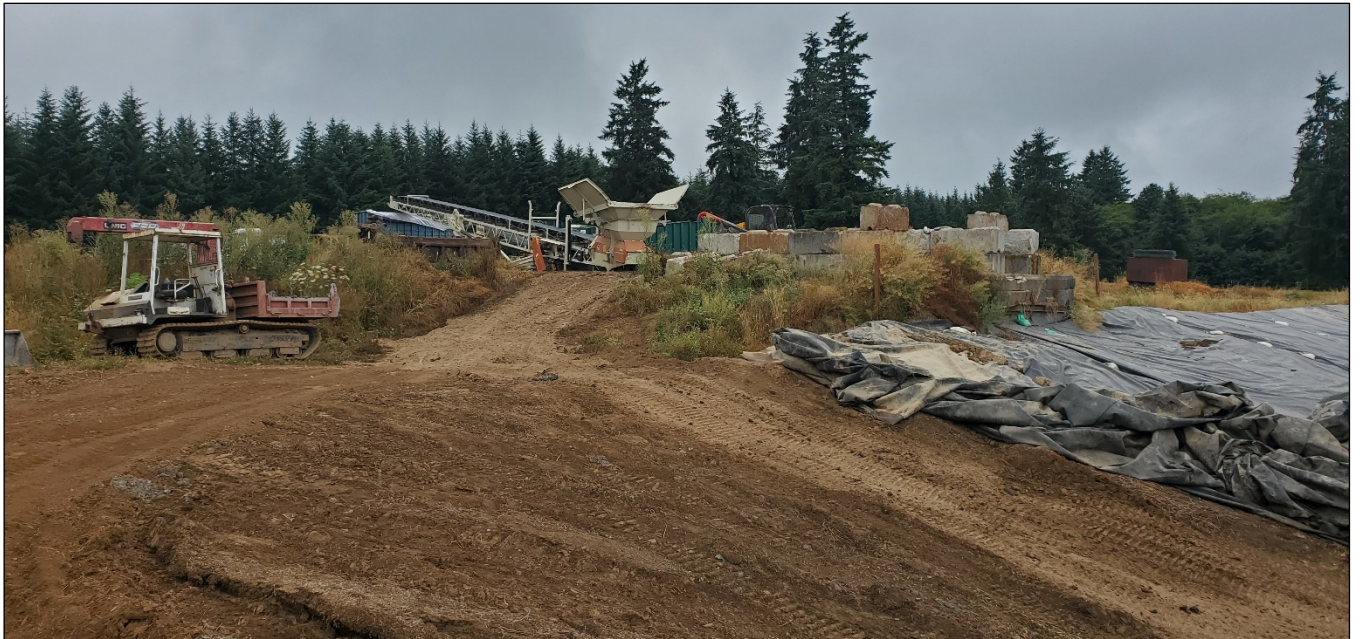
8. 2022: Haul road to conveyor, looking east.

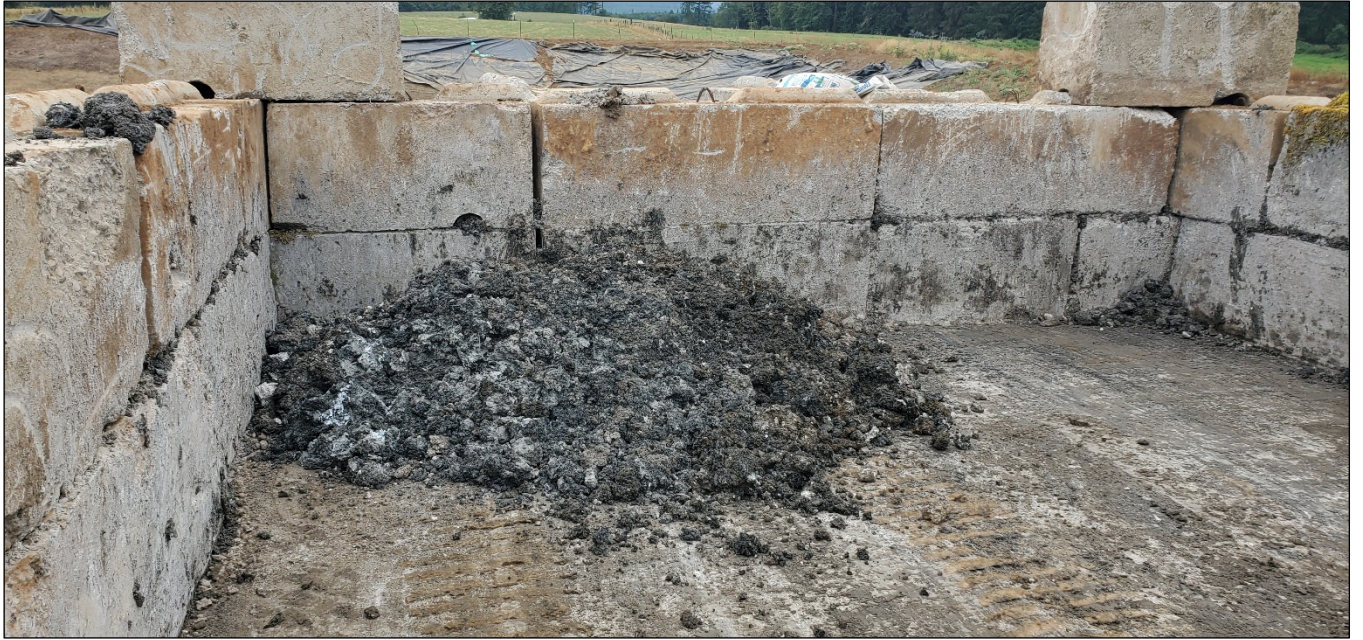
9. 2022: Mixed material temporarily staged on dump slab prior to being loaded onto conveyor.

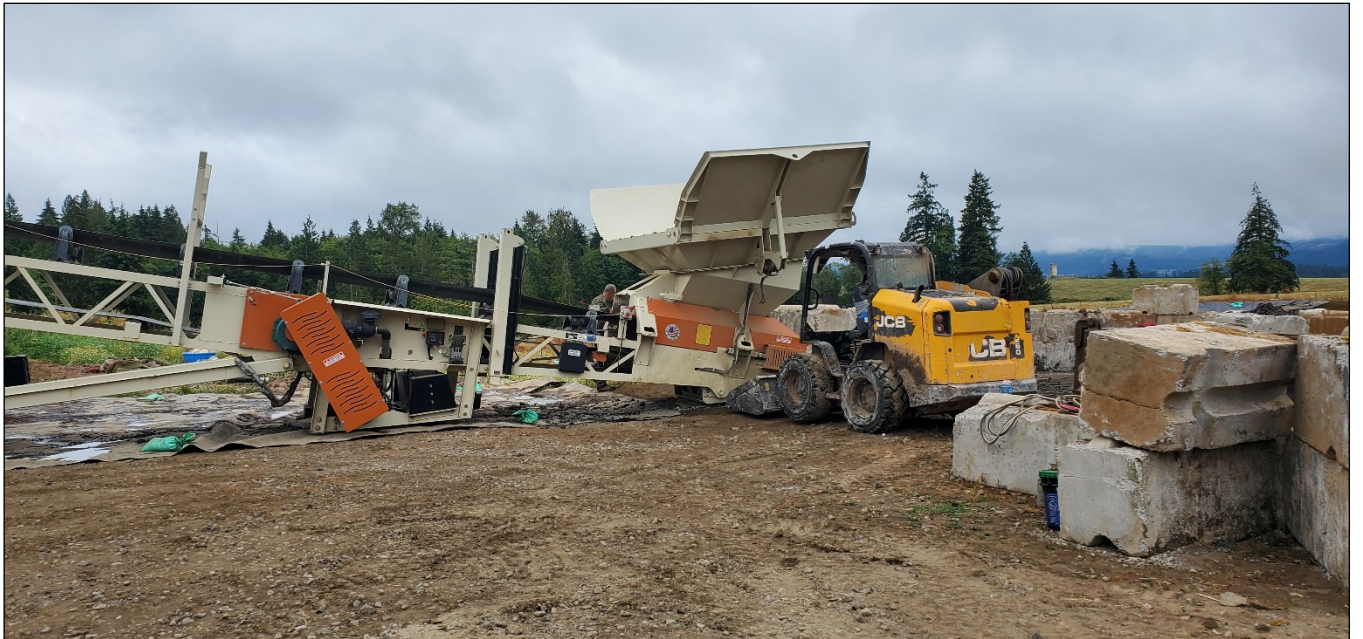
10. 2022: Mixed material being loaded on conveyor.

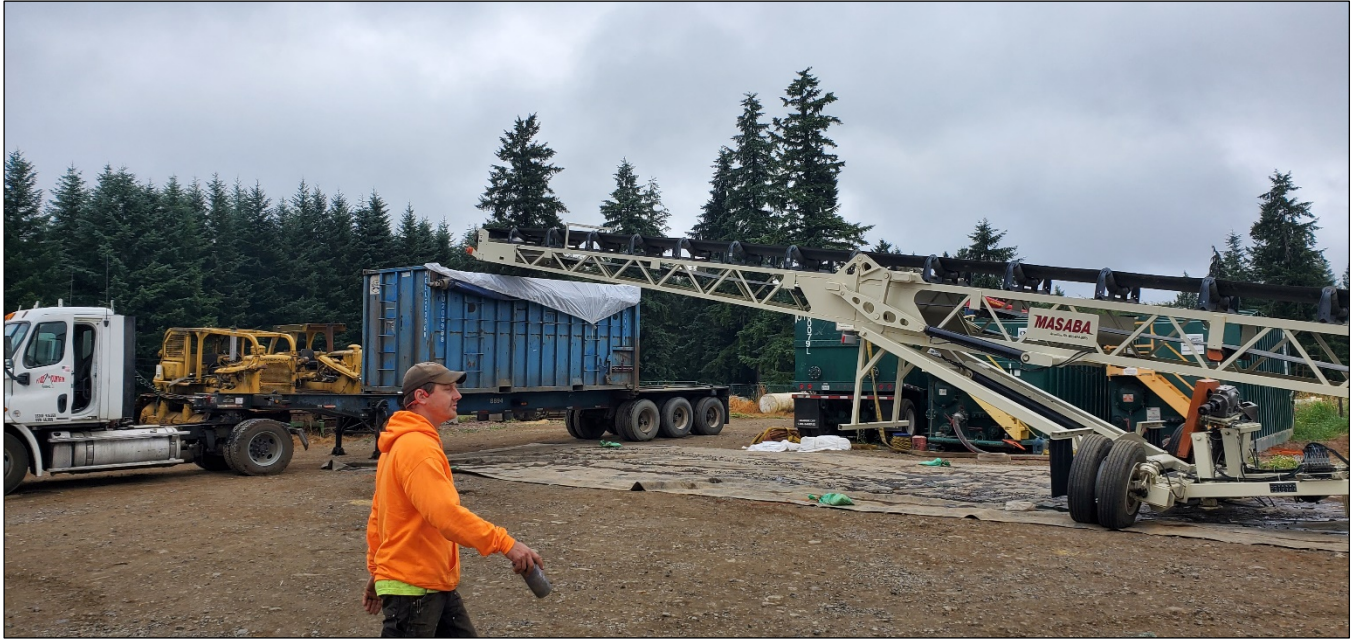
11. 2022: Mixed material conveyed into LeMay containers.

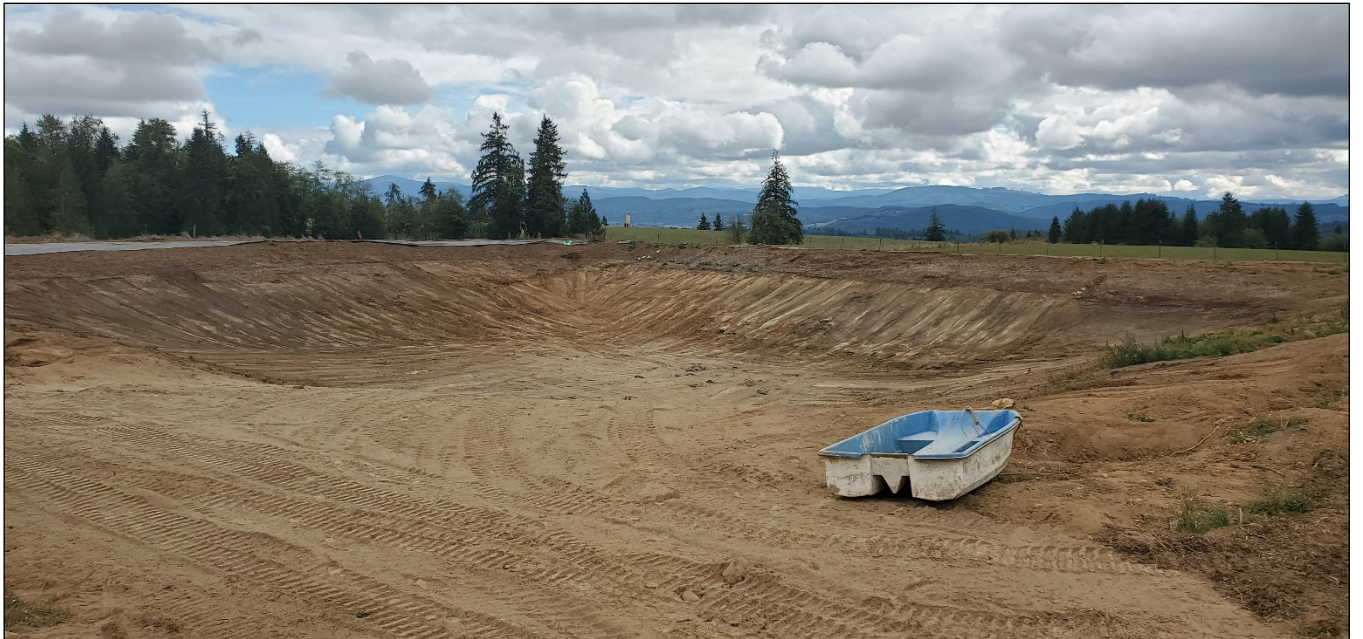
12. 2022: Mixed material removed, looking southeast.

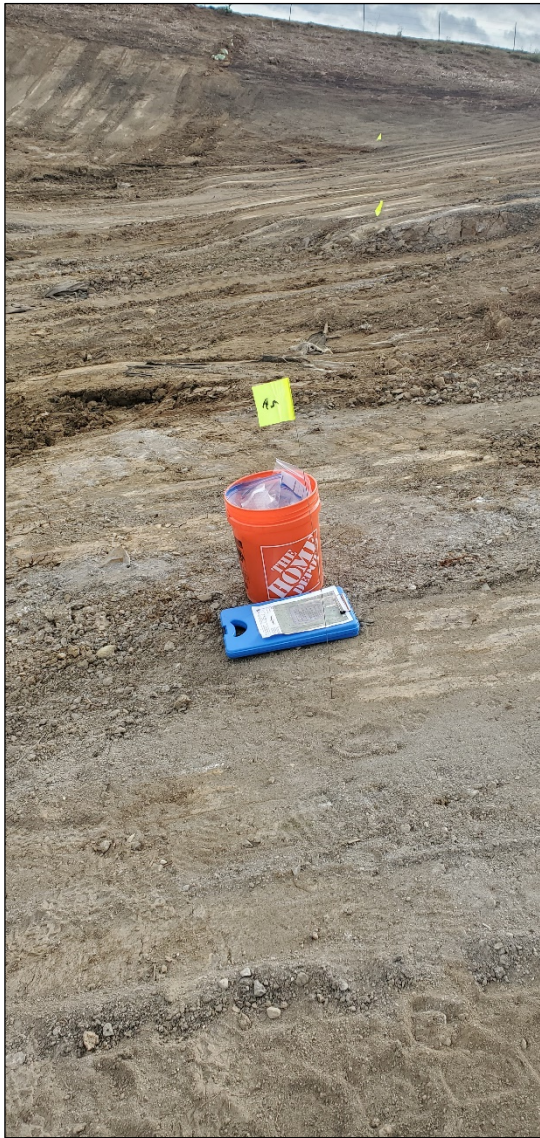
13. 2022: Confirmation sample A5, looking south.

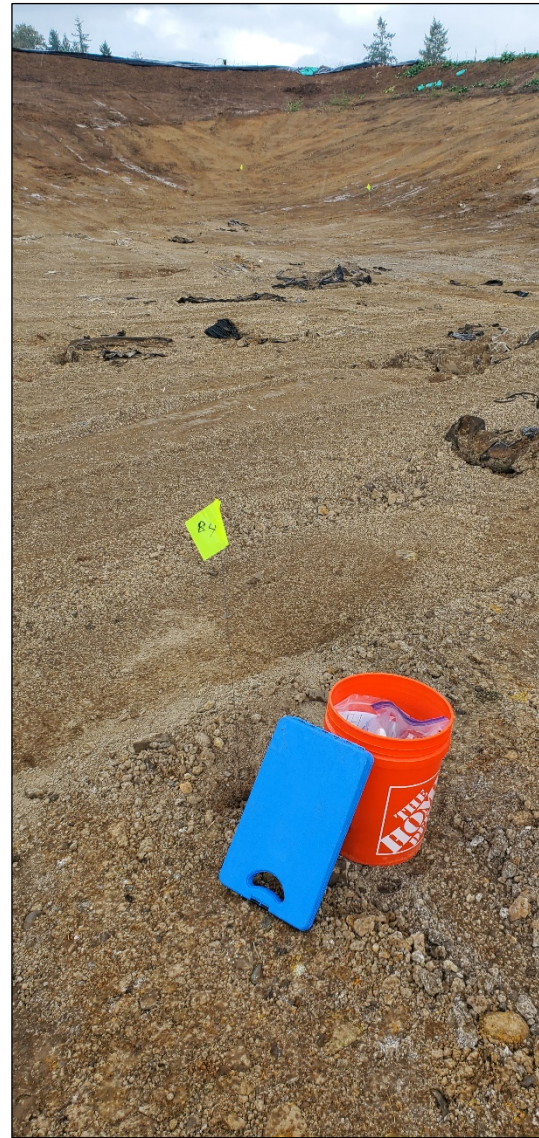
14. 2022: Confirmation sample B4, looking northwest.

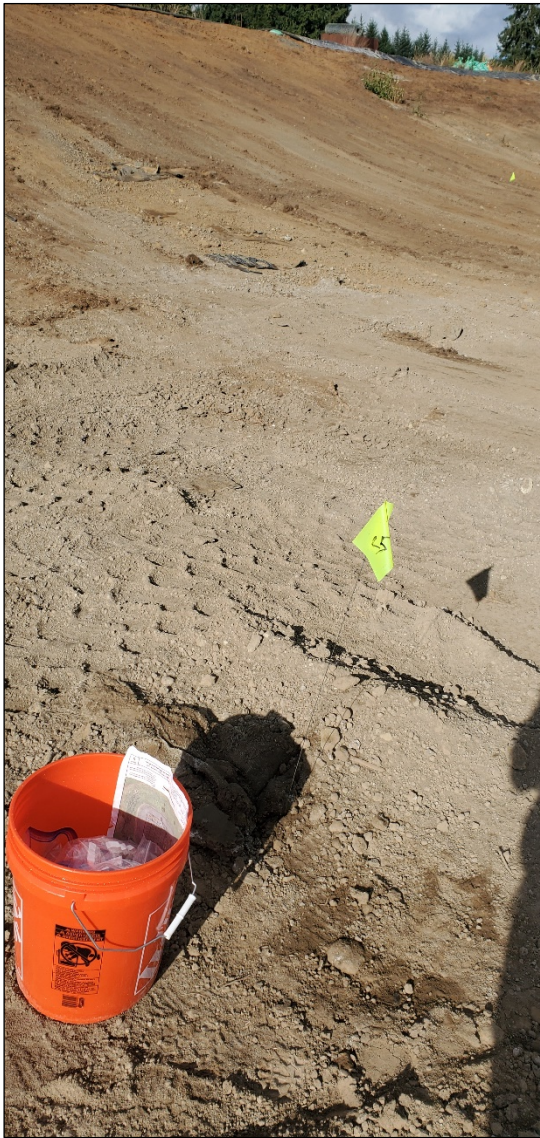
15. 2022: Confirmation sample C5, looking east.

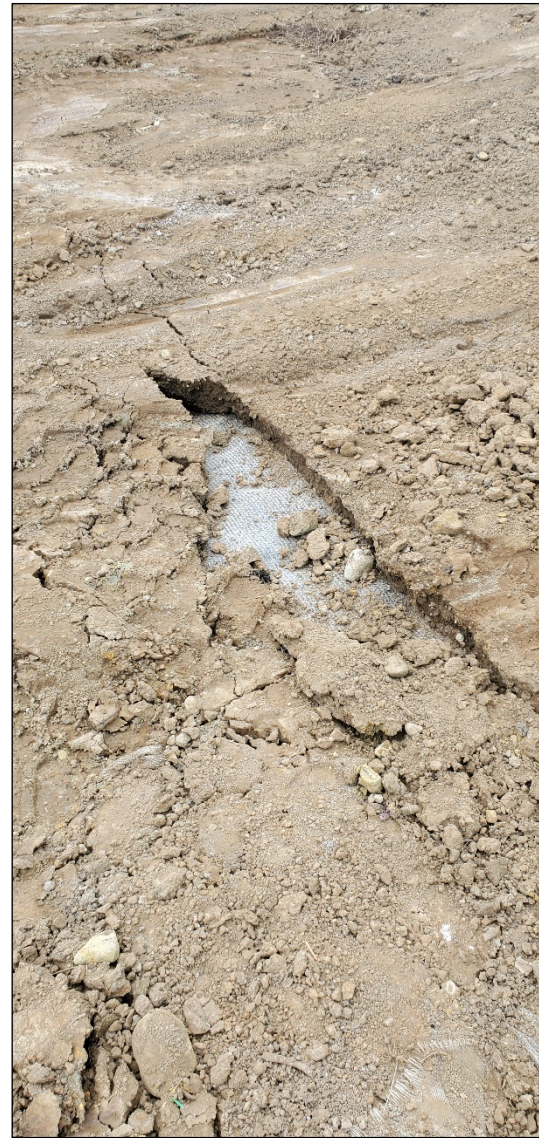
16. 2022: Liner exposed.

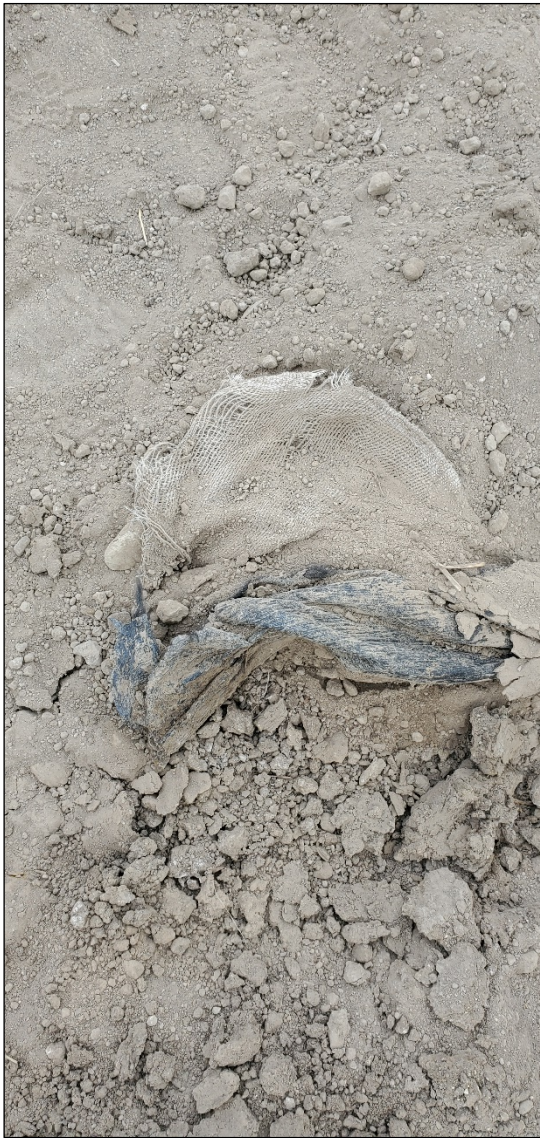
17. 2022: Damaged geosynthetic liner.

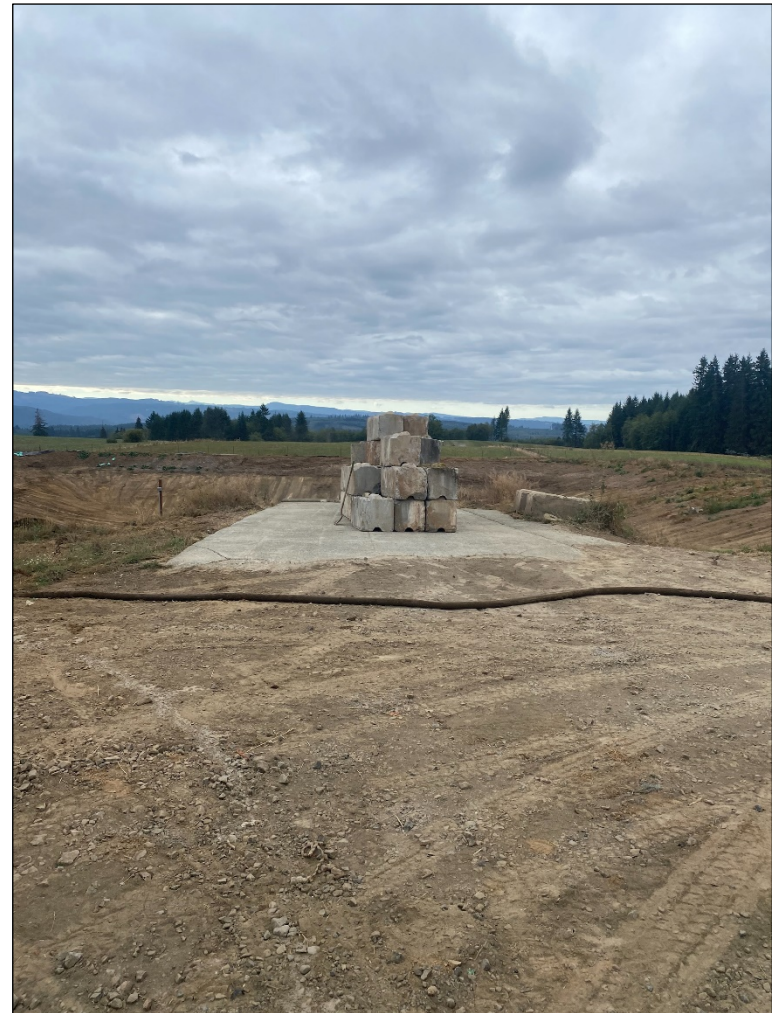
18. 2022: Dump slab loading area (cleaned), looking south.

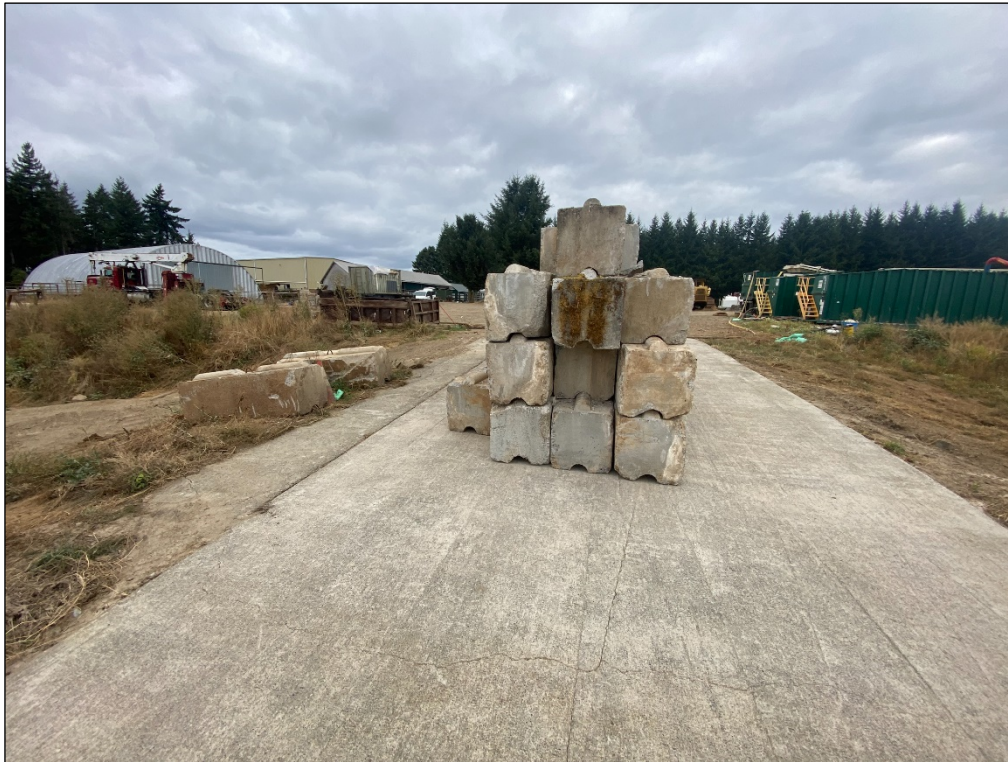
19. 2022: Dump slab truck loading area (cleaned), looking north.

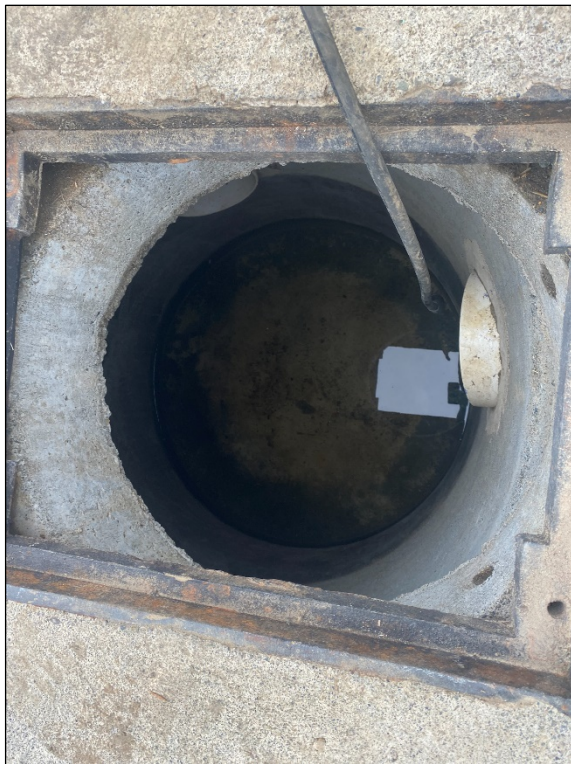
20. 2022: Upland solids staging area, FMF north catch basin after cleaning.

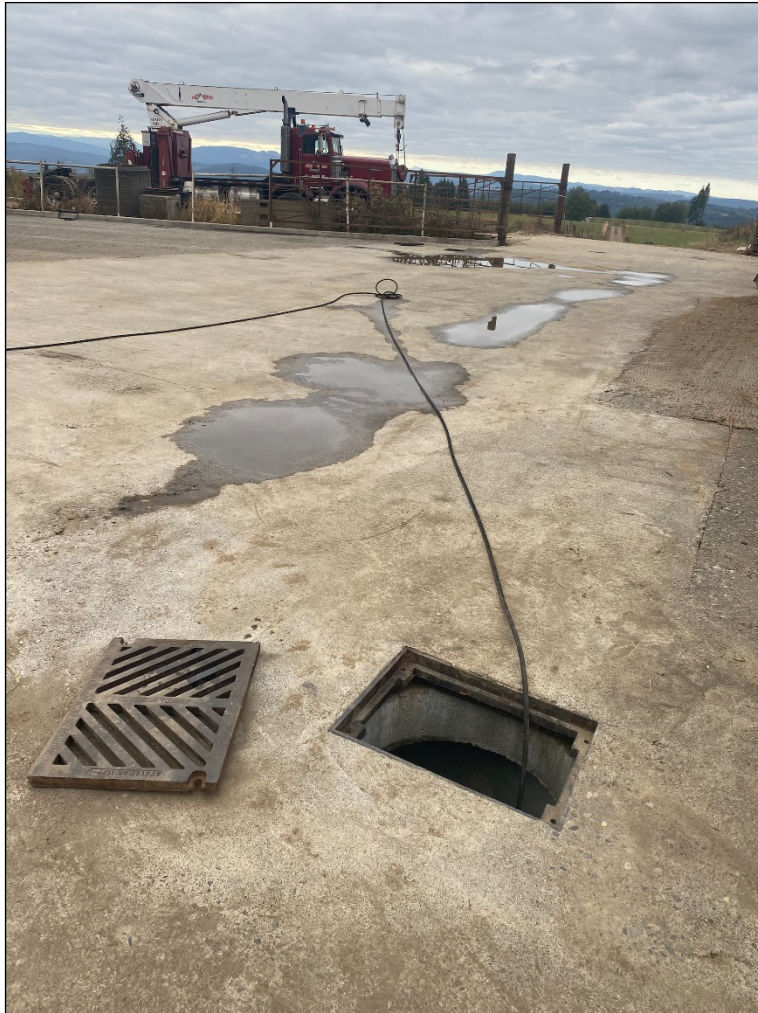
21. 2022: Upland solids staging area, FMF north catch basin sampling location after cleaning, looking south.

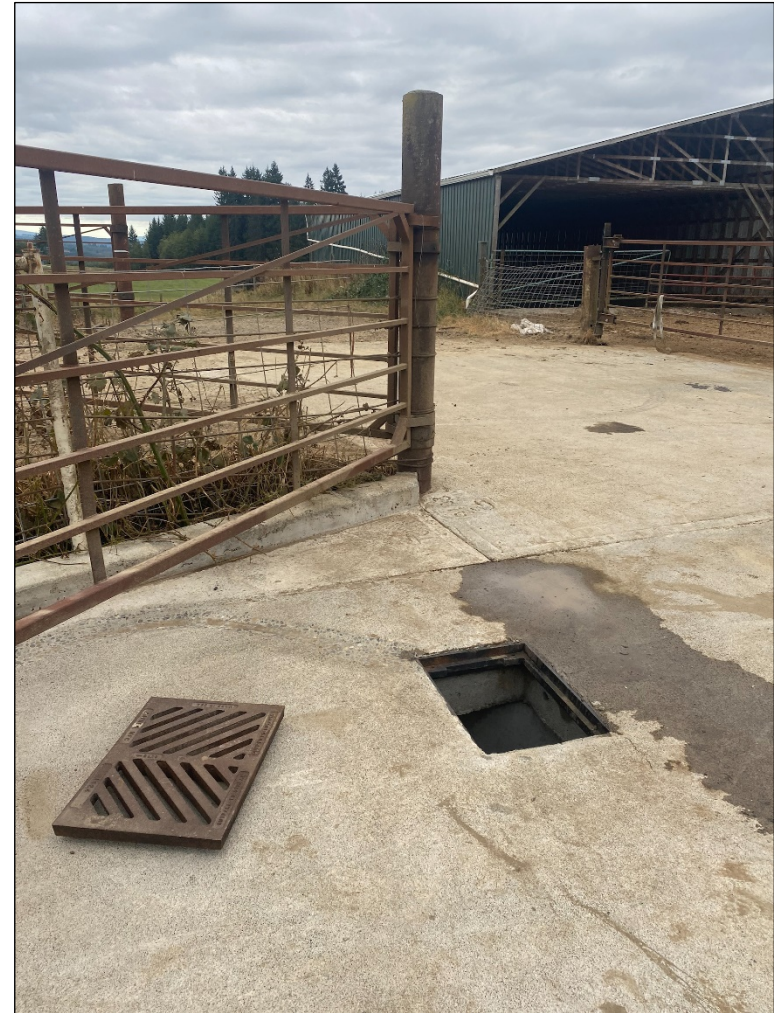
22. 2022: Upland solids staging area, FMF south catch basin sampling location after cleaning, looking west.

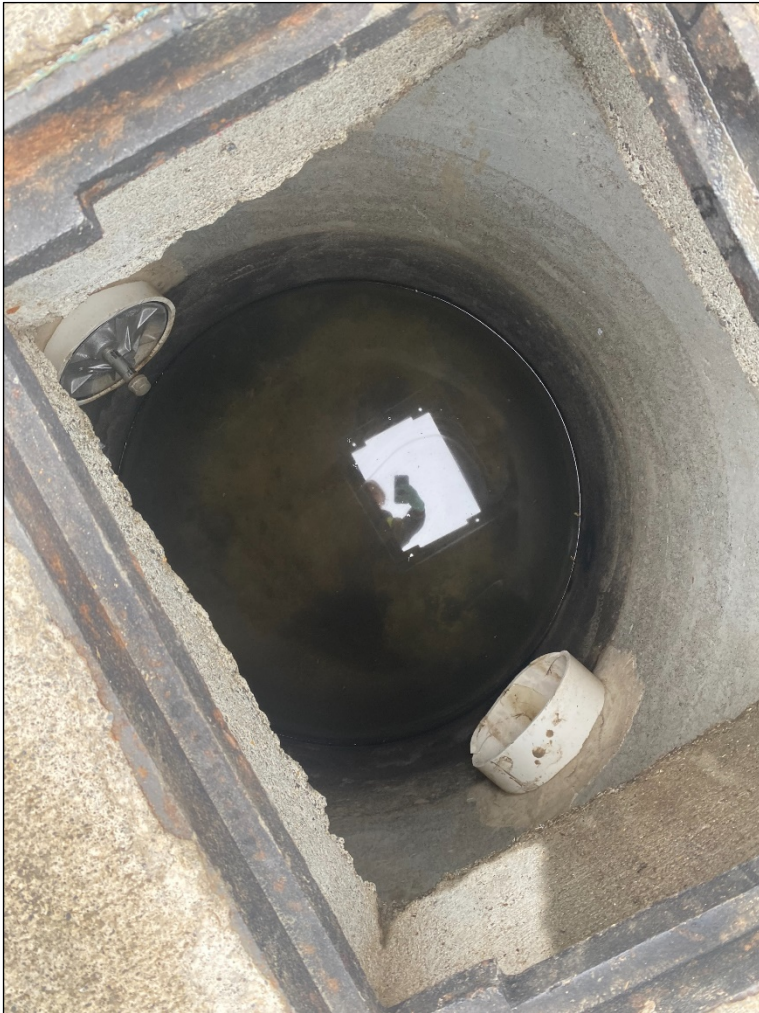
23. 2022: Upland solids staging area, FMF south catch basin after cleaning.
