Technical Memorandum

Date:	January 17, 2023	From:	Kellie M. Miller, L.G.
To:	Washington State Department of Ecology	Project Manager:	Timothy S. Brown, L.Hg.
	15700 Dayton Avenue North	Principal/Associate:	Timothy S. Brown, L.Hg. <i>T.S. Brown</i>
	Shoreline, Washington 98133	Project Name:	Former Mill E/Koppers Facility
Attn:	Ms. Sandra Matthews	Project No:	20050654V001
Subject:	2022 Annual Performance and Compliance Monitoring Report

FORMER MILL E / KOPPERS FACILITY
 EVERETT, WASHINGTON

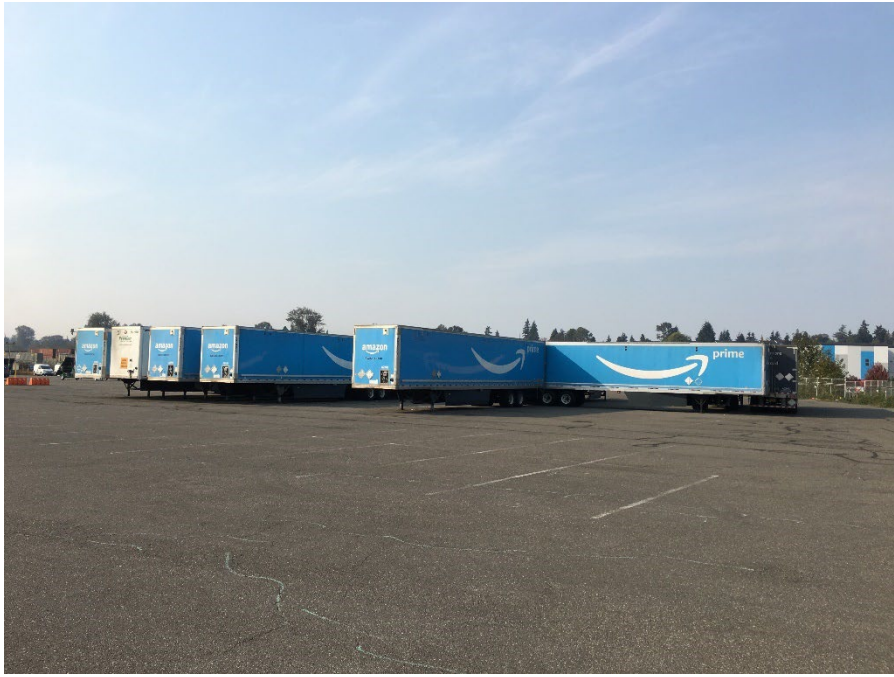
Photo 1. Looking west at the northern portion of the cap. Many cracks are observed to be repaired.

Kellie Miller with AESI was onsite to perform visual site observations. The property is currently occupied by Amazon service vehicles, several which were parked at the time of our visit. White paint marked parking spaces on the site. Majority of the cap, approximately 90 to 95 percent was visible at the time of the site visit. The asphalt cap was observed to be in serviceable condition. The northeast portion of the cap was observed to have repair work done on the cracks (photo 1). An abundant amount of minor cracking was observed on the southern portion of the cap (photo 2). No obvious signs of major cracking, fissures, or pumping were observed. There are areas where shallow depressions were observed, which were less than 2-inches in depth from recent rainfall. These shallow depressions were less than 10 feet in diameter. Drainage ditches had minimal accumulated sediment, less than 1-inch. Minor cracks with vegetation growing through were observed along the southern drainage ditch (photo 3). A newly installed raised asphalt patch was installed surrounding PZ-1A, on the west portion of the cap (photo 4). To maintain the cap in serviceable condition, and to meet the performance objectives to prevent direct contact with contaminated soil and prevent infiltration, AESI recommends removing all visible vegetation from the minor cracks in the drainage ditches and subsequently sealing the cracks.

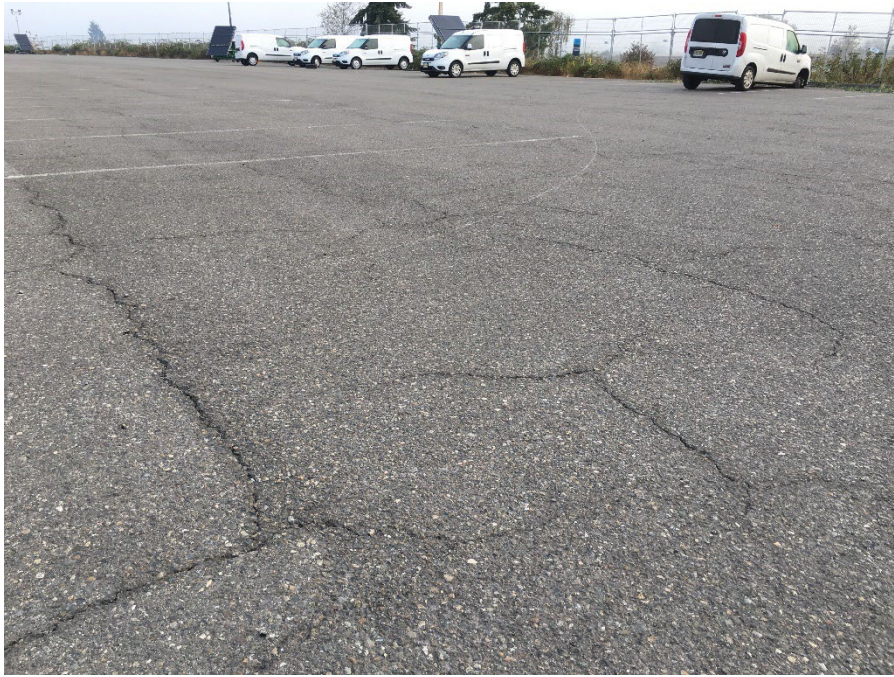
Photo 2. Looking north-northeast at the southern portion of the asphalt cap, observing minor cracking.

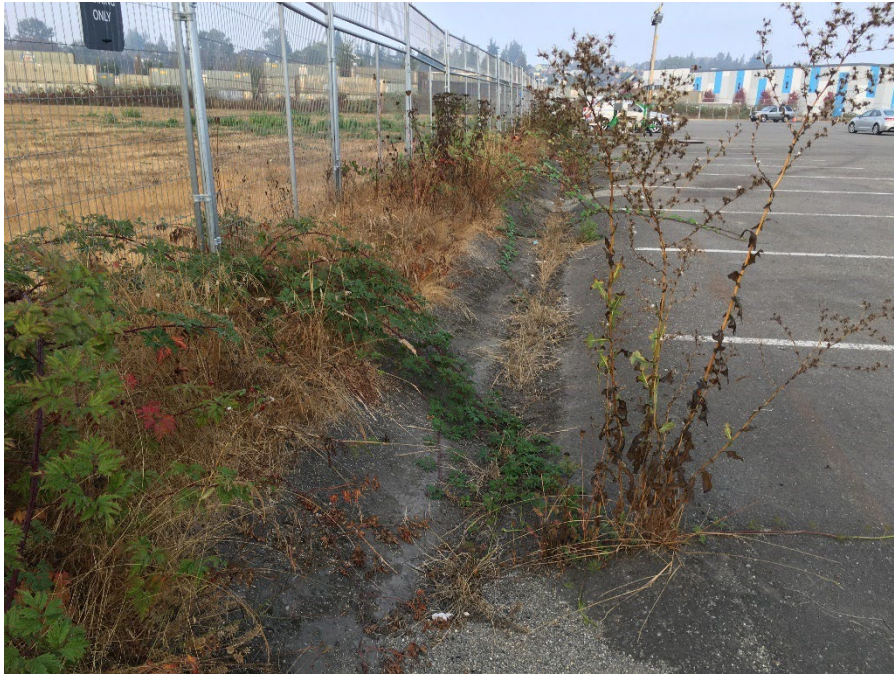
Photo 3. Looking west at the south drainage ditch. Less than 1 inch of accumulated sediment was observed. Vegetation was observed to be growing through minor cracks.

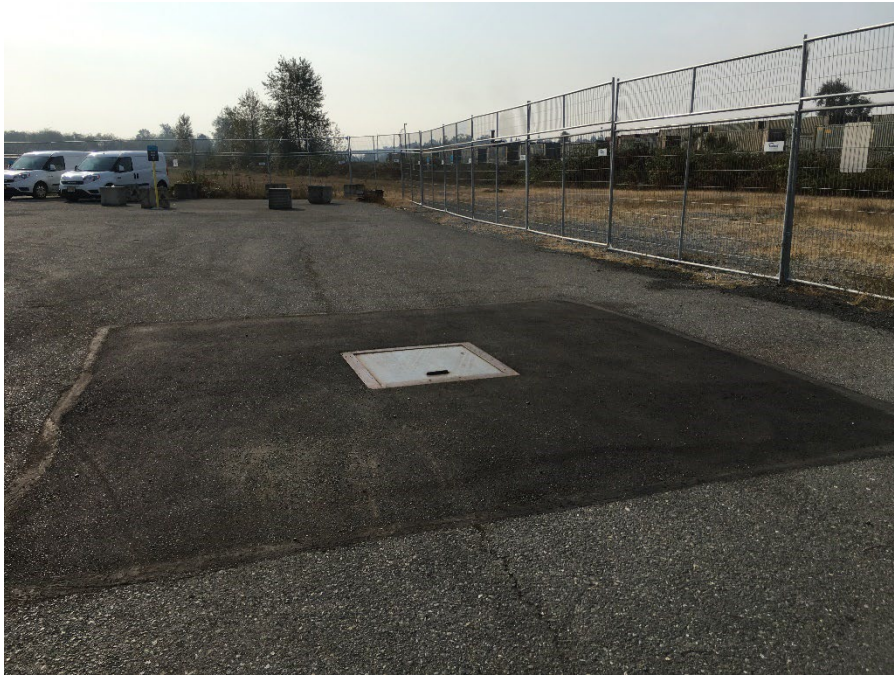
Photo 4. Observing minor cracking on the surface of the asphalt cap in the south portion of the asphalt cap.

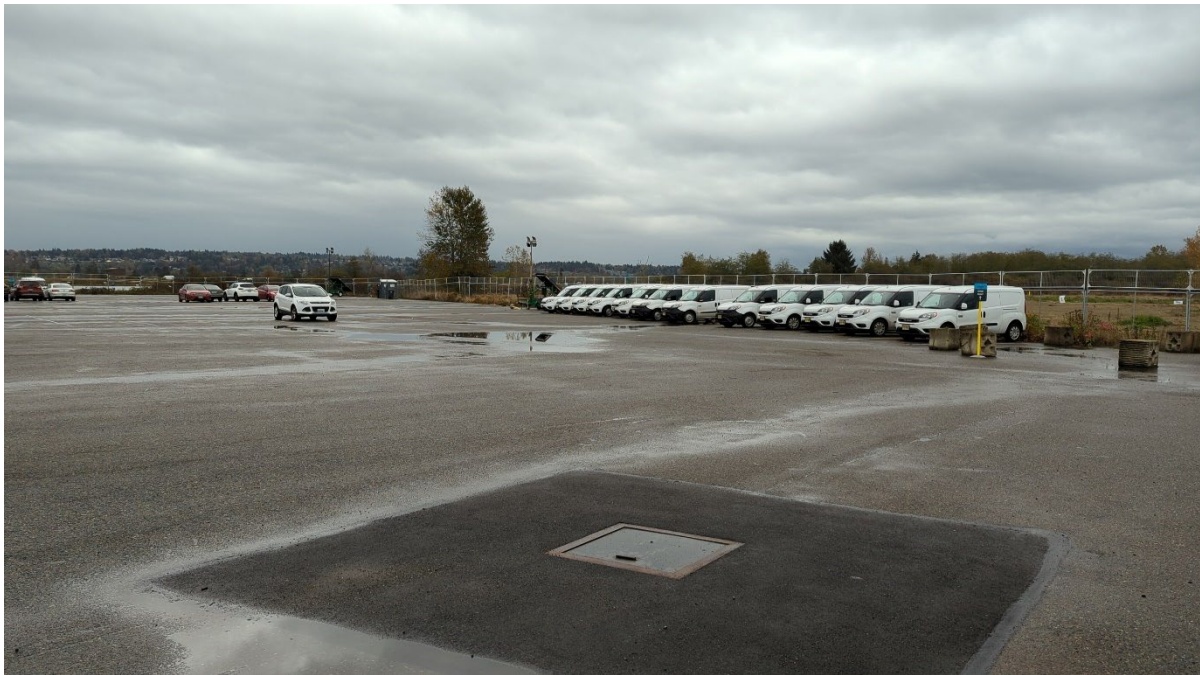
Photo 5. Facing southeast at the western and southern portions of the asphalt cap. Minor ponding is observed after a rainfall event.
