**Subject: 2021 PersulfOx Chemical Injection Event Report
Marysville Excellent Choice Auto Sales
9302, 9310, and 9314 State Avenue
Marysville, Washington 98270
RGI Project No. 2018-244-6**

The Riley Group, Inc. (RGI) is pleased to present our groundwater PersulfOx Chemical Injection Event Report. The PersulfOx chemical injection events were performed on the subject Property, the first event was performed in June of 2021 and the second event was performed in July of 2021.

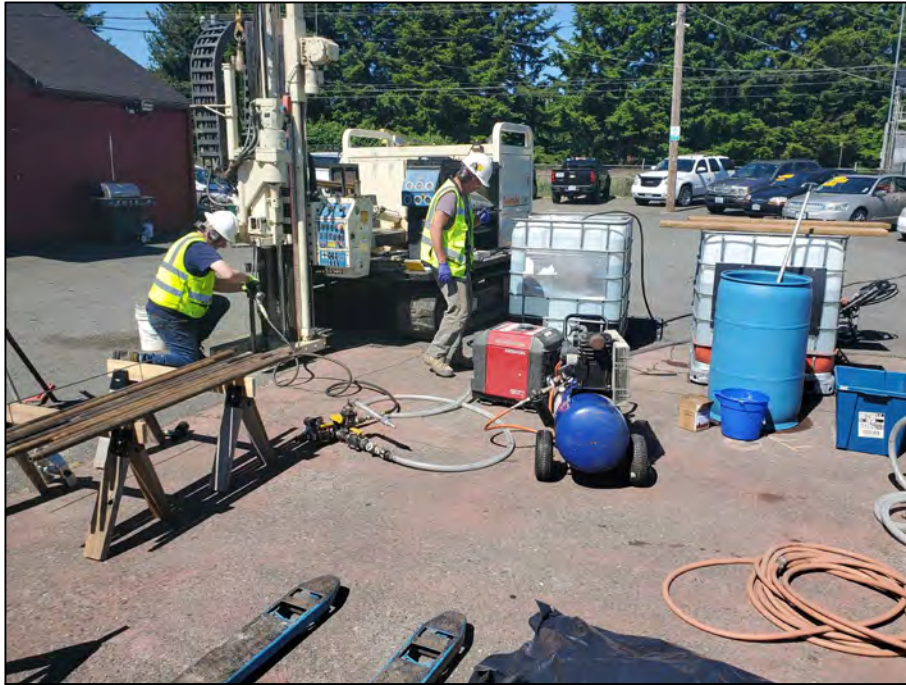
Photograph 1: View of drilling, injection tooling, air diaphragm pump, mixing tanks, rinse drums, electric compressor (later changed to gas compressor), injection manifold, generator, and various hoses and fittings. Photo taken on June 1st, 2021.

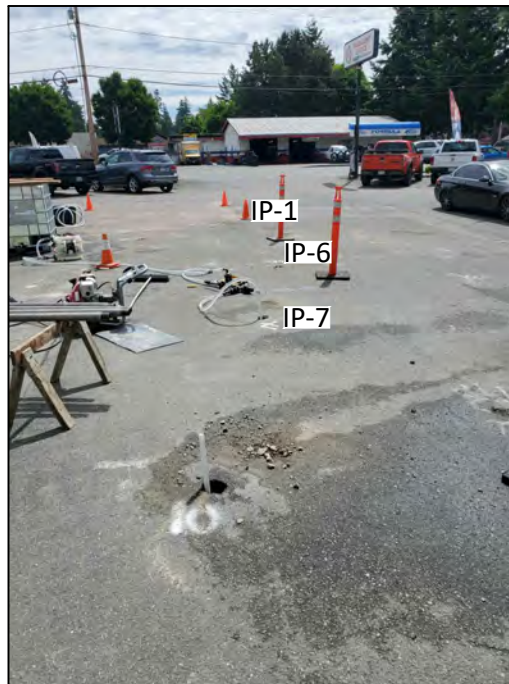
Photograph 2: View of chemical (PersulfOx) injection points 1, 6, 7, and 10, looking east. Photo taken on June 4th, 2021.

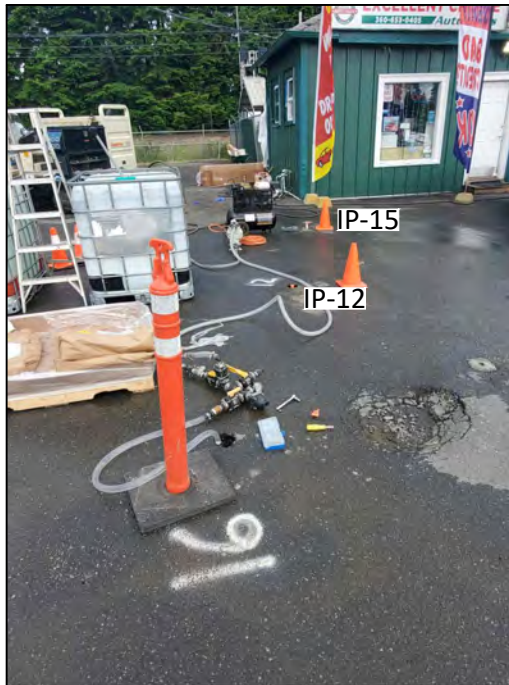
Photograph 3: View of chemical injection points 12, 15, and 16, looking west. Photo taken on June 10th, 2021.

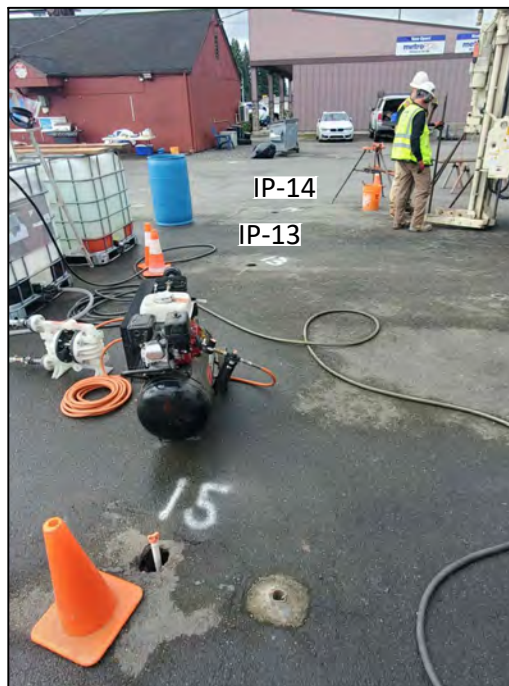
Photograph 4: View of chemical injection points 13, 14, and 15, looking south. Photo taken on June 10th, 2021.

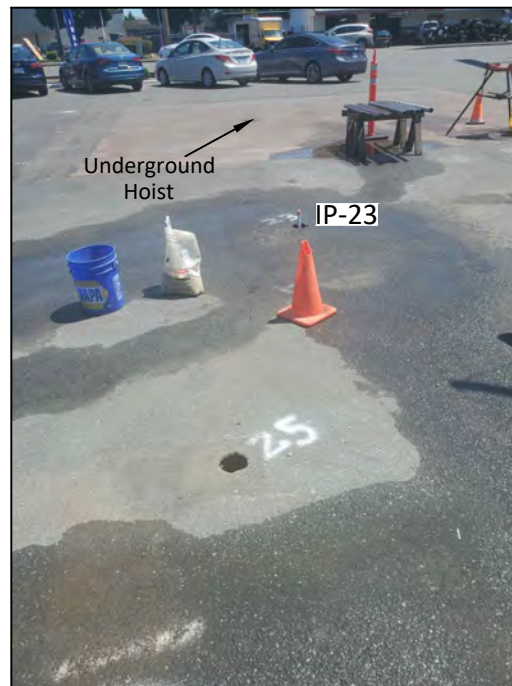
Photograph 6: View of chemical injection points 23 and 25, looking east. Abandoned underground hydraulic hoist visible in concrete slab. Photos taken on July 12th, 2021.

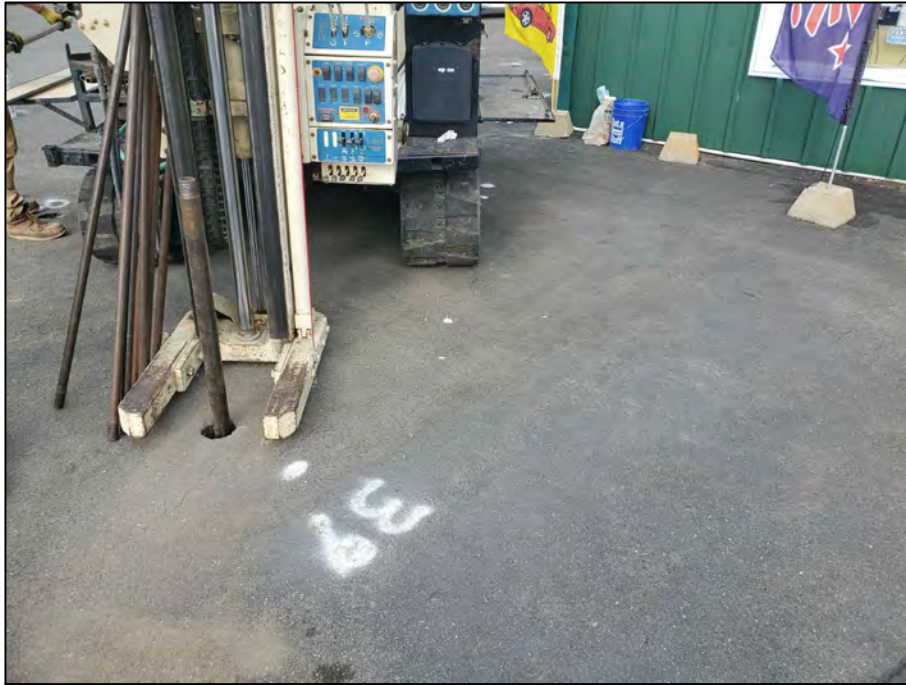
Photograph 9: View of chemical injection point 39, looking west. Photo taken on July 14th, 2021.

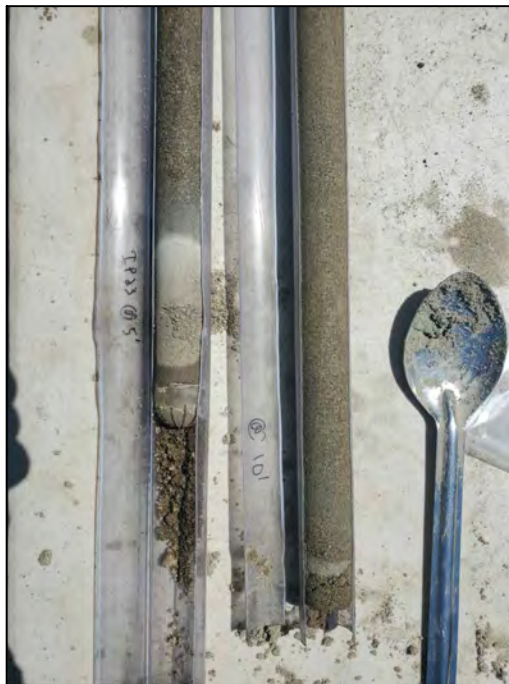
Photograph 10: View of sandy soils typical to depths of at least 37 feet. Injection point 23 sample shows soils at 5 feet and 10 feet bgs.

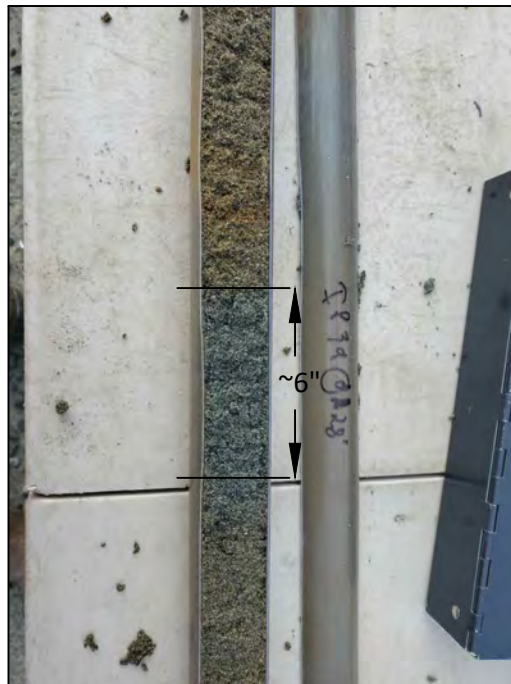
Photograph 12: View of injection point 39 sandy soils at 28 feet bgs (at soil/groundwater interface). Visible blue-gray contaminated soils (approximately 6-inch horizon) as shown. Photo taken on July 14th, 2021. Note: The groundwater grab sample collected from injection point 39, prior to any chemical injections, was non-detect for the contaminants of concern. The soil sample collected from the contaminated soil horizon at 28 feet bgs had a relatively low PID reading of 1.8 ppmv.

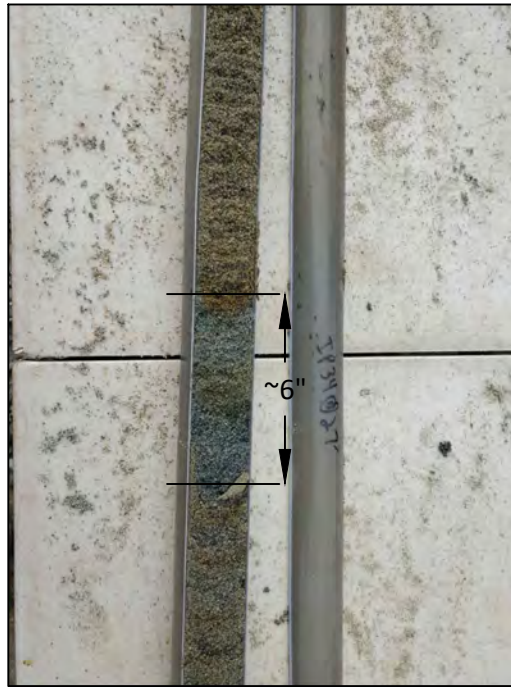
Photograph 13: View of injection point 34 sandy soils at 27 feet bgs (at soil/groundwater interface). Mottled orange and blue-gray contaminated soils (approximately 6-inch horizon) as shown. Photo taken on July 14, 2021.
The soil sample collected from the contaminated horizon at 27 feet bgs had a PID reading of 1.5 ppmv.

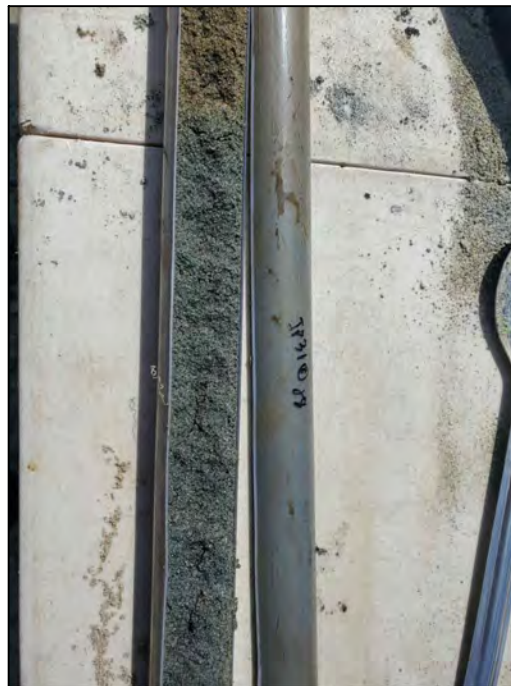
Photograph 14: View of injection point 31 sandy soils at 28 feet bgs (at the soil/ groundwater interface). Blue-gray contaminated soils (approximately 1-foot horizon) were sampled and had a PID reading of 75 ppmv.
Photo taken on July 14th, 2021.

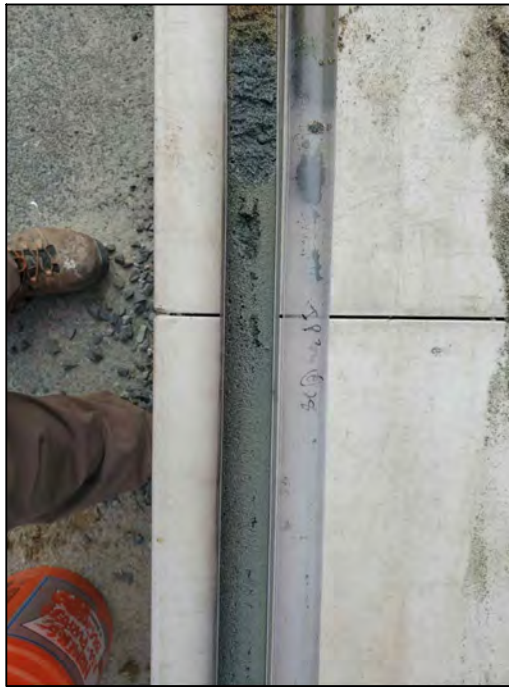
Photograph 15: View of injection point 33 sandy soils at 28 feet bgs (at soil/groundwater interface). Blue-gray contaminated soils had a PID reading of 5,000 ppmv. The contaminated soil horizon was approximately 1 foot in length. Photo taken on July 14th, 2021.

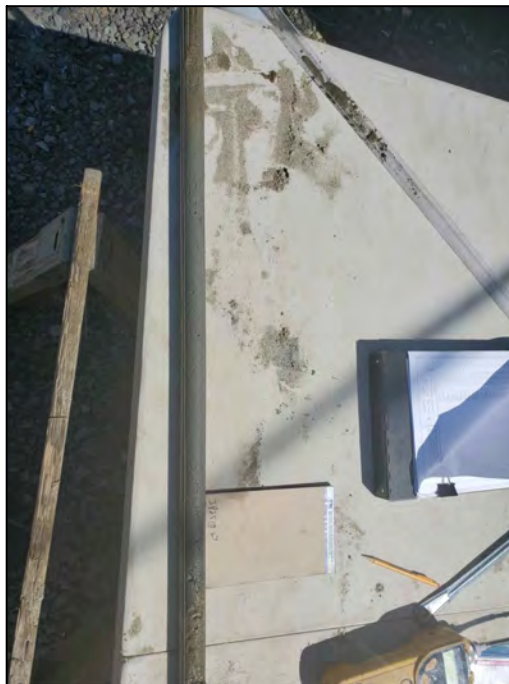
Photograph 16: View of injection point 25 sandy soils at 27 feet bgs (at soil/groundwater interface). Blue-gray contaminated soils were sampled and had a PID reading of 15,000 ppmv. Photo taken on July 12th, 2021 The contaminated soil horizon was approximately 2 feet in length (at the soil/groundwater interface).

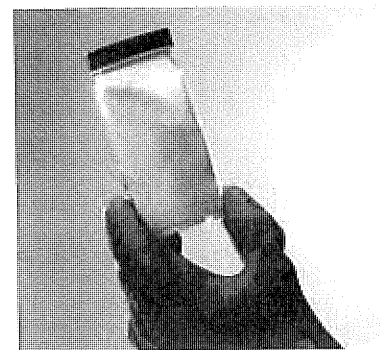
FIGURE 1. SODIUM PERSULFATE CHEMICAL STRUCTURE

PersulfOx is an *In Situ* Chemical Oxidation (ISCO) reagent that destroys organic contaminants found in groundwater and soil through powerful, yet controlled, chemical reactions. A sodium persulfate-based technology (figure 1), PersulfOx employs a patented catalyst to enhance the oxidative destruction of both hydrocarbons and chlorinated contaminants in the subsurface.

Example of PersulfOx

PersulfOx is an *In Situ* Chemical Oxidation (ISCO) reagent that destroys organic contaminants found in groundwater and soil through powerful, yet controlled, chemical reactions. A sodium persulfate-based technology (figure 1), PersulfOx employs a patented catalyst to enhance the oxidative destruction of both hydrocarbons and chlorinated contaminants in the subsurface.
