Remedial Investigation and Feasibility Study

Gas Works Park Site
Seattle, Washington

Puget Sound Energy and the City of Seattle

January 2023

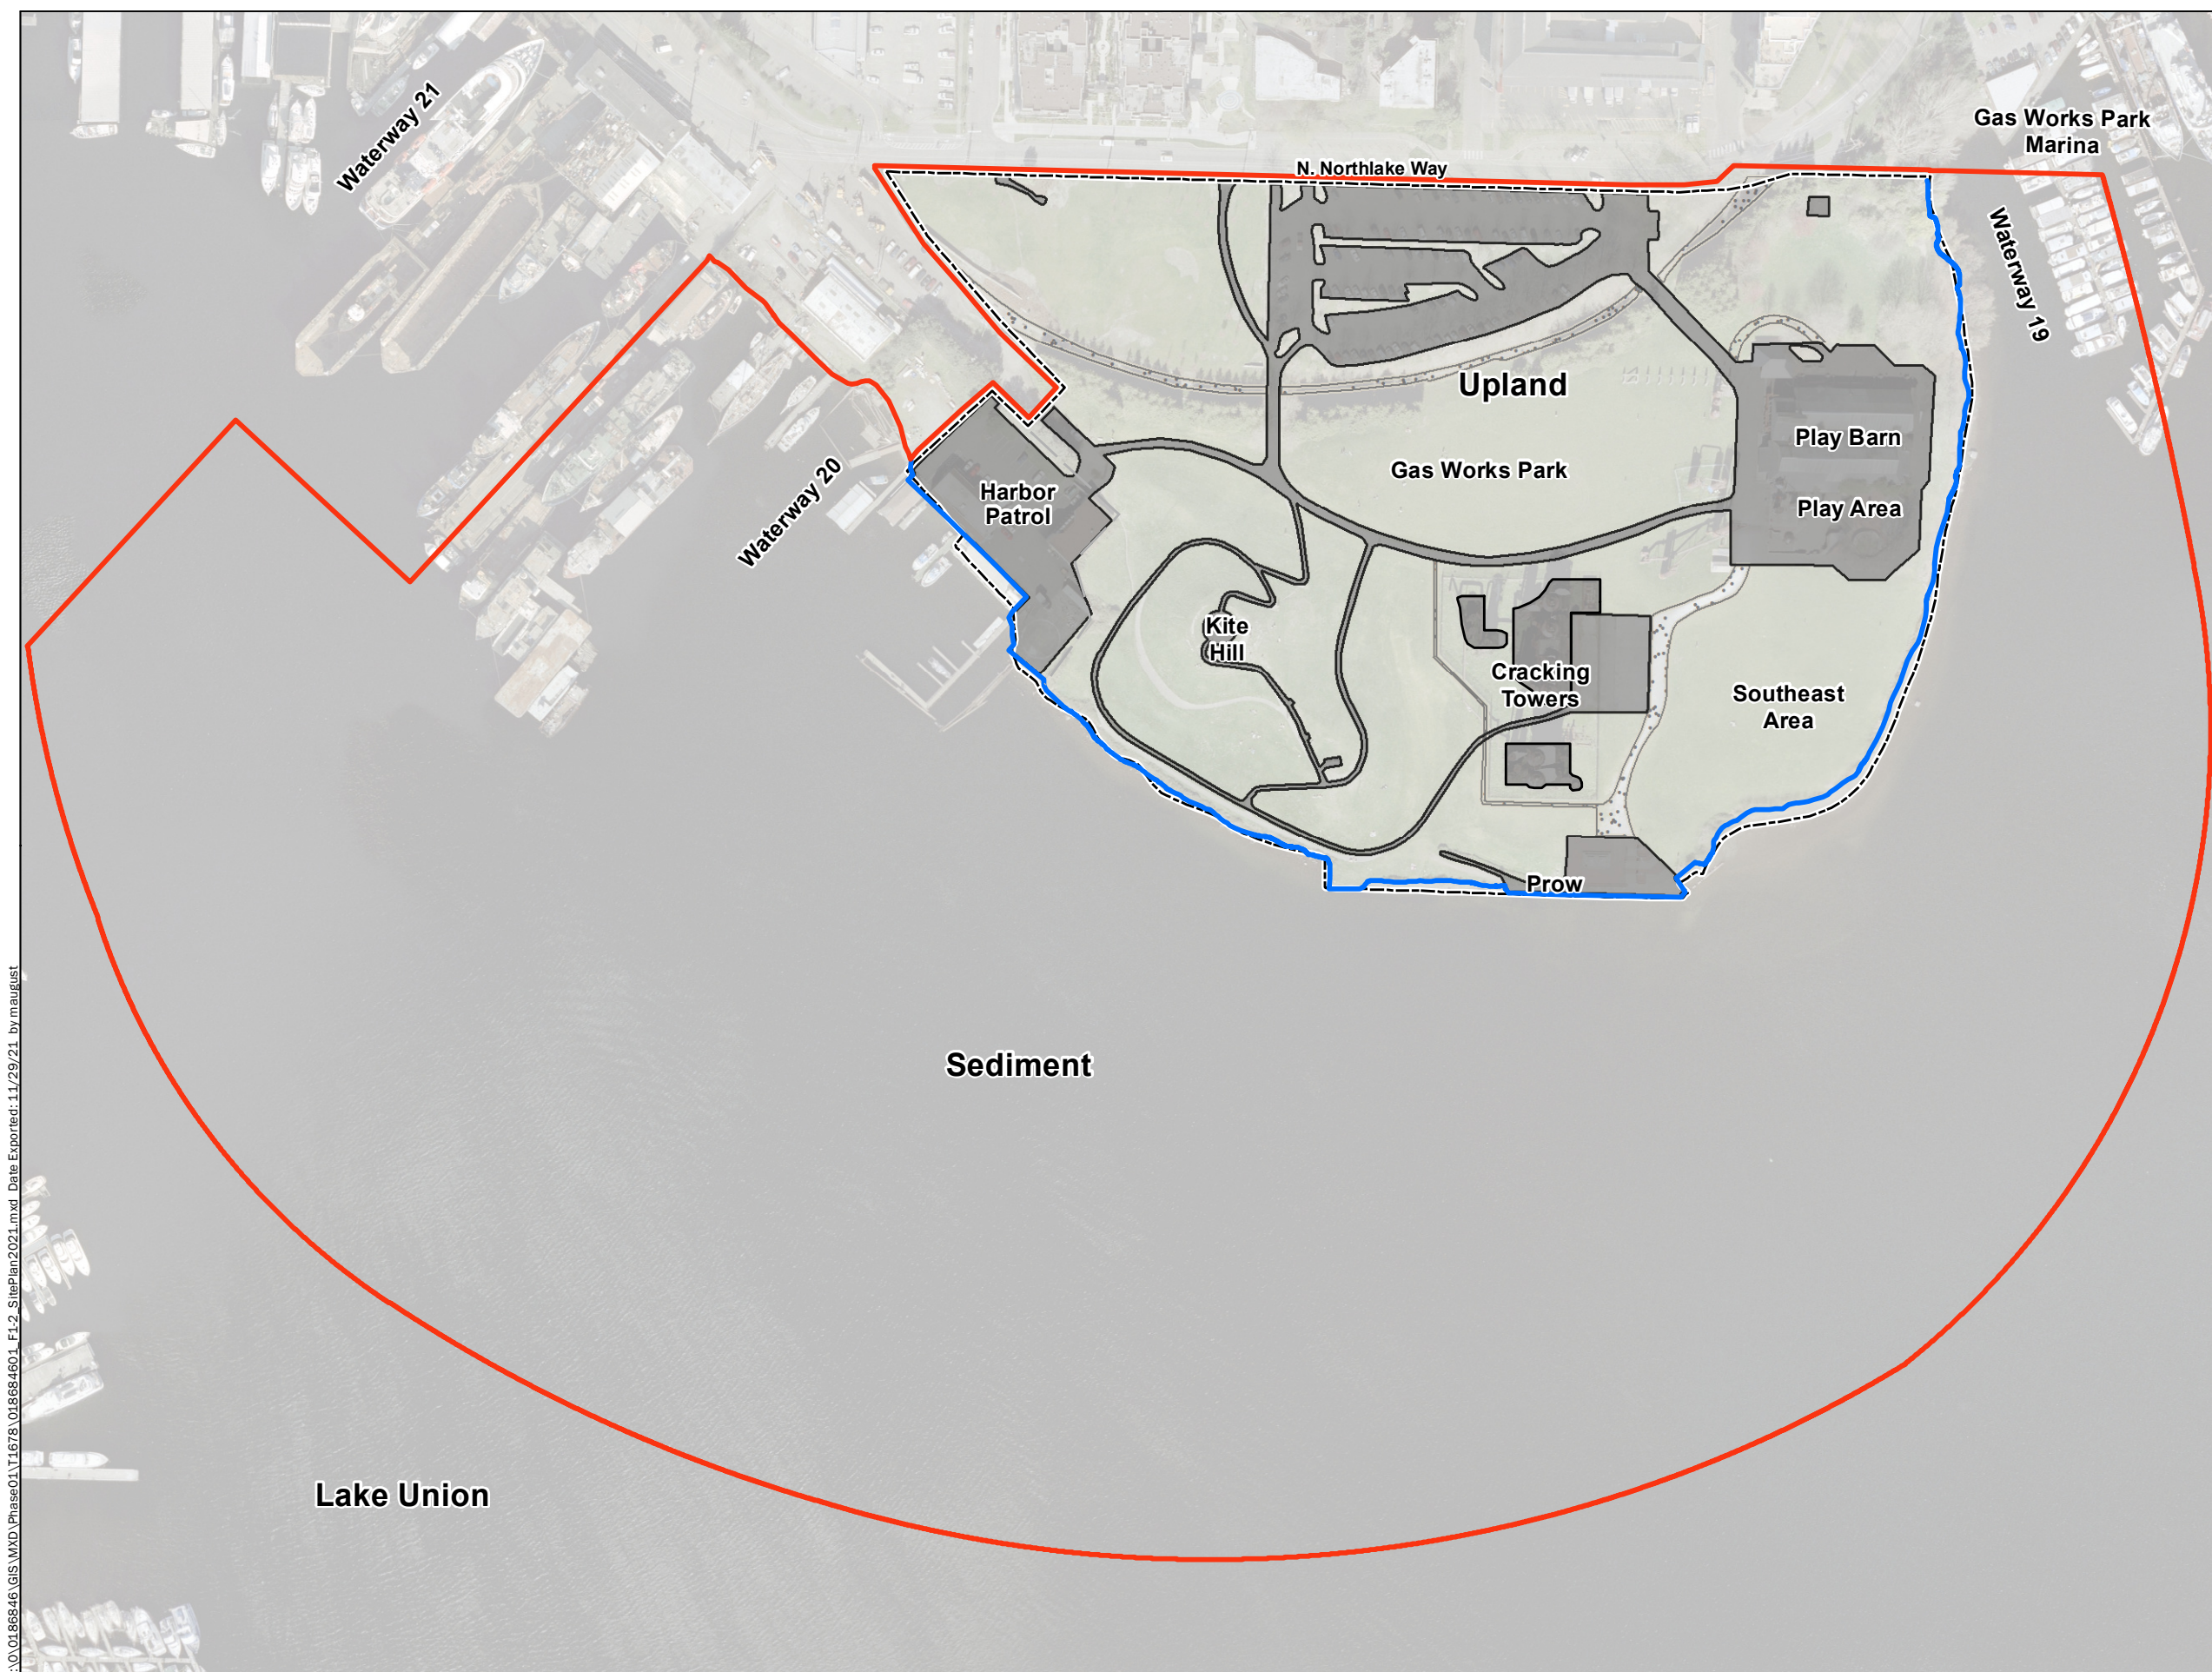
Figure 1B-3

1. The AOI is documented in the 2013 Amendment of Agreed Order DE 2008 (Ecology 2013).
2. Basemap 2005 USGS aerial photograph. Does not show current conditions.
3. Projection: NAD 1983 StatePlane Washington North FIPS 4601 Feet.

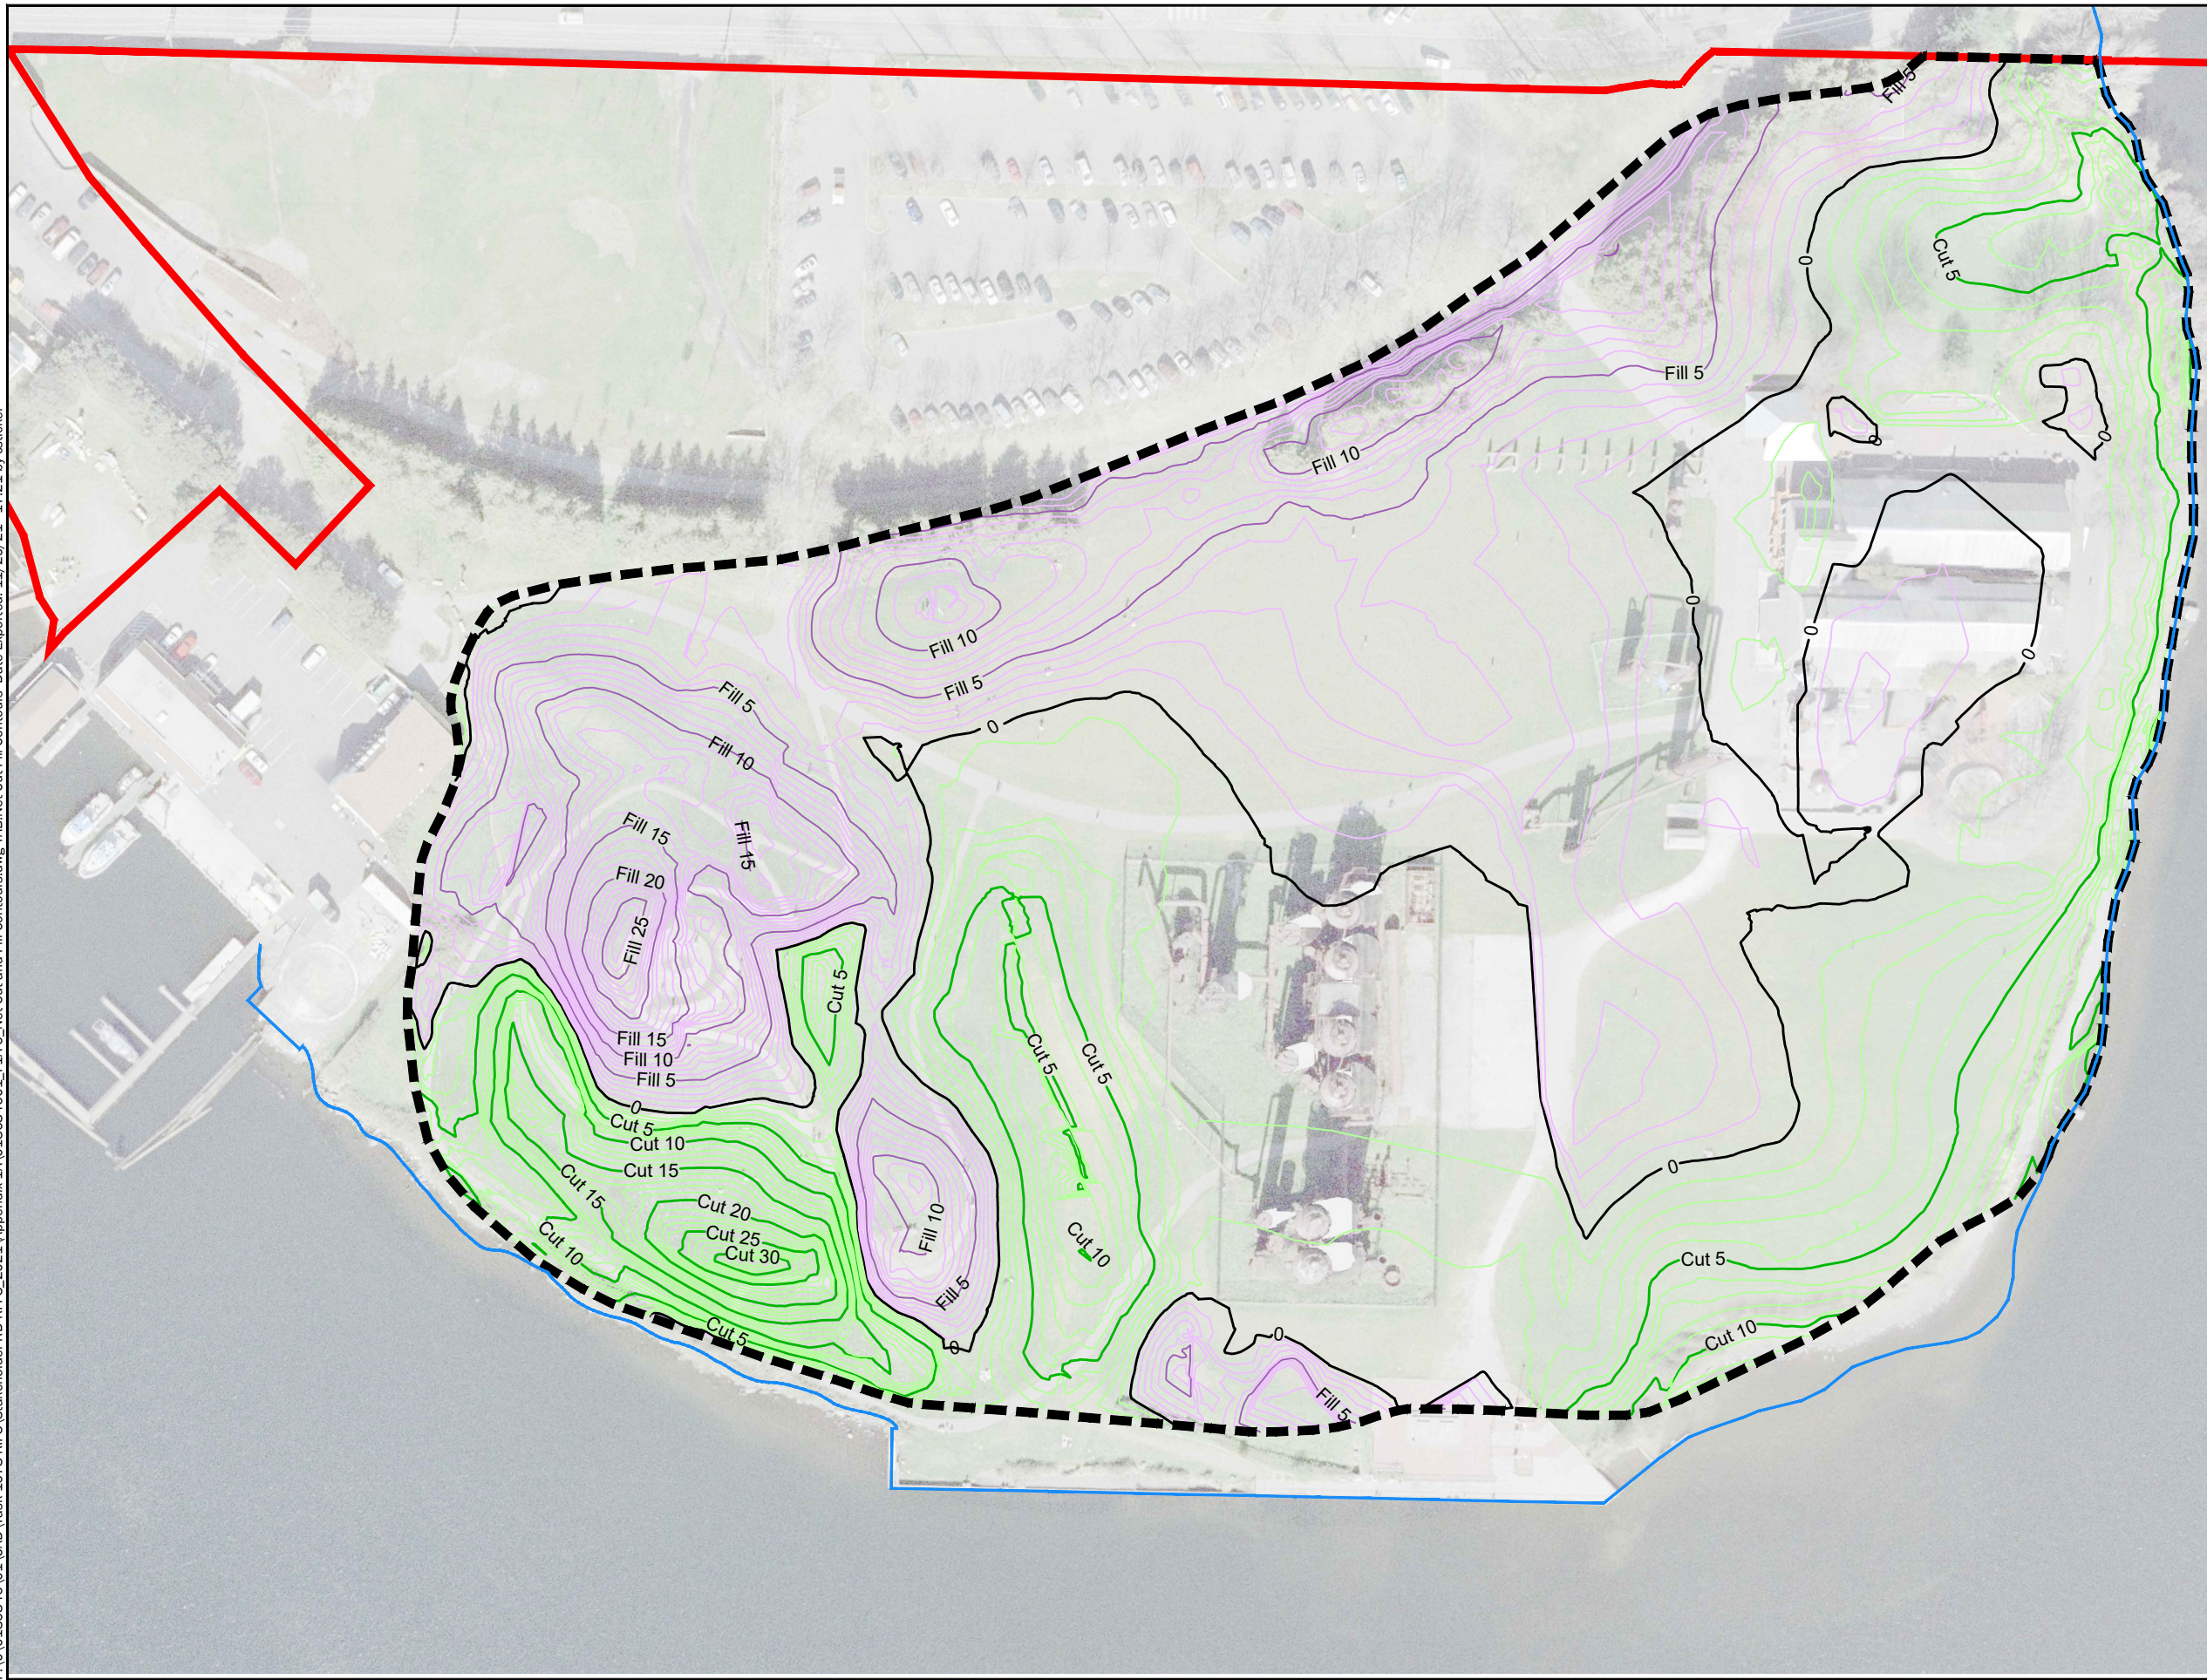
In the course of redevelopment, the vast majority of the former MGP property was recontoured, including the northeast corner, eastern shoreline, and the gully between Kite Hill and Cracking Towers. Net cut-and-fill contours are shown on Figure 1B-6.

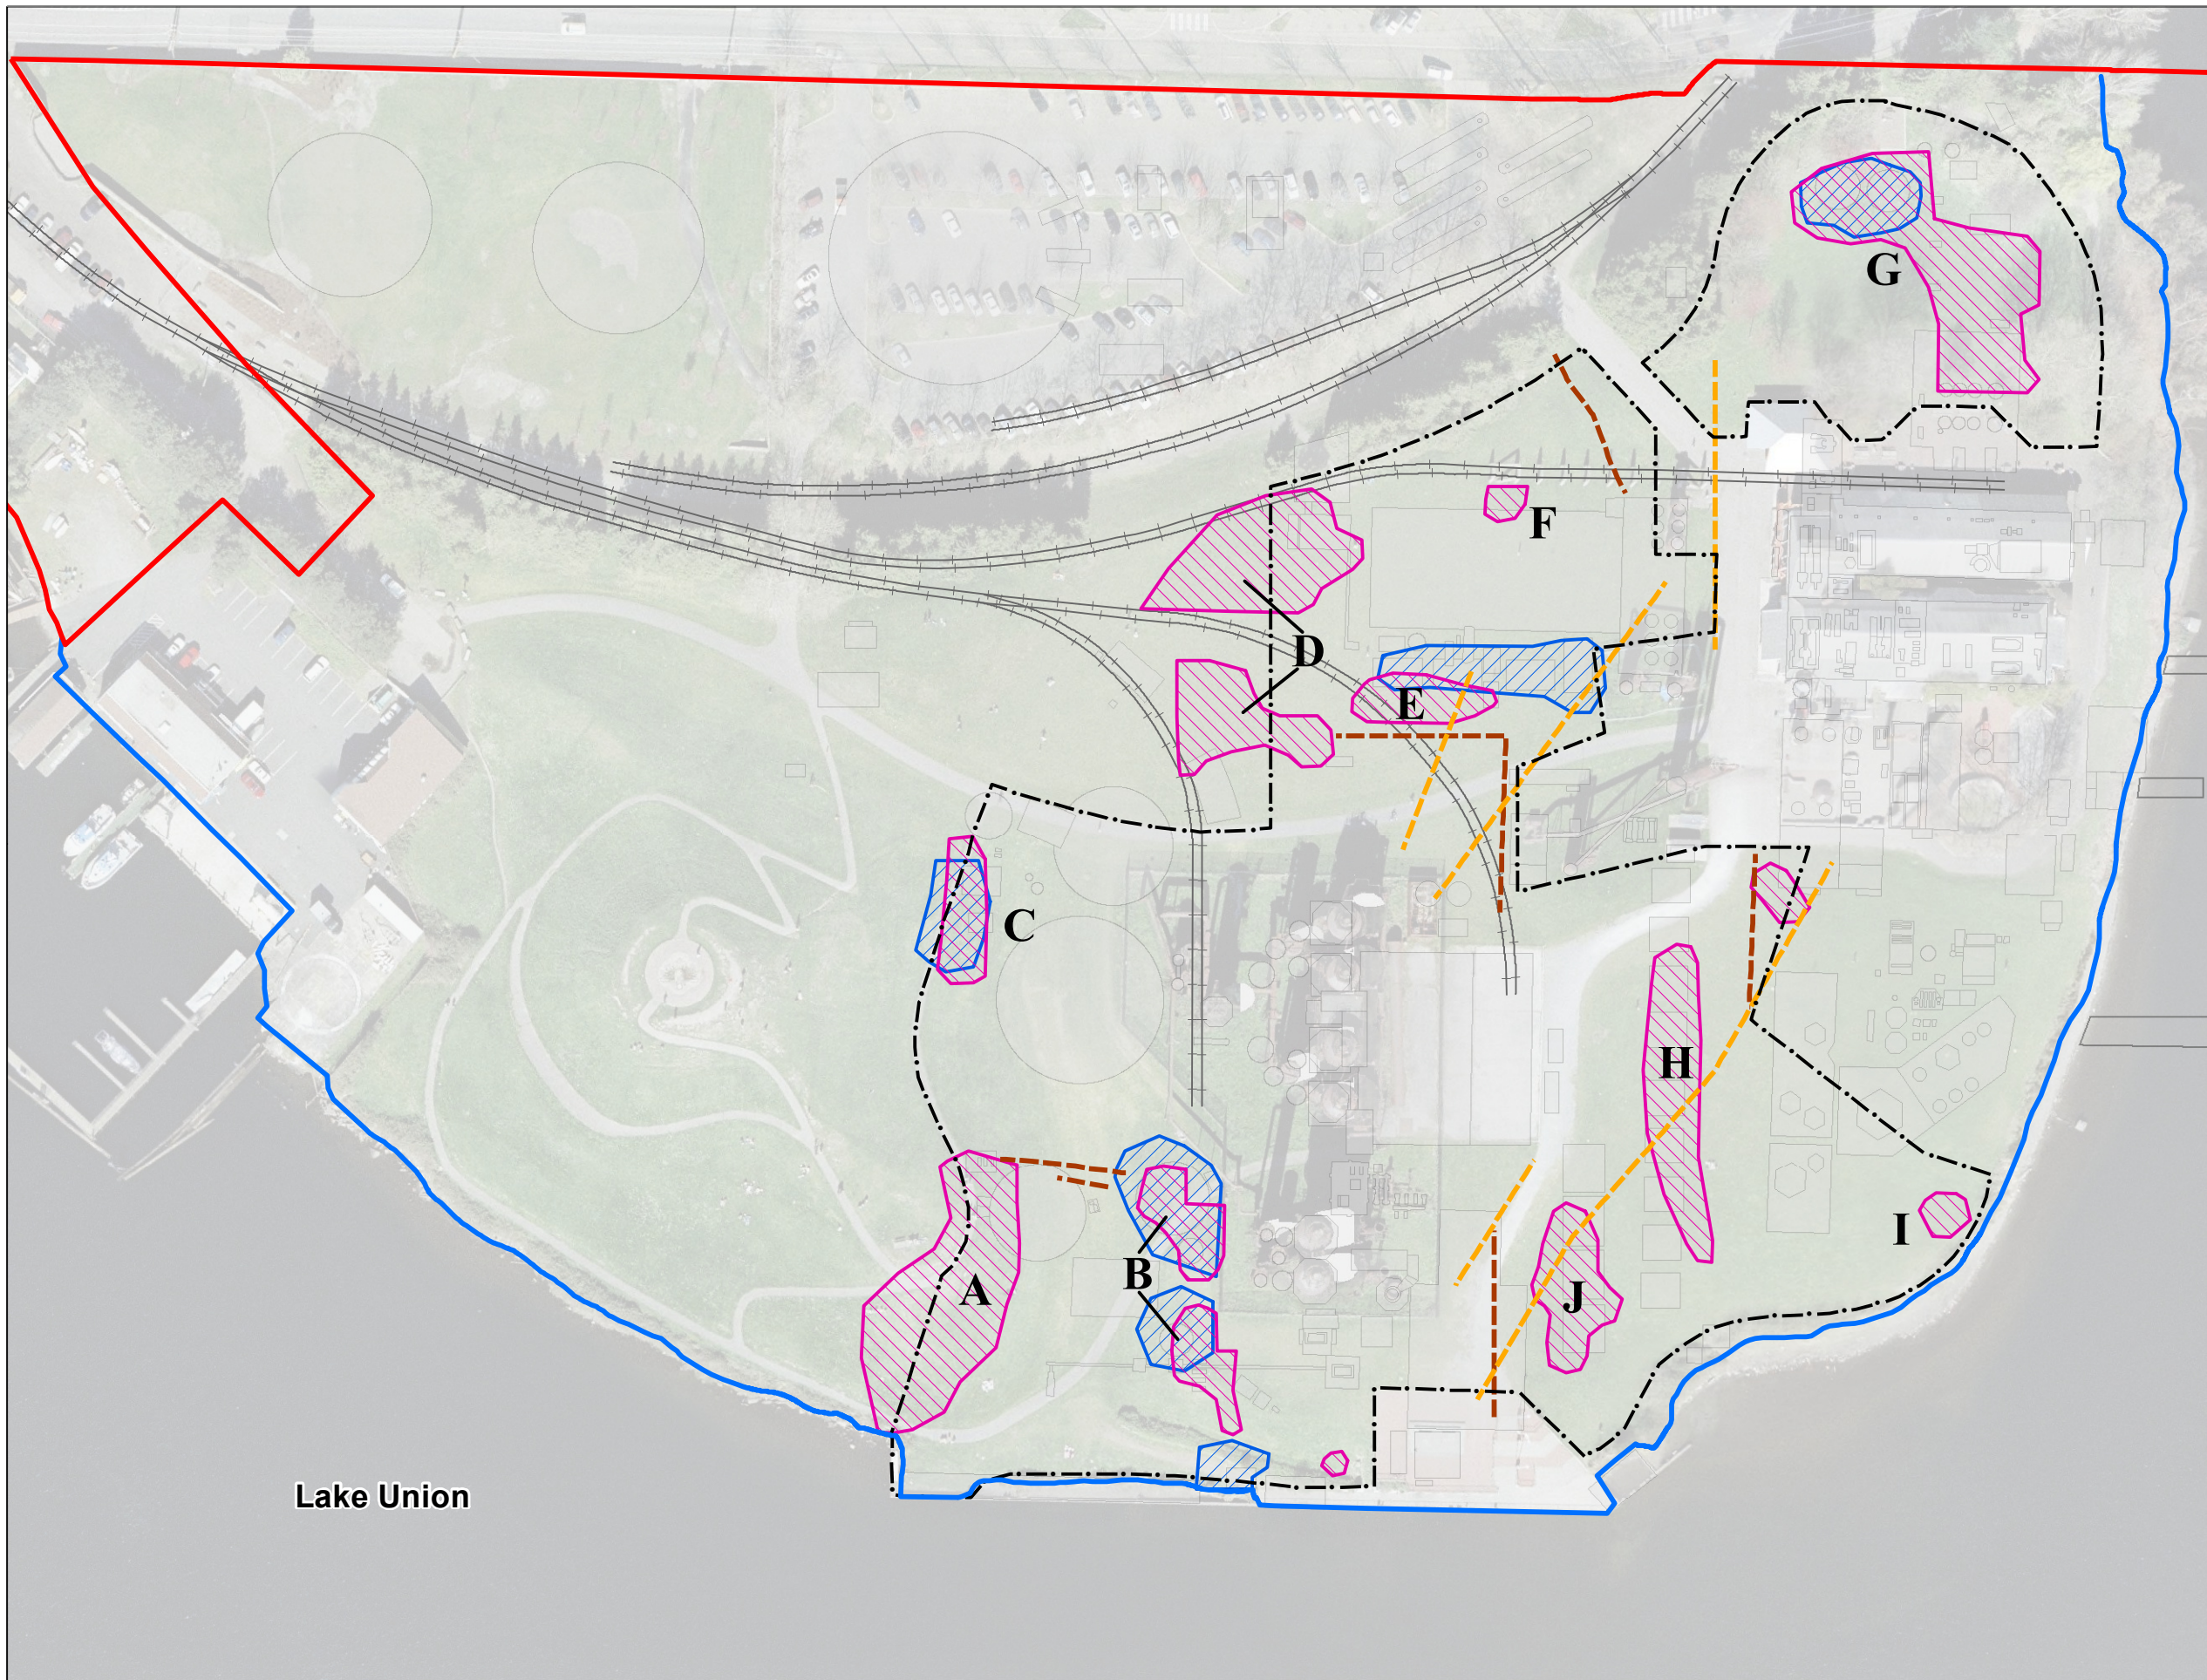
Geophysical Survey Results

Although the survey did not reveal large subsurface anomalies indicative of large buried tanks or structures (Zonge 2013), smaller magnetic and EM anomalies were observed, as noted in the Geophysical Results column of Table 1C-1 and depicted in Figure 1C-2.

In general, the geophysical anomalies coincide with locations of structures indicated in historical records. Anomalies B, E, G, H, and J identified by the geophysical study (Figure 1C-2) align with documented broken bottoms of former structures. Rubble and soil redistribution throughout redevelopment and park construction could explain anomalies A, C, D, and F. Anomaly I is inconclusive; there are no records of MGP structures or utilities in this area. The majority of the linear anomalies identified are current underground utilities. However, the interpreted pipe between anomalies A and B matches the orientation and general area of a former MGP oil line connecting oil heaters (structure 83 in Figure 1C-1) and the fuel oil storage tank (structure 60 in Figure 1C-1) (Seattle Gas Company 1949).
