SUMMARY REPORT
FOR
REMOVAL OF THE 500 GALLON
GASOLINE STORAGE TANK
AT THE
BURLINGTON NORTHERN RAILROAD
INTERBAY CAR REPAIR SHOP
SEATTLE, WASHINGTON

Prepared For: Burlington Northern Railroad Seattle, Washington

Prepared By:
Environmental Management Resources, Inc,
Redmond, Washington
Project 91-253

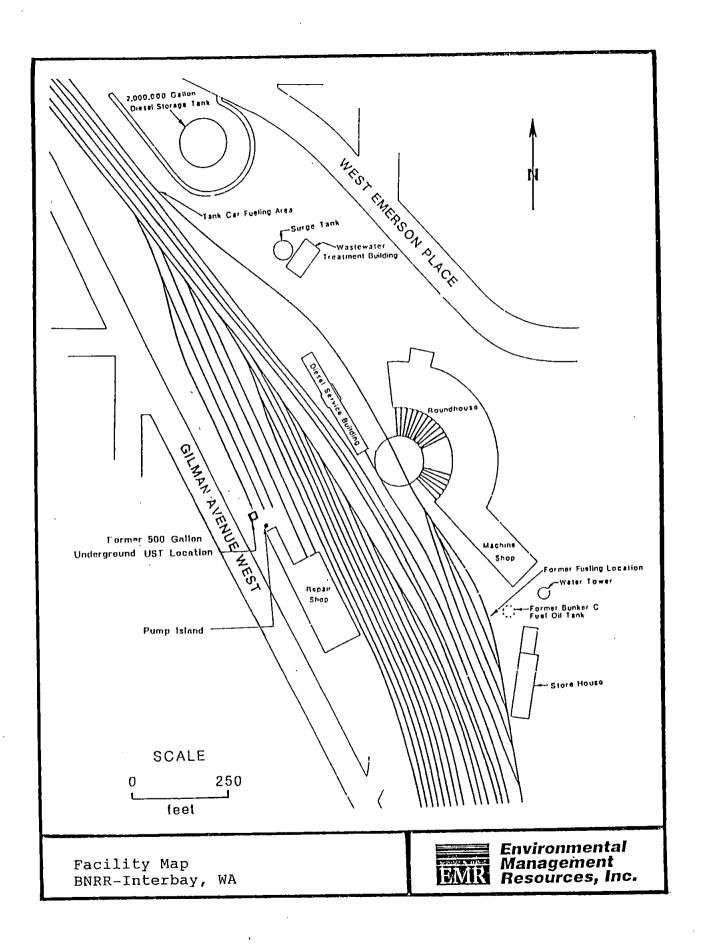
The tank was installed in about 1973 by Burlington Northern Railroad and consisted of a 500-gallon steel cylindrical tank, 40 feet of product line and a single electric suction pump island dispenser and associated tank vent piping. The UST was used to store and dispense gasoline for railroad vehicles. Figure One is a site vicinity map of the area and indicates the tank location with respect to adjacent buildings and roadways.

The tank complex had no hold down or anchoring systems and was overlaid by approximately twelve inches of soil and an eight inch thick steel-reinforced concrete slab surrounded by asphalt pavement. There were no indications of underground utilities of any type in close proximity of the tank complex, as determined by utility locates. A storm drain was present about sixty feet to the southeast of the tank complex.

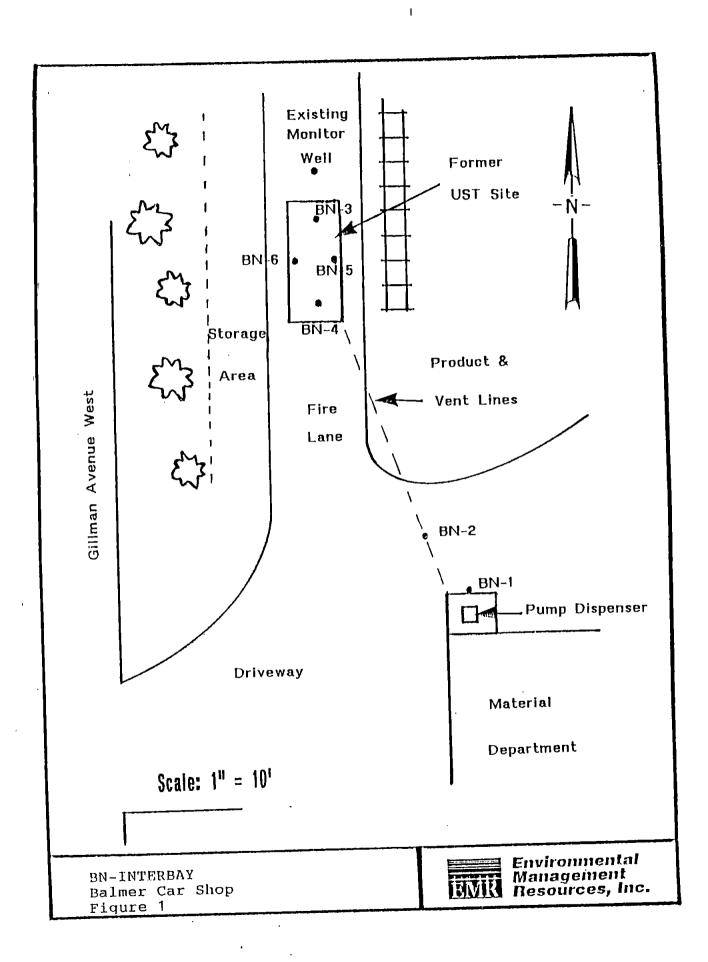
An EMR field engineer collected two sidewall and two bottom soil samples for a total of four discrete soil samples from the tank excavation area (BN-3, 4, 5, and 6). Discrete soil samples were also collected from under the former pump island dispensing equipment (BN-1) and from under the product and vent line trench (BN-2). A composite soil sample was also collected from the pile of excavated soil (BN-7) from the former UST area. The soil sample locations are shown on Figure 2.
