**PHASE I AND II ENVIRONMENTAL SITE  
ASSESSMENT  
PROPOSED HOSPITAL PROPERTY  
APPLE BLOSSOM DRIVE  
LOTS 20 THROUGH 26 AND OPEN SPACE  
TRACT  
CHELAN, WASHINGTON**

**FEBRUARY 6, 2009**

**Phase I and II Environmental Site  
Assessment  
Proposed Hospital Property  
Apple Blossom Drive  
Lots 20 through 26 and Open Space Tract  
Chelan, Washington  
File No. 18155-001-00**

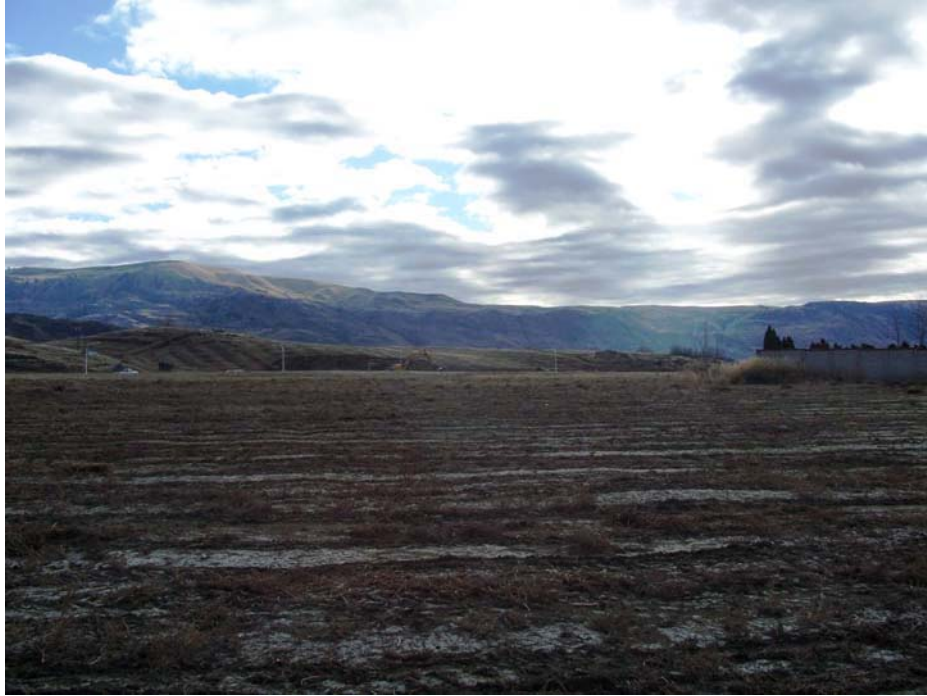
**REPRESENTATIVE VIEW ACROSS PROPERTY  
LOOKING SOUTH FROM NORTHERN PORTION**

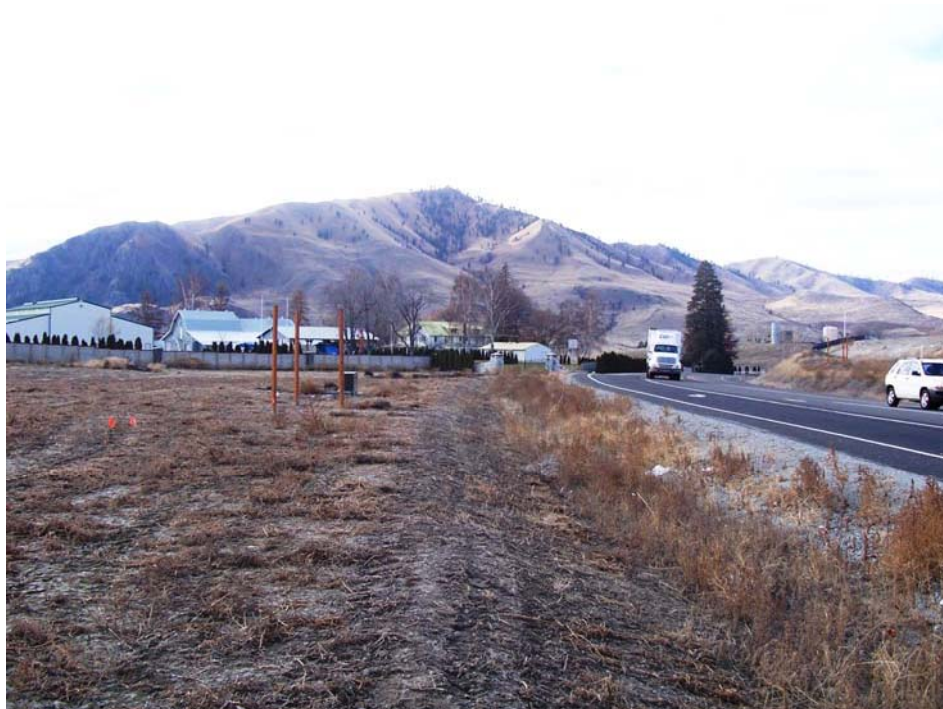
**LOOKING WEST DOWN NORTHERN PROPERTY BOUNDARY  
ADJACENT SR97A ON RIGHT SIDE OF PHOTO**

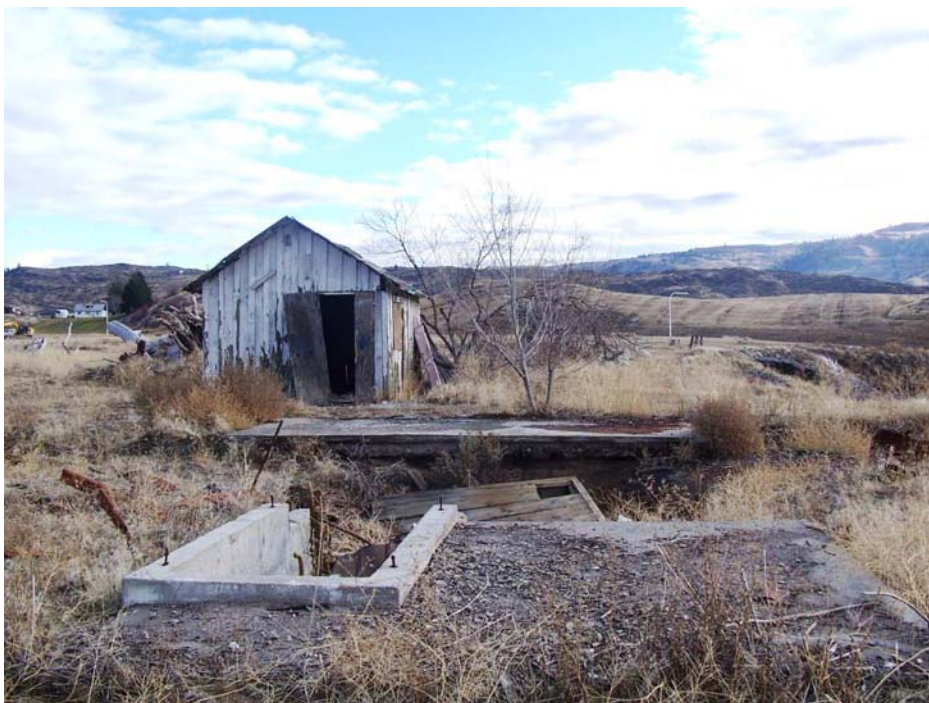
- Relatively small quantities of discarded household and automotive items including mattresses and food packaging, tires, automotive batteries, burned material and a discarded AST (water) were observed near the location of the previous small house in the south portion of the property. Because we were unable to determine whether hazardous substances were discarded at the property; this data gap is considered potentially significant as noted in Section 2.3.3. This data gap was subsequently addressed during the Phase II portion of this study. No evidence of heating oil ASTs or USTs was observed in the vicinity of the house foundation.

**LOOKING EAST AT FORMER HOUSE SITE  
SOUTHERN PORTION OF PROPERTY**

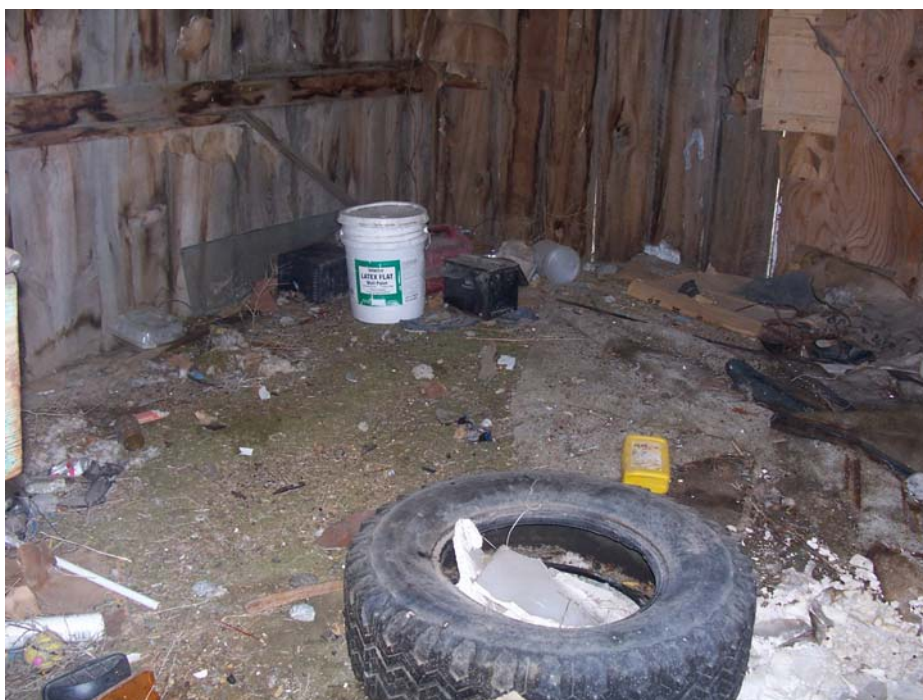
Underground Storage Tanks (USTs) or Evidence of USTs		X	
Drums or Other Containers	X		One 5-gallon bucket, mostly empty but containing a small amount of dried paint, was located inside the wooden shed. No evidence of staining was observed on the ground surface surrounding this container.
Chemicals or Hazardous Materials (other than de minimis quantities of cleaning products)		X	
Evidence of Leaks, Spills or Releases Surrounding ASTs, USTs, and/or Chemical Storage Areas		X	
Stained or Corroded Floors, Walls or Drains (other than apparent water stains or minor oil stains on pavement from parked vehicles)		X	
Pipes of Unknown Origin or Use		X	
On-site Septic System		X	We could not determine the presence or absence of on-site septic systems associated with prior structures on the subject property. Residual components of an historic septic system(s) are not considered an environmental concern for the property.

Feature	Observed		Comment
	Yes	No	
Hazardous Waste Disposal Areas		X	
Uncontained Debris, Refuse or Unidentified Waste Materials	X		Tires, mattresses, and other discarded household items were observed in and around the small shed in the southern portion of the property.
Standing Water or Other Liquids		X	
Catch Basins and Storm Water Drainage		X	Based on our observations, stormwater runoff from adjacent developed properties and roadways enters a municipal drainage system that flows to a stormwater pond south of the subject property. Stormwater on the property essentially infiltrates on the subject property.
Pits/Ponds/Lagoons		X	A stormwater pond is located on an adjacent property to the south. The stormwater pond appears newly constructed and was dry at the time of our site reconnaissance.
Waste or Wastewater Discharges		X	
Unusual Odors		X	
Stressed Vegetation		X	Vegetation over the majority of the subject property was low grasses and shrubs, as would be typical of recent regrowth after property regrading.

**DISCARDED TIRES, CAR BATTERIES, PAINT BUCKET  
INSIDE FORMER HOUSE SITE SHED**

The debris discarded on the property in the vicinity of the former house and shed in the south portion of the site does not appear to include hazardous materials at this time, and does not constitute a REC per the ASTM definition, in our opinion.

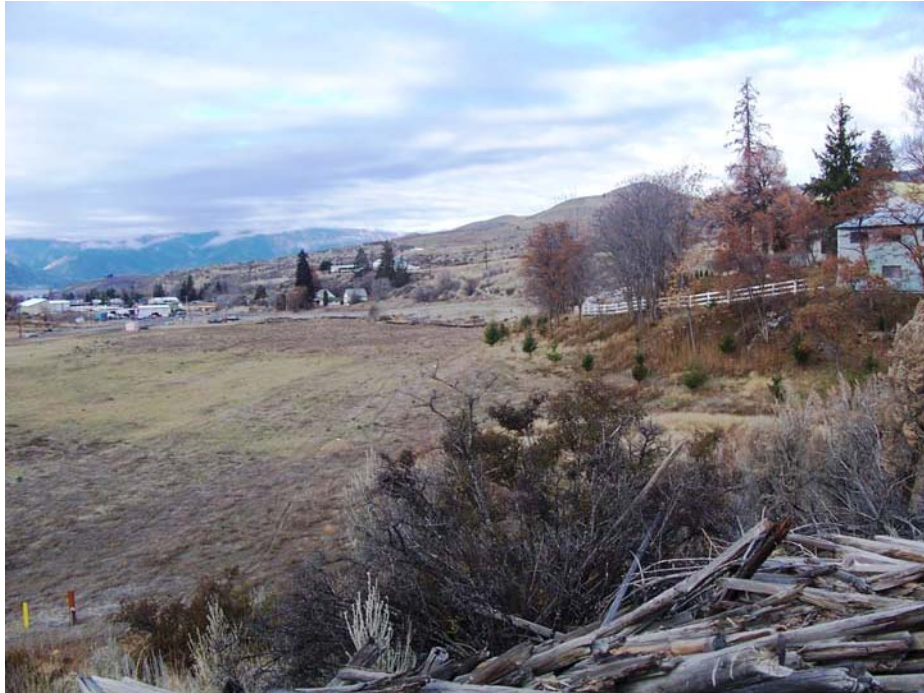
**LOOKING NORTHWEST ALONG WESTERN PORTION OF SUBJECT PROPERTY  
DESIGNATED FUTURE “OPEN SPACE TRACT”**

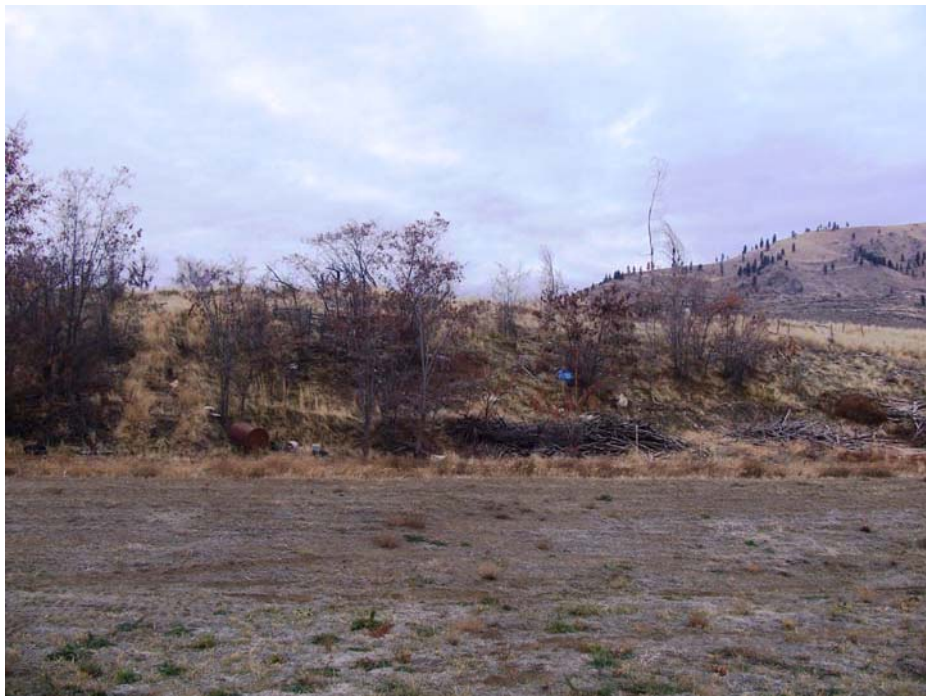
**LOOKING NORTH ACROSS ADJACENT STORMWATER POND PROPERTY  
TOE OF SLOPE IS SOUTHERN EXTENT OF SUBJECT PROPERTY  
DISCARDED WATER TANK, TIRES, OTHER DEBRIS VISIBLE**

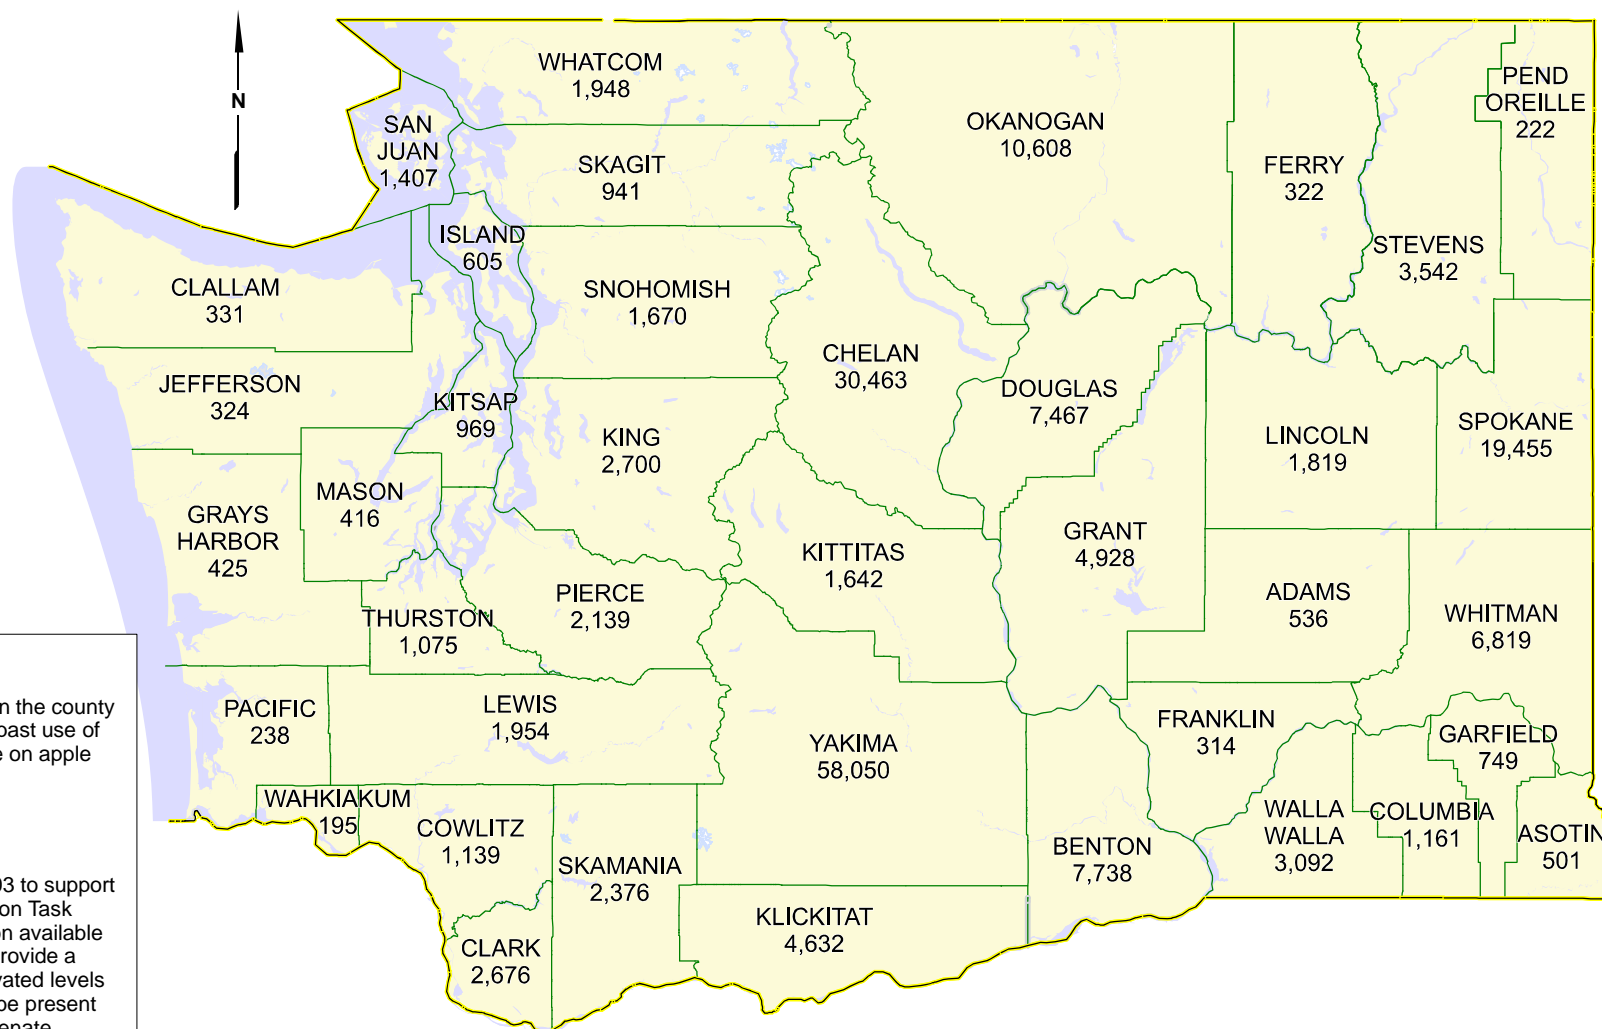
**Figure 4: County Acreage Potentially Affected by Historical Use of Lead Arsenate Pesticide on Apple and Pear Orchards**

1,948 Number of total acres in the county potentially affected by past use of lead arsenate pesticide on apple and pear orchards
