ICS/NW Cooprage Site

Extent of Total PCBs in Soil Less than Five Feet Deep

SUM-008-00 (ICS) March 2018

Dalton, Olmsted & Fuglevand, Inc.

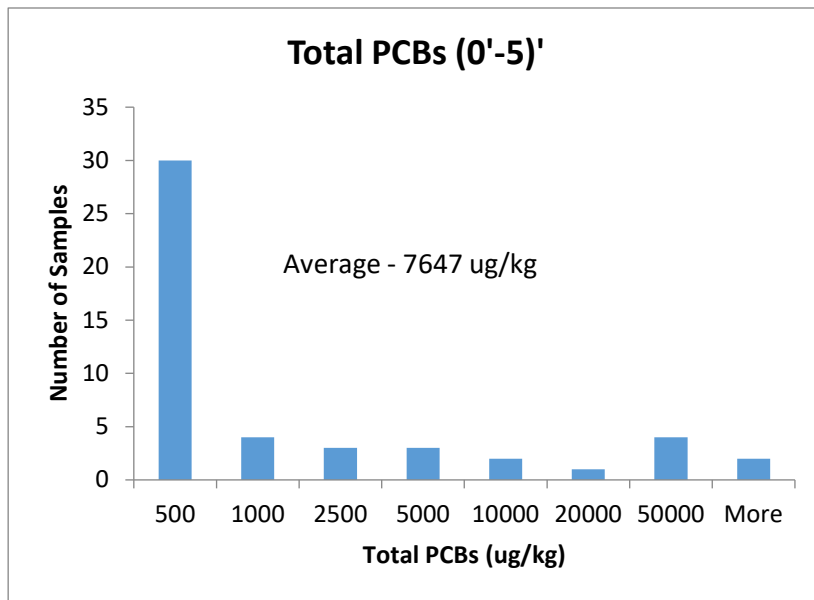
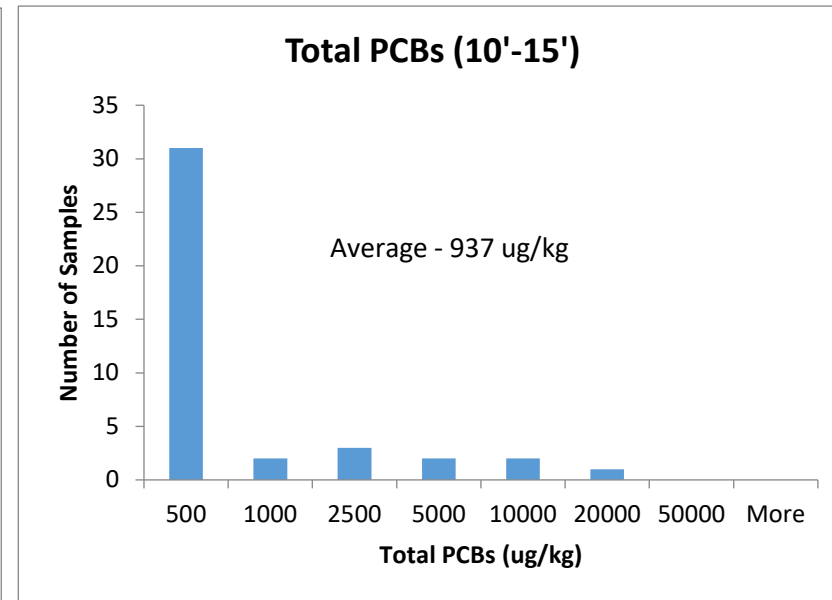
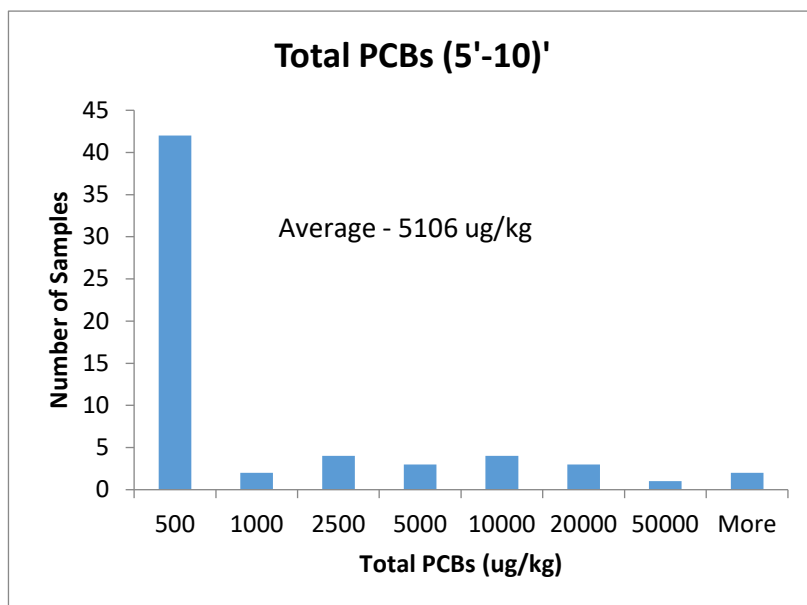
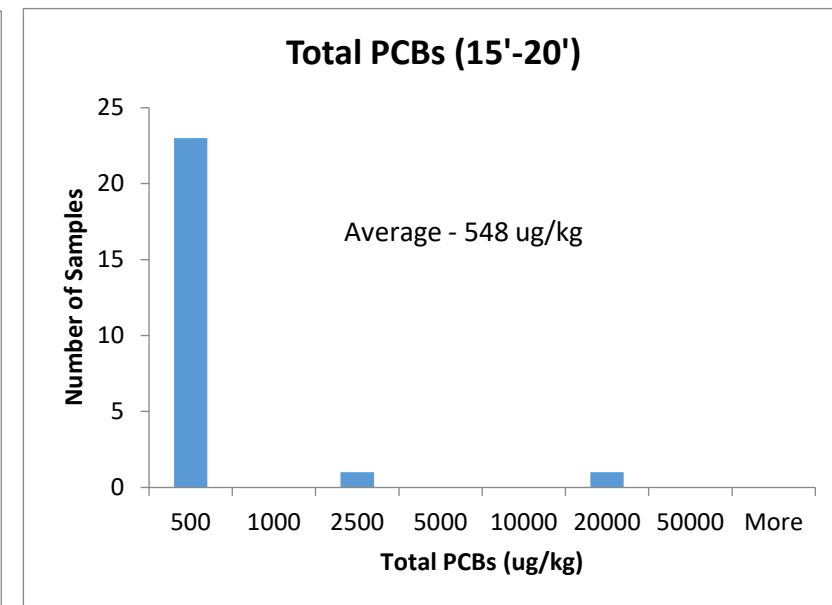
FIGURE 6-1 - Total PCBs In Soil Histograms

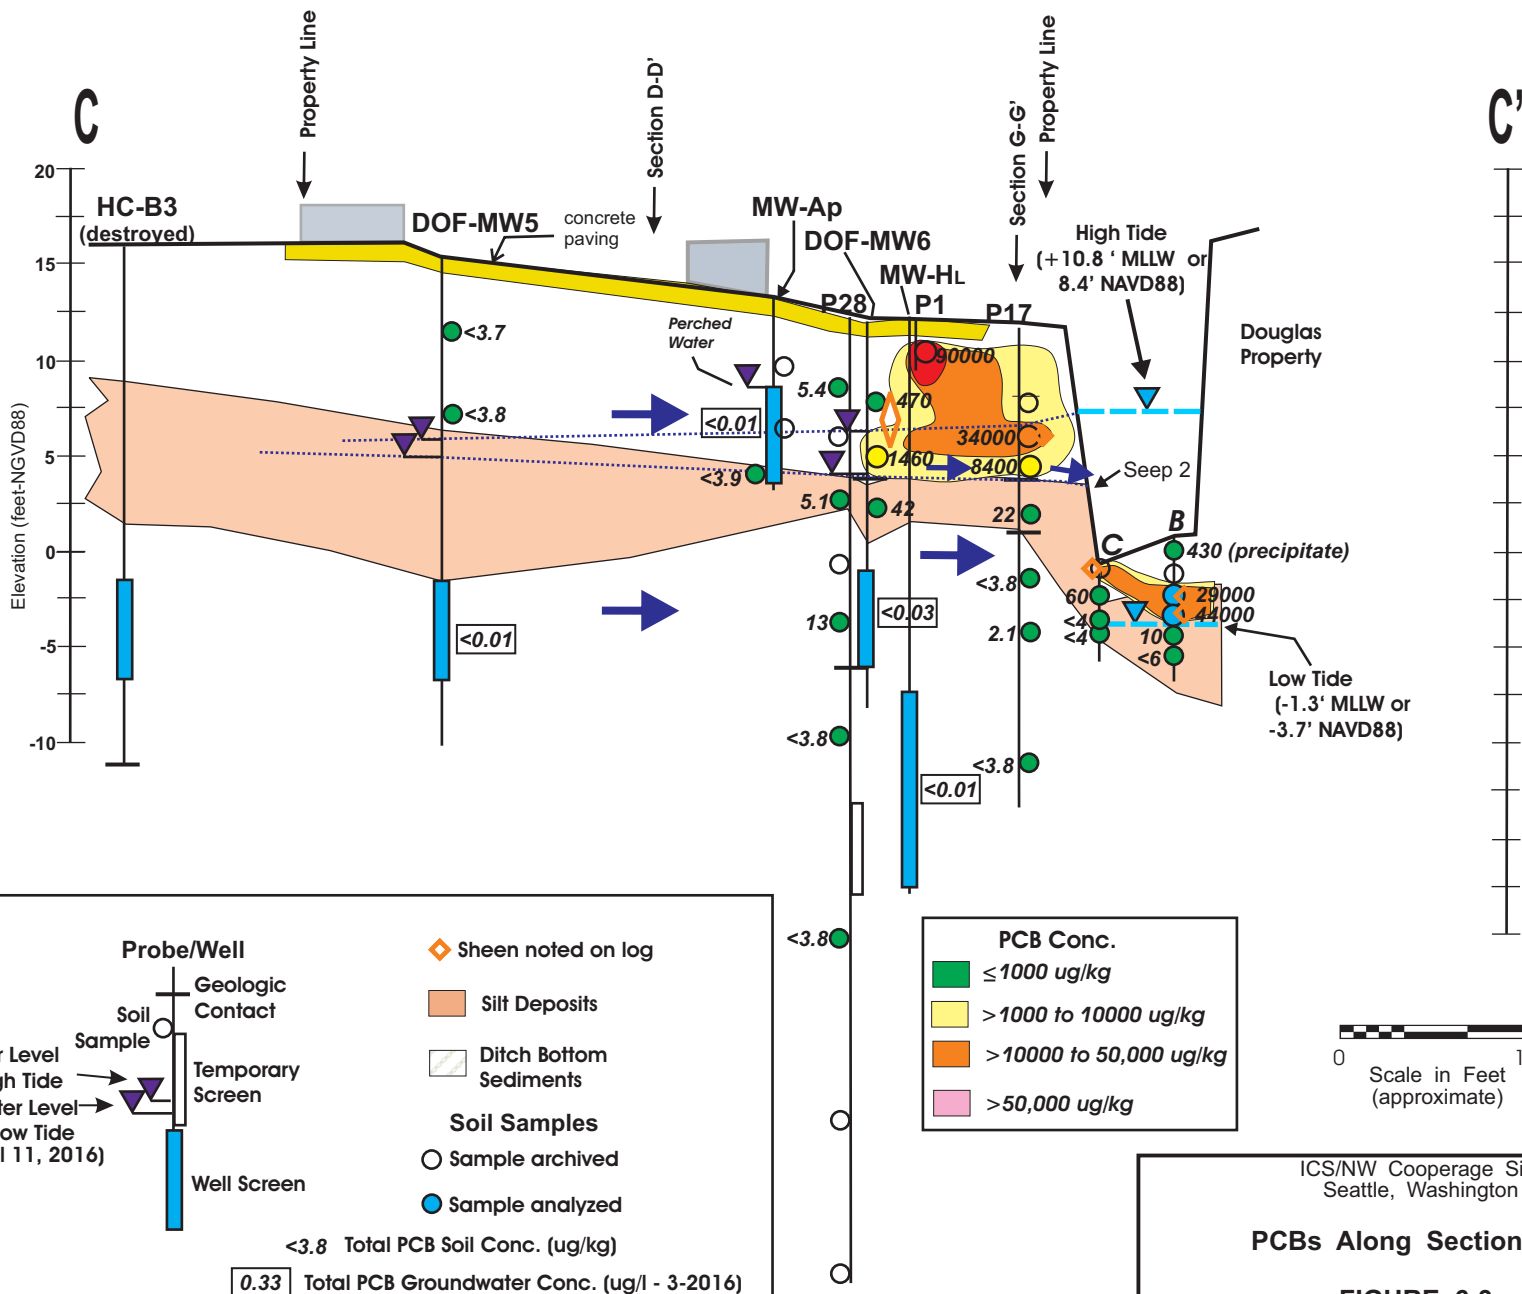
PCBs Along Section C-C'

SUM-008-00 **FIGURE 6-3c** April 2018
Dalton, Olmsted & Fuglevand, Inc.

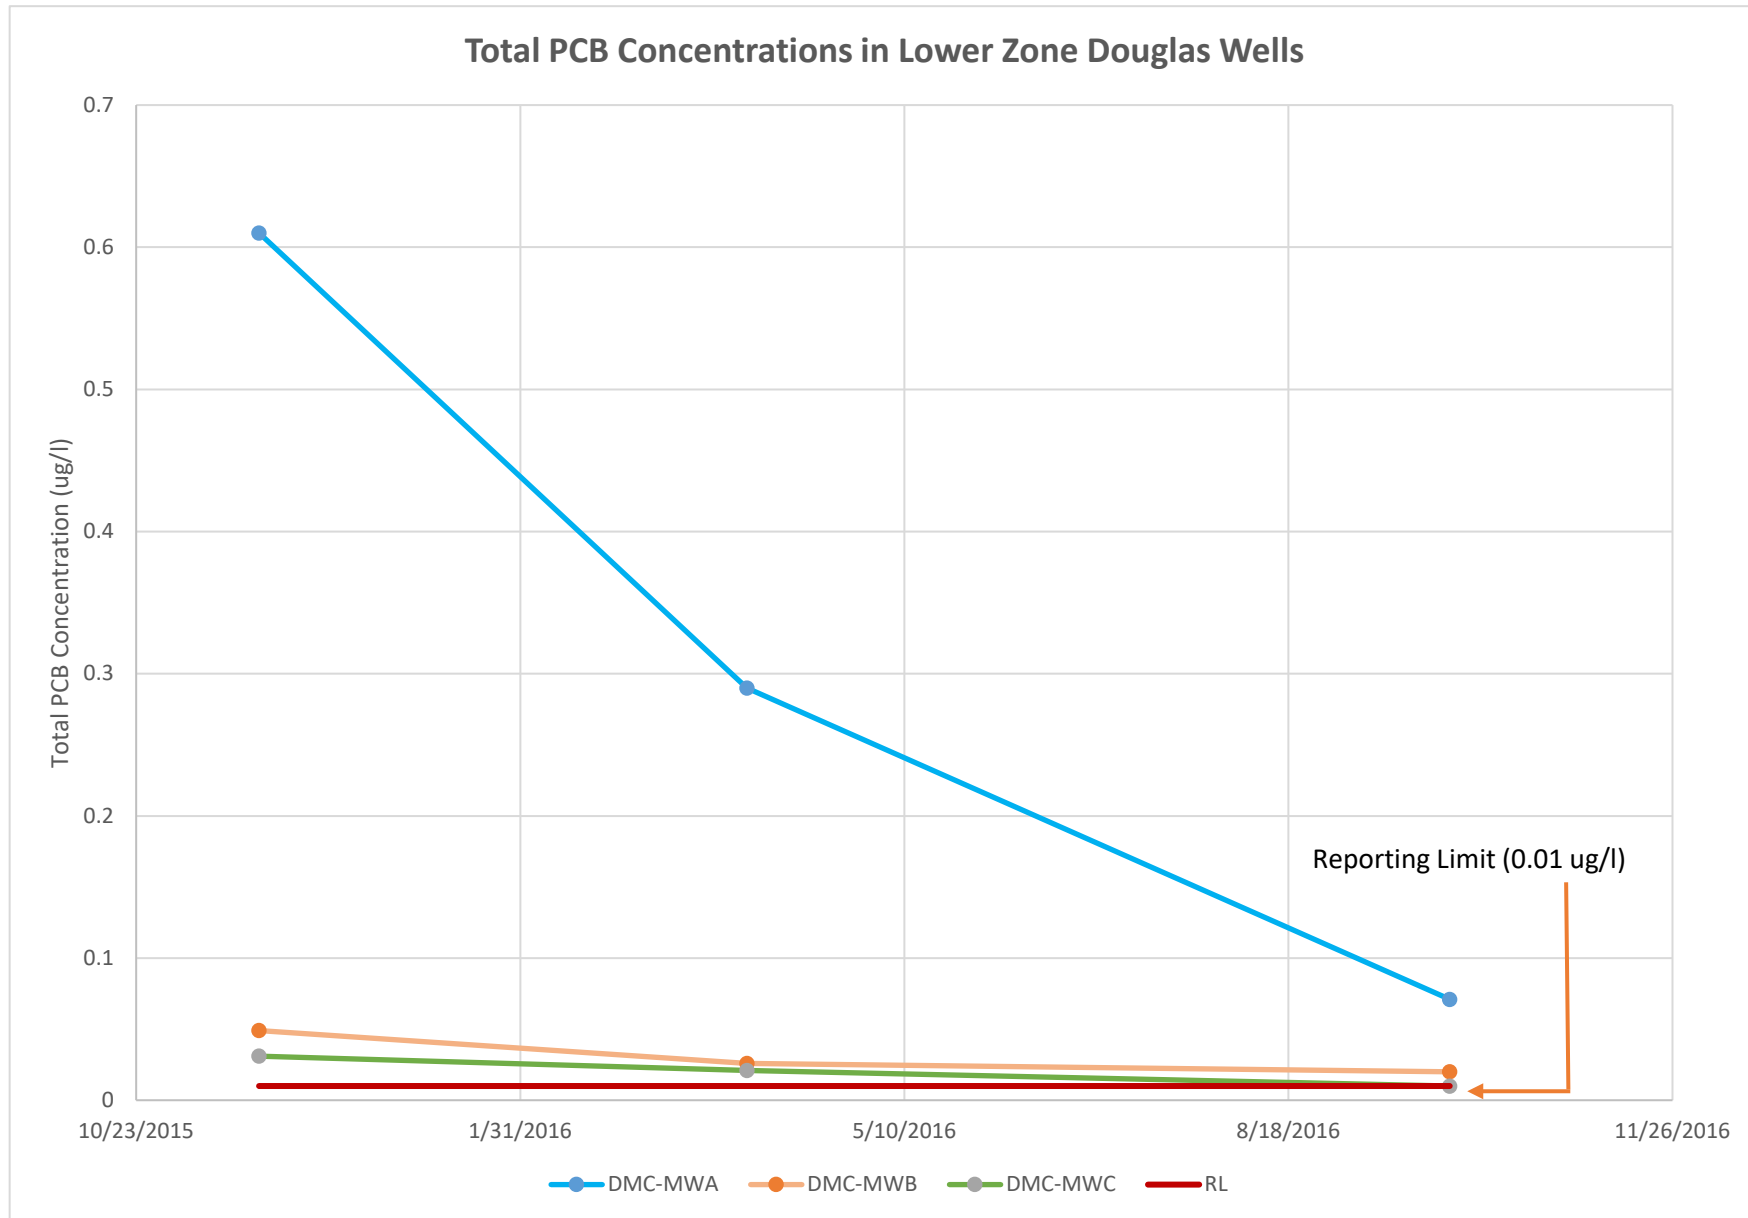
**FIGURE 6-5 - PCB Concentration Trends
Lower Zone Douglas Wells**

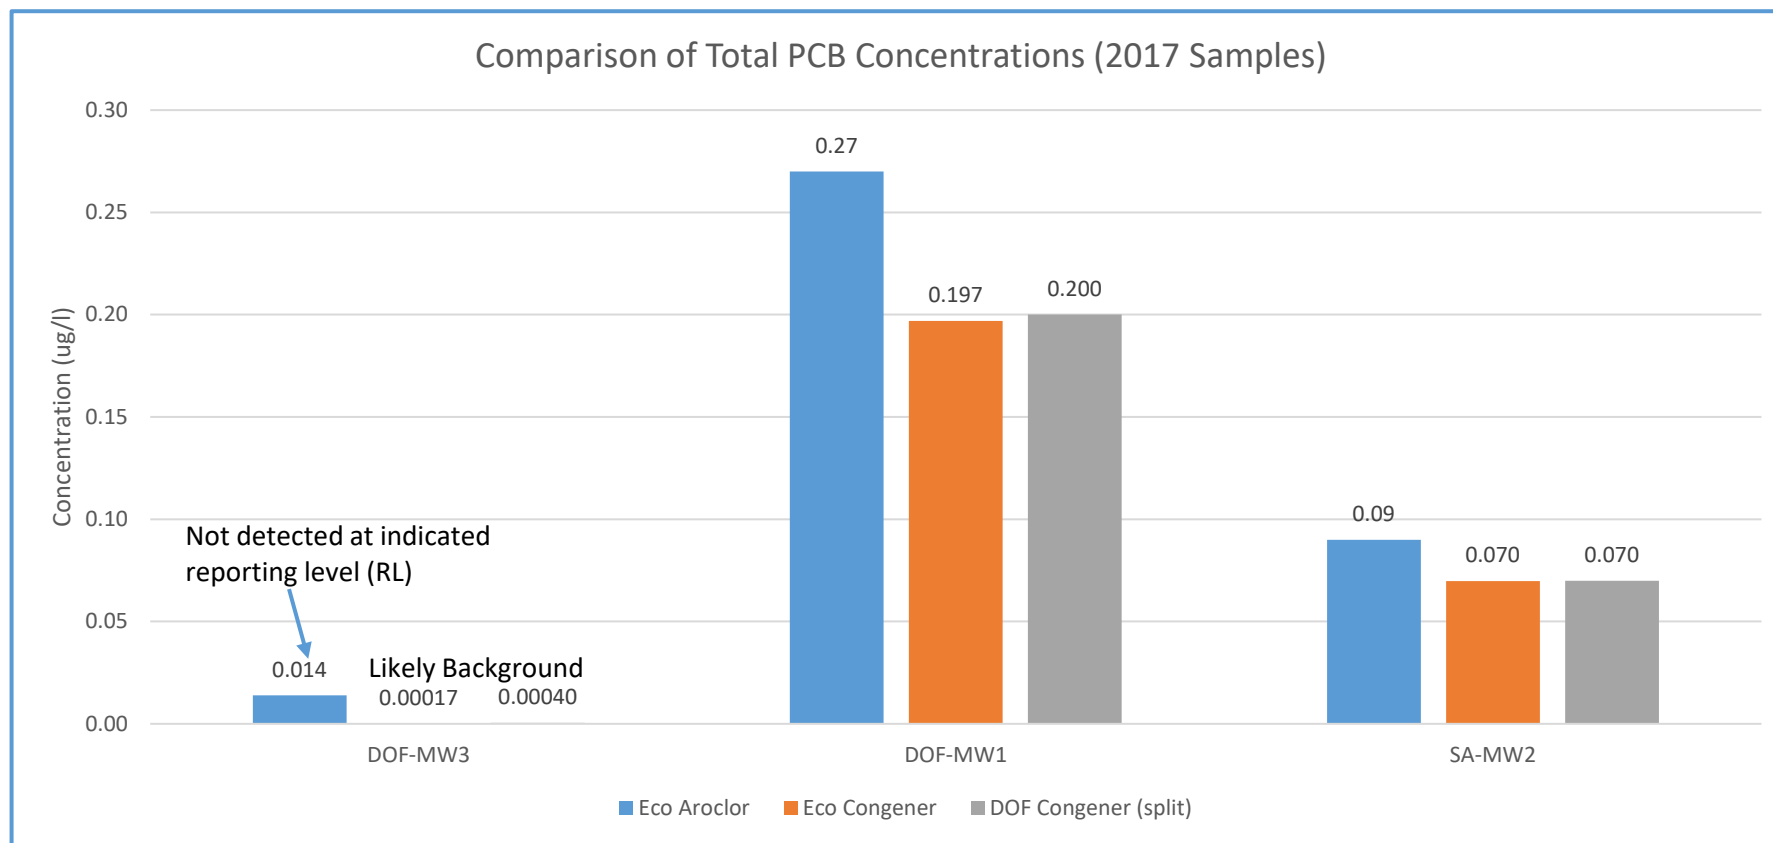
FIGURE 6-6 - Comparison of Aroclor and Congener PCBs in Groundwater

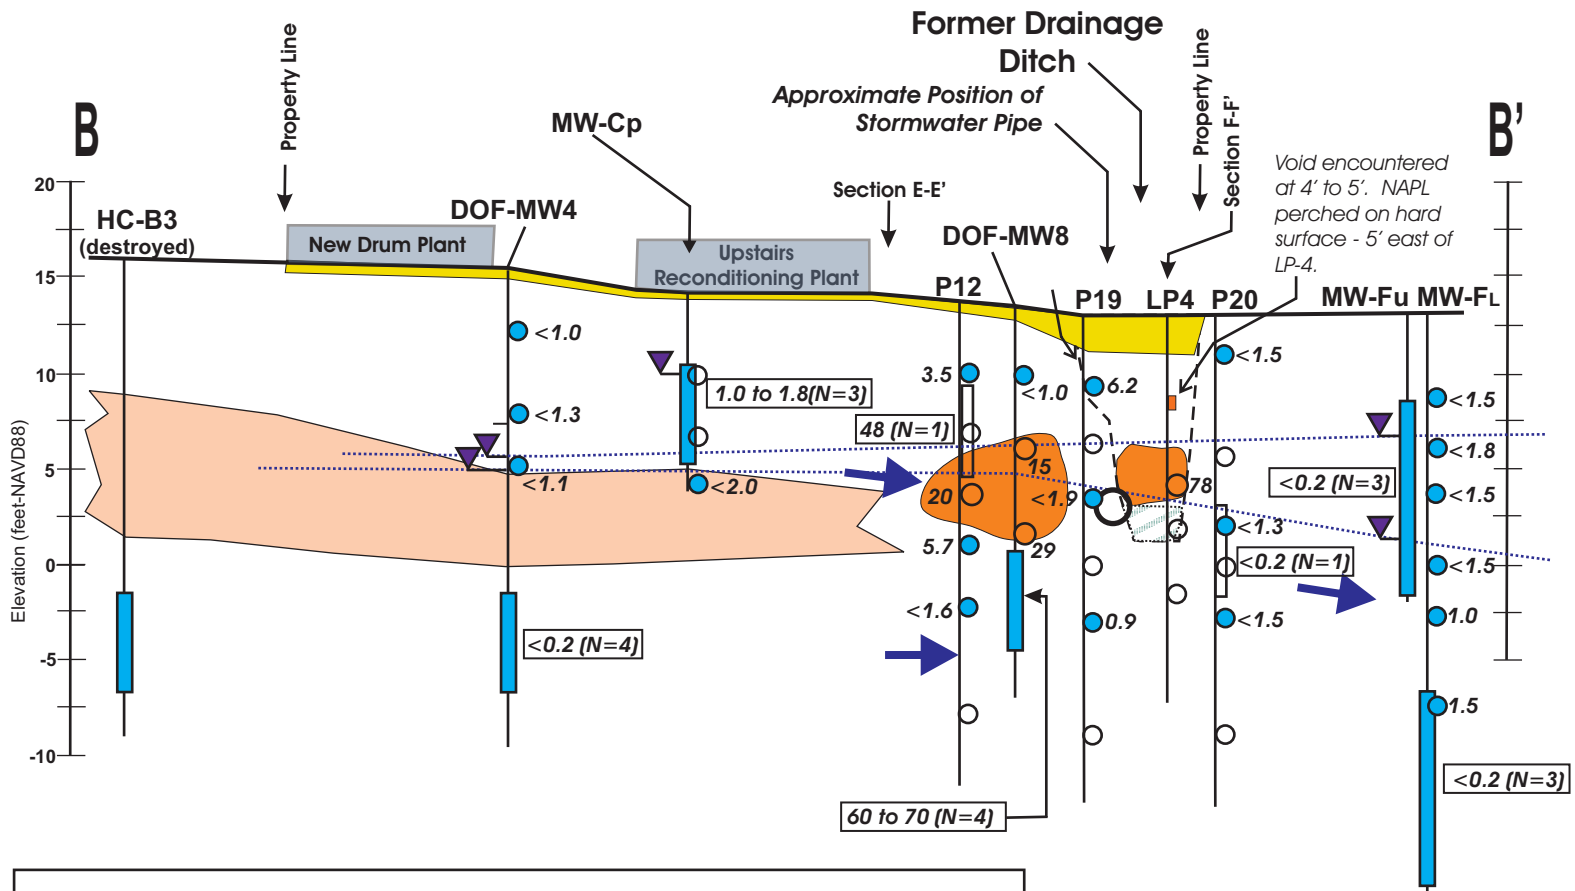
SUM-008-00 **FIGURE 6-12** Mar. 2018
Dalton, Olmsted & Fuglevand, Inc.

Benzene Along Section B-B'

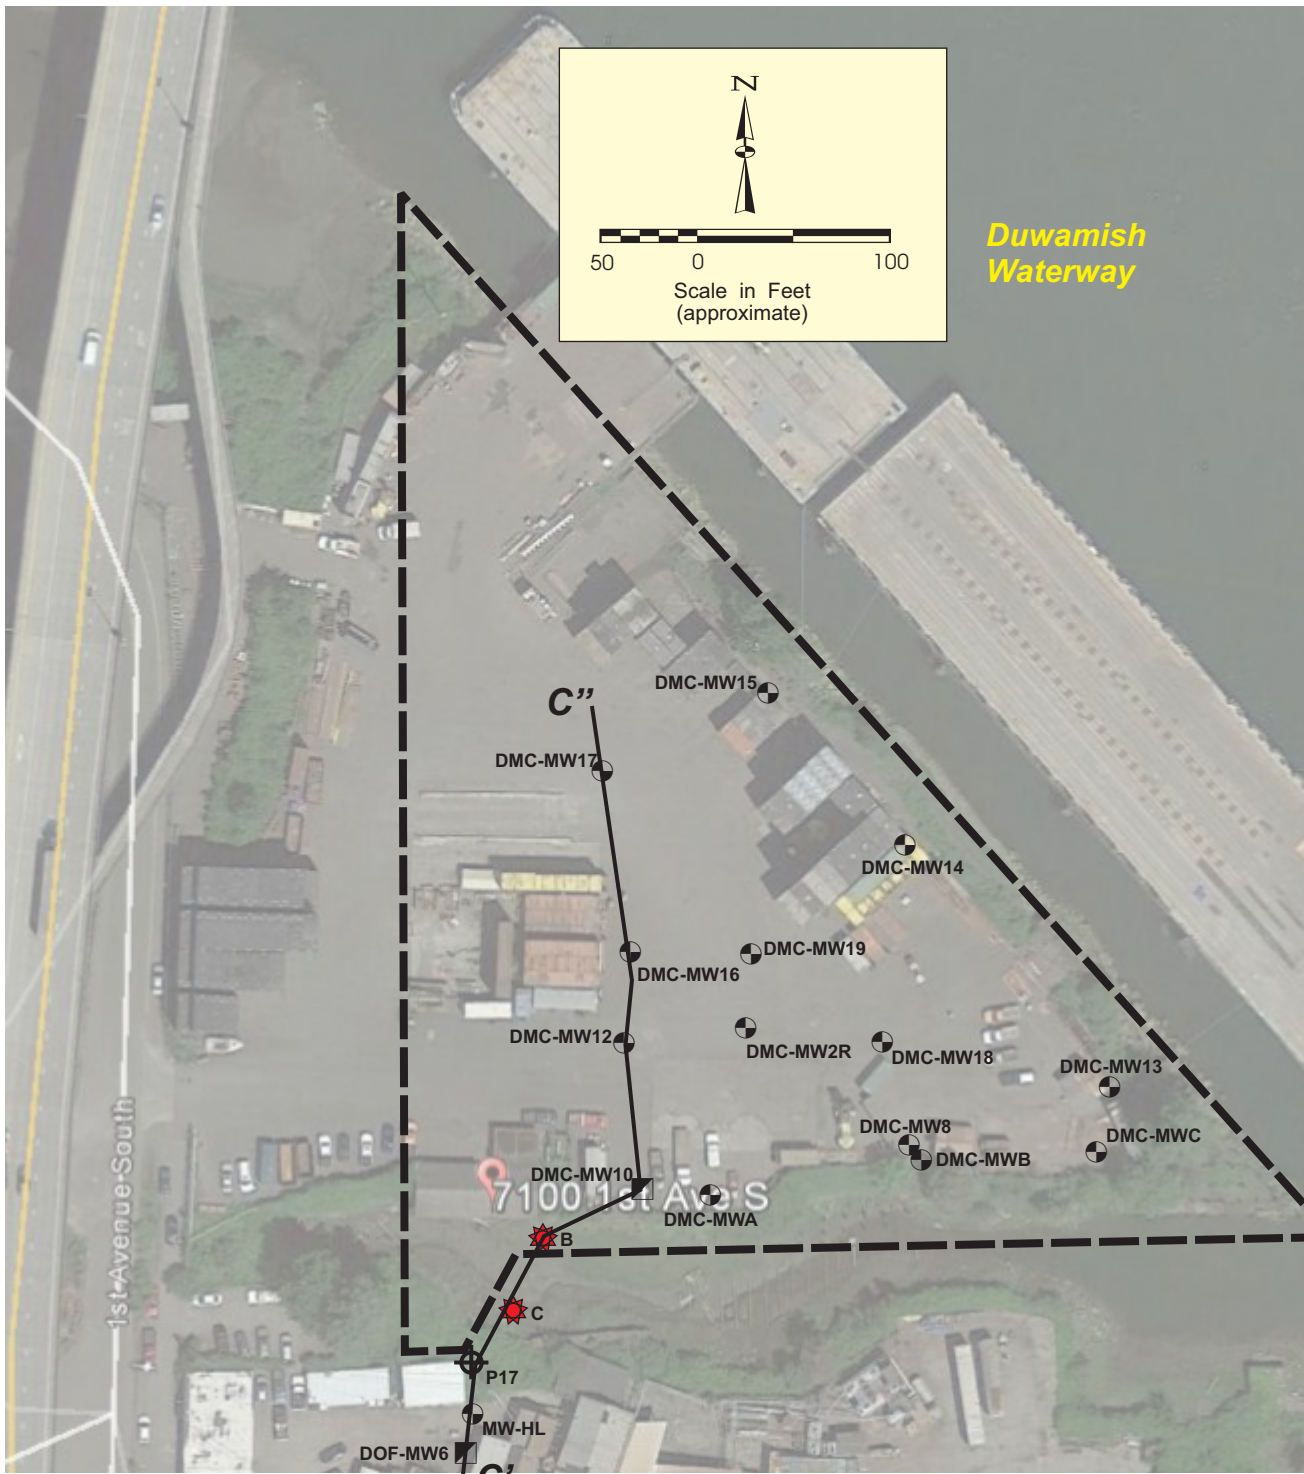
ICS/NW Cooperage Site		FIGURE 6-18
Douglas Property Deeper Soil Sample Locations		
<i>SUM-008-00 (ICS)</i>	<i>April 2018</i>	
<i>Dalton, Olmsted & Fuglevand, Inc.</i>

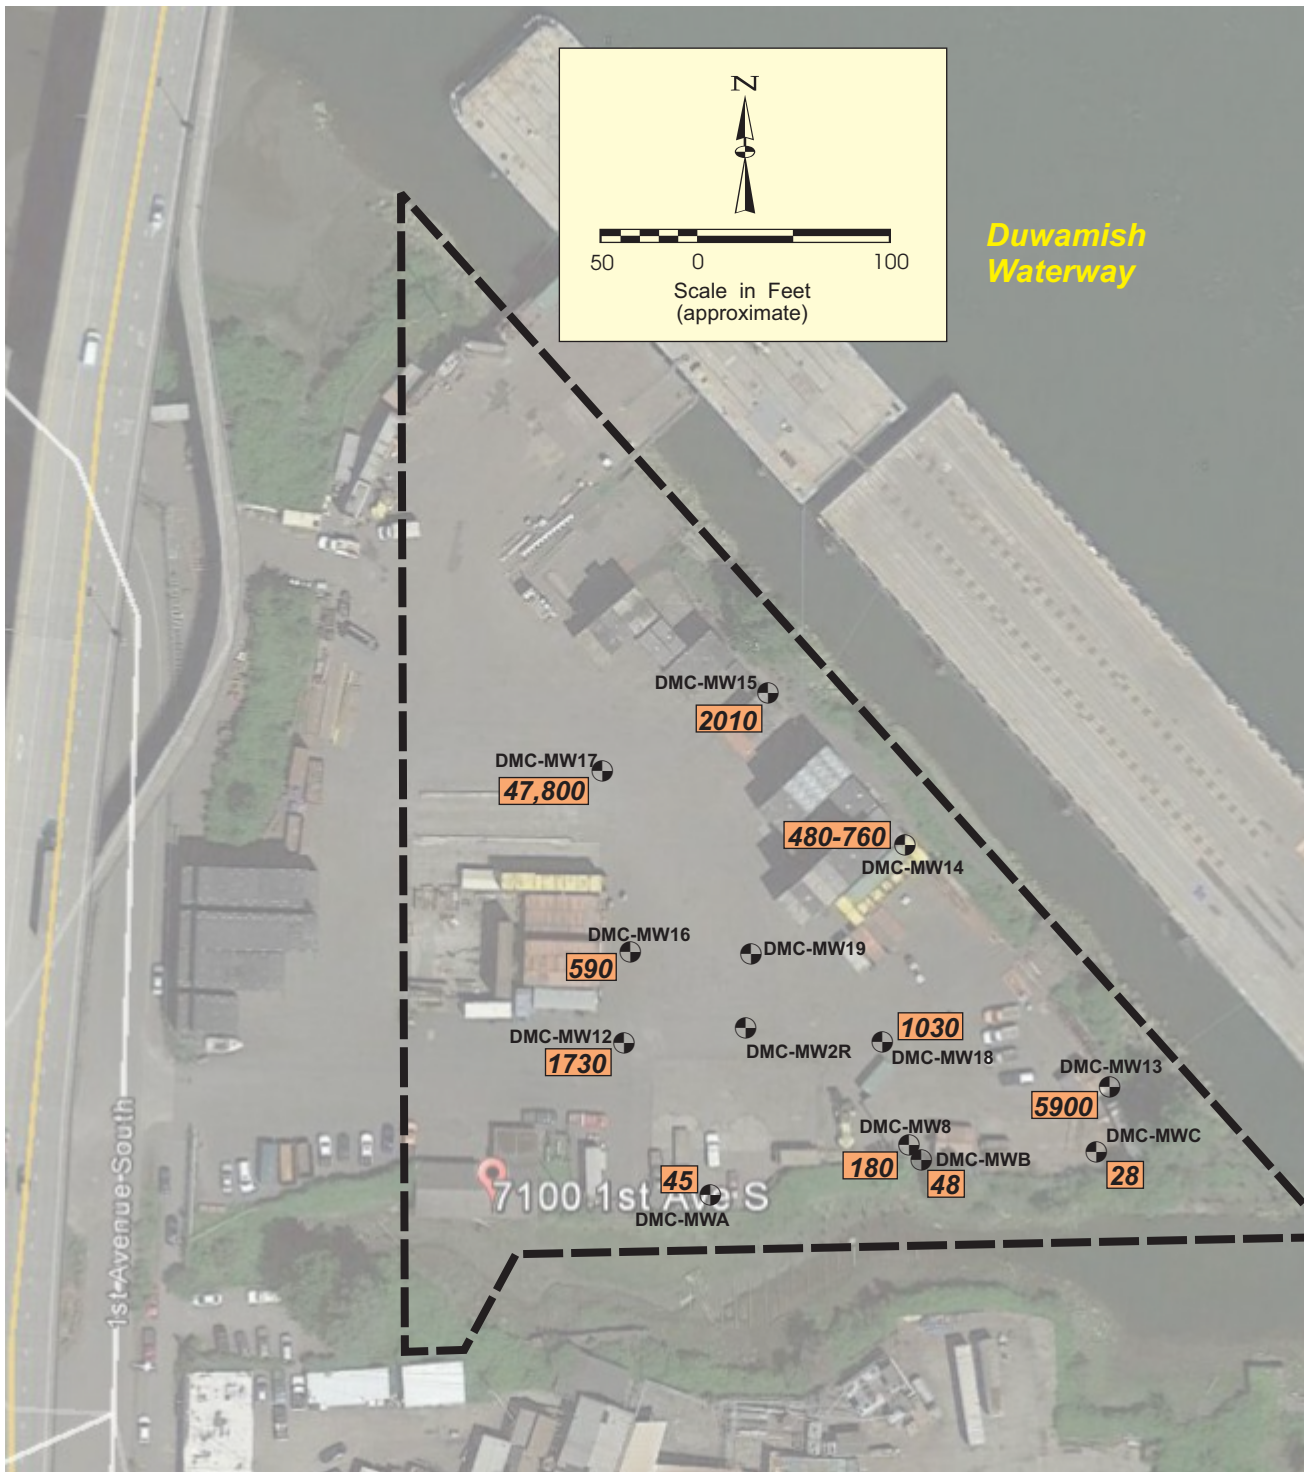
PCB Conc. (ug/kg) in Former Turning Basin Sediment

ICS/NW Cooperage Site		FIGURE 6-20
Douglas Property PCB Concentrations In Turning Basin Bottom Sediment		
SUM-008-00 (ICS)	April 2018	
<i>Dalton, Olmsted & Fuglevand, Inc.</i>
