**DRAFT - Subject  
To Revision**

<b>ICS/NW Cooperaage Site</b>	
<b>Section Trend Locations Douglas Property and Embayment</b>	
SUM-008-00 (ICS)	Mar. 2018
<i>Dalton, Olmsted &amp; Fuglevand, Inc.</i>

**Geologic Section A-A'**

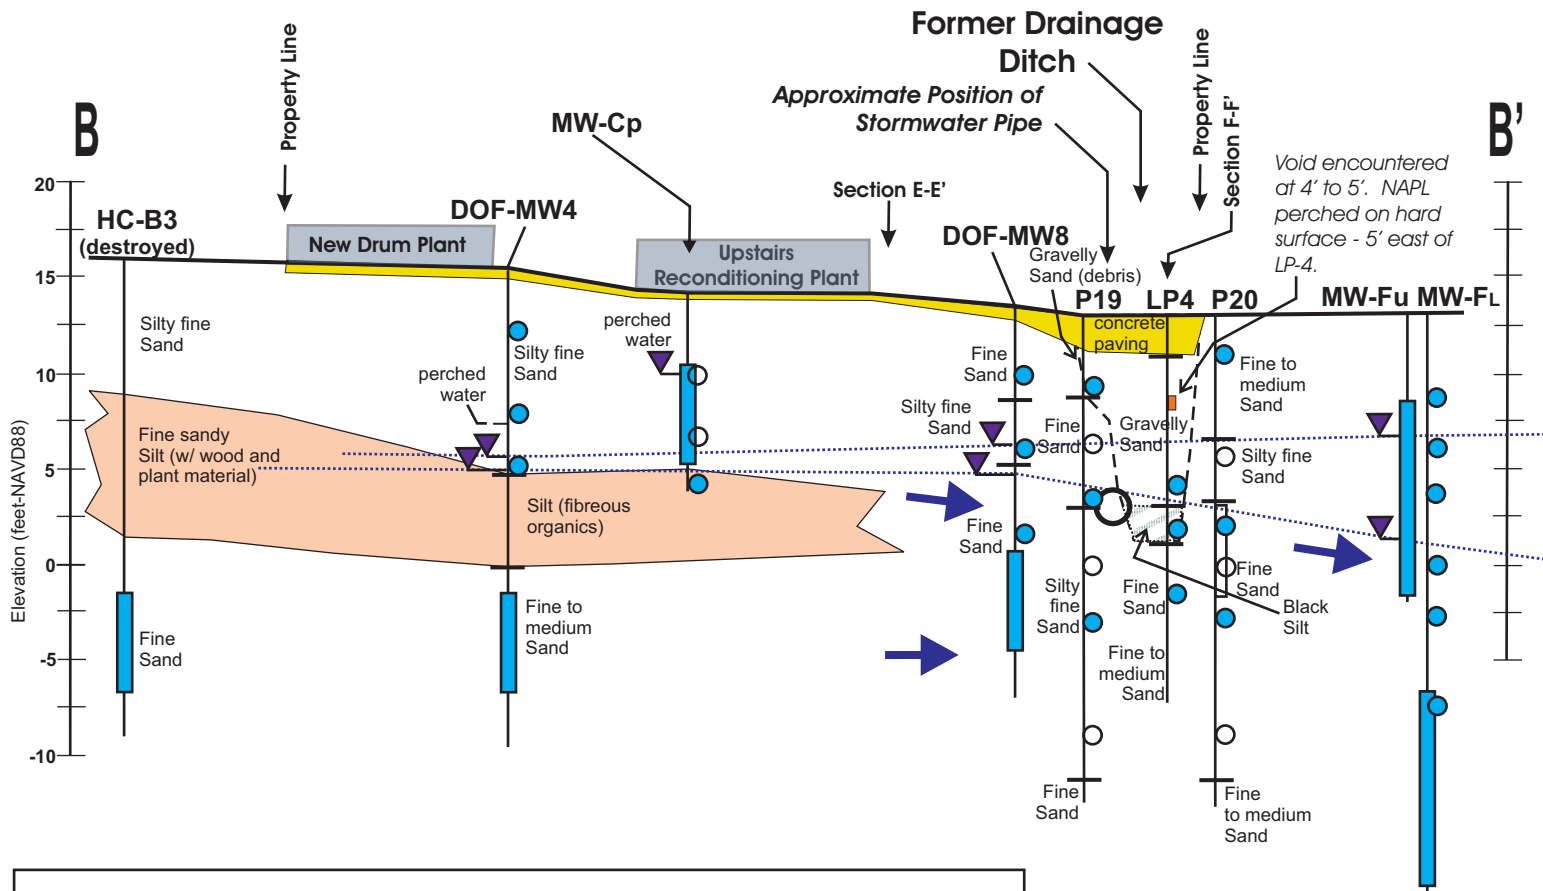
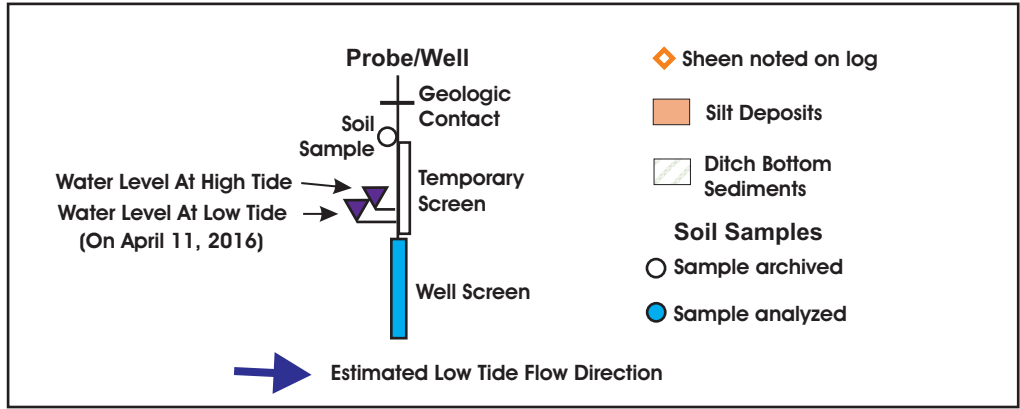
SUM-008-00 **FIGURE 4-3** Mar. 2018  
 Dalton, Olmsted & Fuglevand, Inc.

**Geologic Section B-B'**

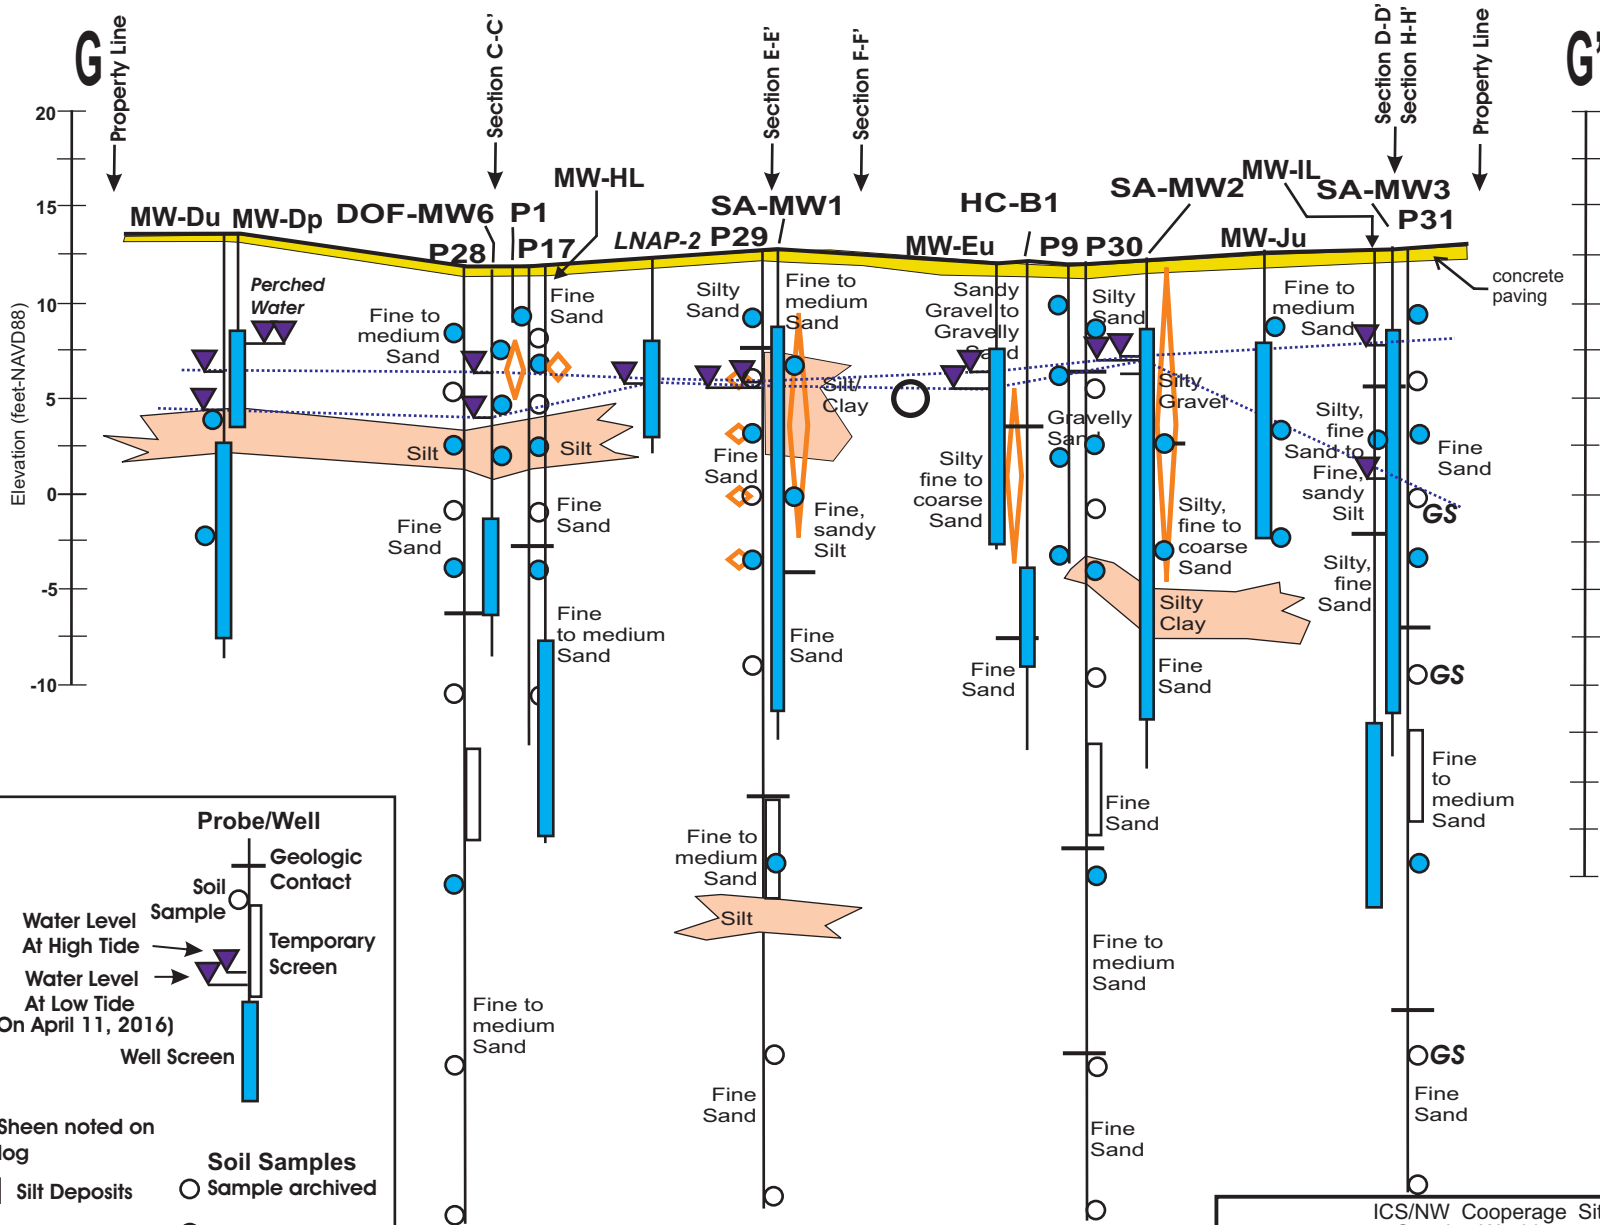
ICS/NW Cooperage Site  
Seattle, Washington  
**Geologic Section G-G'**  
SUM-008-00 **FIGURE 4-8** Mar. 2016  
Dalton, Olmsted & Fuglevand, Inc.

- ◆ Sheen noted on log
- Silt Deposits
- ▨ Ditch Bottom Sediments

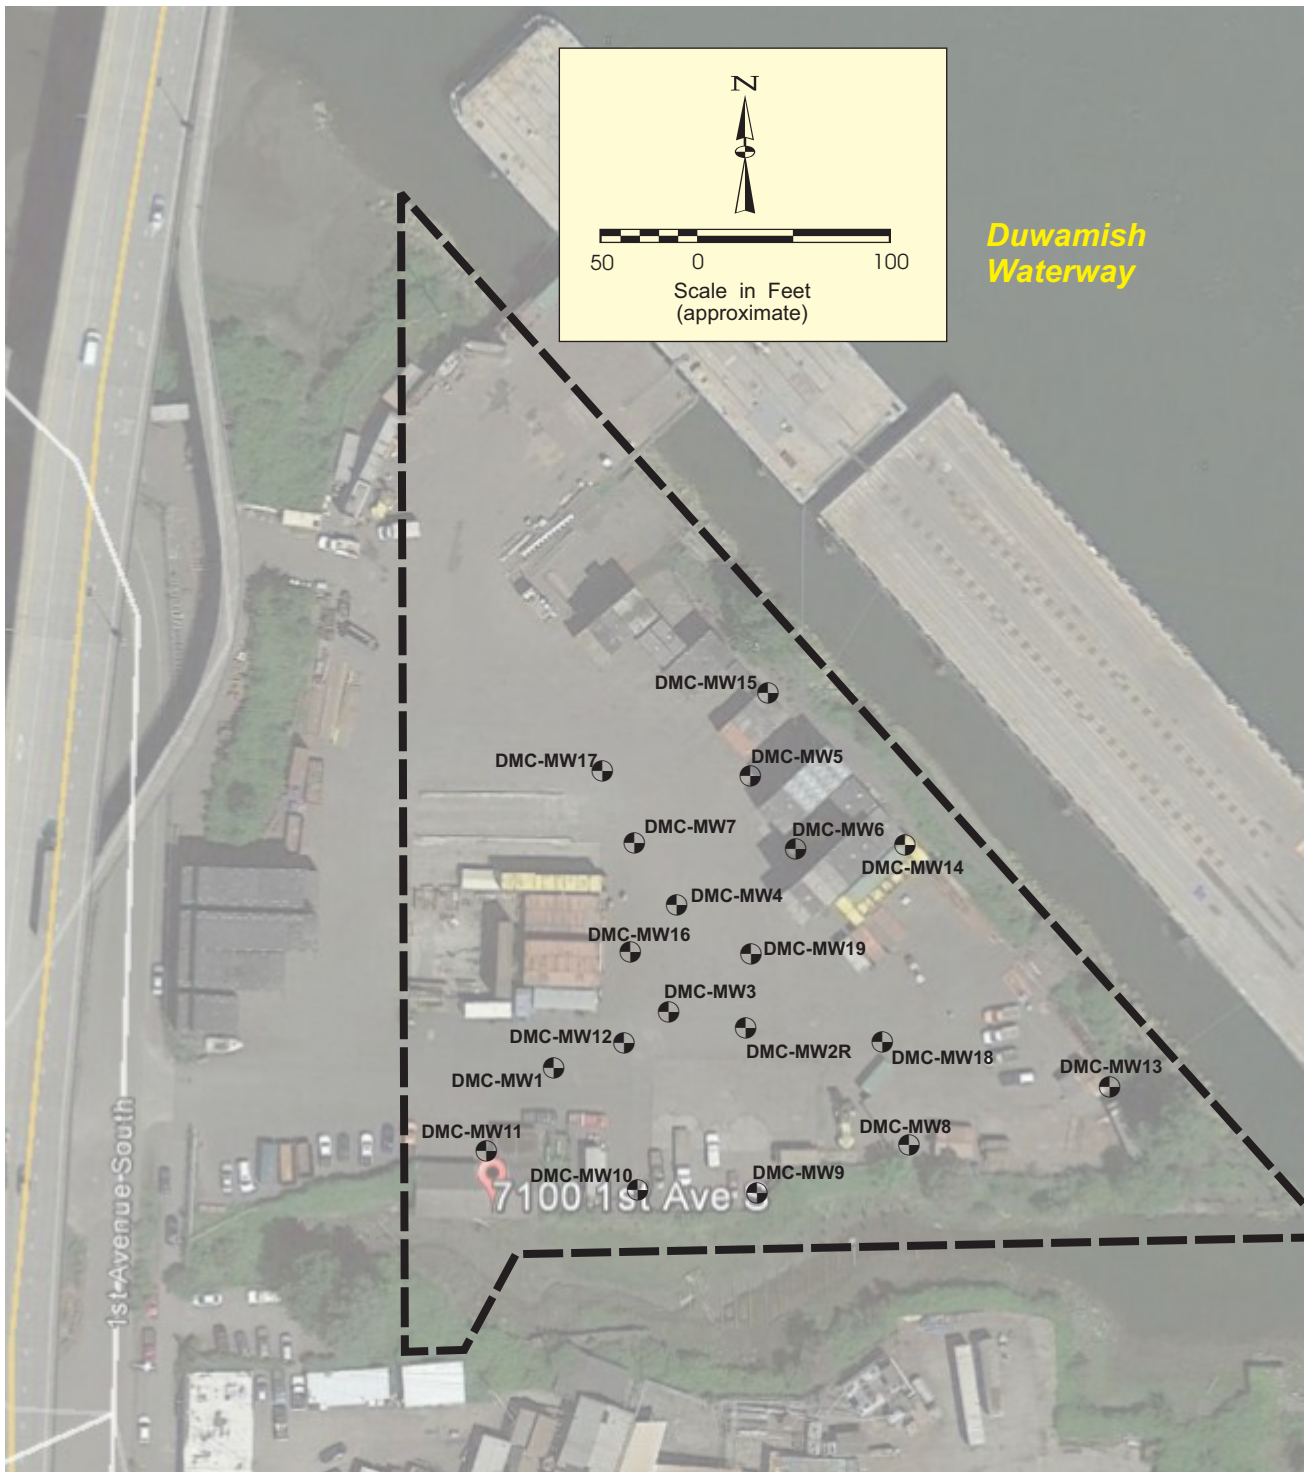
**FIGURE  
4-14**

<b>ICS/NW Cooperage Site</b>	
<b>Douglas Property Water Table/Upper Zone Well Locations</b>	
<i>SUM-008-00 (ICS)</i>	<i>March 2018</i>
<i>Dalton, Olmsted &amp; Fuglevand, Inc.</i>

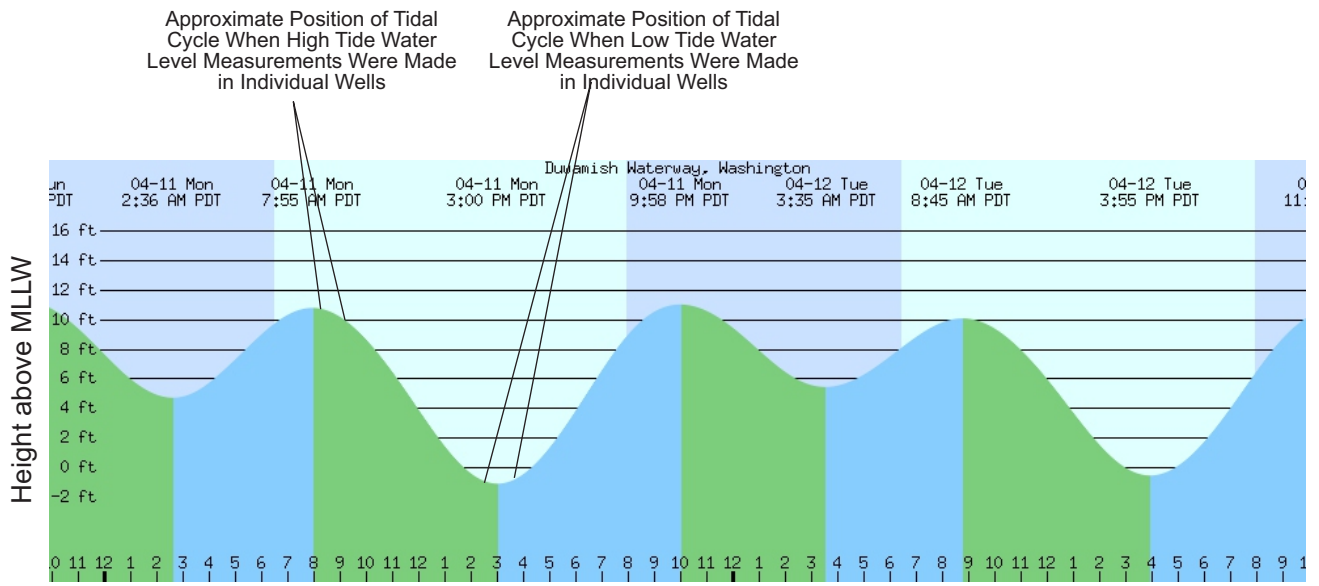
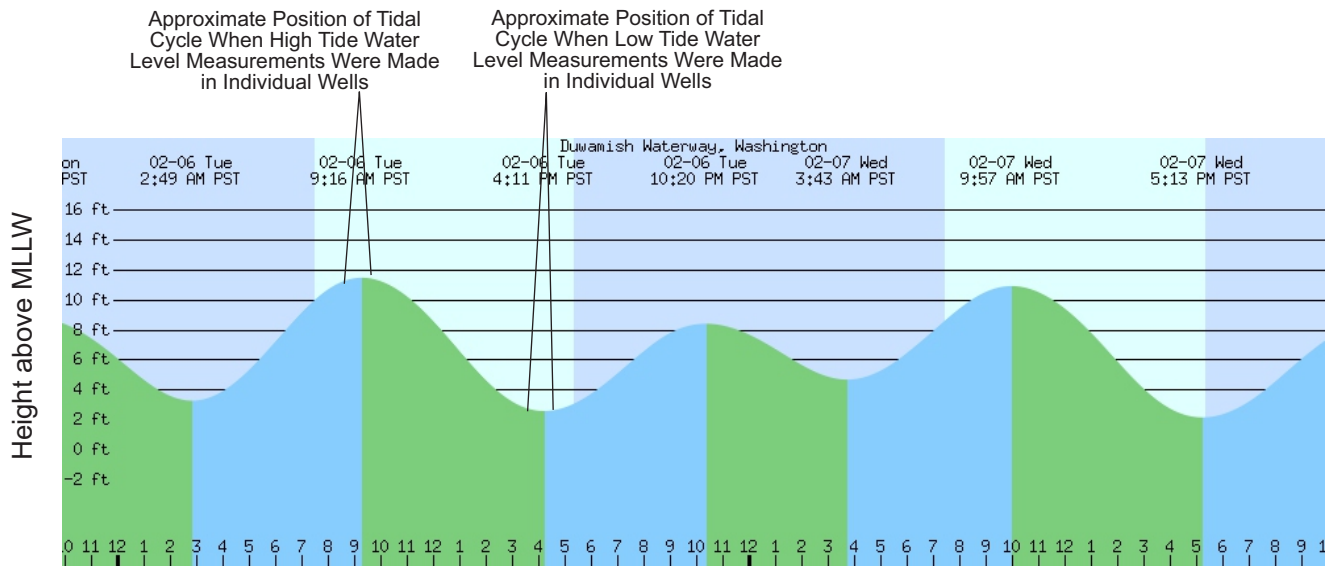
SUM-008-00 **FIGURE 4-15** Mar. 2018  
 Dalton, Olmsted & Fuglevand, Inc.

Notes:  
 The tide charts shown above are predicted tides for Duwamish Waterway  
 Tidal heights are relative to the NOAA chart datum Mean Lower Low Water (MLLW)

ICS/NW Cooperage Site  
 Seattle, Washington  
**TIDE CHARTS**  
**April 2016 and February 2018**

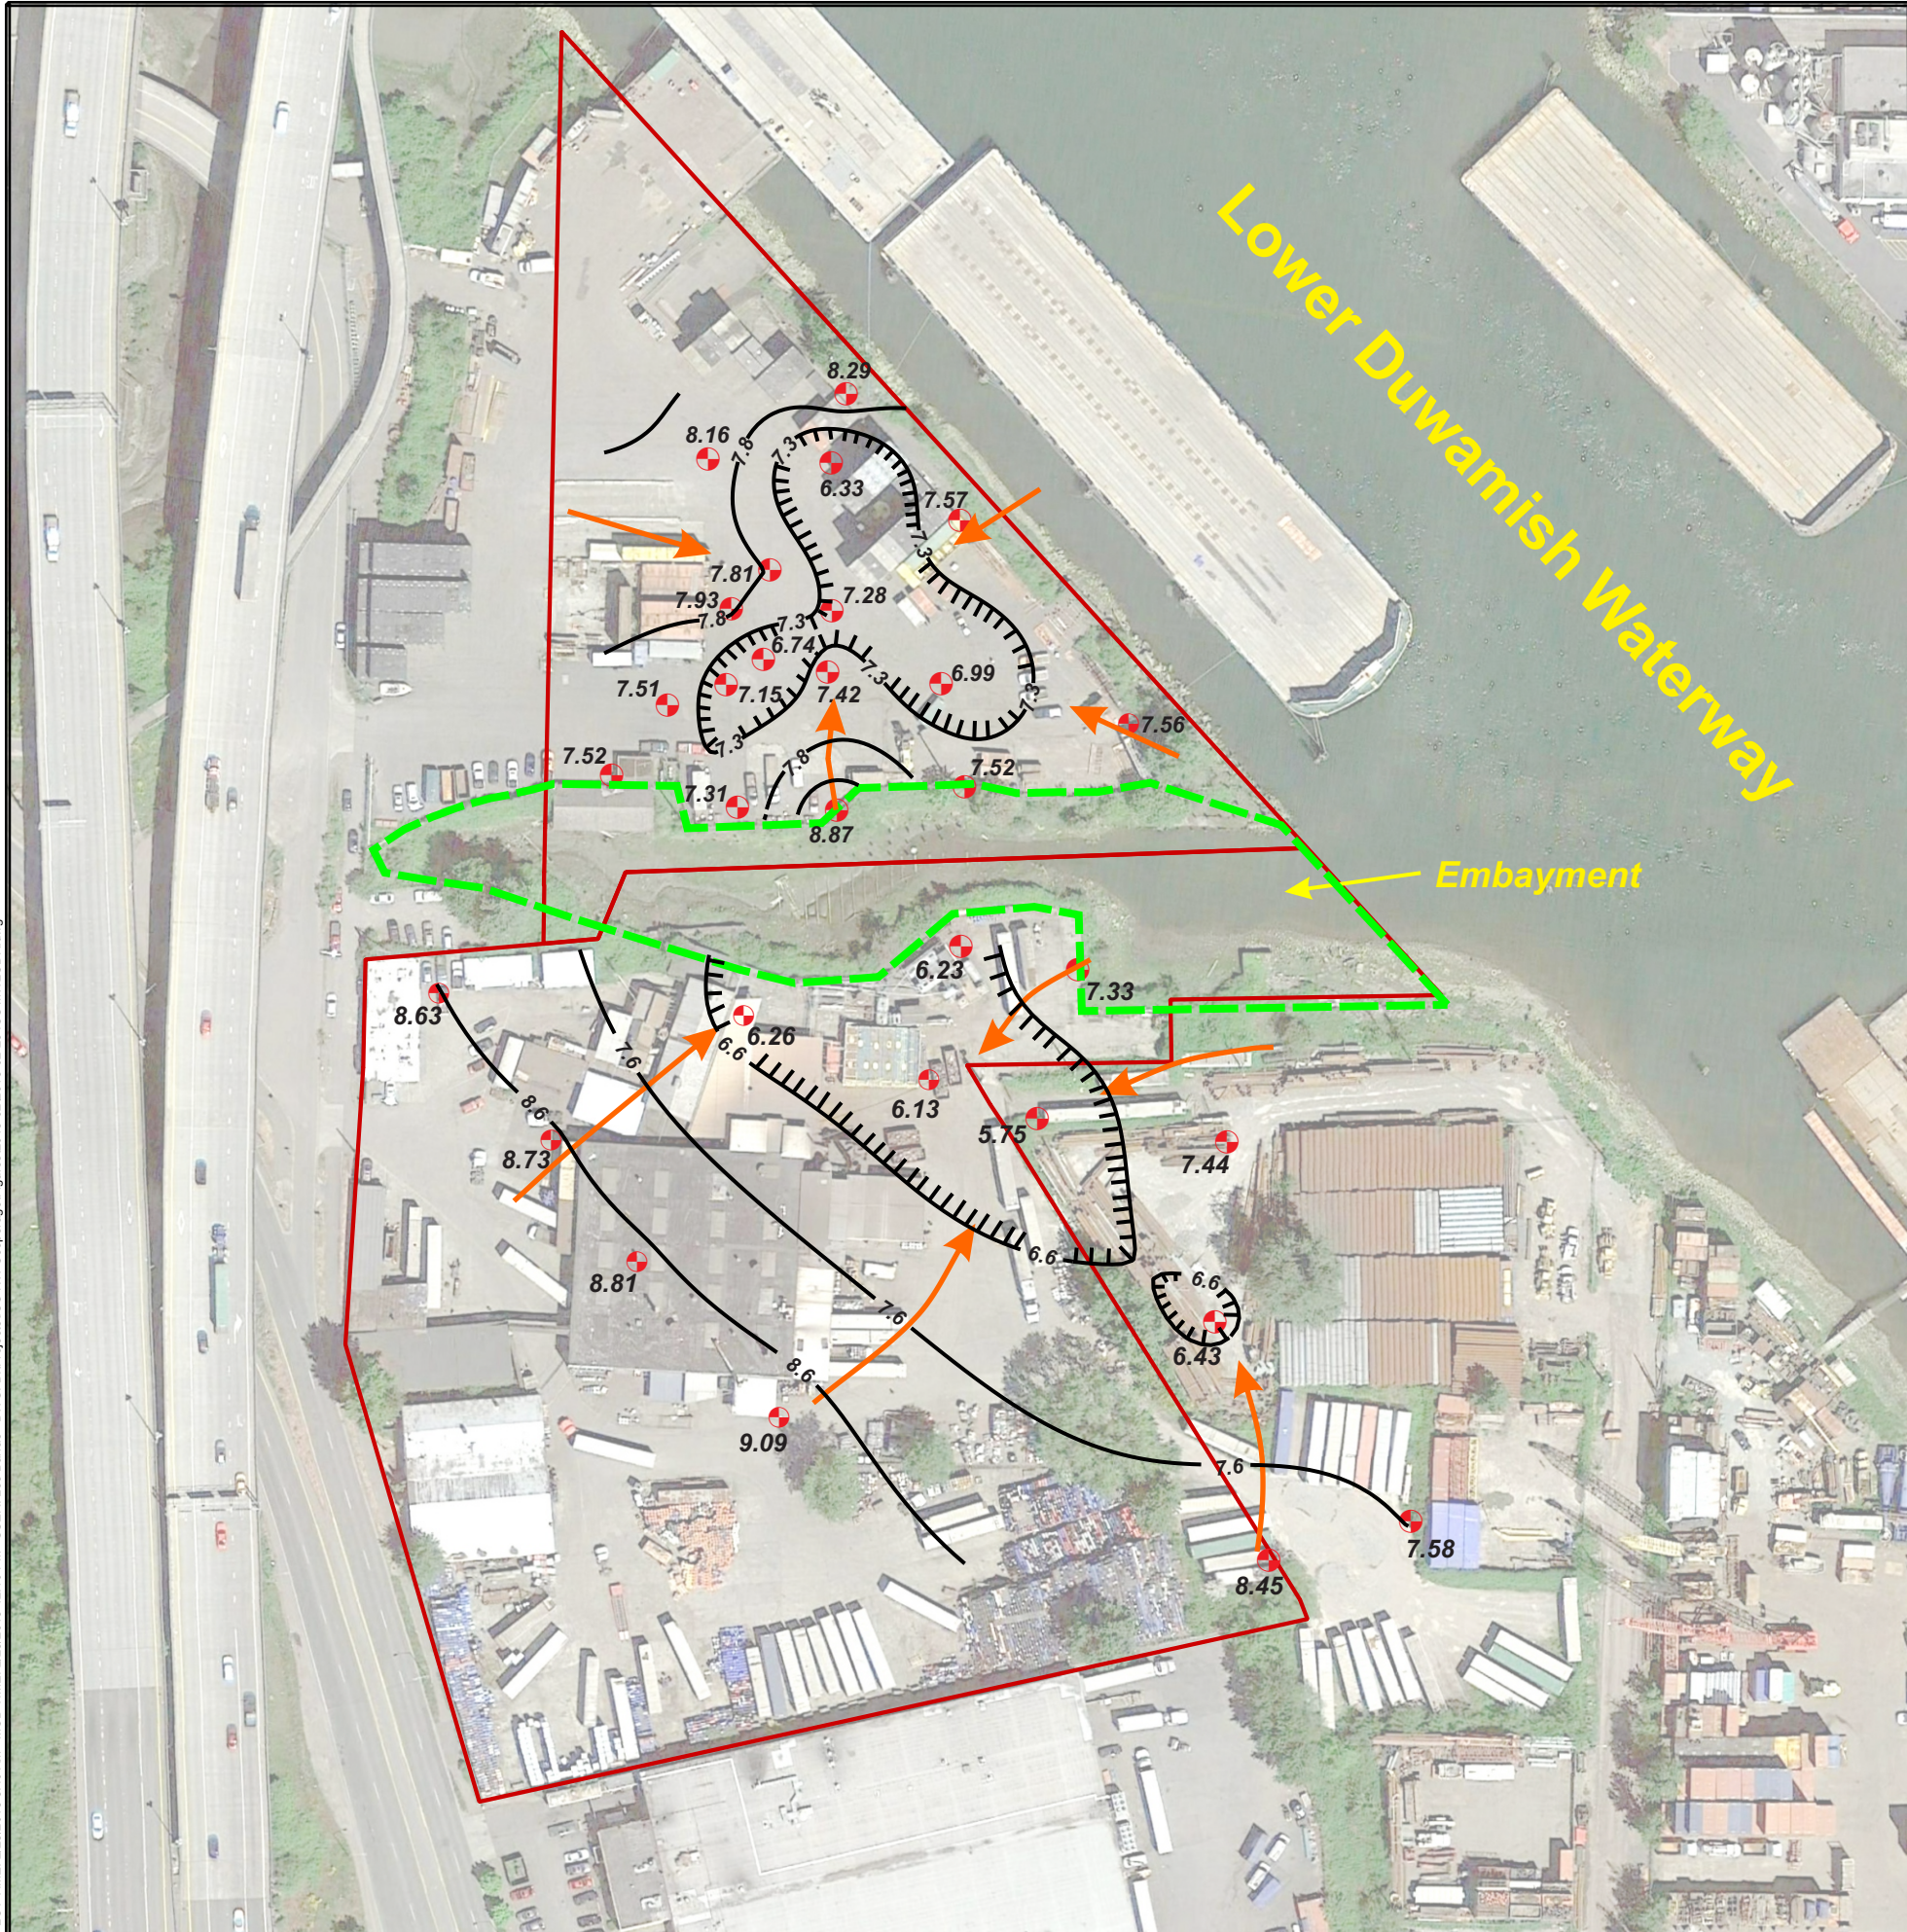
**FIGURE**  
**4-18a**  
March 2018

- 1) Water level measurements were made on February 6, 2018 during a predicted high tide of +9.4 feet NAVD88 (11.8 feet MLLW) at 0923 hours between 0852 hours and 0940 hours.
- 2) The water table and upper zones are not differentiated on the Douglas property.

Groundwater Flow Directions - Water Table Zone  
High Tide (+11.8' MLLW) - February 6, 2018

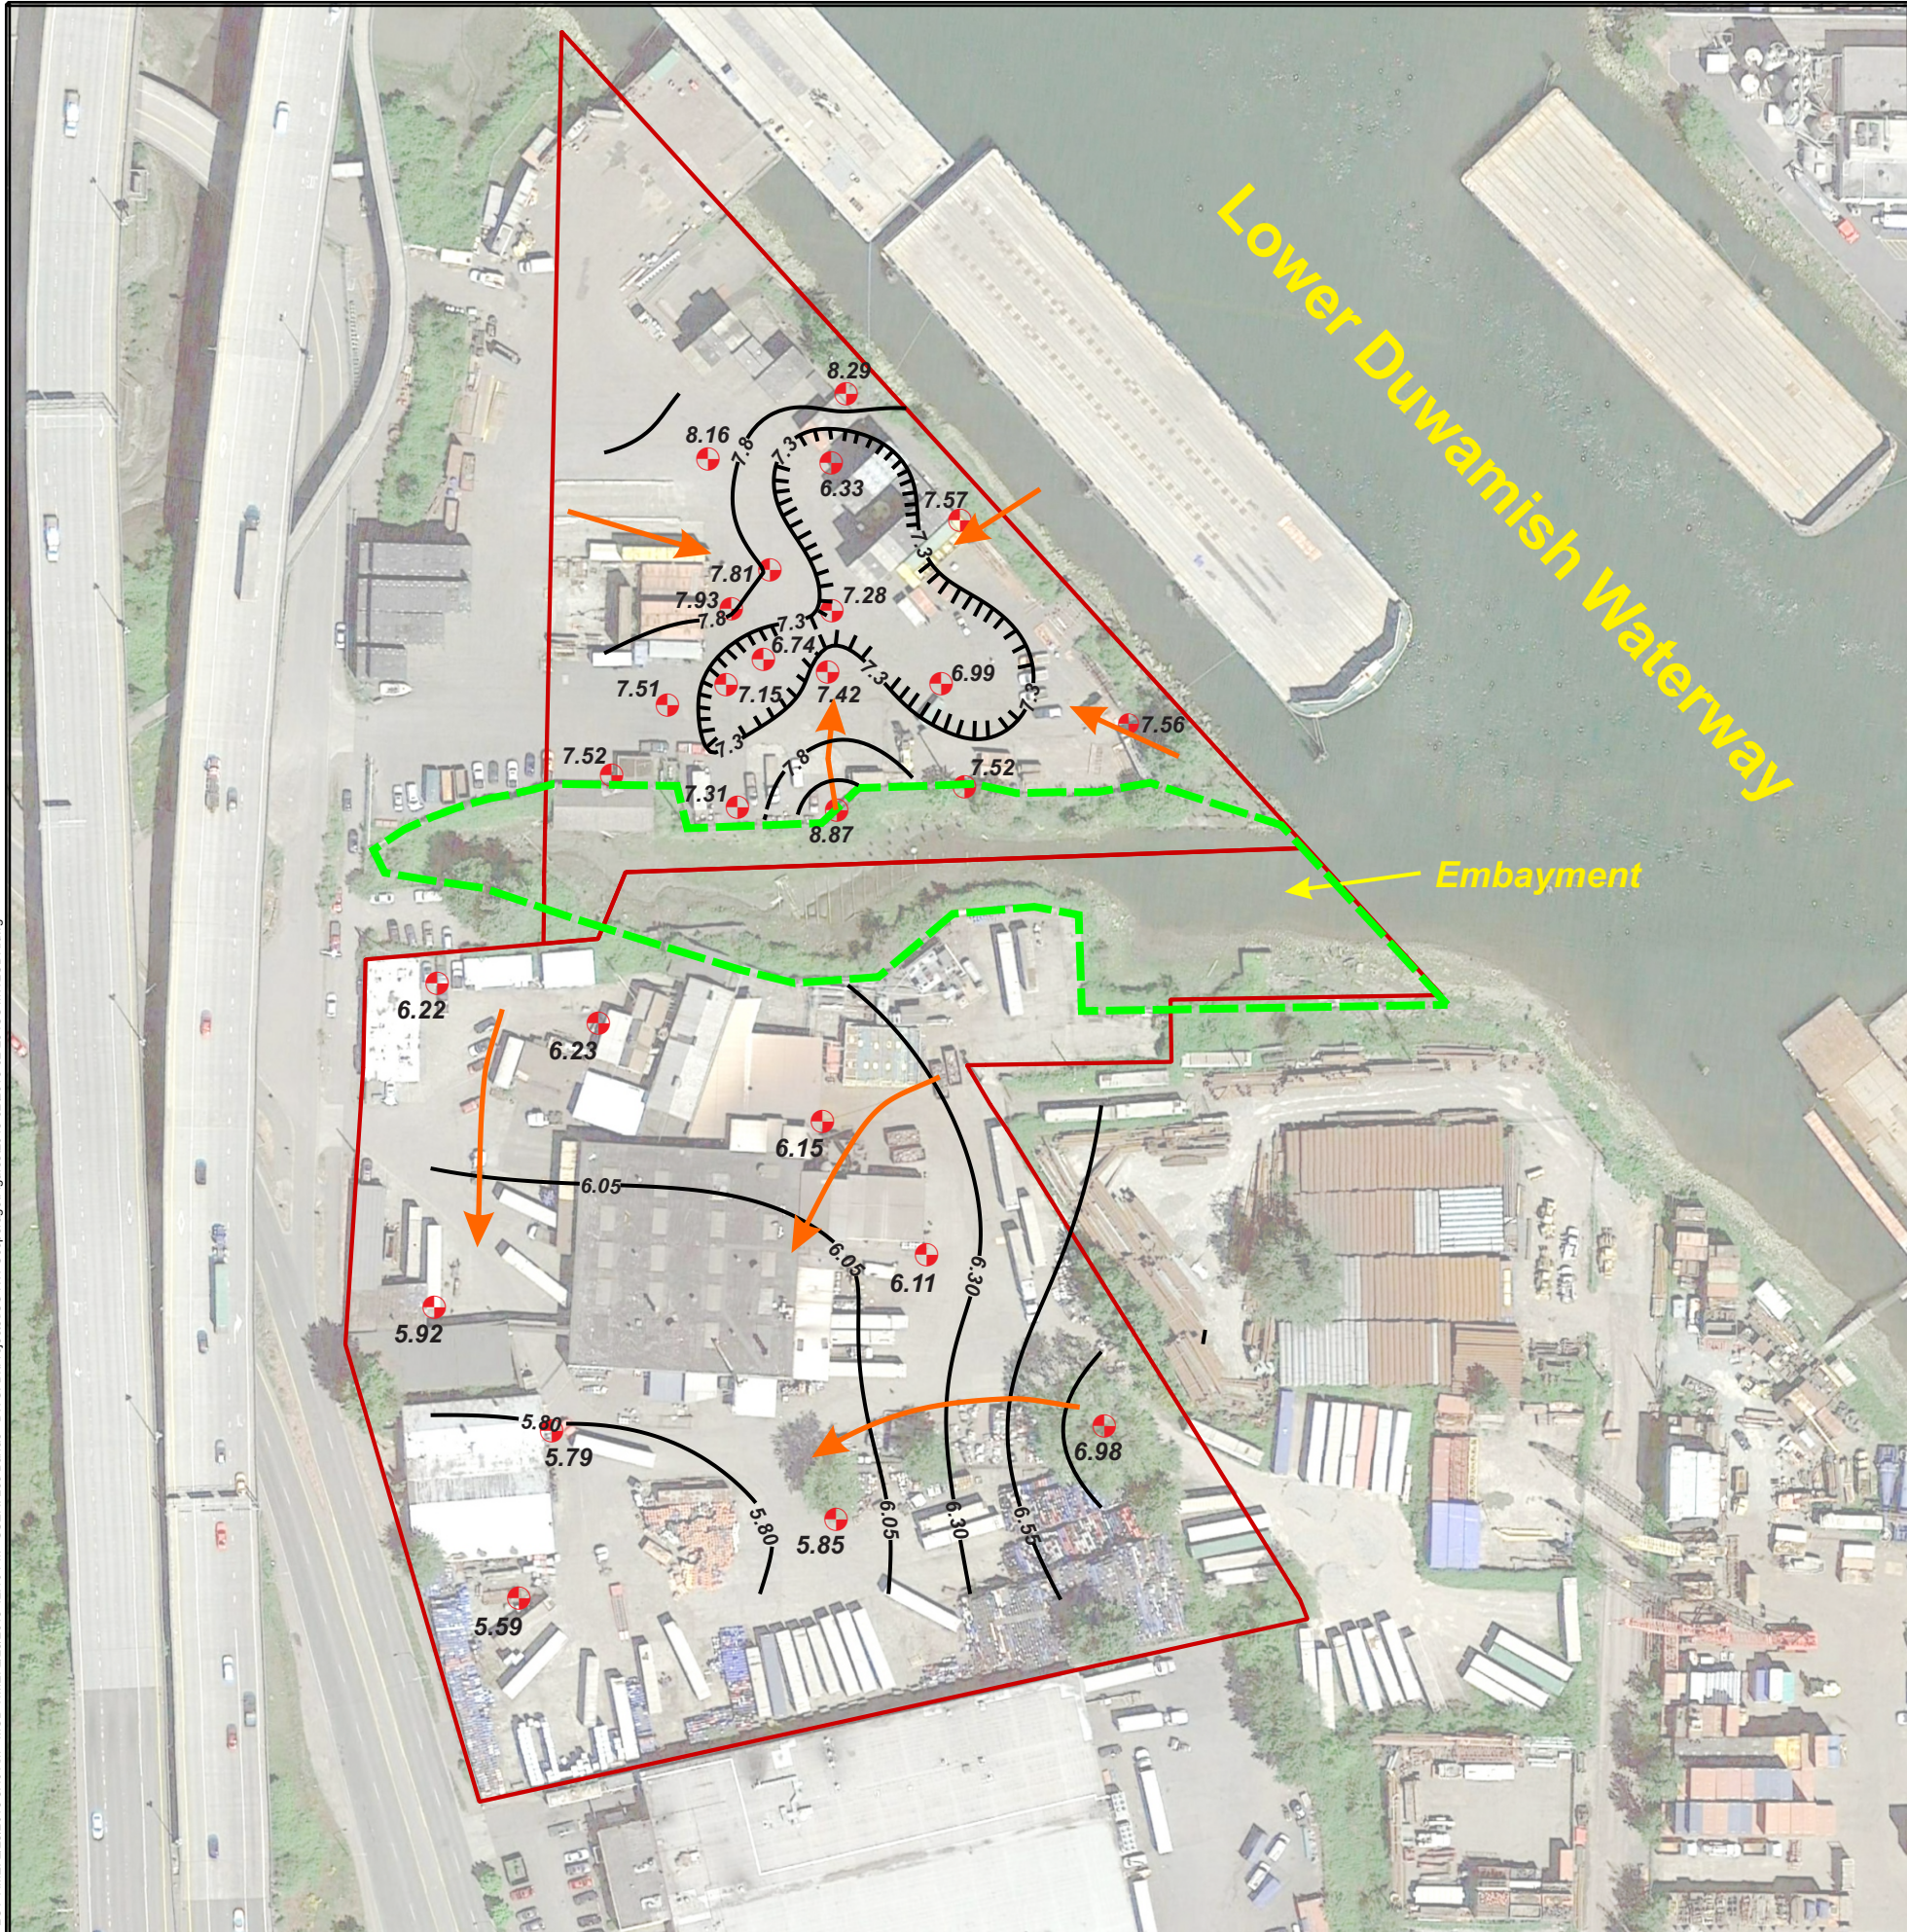
**FIGURE**  
4-19a  
March 2018

1) Water level measurements were made on February 6, 2018 during a predicted high tide of +9.4 feet NAVD88 (11.8 feet MLLW) at 0923 hours between 0852 hours and 0940 hours.

2) The water table and upper zones are not differentiated on the Douglas property.

Groundwater Flow Directions - ICS Upper Zone  
High Tide (+11.8' MLLW) - February 6, 2018

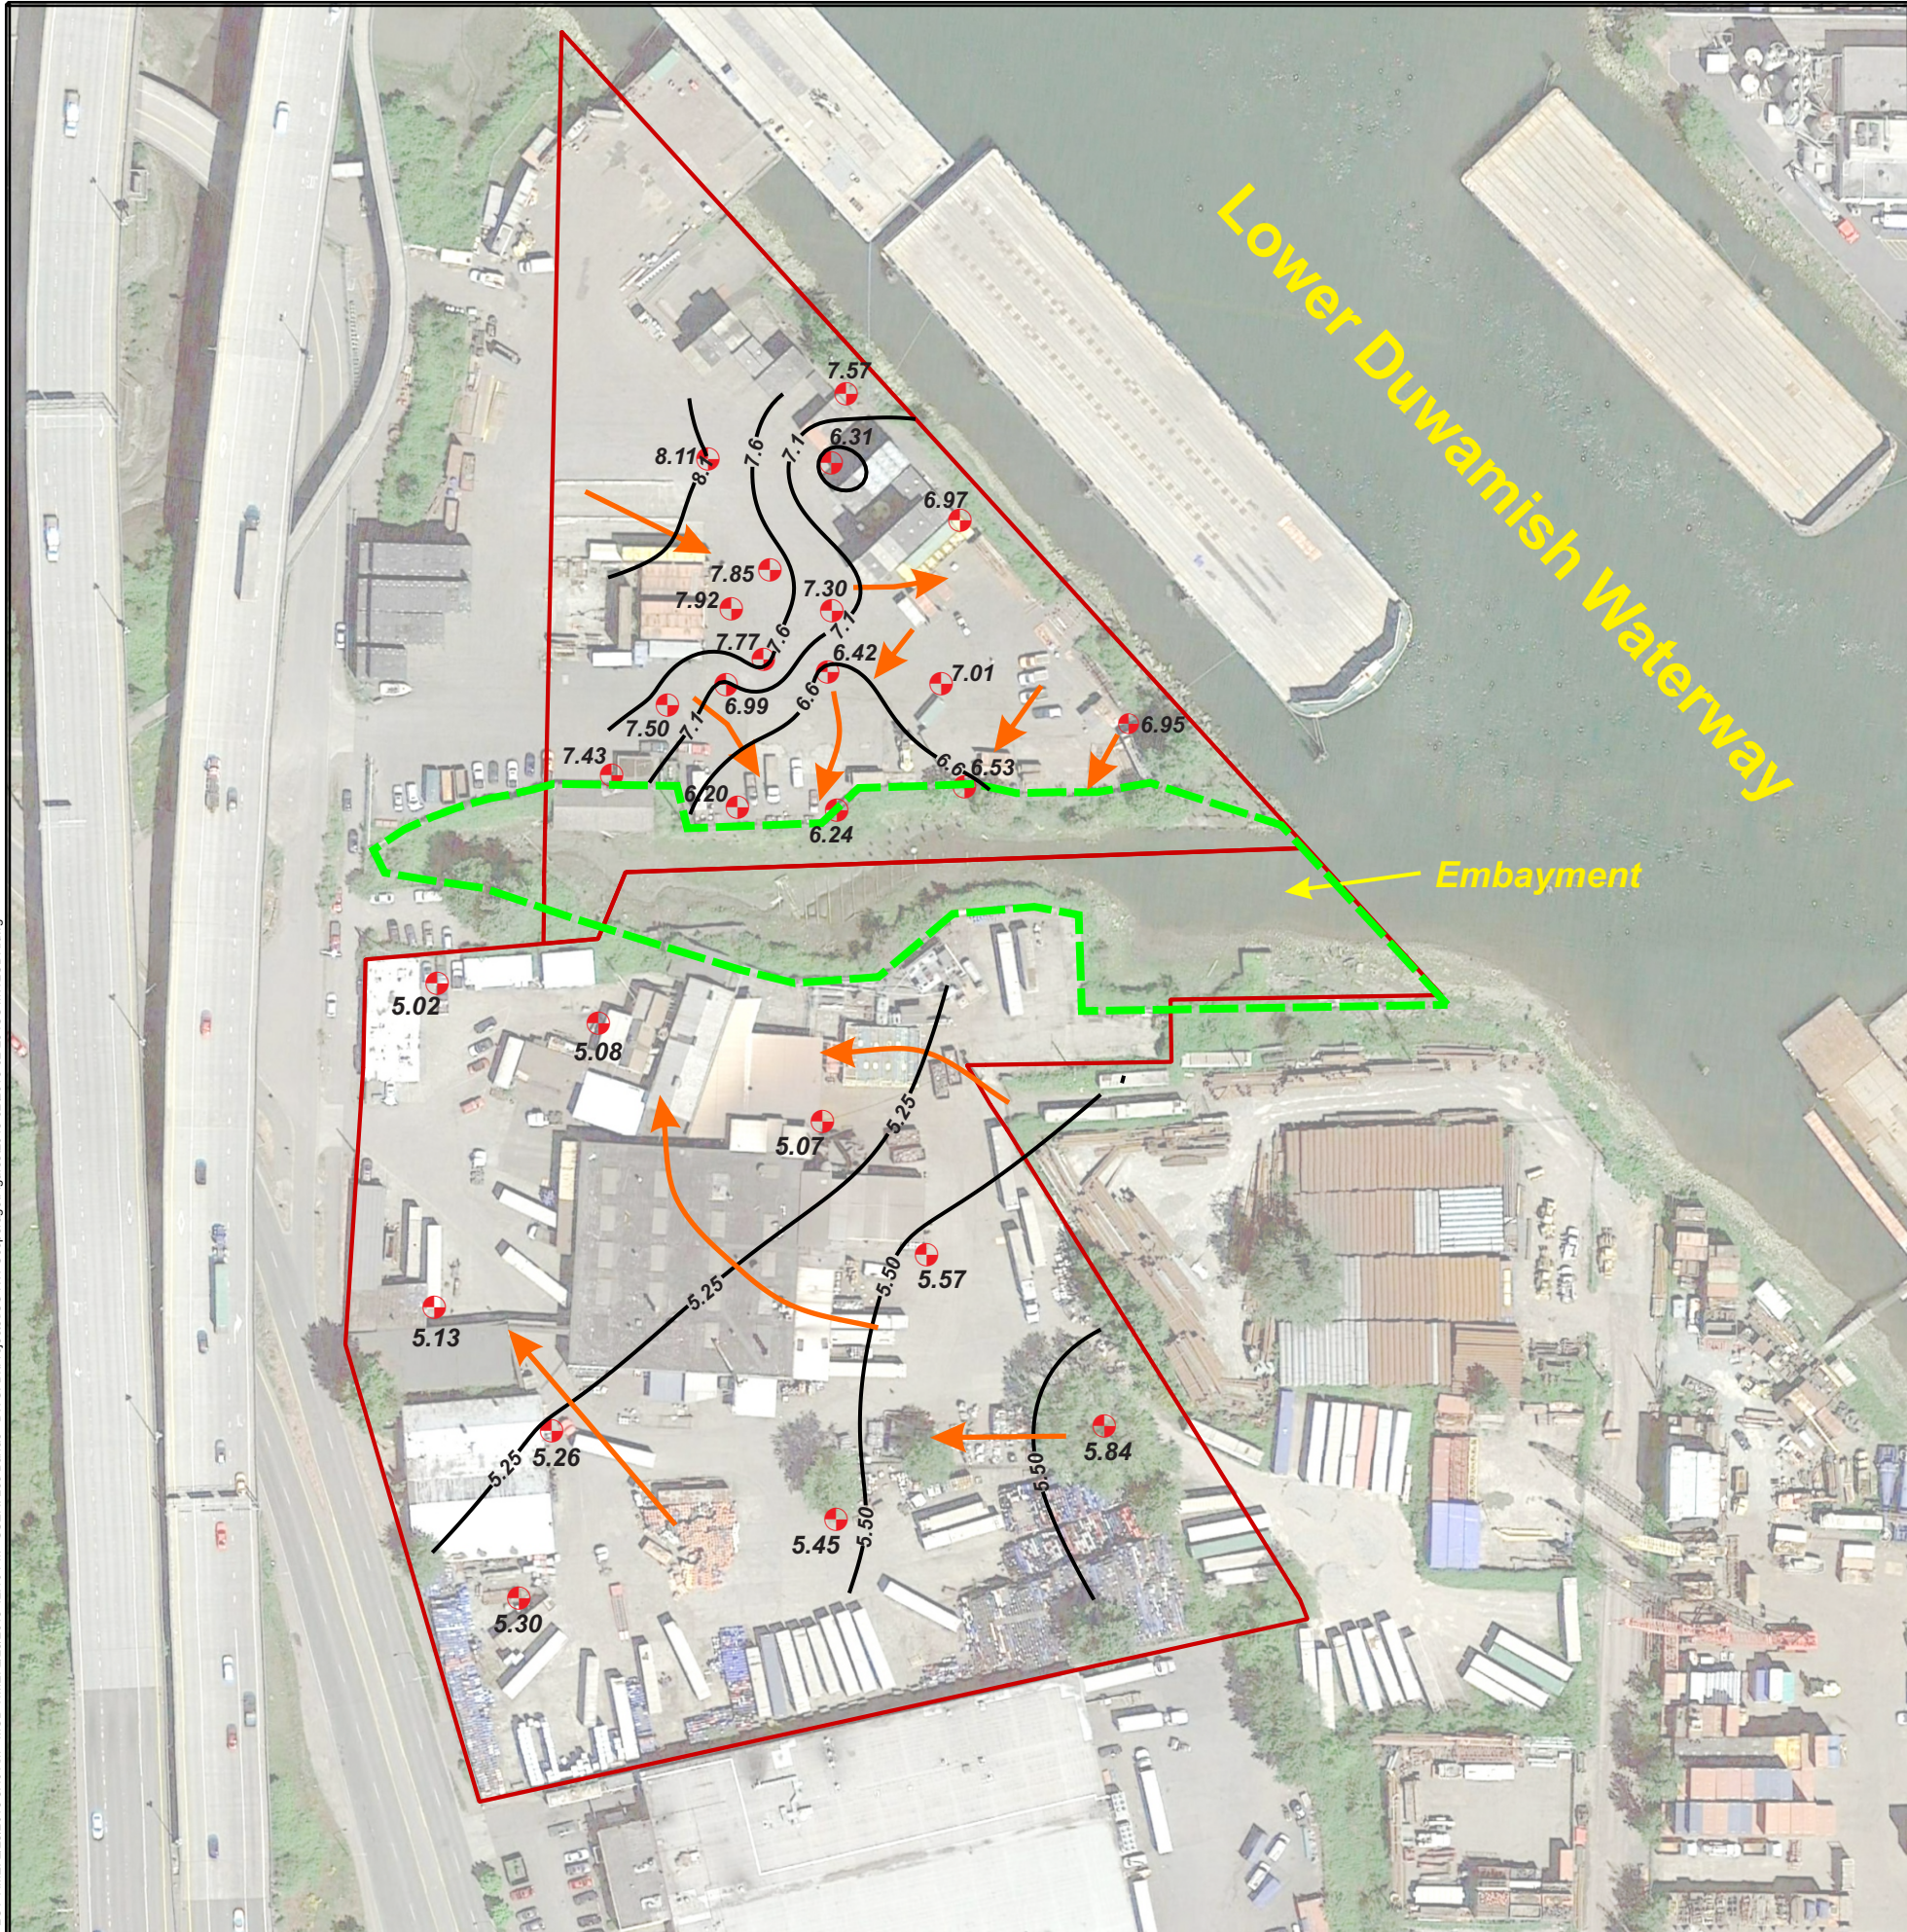
FIGURE  
4-19b

1) Water level measurements were made on February 6, 2018 during a predicted high tide of +9.4 feet NAVD88 (11.8 feet MLLW) at 0923 hours between 0852 hours and 0940 hours.

2) The water table and upper zones are not differentiated on the Douglas property.

Groundwater Flow Directions - ICS Upper Zone  
Low Tide (+2.5' MLLW) - February 6, 2018
