September 2022
Port Gamble Bay Cleanup

Five-Year Review

Washington State Department of Ecology

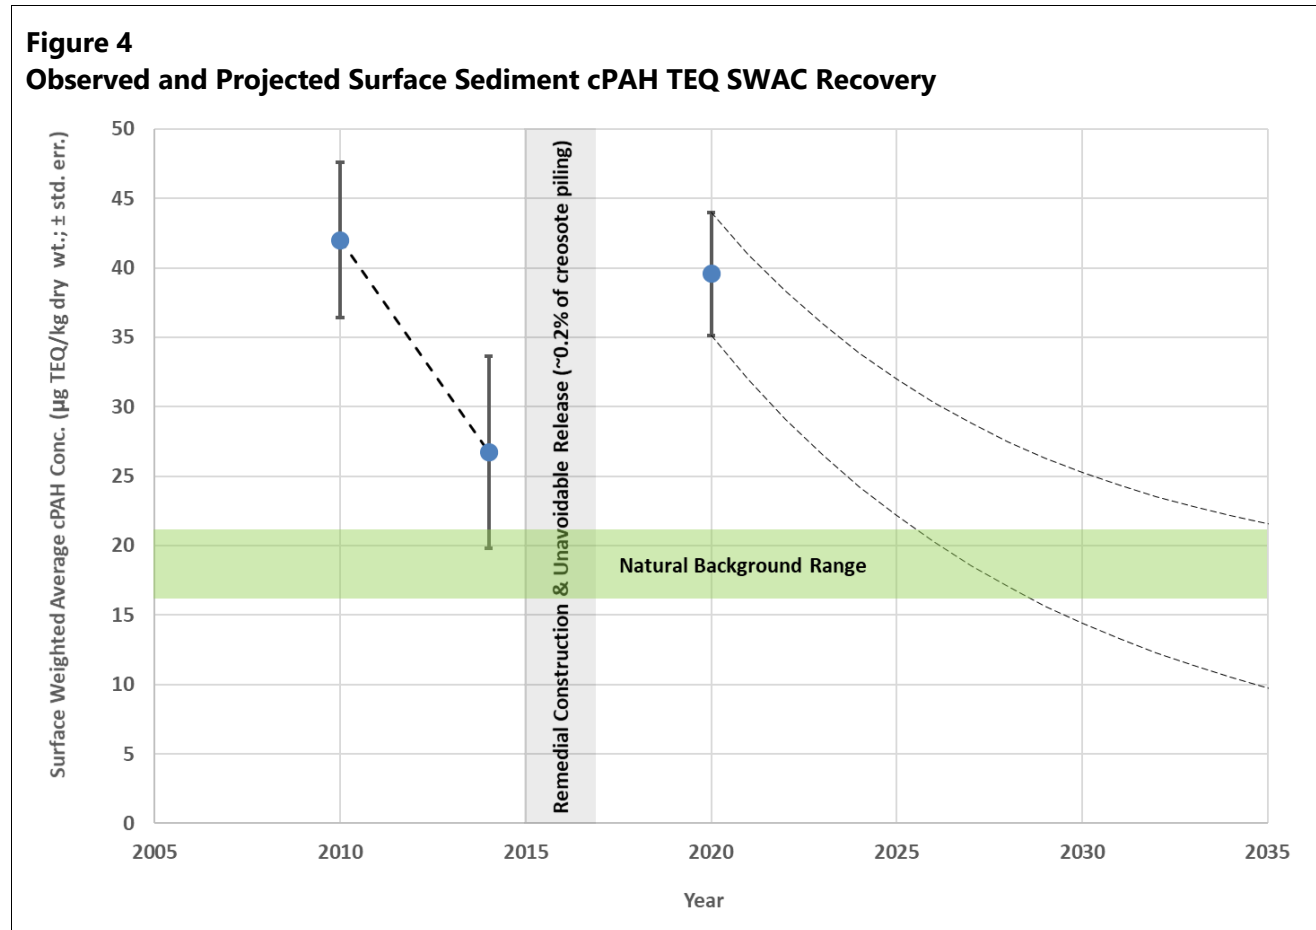
2020 cPAH TEQ SWAC was approximately $21 \pm 7 \mu\text{g}/\text{kg}$ higher than pre-design modeling projections (Figure 4; Anchor QEA 2018a). As explained below, this increase is reasonably attributable to small and unavoidable cPAH releases from piling removal operations. Moreover, as detailed in Section 3.5, shellfish tissue cPAH concentrations have nevertheless been reduced to natural background levels.

The lowest surface sediment cPAH TEQ levels measured in 2020 were in SMA-1 and SMA-2 cap areas, averaging $14 \pm 3 \mu\text{g}/\text{kg}$ in 2020 (Anchor QEA 2021). These data further verify that the SMA-1 and SMA-2 remedy is protective, and that ongoing sources of cPAHs from the former Mill have been controlled. However, compared with 2014 concentrations, surface sediment cPAH TEQ levels were elevated throughout SMA-3 and SMA-5, particularly in the 0- to 2-cm surface interval. These monitoring data are consistent with a cPAH release during remedial construction.

As discussed in Anchor QEA (2021), using literature data on creosote pile dimensions, density, and cPAH concentrations, pulling 8,592 decayed piling during the 2015 to 2017 cleanup, nearly all of which were creosote treated (99.9% of the piling were also successfully pulled without breaking; Section 2.6), removed approximately 1,600 kilograms of cPAH TEQ from the Bay. In comparison, the measured Bay-wide surface sediment cPAH TEQ increase of approximately $21 \pm 7 \mu\text{g}/\text{kg}$ (compared to OMMP model projections; Anchor QEA 2018a) equates to a calculated cPAH TEQ mass increase of approximately 4 ± 1 kilograms. Thus, release of only 0.2% ($4 \div 1,600$) of the creosote pile cPAH TEQ mass removed would account for the observed increase in the 2020 SWAC (Table 2; Figure 4). Based on these calculations, the surface sediment cPAH TEQ increase measured in the Bay in 2020 is reasonably attributable to small and unavoidable cPAH releases from piling removal operations.

Using the same recovery modeling approach described in the OMMP (Anchor QEA 2018a), projected declines in the cPAH TEQ SWAC moving forward are summarized in Figure 4. Because observed recovery of cPAH TEQ between 2008/2011 and 2014 declined faster than model projections, it is likely that cPAH recovery moving forward may also occur more rapidly than the conservative OMMP model projections depicted in Figure 4. Based on the overall weight-of-evidence, the Bay-wide surface sediment cPAH TEQ SWAC appears on track to recover to natural background concentrations. Bay-wide natural recovery monitoring to verify the surface sediment cPAH TEQ SWAC recovery trend is scheduled for 2026 (Section 7.1).

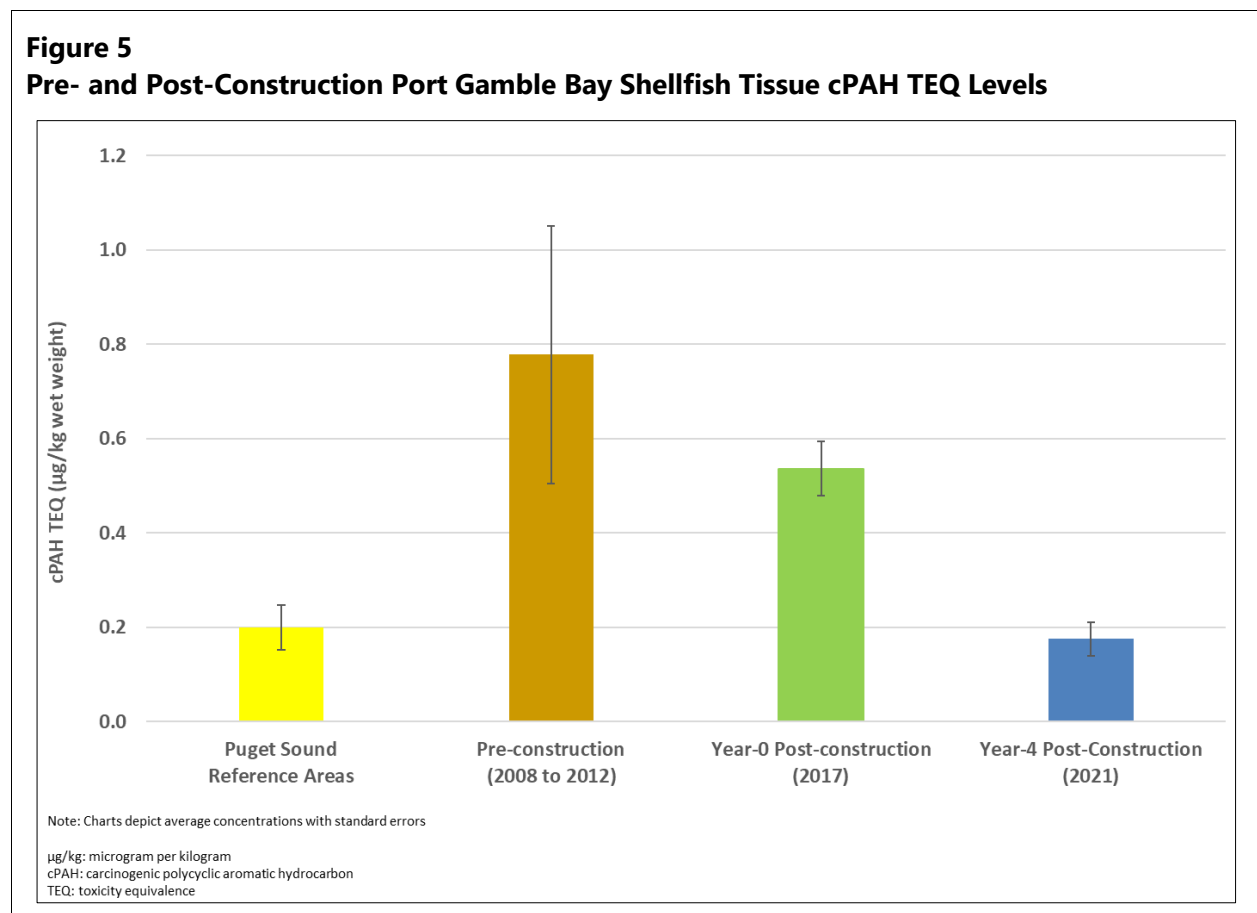
Given the surface sediment recovery monitoring data summarized in Section 3.4, and to help further determine whether human health cPAH risk reduction objectives set forth in CAP (Ecology 2013) have been achieved, PGST again resampled the same in situ shellfish tissue monitoring locations and species in 2021, four years after completion of construction (Anchor QEA and PGST 2022). Tissue samples were analyzed for cPAHs and lipids. Tissue cPAH TEQ levels measured in 2021 were consistent across the four sampling areas and were correlated with lipid content consistent with equilibrium partitioning, indicating similar cPAH exposure across the shellfish tissue sampling locations. As summarized in Figure 5, shellfish tissue cPAH TEQ levels measured in 2021 were significantly lower than 2017 post-construction concentrations, continuing the decline from earlier baseline (2008 to 2012) levels.

The monitoring data summarized above reveal that shellfish tissue cPAH TEQ levels in the Bay (Figure 5) recovered more rapidly than subtidal surface sediments (Figure 4). This observation is consistent with shellfish tissue cPAH uptake occurring predominantly from water column exposure, which was successfully curtailed by source control and remedial actions.

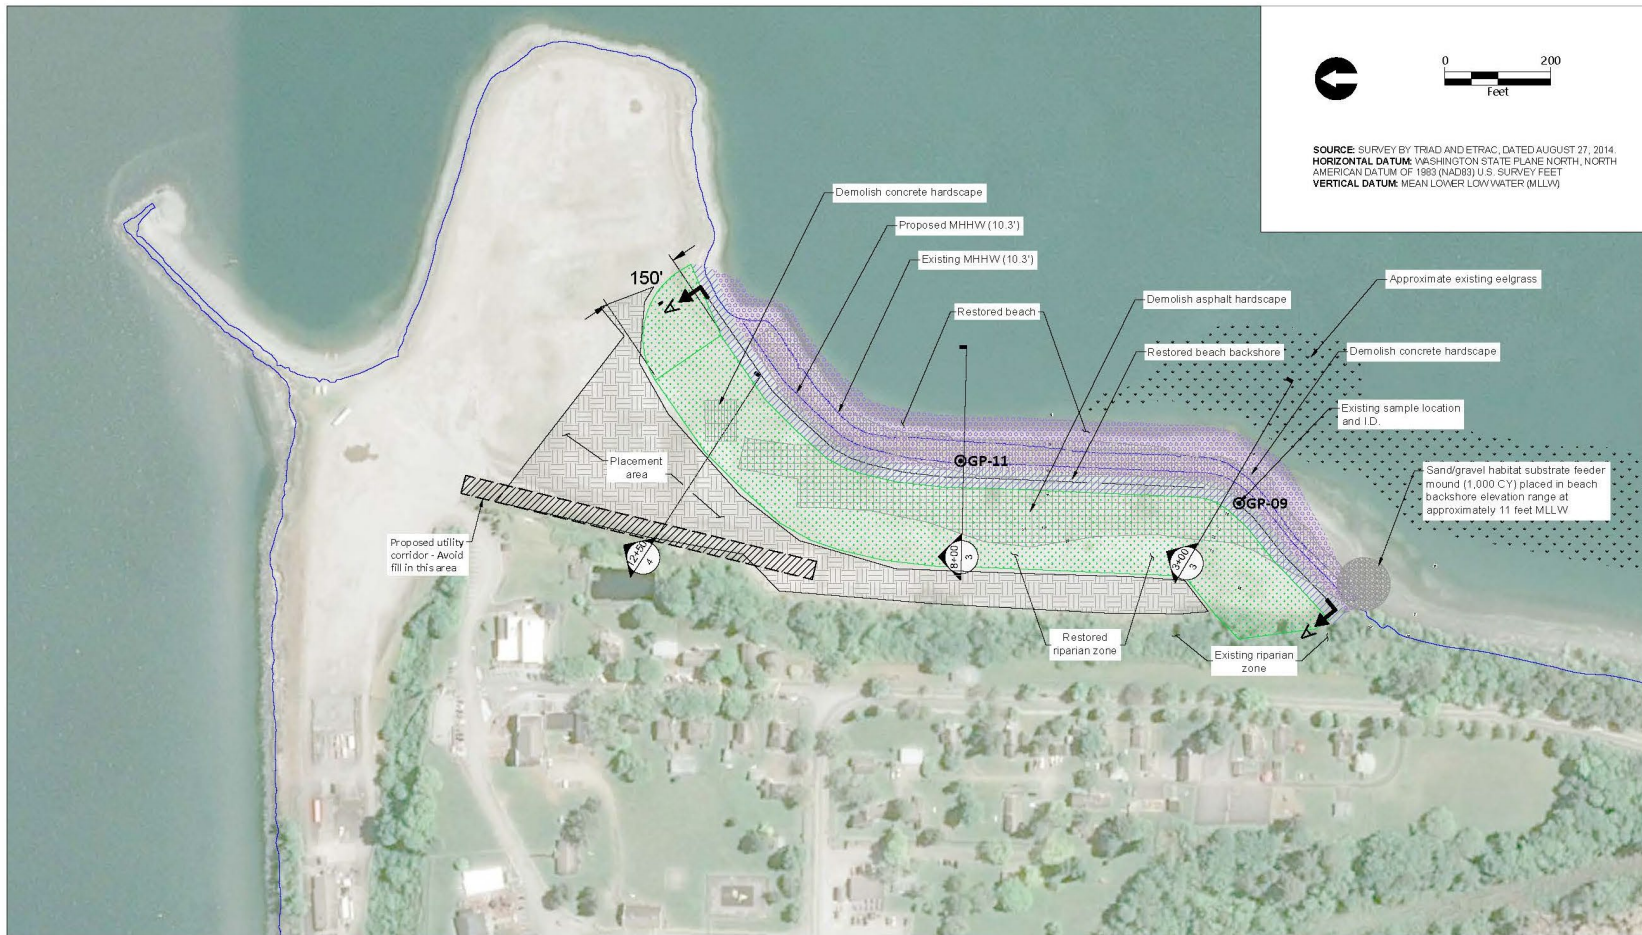
Figure 6
Southern Mill Site Shoreline Restoration Plan

Although angular cap materials provide greater resistance to wave forces and are preferred for protectiveness, rounded materials are preferred for habitat substrate functions and are more suitable for restoration. The remedial design (Anchor QEA 2015) projected that natural beach profile changes of rounded substrate will occur within the surf zone during peak storm events. For example, during 20-year event wave conditions, rounded gravel-sized materials placed on a restored slope were projected to locally move up and down the slope, developing profiles with troughs extending above and below the post-construction surface grade. Balancing cap protection and habitat objectives, the upper portion of the 2-foot cap layer required by the 2013 Consent Decree (and the middle layer of the combined cap/habitat substrate) would consist of a 1-foot-thick layer of rounded cobble/gravel beach substrate with a median diameter of approximately 2 to 3 inches (Figure 7).

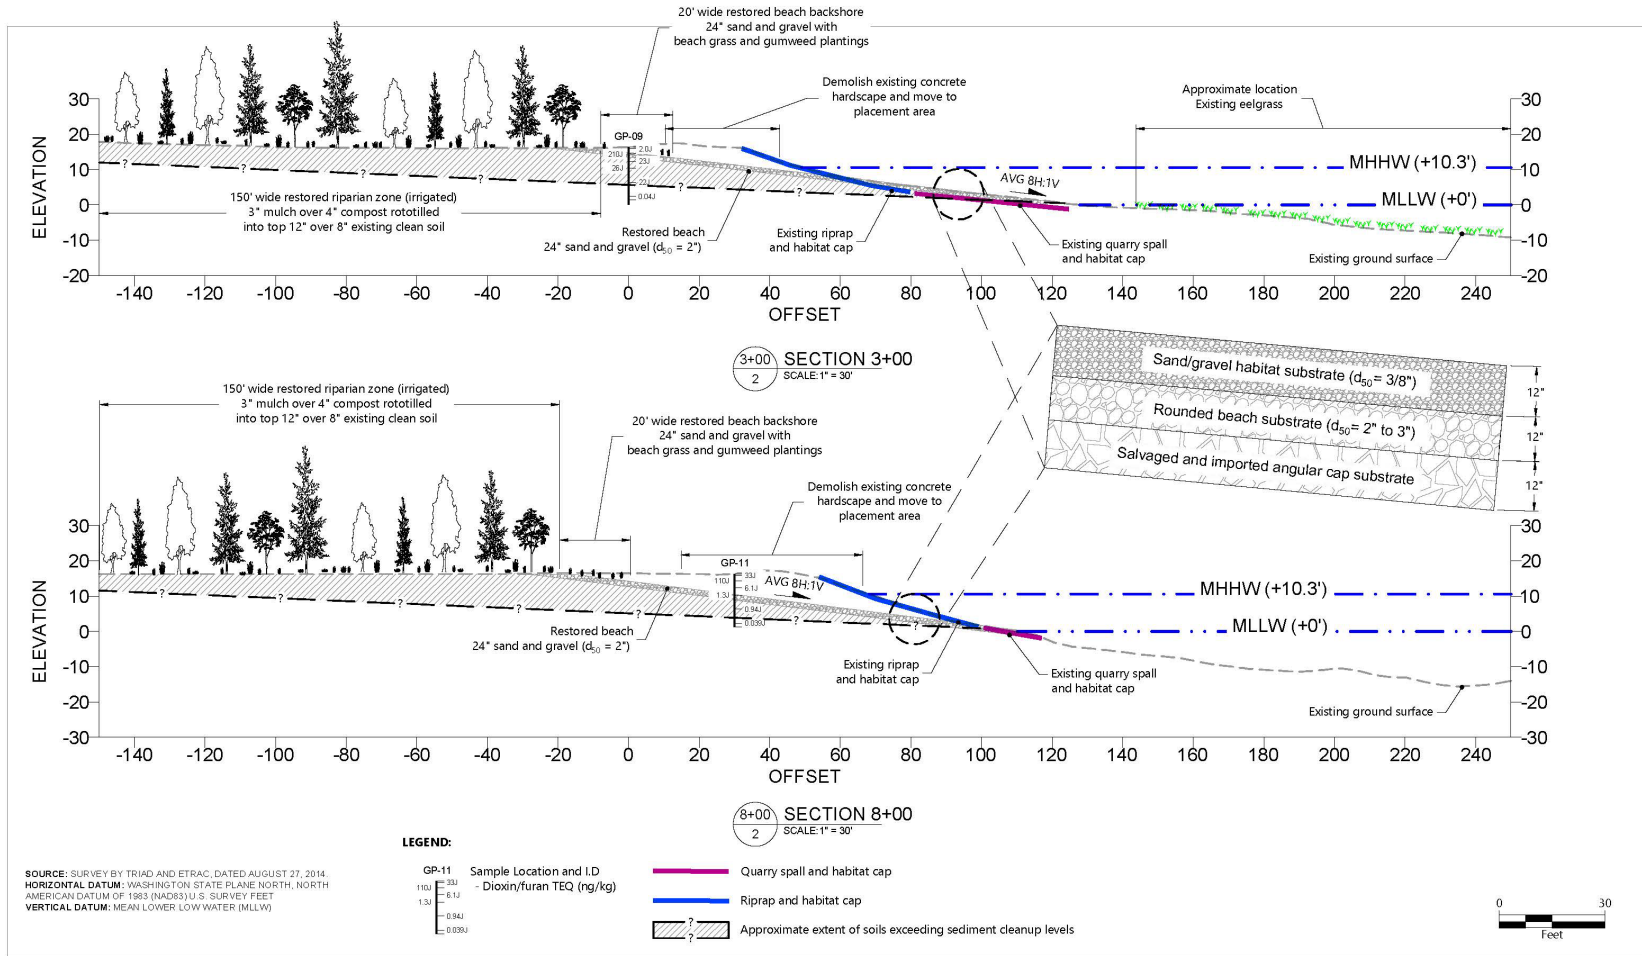
Figure 7
Southern Mill Site Shoreline Restoration Cross Sections

Though cap designs must remain protective under peak wave conditions, restored beach habitat functions are determined by median wave conditions and associated sediment transport patterns.
