UNDERGROUND STORAGE TANK SITE ASSESSMENT AND DECOMMISSIONING REPORT

OVERLAKE HOSPITAL
BELLEVUE, WASHINGTON

DECEMBER 1999

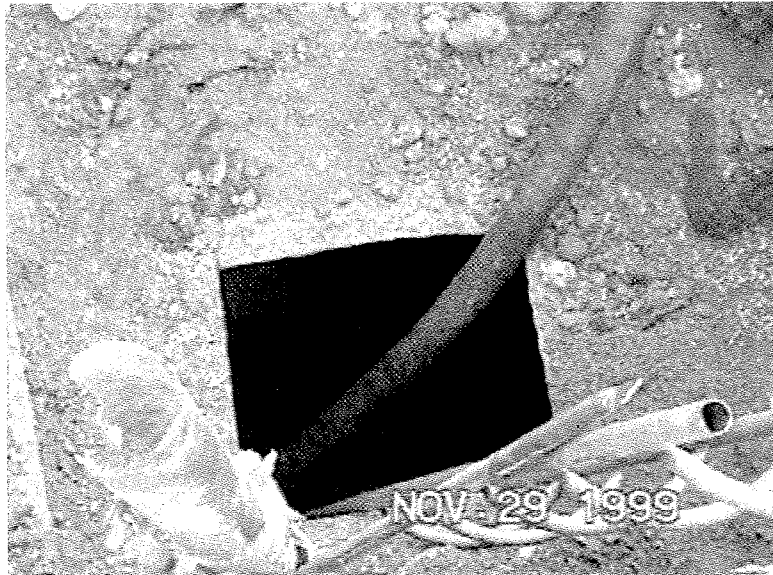
The UST and piping were in good condition. No holes were seen inside the tank or exposed piping.

PHOTOGRAPH 2. View of access port in UST. The tank was in good overall condition.

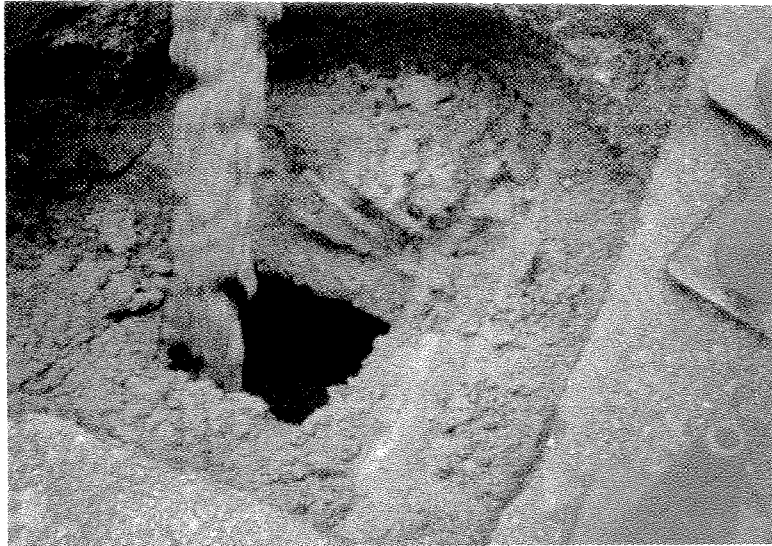
PHOTOGRAPH 4. Controlled density fill material was used to decommission the UST in place.
