REMOVAL ACTION REPORT

*Treoil Industries Biorefinery
Removal Action
Ferndale, Whatcom County, Washington*

*Contract No.: 68HE0720D0005
Task Order Nos.: 68HE0722F0129
68HE0722F0130*

February 2023

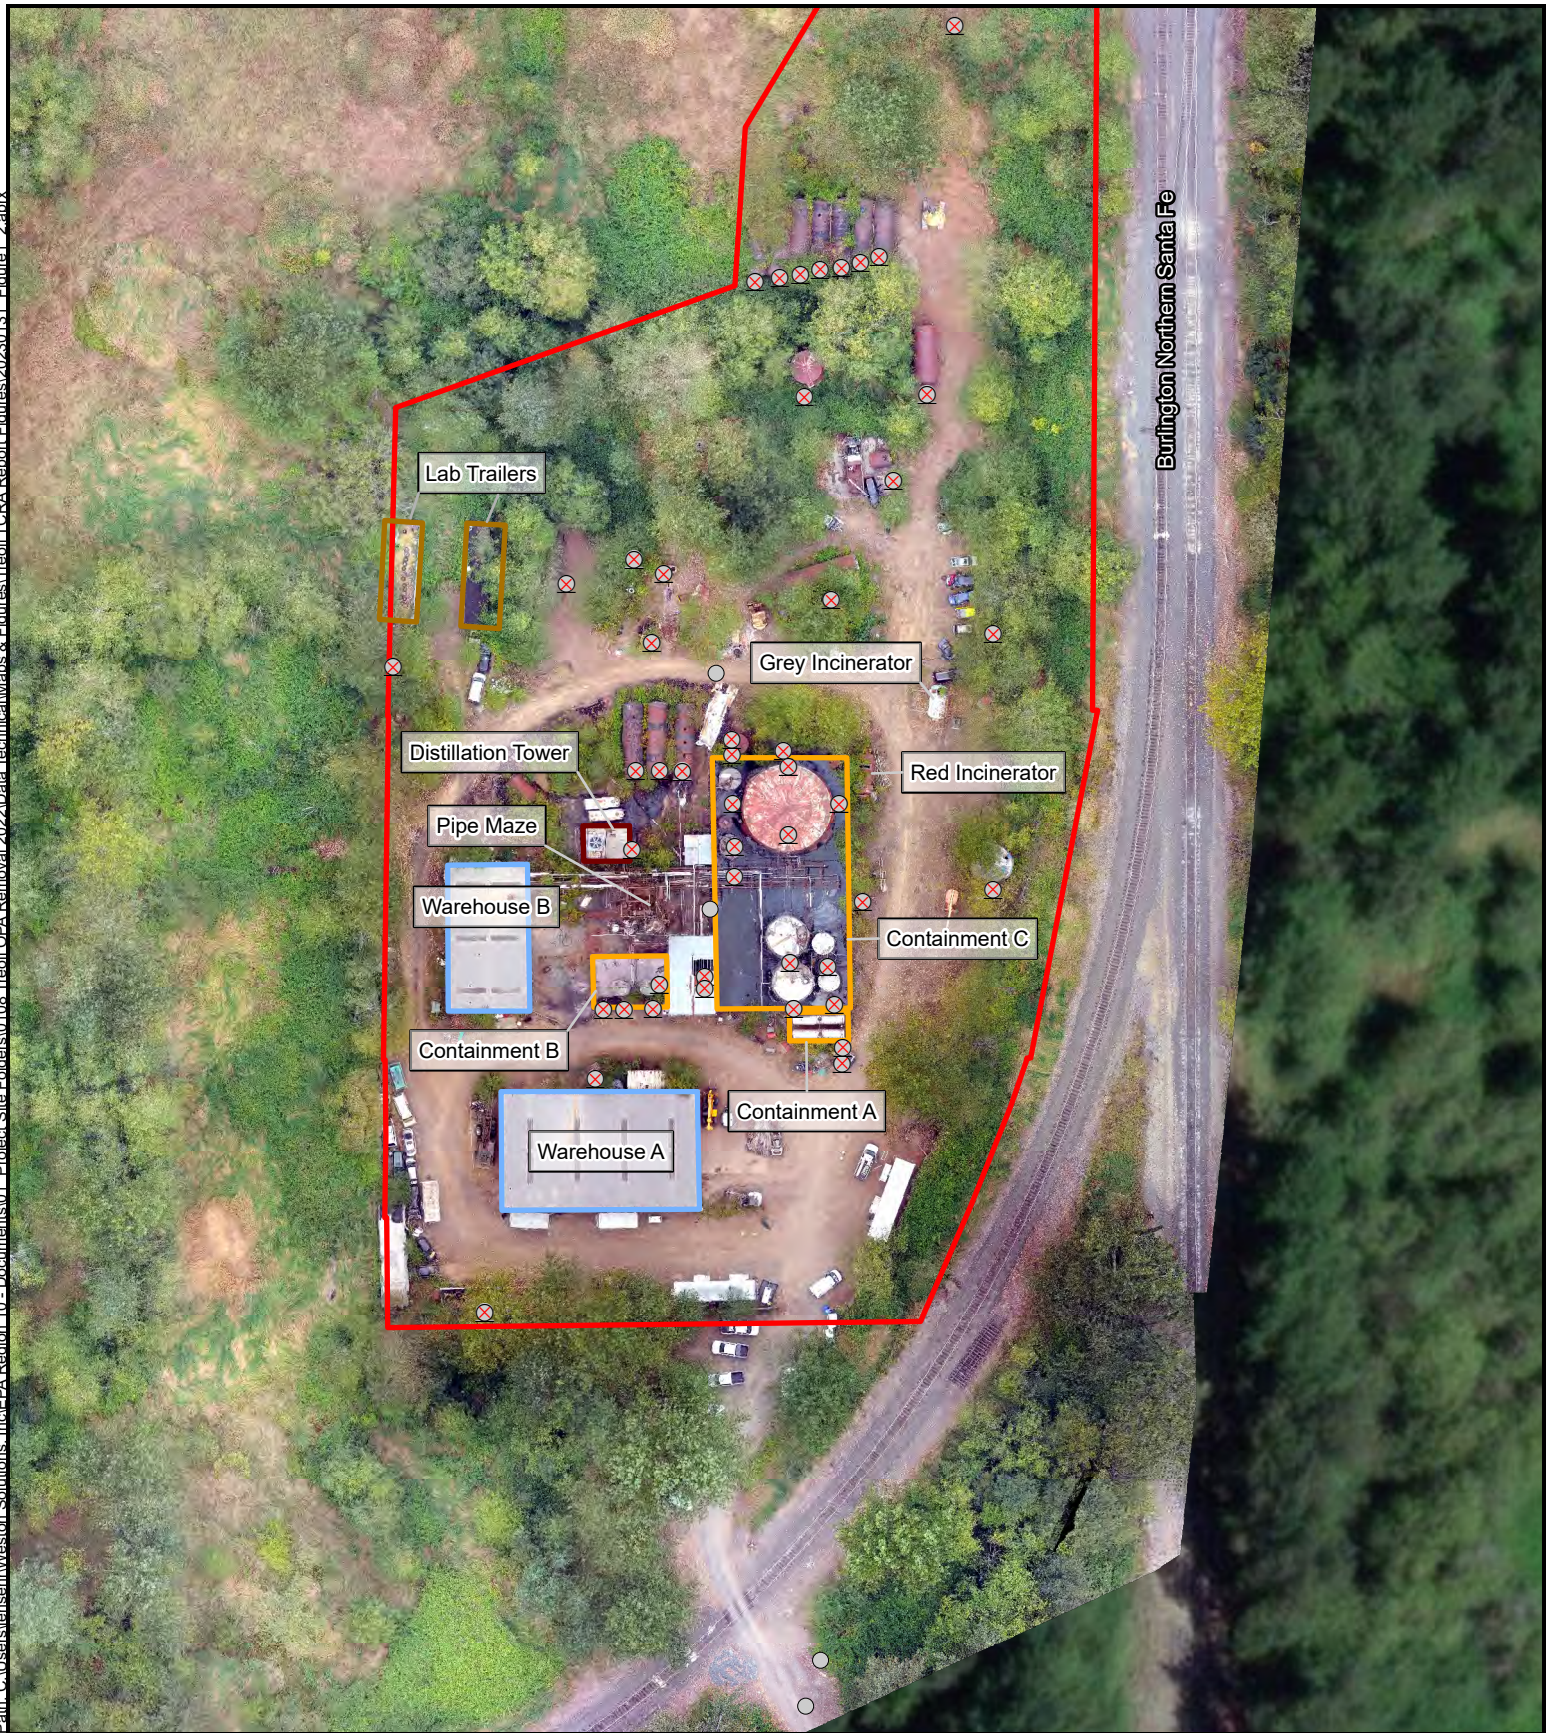
FIGURE 2
SITE VICINITY MAP
TREOIL INDUSTRIES
BIOREFINERY
4242 ALDER GROVE ROAD
FERNDALE, WHATCOM COUNTY
WASHINGTON

The Treoil Industries Biorefinery consists of two primary warehouse buildings, three separate tank farms within secondary containment, a distillation tower, additional tank farm structures, and piping. The property also has two mobile homes, two former laboratory trailers, and numerous pieces of abandoned heavy equipment and collision-damaged vehicles. Various Site features are shown on **Figure 2**.

The Site had three secondary containment structures for 13 ASTs (**Figure 2**). Two of these were flooded with a mixture of oil and rainwater. As observed during the February 2022 Site walk and RSE field activities, the largest containment had cracks in the concrete sidewalls and contents were observed seeping to surface soils. DU 2 (referenced as ‘Containment Liquids’ in the progress dashboard) included tasks associated with the secondary containment structures (A, B and C).

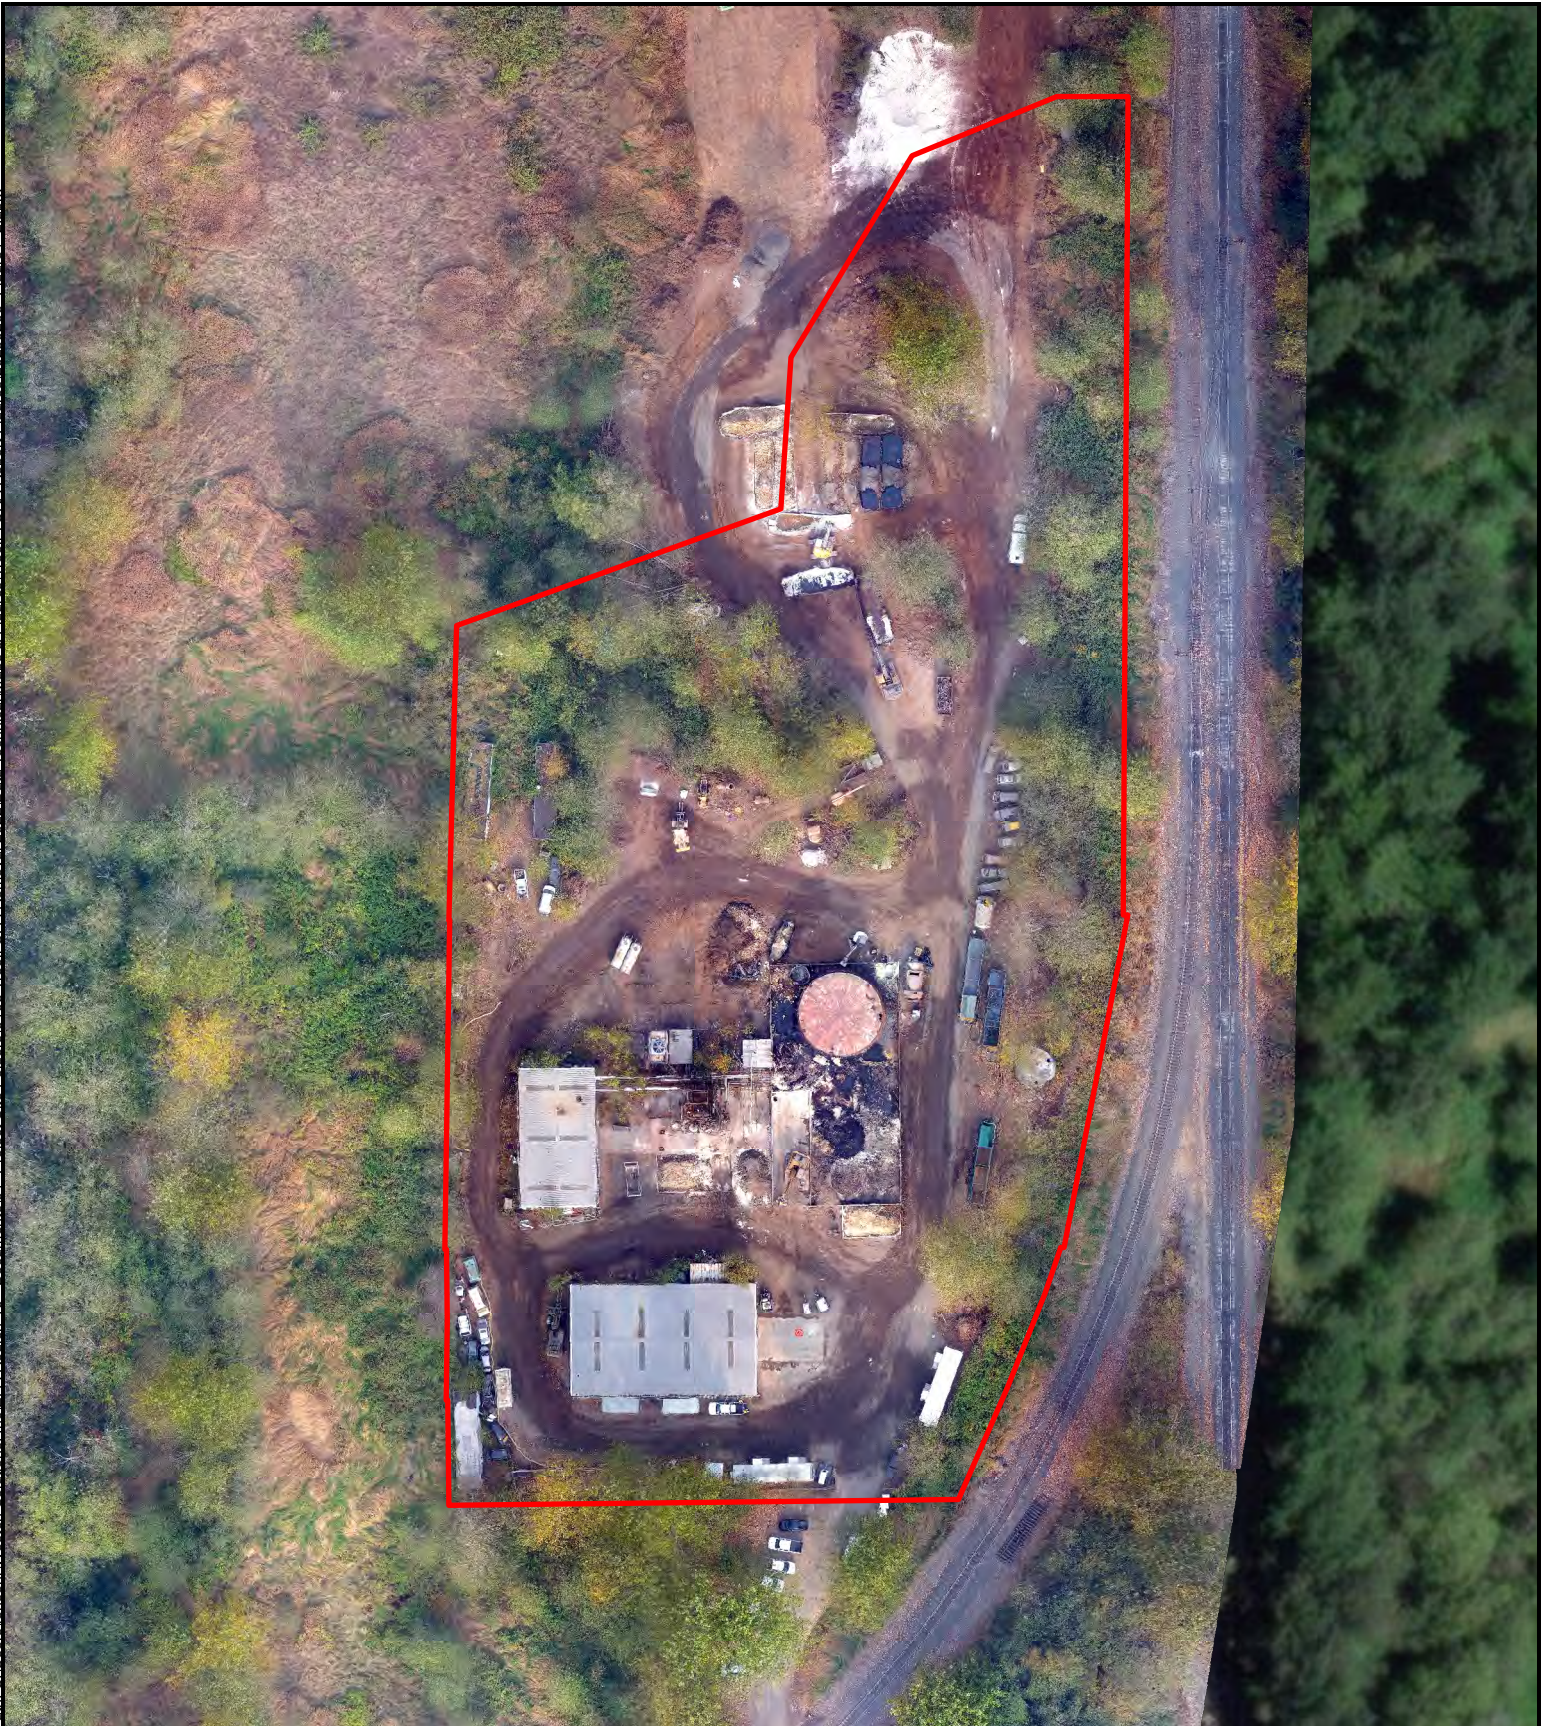
Coordinate System:
WGS 1984 Web Mercator Auxiliary Sphere
Source:
Background: UAS Flight 2022-10-19/ESRI World Imagery
Task Order No.:
68HE0722F0129 / 68HE0722F0130

flights. The first flight occurred on September 15, 2022 (**Figure 6**), the second flight on October 19, 2022 (**Figure 7**), and the third flight on November 11, 2022 (**Figure 8**).

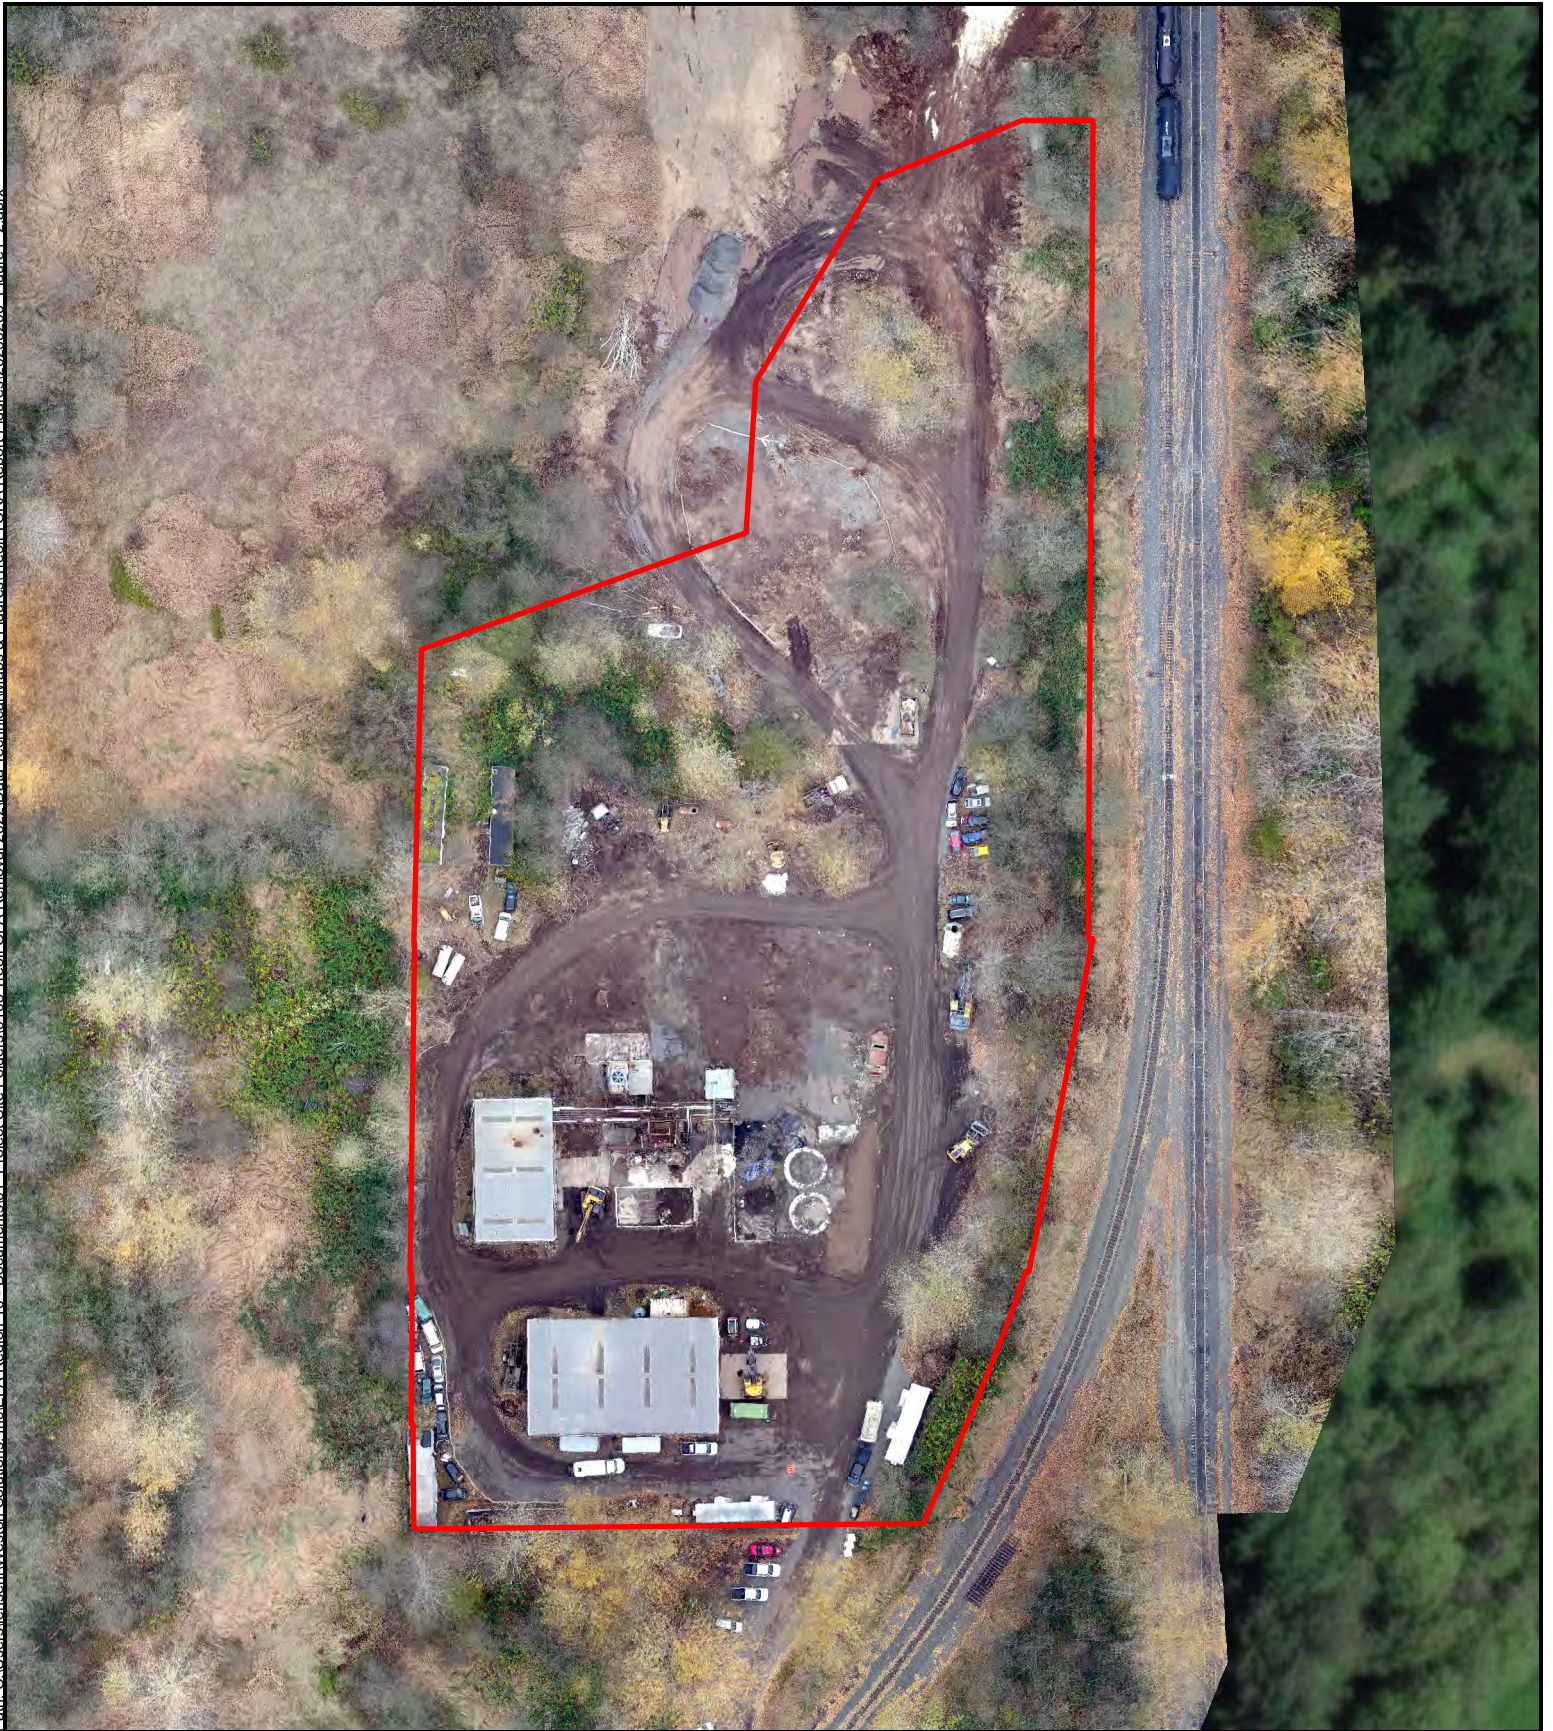
Coordinate System:
WGS 1984 Web Mercator Auxiliary Sphere
Source:
Background: UAS Flight 2022-11-11/ESRI World Imagery
Task Order No.:
68HE0722F0129 / 68HE0722F0130
