February 21, 2023  
Project No. M0615.20.008

Re: Supplemental Investigation Work Plan, Port Parcel 110 and Potter Property  
Taylor Way and Alexander Avenue Fill Area

**Figure 1**  
**Parcel 110 Property**  
**Features and Proposed**  
**Sample Locations**  
 Port of Tacoma  
 TWAFA Site  
 Tacoma, Washington

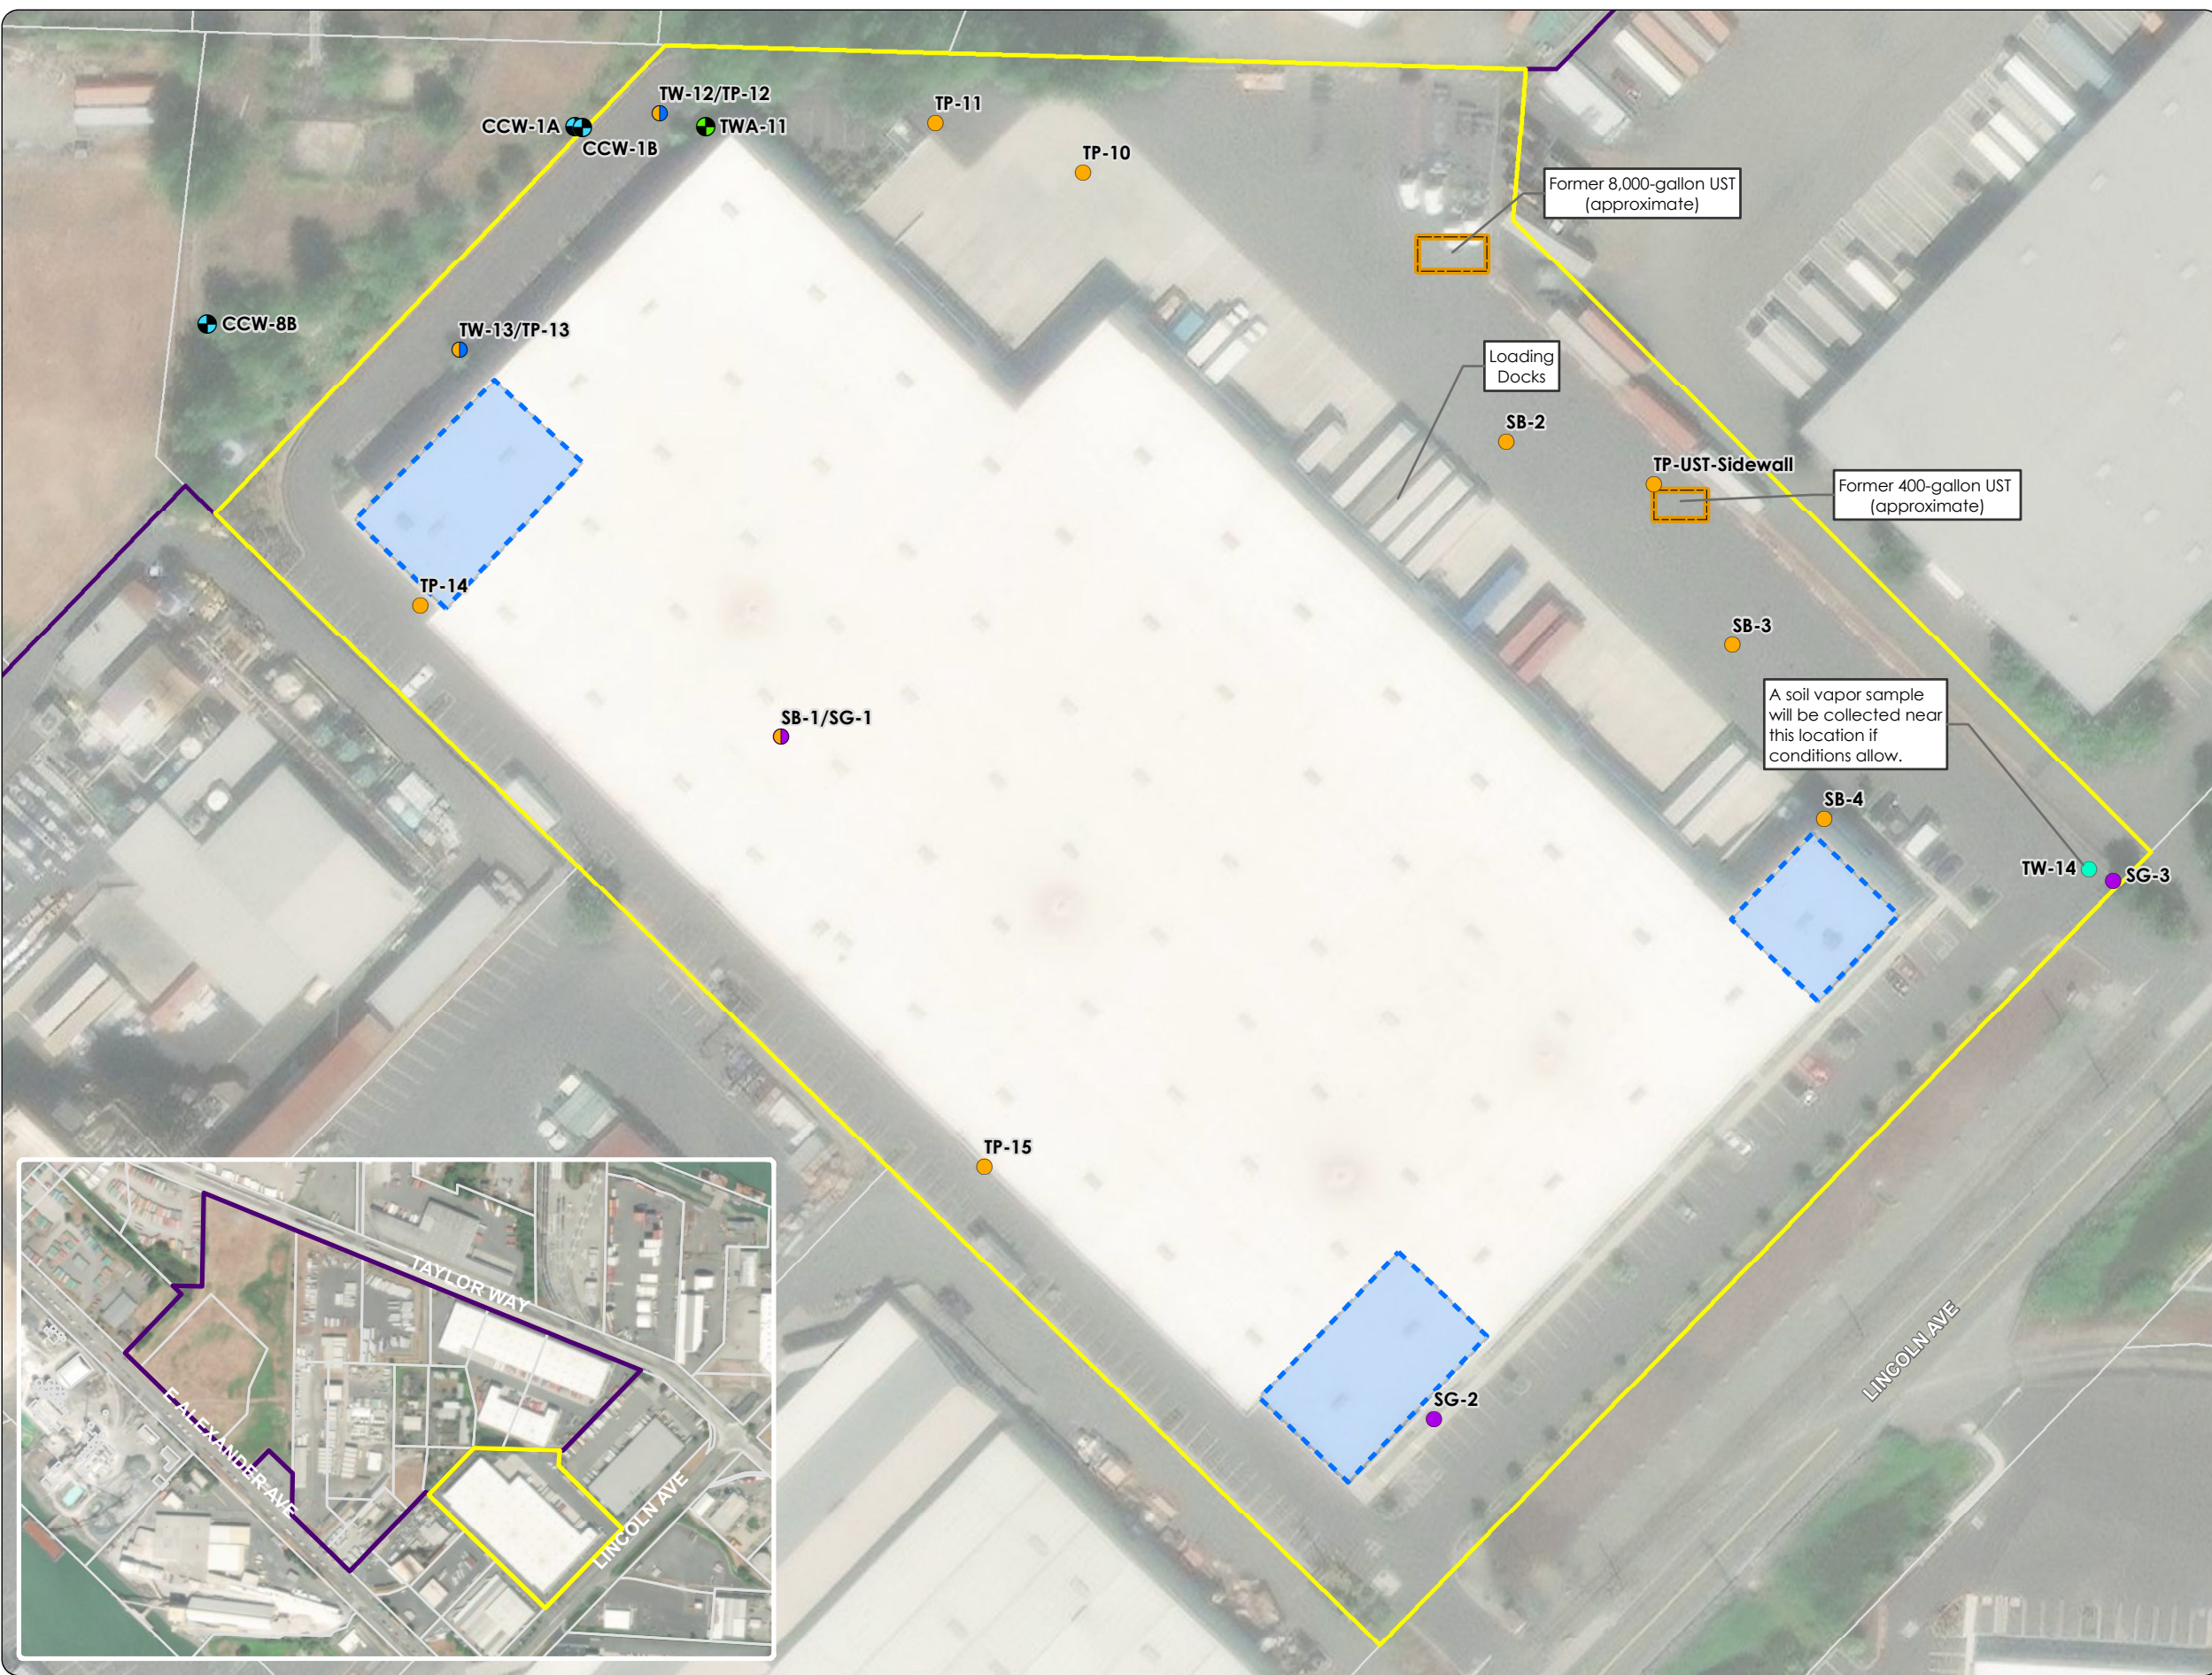
Parcel 110 (Pierce County tax parcel number 321351051) is an approximately 9-acre lot within the TWAAFA site (see Figure 1). Parcel 110 is owned by the Port and is occupied by Article, a furniture manufacturer that uses the building for warehousing and shipping furniture. A wood-frame structure referred to as the Educator Building (Floyd Snider 2007) formerly existed on Parcel 110 and was demolished between 2018 and 2019.

In 2019, the current warehouse building was constructed on Parcel 110 and a new dedicated stormwater system was installed. A loading dock is present along the northern side of the warehouse. The building was constructed with a 6-inch-thick concrete slab-on-grade foundation, with a sub-slab vapor barrier beneath the office areas (see Figure 1).

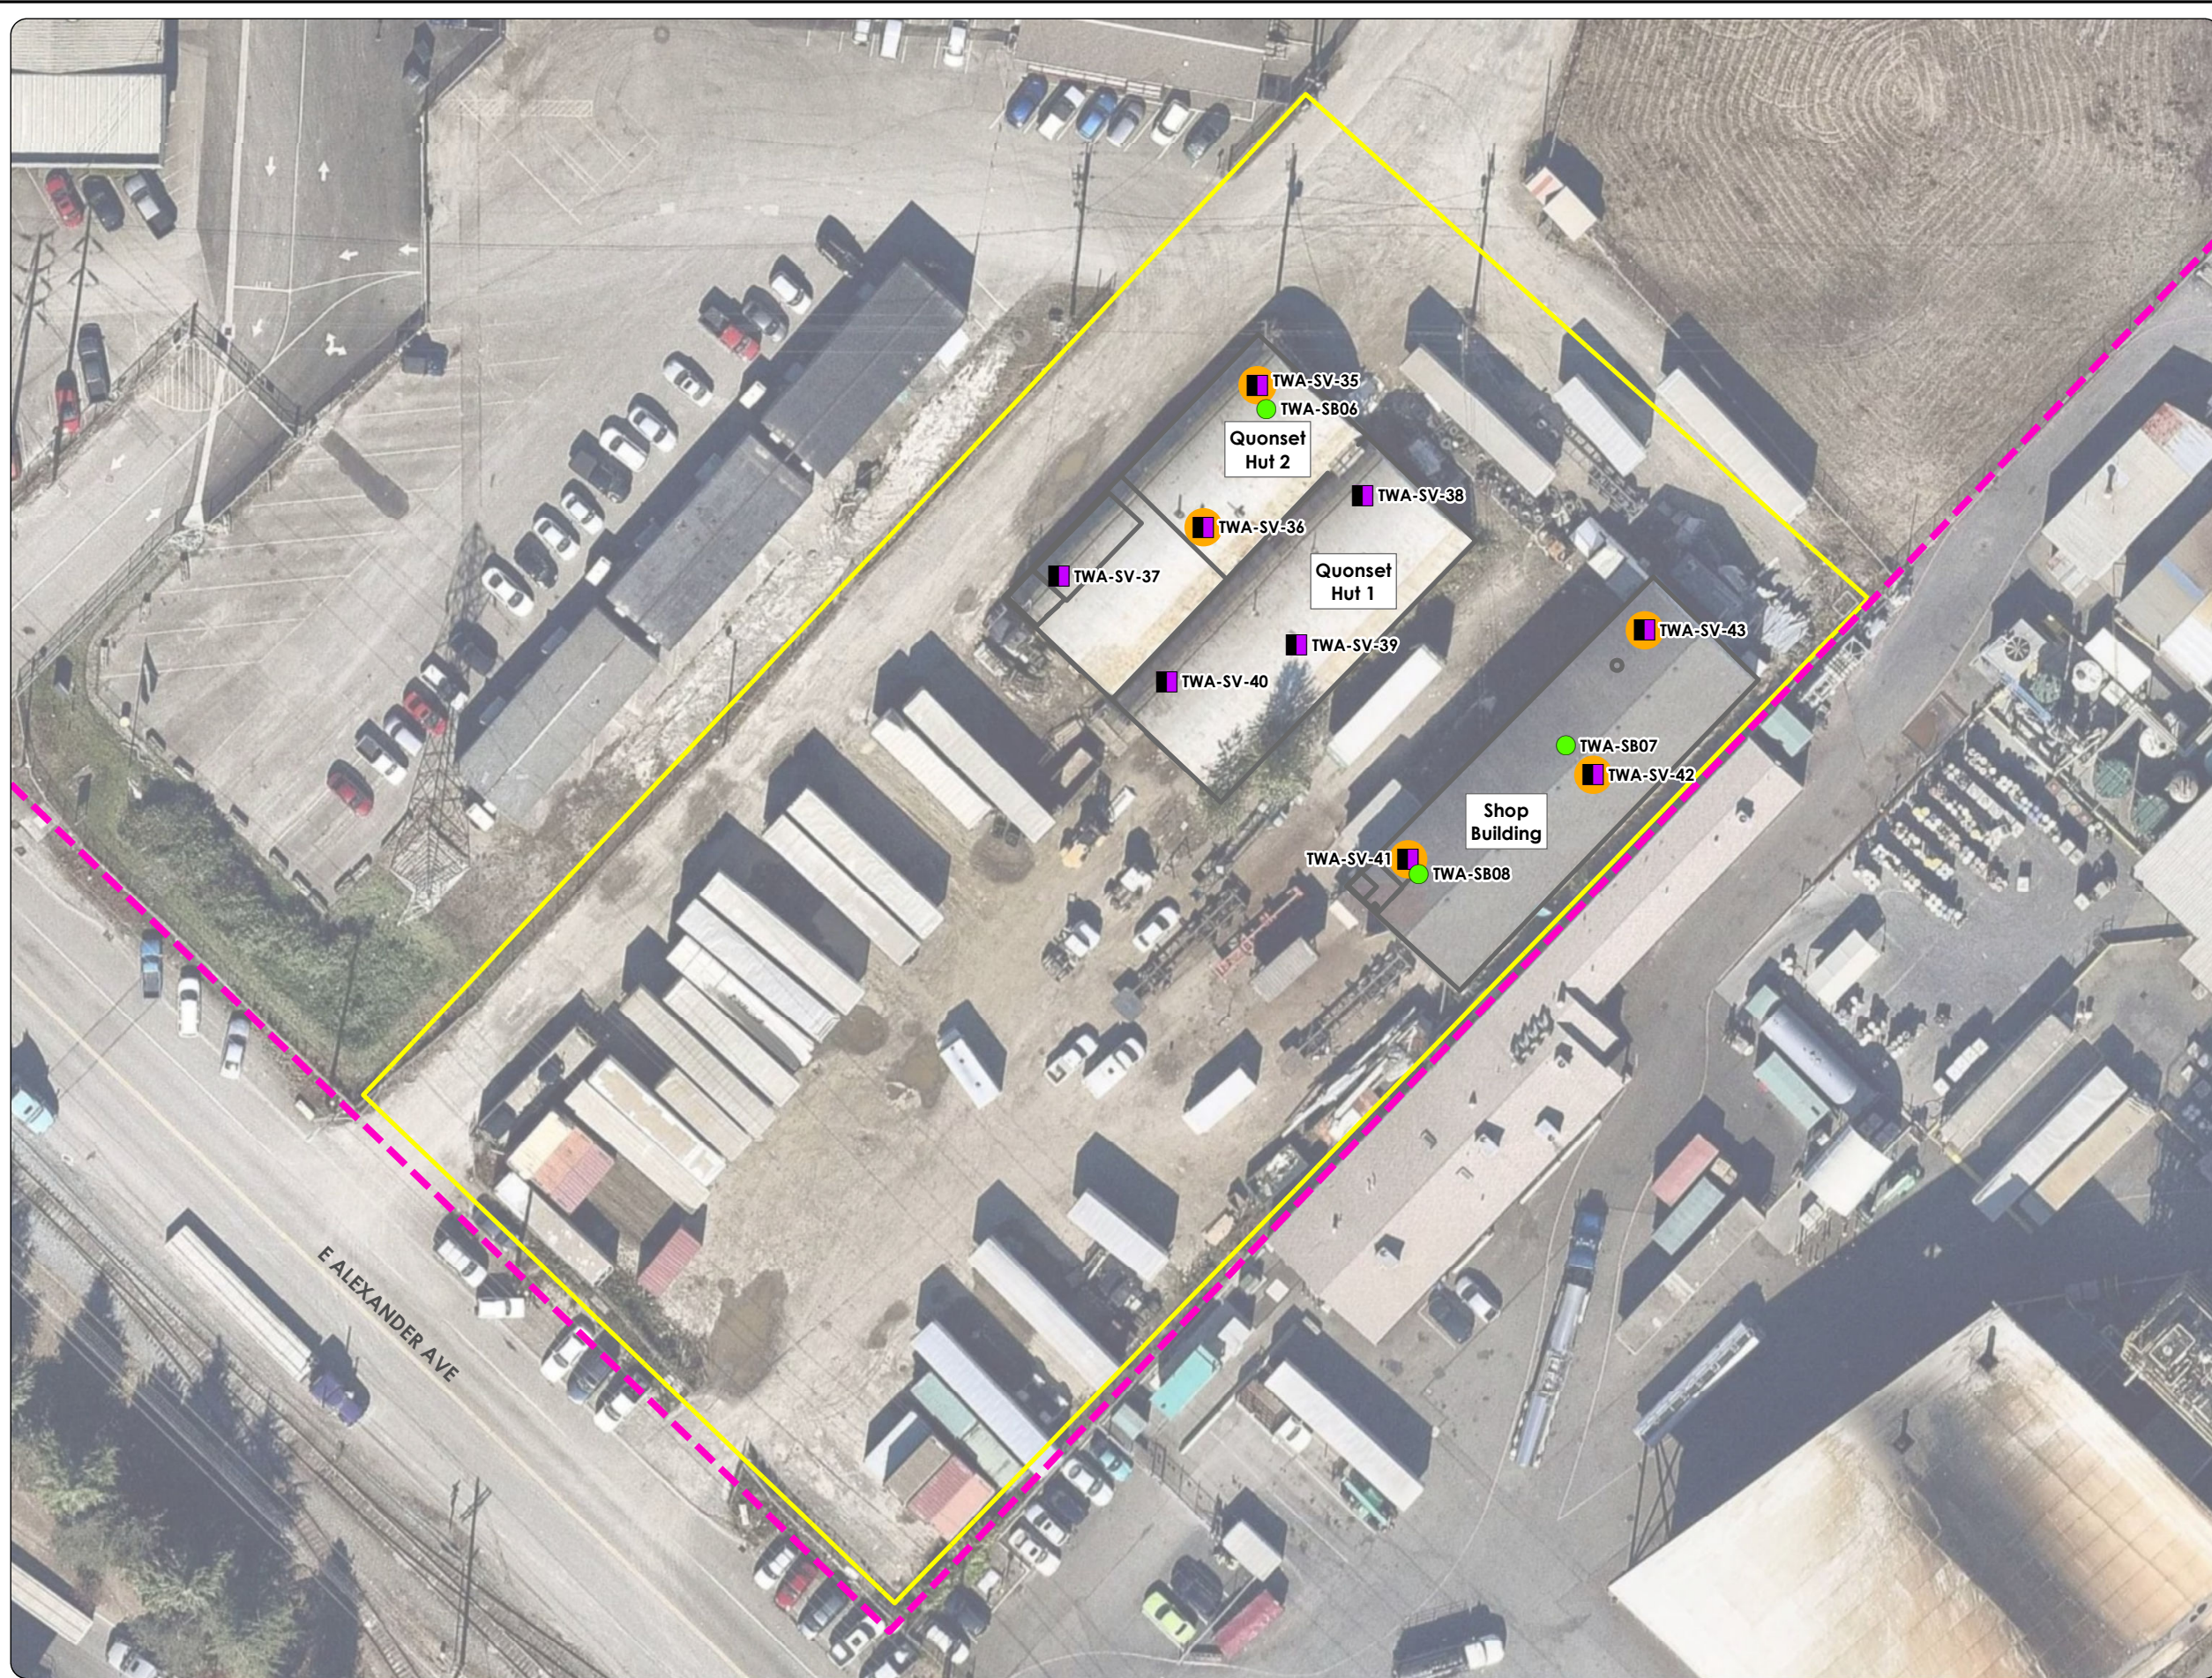
**Figure 2**  
**Potter Property Features and**  
**Proposed Sample Locations**

The Potter Property is owned by the Port and operated by tenant Handan, Inc., a trailer and shipping container repair company. Two buildings are present on the Potter Property: the shop building and the conjoined Quonset huts (Quonset Hut 1 and Quonset Hut 2) (see Figure 2).

Sample locations are approximate. Proposed sample locations may be adjusted based on field conditions.  
 Sub-slab soil gas CUL exceedances are based on MTCA Method B or Method C CULs.  
 CUL = cleanup level.  
 MTCA = Model Toxics Control Act.  
 TWAFA = Taylor Way and Alexander Avenue Fill Area.
