PHASE 2 ENVIRONMENTAL SITE ASSESSMENT AND CLEANUP REPORT Riverside Woodyard

Prepared for: Kimberly-Clark Worldwide Inc.

Project No. 060050-001-05 • December 2006 Final

Aspect Consulting, LLC

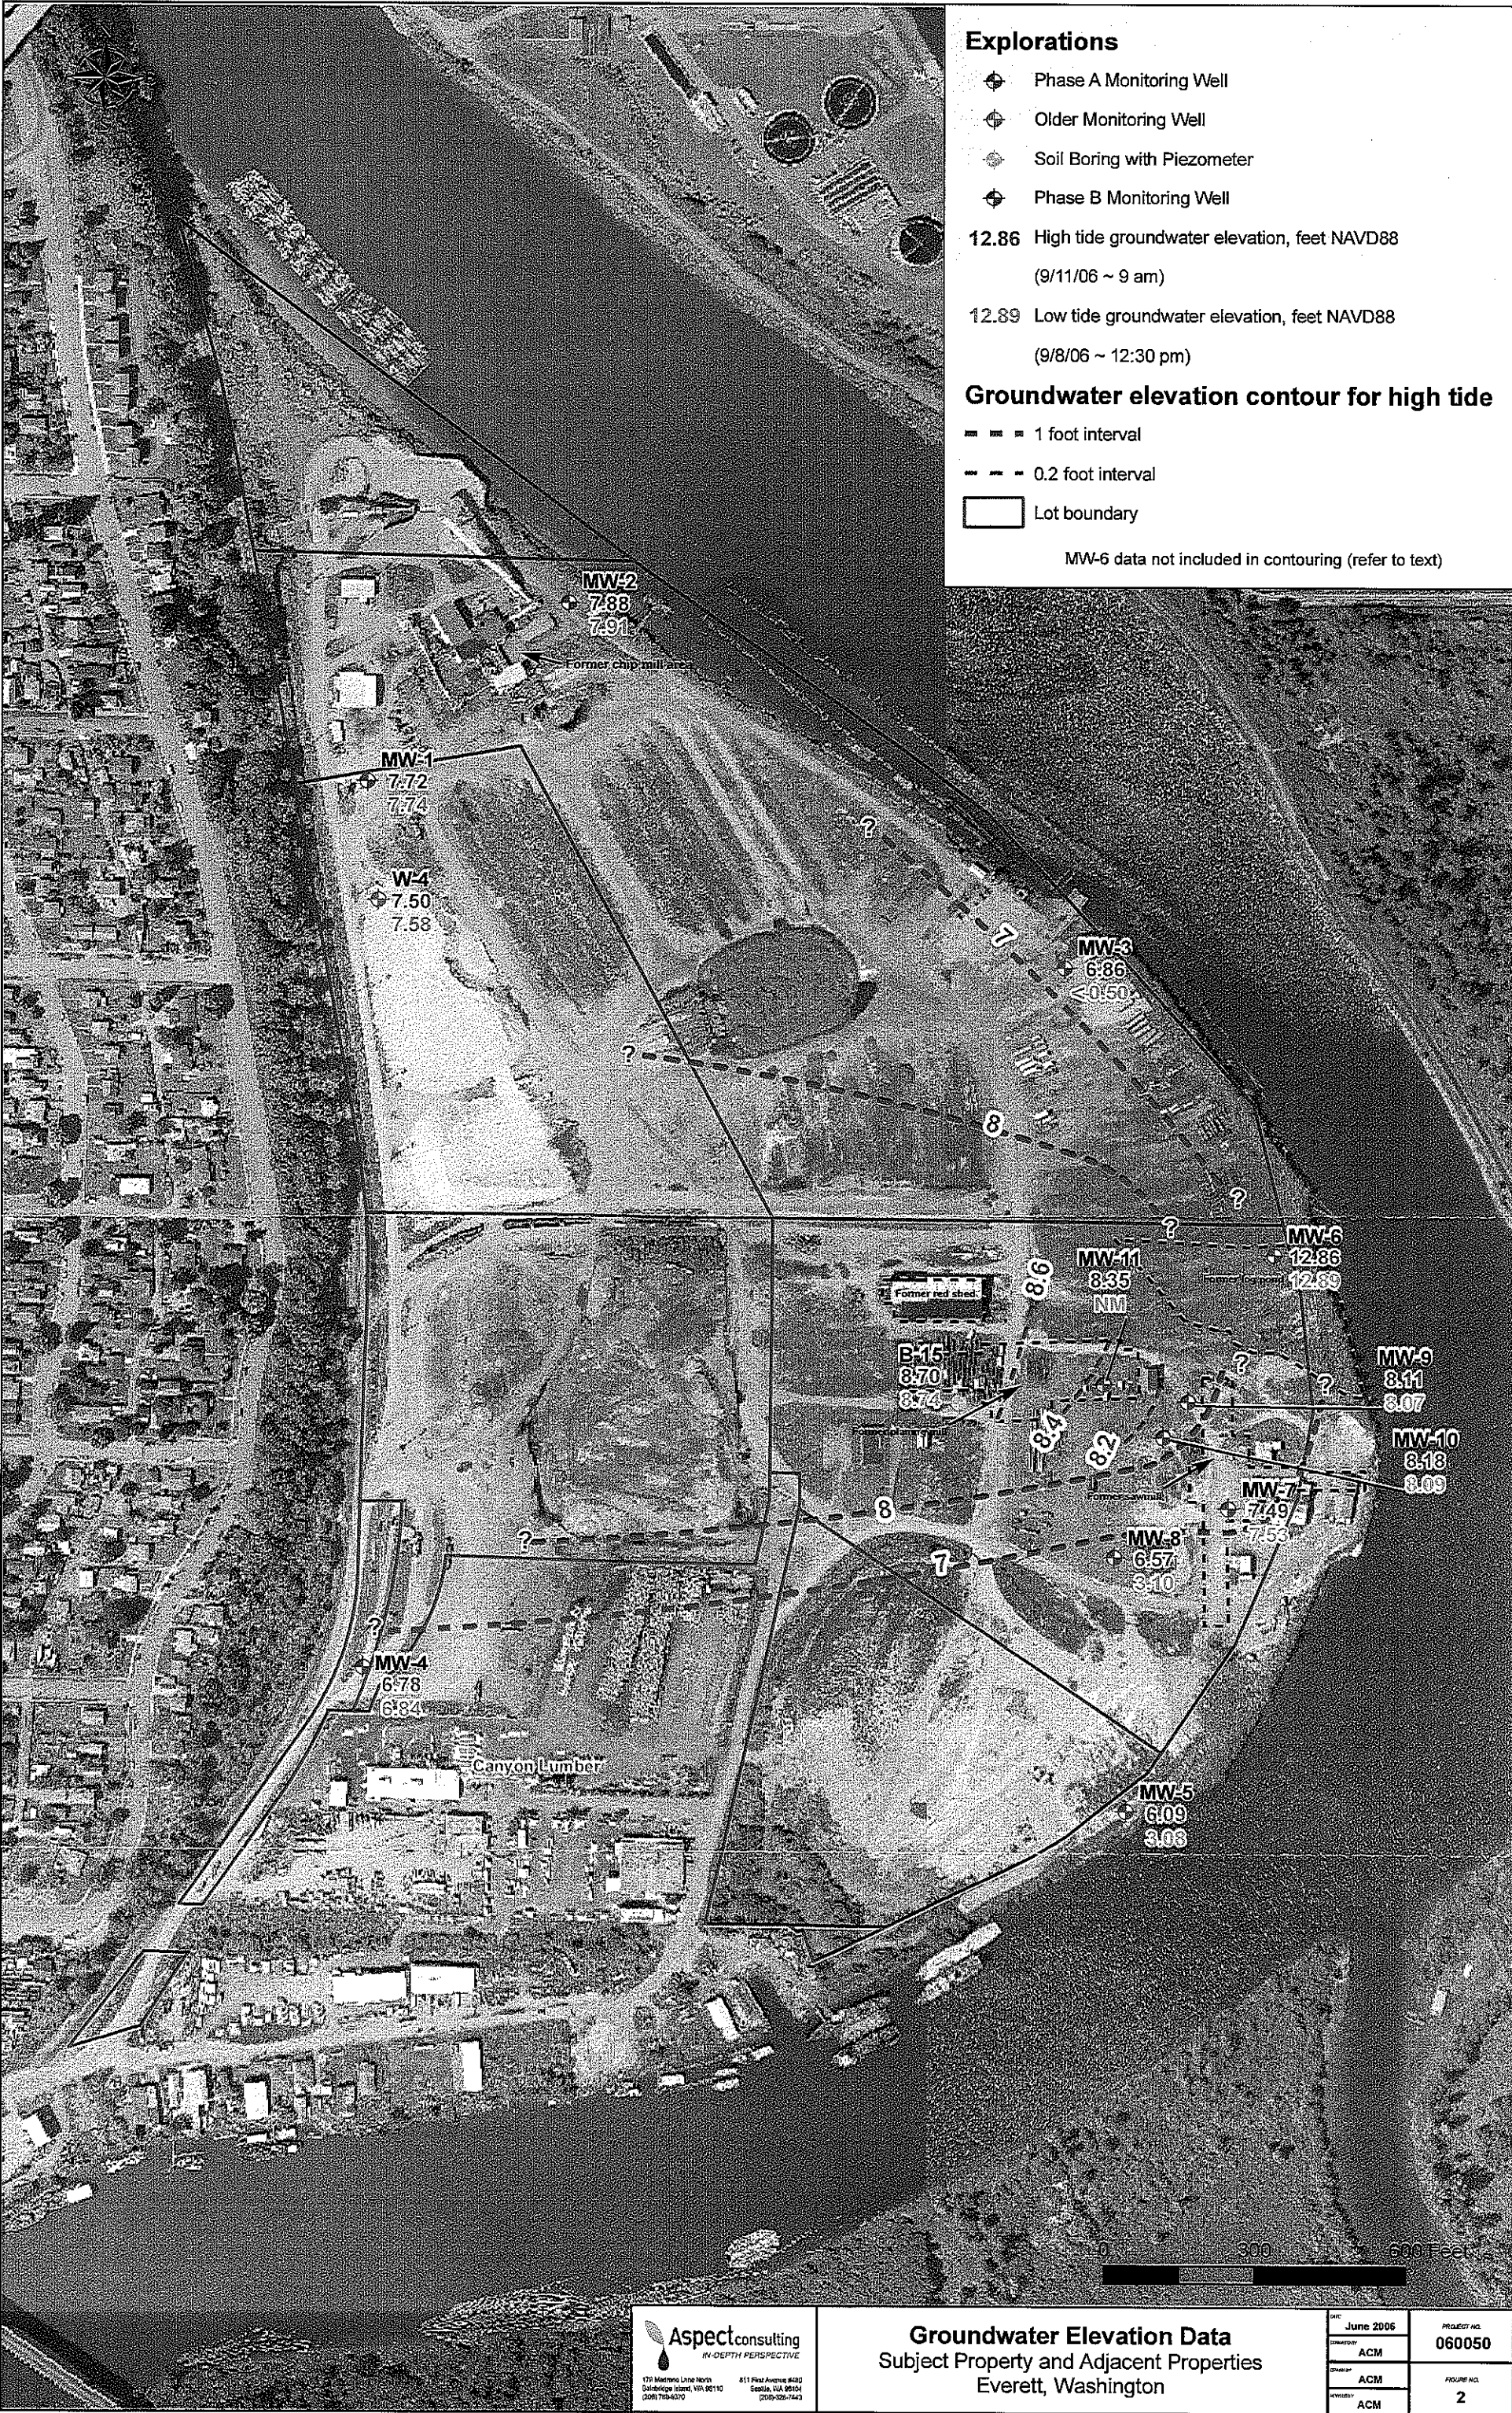
Explorations

Based on materials encountered during drilling and the measured groundwater elevations, we believe that groundwater in MW-6, outside of the Subject Property, represents a thin zone of perched water in a sandy fill layer on top of silt fill. The perched water is not the same water-bearing unit as the water table aquifer observed elsewhere on the properties. The MW-6 water level data are therefore not considered in determination of groundwater flow directions.

MW-6 data not included in contouring (refer to text)

One monitoring well (MW-1) was installed on the Subject Property as part of the site investigation. Four monitoring wells installed at the Former Riverside Chip Mill/Storage Areas (MW-2 through MW-5), six monitoring wells (MW-6 through MW-11) and one piezometer (B-15) installed at the Former Riverside Sawmill, and a previously installed well, W-4, were used for determining the local groundwater flow conditions (Figure 2). Two of these monitoring wells (MW-1 and W-4) are located on the Subject Property. Water level data from these collective wells located on and in the vicinity of the Subject Property provide the best representation of the local groundwater flow conditions.

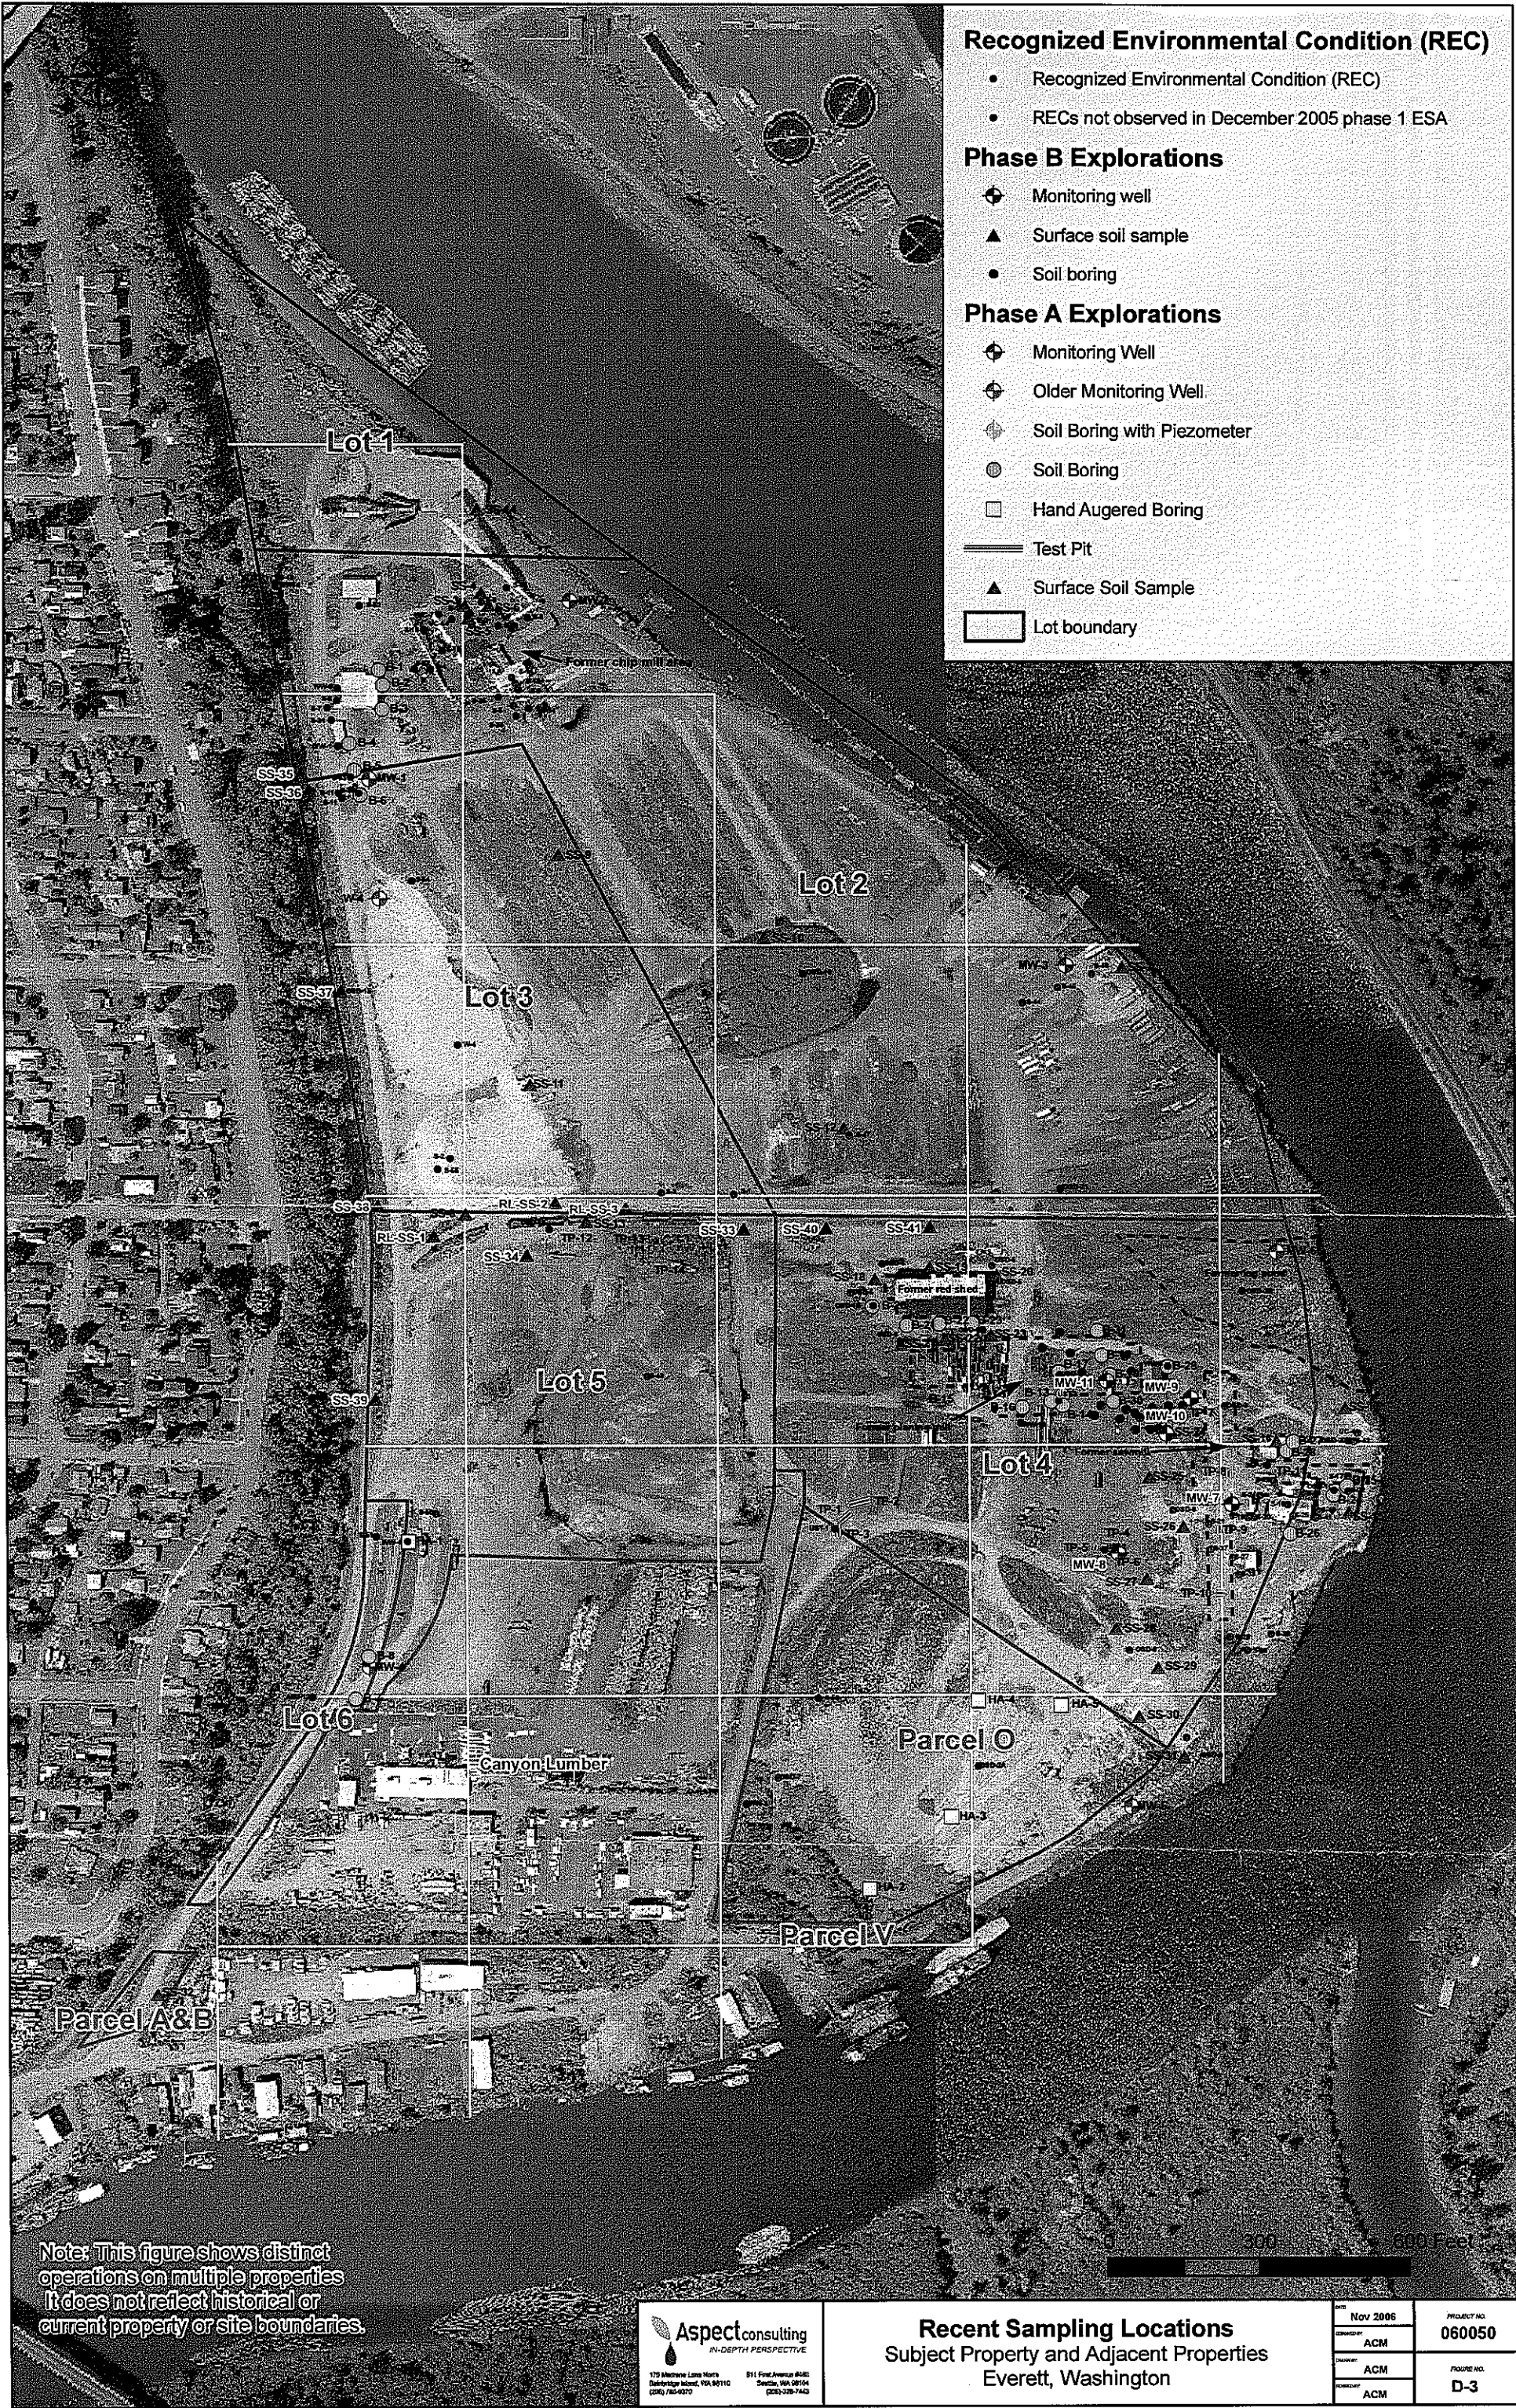
DATE	Nov 2006	PROJECT NO.	060050
COMPILED BY	ACM		
DRAWN BY	ACM	FIGURE NO.	D-3
REVIEWED BY	ACM

Additional surface soil samples (SS-1, SS-2, SS-35) were collected in the swale north of the Subject Property (refer to Figure D-3 in Appendix D). Oil-range petroleum hydrocarbons detected in the three samples ranged from 4,400 to 6,900 mg/kg, respectively. No free-phase petroleum product or sheen was observed while sampling these soils.

downgradient of the swale, three of which are located on the Subject Property (B-5, B-6, MW-1) and four on the Former Riverside Chip Mill/Storage Areas property to the north (B-1 through B-4; Figure D-3). Petroleum was not observed during drilling these seven borings, nor was it detected in any of the samples of saturated soil collected at the water table from the borings.

Recent Sampling Locations
Subject Property and Adjacent Properties
Everett, Washington

As noted in Section 1 of this report, each of the Former Riverside Chip Mill/Storage Areas, Former Riverside Sawmill, and Riverside Woodyard properties have undergone environmental review and characterization through environmental sampling and analysis as part of a cooperative effort by the City and K-C to perform site characterization on all of these properties. The sampling grid showing the soil and groundwater sampling on the various properties is shown on Figure D-3 of Appendix D.
