Periodic Review

Terrace Heights Elementary School

4300 Maple Court, Yakima, Yakima County

May 2021

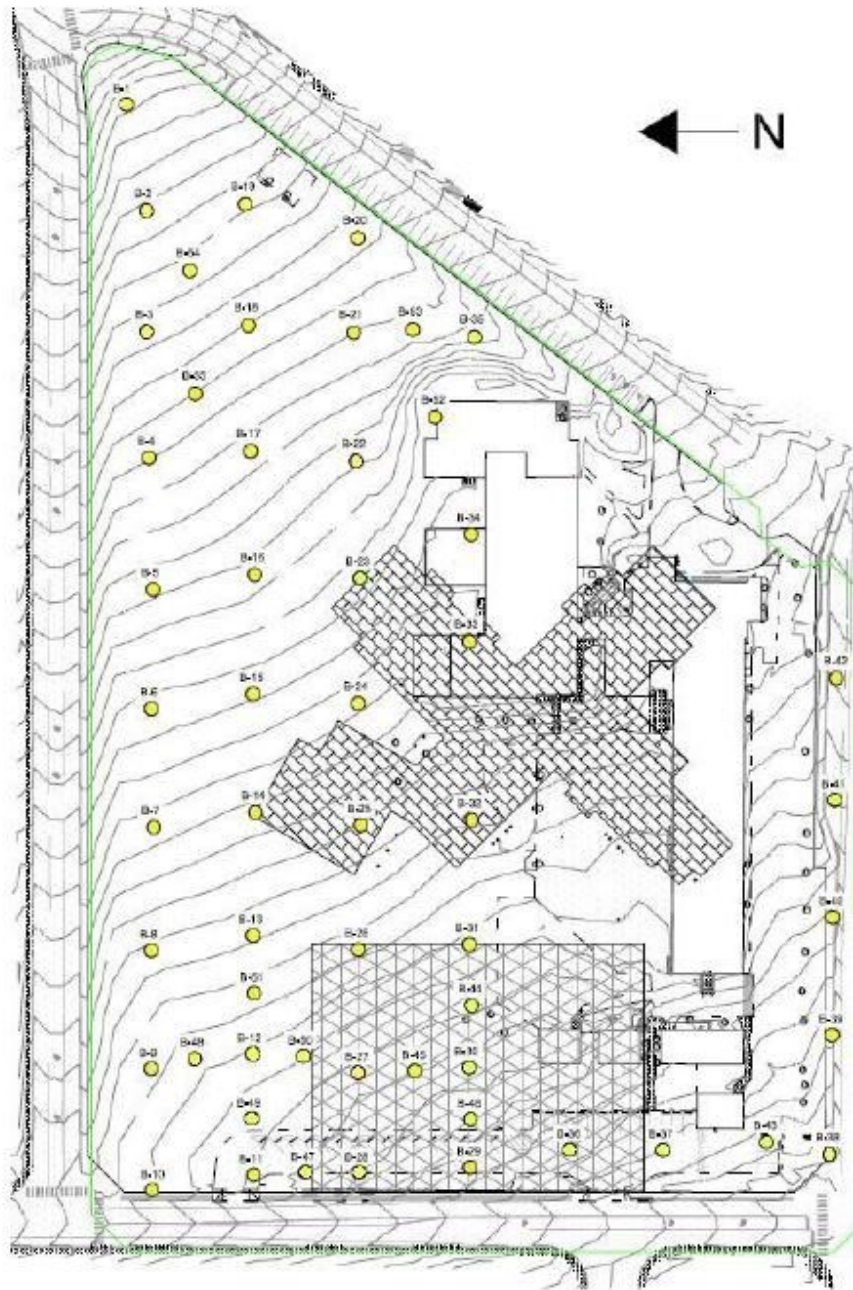
Figure A-2: Remediation Area Map

The remedial action for the Property is based on containing remaining contaminated soil under a cap consisting clean soil and geotechnical fabric and located as illustrated in Exhibit B. The primary purpose of this cap is to prevent exposure and direct contact to contaminated soils. As such, the following restrictions shall apply within the area illustrated in Exhibit B.

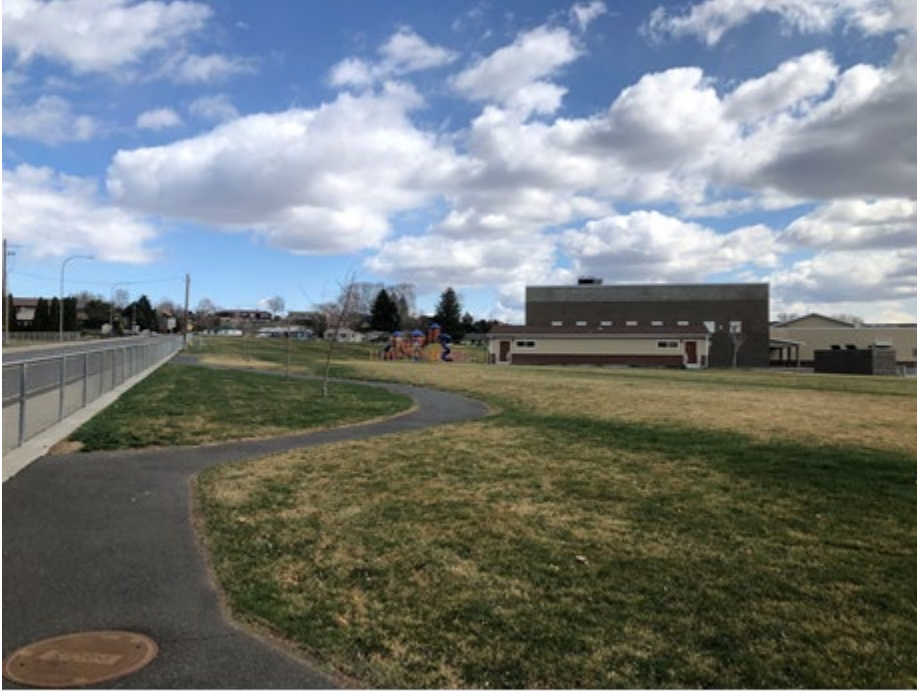
Photo 1: Front of Terrace Heights ES - from the west

Based upon the Site visit conducted on March 22, 2021, the clean soil cap on the Site continues to reduce the human exposure pathway to contaminated soils to acceptable levels. The Site is currently operating as an elementary school. A photo log is in Appendix D.

The cleanup actions were intended to eliminate exposure to contaminated soil at the Site. Exposure pathways to contaminated soils by ingestion and direct contact were reduced by the cleanup soil cap. The cap appears to be in satisfactory condition, and no repair, maintenance, or contingency actions are required at this time.
