Periodic Review Tiger Oil Summitview

5511 Summitvew Avenue, Yakima, Yakima County Facility Site ID: 58425191, Cleanup Site ID: 6338

Toxics Cleanup Program, Central Region

May 2021

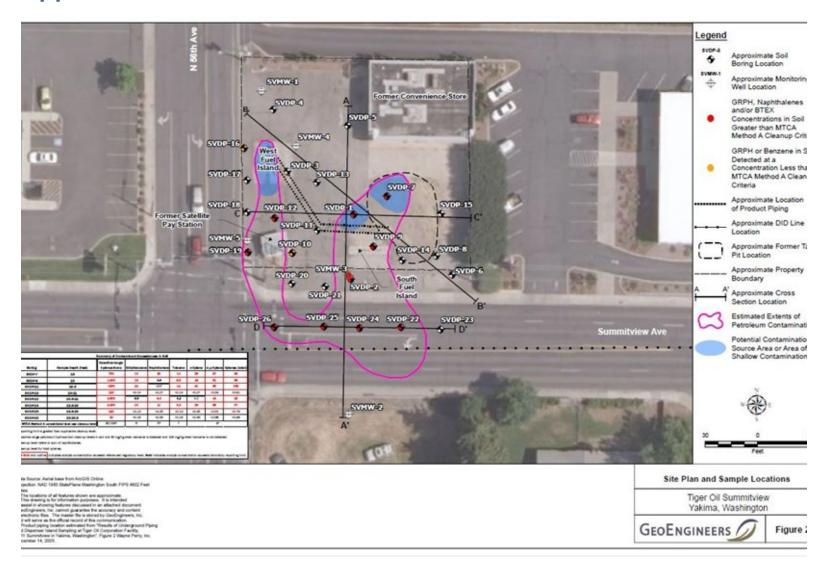
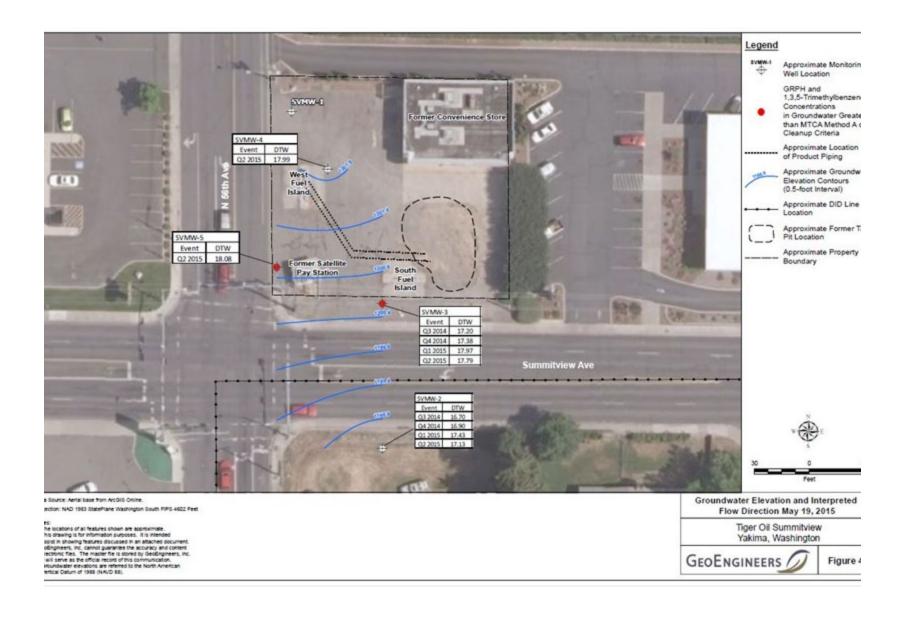
Appendix B. Site Plan

The Tiger Oil Summitview Site is located at 5511 Summitview Avenue in the City of Yakima, Yakima County, Washington. The site previously operated as a retail gasoline station and convenience store until closure in 2001. The property previously contained two buildings and two historic fuel dispenser islands. The historical buildings included a larger former convenience store in the northeast corner of the property and a smaller former satellite pay station in the southwest corner of the property.

Former fuel dispenser islands were located in the south and west areas of the property. A single tank pit was located south of the former convenience store between the convenience store and the southern fuel dispenser island. In 2005, three underground storage tanks (USTs) were decommissioned and removed from the property. The historical site structures were demolished in 2019. The Site now consists of a Bruchi's Cheese Steaks and Subs restaurant, with the new structure constructed on the property in 2019.

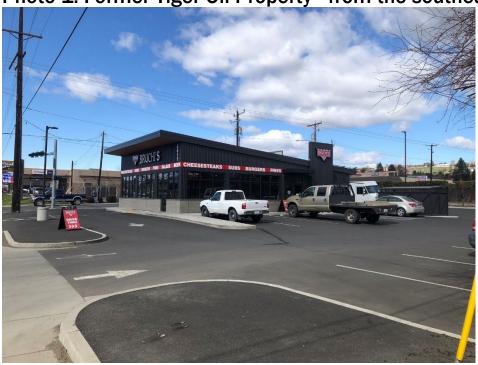
Photo 1: Former Tiger Oil Property - from the southeast

During the Site visit Ecology conducted on March 22, 2021, the contaminated portion of the property is now located beneath the new building and adjacent asphalt pavement. The remainder of the Site is covered by an asphalt parking lot. The pavement was in good condition. The Site is currently operating as a Bruchi's Cheese Steak and Subs restaurant. A photo log is in Appendix C.

Based on this periodic review, Ecology has determined the requirements of the Covenant are being followed. No additional cleanup actions are required by the property owner at this time. The property owner is responsible for continuing to inspect the Site to ensure the integrity of the cap is maintained.
