**RE: No Further Action opinion for the following Property associated with a contaminated Site**

**Site name:** Block 21 Amazon 8<sup>th</sup> & Bell  
**Site address:** 2205 8th Avenue, Seattle, Washington 98121  
**Facility/Site ID:** 49369  
**Cleanup Site ID:** 16643  
**VCP Project No.:** VCP NW3344

Site Description, History, and Diagrams

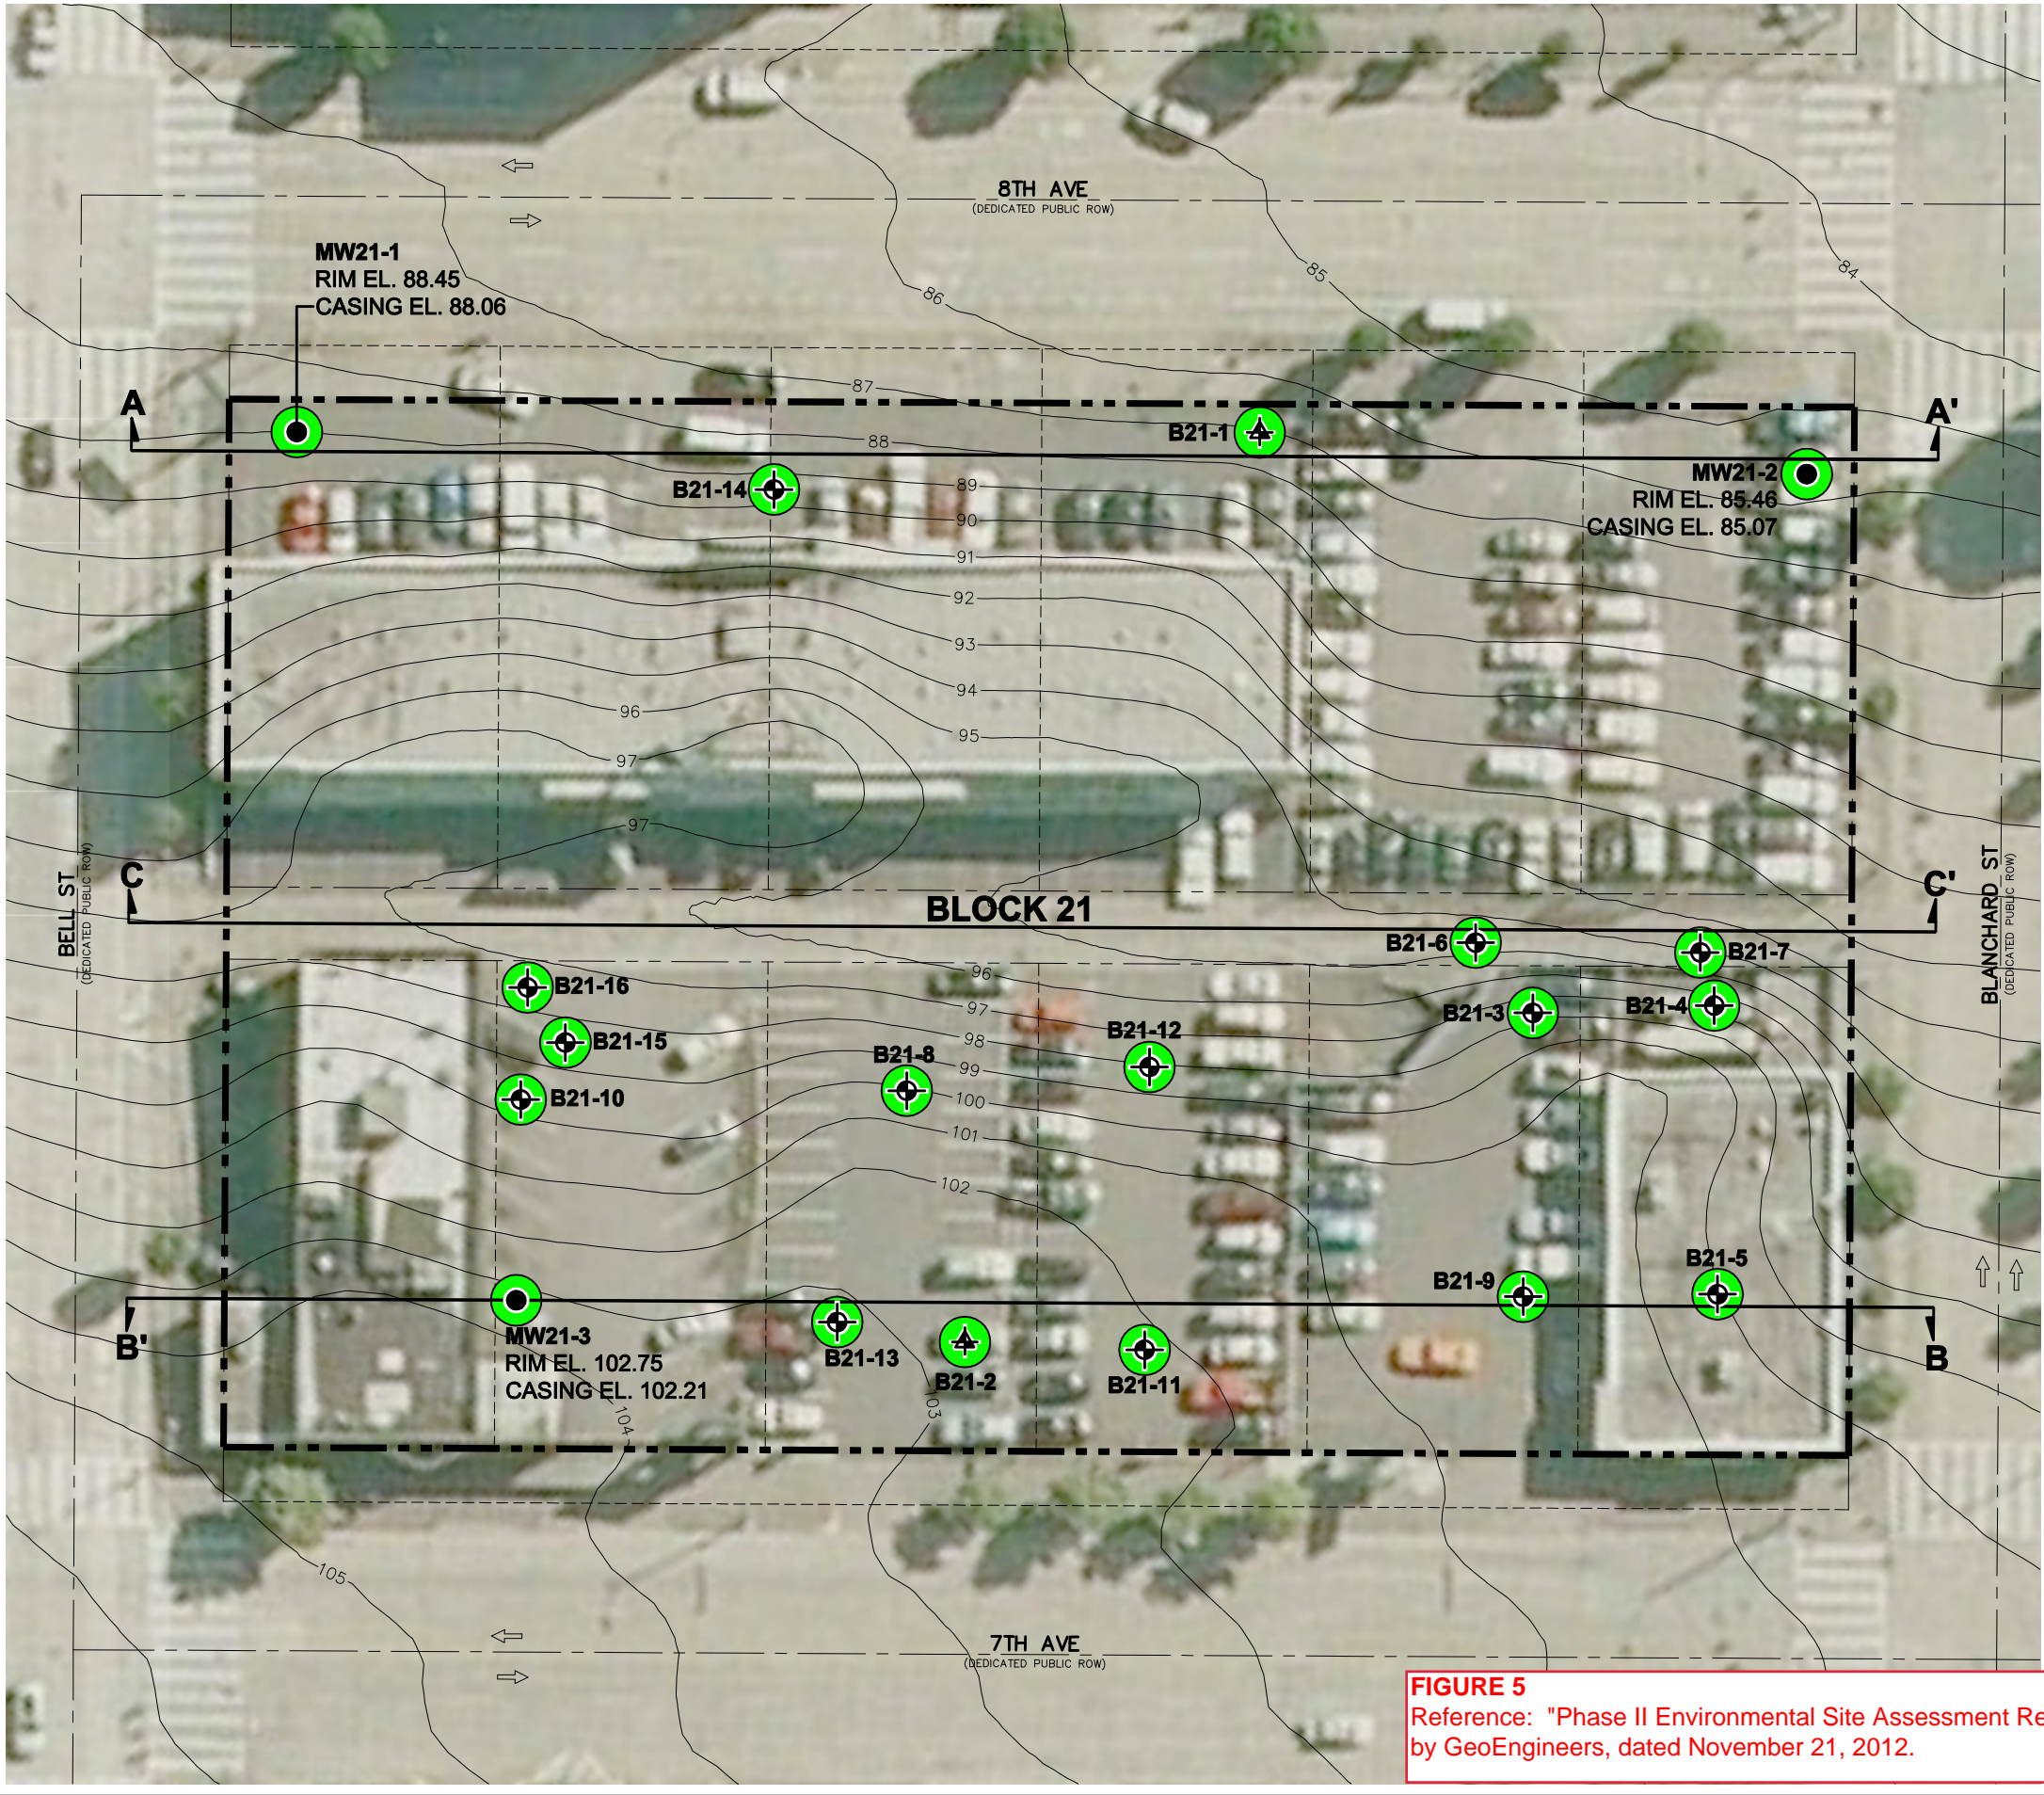
**FIGURE 5**  
Reference: "Phase II Environmental Site Assessment Report,"  
by GeoEngineers, dated November 21, 2012.

**Extent of Soil and Groundwater Contamination:** The lateral extent of soil contamination has been limited to the areas of the former USTs and was limited in depth to approximately 23 feet bgs. Contaminants have not been detected in groundwater beneath the Property. Volatile organic compounds (VOCs) have not been detected in soil; therefore, vapor intrusion is not a risk.
