Subject: Sampling Results from Monroe Auto Salvage

DEPARTMENT OF ECOLOGY
TOXICS CLEANUP PROGRAM
SITE HAZARD ASSESSMENT DATA COLLECTION SUMMARY SHEETS
FOR
WASHINGTON RANKING METHOD

Site Name: Monroe Auto Salvage

To: Monroe Auto Salvage Site File
From: Gary Hanada
Subject: Site Hazard Assessment (SHA)

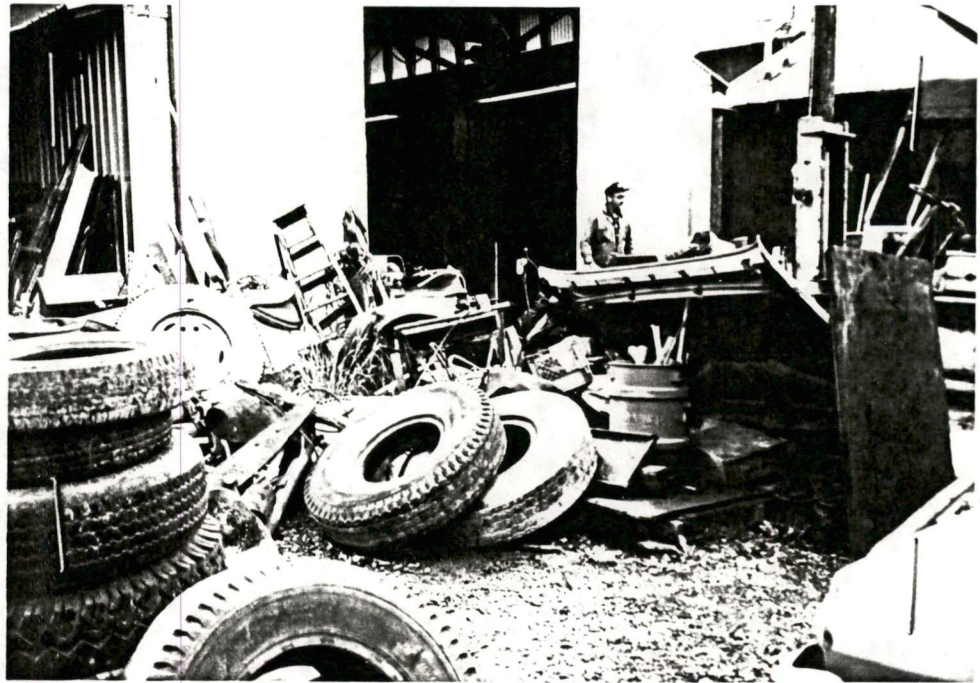
PHOTO No. 2

DESCRIPTION:

North side of the shop on
on the north east side of
of the property.

COMMENTS: Picture taken during Site Hazard Assessment at Monroe Auto Salvage, Monroe

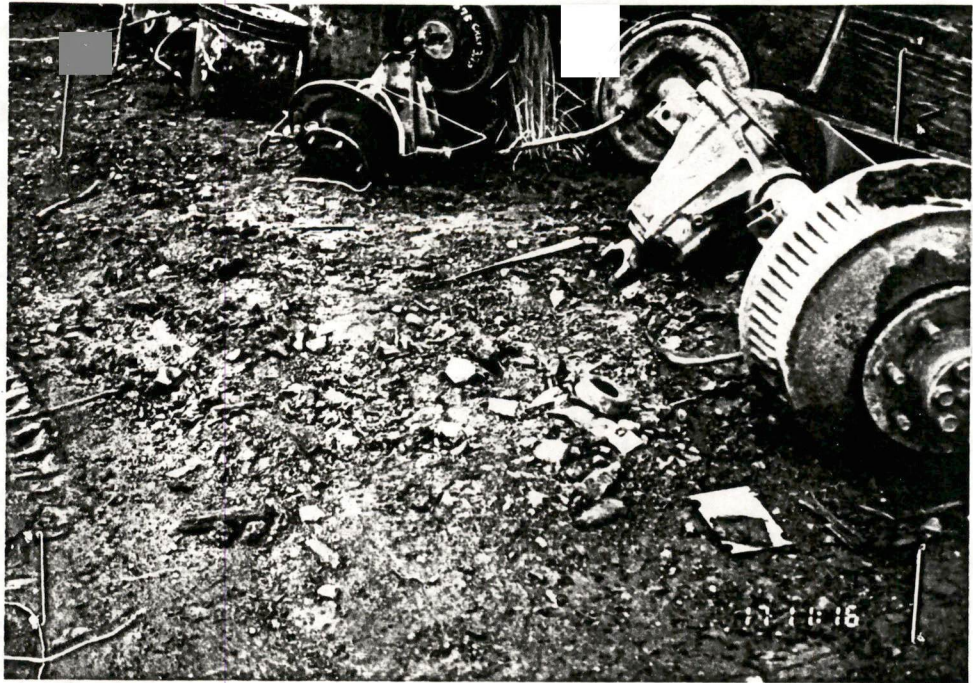
PHOTO No. 4

M-2 southeast of office

building.

COMMENTS: Picture taken during Site Hazard Assessment at Monroe Auto Salvage, Monroe

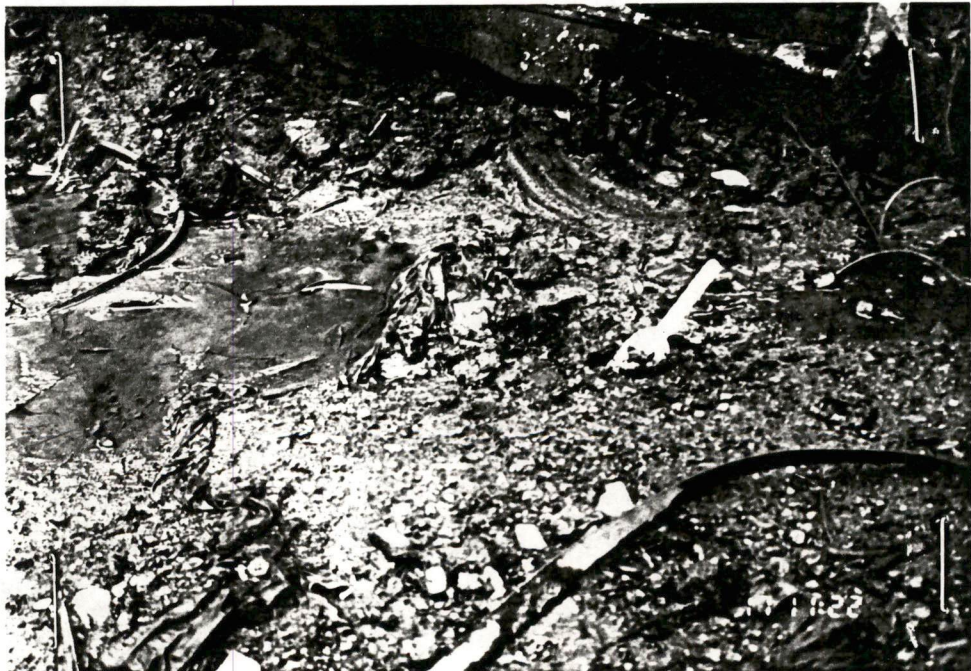
PHOTO No. 5

M-1 southwest of office

building in drainage area.

COMMENTS: Picture taken during Site Hazard Assessment, Monroe Auto Salvage, Monroe.

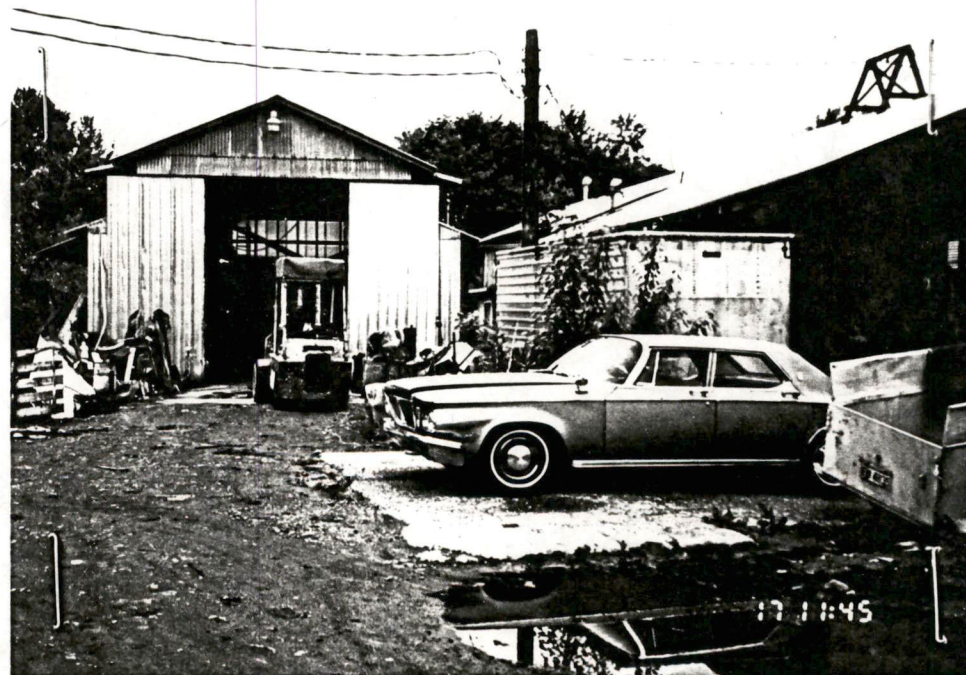
PHOTO No. 11

Arochlor 1016	< 800000		800000
Arochlor 1221	< 3200000		3200000
Arochlor 1232	< 800000		800000
Arochlor 1242	< 800000		800000
Arochlor 1248	< 800000		800000
Arochlor 1254	1800000		800000
Arochlor 1260	< 800000		800000

Area wide picture where

sample M-3 was taken.

COMMENTS: Picture taken during Site Hazard Assessment, Monroe Auto Salvage, Monroe.

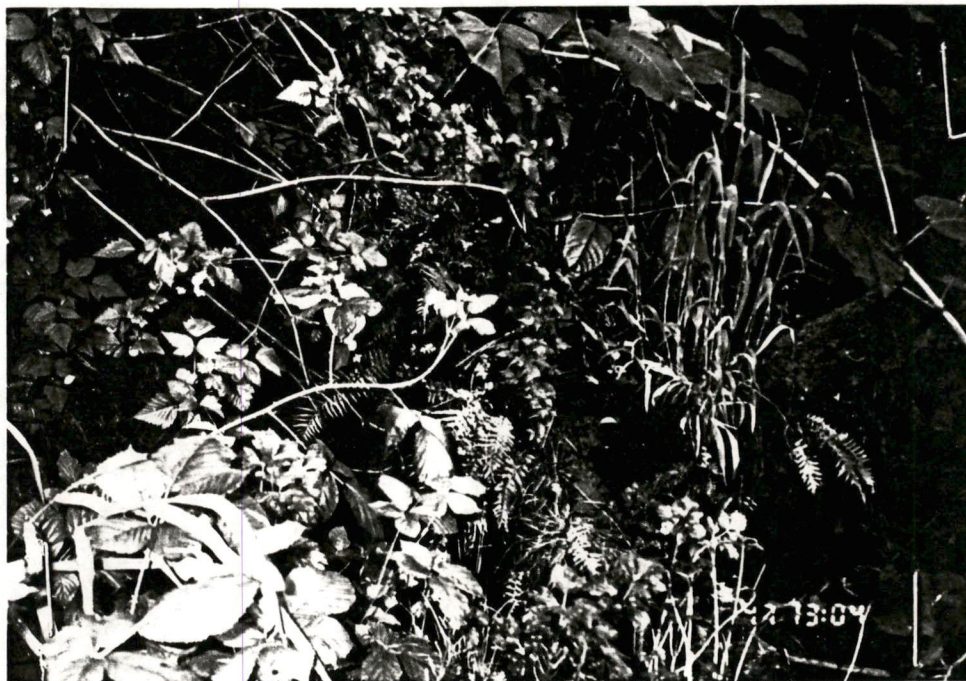
PHOTO No. 12

Arochlor 1016	< 580		580
Arochlor 1221	< 2300		2300
Arochlor 1232	< 580		580
Arochlor 1242	< 580		580
Arochlor 1248	< 580		580
Arochlor 1254	5800		580
Arochlor 1260	< 580		580

South west side of
property near creek.

Soil sample location M-4.

COMMENTS: Picture taken during Site Hazard Assessment at Monroe Auto Salvage, Monroe

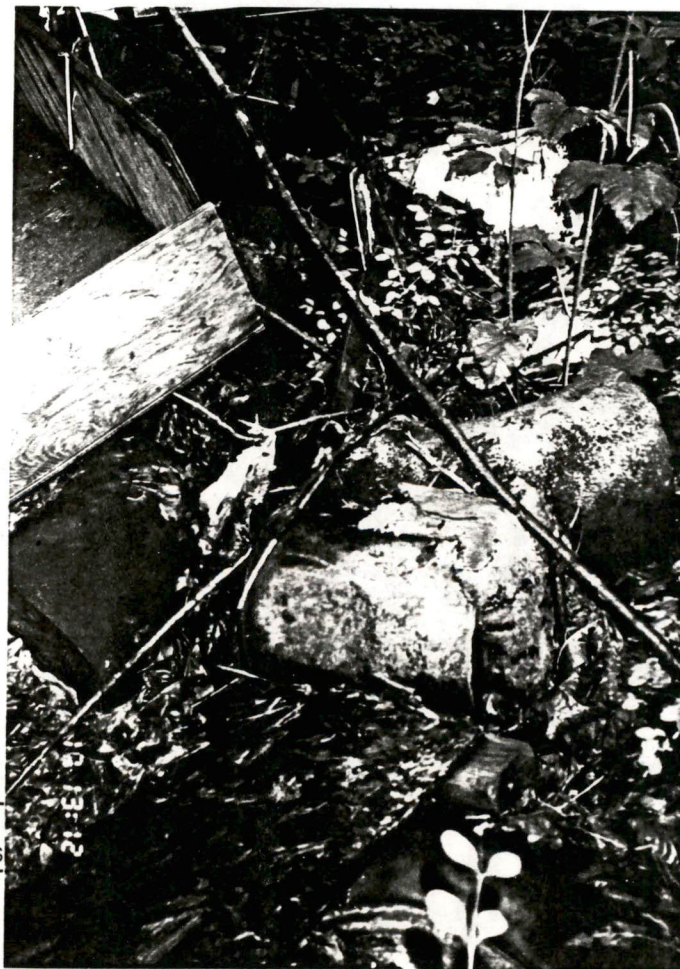
PHOTO No. 7

Dumping on hill side
above creek on south
west side of property.

COMMENTS: Picture taken during Site Hazard Asses

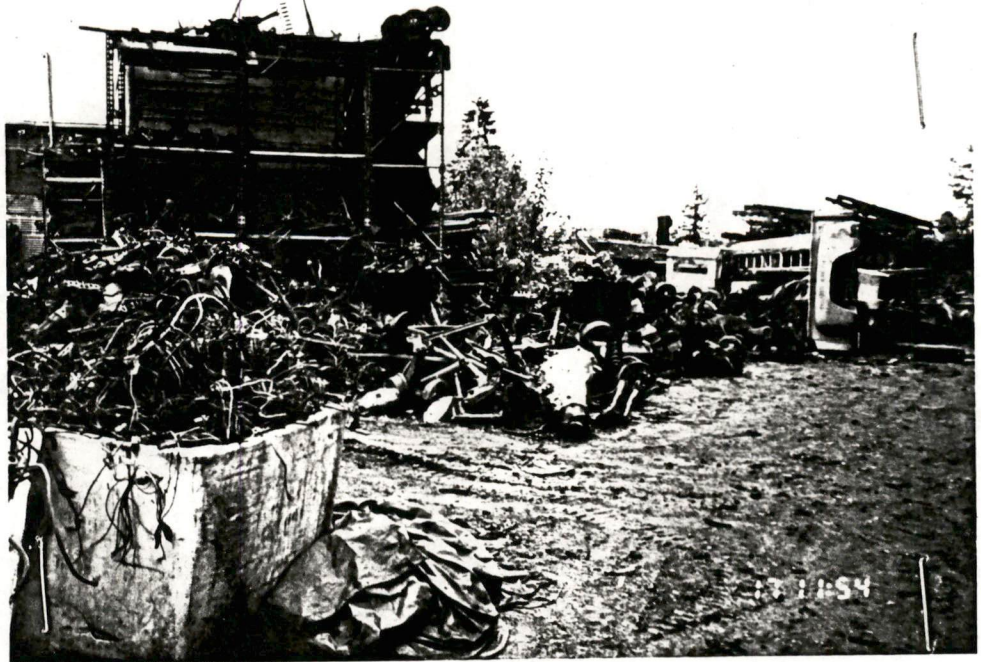
Auto parts stored

southeast of office

building. Picture taken facing northeast.

COMMENTS: Picture taken during Site Hazard Assessment at Monroe Auto Salvage, Monroe

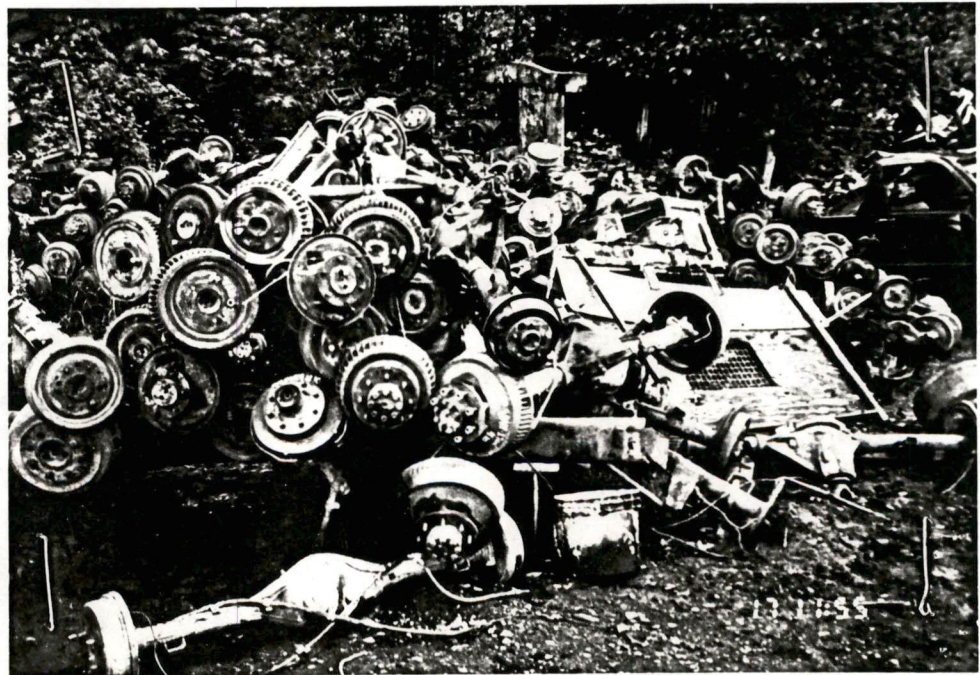
Auto parts stored

southeast of office

building. Picture taken facing south east.

COMMENTS: Picture taken during Site Hazard Assessment, Monroe Auto Salvage, Monroe.
