# *Lake Goodwin Landfill 2015 Annual Environmental Monitoring Report*

This report details the 2015 quarterly groundwater monitoring, monthly landfill gas monitoring and annual topographic survey results for the Lake Goodwin Landfill (*Lake Goodwin Landfill, Site*). The Site is located at 18520 Frank Waters Road in northwestern Snohomish County, approximately 1.5 miles northwest of Lake Goodwin and 5 miles south of the City of Stanwood, Washington (*T31N, R4E, Sections 17 and 20, Willamette Meridian*). The location of the Site relative to existing municipal improvements is shown on the **Vicinity Map** (*Figure 1*).

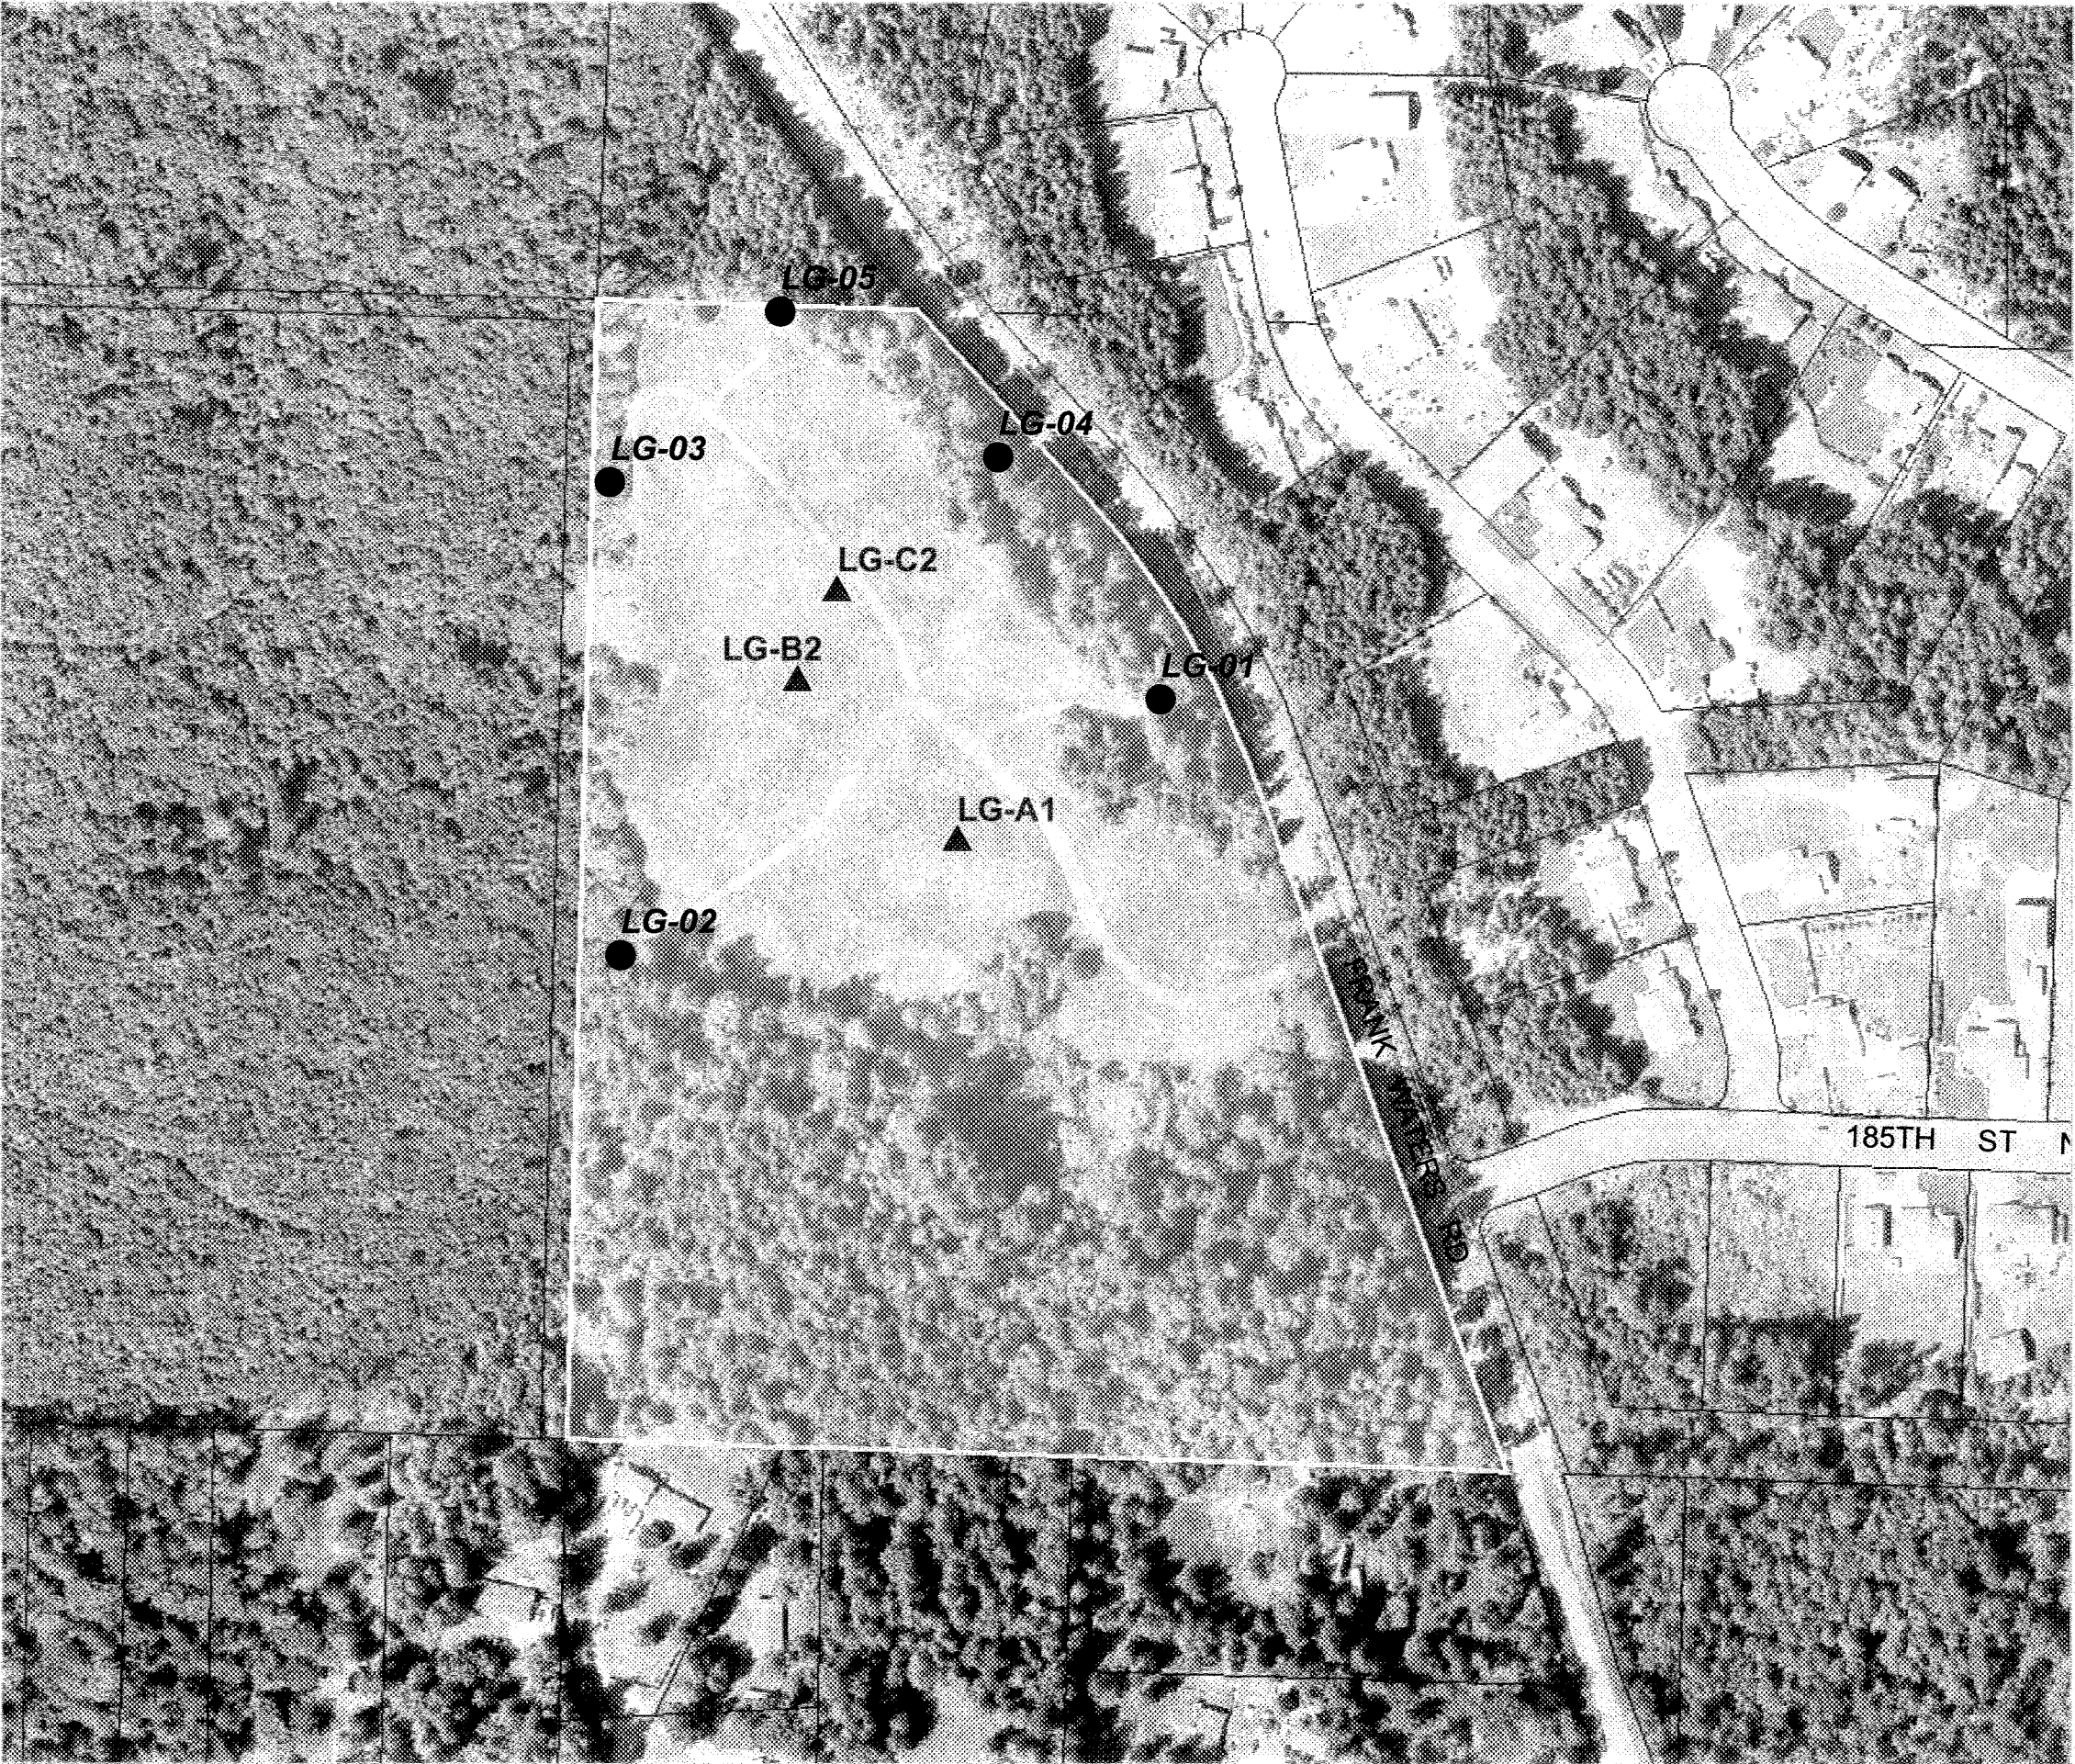
## Monitoring Network

There are currently four-(4) groundwater monitoring wells (*LG-01 and LG-02, and LG-04 and LG-05*) at the Lake Goodwin Landfill Site that are monitored on a quarterly basis. The groundwater monitoring well locations are shown on the **Network Monitoring Map** (*Figure 5*). Of these wells, one-(1) well (*designated LG-02*) characterizes upgradient background groundwater conditions in the immediate vicinity of the Site. The remaining three-(3) wells that are currently monitored per the SAP are located within and/or downgradient of the landfill (*LG-01, LG-04, and LG-05*) and monitor groundwater that may be impacted from the Site. Groundwater monitoring results are discussed in *Section 2.0* below.

Monitoring of methane gas production at the landfill is accomplished by a walking gas probe survey. The three-(3) bar hole punch probe locations used for gas monitoring are shown on the **Network Monitoring Map** (*Figure 5*). This survey was performed on a monthly basis through 2015. The results of methane gas monitoring are discussed in *Section 3.0* below.

March 2012, and three replacement bar holes were installed in November 2013. The existing bar hole probe locations are shown on the **Monitoring Network Map** (*Figure 5*). **Bar Hole Punch Gas Probe Installation Details** are shown in *Table 5* below.

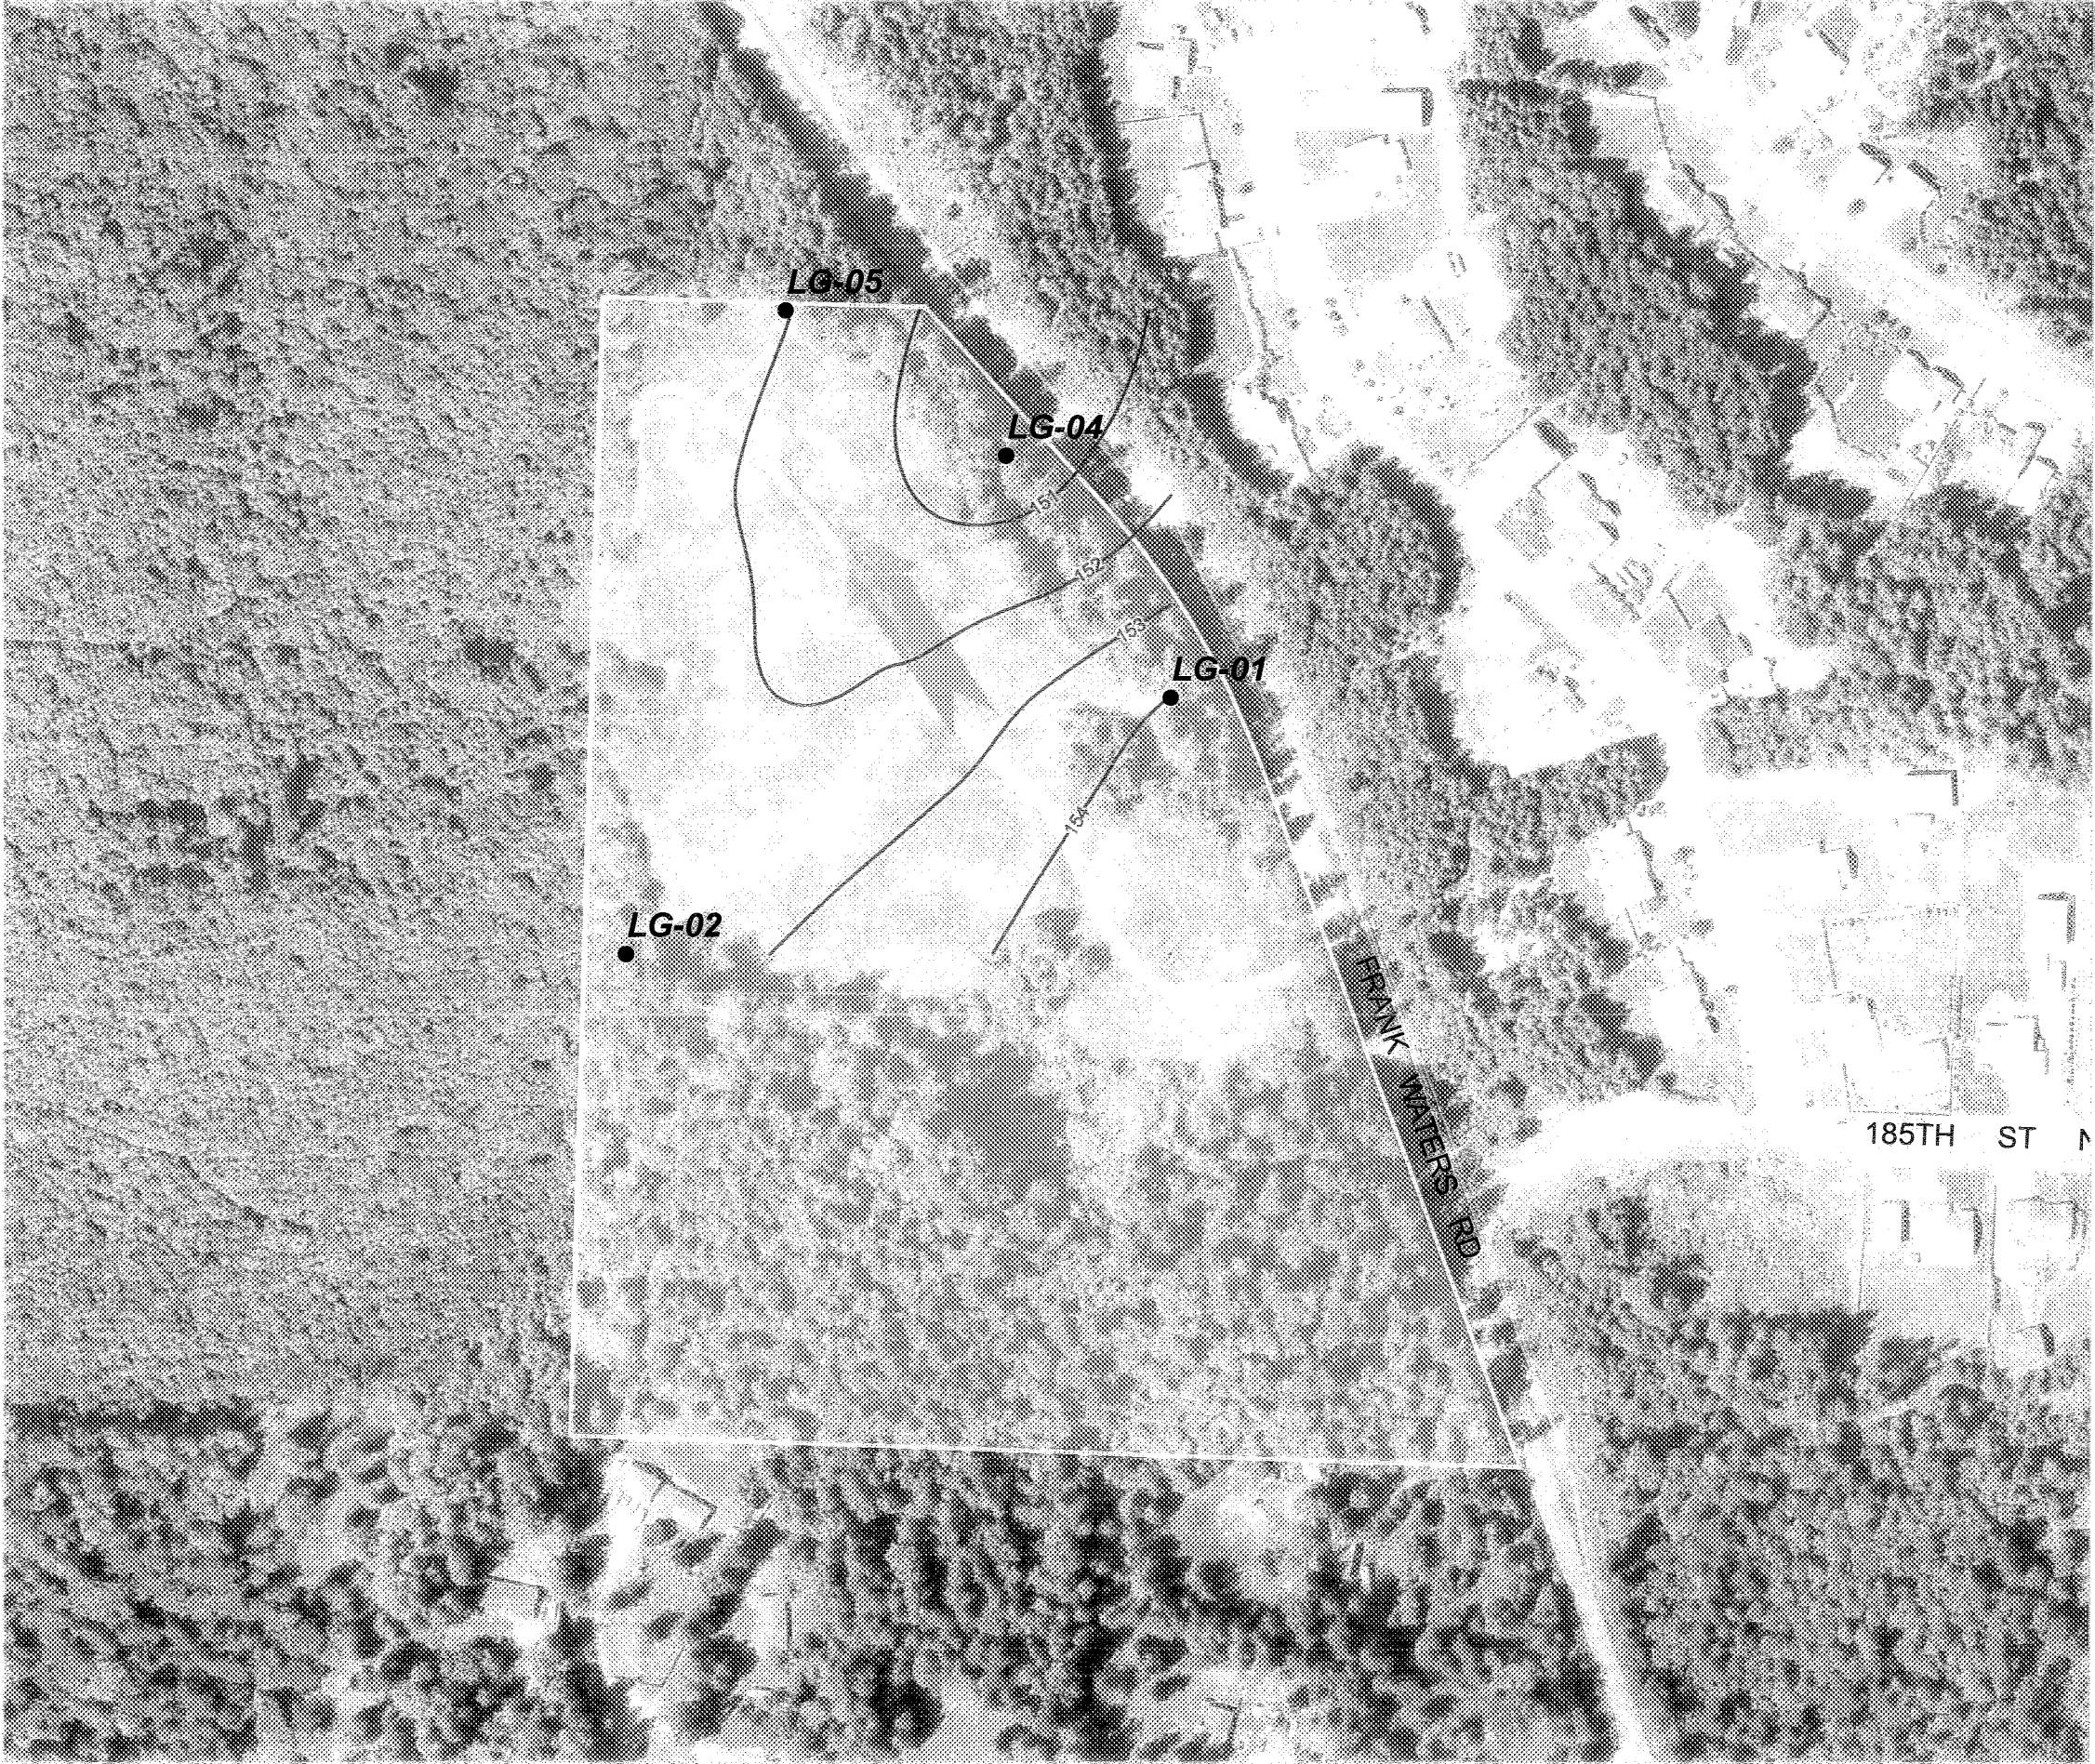
Water Elevation  
First Quarter 2015

**Quarterly Groundwater Measurements** are shown in *Table 1* below, and quarterly groundwater contour maps for the 2015 monitoring events are included as Figures 6a

DIRECTION OF GROUNDWATER FLOW  
1.36 ft / day  
497 ft / year  
123.83 degrees to the positive x - axis

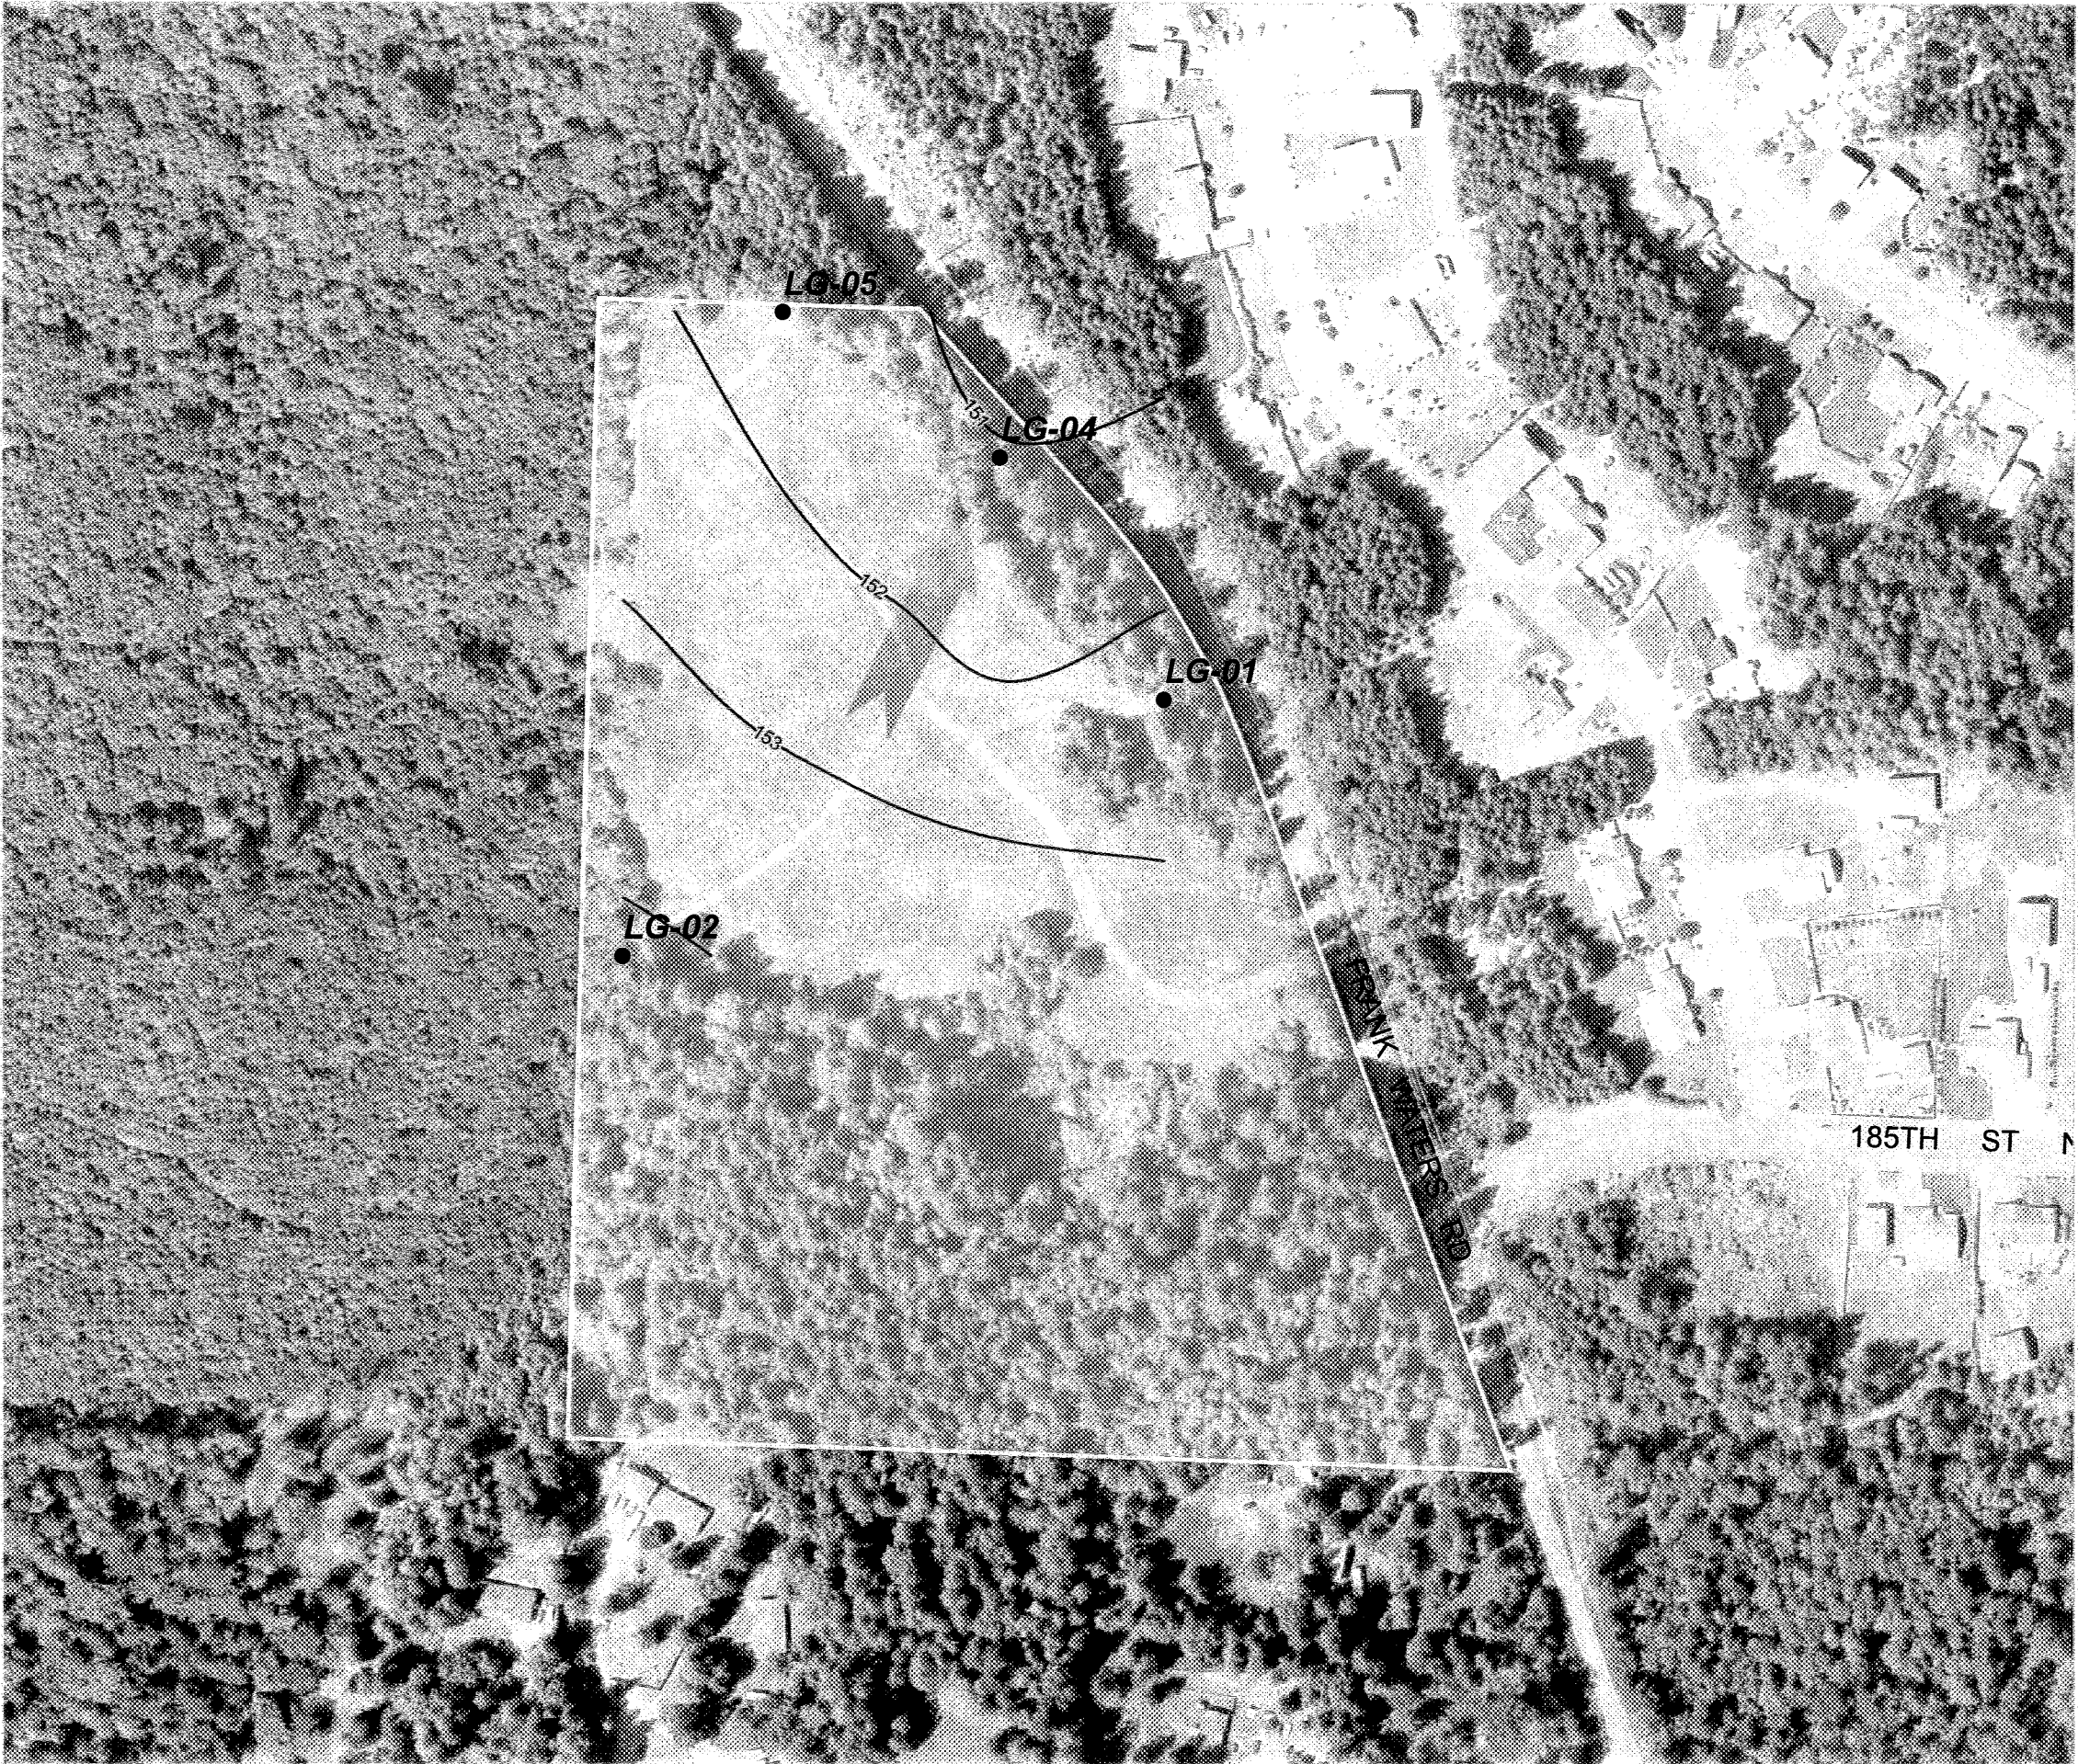
## Water Elevation Contours Second Quarter 2015

- DIRECTION OF GROUNDWATER FLOW  
1.59 ft / day  
581 ft / year  
63.22 degrees to the positive x - axis
- PARCEL BOUNDARY
- SUBJECT PROPERTY BOUNDARY
- 1 FT CONTOUR
- WELL LOCATION

WELL_ID	SAMP_DATE	MEAS_HEAD
LG-01	4/15/2015	152.37
LG-02	4/15/2015	154.18
LG-04	4/15/2015	151.06
LG-05	4/15/2015	151.61
