*Lake Goodwin Landfill
First Quarter 2016 Environmental
Monitoring Report*

Figure 1

Lake Goodwin Landfill

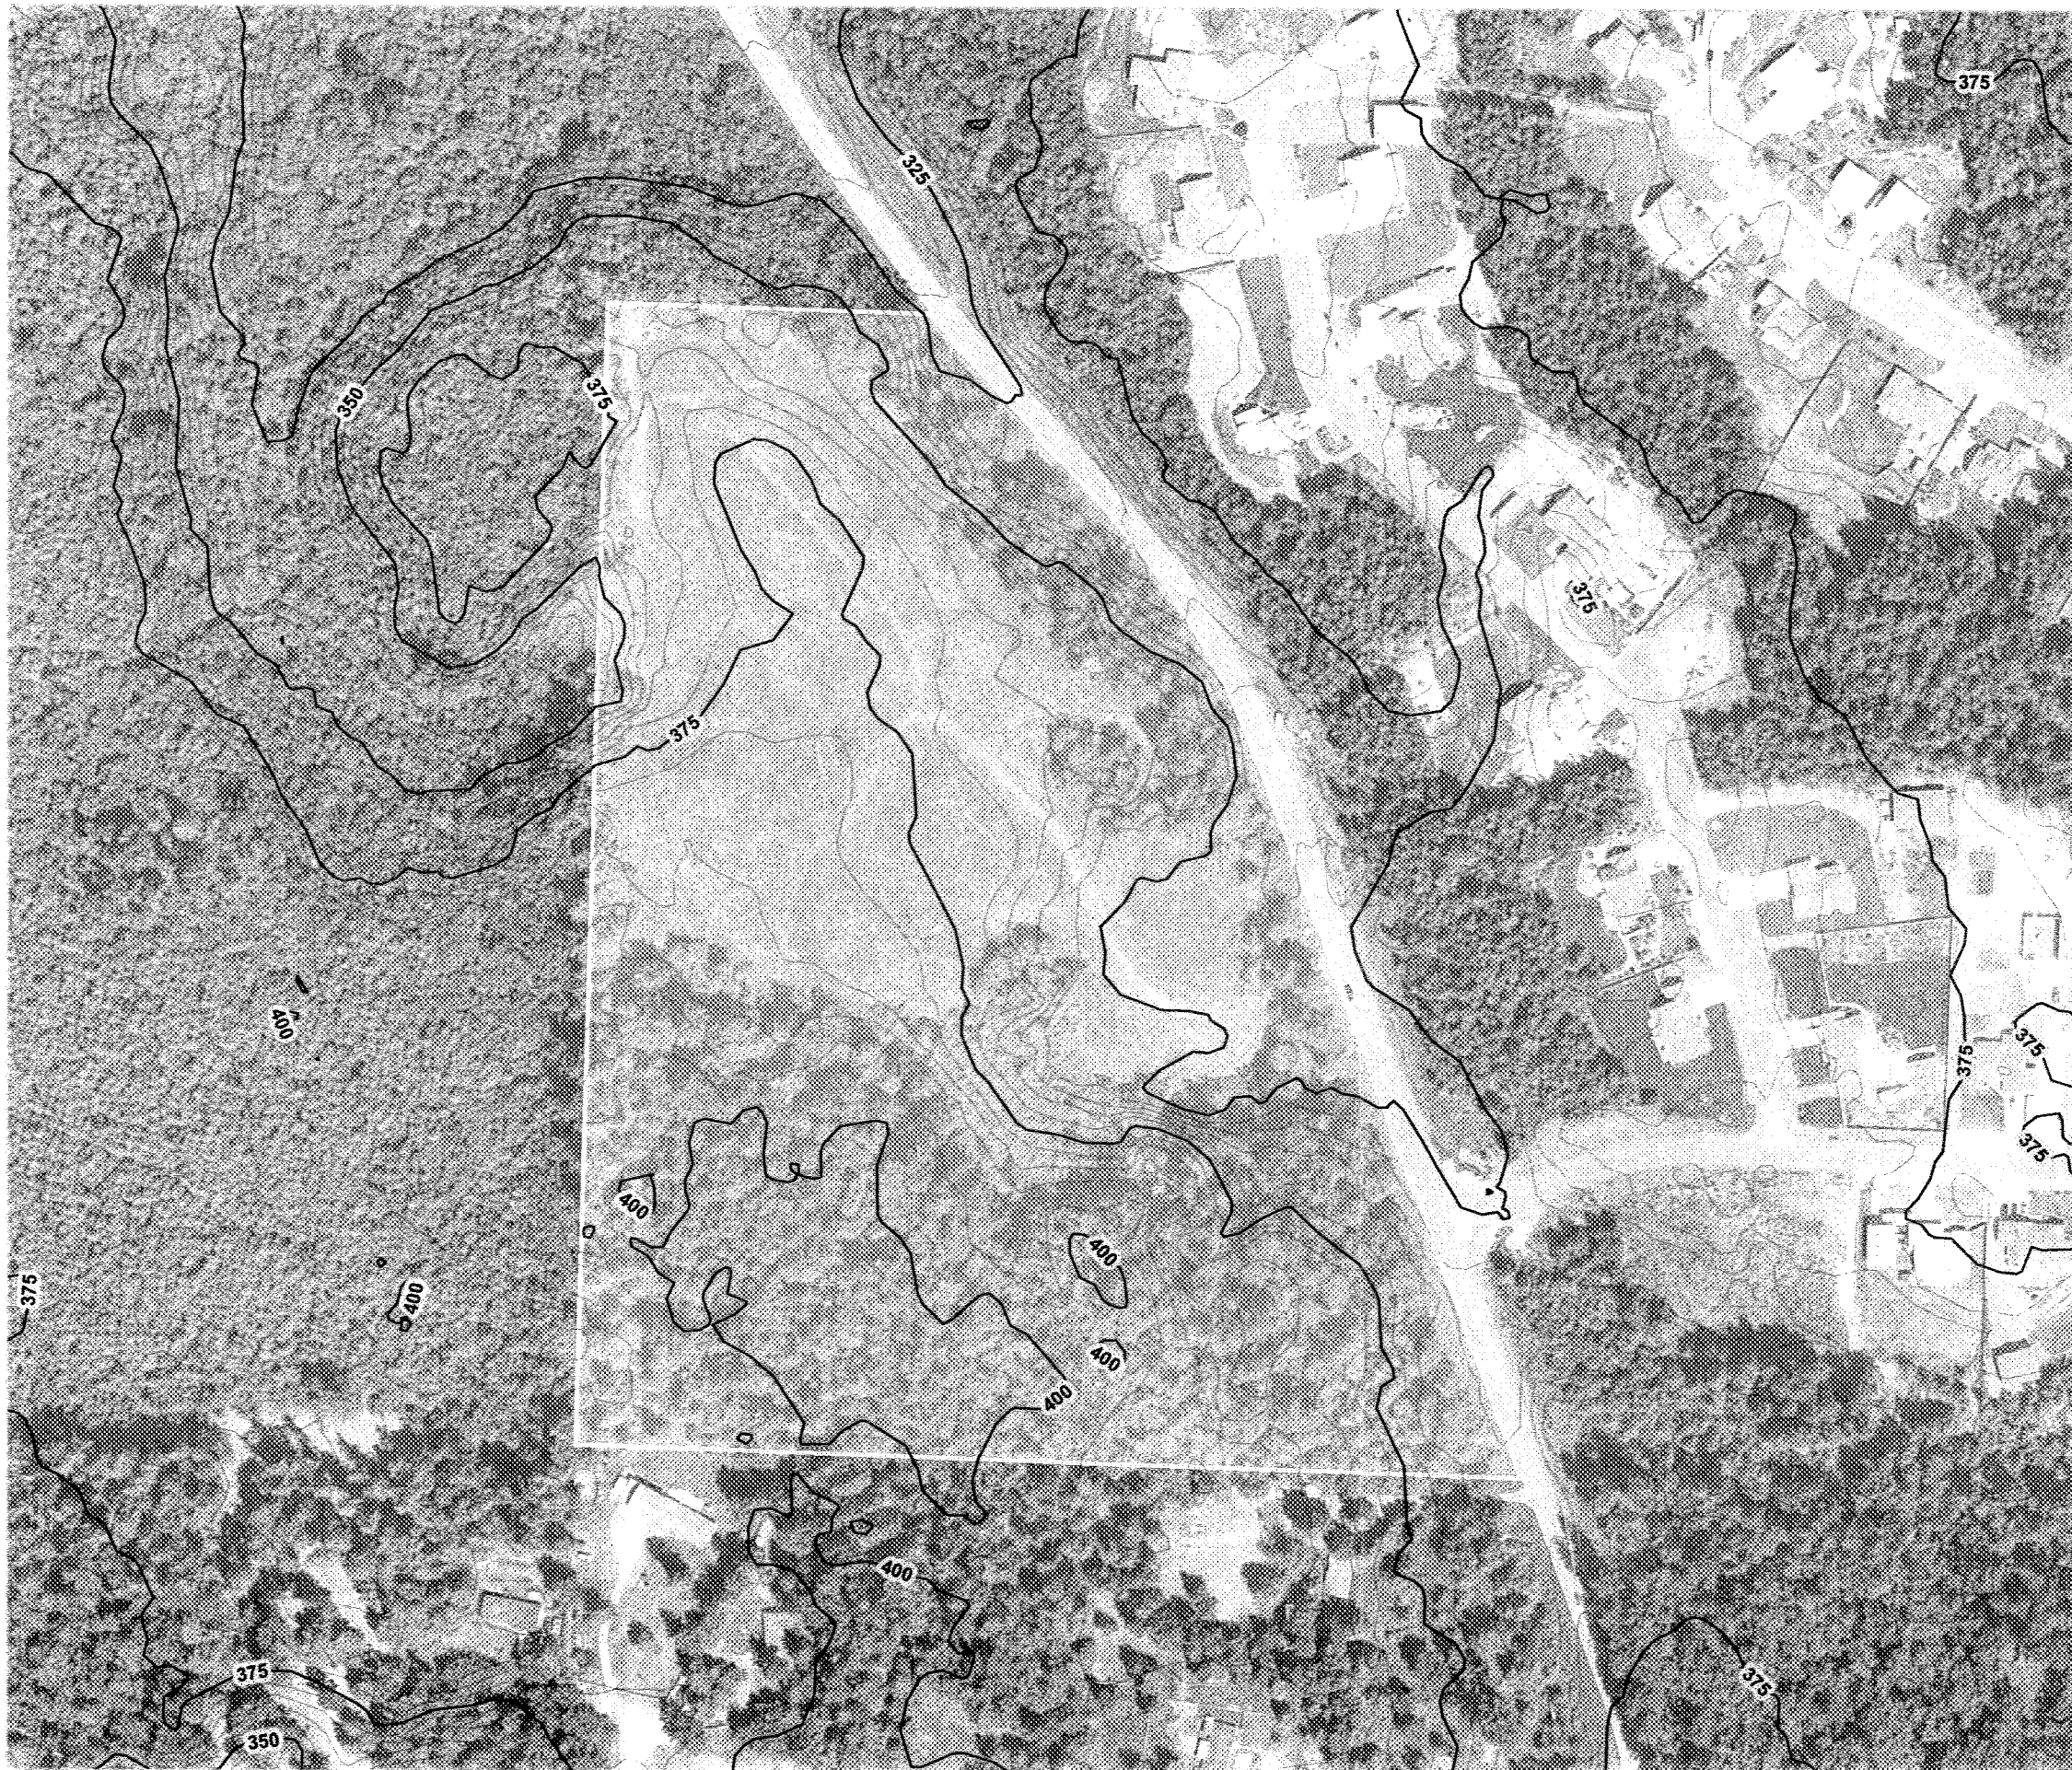
Figure 3

Elevations in the immediate vicinity of the landfill range from approximately 320 to 380 feet above mean sea level. Relative to existing surrounding topography the landfill itself is approximately 60 feet high. It has been graded and slopes gently to the north-northeast. Site Topography is shown on the **Topographic Map** (Figure 3). In most places the landfill cover is well vegetated with grass, clover and weeds. A few Douglas fir have naturally reseeded in the fill cover near the edge of the Site. There are no stormwater detention ponds or leachate collection ponds located onsite.

Lake Goodwin Landfill Topography

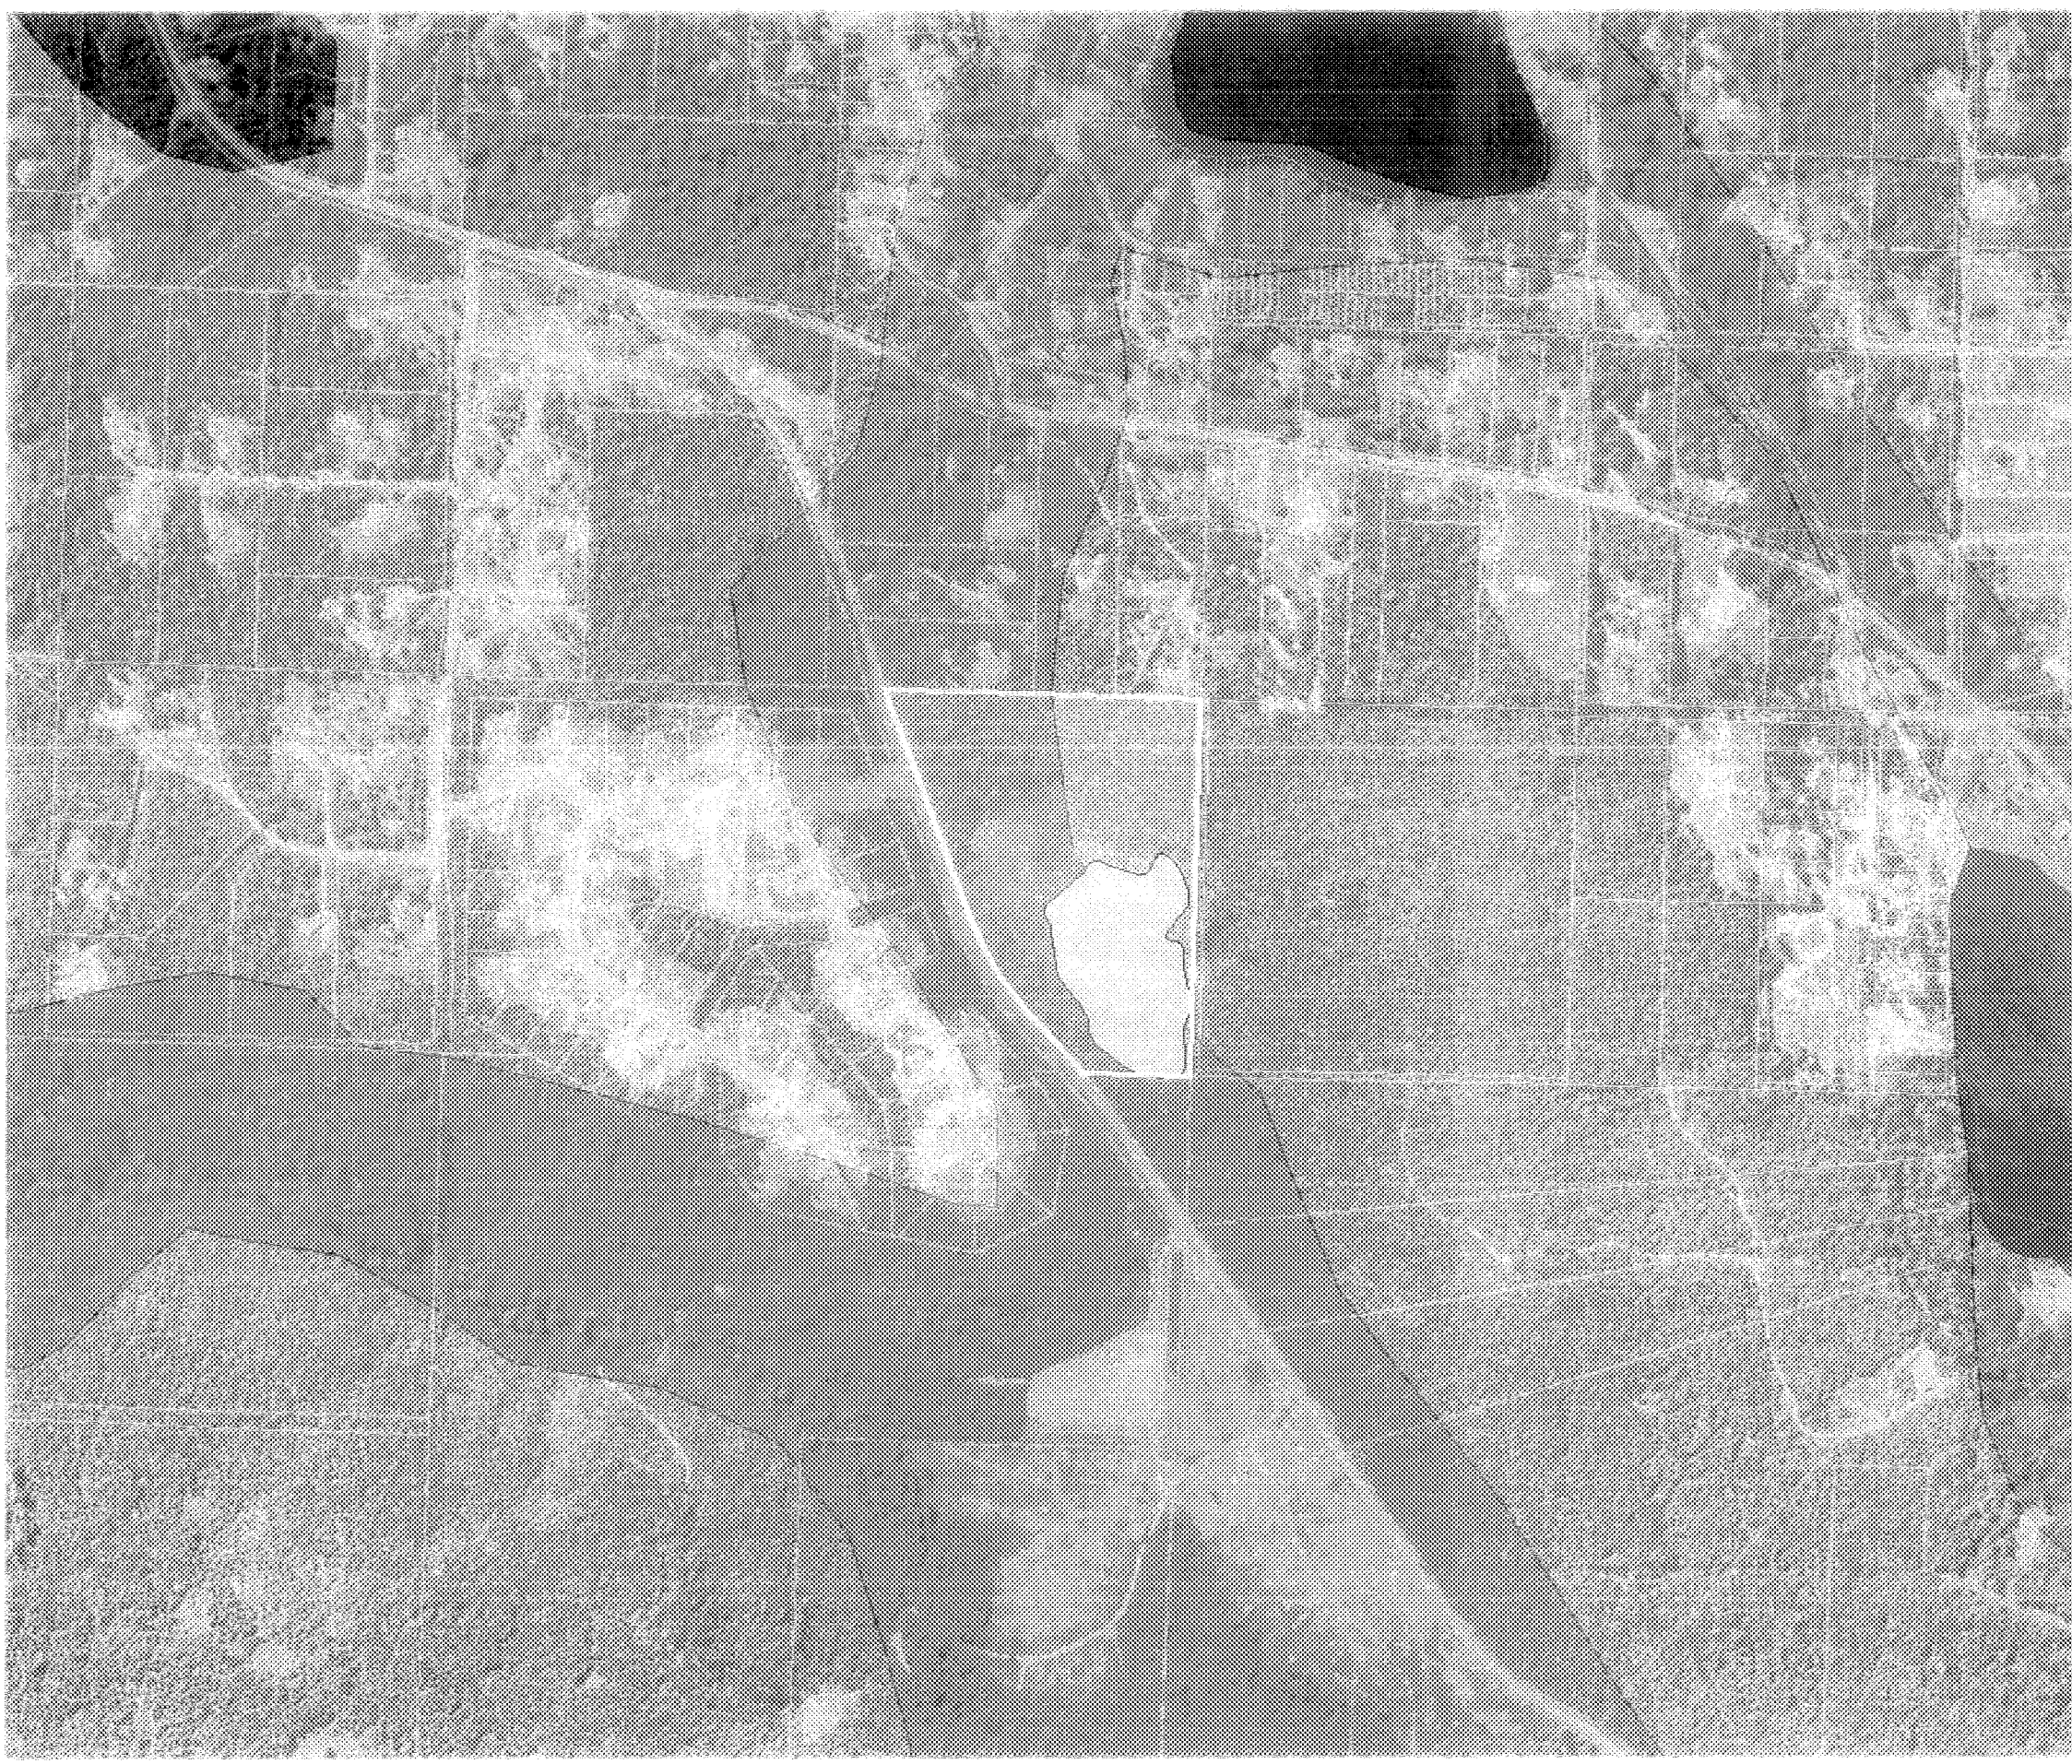
Figure 4

The surficial geology of the Site area is shown on the **Geologic Map** (Figure 4). Based on the geologic map and our interpretation of historical Site investigations, surficial geology at the Site consists of Advance Outwash (*Qva*) sands and gravels locally overlain on the south side of the landfill by sandy silts to silty sands and gravels of the Vashon Glacial Till (*Qvt*).

The most productive aquifer below the Tulalip Plateau is the Advance Outwash (*Qva*) aquifer, which is underlain by Transitional Bed (*Qtb*) silts and clays. Where overlain by Glacial Till (*Qvt*), the aquifer is confined. In the vicinity of the Landfill where Glacial Till (*Qvt*) is absent, the aquifer is unconfined. With the exception of the surficial Glacial Till (*Qvt*) found overlying the Advance Outwash (*Qva*) sands and gravels along the southern edge of the landfill (at monitoring well *LG-02*), permeable soils were encountered from the surface down in all perimeter Site explorations. Groundwater elevations beneath the landfill during the first quarter sampling event ranged from 150.37 feet above mean sea level (*ft MSL*) to 152.83 *ft MSL* with a northeasterly gradient within the unconfined Advance Outwash (*Qva*) aquifer.

Lake Goodwin Landfill Geologic Map

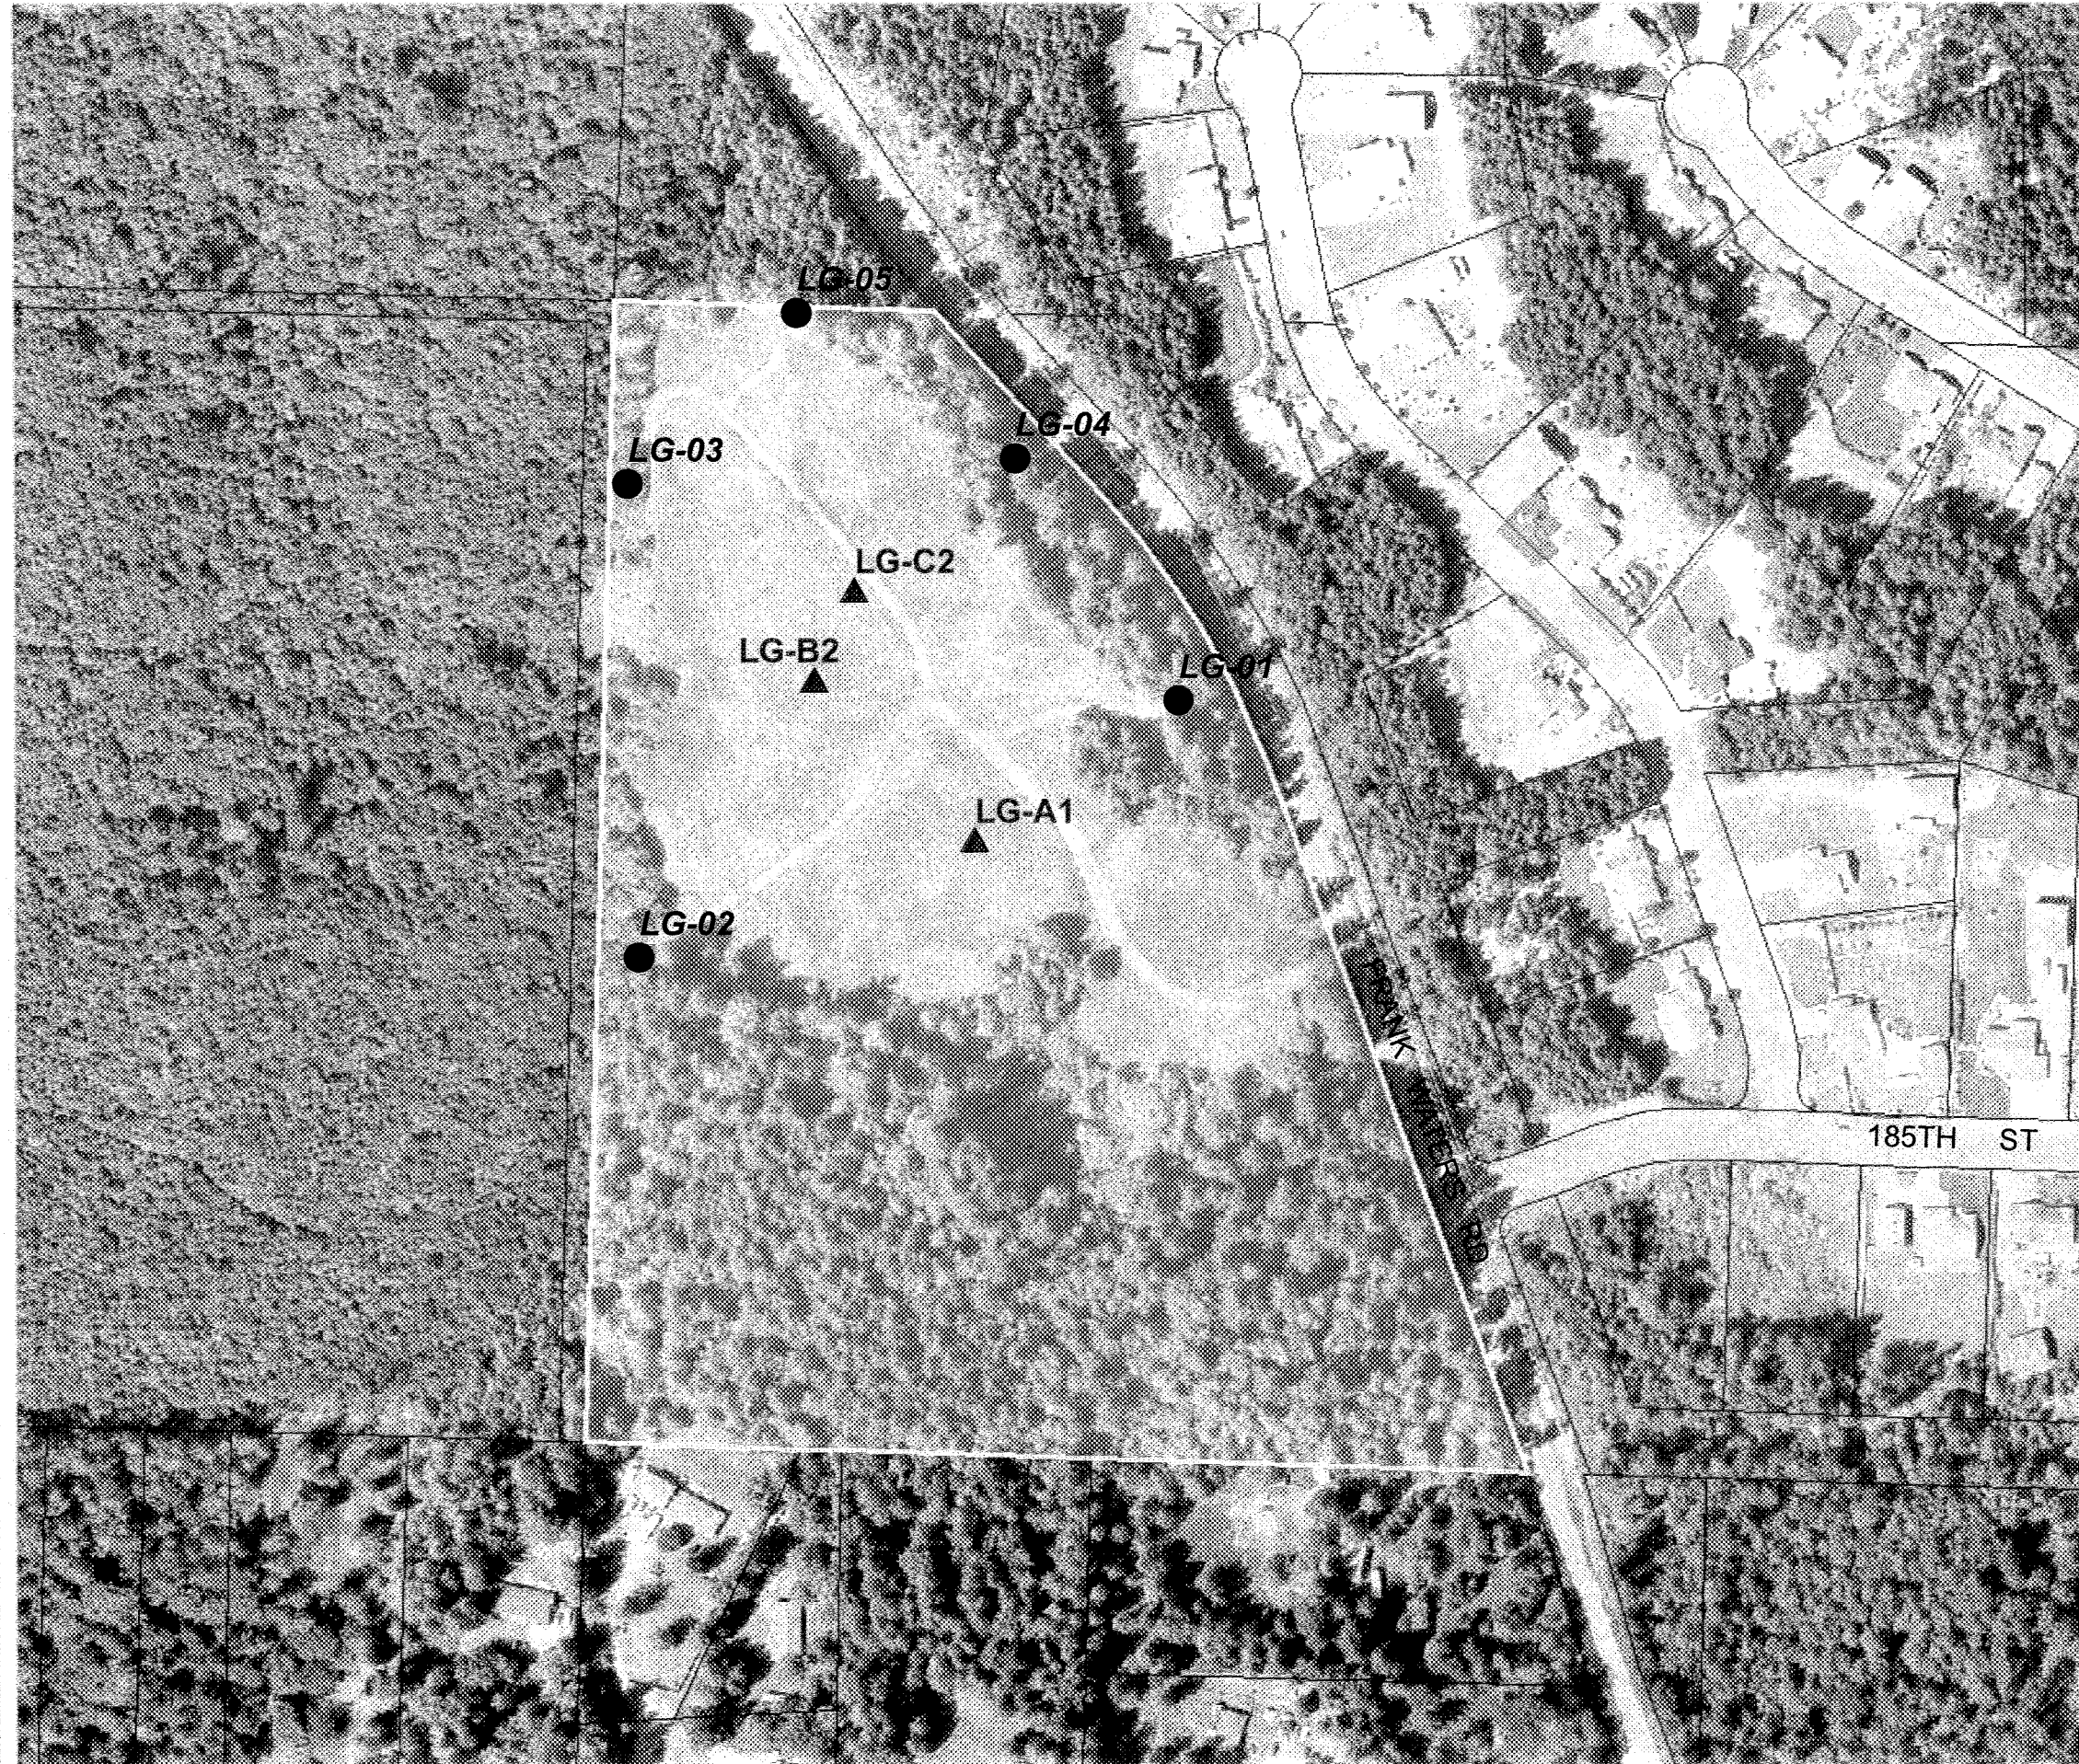
Figure 5

There are currently four groundwater monitoring wells (*LG-01 and LG-02, and LG-04 and LG-05*) at the Lake Goodwin Landfill Site that are monitored on a quarterly basis. The groundwater monitoring well locations are shown on the **Network Monitoring Map** (Figure 5). Of these wells, *LG-02* is located upgradient of the landfill and characterizes the background groundwater

conditions in the immediate vicinity of the Site. The remaining three-(3) wells are located downgradient of the landfill (LG-01, LG-04, and LG-05) and monitor groundwater zones that may be impacted from the Site. Groundwater monitoring results are discussed in *Section 2.0* below.

Lake Goodwin Landfill Monitoring Network

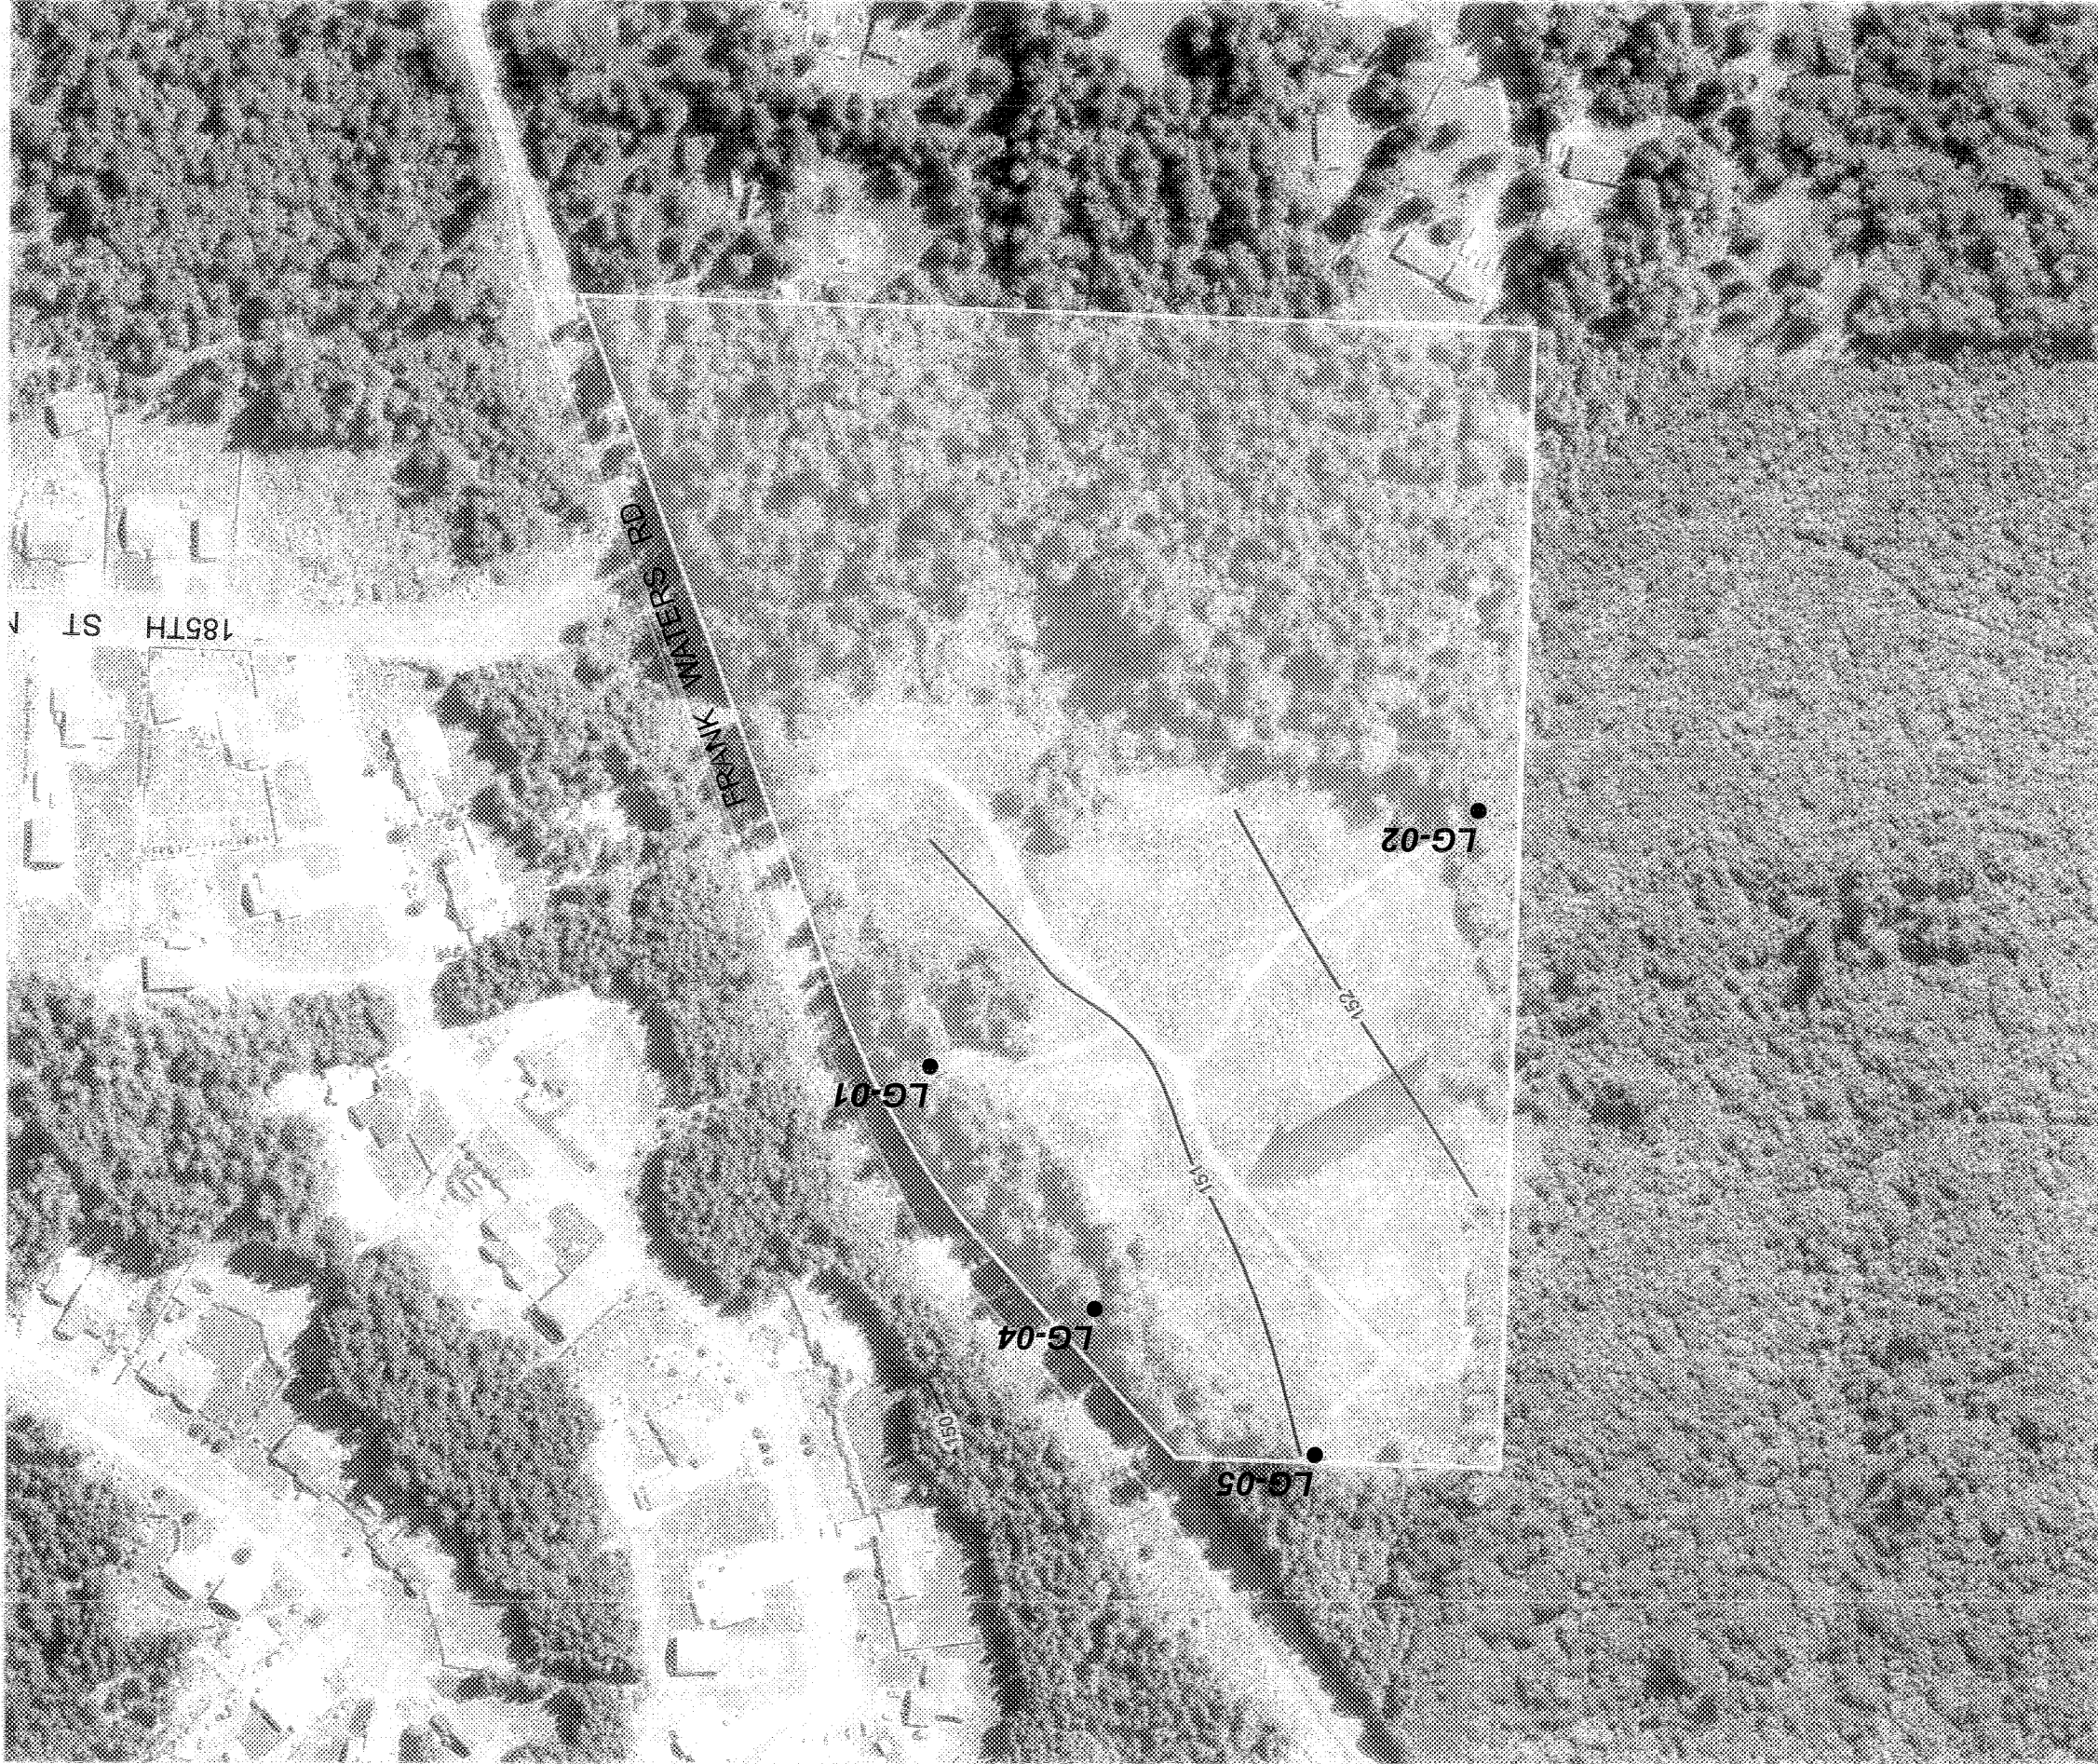
Figure 6

The **First Quarter Groundwater Measurements and Elevations** are shown in *Table 1* below. **Hydrographs** including the first quarter water level data are included in *Appendix A* of this report. Measured groundwater elevations over the last six-(6) years indicate increasing groundwater elevations beneath the landfill. The groundwater level data also confirm that the aquifer is unconfined in the immediate vicinity of the Site. The **First Quarter Groundwater Contour Map** developed from the field data is included as *Figure 6* of this report.

Groundwater Elevation Contours
1st Quarter 2016

DIRECTION OF GROUNDWATER FLOW
1.46 ft / day
534 ft / year
29.92 degrees to the positive x - axis

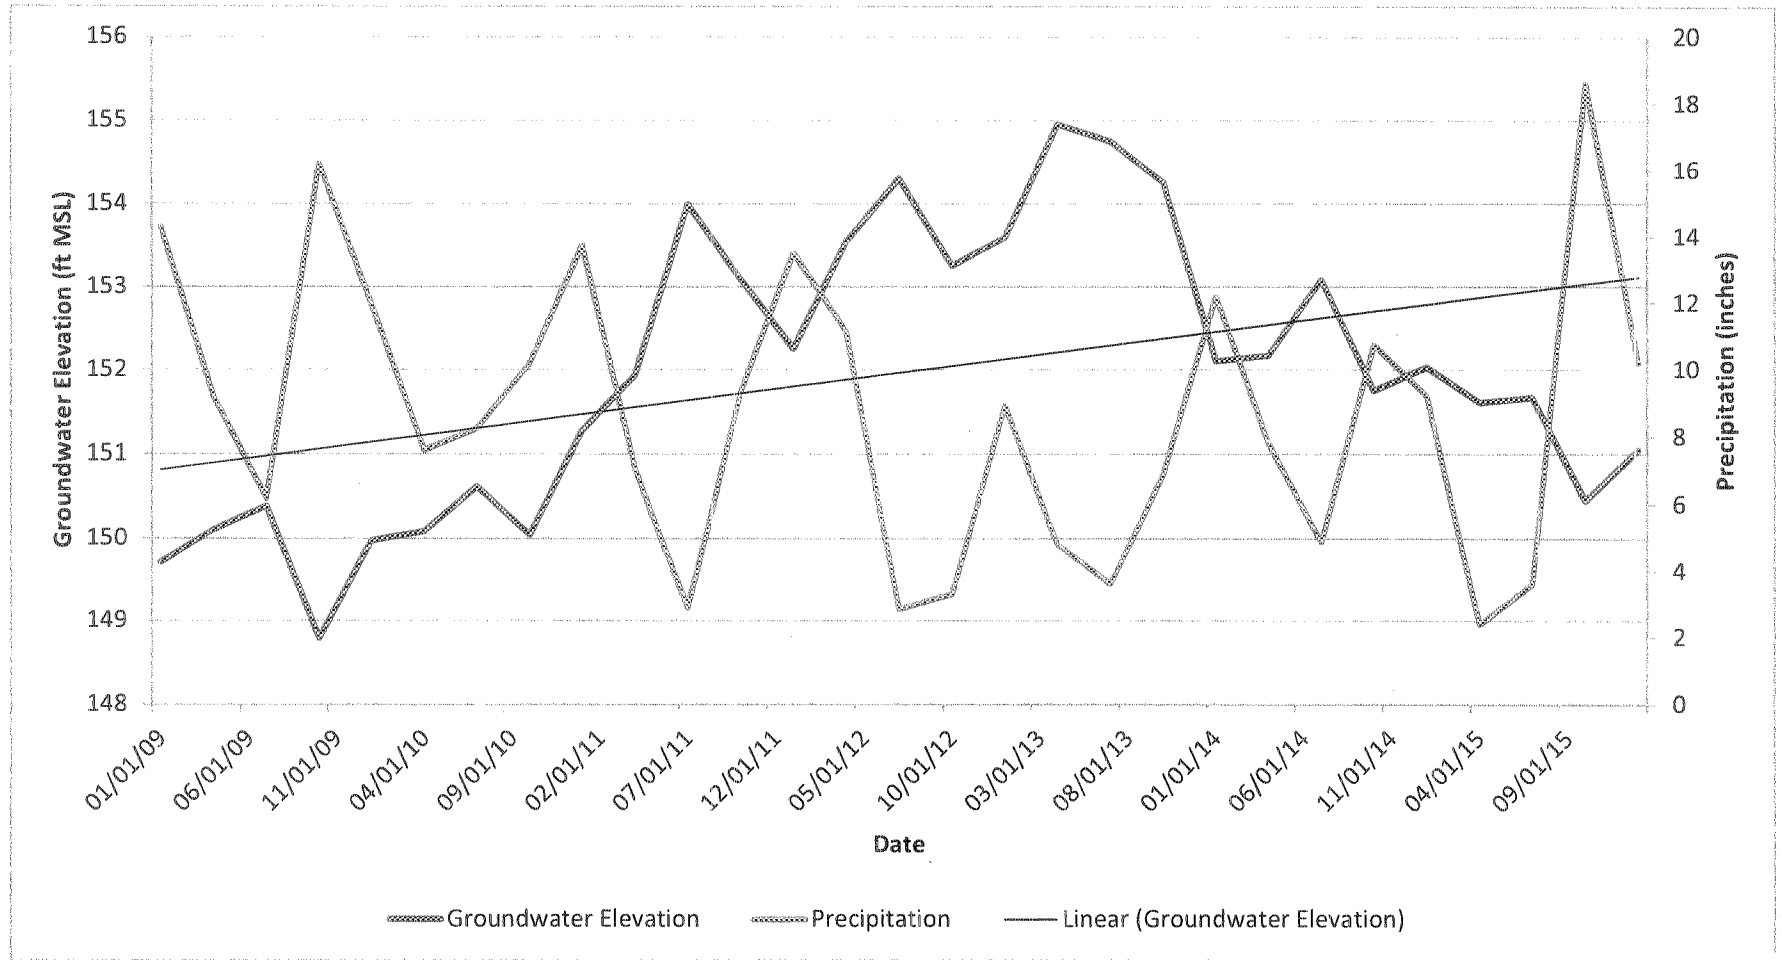
Hydrograph
Lake Goodwin Landfill
Well LG-05
